| 4. TITLE AND SUBTITLE Seismic behavior of grade 80 RC Bridge Columns – Phase 1 and critical bending strain of longitudinal reinforcement | | 5. REPORT DATE June 2018 |

Constructed Facilities Laboratory

Research Report

No. RD-18-02

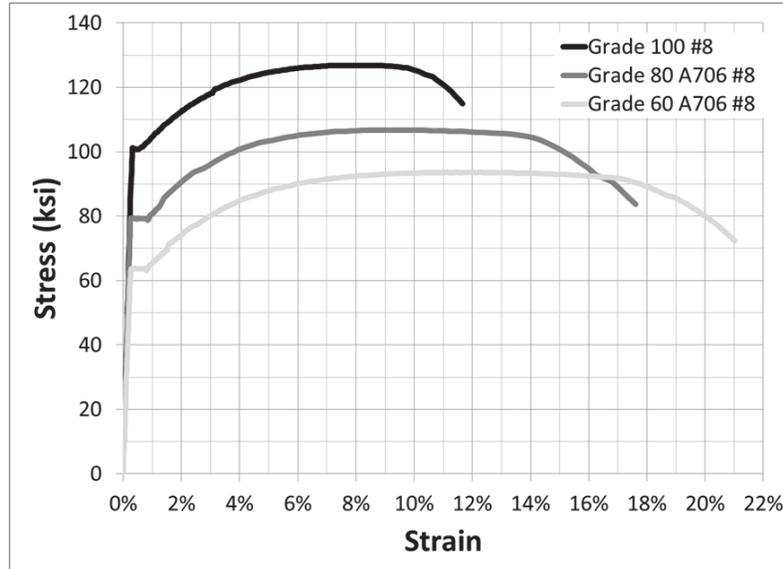
Figure 2-1. Comparison of stress-strain curves (Slavin and Ghannoum, 2015)

Additionally, reinforcement with a higher yield strength was shown to have decreased deformation capacities and lower strains at ultimate strength, as seen in Figure 2-1.

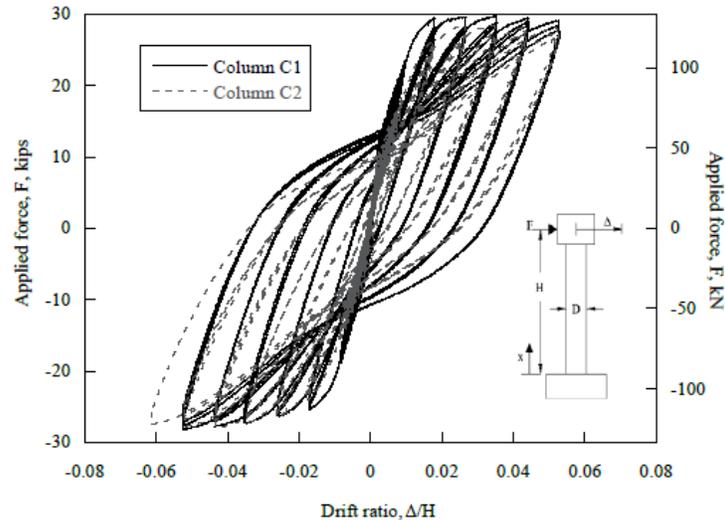
Figure 2-2. Force-displacement response of column C1 of Grade 60) vs. column C2 of Grade 80 (Trejo et al., 2014)

fact that column C1 dissipated more energy (193 kip-ft versus 150 kip-ft at failure as seen in Figure 2-2). The other column pairs had similar displacements at bar fracture, as well as relative amounts of energy dissipation.

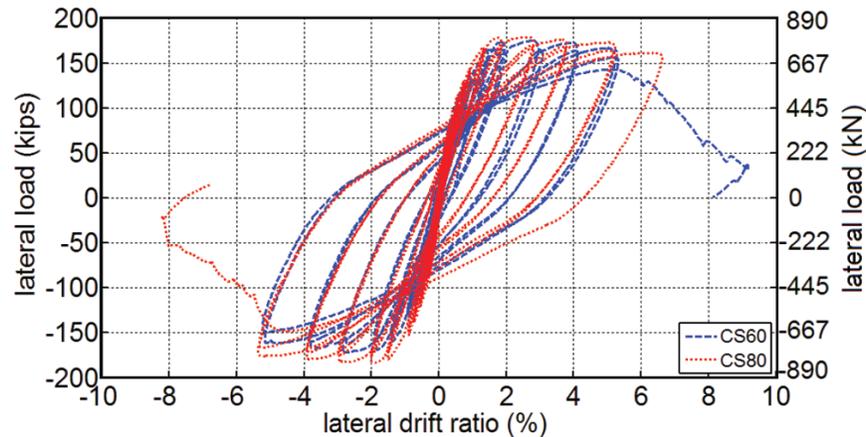
Figure 2-3. Force-displacement response for Grade 60 and 80 columns (Sokoli and Ghannoum, 2016)

Figure 2-3 shows the lateral load versus lateral drift ratio for the Grade 60 and 80 columns. As observed in the Trejo et al. (2014) tests, the force-displacement response of the columns with Grade 60 rebar was slightly “fatter” than that of the Grade 80 rebar, signifying an increase in the hysteretic energy dissipation capacity for the columns reinforced with a larger amount of lower grade rebar. In conclusion, the authors found that the Grade 80 reinforcement was effective at producing the shear transfer necessary for concrete columns under lateral loads, and Grade 80 performed similarly to Grade 60.

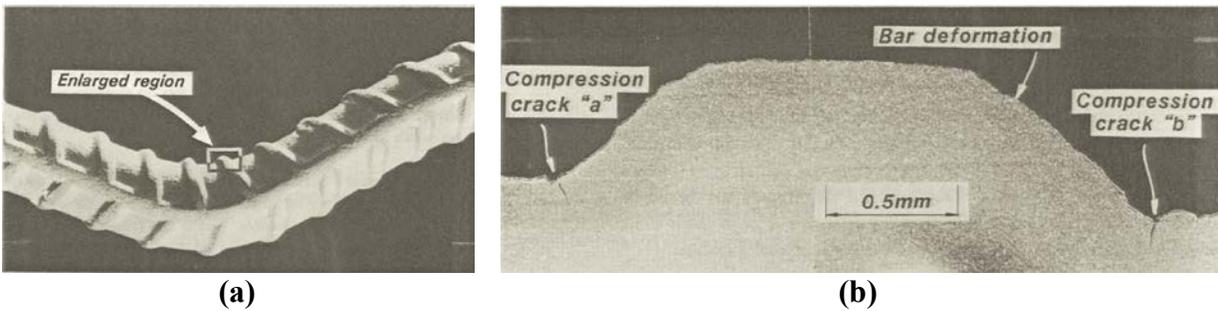
Figure 2-4. (a) Buckled bar; (b) Cracks at base of rebar rib (Restrepo-Posada, 1992)

microscope, as seen in Figure 2-4. The “compression cracks” compromise the tensile capacity of the bar, leading to premature fracture under tensile loads. While Figure 2-4 seems to indicate that the material has cracked under a compressive stress, due to the presence of the rib, the local stress is likely in a state of shear stress at the base of these ribs (Restrepo, 2018, personal communication). High shearing stresses likely weaken the material so that when the compressive load is relaxed, the cracks easily propagate through the affected region.

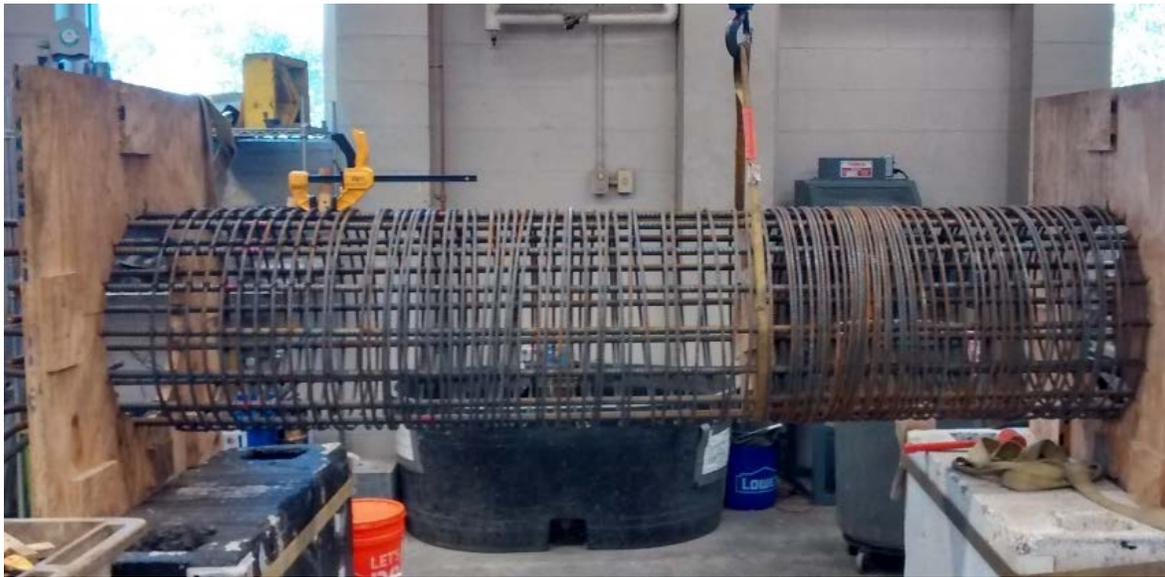
Figure 3-3. Tying column cage

The reinforcement cage of the column was constructed in the lab using plywood forms and a crane to ensure accurate longitudinal bar placement and a straight column cage. The transverse reinforcing steel (spirals) was attached to the longitudinal reinforcing steel with loop ties while wood spacers and clamps maintained a consistent spiral spacing, as seen in Figure 3-3.

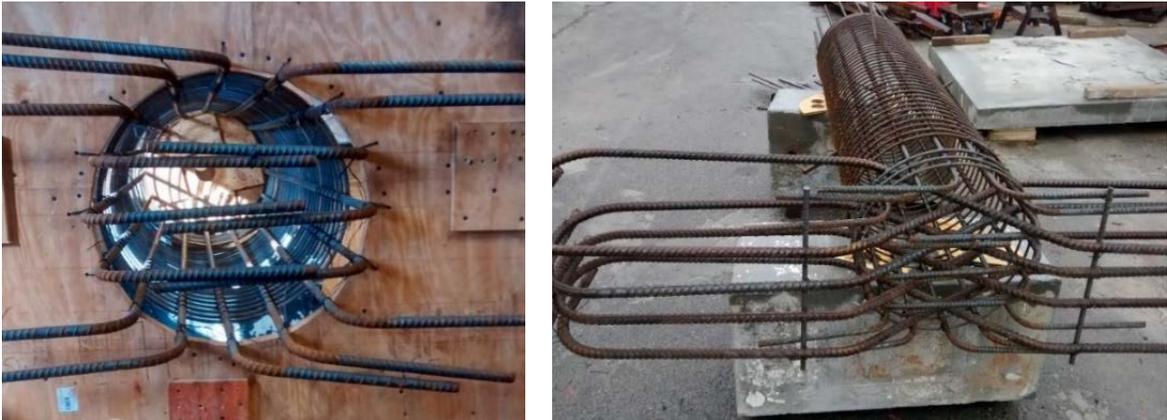
(a) (b)
Figure 3-4. (a) Column longitudinal bar tails; (b) Footing “Z” bars and column cage

The column longitudinal bars were bent to 90° to allow for adequate development. The tails of the bars closest to the extreme fibers of the column turned inward in order to enhance joint shear performance, while the other tails turned outward to improve column stability, seen in Figure 3-4(a). Figure 3-4(b) shows footing longitudinal “Z” bars tied to the bottom of the column cage and individual spirals added to the column longitudinal bars inside the footing.

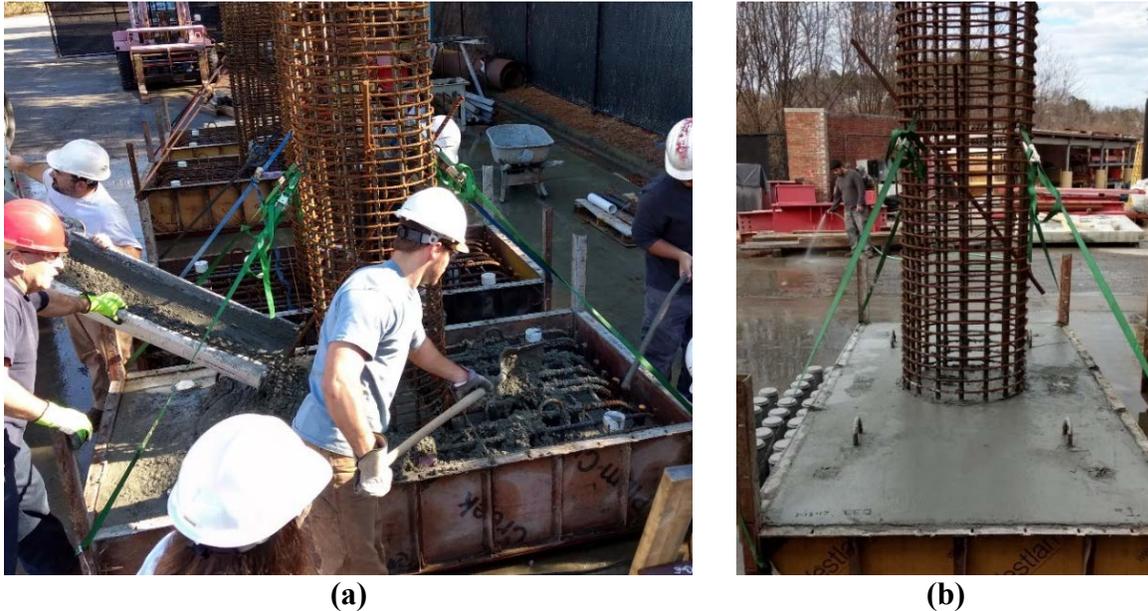
Figure 3-6. (a) Pouring footing concrete; (b) Footing concrete setting

Steel-ply formwork was used for the footing formwork and PVC pipes were added to the formwork in the locations where the specimen would be tied down to the strong floor. In addition, foam block-outs were placed on each side of the column where post-tension bars would be used to apply column axial load. Figure 3-5(a) shows the footing formwork. The column cage was then placed in steel-ply formwork and additional footing rebar was added, as seen in Figure 3-5(b). Figure 3-6(a) shows casting the footing concrete, and Figure 3-6(b) shows the column cage centered and leveled with ratchet straps as the footing concrete sets.

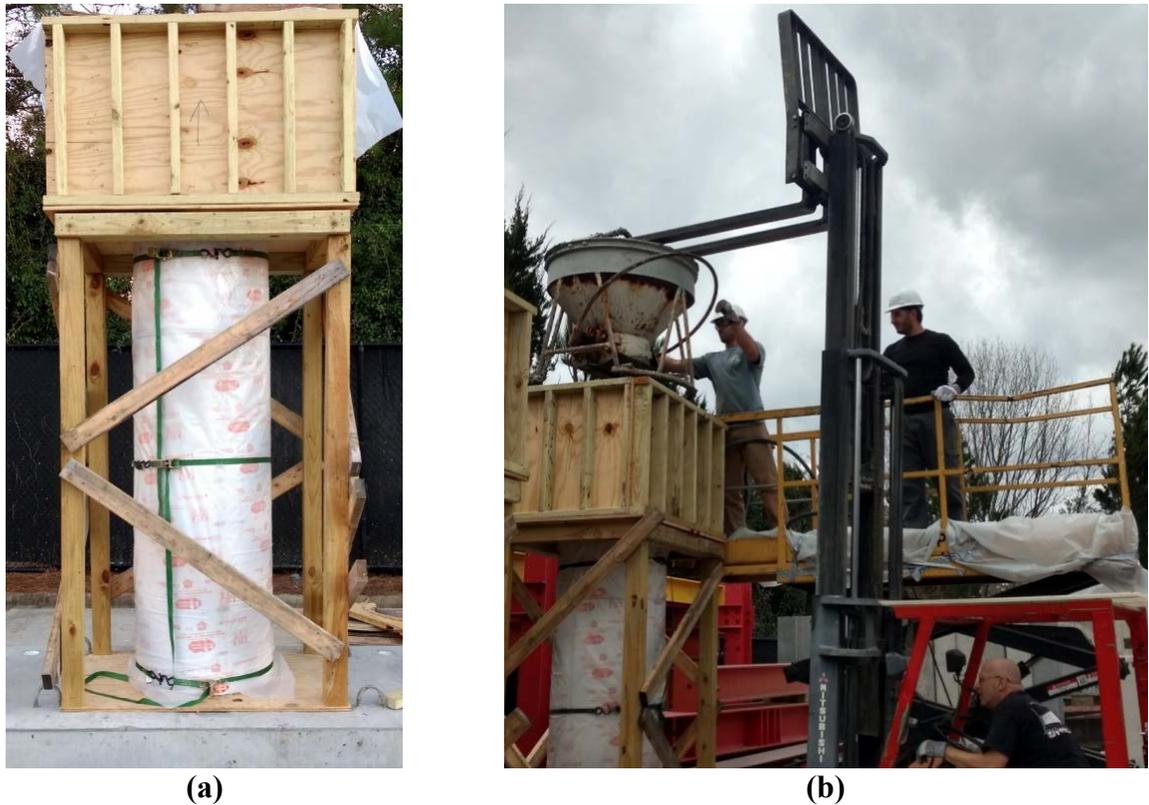
(a) (b)
Figure 3-9. (a) Column formwork; (b) Pouring column concrete

prevent the Sonotube from bursting. A forklift lifted a concrete skip to cast concrete in the column and loading cap, seen in Figure 3-9(b).

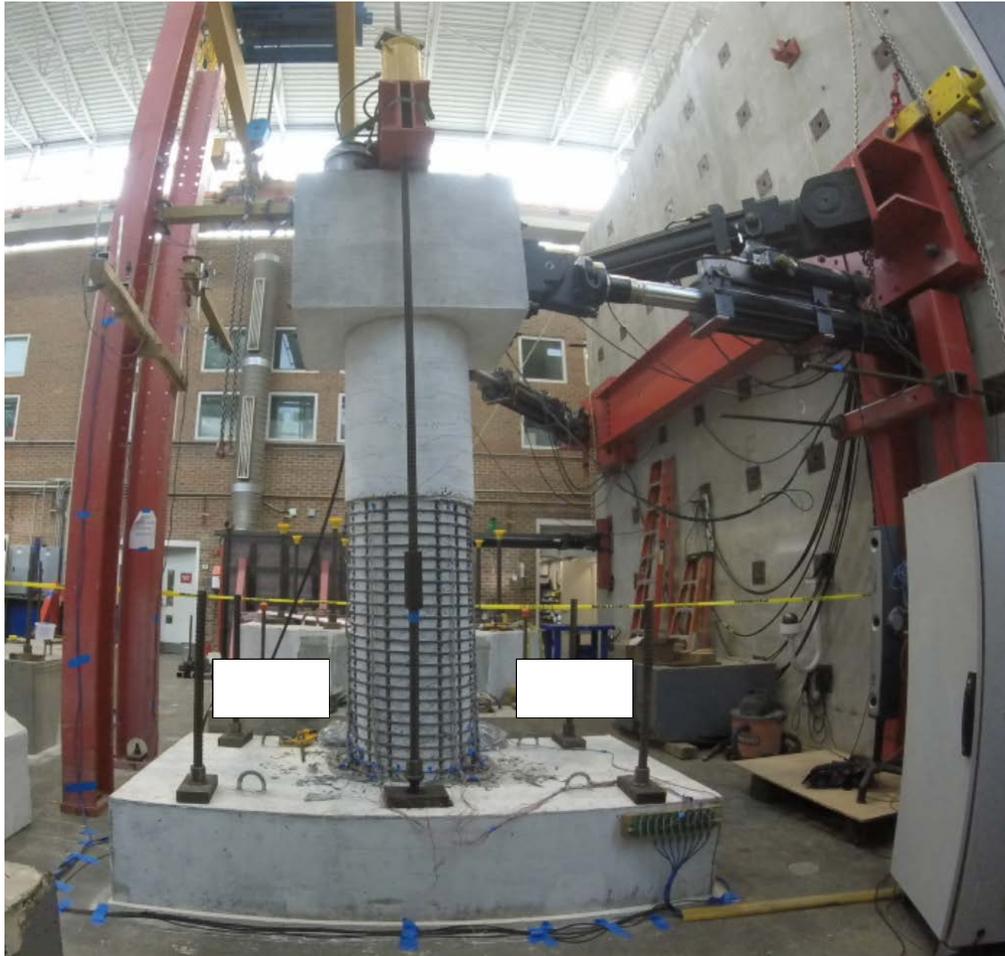
Figure 3-14. Actual test setup

A 110-kip hydraulic actuator applied lateral load to the specimen. However, due to laboratory space restraints, the actuator could not be attached directly to the strong wall. Two HSS 12x8x $\frac{1}{2}$ tubes were connected to the strong wall with an HSS 4x4x $\frac{1}{2}$ and two PT bars, each with approximately 70 kips of force. When the actuator loaded the specimen in the push cycles, it would bear on the strong wall through a 1.5" plate and two smaller HSS tubes. The HSS 12x8 tubes acted as cantilevers when the actuator pulled the specimen and the force was translated to the strong wall with the PT bars. Figure 3-12(b) shows the PT bars holding the HSS tubes in the test setup. Figure 3-13 shows a conceptual render of the test setup, and Figure 3-14 shows a picture of the final test setup. For reference throughout this report, the side of the column closest to the actuator will be referred to as the South, and the opposite as the North, as indicated in Figure 3-14.

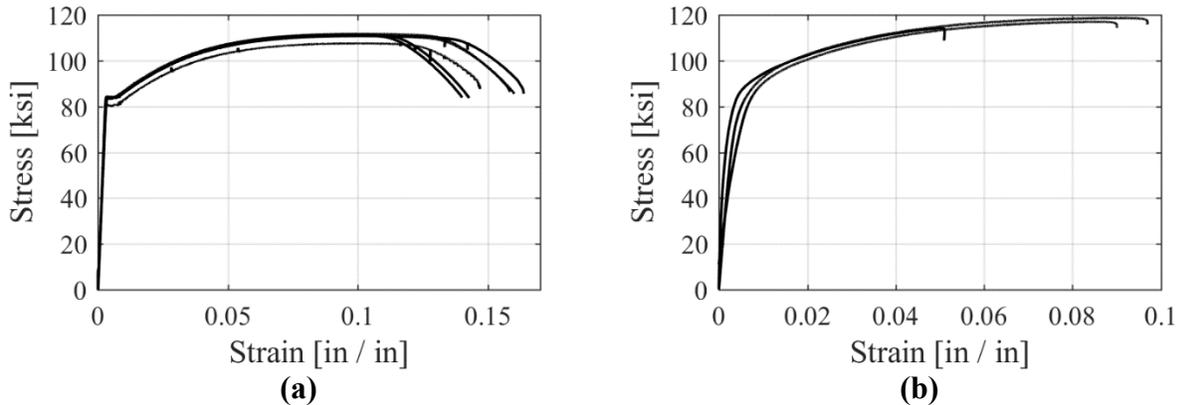
Figure 4-1. (a) Longitudinal steel stress-strain. (b) Transverse steel stress-strain curve

Tensile tests were performed on the longitudinal and transverse reinforcement per ASTM A370. Figure 4-1 shows plots of the stress vs. strain curve for each material and Table 4-2 includes numerical results. The rebar used to construct each specimen came from the same production heat from the same mill; reinforcement properties remained the same in each test. Spiral stress-strain curves in Figure 4-1(b) are slightly different because the spirals were manually straightened in order to conduct materials tests. Cold working affects the material behavior by removing the yield plateau and decreasing strain capacity.

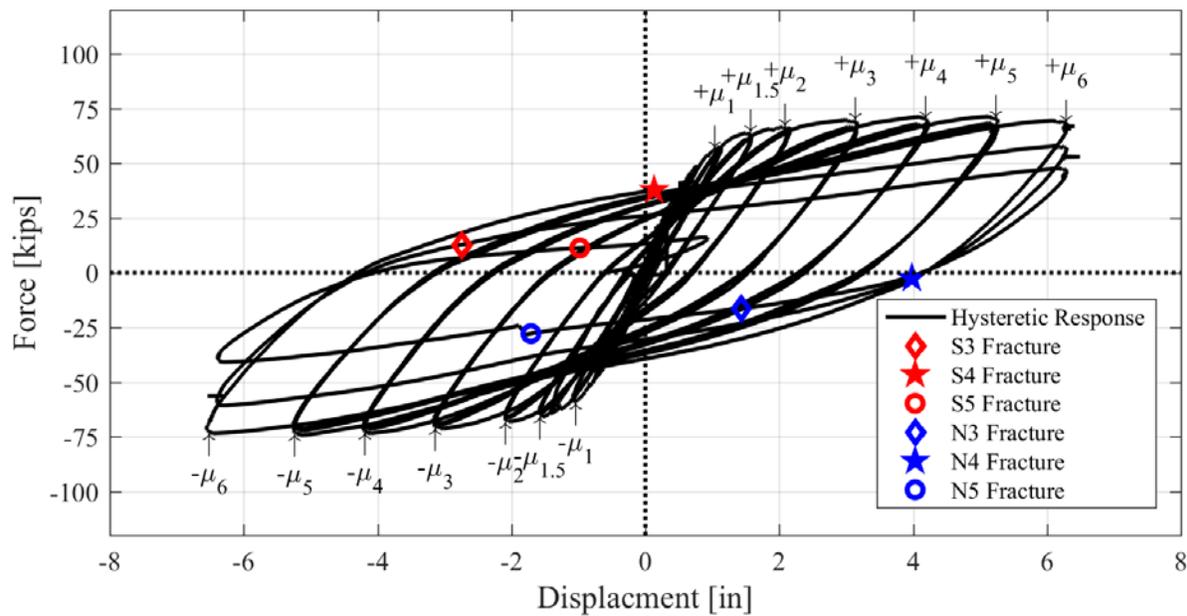
Figure 4-2. Column test 1 force-displacement response with rebar fracture locations

Figure 4-2 displays a plot of the force-displacement response along with a progression of longitudinal reinforcement fractures. Figure 4-3(a) shows the load history for this test, along with similar markings for rebar fracture and two other damage limit states. Figure 4-3(b) displays the bar-labeling scheme. As seen below, the column experiences failure when the longitudinal bars fracture, significantly reducing the lateral load-carrying capacity. Each bar fractures on the loading cycle subsequent to bar buckling.

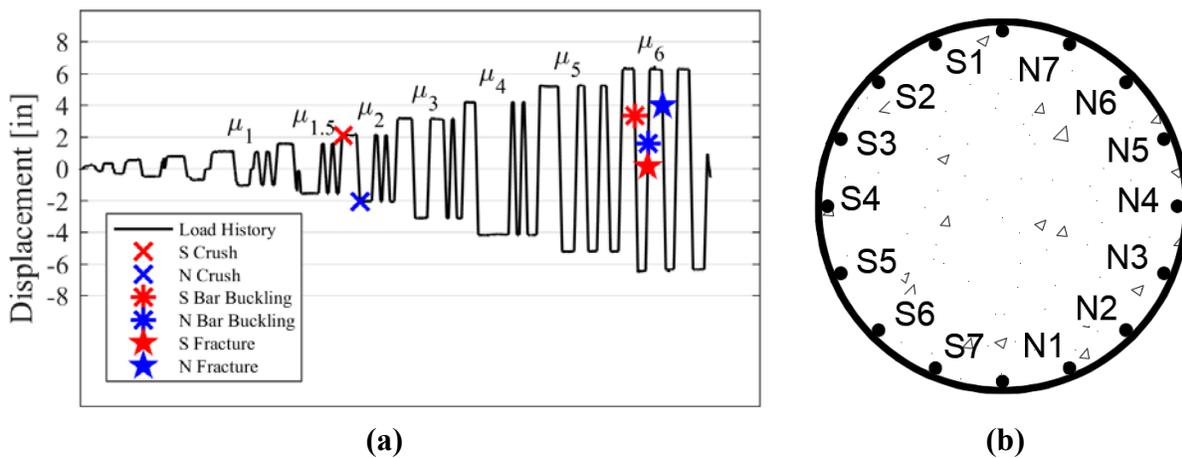
Figure 4-3. (a) Test 1 load history. (b) Test 1 bar labels

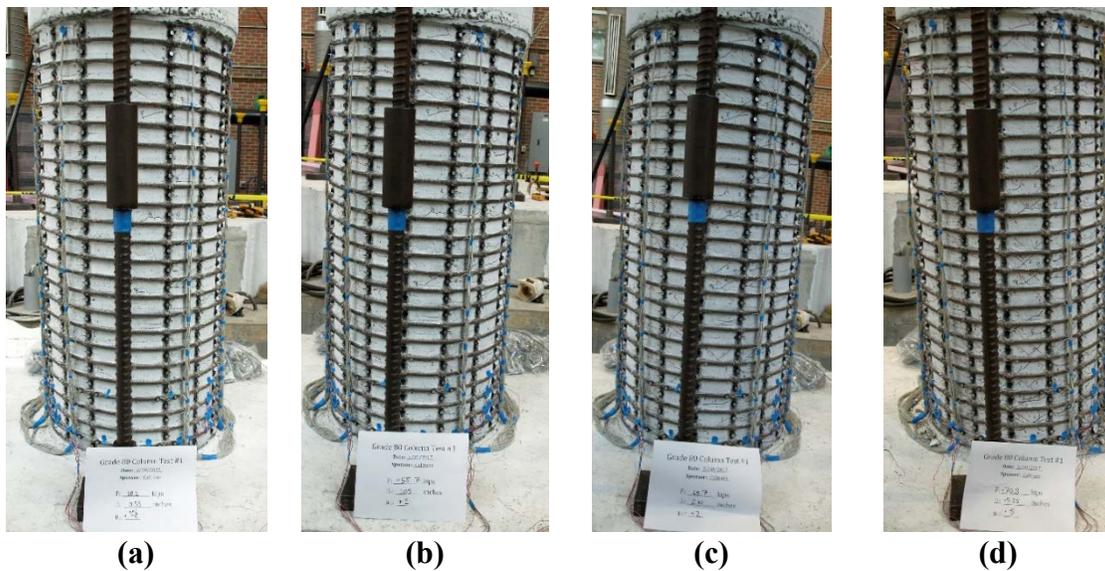
Figure 4-4. Crack pattern after (a) $+ \frac{3}{4} F_y$, (b) $+\mu_1$, (c) $+\mu_2$, (d) $+\mu_5$

Several pictures showing the damage progression over the course of the test are included below. Cracks were marked with black and red markers: black represents the cracks that occurred on the push cycles and red the cracks on the pull cycles. Figure 4-4 shows that cracks developed in a fan pattern throughout the plastic hinge region.

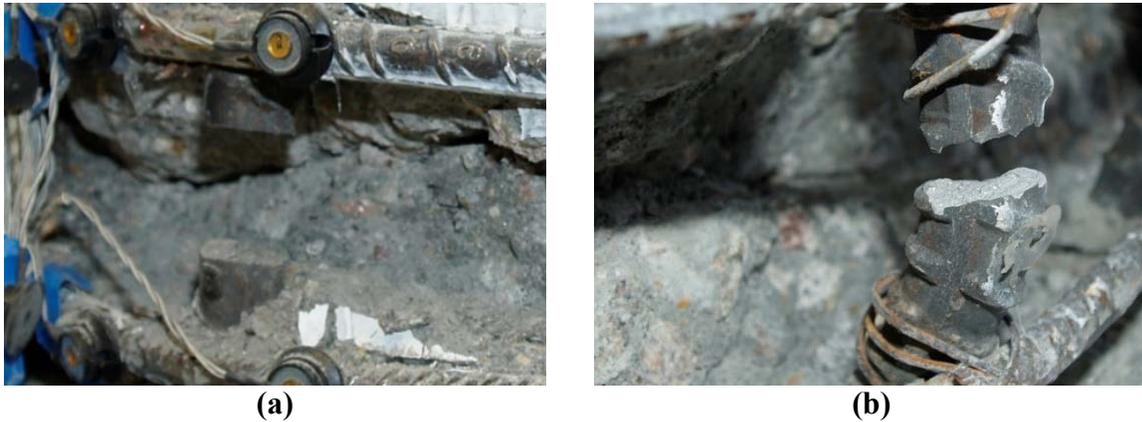
Figure 4-5. (a) Flat bar fracture surface (S4); (b) Uneven bar fracture surface (N4)

During the test, the reinforcement fractured in two different ways. Bars S4 and N5 experienced sudden rupture, which generated a large amount of energy (loud “pop”) and a relatively flat fracture surface, as seen in Figure 4-5(a). The other bars fractured after several quiet “pops,” and the fracture surface was flat on the inside of the buckle and jagged on the other half, as seen in Figure 4-5(b). The cause of this will be discussed later in the report.

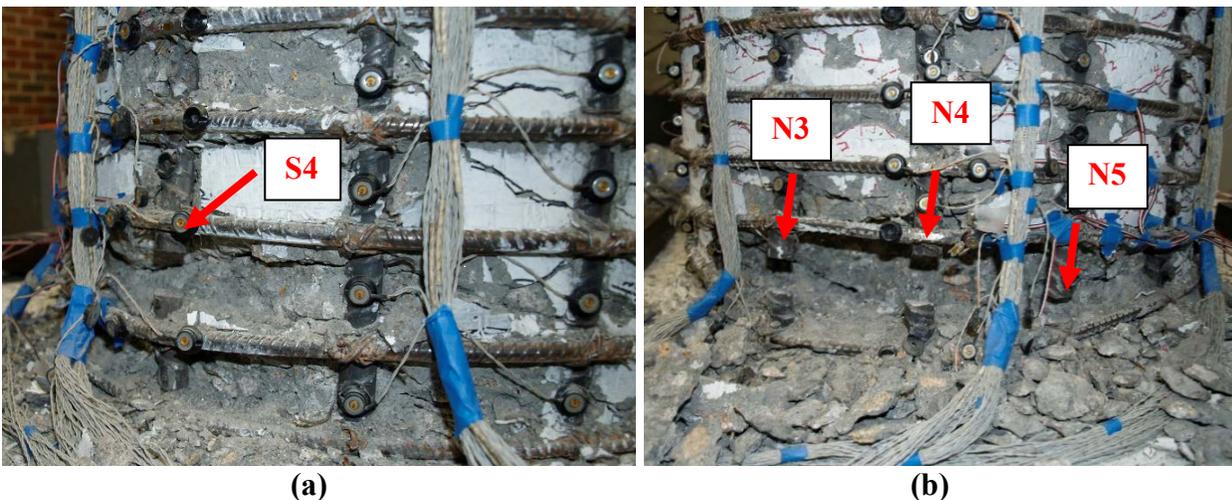
Figure 4-6. Fractured longitudinal bars: (a) S4, (b) N3, N4, and N5

The two pictures in Figure 4-6 show the ultimate limit state. On the left, bar S4 has fractured, and on the right, three of the bars on the north face have fractured. It is evident from both pictures that the spirals are no longer providing confinement to the longitudinal bars to prevent bar buckling. There is also significant crushing of the core concrete.

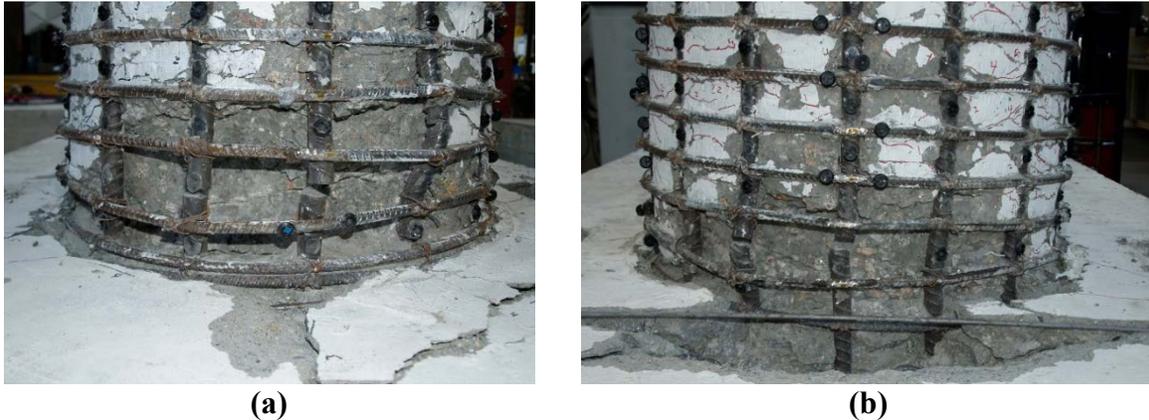
Figure 4-7. (a) South side final damage state; (b) North side final damage state

After the test was completed, the loose concrete was chipped away in order to see the damage on the reinforcing steel. Figure 4-7 shows the damage after the crushed concrete has been removed.

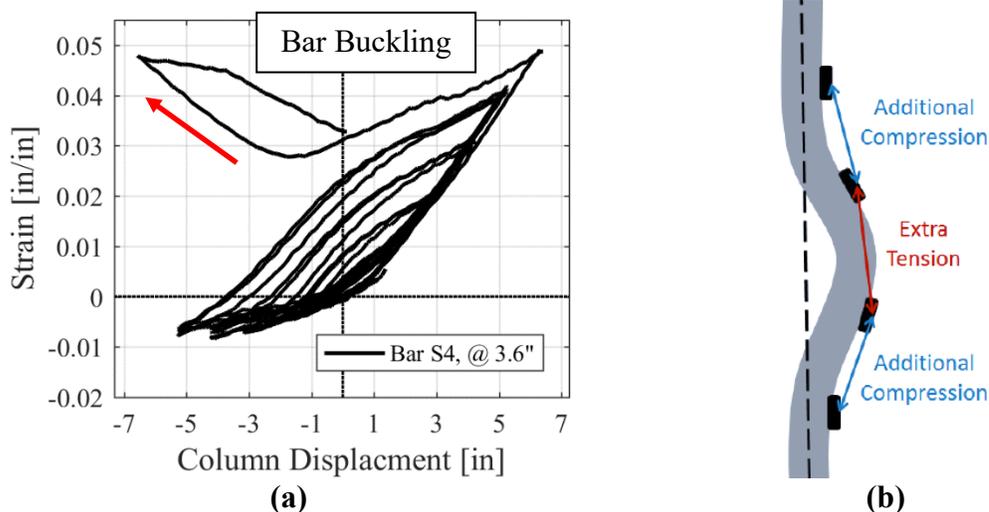
Figure 4-8. (a) Bar S4 strain vs. displacement; (b) Bar buckling animation (Goodnight et al. (2015))

Longitudinal bar buckling is a critical design limit state in reinforced concrete columns representing a level of damage that cannot be easily repaired. The optical measuring system provides a way to determine bar buckling. Figure 4-8(a) plots the strain in bar S4 versus the displacement at the top of the column. As the column is pushed from +6 inches to -6 inches, the longitudinal bar should be experiencing a compressive strain (negative). However, the instrumentation shows that the bar has positive strain. This positive strain is evidence of bar buckling, as shown in the animation in Figure 4-8(b), and corroborates the visual evidence of bar buckling.

By examining the 3D position of each LED marker throughout the duration of the test, strain levels in each of the instrumented longitudinal bars and transverse spirals was available until failure, as seen in Figure 3-11. Longitudinal bar strains on the North extreme face of the column reached 0.031 before buckling was observed. Bar N3 experienced the maximum tensile strain during the first pull cycle of ductility 4 (μ_4^{-}), which is seen in Figure 4-29(b), and on the reversal to μ_4^{+} , the first sign of buckling was observed, shown in Figure 4-29(a). Through visual observation, buckling was difficult to detect because much of the core concrete was still intact, but buckling was observed by examining the strain vs. displacement data of different locations along the longitudinal bar, as shown in Figure 4-8(b).

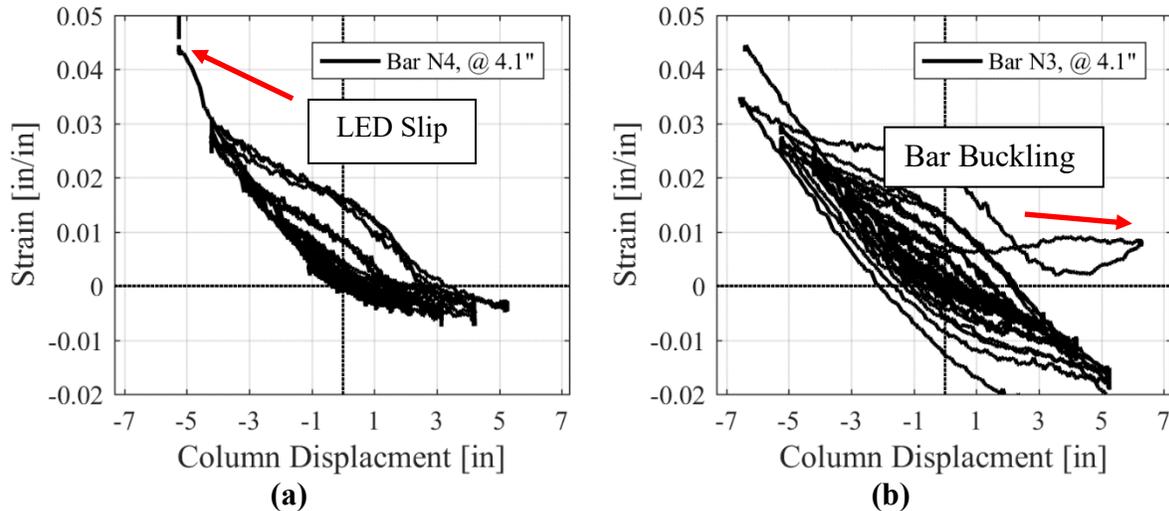
Figure 4-9. (a) Bar N4 strain vs. displacement; (b) N3 strain vs. displacement

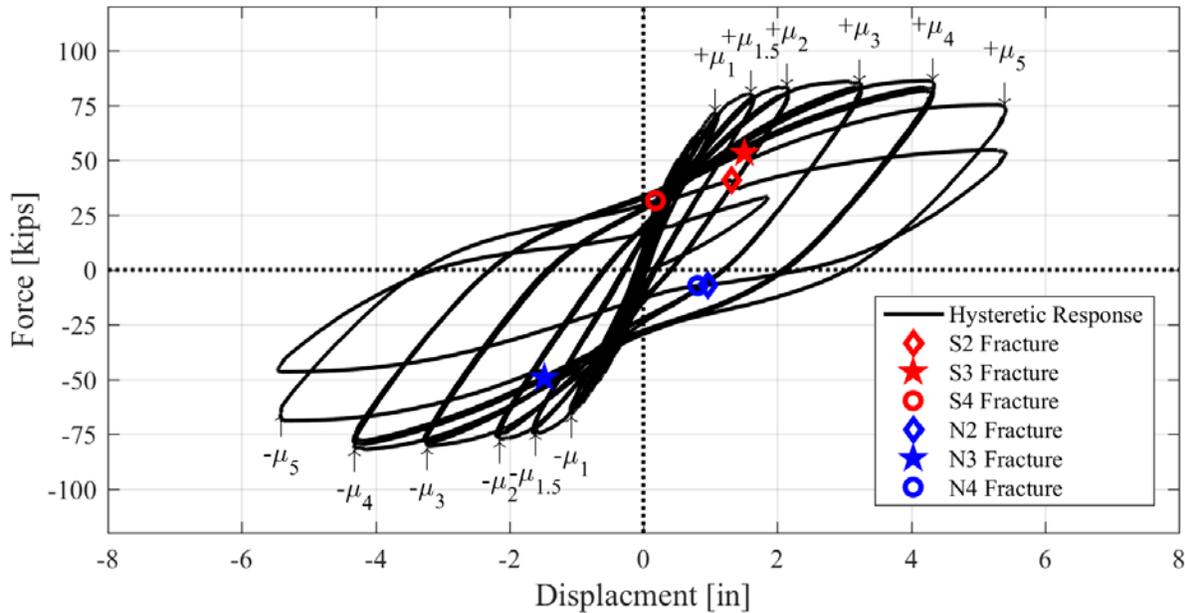
Figure 4-21. Column test 2 force-displacement response with rebar fracture locations

similar markings for rebar fracture and two other damage limit states (core crushing and longitudinal bar buckling). Figure 4-22(b) displays the bar labeling scheme. As seen below, the column experiences failure when the longitudinal bars fracture, significantly reducing the lateral load carrying capacity.

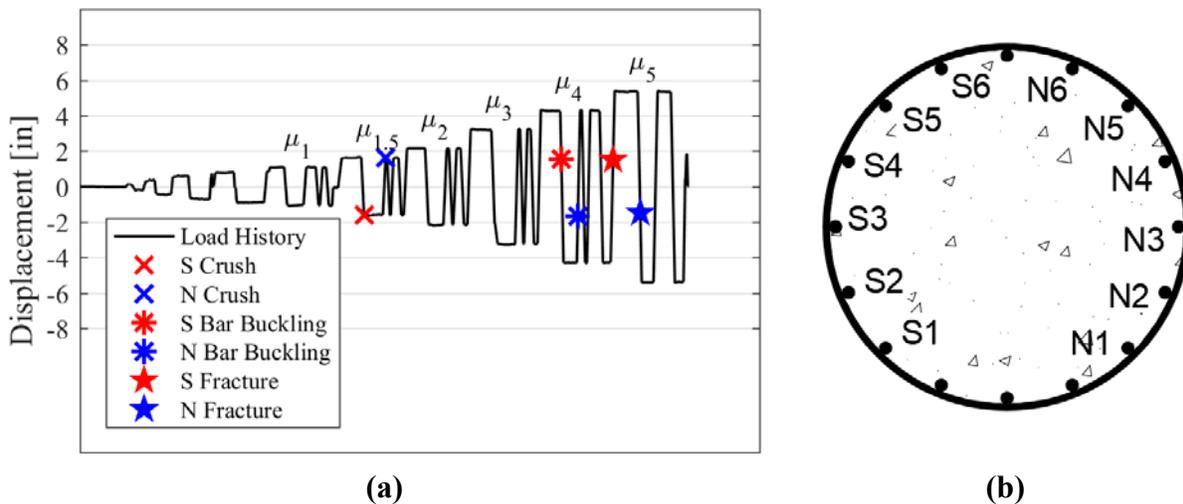
Figure 4-22. (a) Column test 2 load history. (b) Column test 2 bar labels

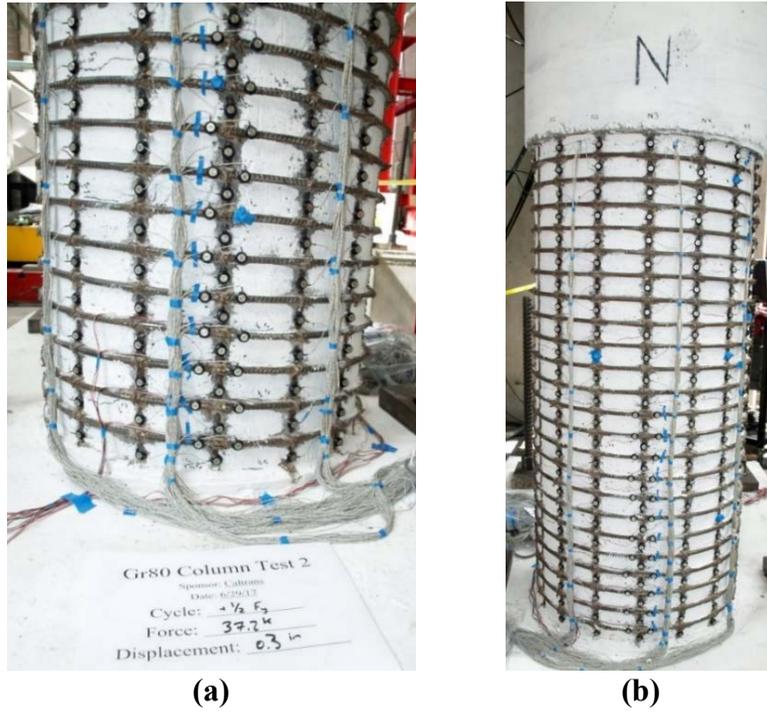
Figure 4-23. (a) First cracking on South, $\frac{1}{2} F_y$; (b) First cracking on North, $-\frac{1}{4} F_y$

Damage occurred in a relatively uniform manner on the North and South sides of the column. Horizontal hairline cracks developed on the extreme faces of the column in the initial pre-yield cycles of the loading history. At half of the yield force, the largest crack widths measured 0.005 inches. At $\frac{3}{4}F_y$, diagonal cracks began to develop on the non-extreme face. These diagonal cracks began at roughly 30" above the footing-column interface. In addition to diagonal cracking, cracks on the footing-column interface began to form at this level, also. At the first cycle at equivalent yield displacement (μ_1), the maximum crack widths measured on the column were 0.01 inches wide. By the third cycle at ductility 1 (μ_1^{3+}), crack widths had grown to 0.016 inches. During $\mu_{1.5}^{1+}$, column concrete began to scale off the column, which was taken to be an indication of the beginning of core concrete crushing. In addition, a crack was observed in the footing perpendicular to the footing-column interface. Maximum crack widths at $\mu_{1.5}$ measured 0.025 inches. In μ_2 , maximum crack widths in the exposed core region of concrete grew to 0.04 inches. Horizontal cracks continued to develop on both of the extreme faces of the column. More diagonal cracks developed on the non-extreme faces and existing cracks spread down the sides of the column. By μ_3 , more cracks had developed in the column, concentrating in the lower third of the column. Cracking of the footing also became more significant, and observations showed the possibility of base rotation of the column. At μ_4 , cracks were concentrated in the bottom portion of the column; maximum crack widths exceeded 0.06 inches. In addition, visual evidence of longitudinal bar buckling was observed, which was examined further in the strain data available from the optical measuring system (Optotrak). Following bar buckling, bar fracture was observed in the extreme fiber bars on each side. These bars did not experience necking and their fracture surface was flat (Figure 4-28) similar to the fracture surface of bar S4 in the first column test (as seen in Figure 4-5(a)). Below are some of the pictures at different stages of damage throughout the test.

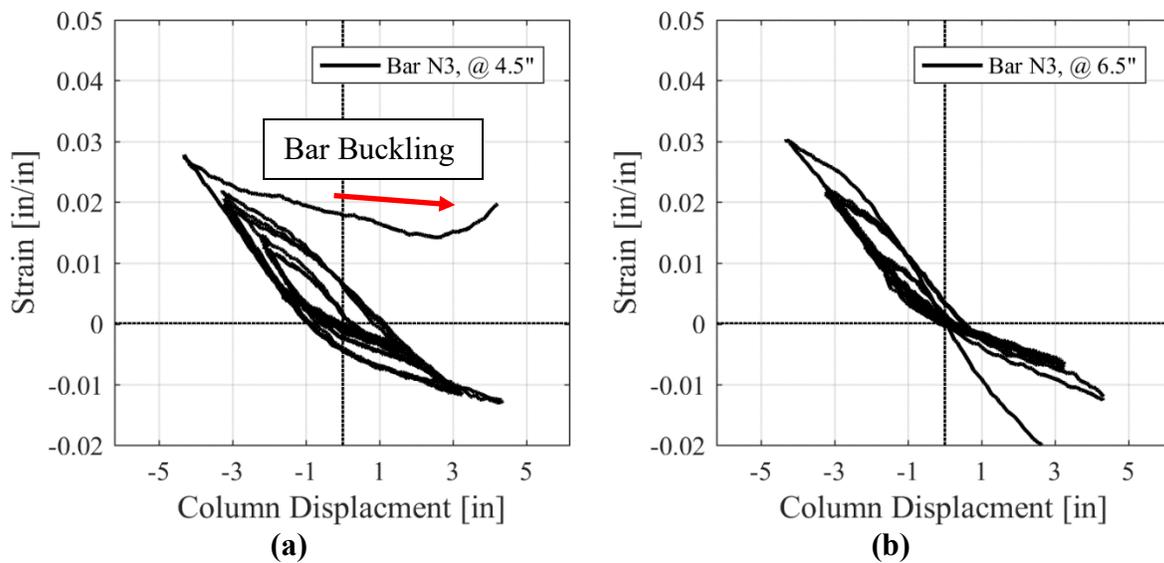
Figure 4-29. Bar N3 strain vs displacement: (a) at 4.5", (b) at 6.5" above footing

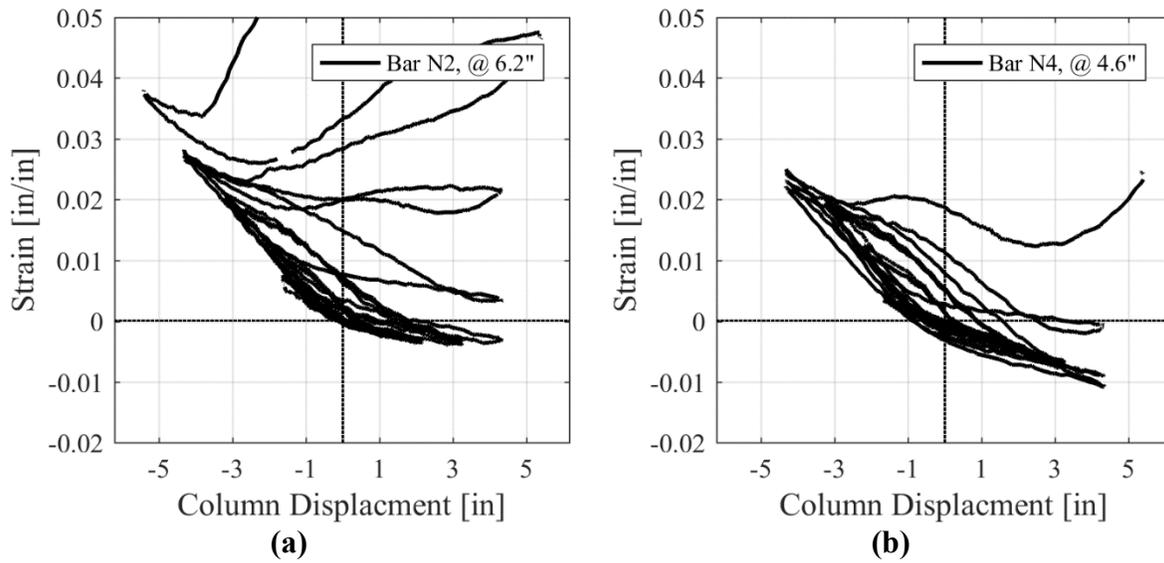
Figure 4-30. Strain vs displacement of (a) bar N2; (b) bar N4

As the extreme fiber bar (N3) buckled and fractured, the bars on either side (N2 & N4) experienced similar buckling at the third cycle of ductility 4 (N2) and the first cycle of ductility 5 (N4), as shown in Figure 4-30. As the extreme fiber longitudinal reinforcing bar buckles, the bar experiences a significant loss in stiffness. Thus, the compressive demands are transferred to the adjacent extreme fiber bars. Once the extreme fiber bar fractures, these bars experience a greater increase in compressive force and buckle more significantly.

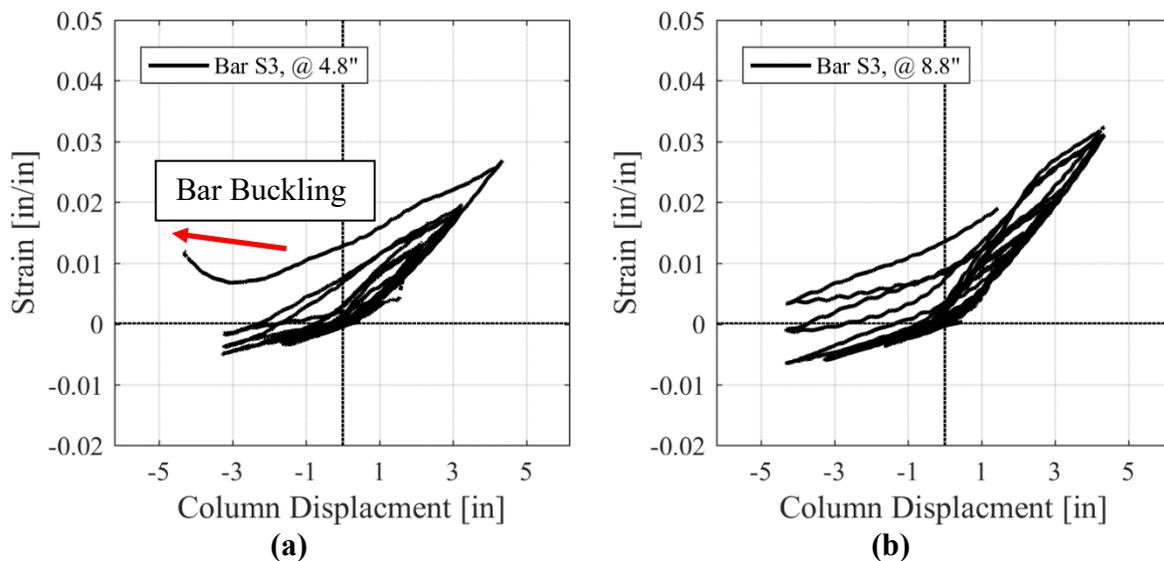
Figure 4-31. Bar S3 strain vs displacement: (a) 4.8" above footing; (b) 8.8" above footing

Similar behavior was seen on the South side. Maximum strains in the extreme fiber bar reached 0.031 before bar buckling was observed. Again, the point at which bar buckling was observed in the test was confirmed by the graph of the strain vs. peak column displacement as shown in Figure 4-31. Buckling was first seen at 4.8 inches above the footing in Figure 4-31(a). Maximum strain was observed at 8.8 inches above the footing in Figure 4-31(b). Similar

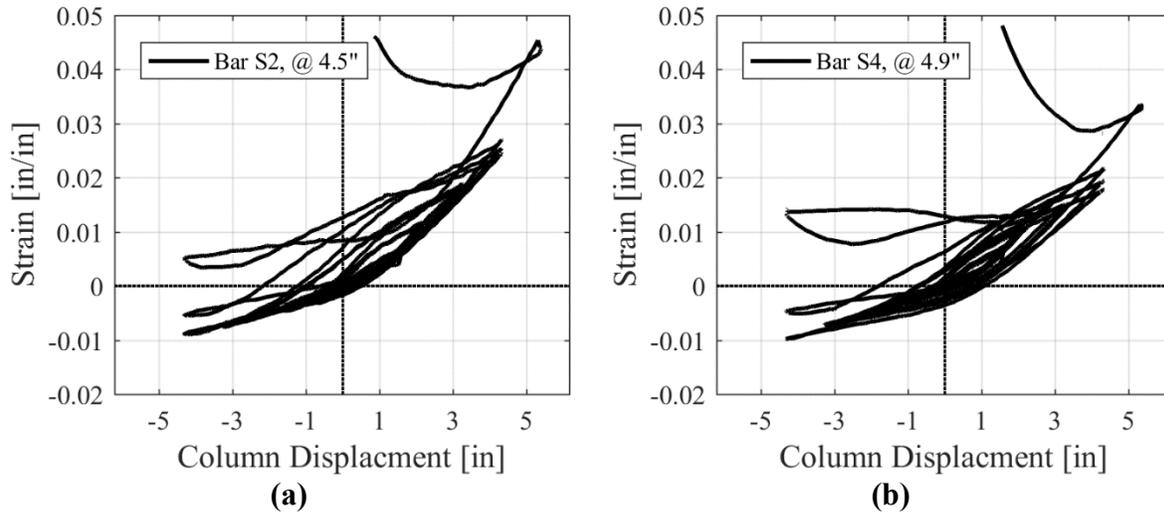
Figure 4-32. Strain vs displacement of (a) bar S2; (b) bar S4

Similar to the North side, as the extreme fiber bar (S3) buckled and fractured, the bars on either side (S2 & S4) experienced similar buckling during the first pull cycle of ductility 5, as shown in Figure 4-32.

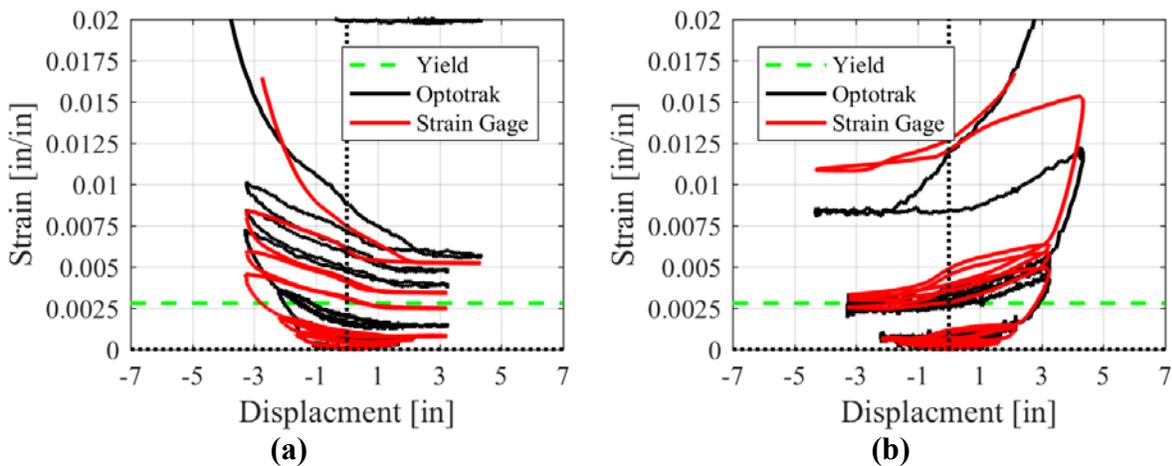
Figure 4-33. (a) Lowest south spiral strain vs. displacement; (b) North spiral (2nd) strain vs. displacement

Figure 4-33 shows the strains in the spiral that confines the plastic hinge region. These spirals were instrumented with a strain gage and Optotrak LED markers. The strain gages on both sides de-bond around tensile strains of 0.017. As the spiral yields, it provides less confinement to the longitudinal rebar, which causes the longitudinal bars to buckle.

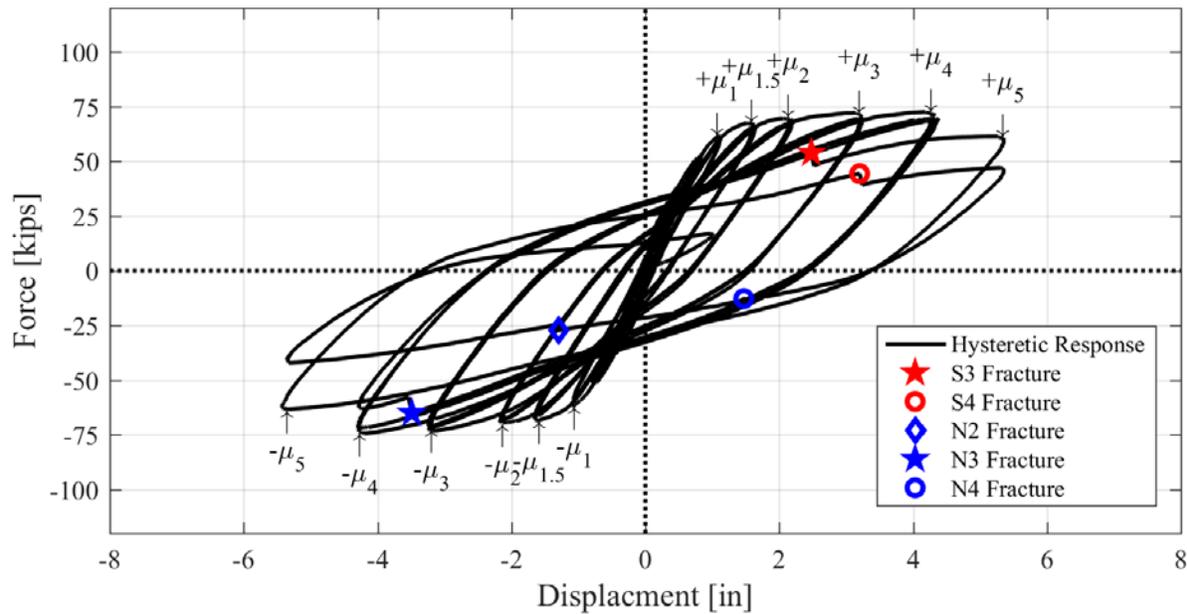
Figure 4-43. Column test 3 force-displacement response with rebar fracture locations

similar markings for rebar fracture and two other damage limit states. Figure 4-44(b) displays the bar labeling scheme. As seen below, the column experiences failure when the longitudinal bars fracture, which significantly reduces the lateral load capacity. Extreme fiber tensile reinforcement on the North side of the column fractures in the last cycle of μ_4 , but the lateral force capacity of the column does not drop below 80% of peak lateral force capacity, signifying that the column does not technically fail until μ_5 .

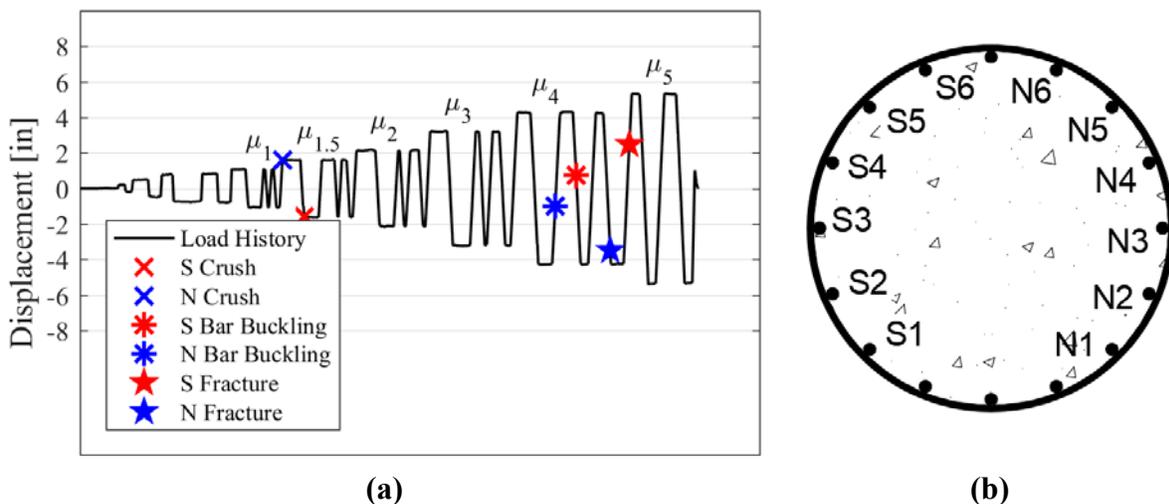
Figure 4-44. (a) Column test 3 load history. (b) Column test 3 bar labels

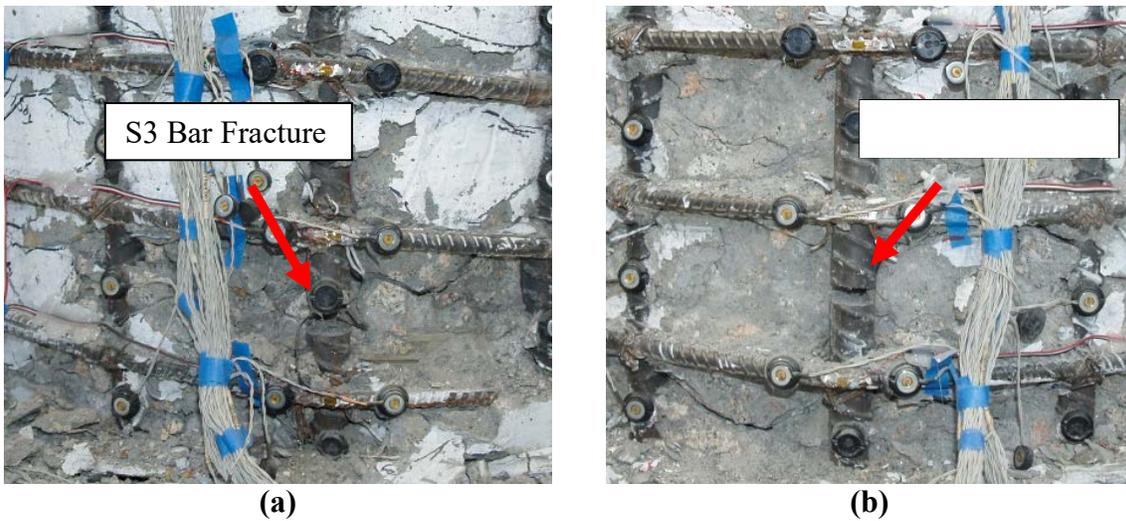
Figure 4-51. (a) South bar fracture (S3), μ_5^{1+} ; (b) North bar fracture (N3), μ_4^{3-}

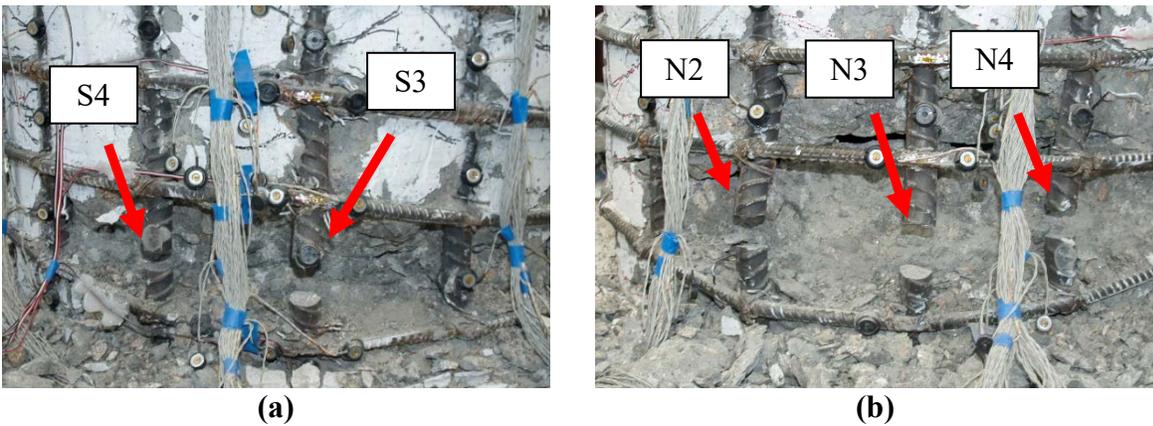
Figure 4-52. Final Damage State: (a) South side, μ_5^{2+} ; (b) North side, μ_5^{2-}

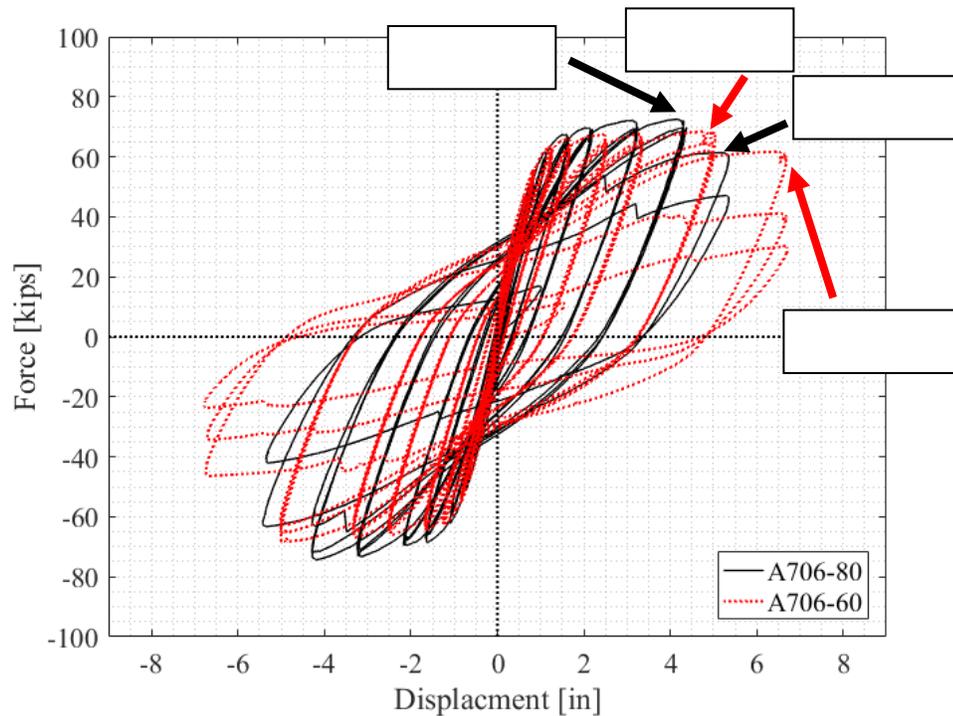
Figure 4-65. *Hysteretic response of Grade 80 Test 3 and comparison Grade 60 column*
