| 4. TITLE AND SUBTITLE Seismic behavior of grade 80 RC Bridge Columns – Phase 1 and critical bending strain of longitudinal reinforcement | | 5. REPORT DATE June 2018 |

Constructed Facilities Laboratory

Research Report

No. RD-18-02

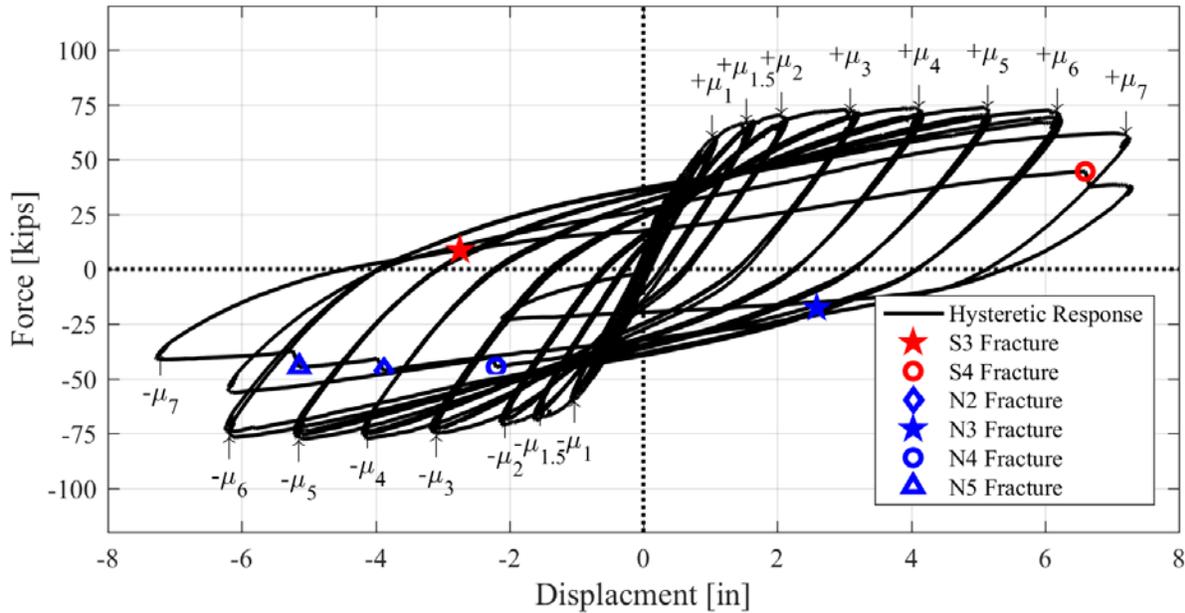
Figure 4-69. Column test 4 force-displacement response with rebar fracture locations

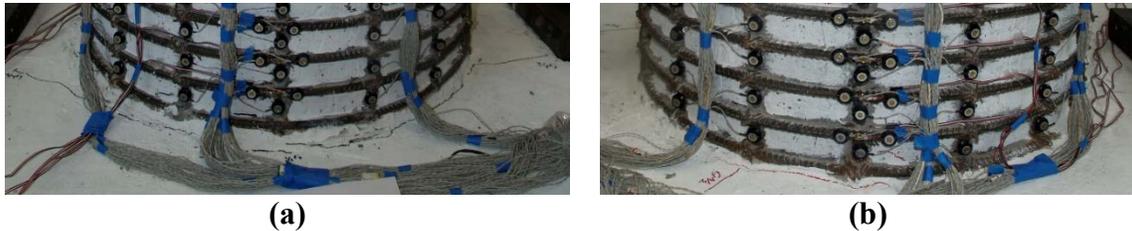
Figure 4-72. Footing Cracking: (a) F'_y on South; (b) $\frac{3}{4} F'_y$ on North

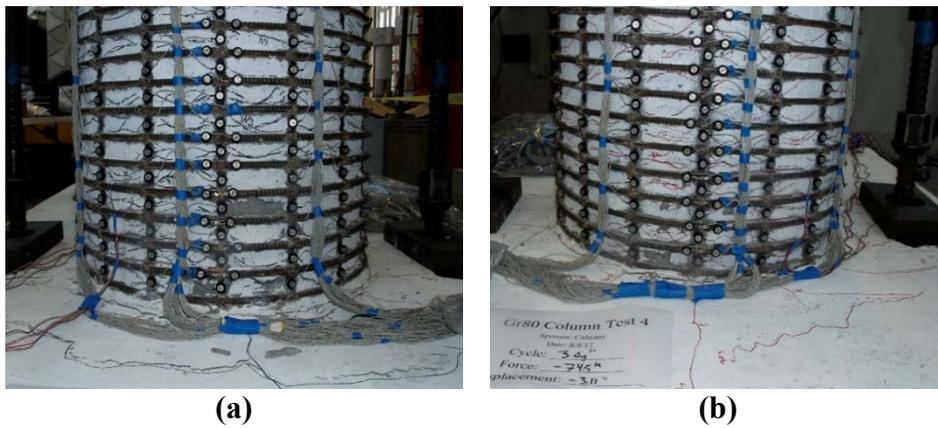
Figure 4-75. Onset of footing concrete "uplift": (a) South, μ_4^{1+} ; (b) North, μ_3^{1-}

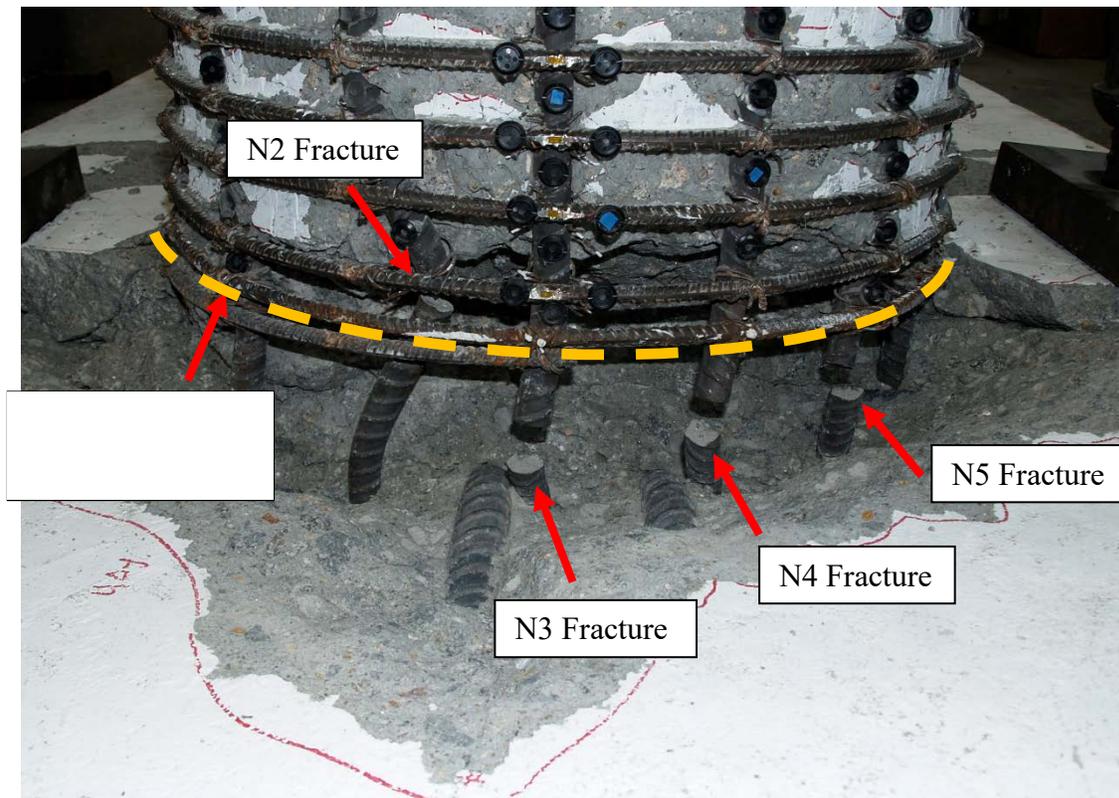
Figure 4-80. Rebar fracture locations on North side of Test 4 and original footing-column interface

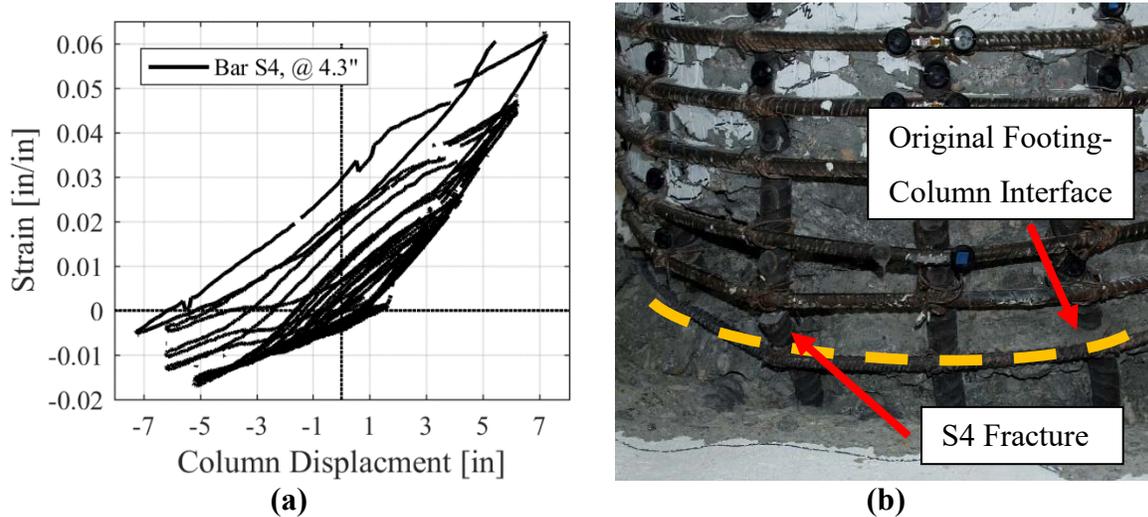
Figure 4-85. (a) Strain vs. displacement of bar S4; (b) Bar S4 after fracture

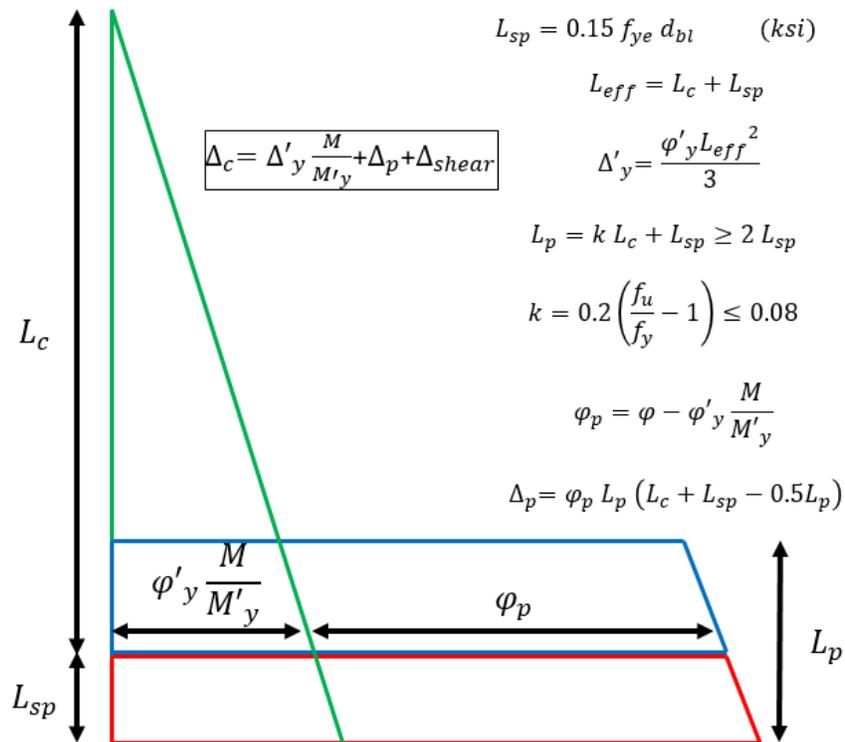
Figure 5-1. PCK plastic hinge method (Priestley, Calvi, and Kowalsky, 2007)

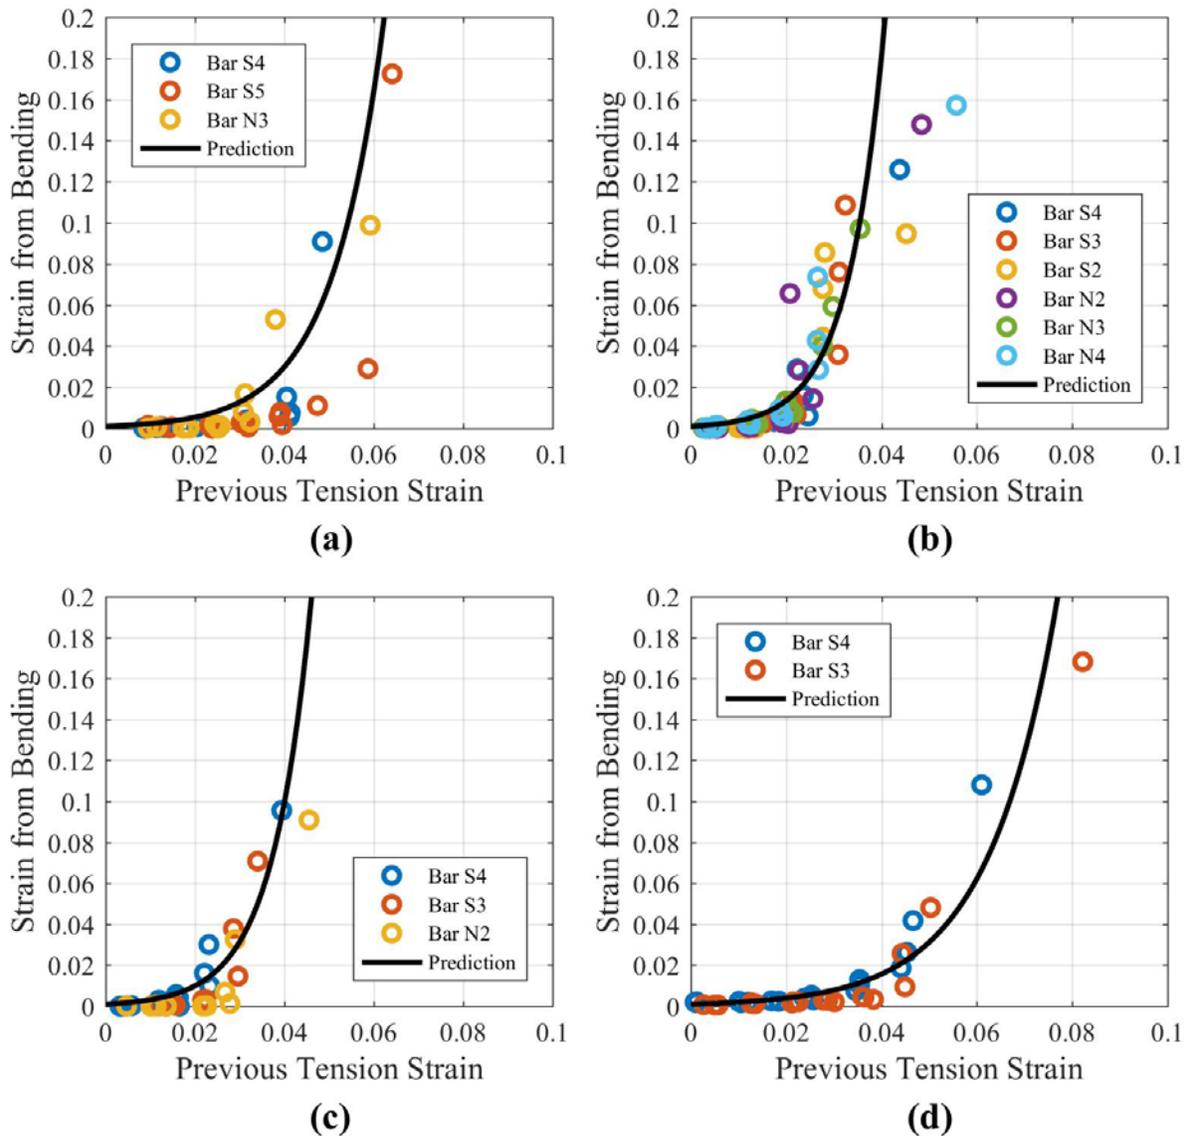
Figure 6-12. Uniaxial vs. bending strain for (a) Gr80 column test 1, $\rho_l = 1.6\%$, $\rho_t = 1.0\%$, ALR = 5%; (b) Gr80 column test 2, $\rho_l = 1.6\%$, $\rho_t = 1.0\%$, ALR = 10%; (c) Gr80 column test 3, $\rho_l = 1.6\%$, $\rho_t = 0.7\%$, ALR = 5%; (d) Gr80 column test 4, $\rho_l = 1.6\%$, $\rho_t = 1.3\%$, ALR = 5%

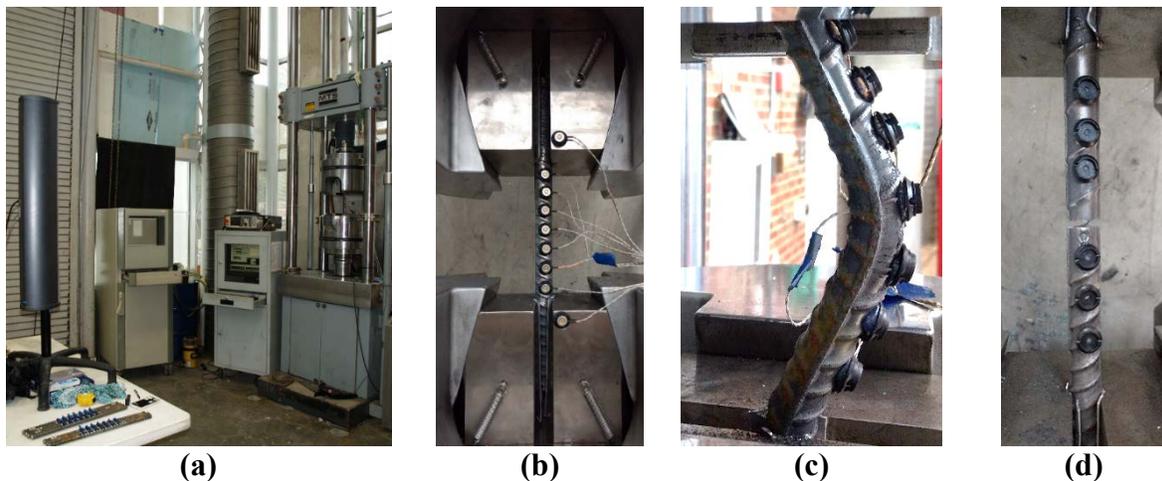
Figure 7-1. (a) BBT test setup; (b) Rebar specimen with optical markers; (c) Buckled specimen; (d) Fractured specimen

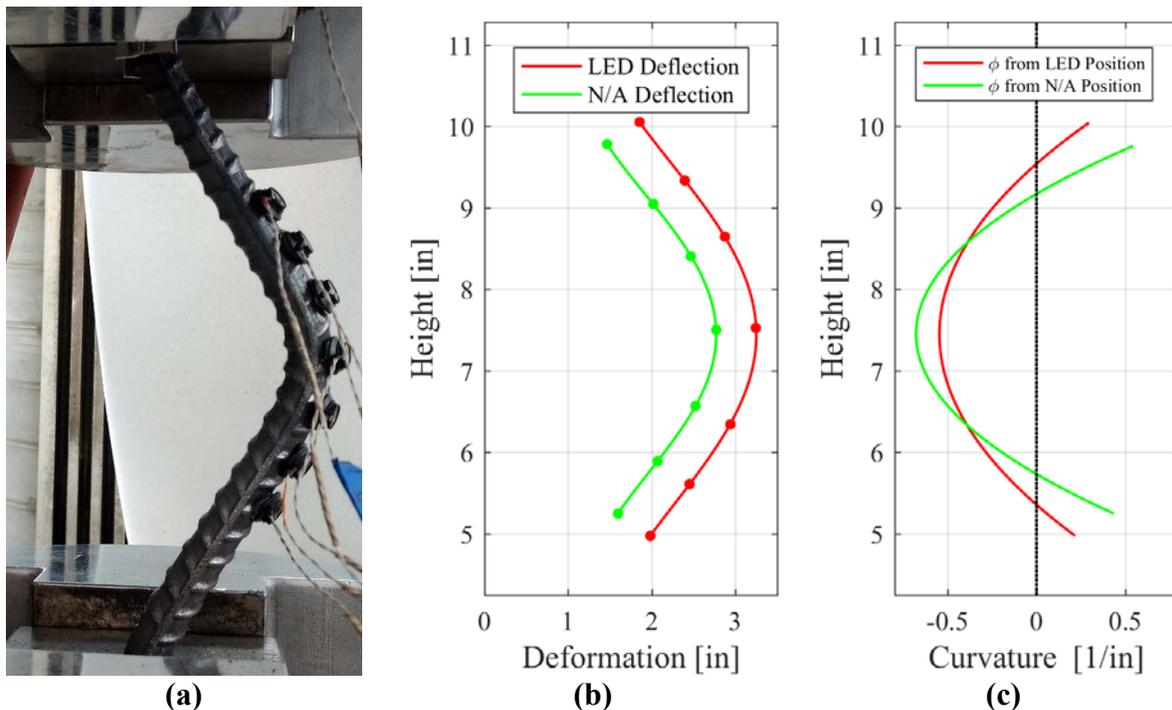
Figure 7-2. (a) Picture of buckled bar; (b) Position of optical markers and adjustment to neutral axis; (c) Calculation of curvature

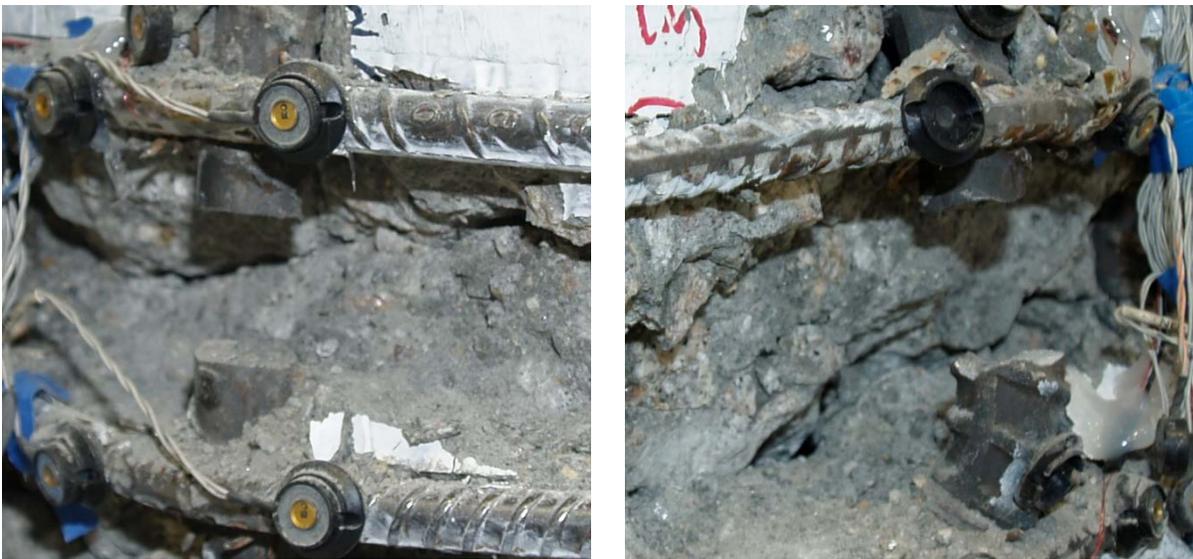
Figure 7-5. Column test bar fracture surfaces

In addition, the fracture surface seen in Figure 7-4(b) resembles the fracture surface seen in the bars that failed during the column test. Figure 7-5 shows pictures of the fracture surfaces of the longitudinal bars from the Grade 80 column tests. These bars had no necking and the failure surface was flat, as in Figure 7-5(a), or flat on the side of global compression and jagged on the tensile side, as in Figure 7-5(b). The failure surface was flat if the bar experienced a lower level of bending strain and jagged with higher levels of strain from bending. All the ruptured column bars had similar failure surfaces; none of the column bars experienced necking prior to fracture, signifying a similar failure mode for each bar.

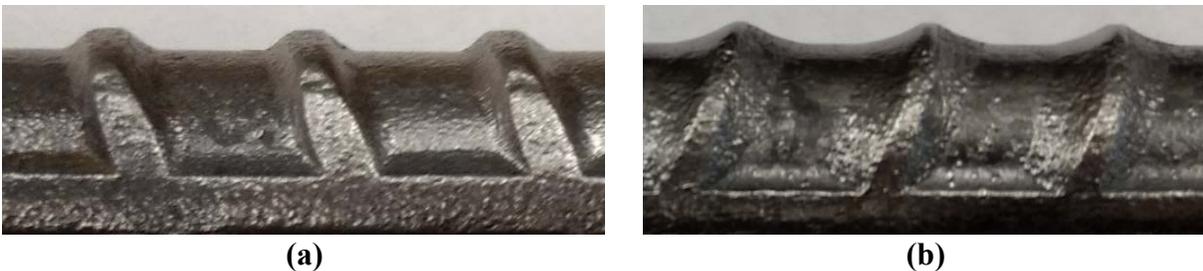
Figure 7-10. (a) Mill 1 bar profile; (b) Mill 2 bar profile

Since rebar yield strength was not seen to influence critical bending strain, further investigation was performed to identify why Grade 80 rebar from Mill 1 performed worse than rebar with similar strength from Mill 2. After observing the details of the rebar from Mills 1 and 2, a pronounced difference in the rebar profile, specifically the geometry of the ribs (also known as deformations or lugs), was observed. Figure 7-10 shows pictures of the profiles of the rebar from each mill.

As seen in Figure 7-10, the radius at the base of the ribs, where the rib joins to the shaft of the rebar, is much larger for the rebar from Mill 2 than Mill 1. A study by Helgason et al. (1976) showed that rib radius was the most critical factor for causing stress concentrations. This has been corroborated by another study by Zheng and Abel (1998) showing that as the rib radius increases, the stress concentration decreases. As the bar buckles and compressive force demand increases, these stresses will concentrate at the base of the rebar ribs. If the stress concentration factor is higher, these stresses will weaken the material and cause the onset of cracks under tensile load, as seen in Figure 2-4. Helgason et al. (1976) and Zheng and Abel (1998) studied the impacts of stress

Figure 7-21 shows the rib profile as well as a photo of the surface of each side of the bar. Side A has a similar rib profile and surface roughness to the Mill 2, Grade 80-v0 rebar, which is shown in Figure 7-10(b). However, the rib radius of side B is sharper than on side A, but the surface of B is much rougher than the surface of A. This also suggests that the rib radius as well as surface roughness influences the critical bending strain.

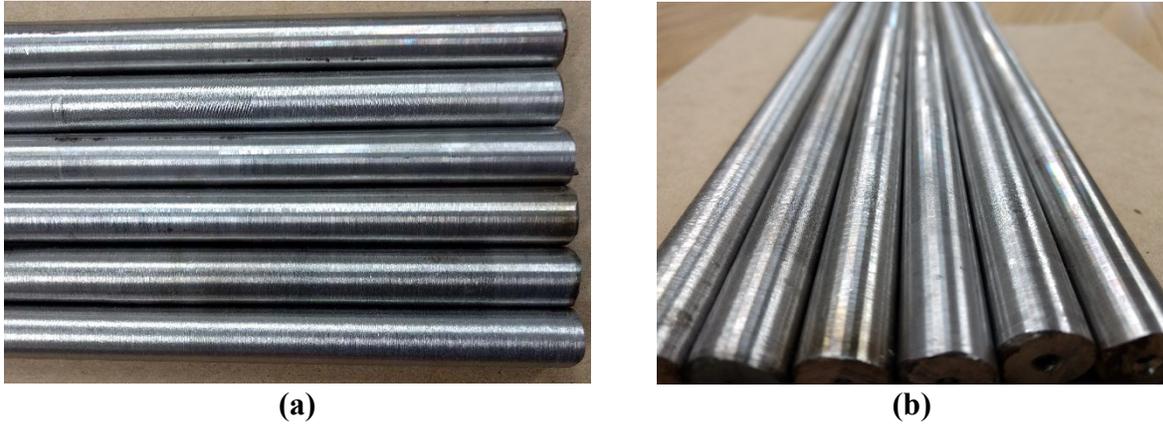
Figure 7-15. *Turned down rebar: (a) Plan view; (b) View along length*

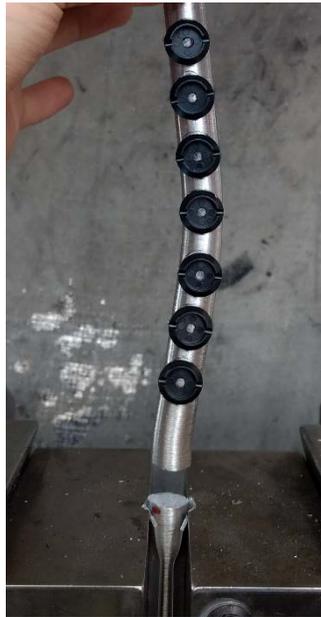
Figure 7-17. Brittle failure of turned down bar in undesired location

However, it was also noticed that the precision to which the rebar ribs were removed affected the performance. Each bar was turned down in a lathe, but at some regions, the bars had small grooves due to the machining process. These small grooves caused the bar to fail in a brittle

manner in the locations of the groove, rather than in the location of maximum compressive strain, as seen in Figure 7-17. When this failure mode was observed, machine rebar for future tests were smoothed even more with wire brushes and sandpaper. Even small grooves may cause stress concentrations, so it is uncertain whether the roughness of each bar affects the bar performance. However, for the majority of the bars, a trend was observed in the critical bending strain, indicating that this likely did not significantly affect the results.

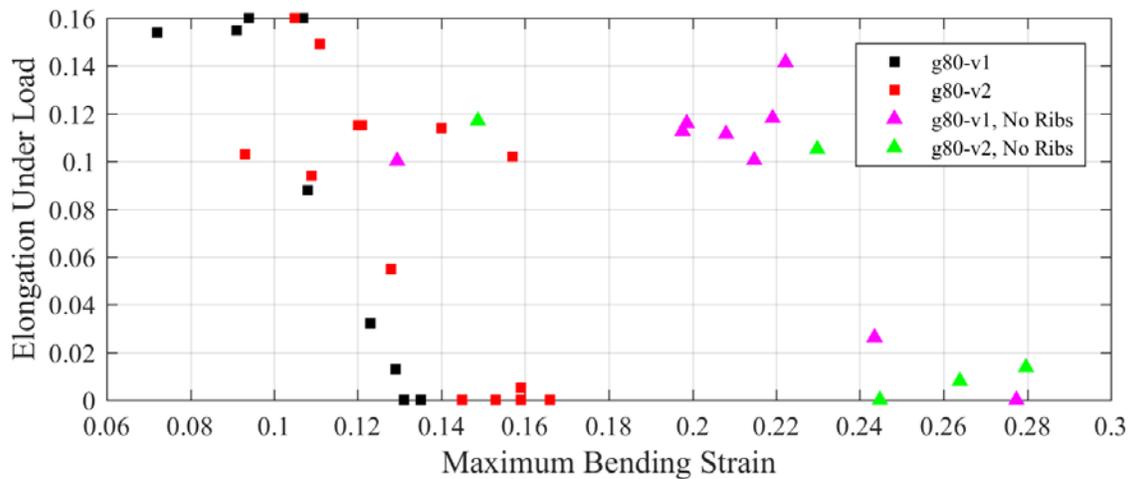
Figure 7-18. BBT results for rebar with and without ribs

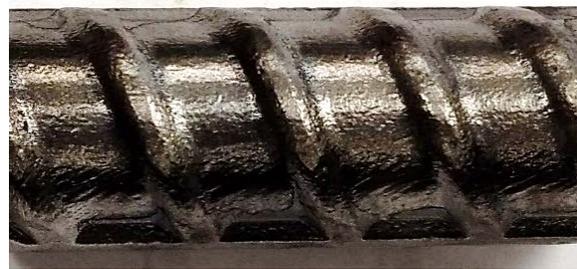
Figure 7-19. (a) BBT on Mill 1, Grade 80-v0 rebar; (b) Bar profile for Grade 80-v0 rebar

shown in Figure 7-19(a). As seen in this figure, the critical bending strain for the Grade 80-v0 rebar is approximately 0.14, which corresponds to the critical bending strain of the Grade 60 rebar. In order to understand this difference, the profile of the rebar was examined as shown in Figure 7-19(b). The rib radius on this rebar was not significantly different from the other rebar from Mill 1, although the transition from rebar shaft to rib does resemble the ribs of the Grade 80-v2 rebar from Mill 1, which had improved behavior. The surface of this rebar was also much rougher than the other rebar from Mill 1, suggesting that surface roughness could result in improved performance.
