1. REPORT NUMBER CA19-3078	2. GOVERNMENT ASSOCIATION NUMBER	3. RECIPIENT'S CATALOG NUMBER
4. TITLE AND SUBTITLE Safety Effects of the Yellow Light Border (YPB) Pedestrian Signal		5. REPORT DATE 01/31/2019
		6. PERFORMING ORGANIZATION CODE
7. AUTHOR(S) Sarder Rafee Musabbir, Shenyang Chen, Michael Zhang		8. PERFORMING ORGANIZATION REPORT NO.
9. PERFORMING ORGANIZATION NAME AND ADDRESS University of California, Davis P.O. Box 989062 Davis, California 95616-5294		10. WORK UNIT NUMBER
		11. CONTRACT OR GRANT NUMBER 65A0627
12. SPONSORING AGENCY AND ADDRESS California Department of Transportation Division of Research, Innovation, and System Information MS-83 PO Box 942873 Sacramento, CA 94273-0001		13. TYPE OF REPORT AND PERIOD COVERED Final Report
		14. SPONSORING AGENCY CODE
15. SUPPLEMENTARY NOTES

Safety Effects of the Yellow Light Border (YPB) Pedestrian Signal

An Evaluation Study

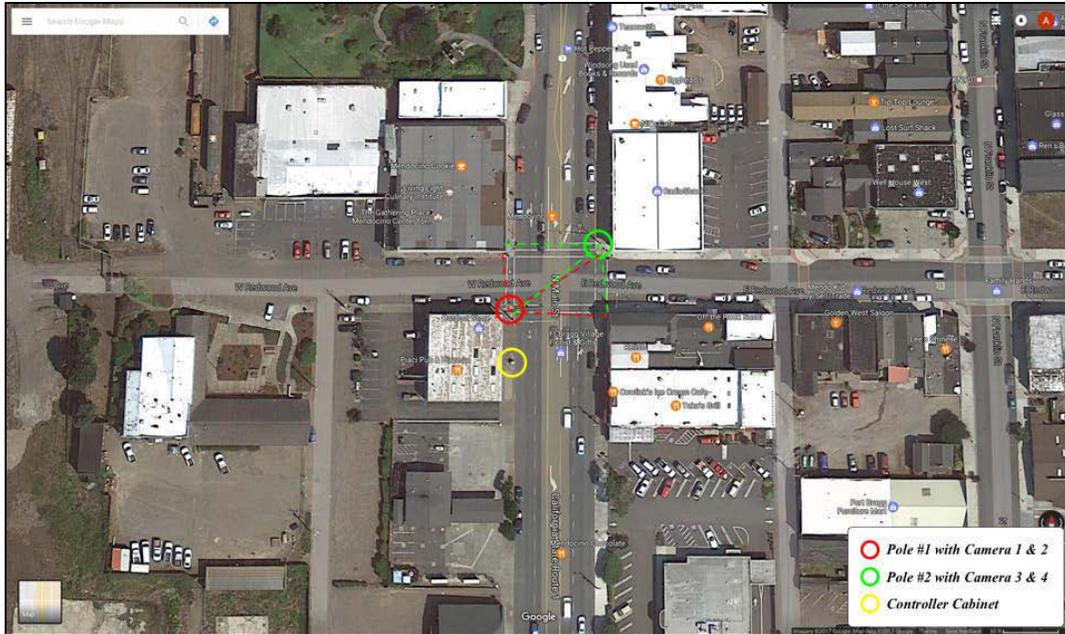
Figure 6: Intersection of West 14 St. / Redwood Hwy (SR-101), Fort Bragg, Humboldt County, District 1, Caltrans

The third study location was the intersection of Redwood Avenue / Main St. (Figure 6) at Fort Bragg, Mendocino County. The traffic signal at this intersection is operated and maintained by District 1, Caltrans. The Redwood Hwy approach consists of five lanes both ways including a

For this location, though the cameras were fitted to appropriate vantage points such as traffic signal poles to capture the full width of the corresponding crosswalks, the observation of the extra-push events were much limited. This limitation can be attributed to the distance, locations, and visibility of the push button from the camera position. The video data for the before condition were collected for more than three weeks at the intersection and from that pool of data seven consecutive days were selected for analysis. Similarly, data from two consecutive weeks was recorded for the after-condition study and from that data pool seven consecutive days were selected for analysis.

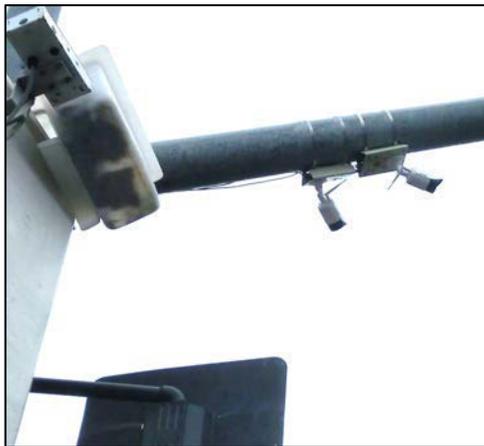
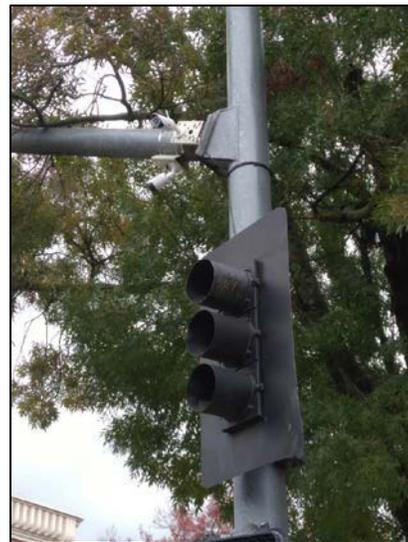
Figure 9 ((a) & (b)): Two types of Camera position on the Signal Pole Mast

The camera installation process for this study involved three different steps: (i) wire installation; (ii) Power installation; and (iii) Camera installation. The most common installation point for the cameras were the signal poles or light poles on the corners of the intersections. For installation on the Signal poles the cameras were mounted on the mast or arm of the pole and positioned to cover the entire width of the studied crosswalk. In some instances, two cameras were mounted on the same signal pole focusing different crosswalks to make use of the height and distance. Also, because some intersections had two large signal poles with adequate height for the cameras for major-minor type connection such as Location 1 (Napa Valley).

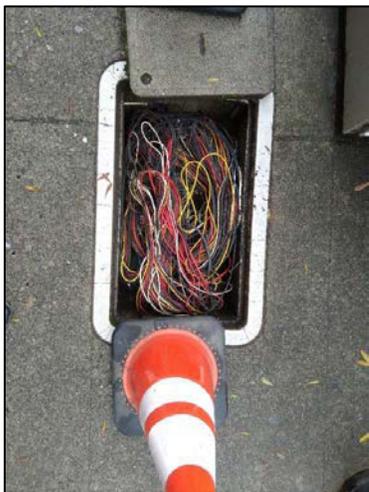
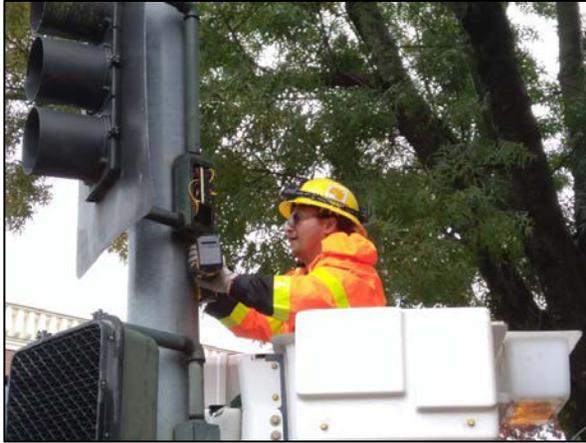
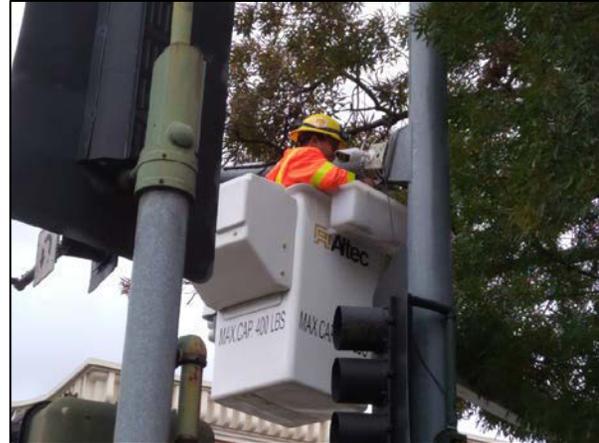
(a) Wire Cabinet beside the Signal Pole

(b) Schematic Drawing of the Wire Cabinets at a Typical Four-way Intersection

(c) Drilling hole in the small wire box on the signal pole

(d) Installing camera on the signal pole mast

Figure 11: Wire Installation and Camera Mounting on the Signal Pole

The wire installation process involves pulling the wire through the wire cabinet at each corner of the intersection where the camera was installed. Four sets of camera installation involved four distinct wires pulled through the wire cabinet towards the signal controller box where the power sources were housed.

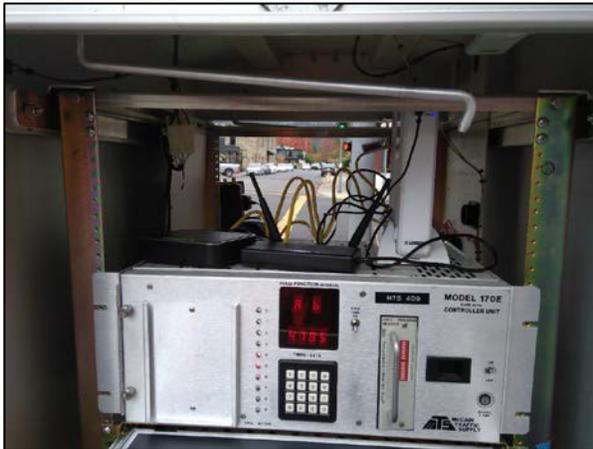
Figure 12 (a)-(b): Typical arrangement of the equipment housed inside the Signal Controller cabinet to provide power for the cameras and other devices

The power source (Power-surge), video recording DVR, wireless signal receiver, and internet modem were placed in the signal controller cabinet for all the study locations. Notably, the Wi-Fi signal strength of the cameras were interrupted and weakened due to the distance from the mounting location and the steel structure of the cabinet.

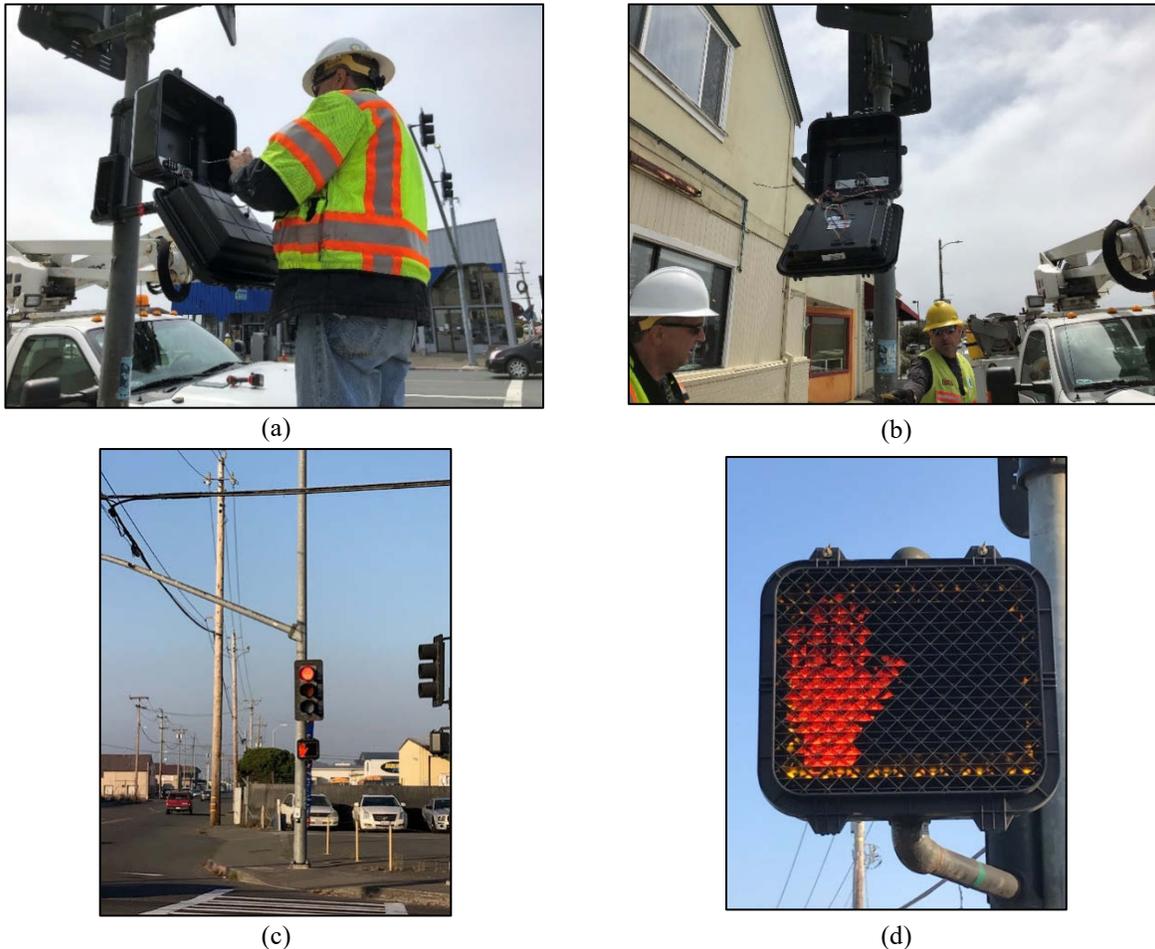
Figure 13 (a-d): Typical installation of the YPB modules at the study locations by the Caltrans Maintenance team

Forty prototype YPB modules were manufactured to conduct the evaluations at five intersections. In most of the study locations, the modules were setup during the camera installation or in the same week and the yellow LED border feature were turned off during the before condition study period. The YPB modules were installed by the electrical maintenance team of Caltrans Districts 1, 4, and 12.
