1. REPORT NUMBER CA20-2970	2. GOVERNMENT ASSOCIATION NUMBER N/A	3. RECIPIENT'S CATALOG NUMBER N/A	
4. TITLE AND SUBTITLE Vision-Based Sensor System for Site Monitoring: Wrong-Way Driving, Phase 1		5. REPORT DATE June 5, 2020

7. AUTHOR Ty A. Lasky, Kin Yen, Stephen Donecker, Wil White, Duane Bennett, Travis Swanston, and Bahram Ravani		6. PERFORMING ORGANIZATION CODE AHMCT Research Center, UC Davis

16. ABSTRACT This report presents results for research on a Vision-Based Site Monitoring (VBSM) system for monitoring Wrong-Way Driving (WWD) events. This system integrates a camera, solar power panels, and a modem into a pole-mounted package for deployment on freeway exit ramps to monitor for WWD events. The system incorporates on-camera analytics for WWD detection as well as traffic counts. Collection of WWD video is triggered by the camera analytics, and the system stores the videos for a period before and after the WWD event. The system was deployed at ten exit ramps in Northern California, and two exit ramps in Southern California. Data collected over a 39-month period (June 5, 2016-August 31, 2019) is presented, illustrating the effective performance of the VBSM system as a self-c

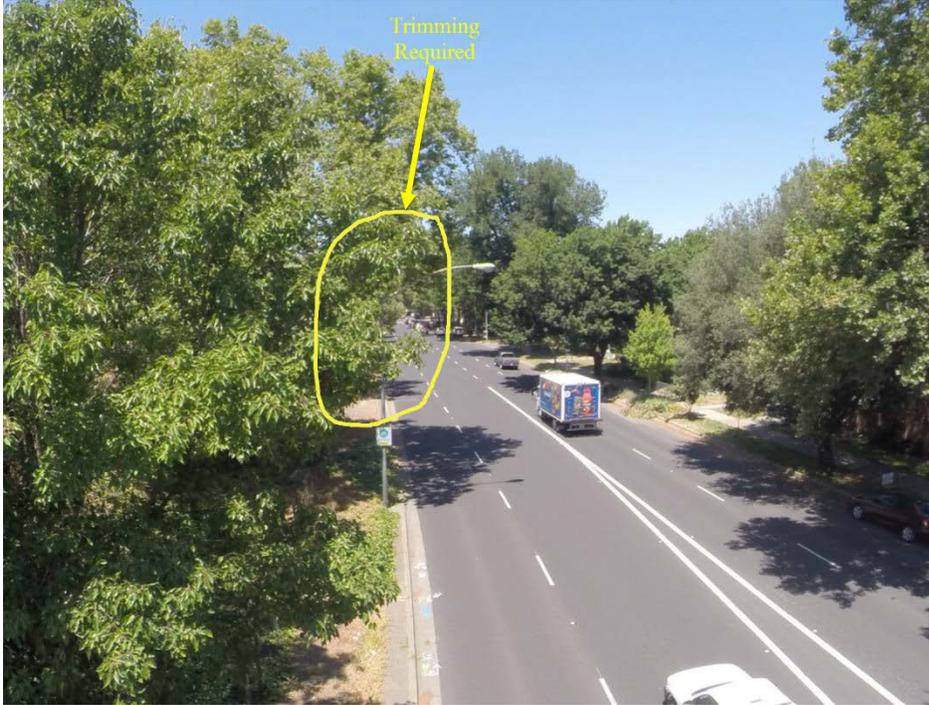
Figure 3.2: Example of tree trimming required to provide better camera FOV (US 50 WB 10th St exit)

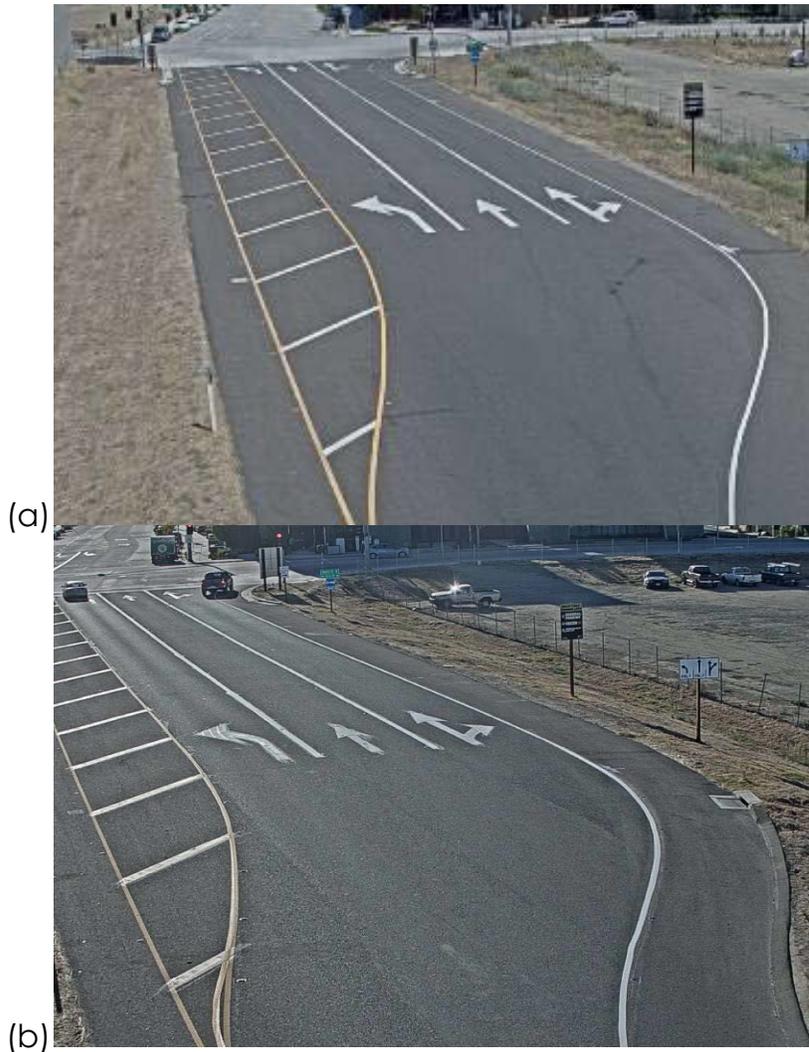
Figure 3.7: Effect of pole twist on the US 50 WB South River Road exit ramp WWD monitoring installation. (a) Camera FOV immediately after installation. (b) Camera FOV three months after installation.

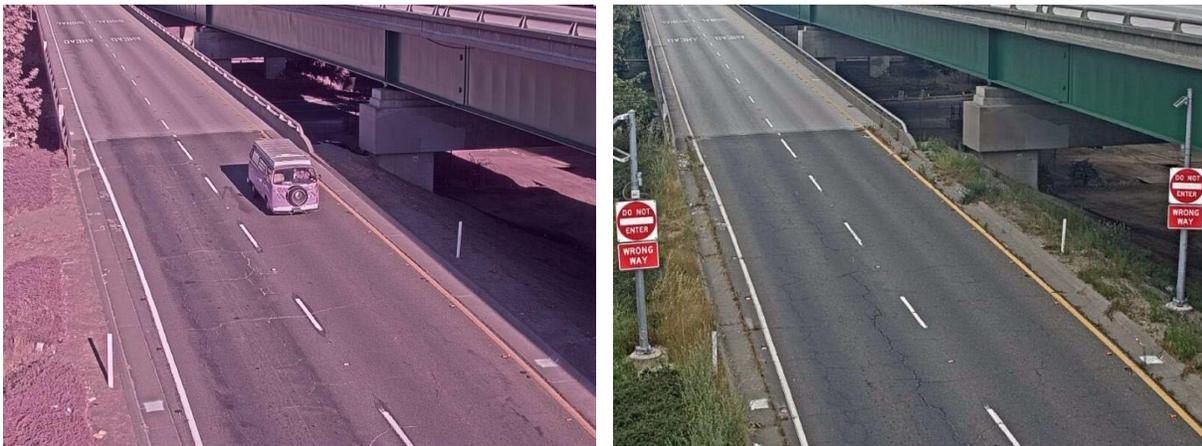
Figure 3.8: Illustration of the IR filter failure. The left image was taken before the camera replacement. The right image was taken after the camera replacement.

One Axis Q1615-E camera had internal failure which eliminated the built-in infrared (IR) filter causing a red tone in the image and video as shown in Figure 3.8. The failure occurred right after the field installation. The camera was repaired under warranty.

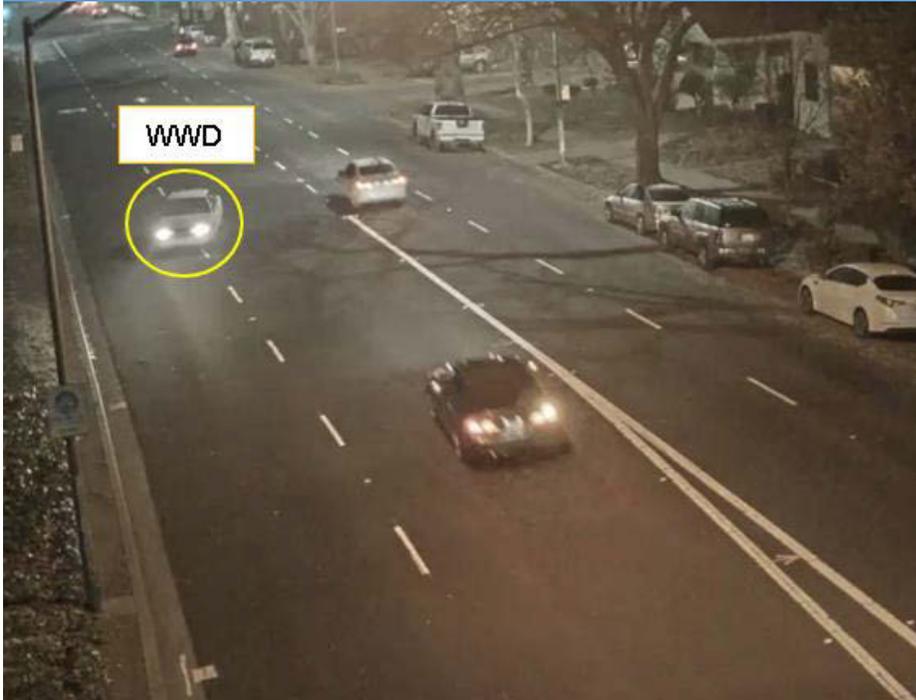
Figure 4.16: Wrong-way driver (circled in yellow) entering the exit ramp at WB US 50 at 10th Street. The driver continued onto the exit ramp despite at least five cars passing in the other (correct) direction.

- One WWD event occurred under poor visibility and rain conditions.
- In one WWD event, the driver appears to be under the influence based on the car's weaving during its approach to the exit ramp. In that case, the WWD driver passed five or more vehicles driving in the right direction and still proceeded wrong-way onto the exit ramp (see Figure 4.16).

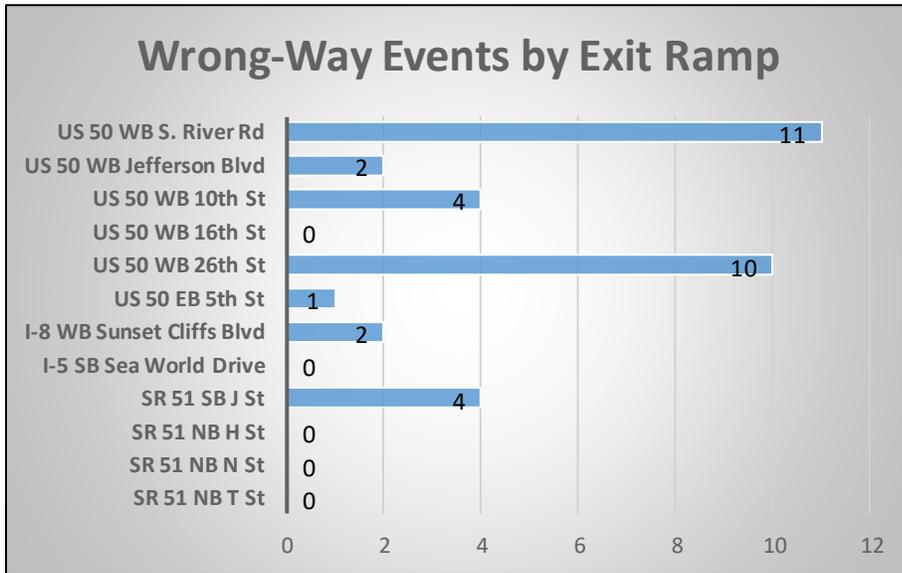
Figure 4.17: All WWD events classified by exit ramp

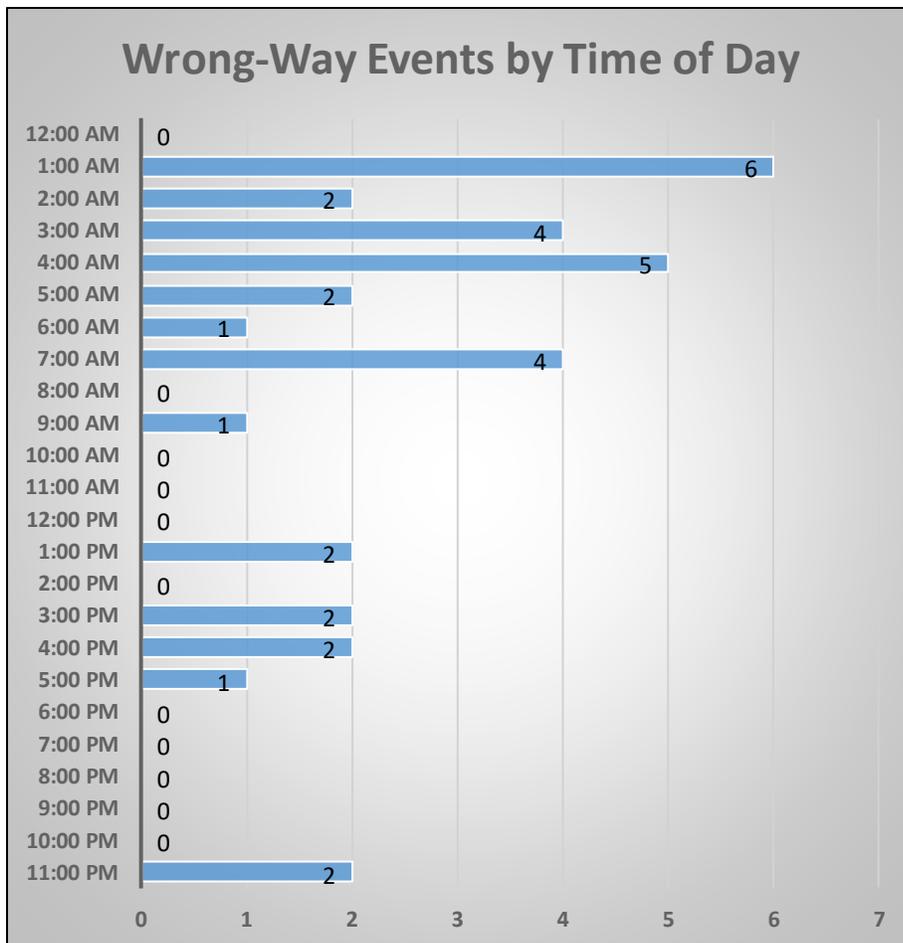
Figure 4.19: All WWD events classified by time of day

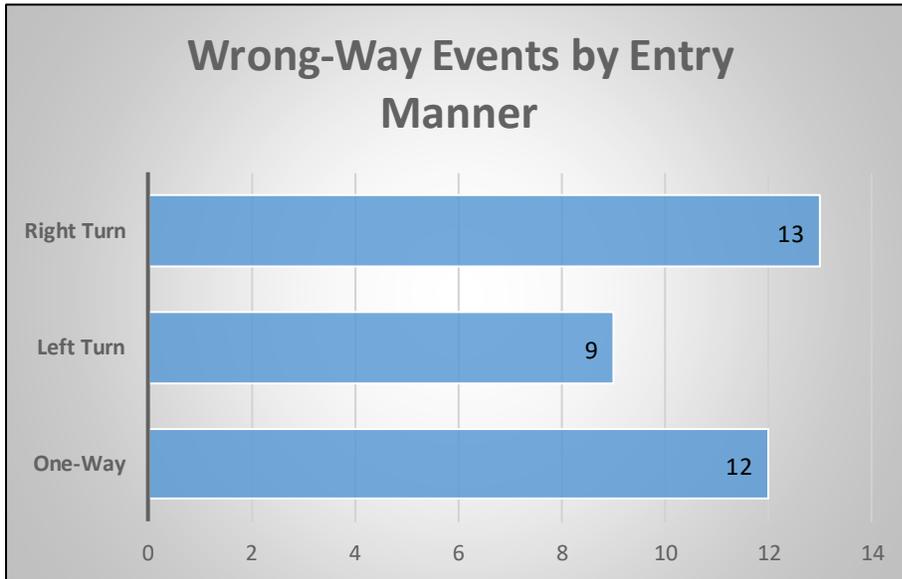
Figure 4.22: All WWD events classified by entry manner

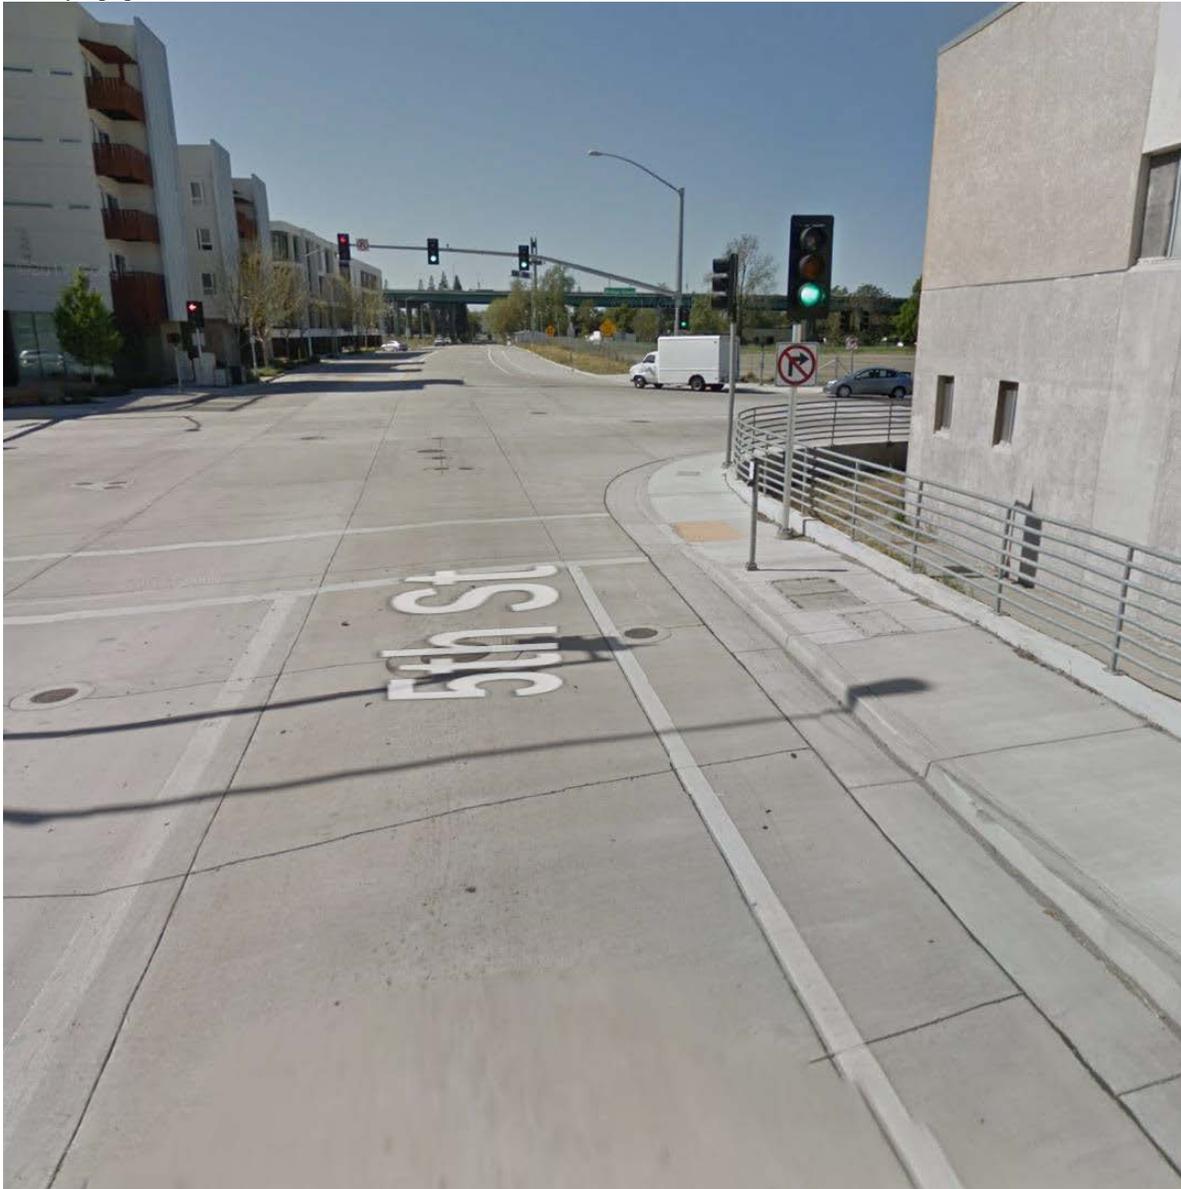
Figure 4.23: View of the approach from the north to the South River Road exit ramp. A right turn would lead to a WWD event. Image courtesy of Google Street View.

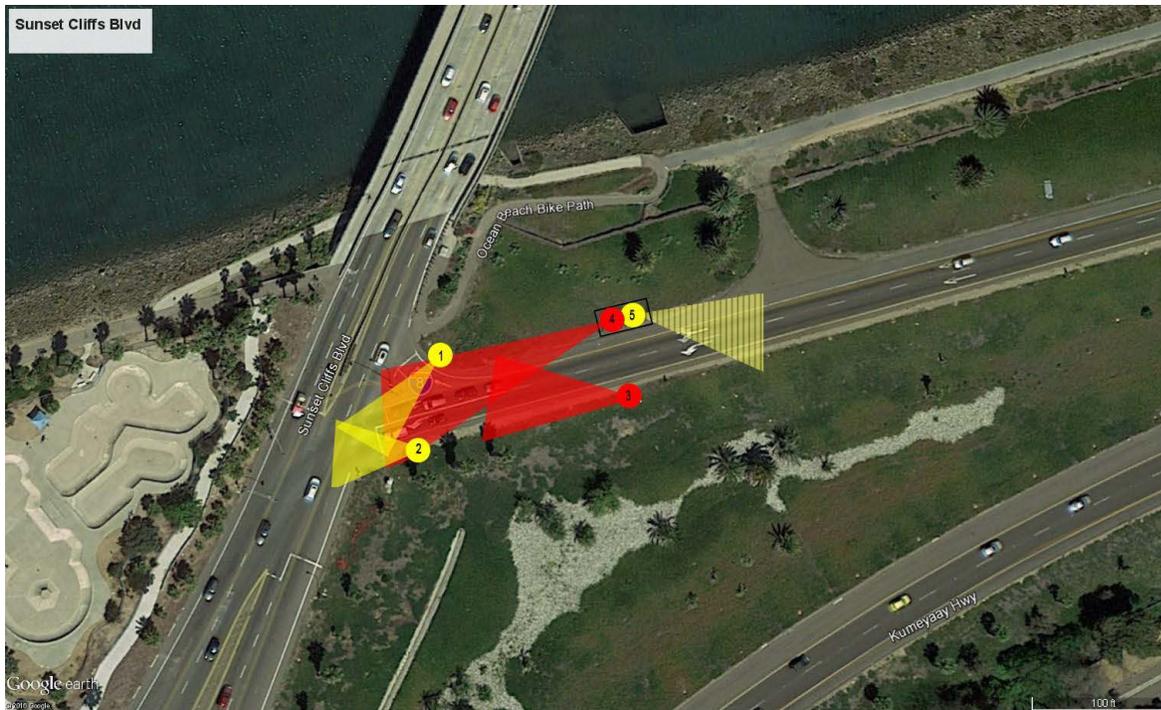
Figure 4.42: Bird's-eye view of TrafficCalm system configuration at Sunset Cliffs Blvd. exit ramp, including sign location and numbering. Courtesy of TrafficCalm.
