1. REPORT NUMBER CA21-3021	2. GOVERNMENT ASSOCIATION NUMBER	3. RECIPIENT'S CATALOG NUMBER
4. TITLE AND SUBTITLE Fiber Optic Monitoring of Base Grouted Piles	5. REPORT DATE July, 2021	
	6. PERFORMING ORGANIZATION CODE	
7. AUTHOR R.A. Yeskoo, K. Soga	8. PERFORMING ORGANIZATION REPORT NO. n/a	
9. PERFORMING ORGANIZATION NAME AND ADDRESS UC Berkeley Berkeley CA.	10. WORK UNIT NUMBER	
	11. CONTRACT OR GRANT NUMBER Contract No. 65A0645	
12. SPONSORING AGENCY AND ADDRESS California Department of Transportation (Caltrans) Division of Research, Innovation & System Information, MS-83 2963 R Street, Sacramento CA 95816	13. TYPE OF REPORT AND PERIOD COVERED Final Report	
	14. SPONSORING AGENCY CODE

This report documents the field application of distributed fiber-optic strain (DFOS) sensing for measuring strain in drilled shaft foundations. Nine 5-foot diameter reaction shafts and four 3-foot diameter test shafts were subjected to base grouting. Following several weeks of set-up the test shafts were then loaded from the top in a conventional quasi-static load test. Distributed fiber optic strain sensing techniques were used to measure strain along the entire shaft length along four separate fi

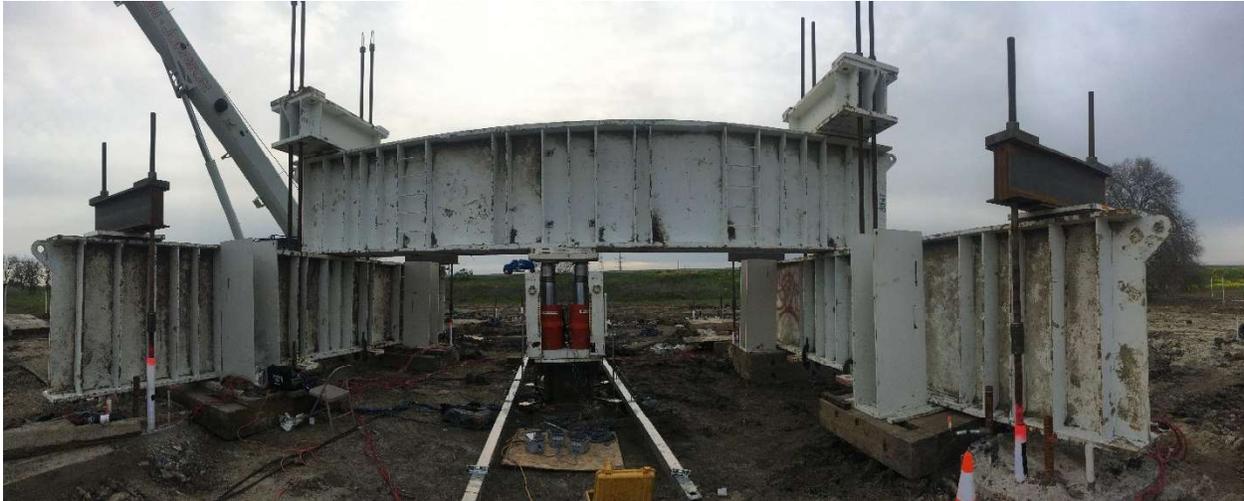
Figure 1-3: Load test frame

After the base grouting was complete, the four test shafts were load tested. The axial loads were imposed on the test pile using four hydraulic jacks, connected to the four surrounding reaction piles through a steel load frame. A photo of the load test frame is shown in Figure 1-3.

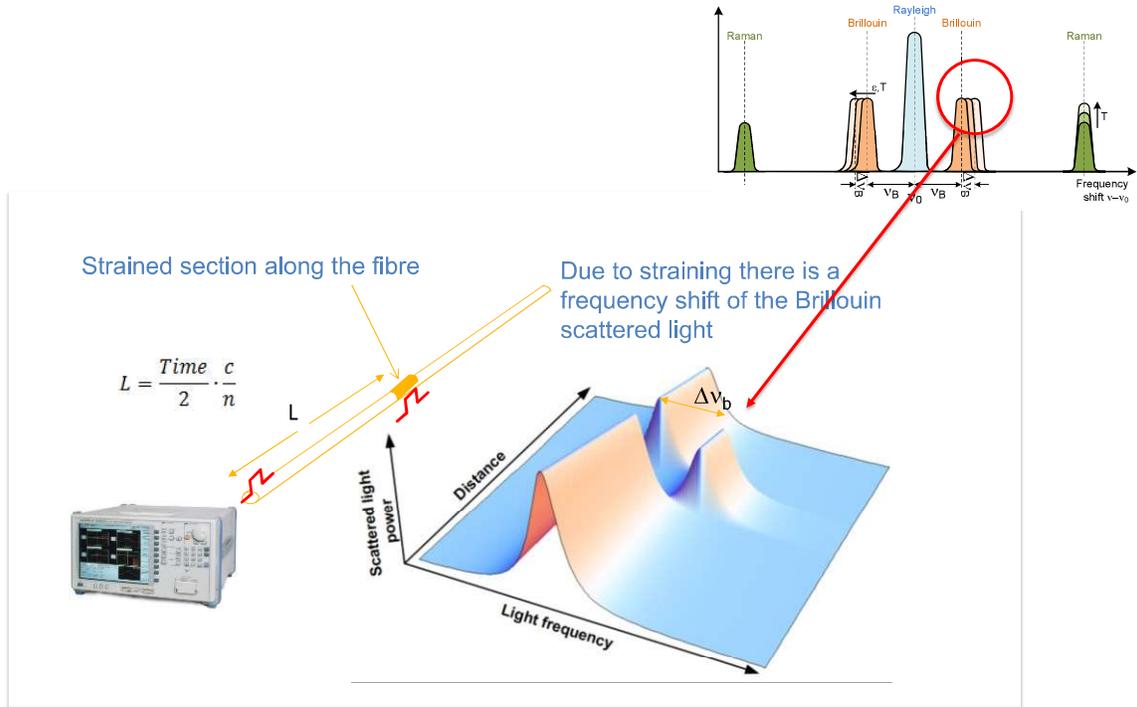
Figure 1-7: 3D power spectrum along the fiber

For a given reading, Brillouin peak frequency can be identified at each sensing point and Figure 1-9 shows a plot of Brillouin peak frequency versus distance. The output of the analyzer will be a 2D matrix with the distance from the analyzer in the first column and the peak Brillouin frequency in the second. Although a single Brillouin peak frequency value is presented in the common output of the analyzer (Figure 1-9), each point along the fiber has an entire power spectrum with amplitudes of each scanned frequency within the reading window (Figure 1-8). The combination will produce a 3D plot like the one shown in Figure 1-7.

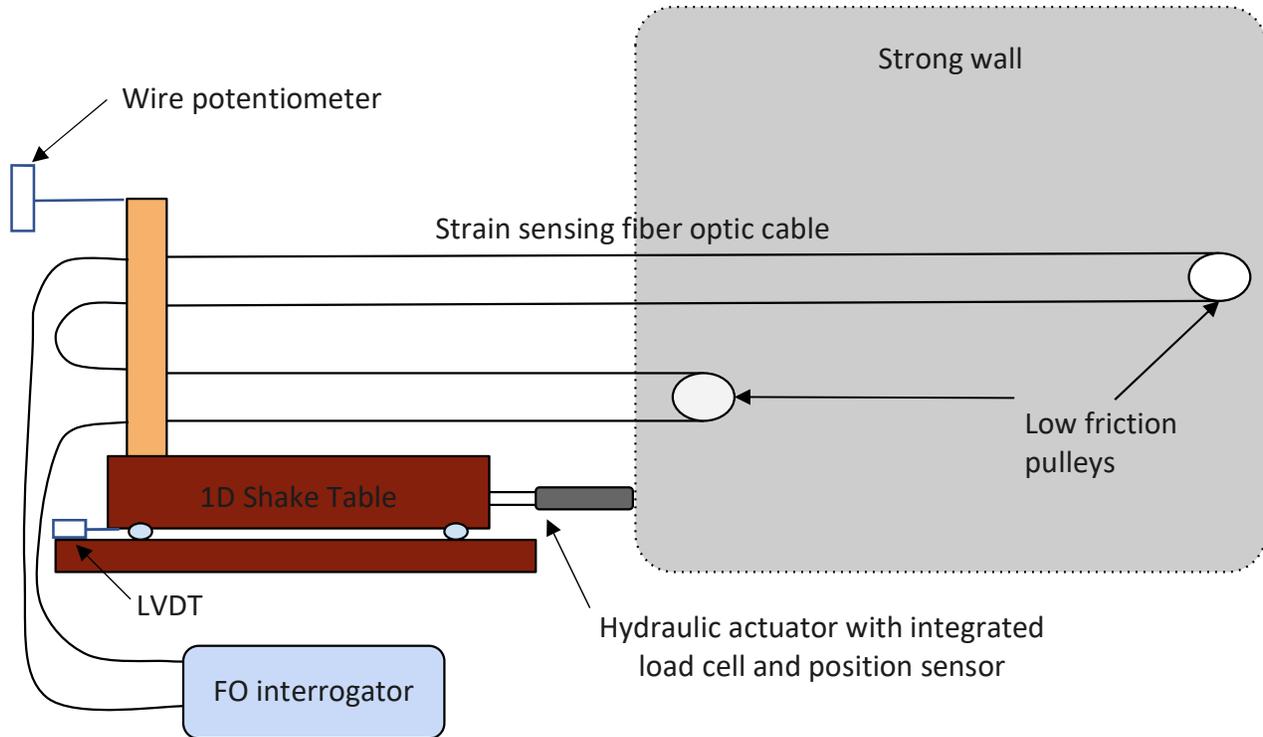
Figure 3-1: Component diagram of the test layout

the strong wall blocks, while the clamping mechanism was assembled using steel members at the east end of the Single Degree of Freedom shake table. A component diagram of the test layout is shown in Figure 3-1.

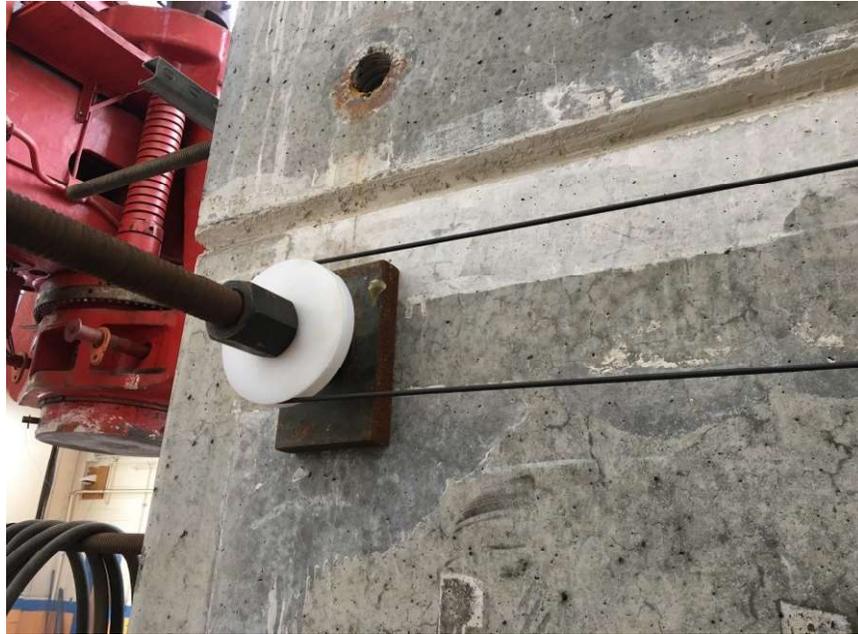
Figure 3-2: Photo of Loop 2 (long loop) pulley mounted on strong wall

The pulleys, as shown in Figure 3-2, were selected to be made of a low friction material to allow the cable to rotate around the pulley axis freely. The pulleys were 6" in diameter; chosen based on the center-to-center clamp spacing as well as ensuring a large enough curvature to prevent the risk of signal loss or breakage in the fiber optic cable during testing. The pulleys had a circular cross-section channel $\sim\frac{1}{4}$ " deep to route the cable within. The pulleys were mounted vertically using a threaded rod in the anchor holes in the first and last blocks of the strong wall. The clamps and pulley heights were selected to have the cable arms as close to horizontal as possible. Nuts were installed on the threaded rod to prevent the pulleys from moving along the bar, although a small gap was left between the nuts and pulleys to allow free rotation of the pulley on the bar.

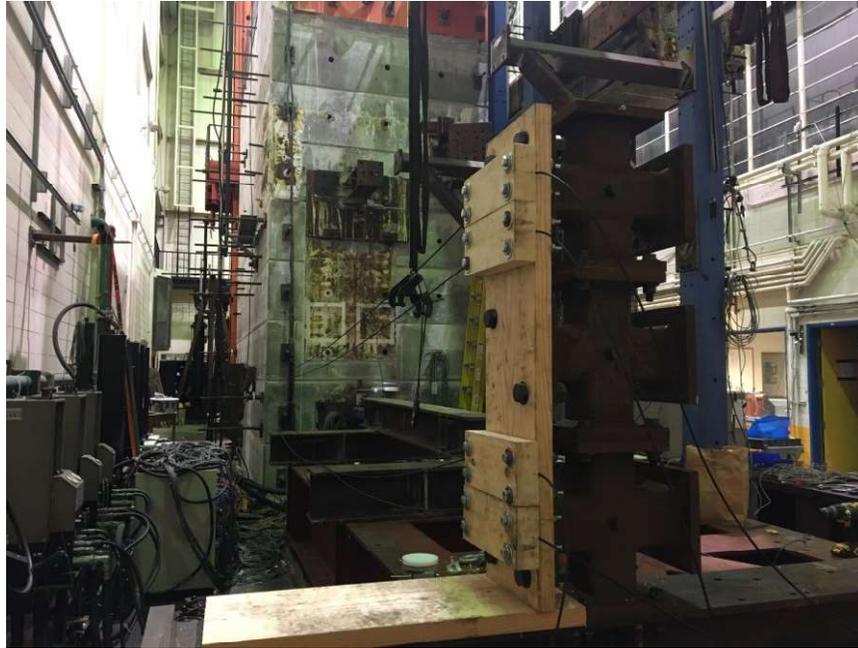
Figure 3-3: Photo of wood clamp setup at far corner of 1D shake table

Each clamping mechanism was made of two separate pieces of wood (see Figure 3-3). The first was a vertical length of 2x12 lumber, connected to a stack of cross steel members that were bolted to a horizontal extension from the shake table. This vertical board provided the clamping face for all four loops. Adhesive discs of 40-grit sandpaper were adhered to the face of the 2x12 along the four cable paths to increase the friction between the wood and the cable. Four 11.25" long wood boards (custom planed lumber 2" x 5") were then bolted to the clamping face of the lumber using 1/2" diameter bolts with fender washers to distribute the clamping load along the board. A triangular channel was cut into the centerline of each board using a table saw with the blade tilted at a 45° angle, then smoothing the lip using a hand plane. Various depths of the channel were tested to maximize the clamping force while avoiding crushing (and potentially damaging) the cable. A final depth of the channel of 3mm (for the 5mm diameter cable) was chosen. The clamping bolts were tightened in an alternating pattern to ensure the clamping force was applied symmetrically. During the tightening of the clamps, the fiber optic cable was pulled taught by hand to remove slack in the system and apply an initial pretension to the cable. The bolts were then tightened to 10 foot-lbs using a torque wrench to ensure an even clamping force between all four boards. Tell-tale marks were made on each cable at the front and rear of the clamp to provide a visual check of any slippage of the cable during the test.

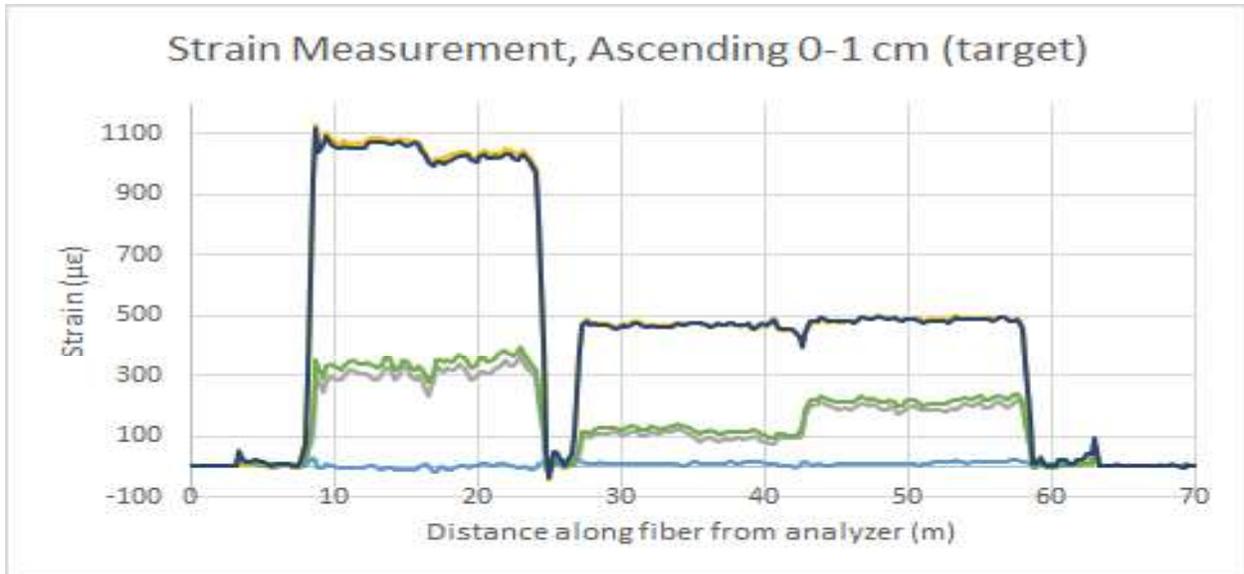
Figure 3-5: Ascending strain measurements, run 1 (grey) and 2 (green)

As shown in Figure 3-5, the higher lines represent the static strain measurements at 10 mm (target) displacement, while the intermediate lines represent the readings taken during the two ramp cycles (run 1 (grey line) and run 2 (green line) in Figure 3-5). It is clear that the intermediate strains do not represent an average (visually halfway) of the applied strains during the ramp cycle, indicating that the reported strain measurements were taken at different times during the 5 minute load. The Brillouin peak frequency values during the two ramp readings from 0 - 10 mm (target) are shown in Figure 3-6. Comparing the order of the Brillouin frequency, from smallest to largest, to the overall percentage of the total applied strain, it can be observed that an increase in the 3 starting frequencies correlate to the magnitude of the strain measurement during the transient reading. Since the strain is increasing linearly, this intuitively supports that the lower frequency portions of the fiber are being interrogated by the analyzer earlier than sections with higher frequency.

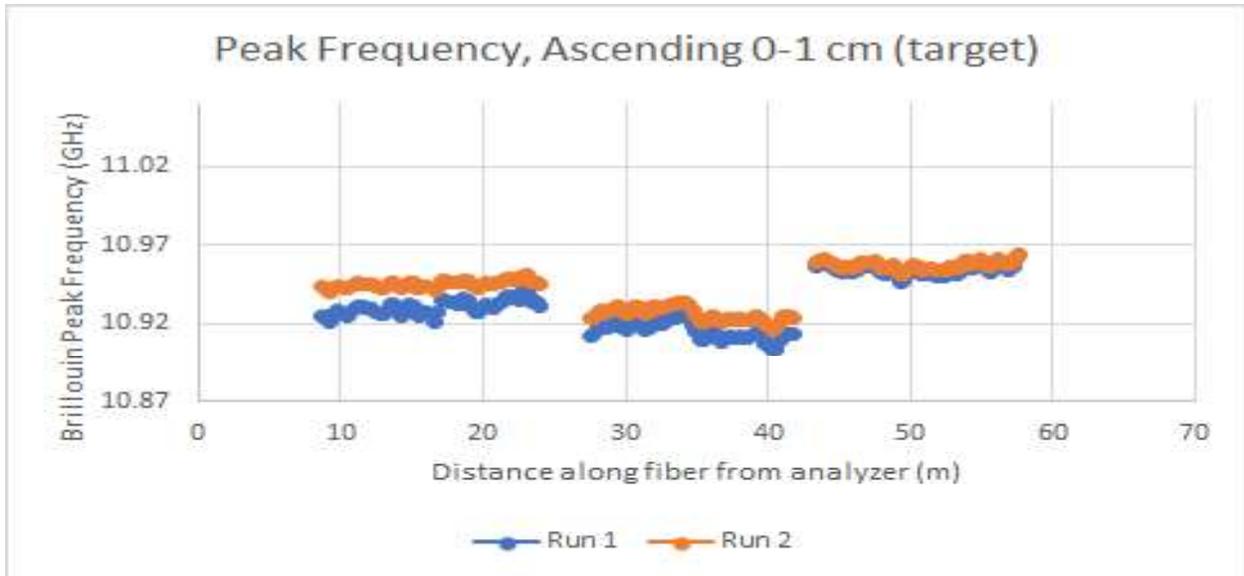
Figure 3-6: Peak frequency during two ascending strain reads

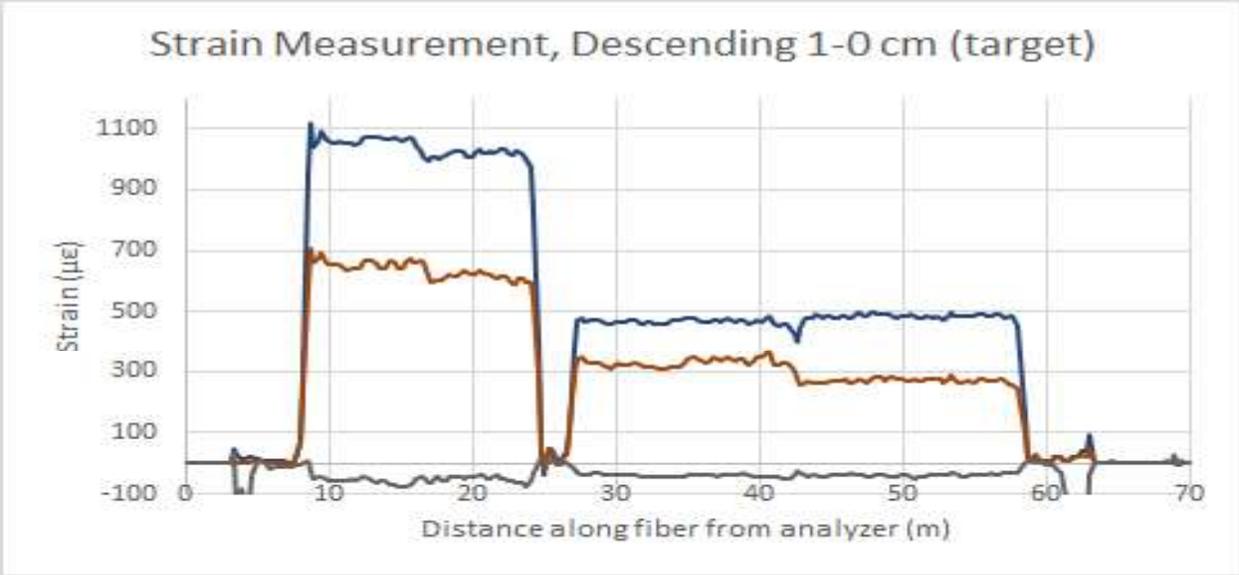
Figure 3-10: Descending strain measurements (brown)

A third load cycle was performed ramping down from 10 - 0 mm. In this case, the trends observed in the two ascending load tests were reversed. Figure 3-10 shows the strain profiles at 10 mm displacement (blue line), 5 mm displacement (red line) and 0 mm displacement (grey line). It is noted that in the final descending load cycle, the fixed table overran the 0 cm setpoint, resulting in a negative strain relative to the pretension baseline. The strain vs. peak frequency plot during descending read is given in Figure 3-11 for loop 1 and Figure 3-12 for loop 2. Again, the strain readings during the ramp cycle plot linearly depending on their peak frequency between the minimum and maximum window frequency limits and the associated minimum and maximum strain (measured in static readings).

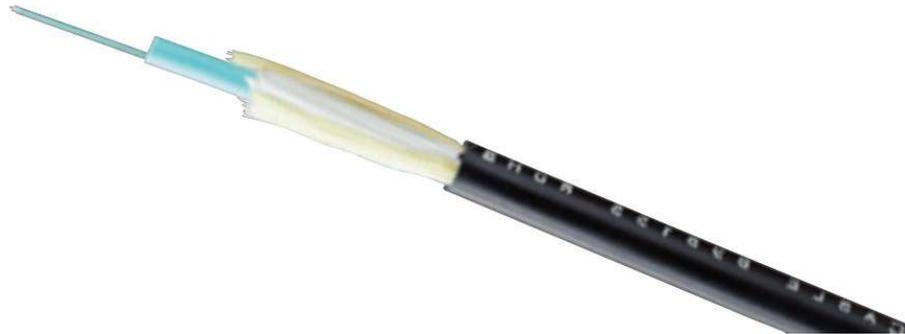
Figure 4-2: Photo of Belden 8 mm thermal cable (photo credit: Belden Optical Fiber Catalog)

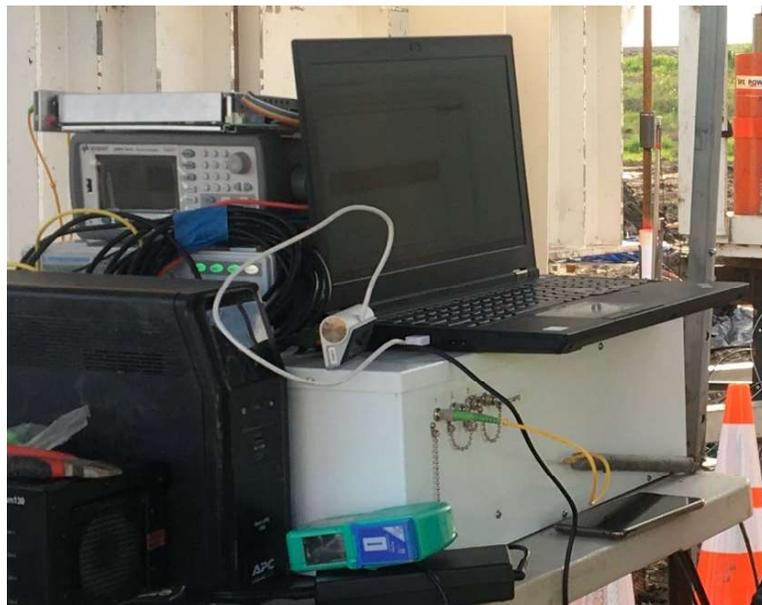
Figure 4-8: ALICIA fiber optic analyzer during load test

The ALICIA fiber optic analyzer (see Figure 4-8) is a research-based analyzer, first developed in Professor Kenichi Soga’s research group at the University of Cambridge in 2015. It is a single ended system; only connecting to one end of the sensing fiber optic installation. While the

system approach relies on the same Brillouin scattering based distributed sensing as the Omnisens analyzer, most closely mimicking it in BOTDR mode, the unique ALICIA system architecture uses digital methods for signal processing rather than the analog frequency sweeping method of the Omnisens analyzer. This results in much faster data acquisition speed, with readings taken in 1-2 seconds as opposed to 5 minutes. The system has an effective spatial resolution of 1 m with a sampling interval of 0.02 m. Being a research-based system, the system design requires the use of separate components in addition to a control laptop to function, rather than the integrated single box employed by the Omnisens analyzer. While this allows for flexibility during lab testing and system development, work is ongoing to develop the system into a single box.

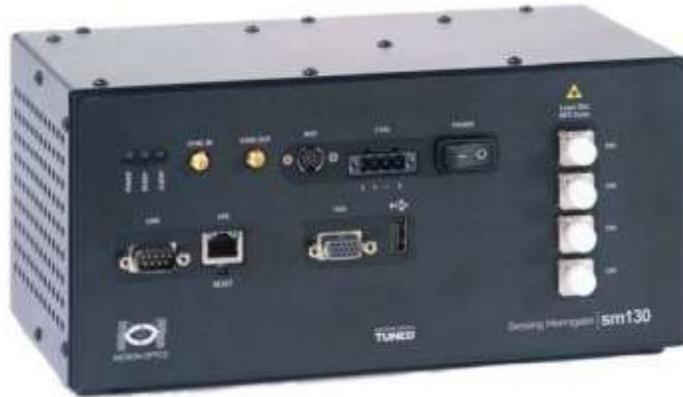
Figure 4-9: Micron Optics SM130 FBG interrogator (photo credit: Micron Optics)

The Micron Optics SM130 (Figure 4-9) is an FBG optical interrogator, capable of simultaneously reading up to four channels of FBG strands. Each channel is individually calibrated with the manufacturer-provided central frequency for all the FBG sensing nodes in the string. The interrogator then uses these calibration factors to calculate the frequency shift, which is then converted into differential strain. The control software tracks the peak frequency of each grating continuously during monitoring at a maximum scanning frequency of 2 KHz. For this

project, data was saved at a 1 second frequency during monitoring. The wavelength accuracy of the analyzer is 1 pm, which for the strain sensitivity of the FBGS cable, corresponds to a strain resolution of 0.8 $\mu\epsilon$.

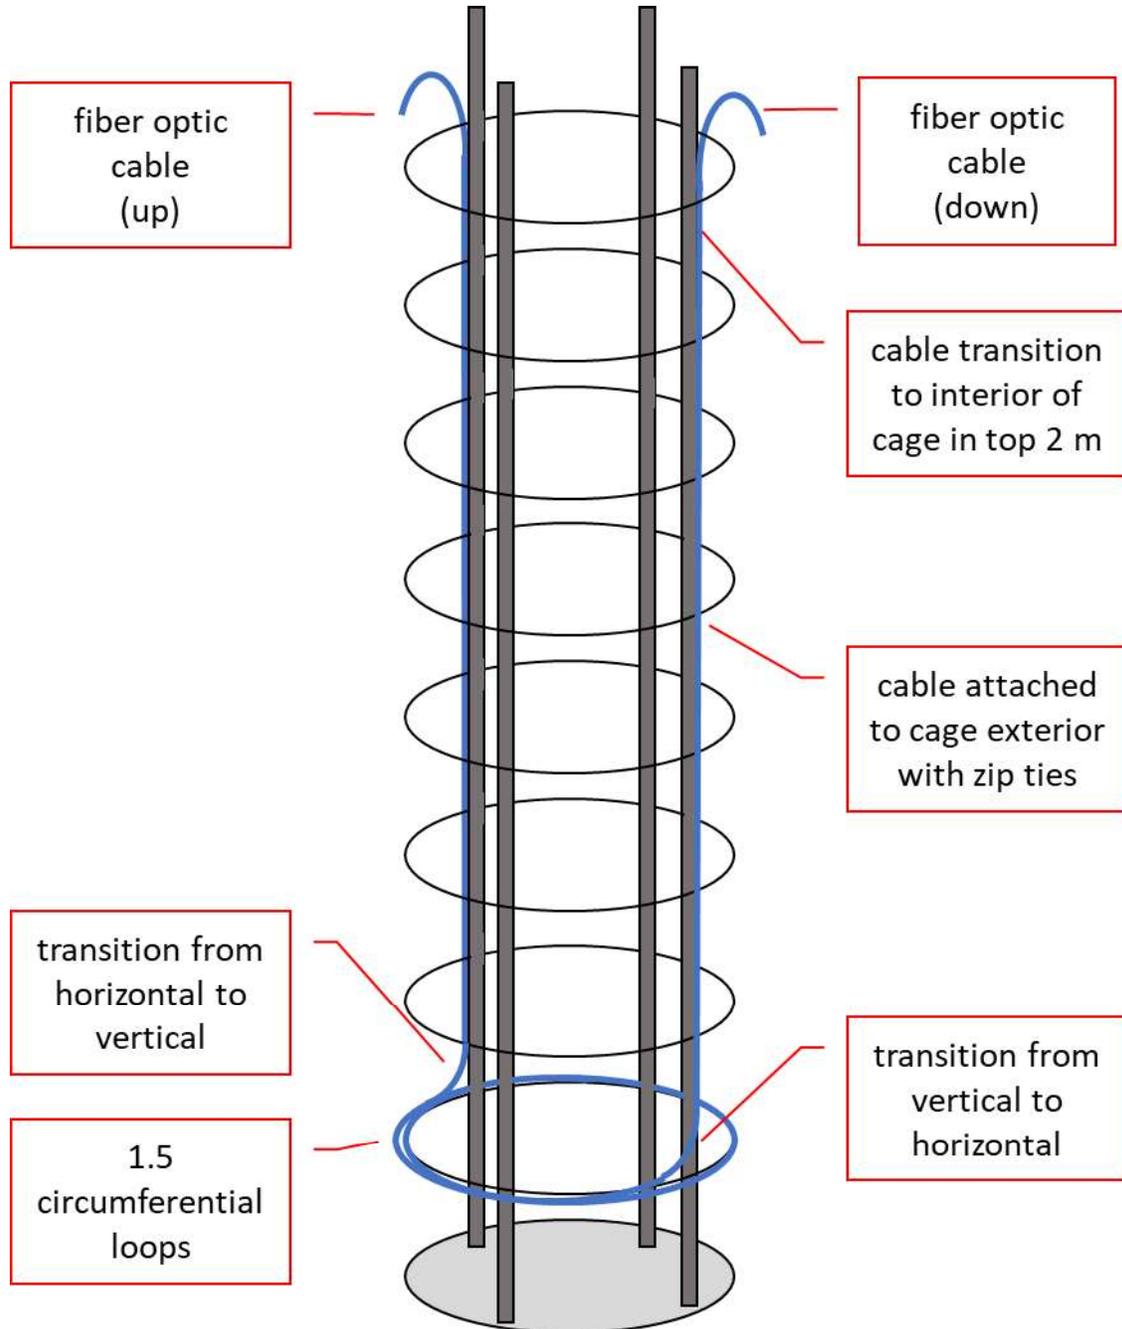
Figure 4-11: Fiber optic cable routing for a single loop

spacing and number of horizontals are not to scale). While each pile had several fiber optic loops, for simplicity the figure shows the routing of just a single loop (down, 1.5 circumferential loops, up).

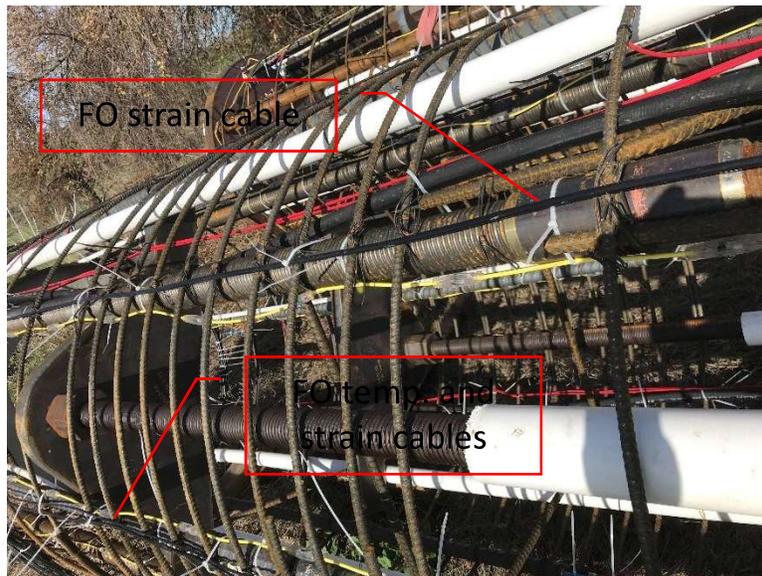
Figure 4-12: Instrumentation installed on reinforcement cage

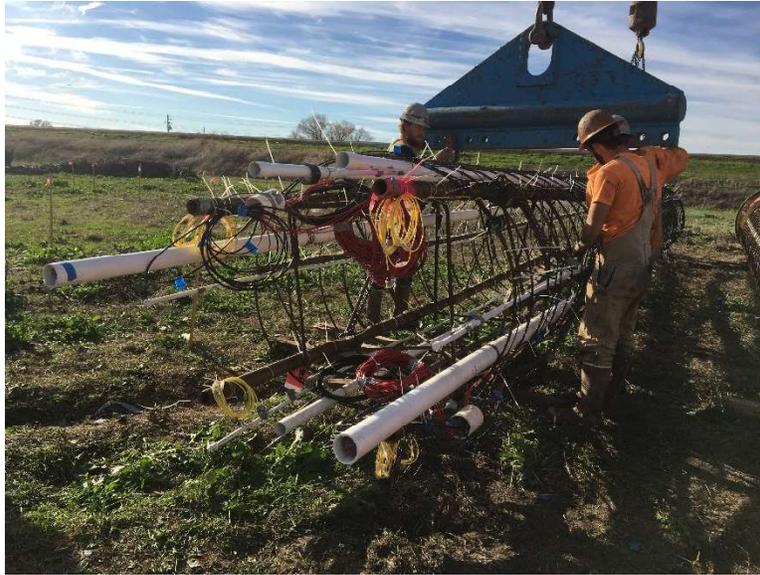
Figure 4-14: All instrumentation wiring installed and coiled, cage prepared for final pick

At the top of the pile, the cable was once again routed inside the cage 2 m below the top horizontal bar. This setup – the vertical “down”, 1.5 circumferential loops, and a vertical “up” – constitutes a single loop, as shown in Figure 4-11. For piles with multiple loops of the same type, 7 m of cable was left between each loop to allow for reconnection in the event of a fiber break within the pile. The installation of all the fiber optic cable on the cage took approximately 2-3 hours after delivery to site with 2 researchers. Figure 4-14 shows the top of a reinforcement cage prepared for lifting into the pile bore with all cabling coiled and secured to the top bars. The fiber optic cable bundles are black, while the red cable are the conventional strain gauges and the yellow cables are the conventional thermal wire.

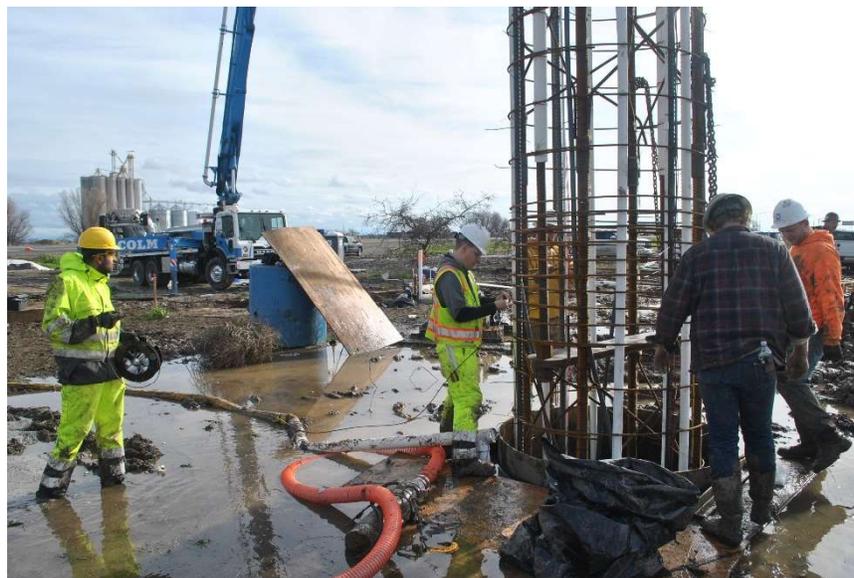
Figure 4-16: Installation of final fiber optic cable vertical during lowering of reinforcement cage
Following the lowering of the cage, all fiber optic and conventional sensor cables were routed out of two PVC pipes to protect the cables from bending or damage during later pile work. The

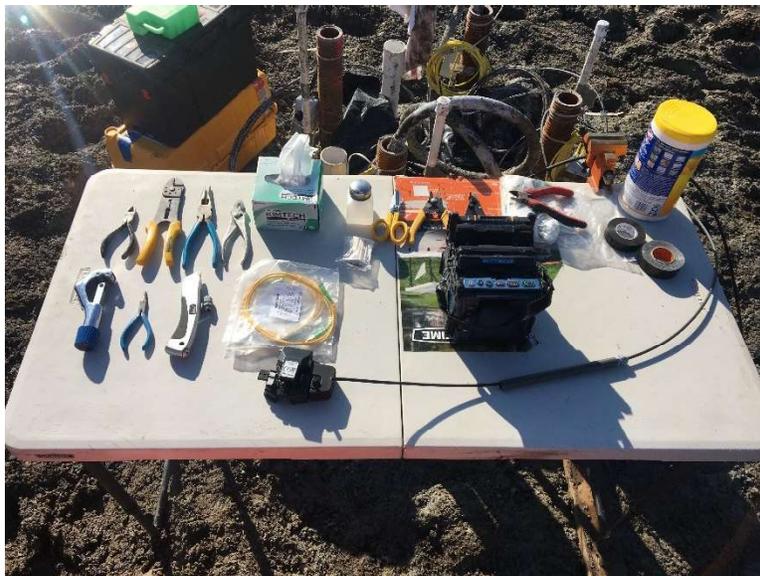
Figure 4-17: Photo of the field setup and tools used for splicing fiber optic cables from the piles

At the completion of the pile concreting, the temperature and strain cables were spliced together and FC connectors were connected to the remaining 2 free ends. A photo of the field setup for splicing the fiber optic cables after the piles were installed is shown in Figure 4-17. The field setup was laid out on a portable folding table. Disinfecting wipes were used to carefully clean the cable ends of mud and dirt, as well as wipe down the table. The tools on the left of the table were used to remove the outer layers of the fiber optic cables include a pipe cutter, cable snips, wide and needle nose pliers, a matte knife, and wire strippers. The yellow-handled tools in the upper center part of the table were used to prepare the fiber core – stripping any protective coating and buffer to expose the core. The core was cleaned with a sterile wipe wetted with alcohol (center top, left). The core was cleaved (center bottom, left), then installed in the holder within the splicer (center, right). The process was repeated for the other section of fiber which was being spliced.

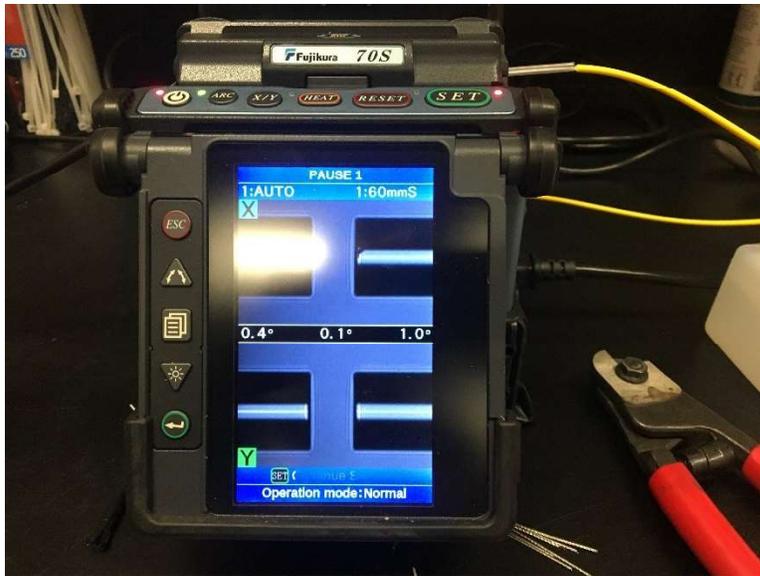
Figure 4-19: Fujikura fusion splicer, joining strain cable (left) and FC patch cable (right)

The splicing process entails carefully removing the protective sheathing around the fiber optic strand, cleaving the end of the fiber optic cable to a 90° face, splicing the two cable cores together using a fiber optic fusion splicer, and securing a protective sheath around the completed splice. A photo of a splice between the strain cable and an FC connector patch cable is shown in Figure 4-19. This photo was taken of a splice performed in the lab between the Nanzee 5 mm cable and an FC connector patch cable. The image on the screen shows a close-up view of the two fiber optic cores which are aligned and measured for squareness of the cut. Any incompatibility of the angle of the two cuts will result in an error from the splicer and the fiber would have to be recut.

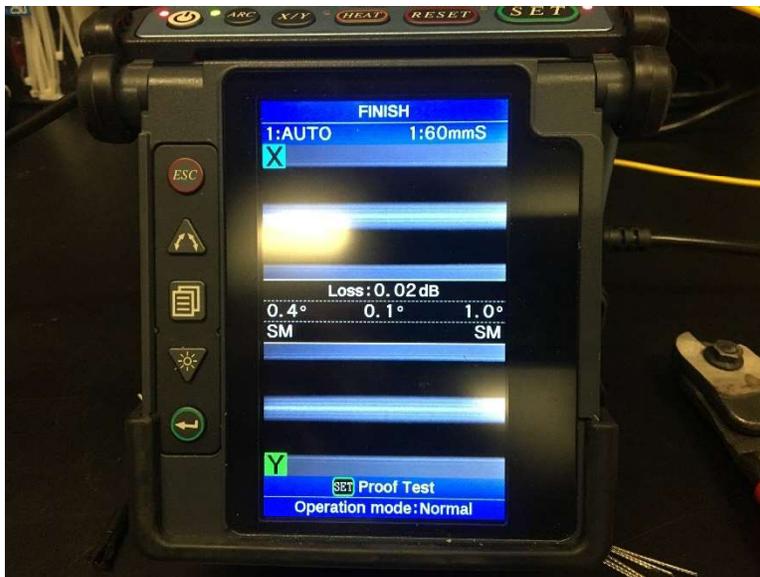
Figure 4-20: Photo of completed splice between strain cable (left) and FC patch cable (right)

The maximum optical loss for each splice was set at 0.1 dB – any splice over this value would be cut and repeated. A photo of the same cable shown in Figure 4-19 after the splice is completed is shown in Figure 4-20.

Following the completion of the splice, continuity was confirmed through all connections using an Optical Time Domain Reflectometer (OTDR) testing device. This allows for testing of both the continuity of the splice as well as checking for any breaks or sharp bends in the fiber optic cable

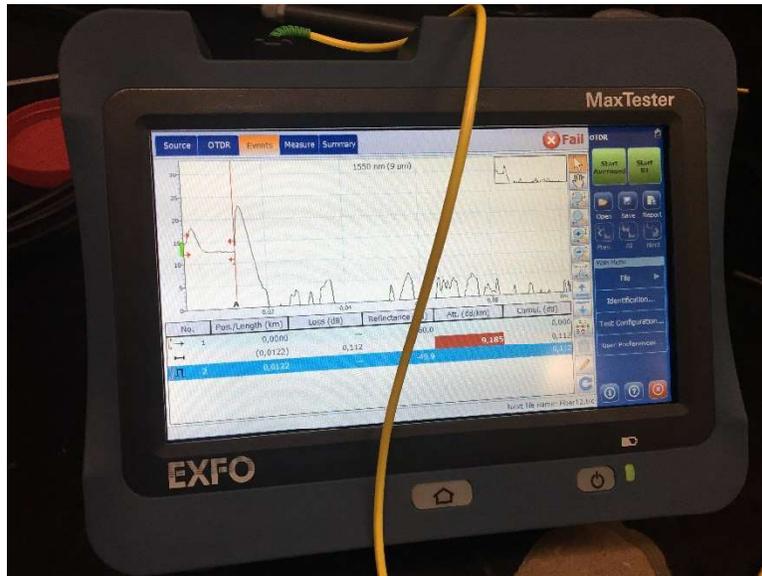
Figure 4-21: OTDR readout of a fiber optic splice and length of cable

in the pile. A photo of the OTDR readout of the previous splice is shown in Figure 4-21. The readout shows the reflectance of the splice, as well as the loss along the cable length. This cable has a large reflectance at the end since it is a bare cut (no splice or termination), causing the reading to fail in this scan. Attaching another splice to the other end greatly diminishes the reflection at the opposite end.

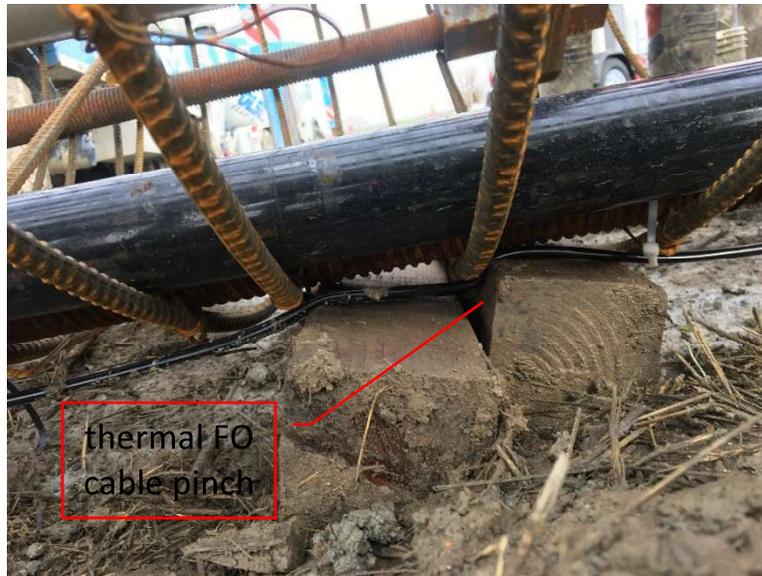
Figure 4-22: Thermal fiber optic cable pinched under reinforcement during handling prior to installation

None of the installed distributed fibers were broken during installation, including a section of temperature cable that was pinched between the reinforcement and cribbing during handling of the cage prior to picking. A photo of the kink in the cable is shown in Figure 4-22. After the cage was repositioned, an integrity test was performed on the cable using the OTDR which showed no breakage or loss at the pinch point.

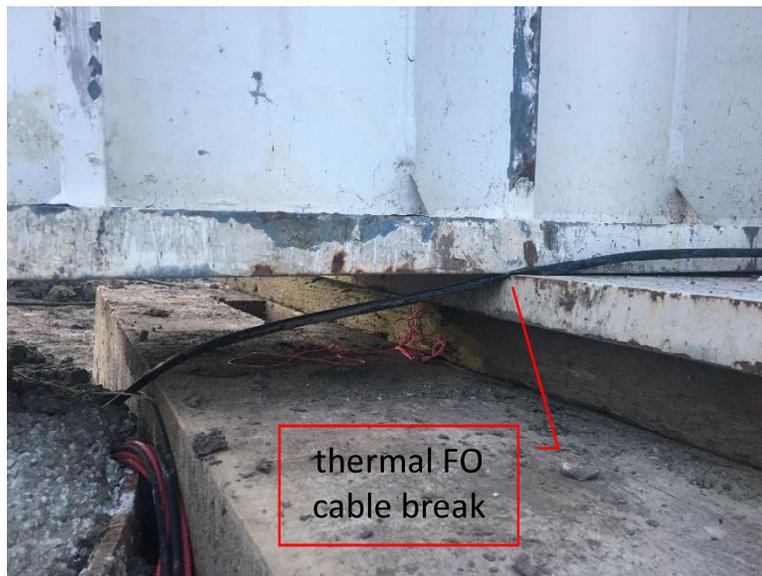
Figure 4-23: Thermal fiber optic cable severed by load frame

The only breakage of a cable occurred during the load test of test pile T3. During the penultimate unload cycle, the load frame, which had previously lifted off its cribbing due to the high reaction force from the applied load, settled onto a section of thermal cable which had shifted slightly during the test. The cable was caught on a sharp edge between the two steel pieces, severing the fiber optic core. A close-up of the break is shown in Figure 4-23.

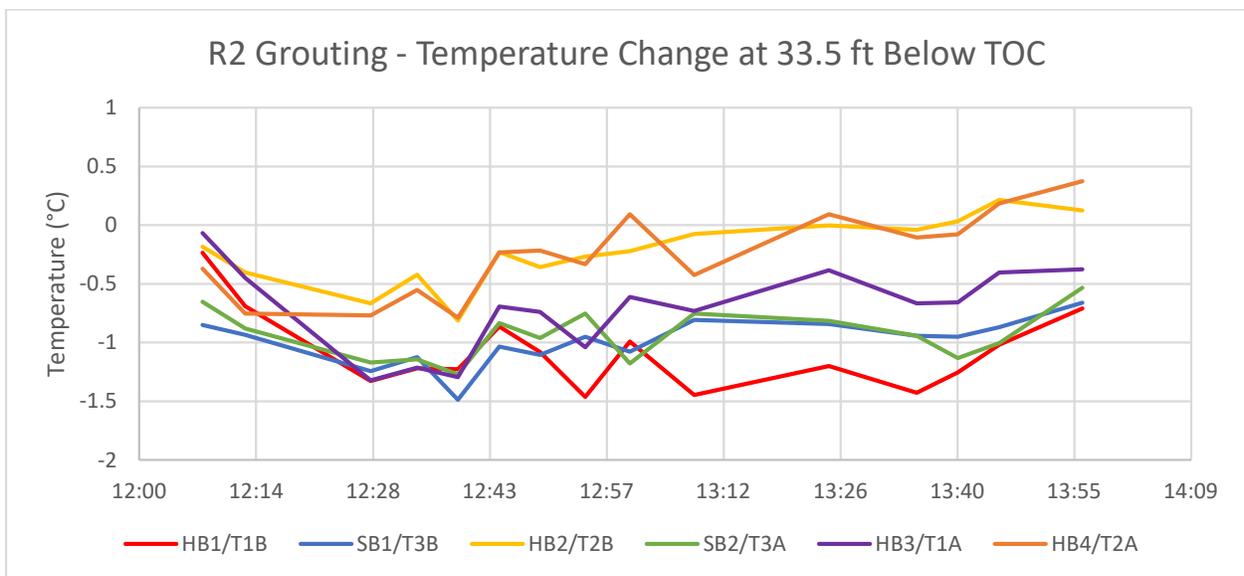
Figure 5-1: Temperature change in shaft R2 during grouting

Converting into strain using the thermal coefficients of the strain cable, this corresponds to an associated range of thermally-induced strains of 32-96 $\mu\epsilon$. For illustration, the temperature readings taken during the base grouting of shaft R2 (open-type system) are shown in Figure 5-1

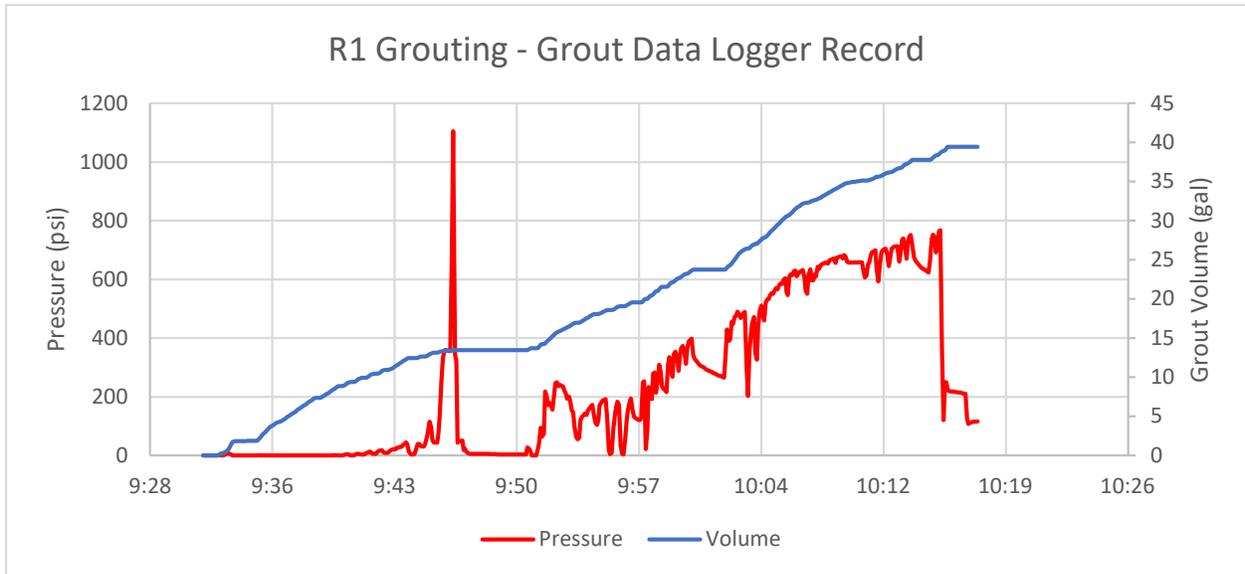
Figure 5-2: R1 grouting, grout data logger record

Reaction Shaft R1 was grouted on February 6, 2019. The grout data logger record of pressure and volume at the grout plant is presented in Figure 5-2. After some problems with the grout plant, including a pressure spike 9:46, grouting of the pile began at 9:51. The pressure was initially attempted to be held at 200 psi at 9:52, after which subsequent holds were attempted at 600 psi at 10:08 and 800 psi at 10:16. At 800 psi, a vent cap at the top of the pile burst off and a stream of water was released, dropping the pressure in the line to 250 psi and pumping was stopped. The measured volumes are not adjusted for the initial flush or grout in the lines and therefore represent an upper bound of the volumes placed at the pile base.

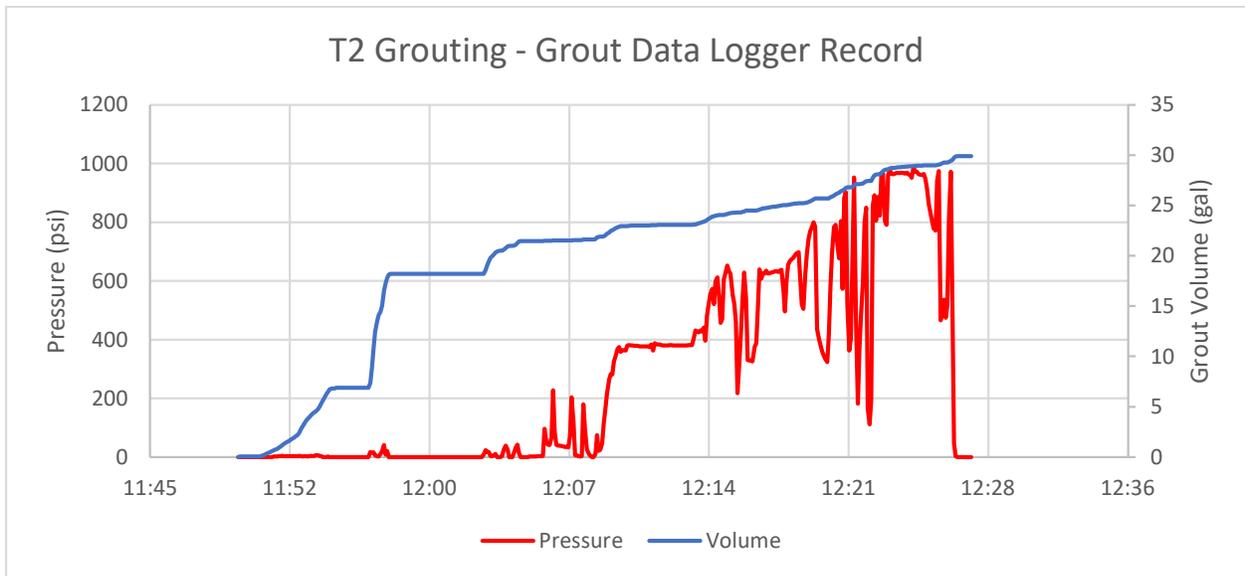
Figure 5-8: T2 grouting, grout data logger record

Test Shaft T2 was grouted on February 6, 2019. The grout data logger record of pressure and volume at the grout plant is presented in Figure 5-8. Grouting of the pile with all return valves commenced at 12:08. An initial pressure hold was performed at 400 psi at 12:11. A second hold at 600 psi at 12:14 was performed with pressures fluctuating widely between 500 and 700 psi. A peak pressure of 965 psi was observed at 12:24 prior to a vent cap burst at 12:27 at which point the pressure dropped to 0 psi and pumping was stopped. The measured volumes are not adjusted for the initial flush or grout in the lines and therefore represent an upper bound of the volumes placed at the pile base.

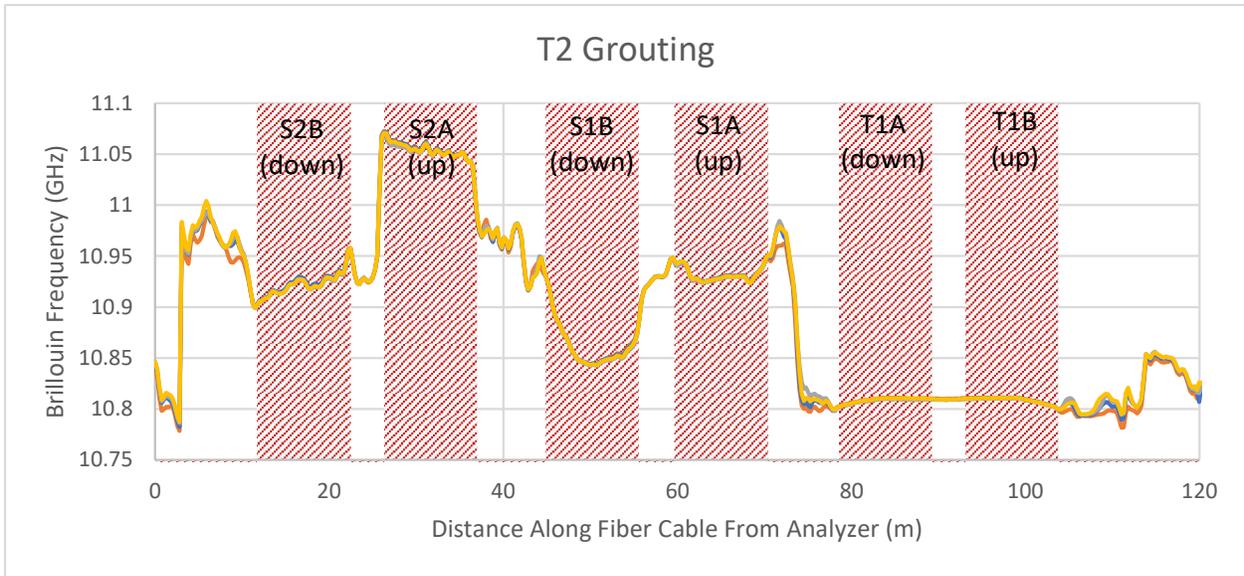
Figure 5-9: T2 grouting, raw Brillouin frequency

The fiber optic record for shaft T2 is divided into 4 strain verticals and 2 temperature verticals. The raw frequency and segment divisions are shown in Figure 5-9.

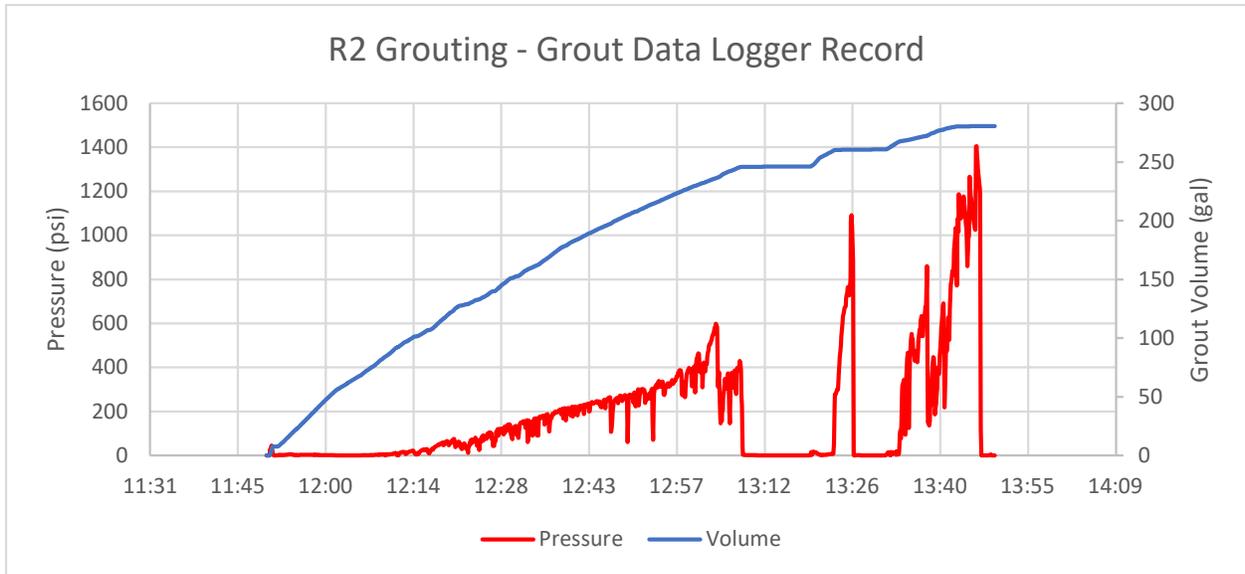
Figure 5-14: R2 grouting, grout data logger record

Reaction Shaft R2 was grouted on February 7, 2019. The grout data logger record of pressure and volume at the grout plant is presented in Figure 5-14. Grouting was performed on three circuits, with the center circuit primed and grouted first. Grouting on the center circuit with the return valve closed began at 12:10 and continued to 13:08, at which time grouting was switched to the south circuit. The south circuit was grouted for approximately 4 minutes from 13:23 to 13:27. At 13:27, grouting was switched to the north circuit. The north circuit was grouted from 13:33 to 13:47, at which time grouting was ceased. The measured volumes are not adjusted for the initial flush or grout in the lines and therefore represent an upper bound of the volumes placed at the pile base.

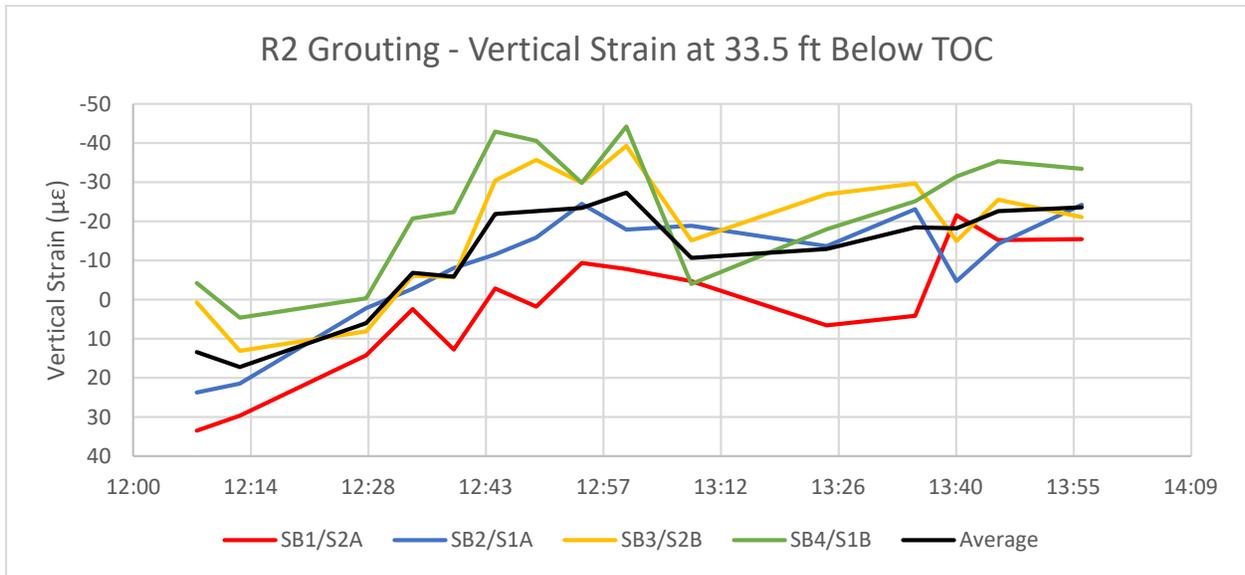
Figure 5-16: R2 grouting, vertical strains at 33.5 feet below TOC

grouting was ceased on the center circuit at 13:08, the average strain remained between 10 and 25 $\mu\epsilon$. The strains on SB1, which were shown as approximately 35 $\mu\epsilon$ in tension shortly after the start of the water and grout flush, showed an increase of 25 $\mu\epsilon$ in compression during the final grouting on the north circuit, potentially indicating that the grout injection at this point was still having an effect at the base of the pile. The final readings after the pressure was released show little immediate decay of the prior strains.

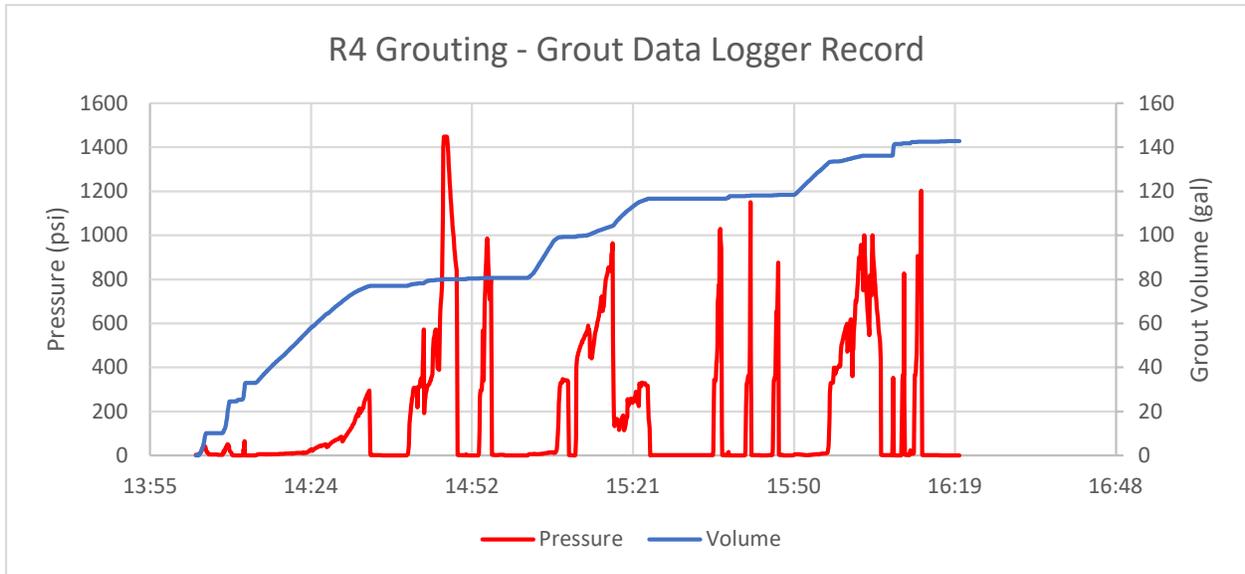
Figure 5-20: R4 grouting, grout data logger record

Reaction Shaft R4 was grouted on February 6, 2019. Grouting was performed on three circuits, with the center circuit primed and grouted first. The grout data logger record of pressure and volume at the grout plant is presented in Figure 5-20. Grouting on the center circuit began at 14:05, with multiple starts and stops as leaks developed and pressure spikes were observed at the grout plant. The grout line was switched to the south circuit at 15:03 and continued until 15:42 with multiple pressure spikes at or above 1000 psi, at which point the grout line was switched to the north circuit. Grouting on the north circuit was performed from 15:56 to 16:09, at which point grouting was halted on the pile. The measured volumes are not adjusted for the initial flush or grout in the lines and therefore represent an upper bound of the volumes placed at the pile base.
