1. REPORT NUMBER CA21-3021	2. GOVERNMENT ASSOCIATION NUMBER	3. RECIPIENT'S CATALOG NUMBER
4. TITLE AND SUBTITLE Fiber Optic Monitoring of Base Grouted Piles	5. REPORT DATE July, 2021	
	6. PERFORMING ORGANIZATION CODE	
7. AUTHOR R.A. Yeskoo, K. Soga	8. PERFORMING ORGANIZATION REPORT NO. n/a	
9. PERFORMING ORGANIZATION NAME AND ADDRESS UC Berkeley Berkeley CA.	10. WORK UNIT NUMBER	
	11. CONTRACT OR GRANT NUMBER Contract No. 65A0645	
12. SPONSORING AGENCY AND ADDRESS California Department of Transportation (Caltrans) Division of Research, Innovation & System Information, MS-83 2963 R Street, Sacramento CA 95816	13. TYPE OF REPORT AND PERIOD COVERED Final Report	
	14. SPONSORING AGENCY CODE

This report documents the field application of distributed fiber-optic strain (DFOS) sensing for measuring strain in drilled shaft foundations. Nine 5-foot diameter reaction shafts and four 3-foot diameter test shafts were subjected to base grouting. Following several weeks of set-up the test shafts were then loaded from the top in a conventional quasi-static load test. Distributed fiber optic strain sensing techniques were used to measure strain along the entire shaft length along four separate fi

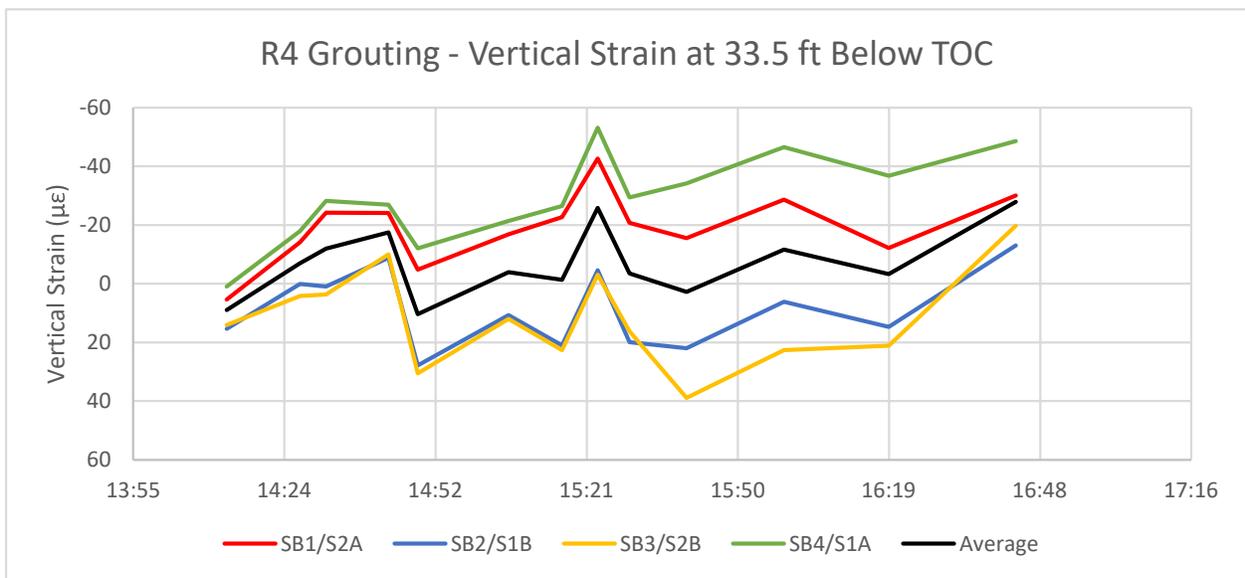
Figure 5-22: R4 grouting, vertical strains at 33.5 feet below TOC

major strain spike is observed at 15:23, after pumping had switched to the south circuit with a pressure dropping sharply from 900 psi to 150 psi. At this time water was noted returning from HB2 (not connected to any of the grout circuits). Although this spike was observed on all strain verticals, SB2 and SB3 were observed to be in slight tension while SB 1 and SB4 were observed in compression, implying that there was non-uniform loading at the base of the pile. The strains roughly plateaued during pumping on the north circuit. However, they showed a sharp increase of an average of 22 $\mu\epsilon$ in compression approximately 30 minutes after the stop of pumping. It is unclear to what this rise in strain is attributed to.

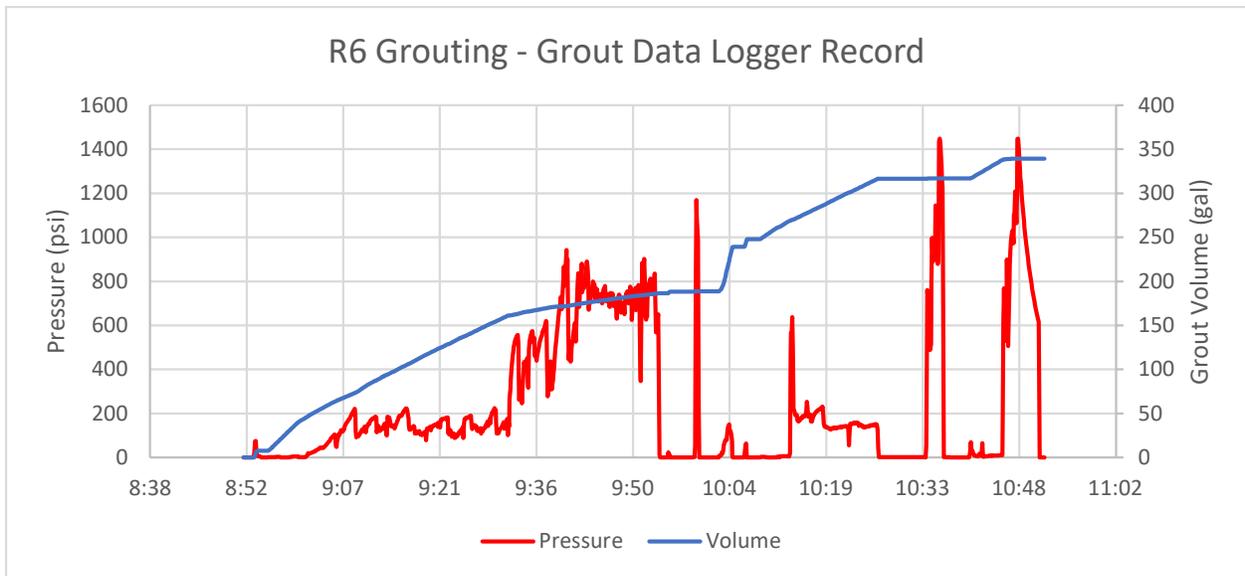
Figure 5-26: R6 grouting, grout data logger record

Reaction Shaft R6 was grouted on February 8, 2019. The grout data logger record of pressure and volume at the grout plant is presented in Figure 5-26. Grouting was performed on three circuits, with the center circuit primed and grouted first. Grouting on the center circuit began at 9:01 and continued through 9:59. The grout line was switched to the south circuit at 9:59 and continued until 10:35, at which point the grout line was switched to the north circuit. Grouting on the north circuit was performed from 10:46 to 10:51, at which point grouting was halted on the pile. The measured volumes are not adjusted for the initial flush or grout in the lines and therefore represent an upper bound of the volumes placed at the pile base.

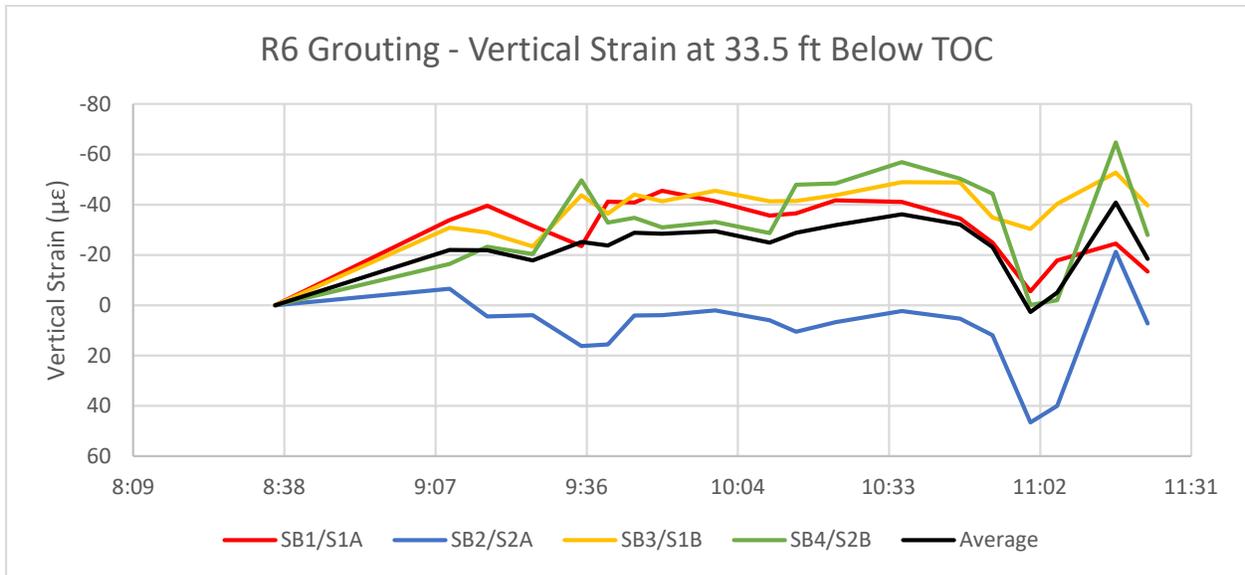
Figure 5-28: R6 grouting, vertical strains at 33.5 feet below TOC

SB4 increased again at 10:15, immediately after pumping had switched to the south circuit. Strains in SB1 and SB3 were generally consistent with those on SB4 during this time, with strains on SB2 remaining at or just below 0 $\mu\epsilon$. A major drop in compressive strain was observed at 11:00 on all 4 verticals immediately following the venting of all circuit valves on the pile after the conclusion of grouting. These strains rebounded somewhat in further readings, with a final measured average strain in the pile of 20 $\mu\epsilon$, +/- 20 $\mu\epsilon$ at 11:22.

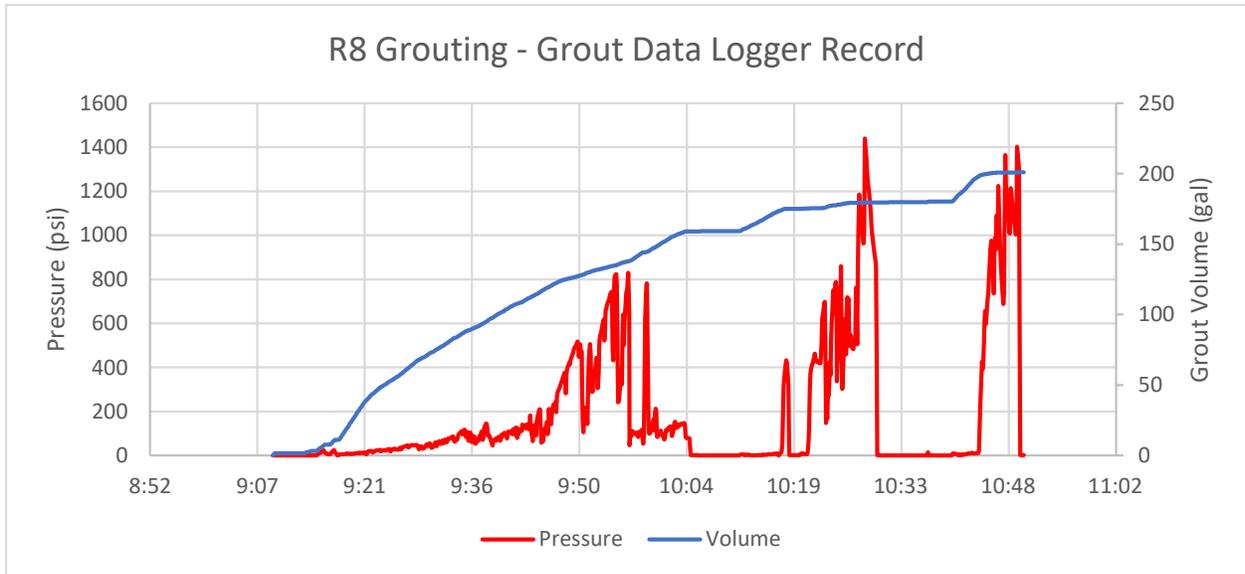
Figure 5-32: R8 grouting, grout data logger record

Reaction Shaft R8 was grouted on February 7, 2019. The grout data logger record of pressure and volume at the grout plant is presented in Figure 5-32. Grouting was performed on three circuits, with the center circuit primed and grouted first. Grouting on the center circuit with the return valve closed was performed from 9:21 to 10:05. The grout line was switched to the south circuit and was grouted from 10:17 through 10:28. The grout line was then switched to the north circuit, which was grouted from 10:43 to 10:49, after which grouting was concluded. The measured volumes are not adjusted for the initial flush or grout in the lines and therefore represent an upper bound of the volumes placed at the pile base.

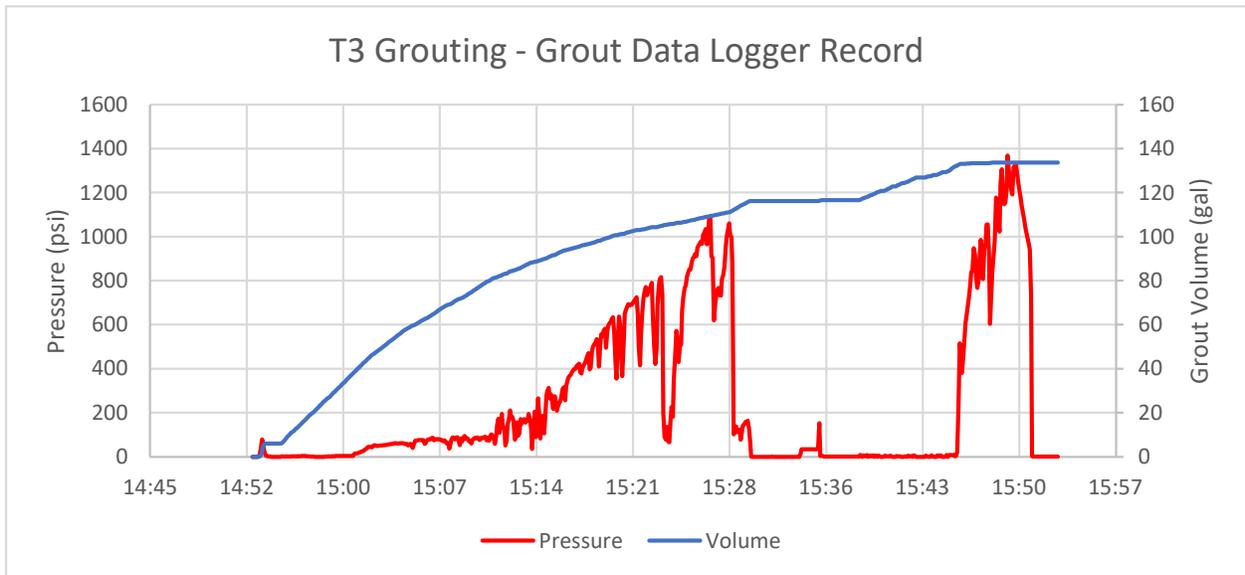
Figure 5-38:: T3 grouting, grout data logger record

Test Shaft T3 was grouted on February 7, 2019. The grout data logger record of pressure and volume at the grout plant is presented in Figure 5-38. Grouting was performed on two circuits, with the east circuit primed and grouted first. Grouting on the east circuit with the return valve closed was performed from 15:09 to 15:30. The grout line was switched to the northwest circuit and was grouted from 15:45 through 15:51, at which point grouting was halted. The measured volumes are not adjusted for the initial flush or grout in the lines and therefore represent an upper bound of the volumes placed at the pile base.

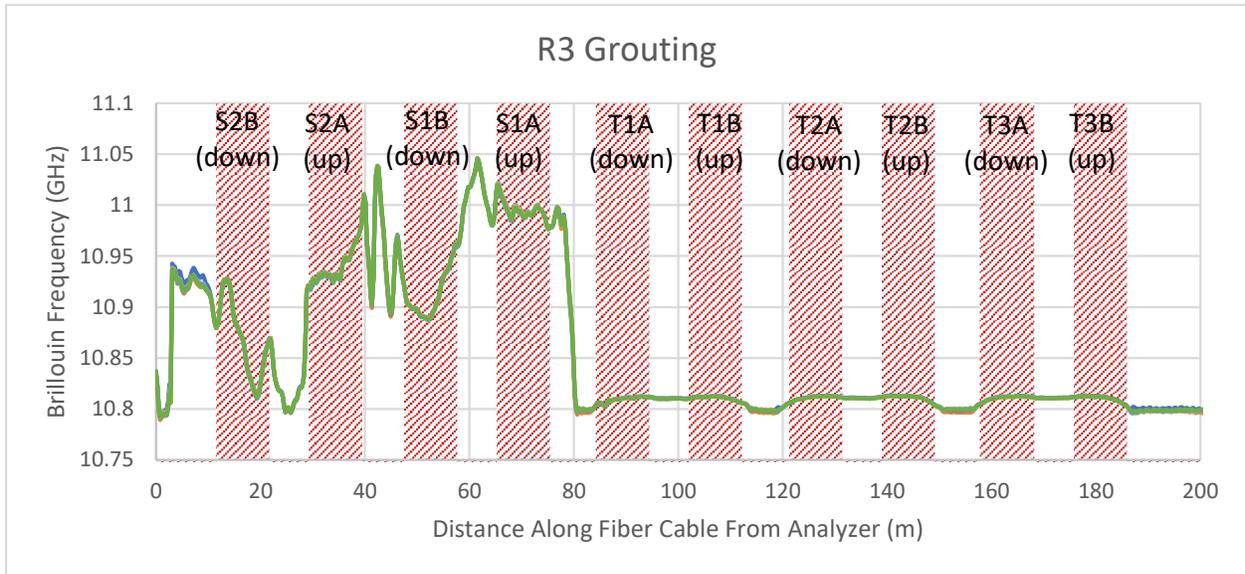
Figure 5-45: R3 grouting, raw Brillouin frequency

The fiber optic record for shaft R3 is divided into 4 strain verticals and 6 temperature verticals. The raw frequency and segment divisions are shown in Figure 5-45.

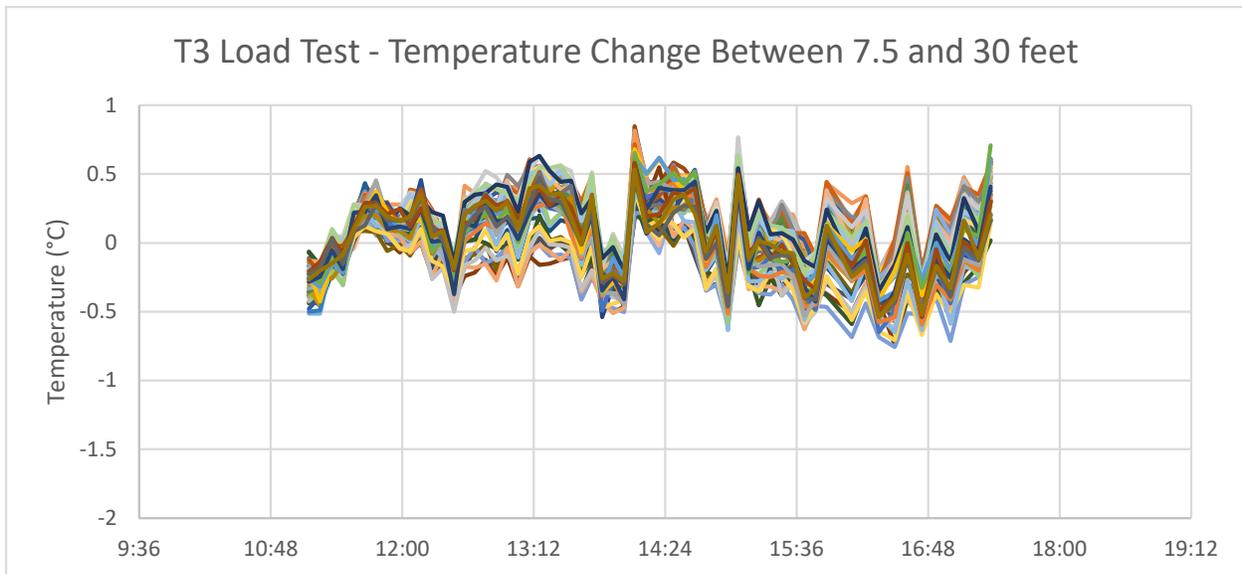
Figure 6-2: Recorded temperature variation in Test Pile T3 during load test

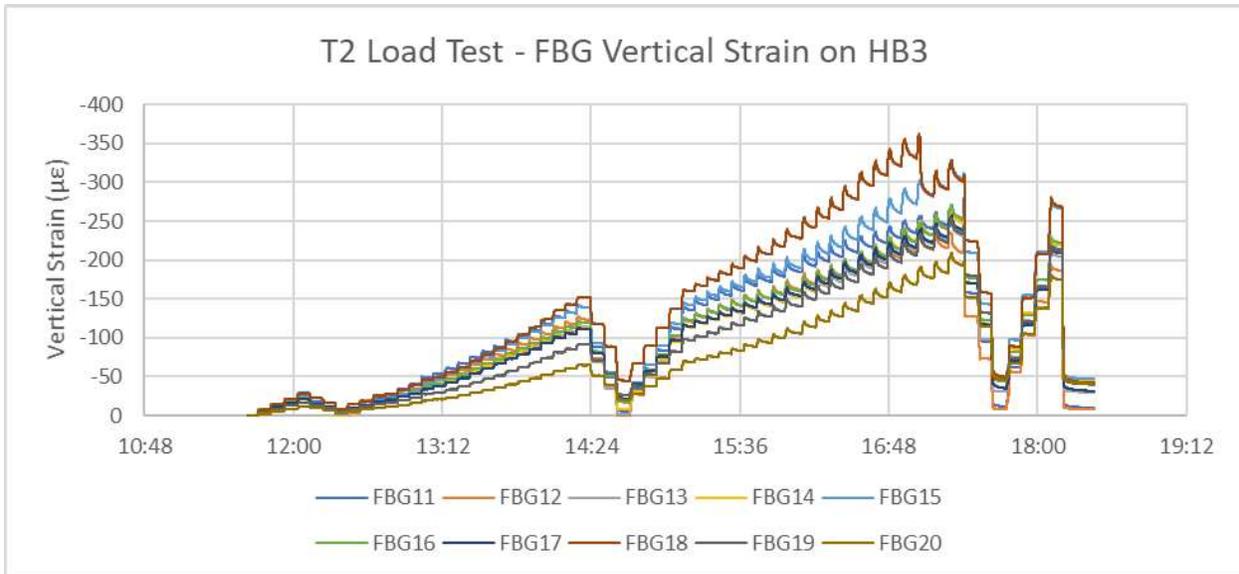
Figure 6-22: T2 load test FBG fiber optic strain readings over time

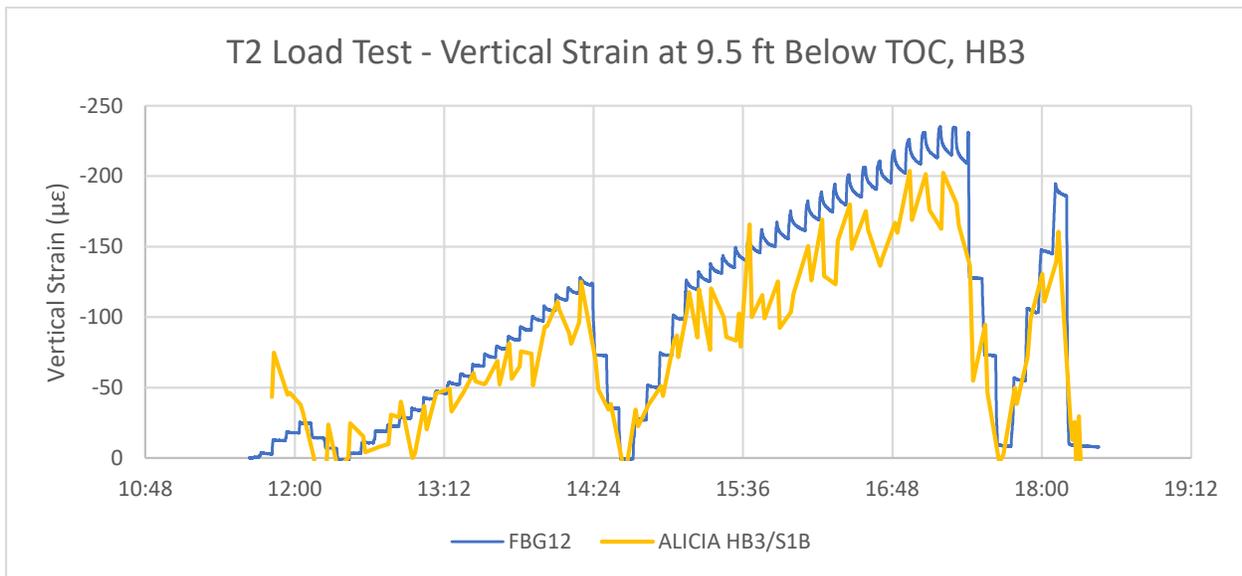
Figure 6-23: Point and distributed T2 vertical strain at 9.5 ft below top of casing over time

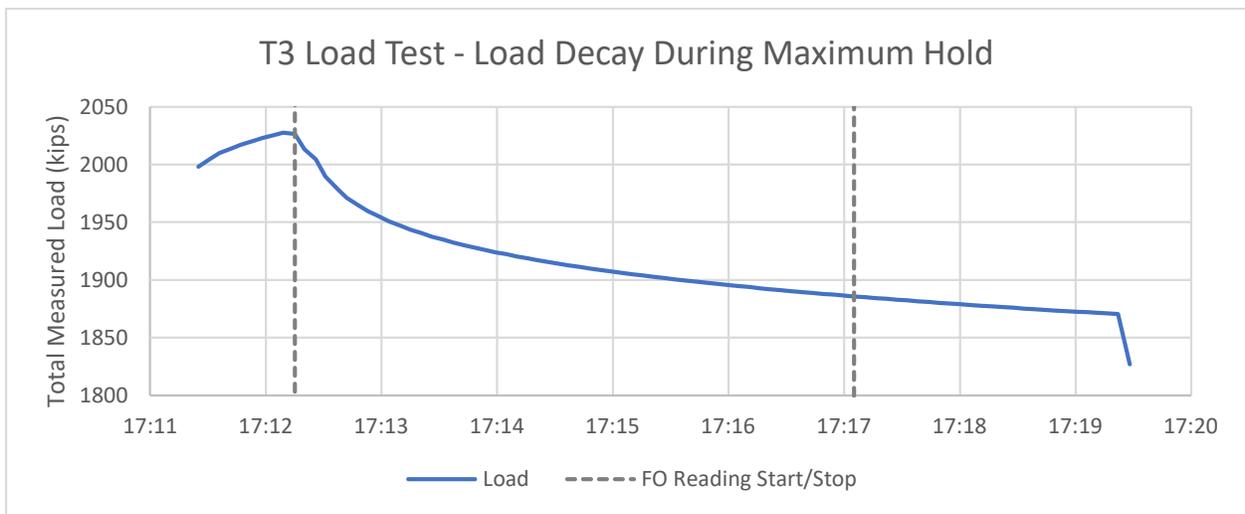
Figure 7-49: Load decay during peak interval in T3 load test

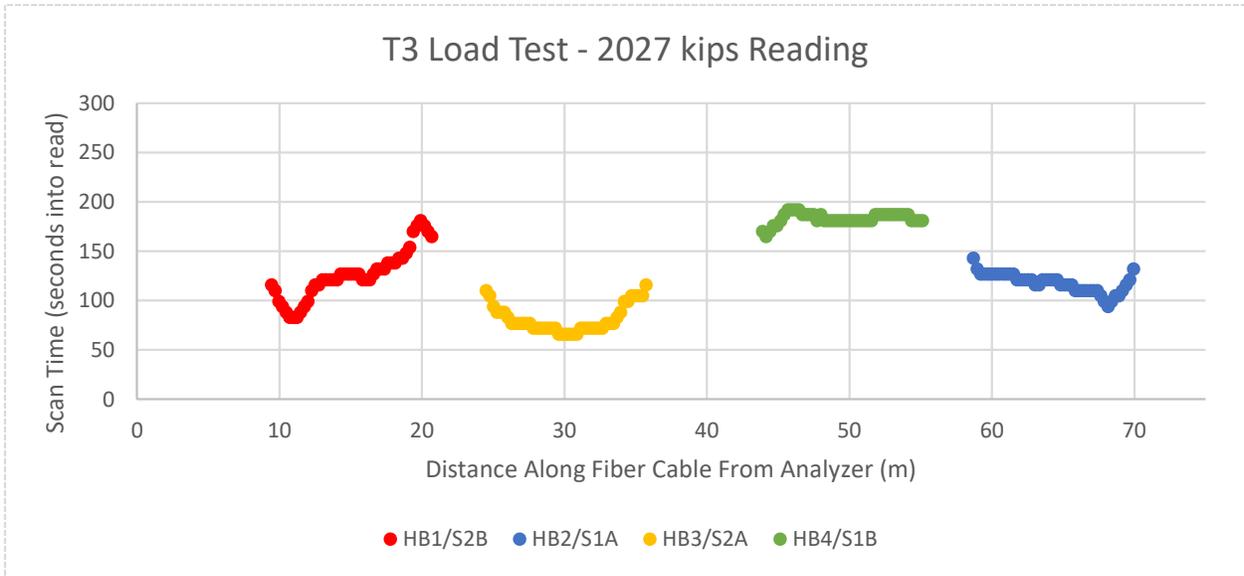
Figure 7-52: Scan time of each reading point within the 4 strain verticals
