1. REPORT NO. <b>FHWA/CA22-3033</b>	2. GOVERNMENT ACCESSION NO.	3. RECIPIENT'S CATALOG NO.	
4. TITLE AND SUBTITLE DEVELOPMENT AND CRASH TESTING OF A STEEL POST-AND-BEAM BRIDGE RAILING, CALIFORNIA ST-75		5. REPORT DATE August 2022

16. ABSTRACT  Three full-scale crash tests of the California ST-75 Bridge Rail (ST-75) were completed to meet the Implementation Agreement for Manual for Assessing Safety Hardware (MASH) 2016. California Department of Transportation (Caltrans) needed a MASH 2016 compliant steel post and beam bridge rail to replace existing NCHRP Report 350 (Report 350) rails. The July 2019 Caltrans "MASH Implementation for California Bridge Railings" identified the ST-75 as a design intended to replace existing Caltrans bridge rails: the ST-10, ST-20S, ST-30 and the ST-70.  The ST-75 is a 914 mm (36 in) vehicular and a 1067 mm (42 in) high combination (vehicular and bicycle) bridge rail. The rail elements are ASTM A500/A500M, Grade B, hollow structural 203 mm x 102 mm x 8 mm (8 in x 4 in x 5/16 in) sections bolted to A709 Grade 36 steel posts. The post spacing is 3m (10 feet) and are anchored using ASTM F1554, Grade 105, bolts to a 6-inch-high concrete curb. The tested ST

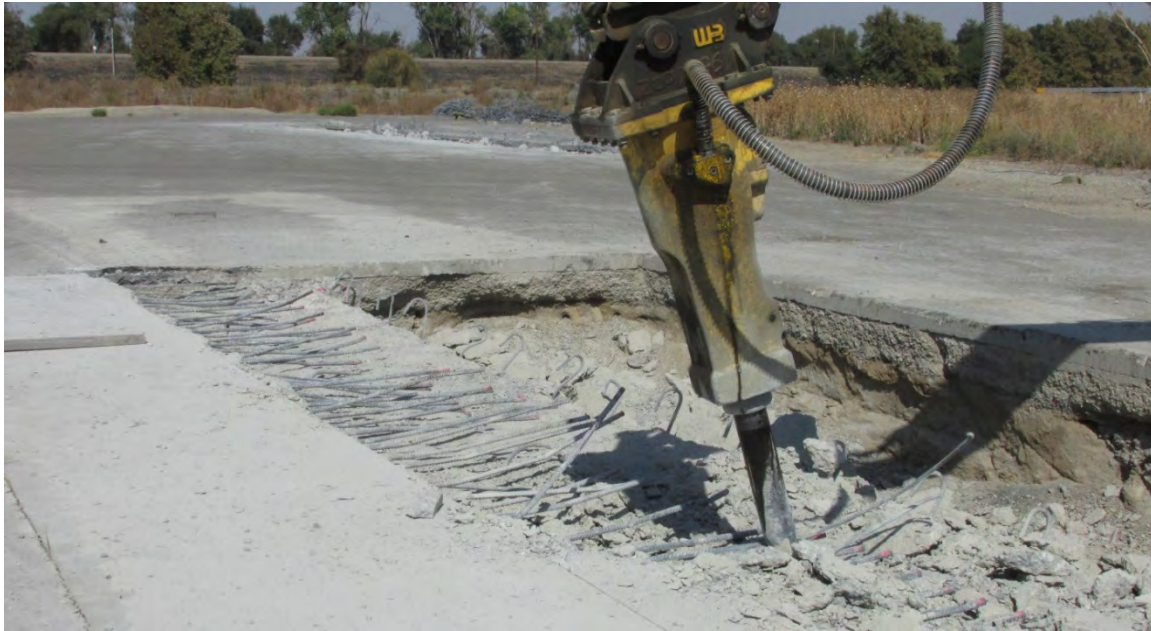
**Figure 2-2 Top 12 Inches of Concrete Being Removed from Anchor Block**

Construction was completed in different stages. First, the existing simulated bridge deck and top 305 mm (12 in) of concrete of the existing anchor block were removed. The concrete slab foundation for the downstream end was then constructed, leaving rebar and anchor bolts exposed for future construction of the concrete curb and installation of the ST-75 steel bridge rail. Then, after addition of new rebar for the ST-75 bridge rail, the next concrete pour was to repair the top 305 mm (12 in) of the anchor block and construct the new bridge deck, again leaving rebar and anchor bolts exposed for future construction of the concrete curb and installation of the ST-75 steel bridge rail. Each concrete pour was sampled and cast into standard 152 mm x 305 mm (6 in x 12 in) cylinders for testing. The minimum 28-day concrete for any of the three concrete pours was 38 MPa (5,500 psi). A615 Grade 60 rebar with a tested yield strength of approximately 63 ksi (434 MPa) minimum was used for reinforcement. The ST-75 posts were A709 Grade

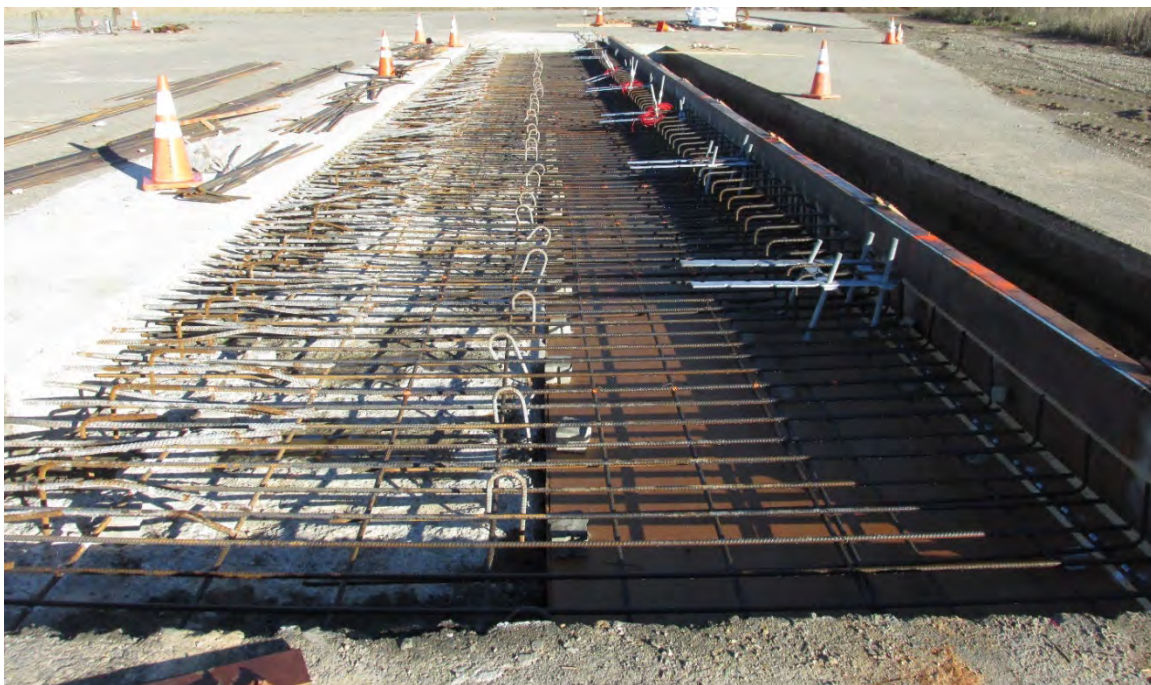
**Figure 2-3 Rebar and Strain Gauges in Place for Anchor Block Concrete Replacement and Deck Overhang**

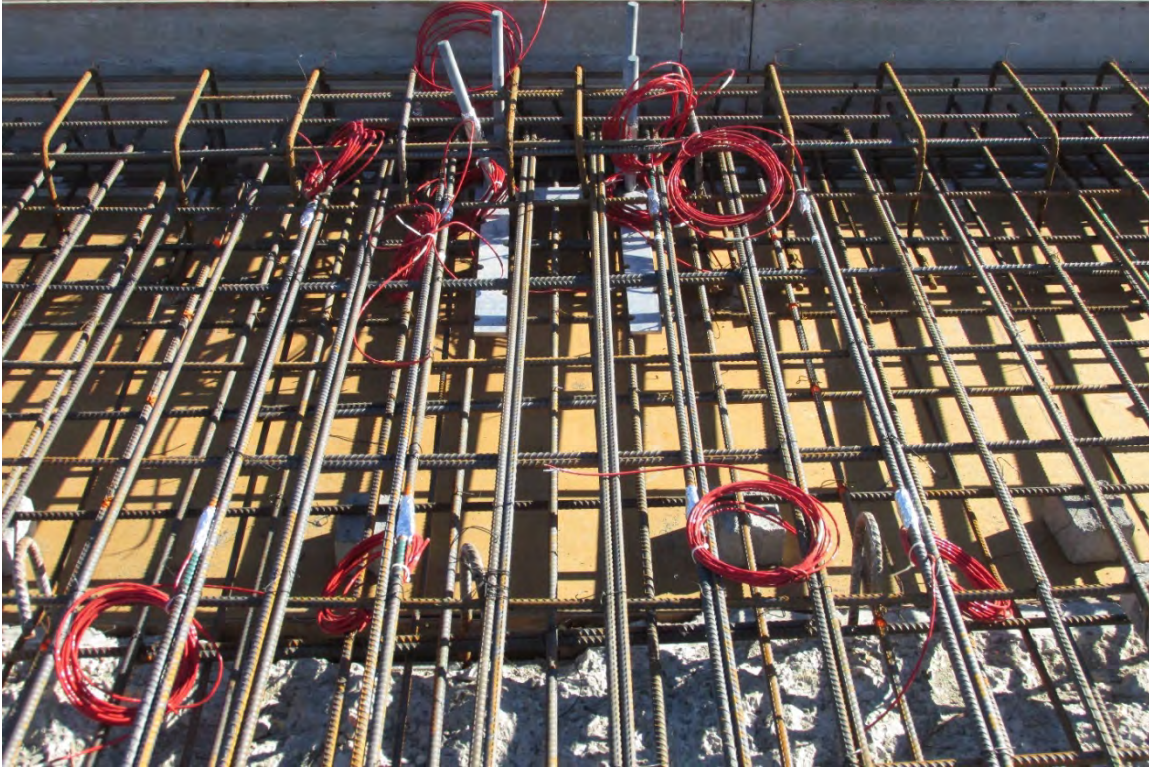
**Figure 2-4 Uniaxial Strain Gauges and Cable Prior to Deck Pour**

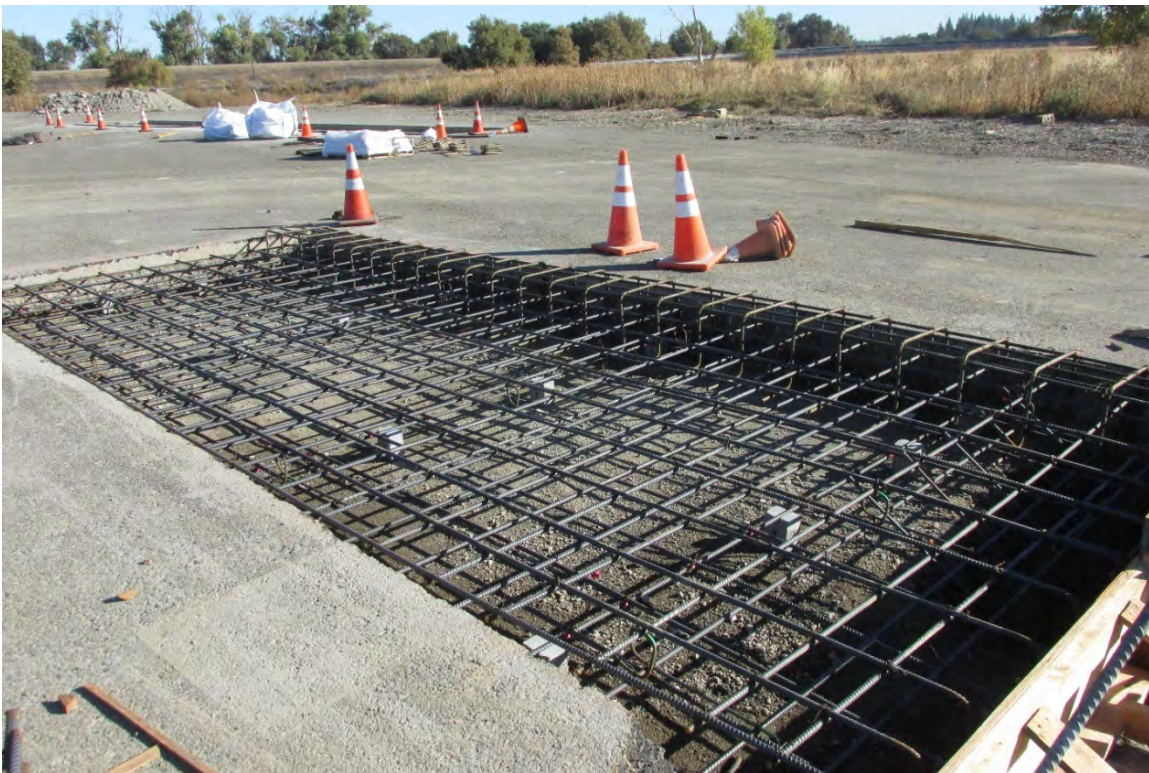
**Figure 2-5 Rebar in Slab Footing for Downstream Section**

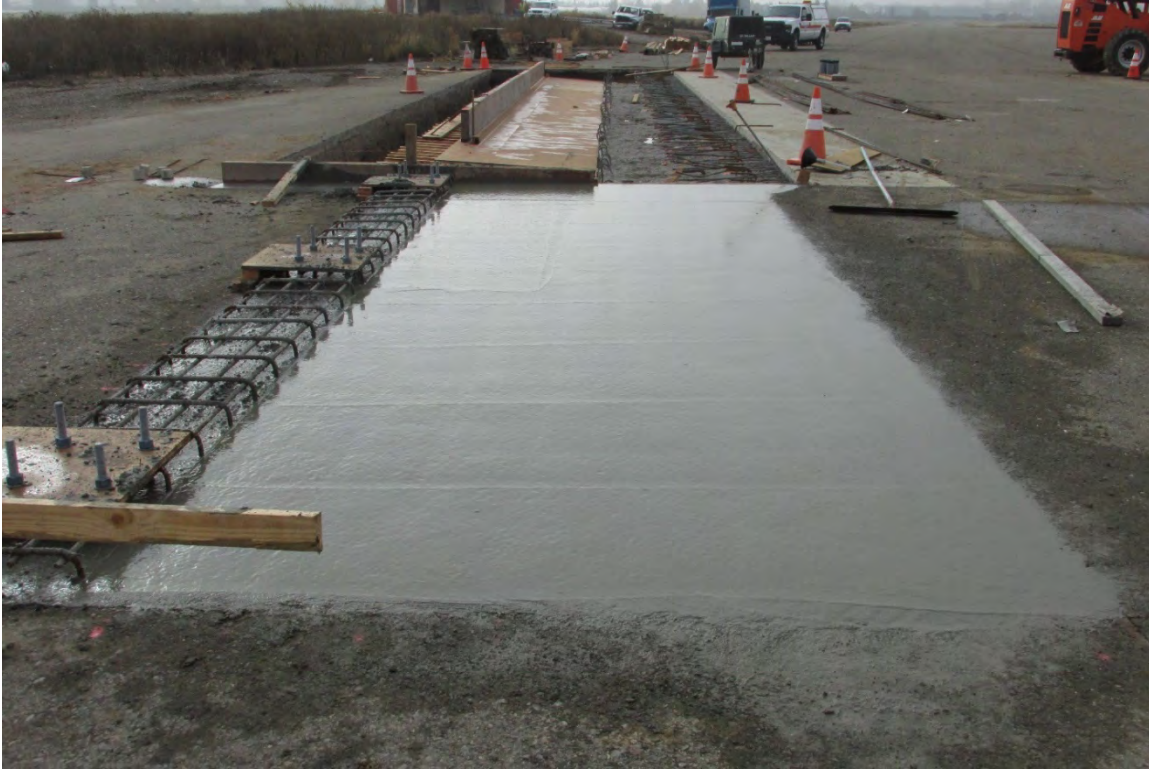
**Figure 2-6 Downstream Section on Slab Complete**

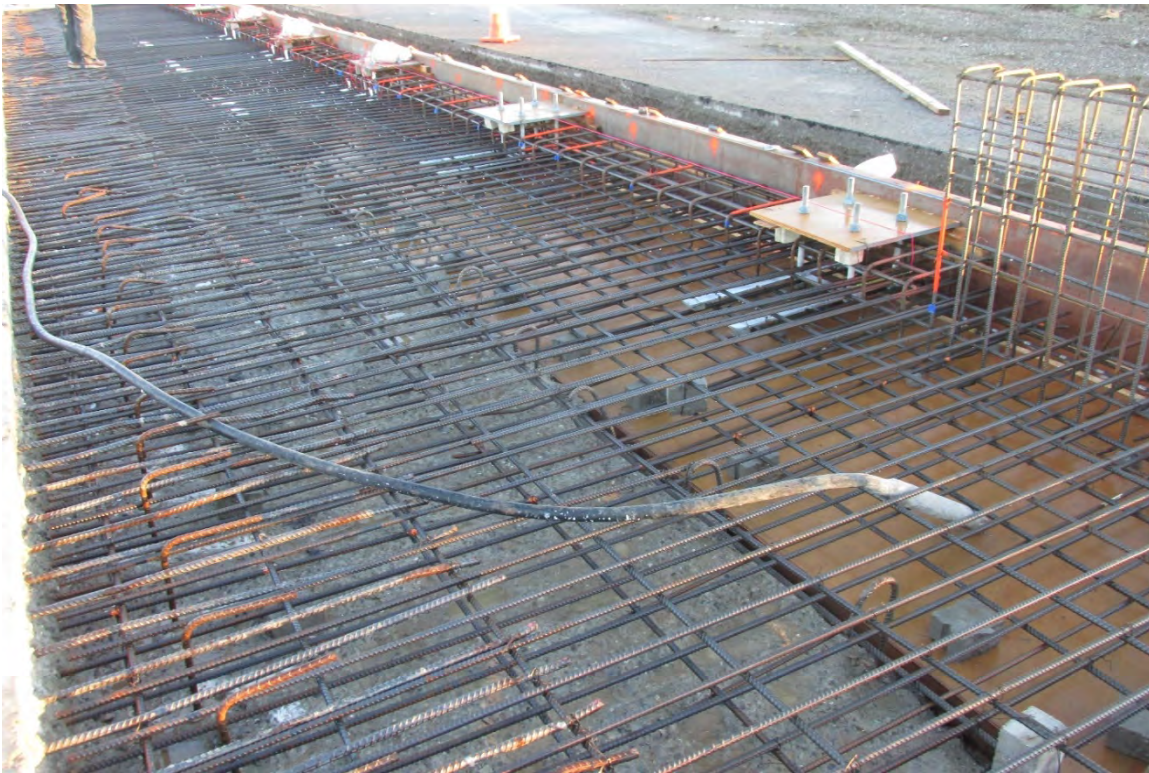
**Figure 2-7 Reaction Block and Deck Rebar in Place for Concrete Pour**

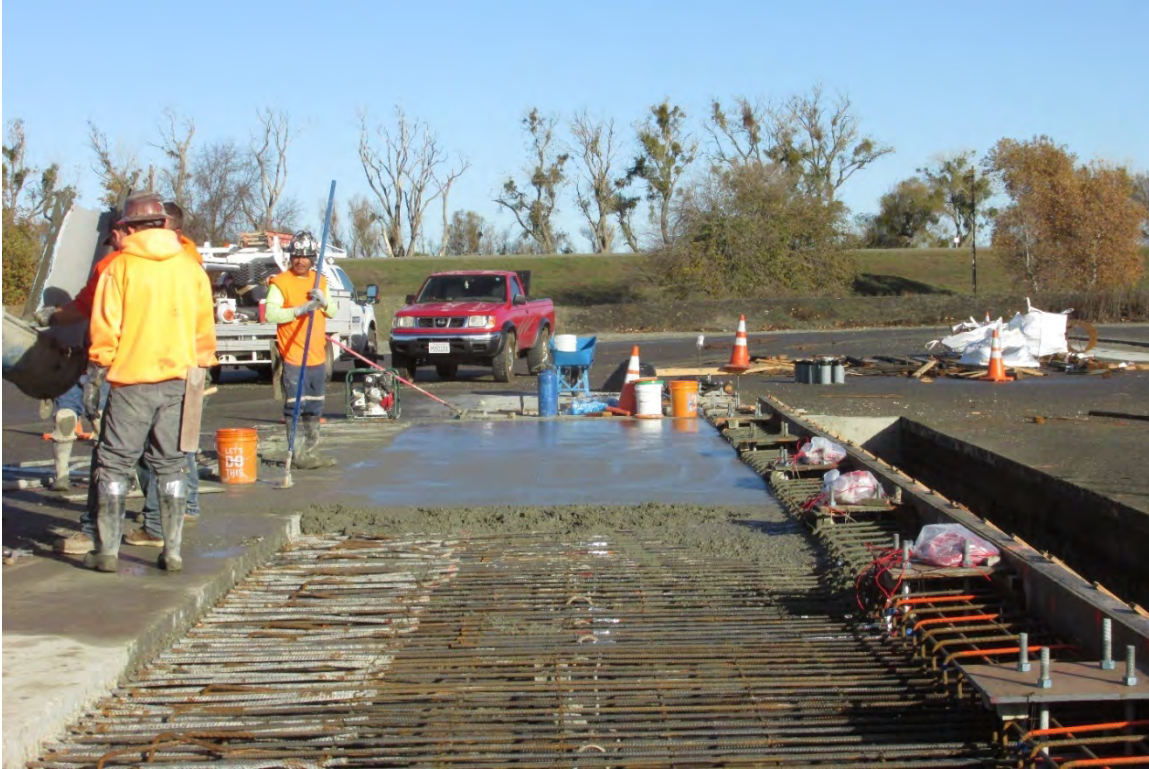
**Figure 2-8 Formwork and Rebar in Place for Simulated Deck Concrete Pour**

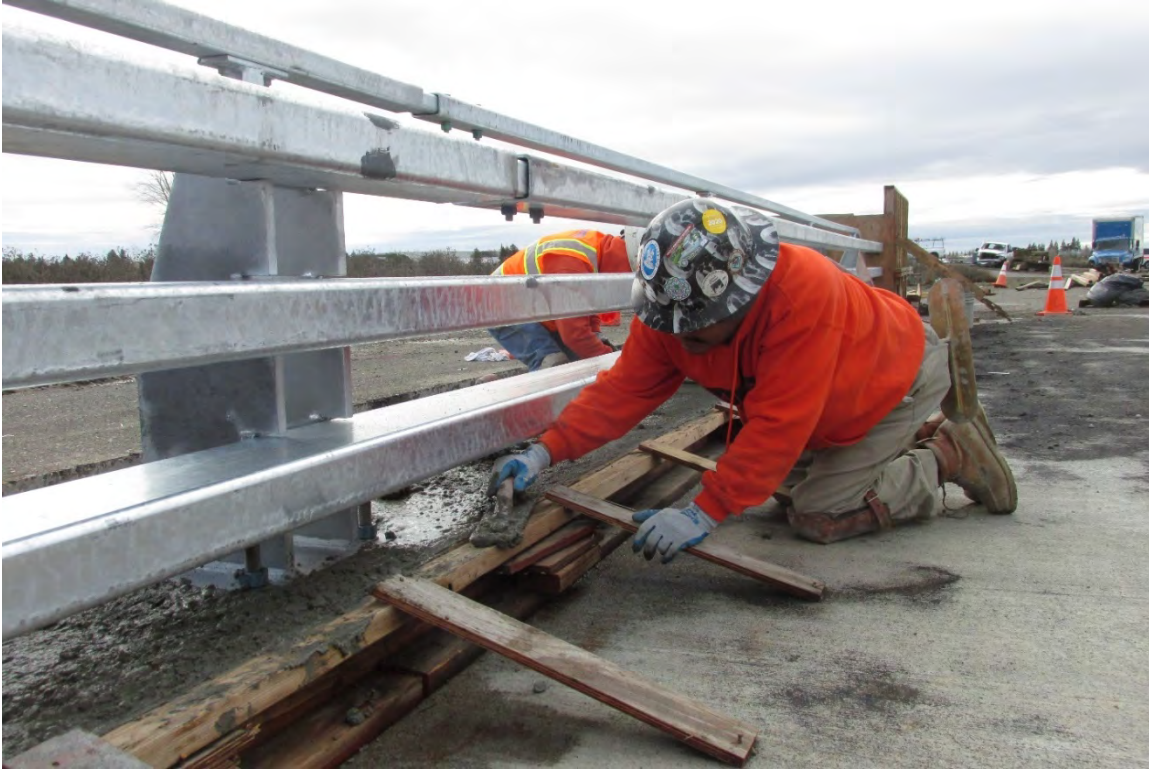
**Figure 2-10 Bridge Rail Curb Concrete Pour**

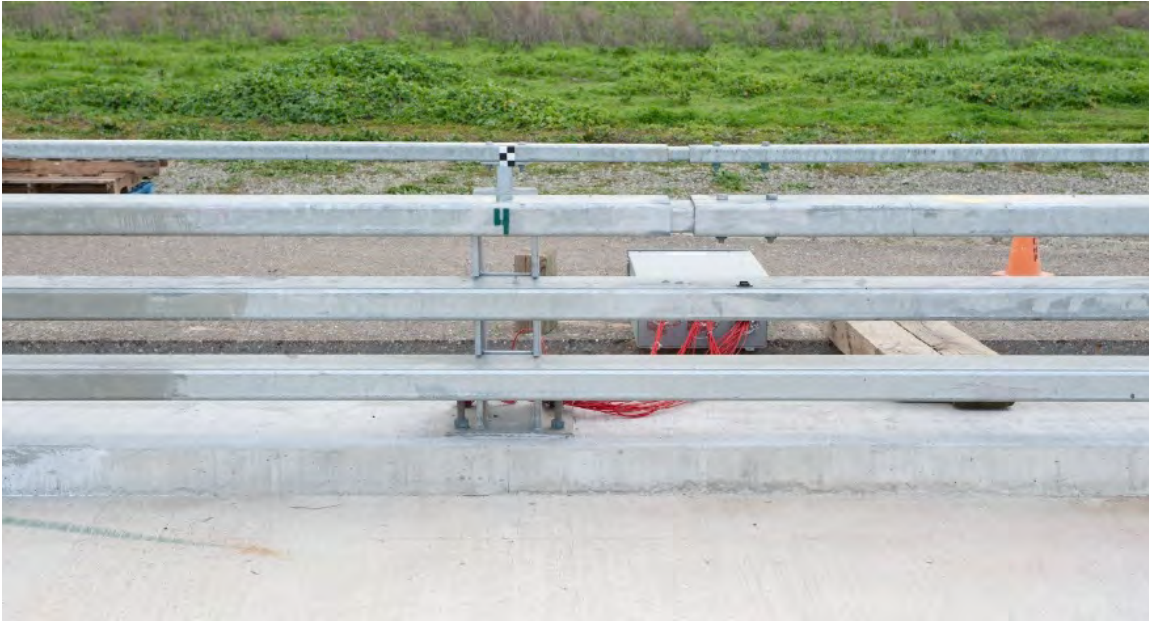
Figure 5-1 Test Article Impact Area Pre-Test 4-10

The Critical Impact Point selected was 3.6 ft (1.1 meters) upstream from the centerline of post 4, as recommended in Table 2-7 of MASH 2016 (AASHTO, 2016). The impact angle of 25° was set with a Total Station. The intended impact speed was 100 kph (62 mph).

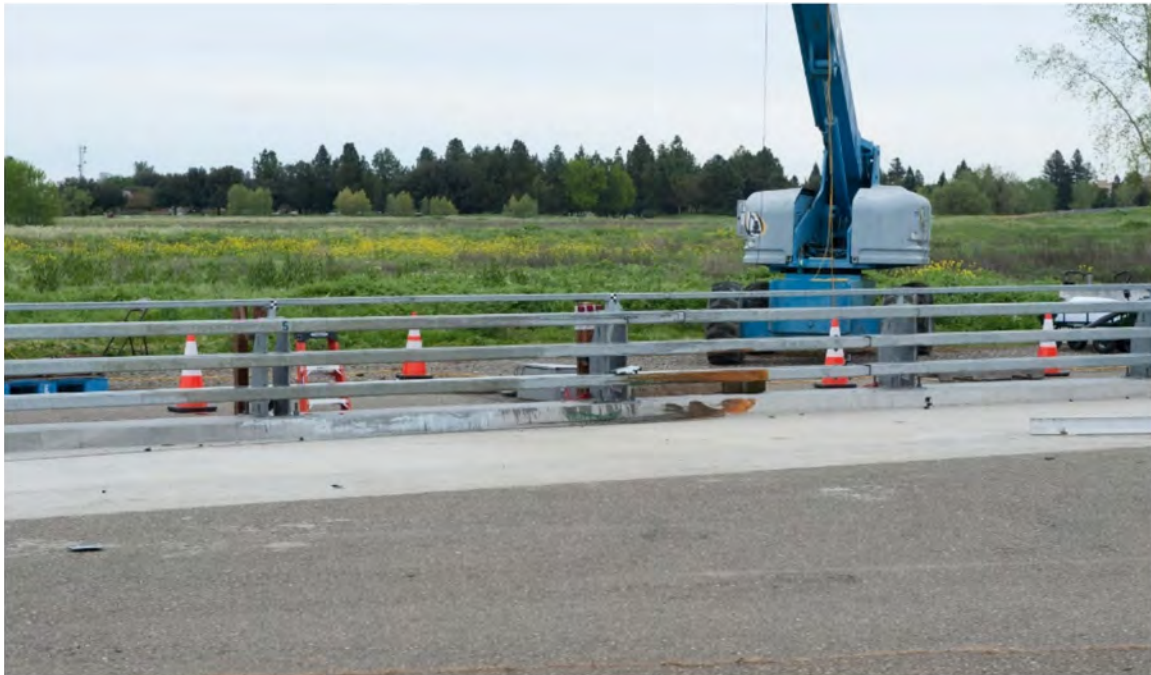
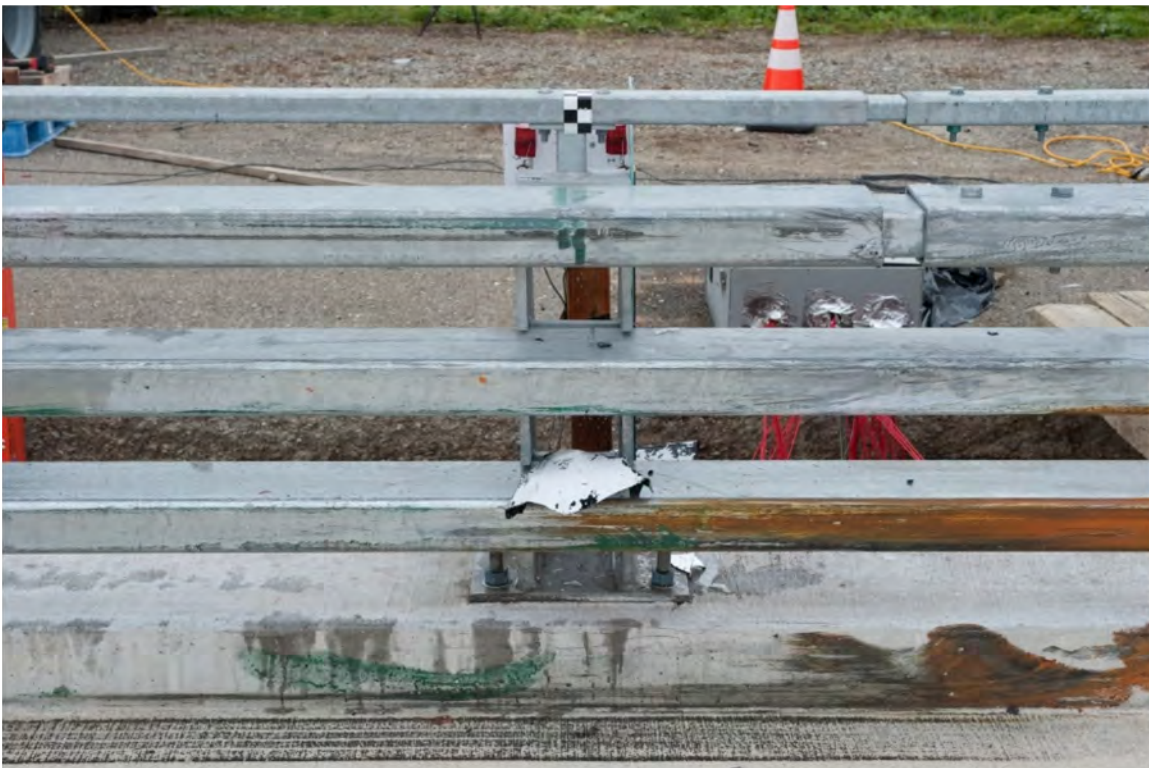
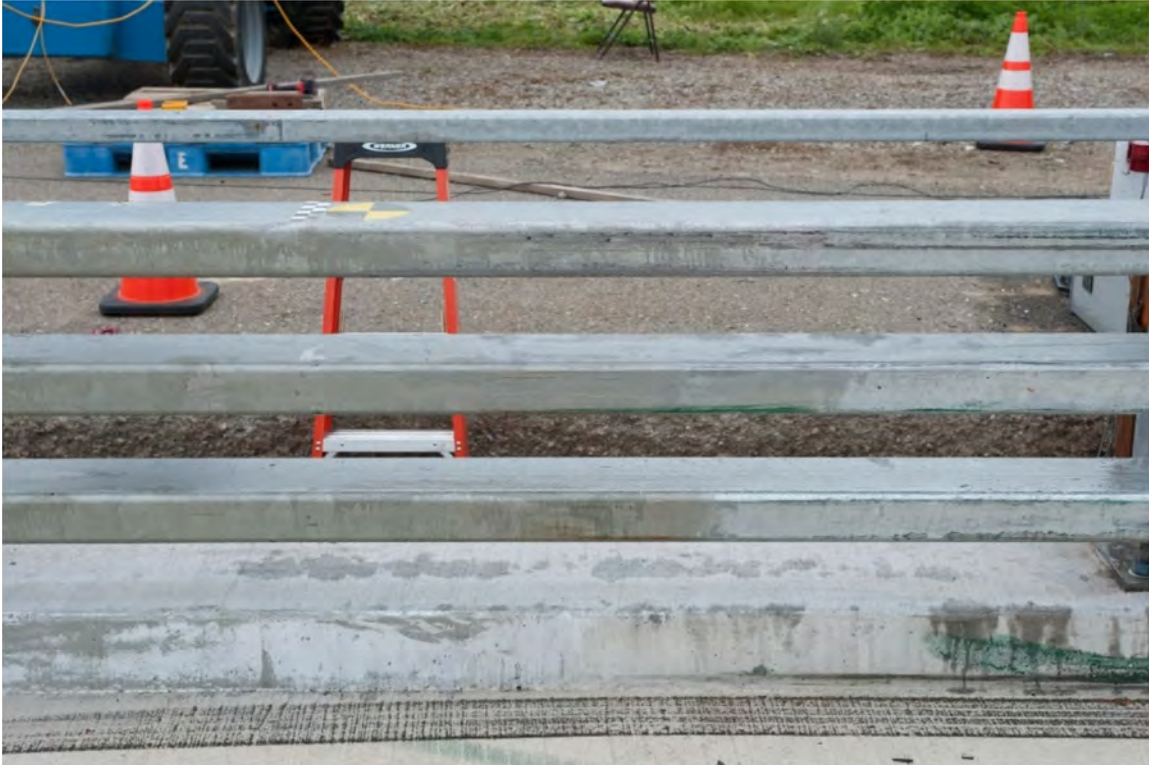
**Figure 5-6 Test 4-10 Overview of Barrier Post-Test**

**Figure 5-8 Test 4-10 Post 4 Post-Test**

**Figure 5-9 Test 4-10 Downstream of Post 4 Post-Test**

There was no significant damage to the barrier. The only damage was extremely minor surface scrapes and gouges of the steel rail. Barrier damage is shown in Figure 5-6 through Figure 5-9. The orange contact marks are from the front right tire. The green contact marks are from the rear right tire. Dynamic deflection of the bridge rail measured from overhead video was 15 mm (0.6 in). There was no permanent deflection. String potentiometer and strain gage data were collected during the test. They do not fall under the Scope of Accreditation but are available upon request.

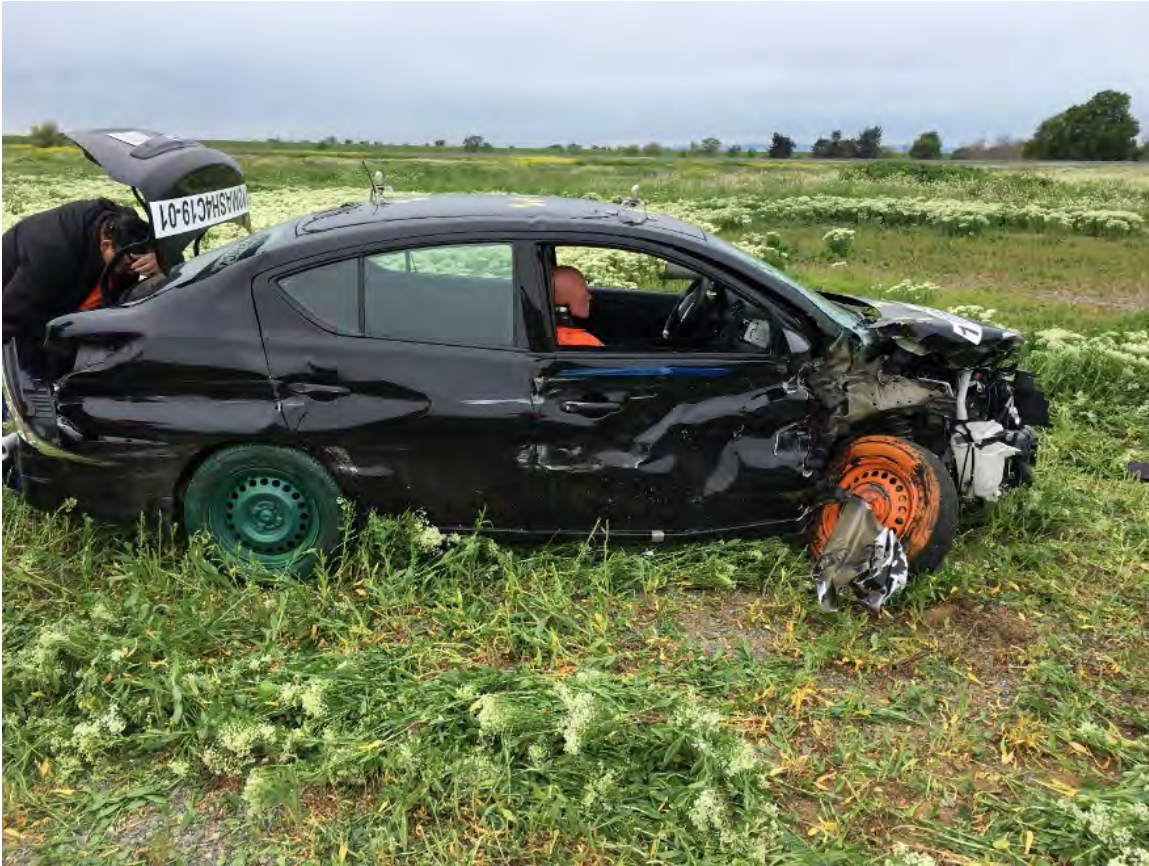
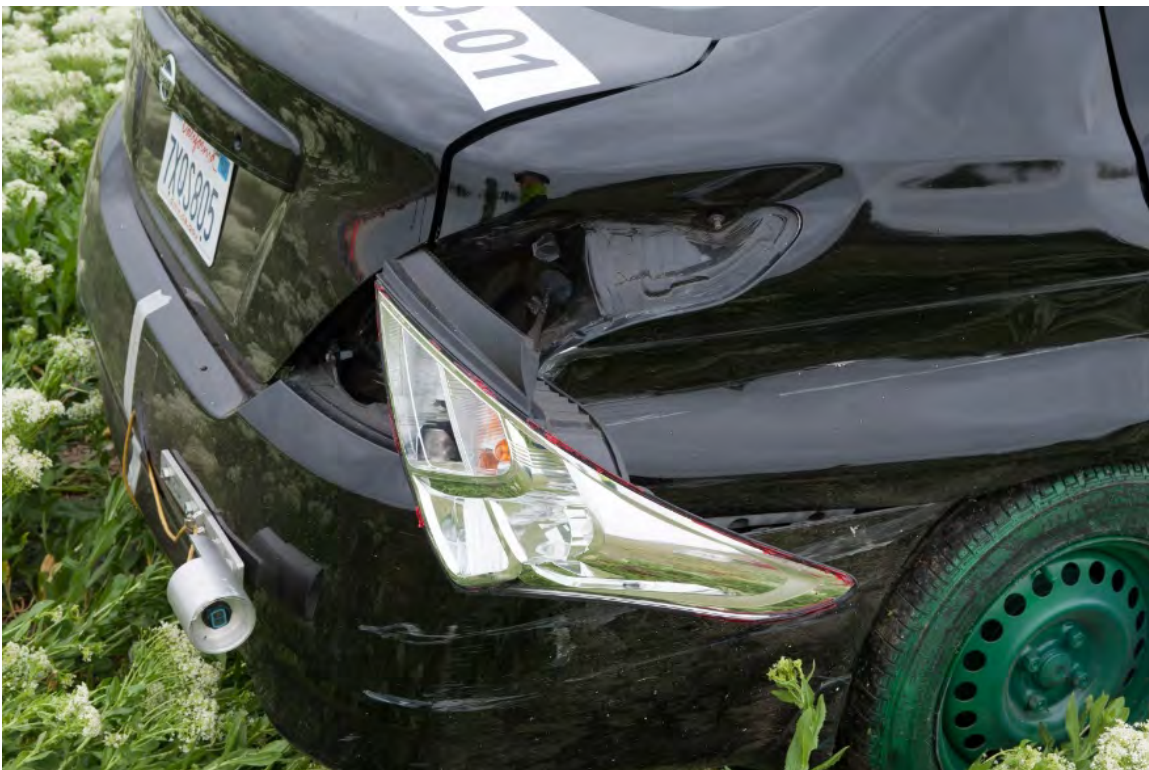
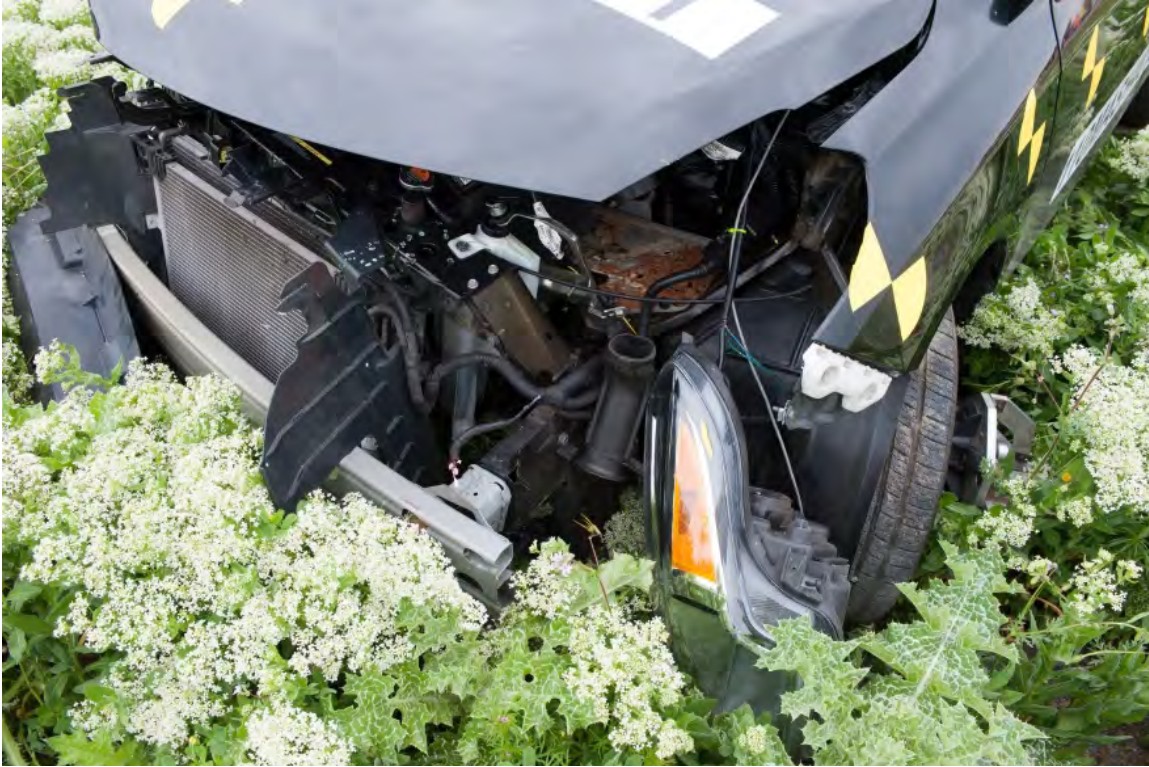
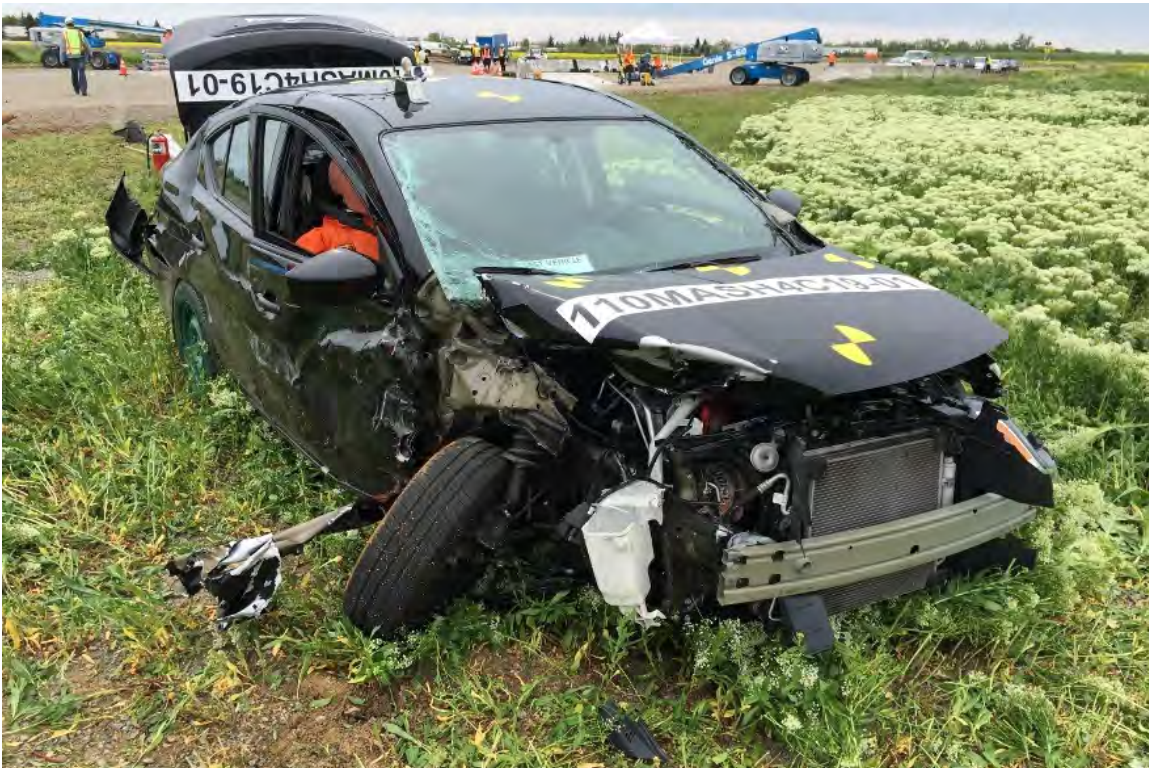
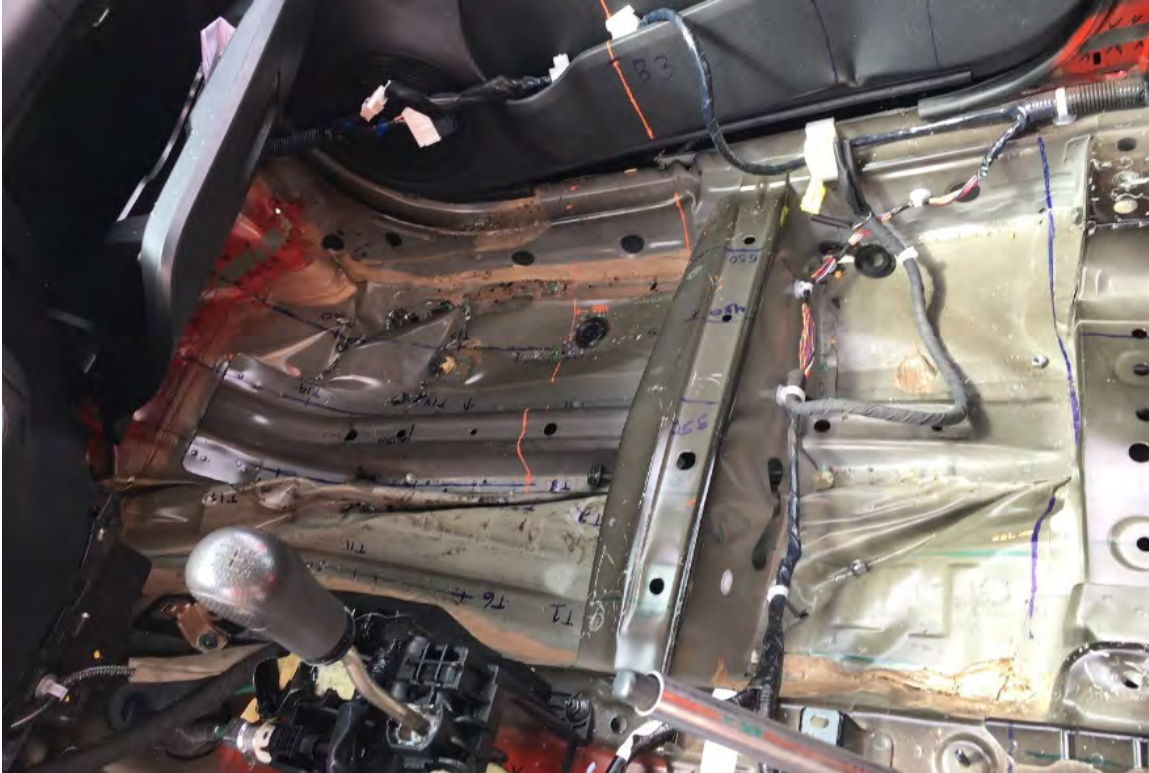
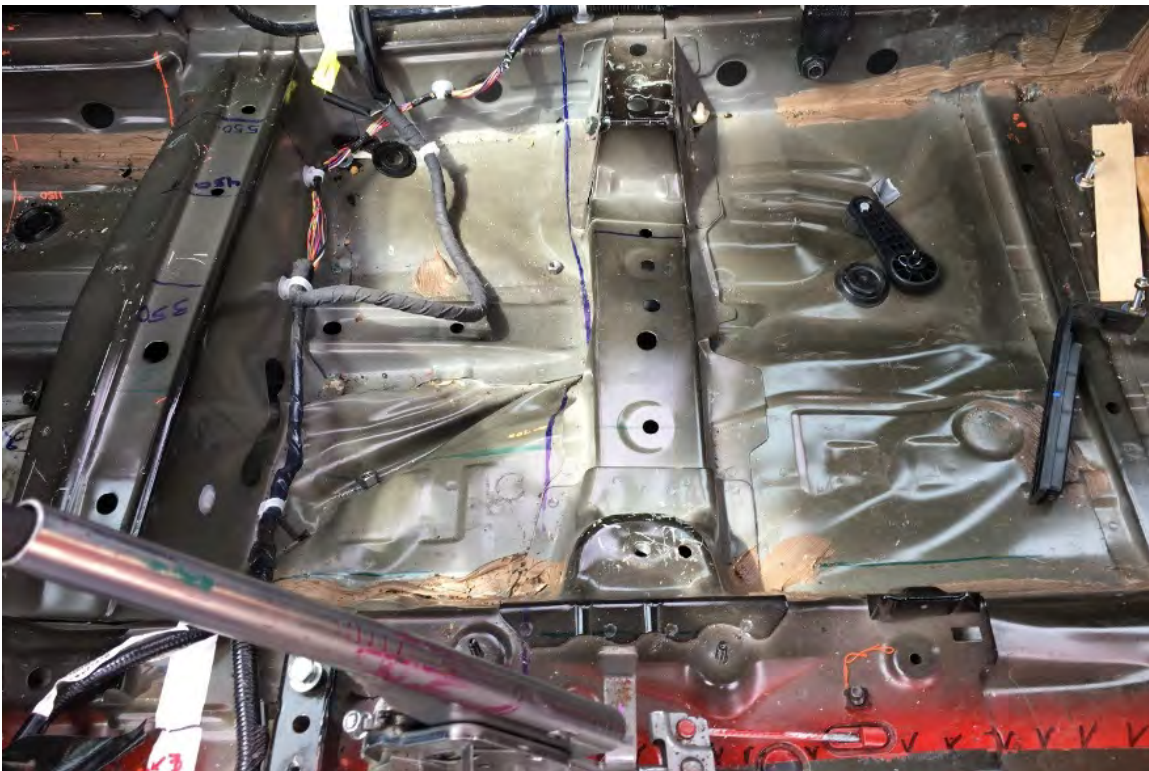
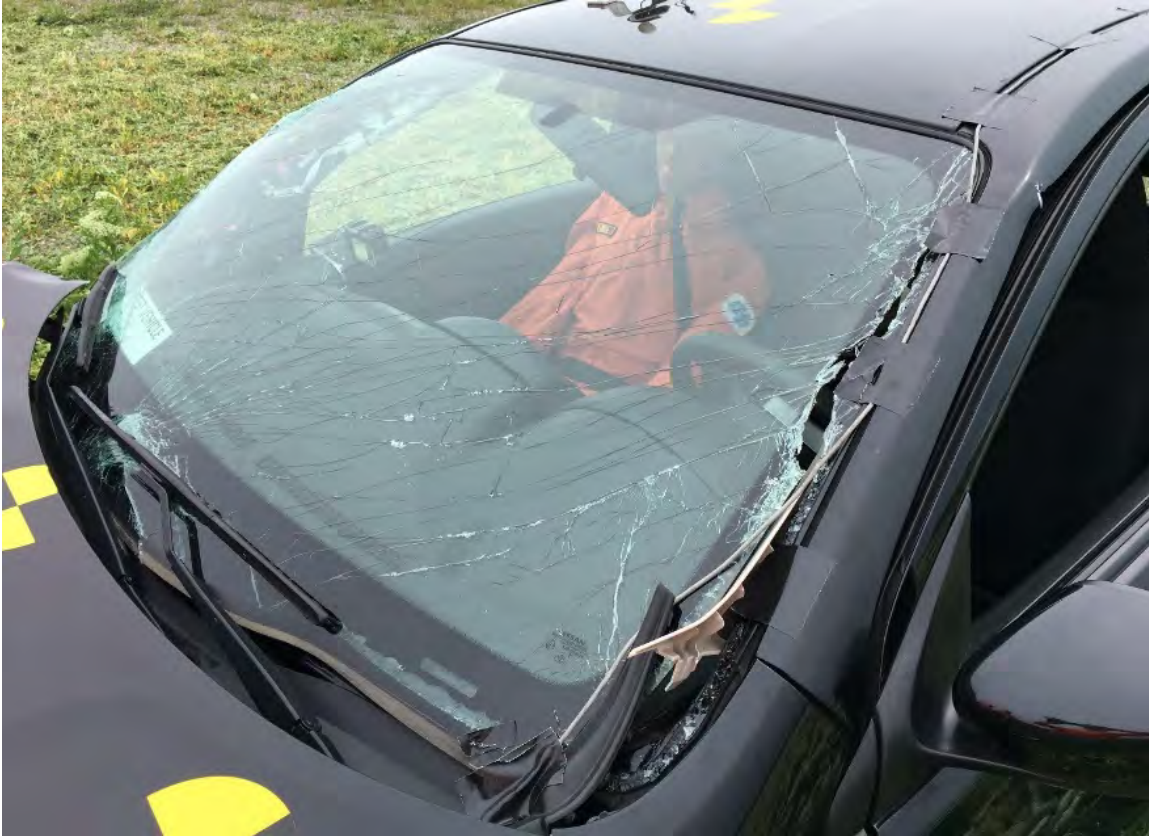
Figure 5-10 Test 4-10 Test Vehicle Damage (Right Side)

Figure 5-11 Test 4-10 Test Vehicle Damage (Rear Right)

**Figure 5-12 Test 4-10 Test Vehicle Damage (Front Left)**

**Figure 5-13 Test 4-10 Test Vehicle Damage (Front Right)**

**Figure 5-14 Test 4-10 Test Vehicle Occupant Compartment Floorboard Deformation**

**Figure 5-15 Test 4-10 Test Vehicle Occupant Compartment Deformation (Front Seat Area)**

**Figure 5-16 Test 4-10 Test Vehicle Windshield Separation**

The 1100C front right corner, passenger's side, and front end of the test vehicle sustained damage during the impact. The entire length of the passenger side of the vehicle made contact with the barrier. The front passenger wheel was pushed back and partially torn off. The entire front bumper cover separated from the vehicle along with both headlights. The windshield spider-cracked and was pushed sideways about two inches, creating a separation at the driver's side "A" pillar. The passenger side front window was shattered and broken out due to door deformation. The remaining window glass was undamaged. The interior metal bumper, its support bracket and connecting frame member were deformed, possibly from snagging slightly on the upstream vertical member of post 4. The hood and front right door and front fender were severely damaged. The airbags did not deploy because the vehicle was towed and there was no power to the airbag system. The maximum amount of passenger compartment deformation measured by known points was 125 mm (4.9 in), which occurred at the toe pan/wheel well area of the floorboard. All interior deformation measurements are shown in Table 9-11 through Table 9-14.

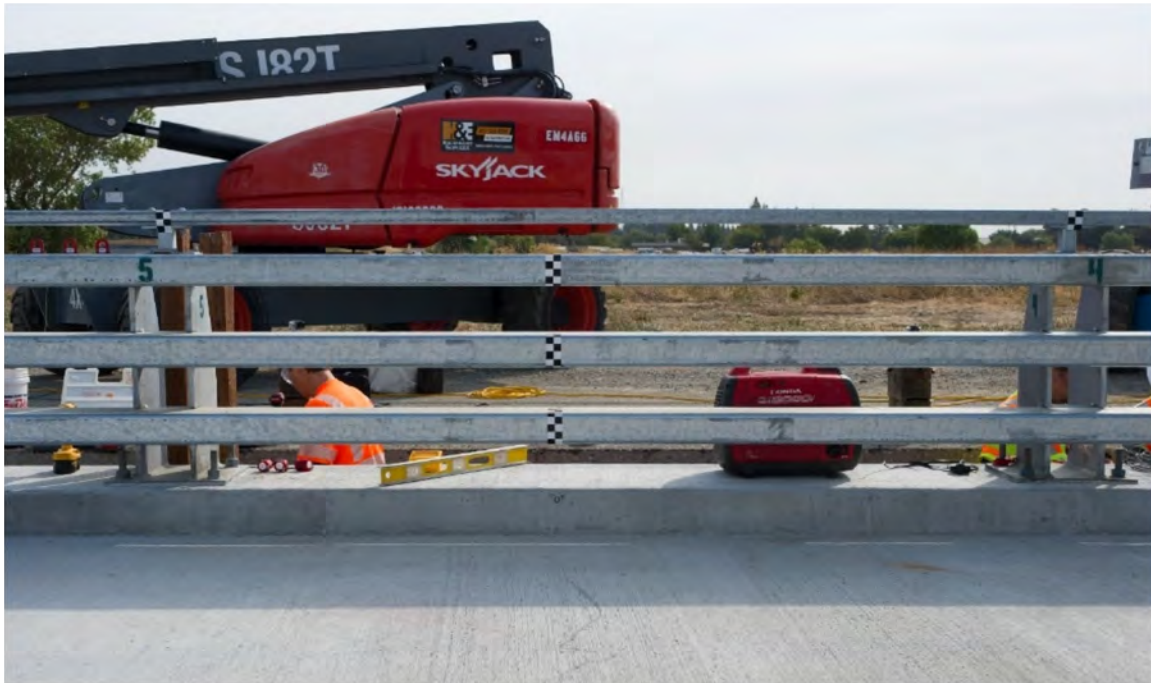
Figure 6-1 Test 4-11 Critical Impact Point Pre-Test

The Critical Impact Point selected was 1.3 meters (4.3 ft) from the centerline of post 5, as recommended in Table 2-7 of MASH 2016 (AASHTO, 2016). The impact angle of 25° was set with a Total Station. The intended impact speed was 100 kph (62 mph).

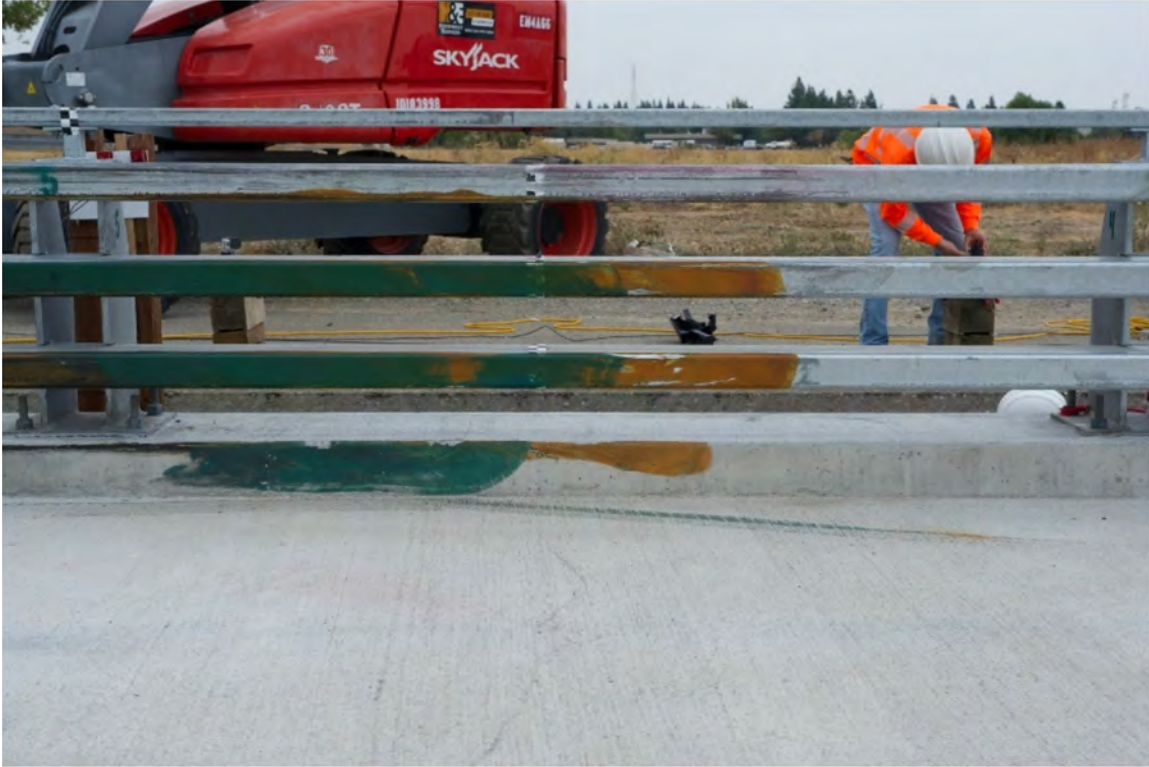
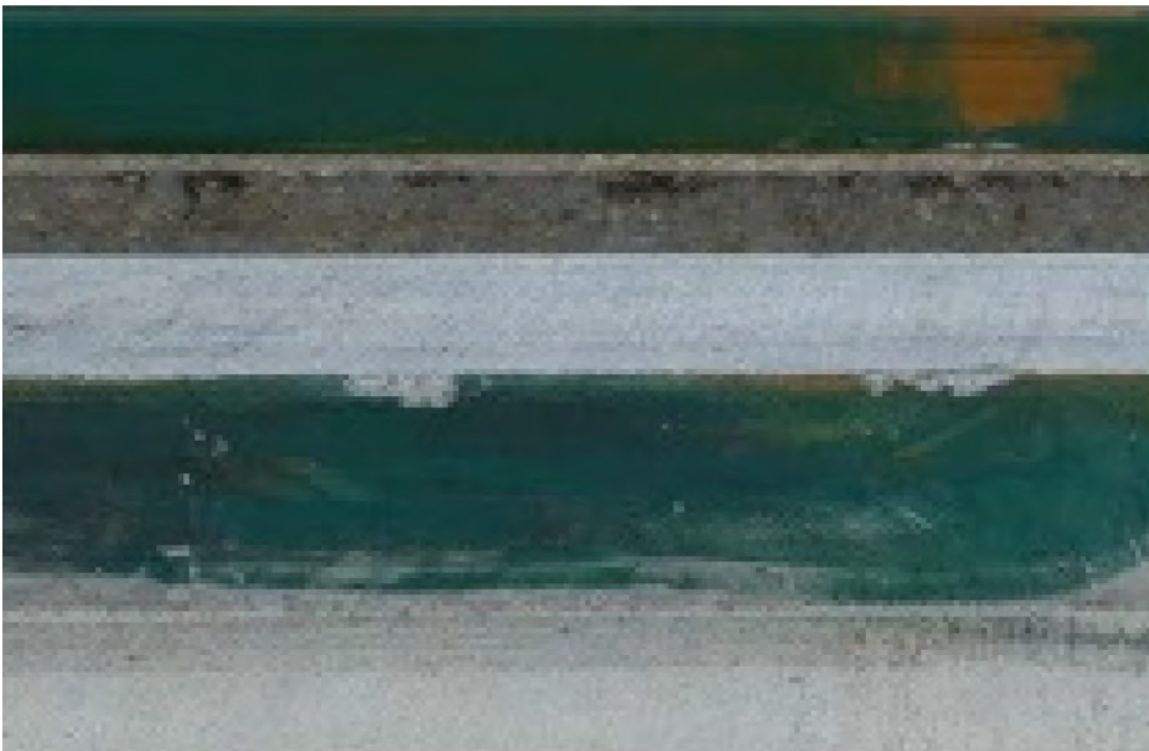
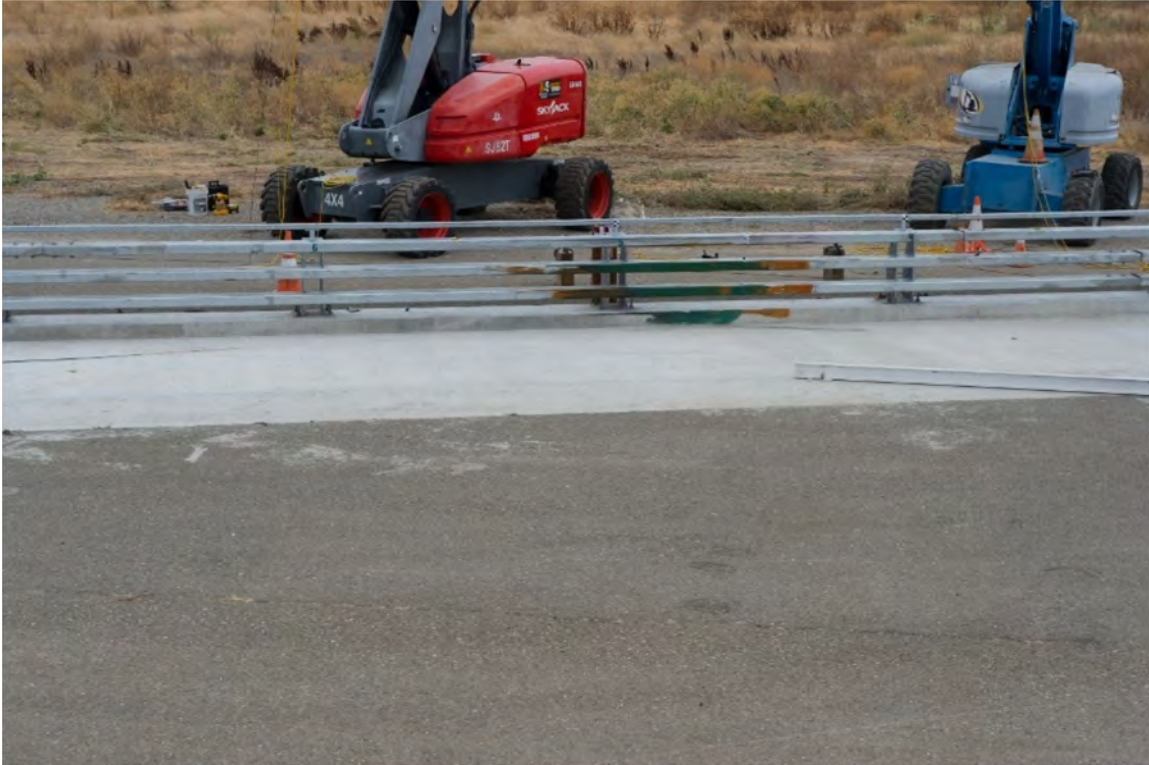
**Figure 6-6 Test 4-11 Vehicle Marks on ST-75 at Impact Point Post-Test**

**Figure 6-7 Test 4-11 Minor Concrete Spalling of Concrete Curb Post-Test**

**Figure 6-8 Test 4-11 ST-75 Bridge Rail Post-Test Downstream of Impact Post-Test**

There was no significant damage to the barrier. The only damage was extremely minor surface scrapes and gouges of the steel rail, and minor spalling of the concrete curb. Barrier damage is shown in Figure 6-6 through Figure 6-8. The orange contact marks are from the front right tire. The green contact marks are from the rear right tire. Dynamic deflection of the bridge rail measured from overhead video was 30 mm (1.2 in). There was no permanent deflection. String potentiometer and strain gage data were collected during the test. They do not fall under the Scope of Accreditation but are available upon request.
