1. REPORT NO. <b>FHWA/CA22-3033</b>	2. GOVERNMENT ACCESSION NO.	3. RECIPIENT'S CATALOG NO.	
4. TITLE AND SUBTITLE DEVELOPMENT AND CRASH TESTING OF A STEEL POST-AND-BEAM BRIDGE RAILING, CALIFORNIA ST-75		5. REPORT DATE August 2022

16. ABSTRACT  Three full-scale crash tests of the California ST-75 Bridge Rail (ST-75) were completed to meet the Implementation Agreement for Manual for Assessing Safety Hardware (MASH) 2016. California Department of Transportation (Caltrans) needed a MASH 2016 compliant steel post and beam bridge rail to replace existing NCHRP Report 350 (Report 350) rails. The July 2019 Caltrans "MASH Implementation for California Bridge Railings" identified the ST-75 as a design intended to replace existing Caltrans bridge rails: the ST-10, ST-20S, ST-30 and the ST-70.  The ST-75 is a 914 mm (36 in) vehicular and a 1067 mm (42 in) high combination (vehicular and bicycle) bridge rail. The rail elements are ASTM A500/A500M, Grade B, hollow structural 203 mm x 102 mm x 8 mm (8 in x 4 in x 5/16 in) sections bolted to A709 Grade 36 steel posts. The post spacing is 3m (10 feet) and are anchored using ASTM F1554, Grade 105, bolts to a 6-inch-high concrete curb. The tested ST

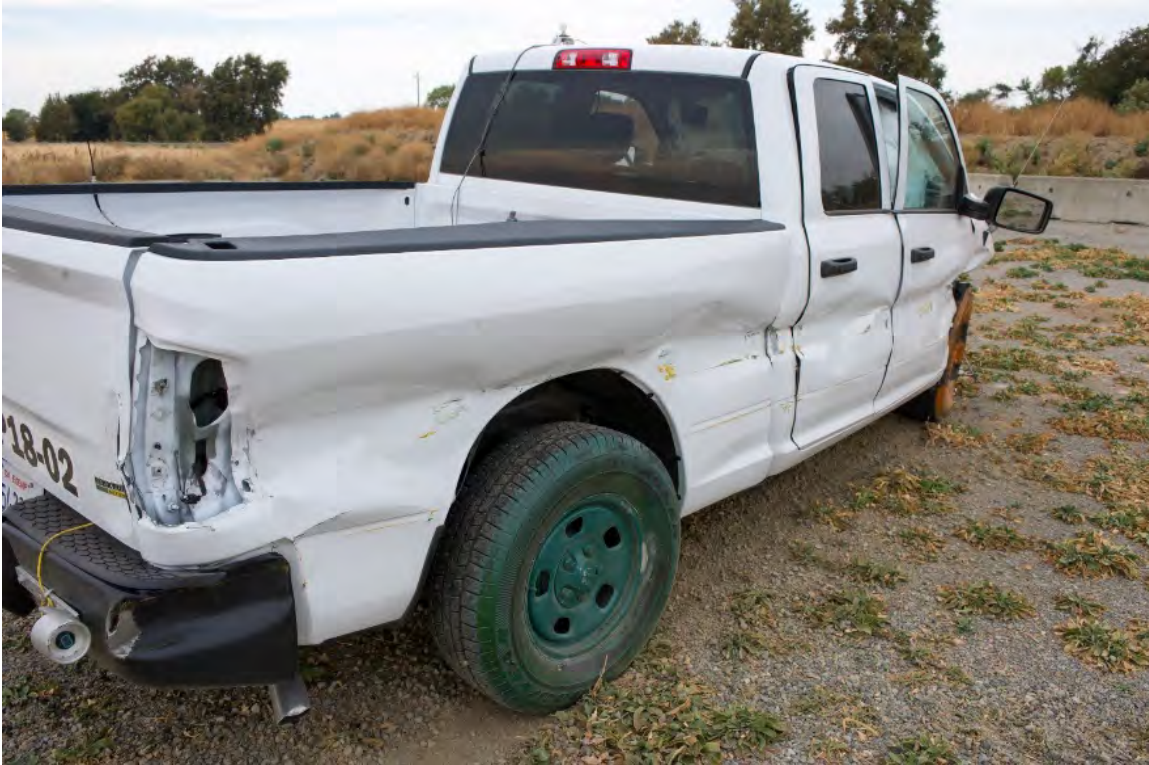
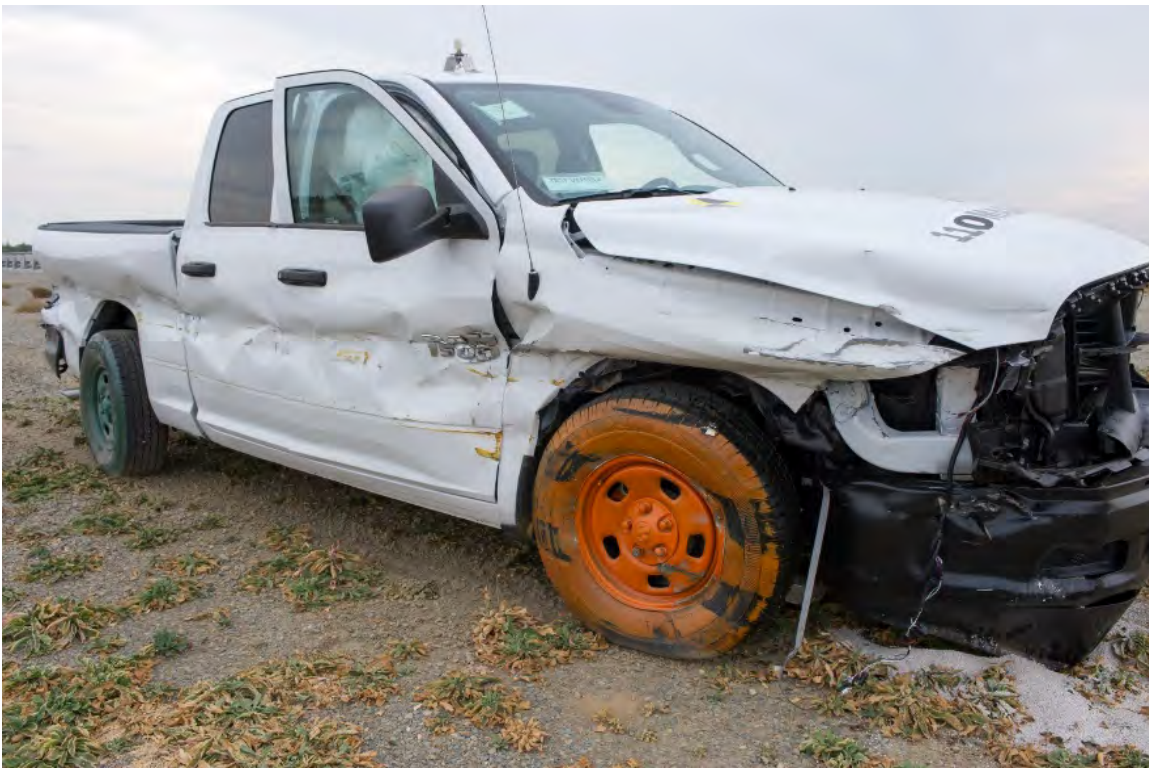
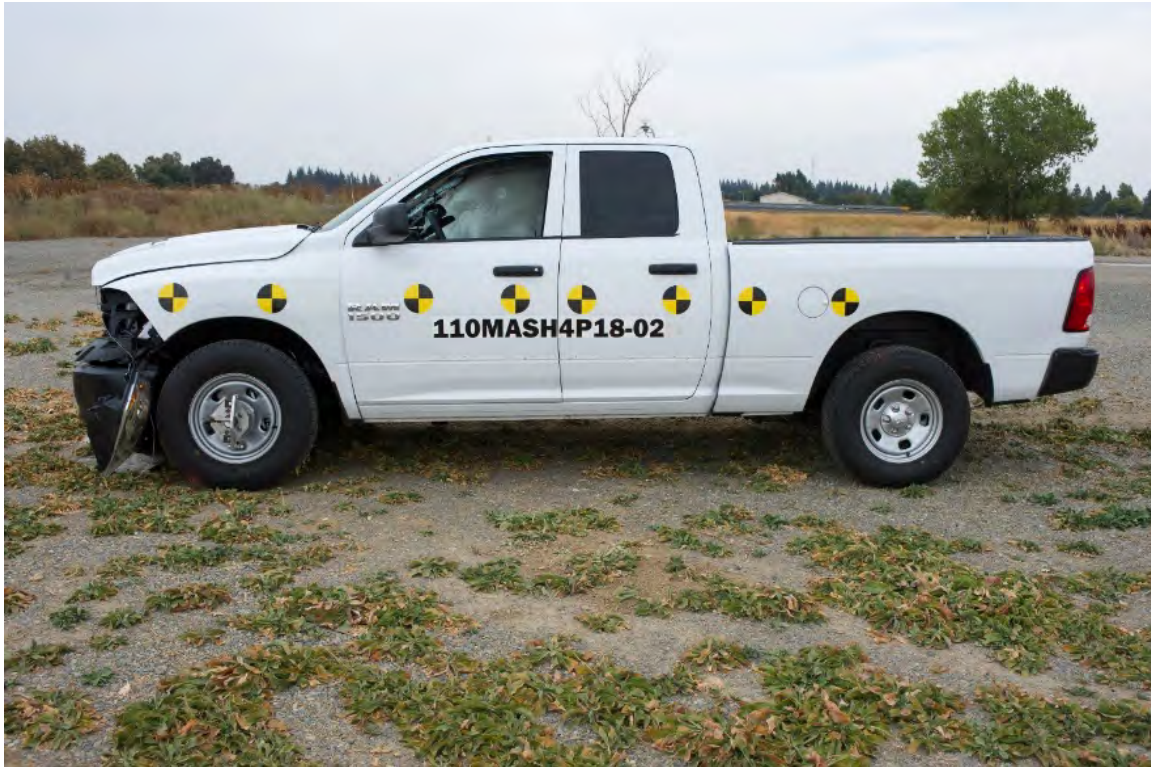
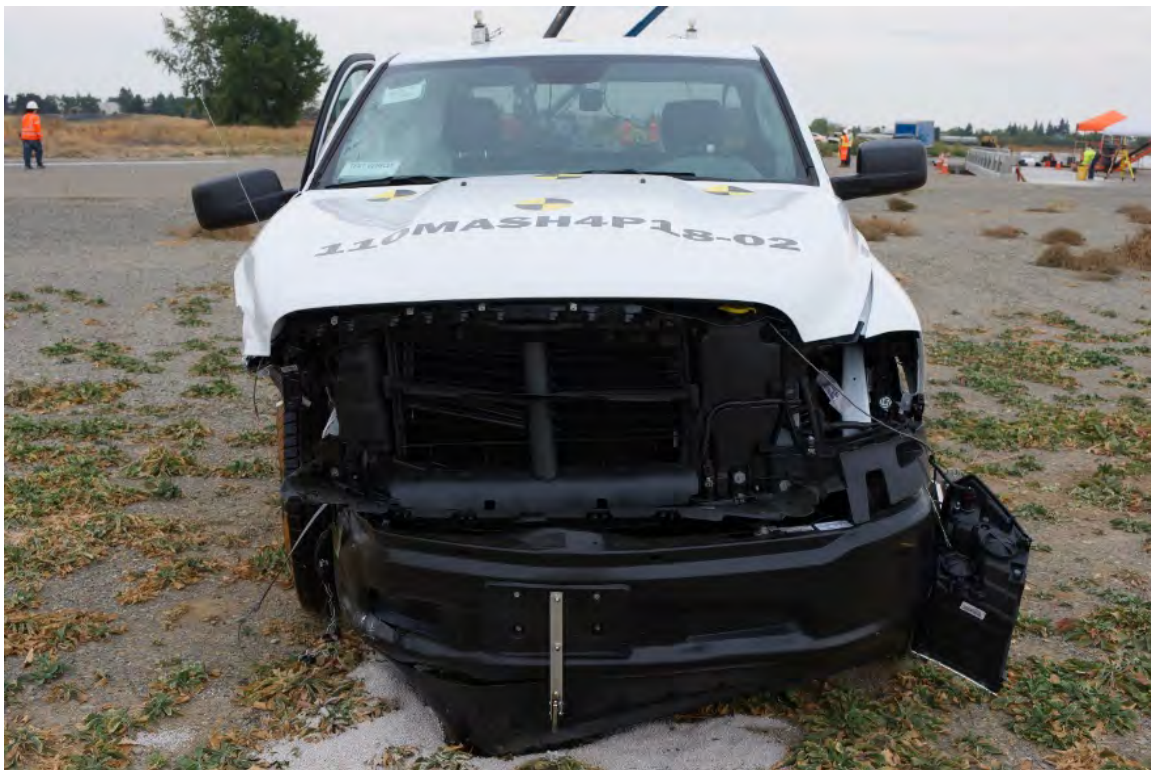
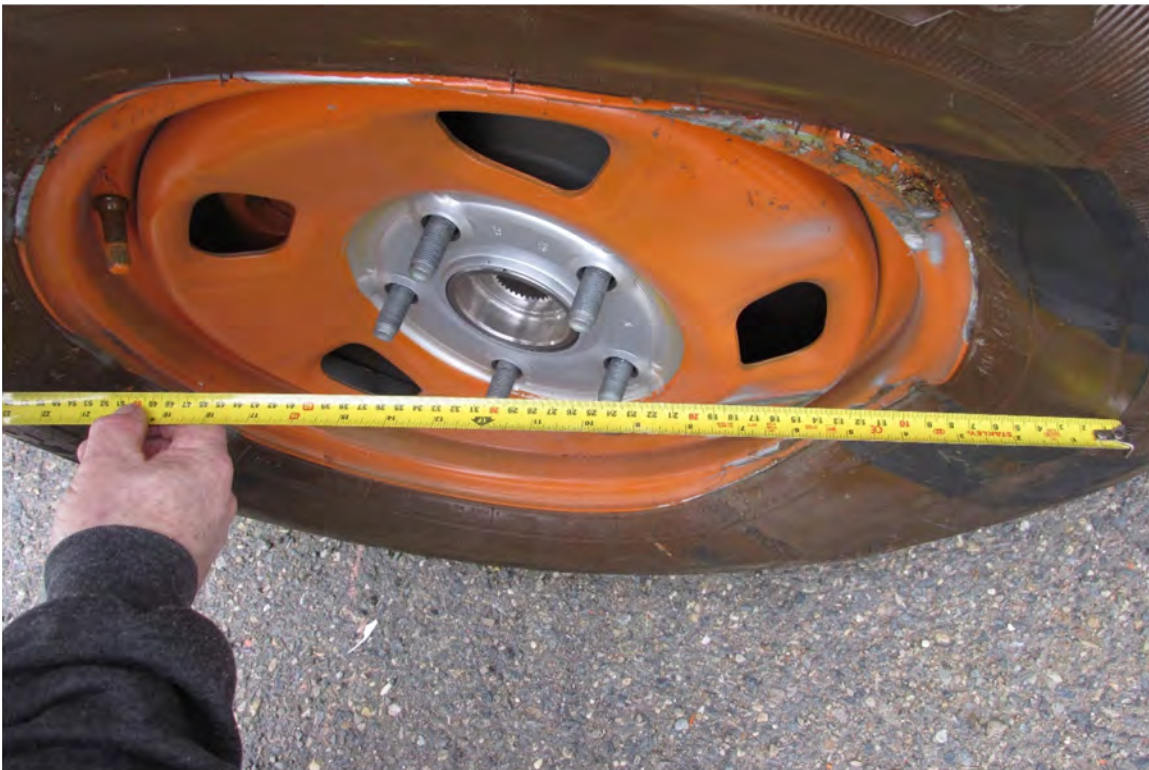
**Figure 6-9 Test 4-11 Test Vehicle Damage (Rear Right)**

**Figure 6-10 Test 4-11 Test Vehicle Damage (Front Right)**

Figure 6-11 Test 4-11 Test Vehicle Damage (Left Side)

Figure 6-12 Test 4-11 Test Vehicle Damage (Front)

Figure 6-13 Test 4-11 Test Vehicle Damage Front Passenger Floorpan (Occupant Compartment Deformation)

Figure 6-14 Test 4-11 Test Vehicle Front Right Wheel Deformation

The 2270P front right corner and right side of the test vehicle sustained most of the damage from the impact. The front bumper was damaged, mainly the front right portion during initial impact with the barrier. The right headlight was shattered and detached from the vehicle. The front passenger wheel was pushed back significantly but the suspension system remained attached except for the aluminum lower control arm front connection to the frame. The entire length of the passenger side of the vehicle made contact with the barrier including the right front fender, right doors, and the right side of the bed. All of the test vehicle doors remained closed and latched during impact except the window frame of the front passenger door deformed outward, creating an opening. The windshield had minor cracking and the remaining window glass was undamaged. The front grill and left headlight were also detached during the impact. The maximum amount of passenger compartment deformation measured by known points was 100 mm (4.0 in), which occurred at the footwell. All interior deformations were below the maximum MASH 2016 limits and are shown in Figure 9-22 through Figure 9-24.

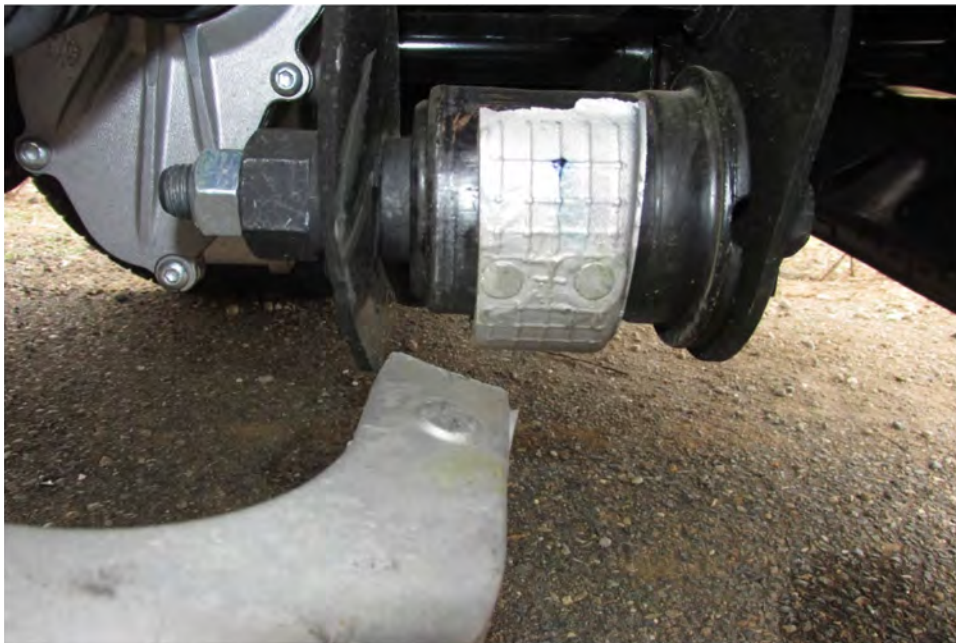
**Figure 6-16 Test 4-11 Test Vehicle Front Right Suspension Lower Control Arm Connector Fracture**

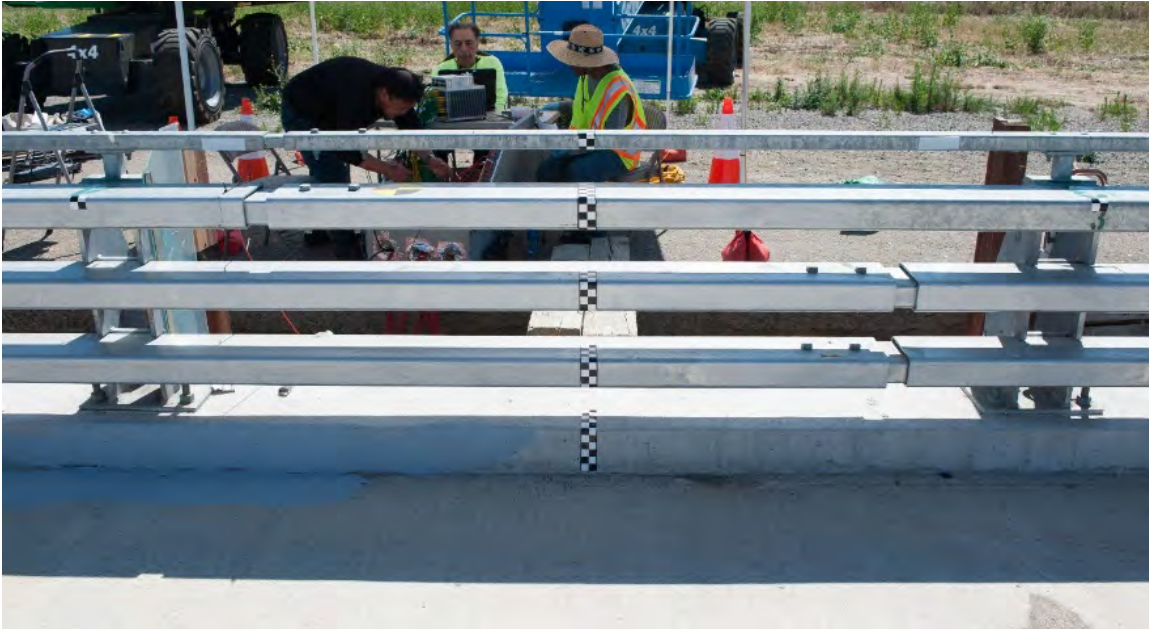
Figure 7-1 Test 4-12 ST-75 Impact Area with Checkered Tape at Impact Point Pre-Test

The Critical Impact Point selected was 1.5 meters (5.0 ft) from the centerline of post 5, as recommended in Table 2-7 of MASH 2016 (AASHTO, 2016). The impact angle of 15° was set with a Total Station. The intended impact speed was 90 kph (56 mph).

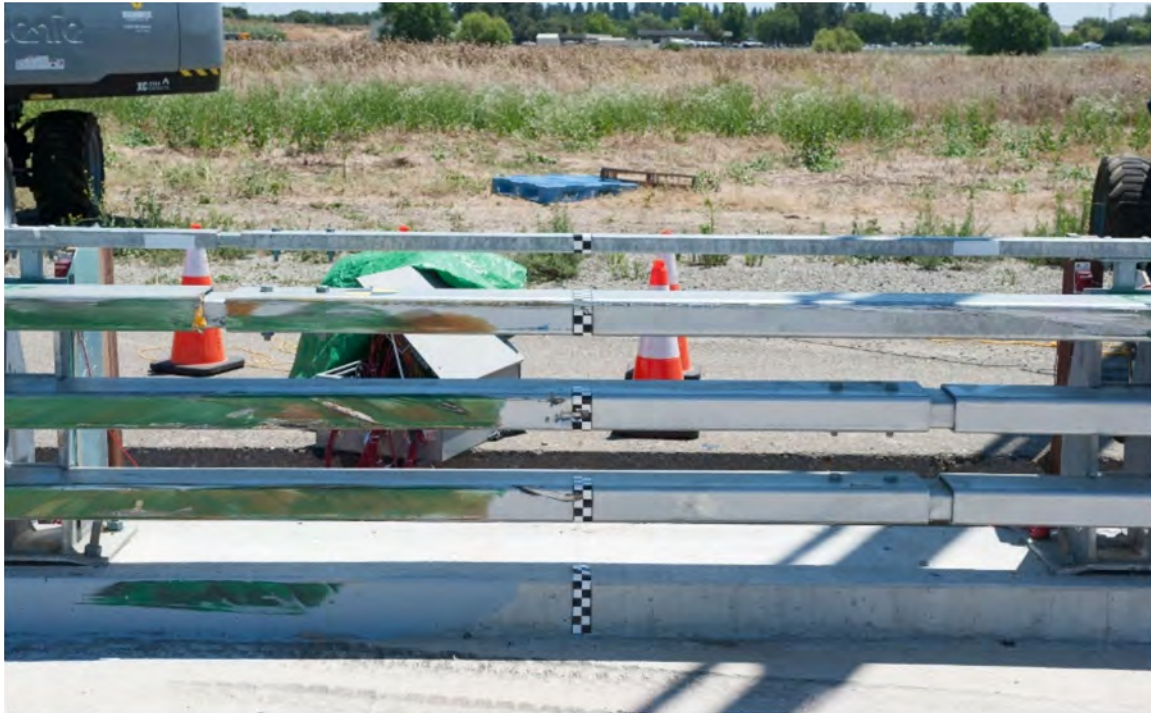
**Figure 7-8 Test 4-12 Vehicle Marks on ST-75 Impact Point Between Posts 3 and 4 Post-Test**

Other damage to the barrier included minor surface scrapes and gouges. See Figure 7-8 through Figure 7-13 for photos of barrier damage. The orange contact marks are from the front right tire. The green contact marks are from the rear right tire. String potentiometer and strain gage data were collected

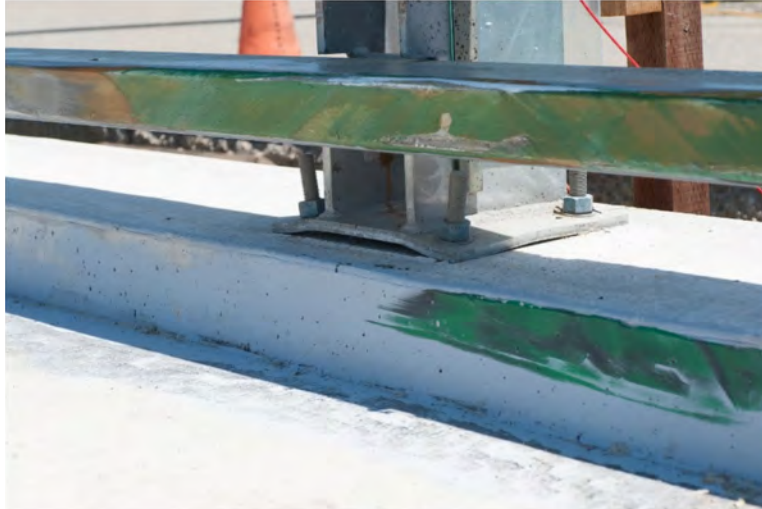
**Figure 7-13 Test 4-12 Post 4 Bent Bottom Plate Close Up Post-Test**

There was minor to moderate damage to the barrier. The traffic side of the base plates at Posts 3, 4, and 5 were permanently deformed from the moment created during impact, see Figure 7-11 through Figure 7-13. The deformation left a gap between the middle portion of the plate and concrete curb. Base plate deformation at Posts 3, 4, and 5 were approximately 8 mm (5/16 in), 6 mm (1/4 in), less than 2 mm (1/16 in), respectively. As a result of the base plate deformation, the anchor bolts bent outward. The anchor bolt bending and after impact straightening, as part of barrier repairs, was thought to be a concern due to the high levels of plastic deformation. To better understand the condition of the bolts, bolt material properties were investigated. A barrier quasi-static (push) test and bolt tensile tests were performed to determine remaining bolt strength and roughly how far the bolts had elongated or otherwise progressed into yield. These tests are not within the Lab's Scope of Accreditation. The results showed that the bolts at Posts 3 and 4 (which were impacted during the crash test) were slightly in the plastic range and the Post 6 bolt (which was deformed during the push test) had high residual strength but was far into the plastic range. The tensile tests for Posts 3 and 4 concluded that after the TL-4 impact, the bolts were still above design tensile strength requirements and still had some ductility. However, the bending caused by the base plate deformed the threads enough to potentially complicate repairs if a post needed to be removed. A brief summary of the quasi-static push test and tensile load tests are shown in 11 Appendix C: Quasi-static Push Test and Anchor Bolt Tensile Testing. Photos of the anchor bolts at posts 3 and 4 with the posts removed are also included in Appendix C.

For reduced maintenance after more severe hits such as Test 4-12 in this report, it is recommended to stiffen the post base plates in order to reduce or eliminate the type of deformation observed in Test 4-12. The ST-75 demonstrated it has significant remaining capacity to contain and redirect the 10000S test vehicle and stiffening the base plate would likely not compromise this capacity. Also, this base plate change should have no adverse effect on the results of Tests 4-10 and 4-11 since the post base plates were already rigid enough to withstand those impacts without permanent deformation. The statements in this paragraph are outside the Lab's Scope of Accreditation.

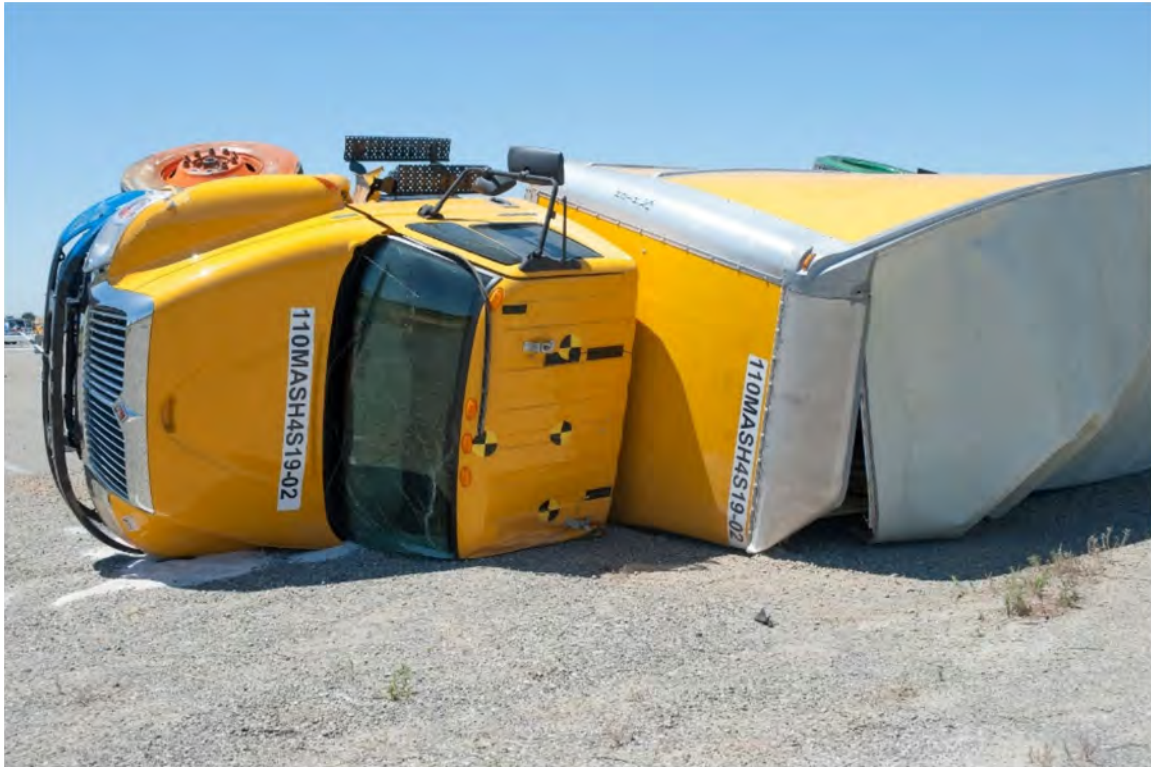
**Figure 7-14 Test 4-12 Test Vehicle Top Post-Test**

The 10000S front right corner and passenger's side of the test vehicle sustained most of the damage from the initial impact with the steel rail and post system. The entire length of the passenger side of the vehicle made contact with the bridge rail. The driver's side of the front bumper was deformed, the headlight was torn loose, and part of the right front fender was broken off. The right front wheel and suspension remained intact with the exception that the ends of the leaf springs fractured near their mounts at both forward and rear connection points. The left front and rear suspension remained attached as well as all the vehicle wheels and tires. All tires remained inflated. The steps on the passenger side were deformed from making contact with the steel rail. The driver's side door, A-pillar, fender, and cab roof were deformed when the vehicle rolled onto its side, including cracking the windshield. All the window glass was undamaged during interaction with the test article. Nearly all the damage to the cargo box also occurred when the vehicle rolled onto its side. The shear plates on the frame were slightly bent but otherwise remained intact. The bed shifted a minor amount. The threaded rods to secure the ballast were undamaged and helped to keep motion of the ballast to a minimum. Photos of the vehicle post-impact can be found in Figure 7-14 through Figure 7-24. The maximum amount of passenger compartment deformation measured by known points was 81 mm (3.2 in), which occurred at the floorboard. All interior deformations were below the maximum MASH 2016 limits. All interior deformation measurements are shown in Table 9-29 through Table 9-32.

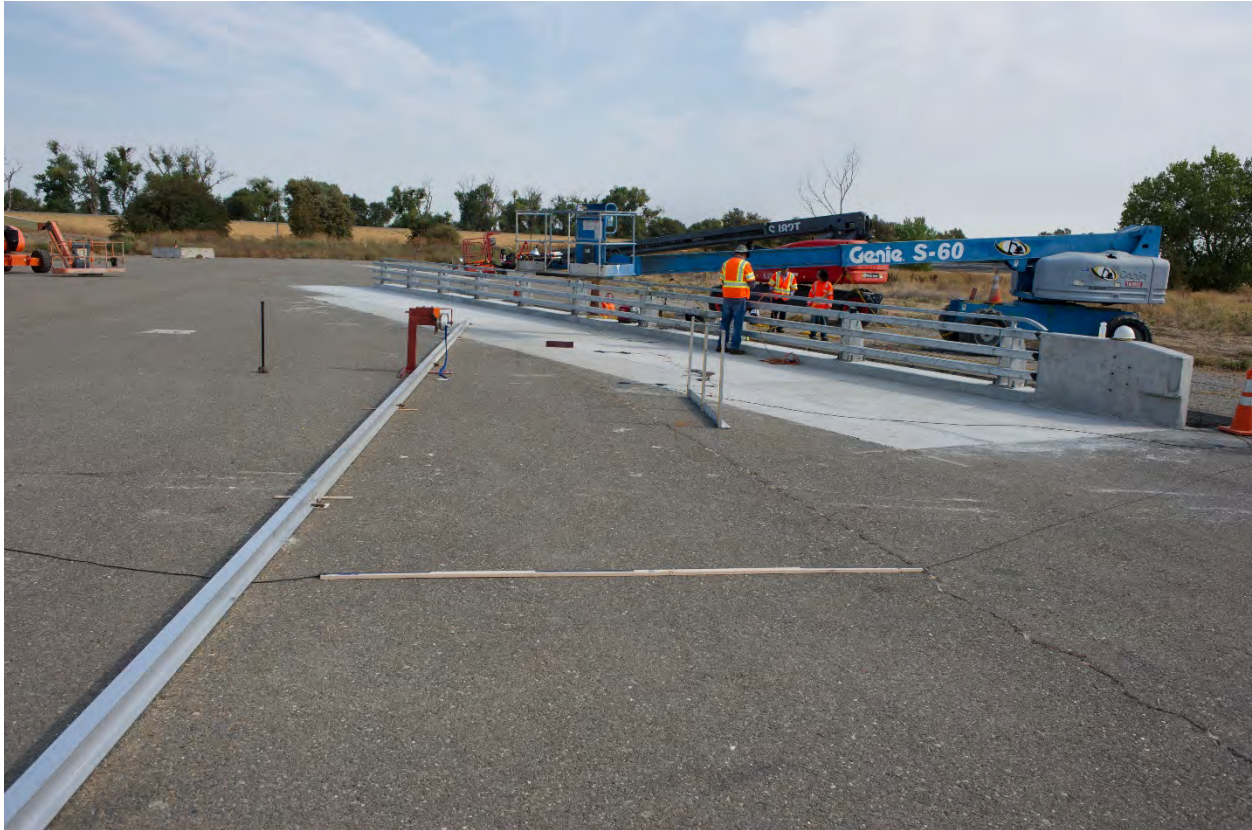
Figure 9-8 Typical Guidance System Layout

A rail guidance system directed the vehicle into the barrier. The guidance rail, anchored at approximately 3.8 m (12.5 ft) intervals along its length was used to guide a mechanical arm, which was attached to the hub of the front left wheel of the vehicle. A plate and lever were used to trigger the release pin on the guidance arm, thereby releasing the vehicle from the guidance system before impact.
