1. REPORT NO. FHWA/CA22-3033	2. GOVERNMENT ACCESSION NO.	3. RECIPIENT'S CATALOG NO.	
4. TITLE AND SUBTITLE DEVELOPMENT AND CRASH TESTING OF A STEEL POST-AND-BEAM BRIDGE RAILING, CALIFORNIA ST-75		5. REPORT DATE August 2022

16. ABSTRACT Three full-scale crash tests of the California ST-75 Bridge Rail (ST-75) were completed to meet the Implementation Agreement for Manual for Assessing Safety Hardware (MASH) 2016. California Department of Transportation (Caltrans) needed a MASH 2016 compliant steel post and beam bridge rail to replace existing NCHRP Report 350 (Report 350) rails. The July 2019 Caltrans "MASH Implementation for California Bridge Railings" identified the ST-75 as a design intended to replace existing Caltrans bridge rails: the ST-10, ST-20S, ST-30 and the ST-70. The ST-75 is a 914 mm (36 in) vehicular and a 1067 mm (42 in) high combination (vehicular and bicycle) bridge rail. The rail elements are ASTM A500/A500M, Grade B, hollow structural 203 mm x 102 mm x 8 mm (8 in x 4 in x 5/16 in) sections bolted to A709 Grade 36 steel posts. The post spacing is 3m (10 feet) and are anchored using ASTM F1554, Grade 105, bolts to a 6-inch-high concrete curb. The tested ST-75 rail

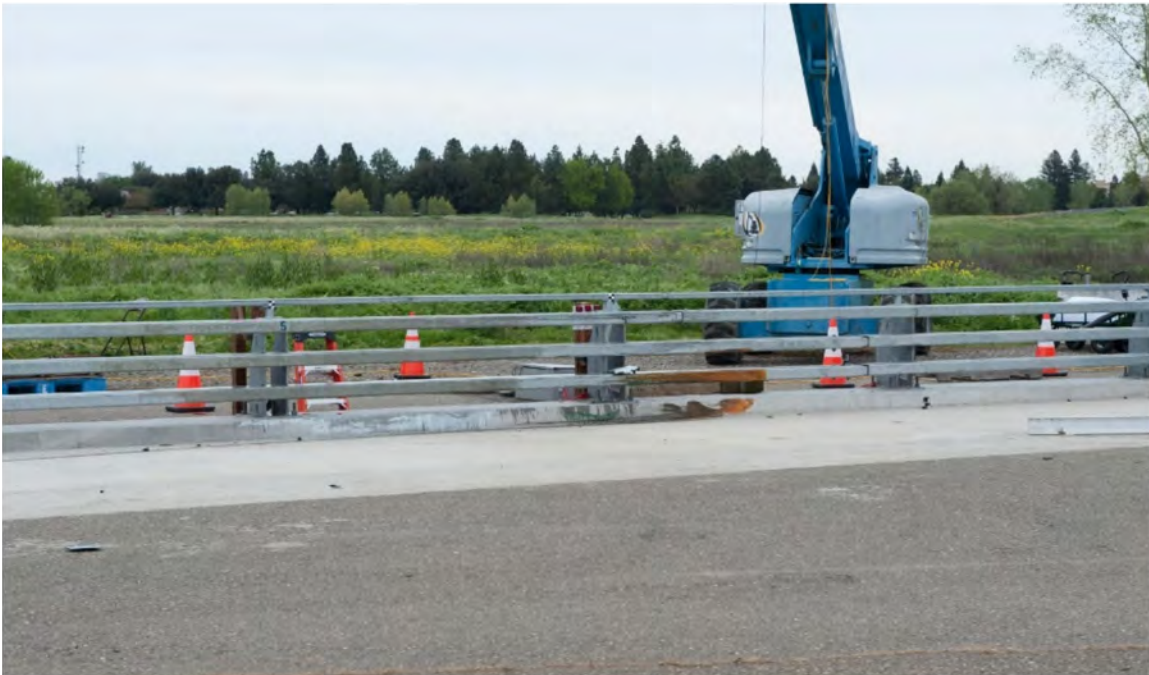
Figure 5-6 Test 4-10 Overview of Barrier Post-Test

There was no significant damage to the barrier. The only damage was extremely minor surface scrapes and gouges of the steel rail. Barrier damage is shown in Figure 5-6 through Figure 5-9. The orange contact marks are from the front right tire. The green contact marks are from the rear right tire. Dynamic deflection of the bridge rail measured from overhead video was 15 mm (0.6 in). There was no permanent deflection. String potentiometer and strain gage data were collected during the test. They do not fall under the Scope of Accreditation but are available upon request.

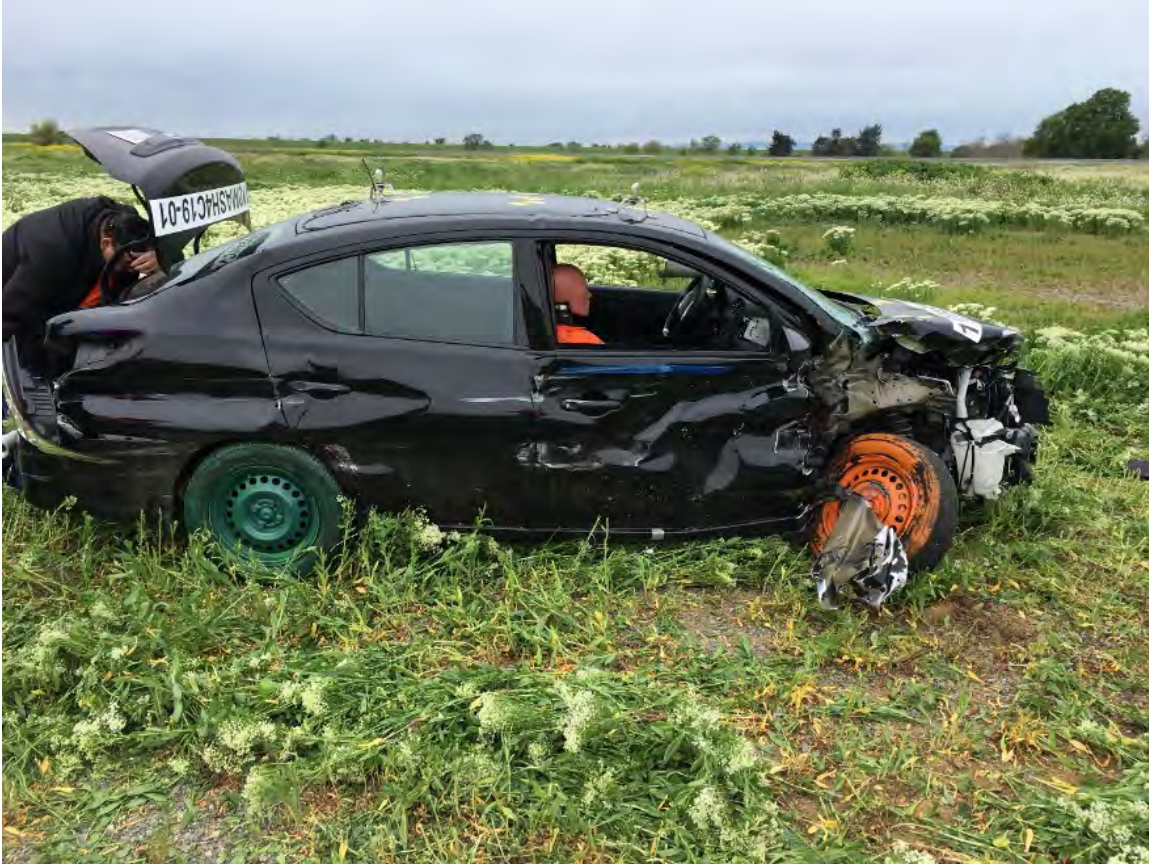
Figure 5-10 Test 4-10 Test Vehicle Damage (Right Side)

The 1100C front right corner, passenger's side, and front end of the test vehicle sustained damage during the impact. The entire length of the passenger side of the vehicle made contact with the barrier. The front passenger wheel was pushed back and partially torn off. The entire front bumper cover separated from the vehicle along with both headlights. The windshield spider-cracked and was pushed sideways about two inches, creating a separation at the driver's side "A" pillar. The passenger side front window was shattered and broken out due to door deformation. The remaining window glass was undamaged. The interior metal bumper, its support bracket and connecting frame member were deformed, possibly from snagging slightly on the upstream vertical member of post 4. The hood and front right door and front fender were severely damaged. The airbags did not deploy because the vehicle was towed and there was no power to the airbag system. The maximum amount of passenger compartment deformation measured by known points was 125 mm (4.9 in), which occurred at the toe pan/wheel well area of the floorboard. All interior deformation measurements are shown in Table 9-11 through Table 9-14.

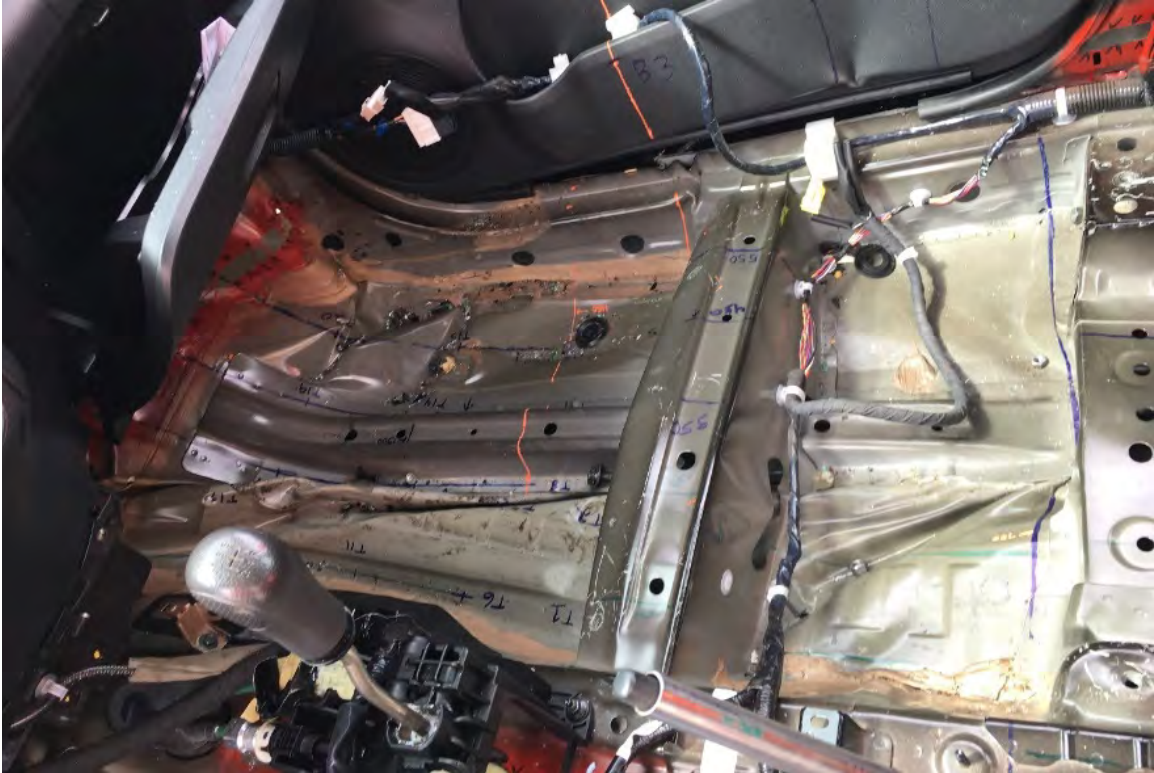
Figure 5-14 Test 4-10 Test Vehicle Occupant Compartment Floorboard Deformation

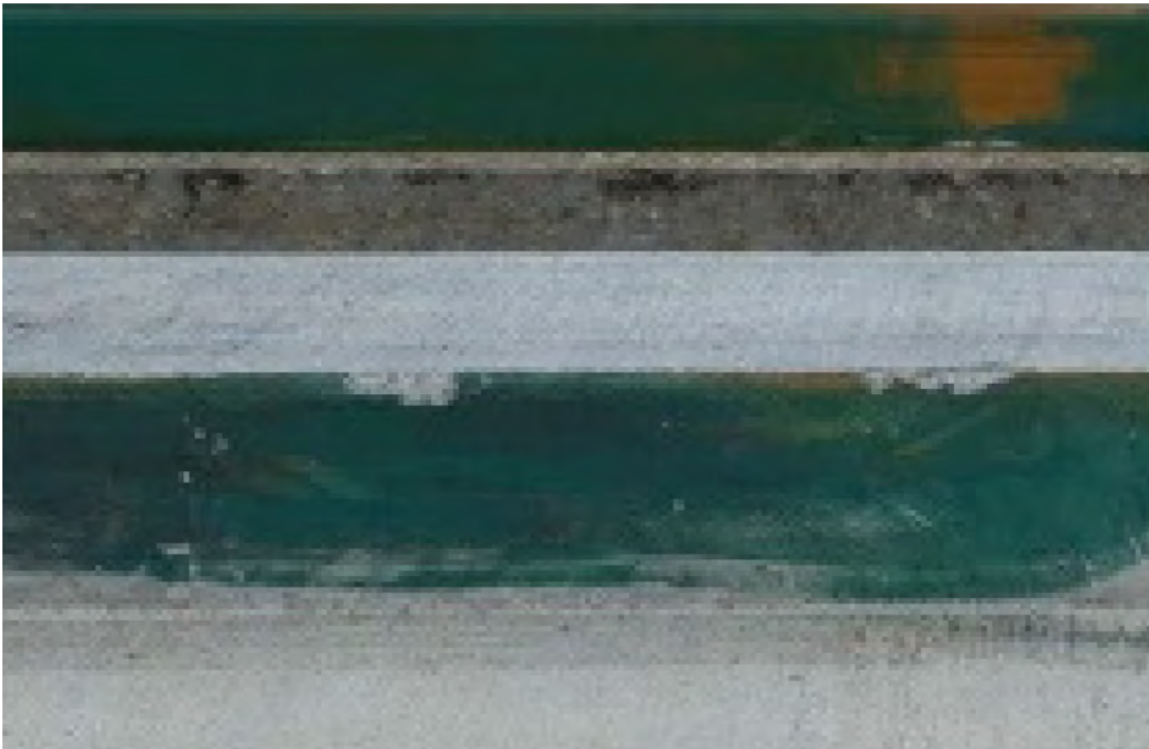
Figure 6-7 Test 4-11 Minor Concrete Spalling of Concrete Curb Post-Test

There was no significant damage to the barrier. The only damage was extremely minor surface scrapes and gouges of the steel rail, and minor spalling of the concrete curb. Barrier damage is shown in Figure 6-6 through Figure 6-8. The orange contact marks are from the front right tire. The green contact marks are from the rear right tire. Dynamic deflection of the bridge rail measured from overhead video was 30 mm (1.2 in). There was no permanent deflection. String potentiometer and strain gage data were collected during the test. They do not fall under the Scope of Accreditation but are available upon request.
