1. REPORT NUMBER <b>CA25-3836</b>	2. GOVERNMENT ASSOCIATION NUMBER N/A	3. RECIPIENT'S CATALOG NUMBER N/A
4. TITLE AND SUBTITLE <b>Orange Contrasted Temporary Pavement Delineation in Construction Zones</b>		5. REPORT DATE <b>04-04-2025</b>

6. PERFORMING ORGANIZATION CODE AHMCT Research Center, UC Davis
7. AUTHOR Barbara Linke, Wilderich White, Kin Yen, Anh Duong, Felicia Fashanu, Nathan Byrd		8. PERFORMING ORGANIZATION REPORT NO. <b>UCD-ARR-25-03-31-01</b>

11. CONTRACT OR GRANT NUMBER <b>65A0749 Task 3836</b>
12. SPONSORING AGENCY AND ADDRESS <b>California Department of Transportation P.O. Box 942873, MS #83 Sacramento, CA 94273-0001</b>		13. TYPE OF REPORT AND PERIOD COVERED <b>Final Report 04/21 - 03/25</b>

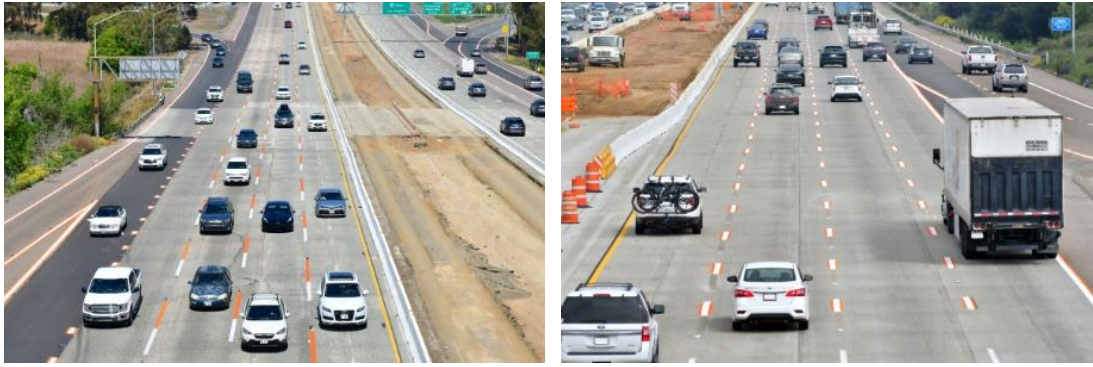
**Figure 1.2: Orange preceding white striping in the SB direction (left); orange along both sides of white striping in the NB direction (right) (photos: courtesy of Caltrans)**

This project assessed the influence of orange pavement delineation in a work zone in Caltrans District 11 in the Interstate 5 (I-5) North Coast Corridor (NCC) Construction Project in San Diego County (Figure 1.1). The work was done in two stages, and in both stages the construction started with standard temporary white striping and then temporary orange contrast striping was added later. The different time periods with white and orange temporary striping allowed the researchers to compare driver behavior and evaluate the effectiveness of the orange temporary delineation. In stage 1, there were two alternatives used for orange striping with lanelines. The southbound (SB) direction had orange preceding white temporary striping (Figure 1.2 left); the northbound (NB) direction had orange along both sides of white striping (Figure 1.2 right). The orange contrast with the right edge line, lane drop, and gores was the same in both directions. In stage 2, only orange preceding white temporary striping was used.

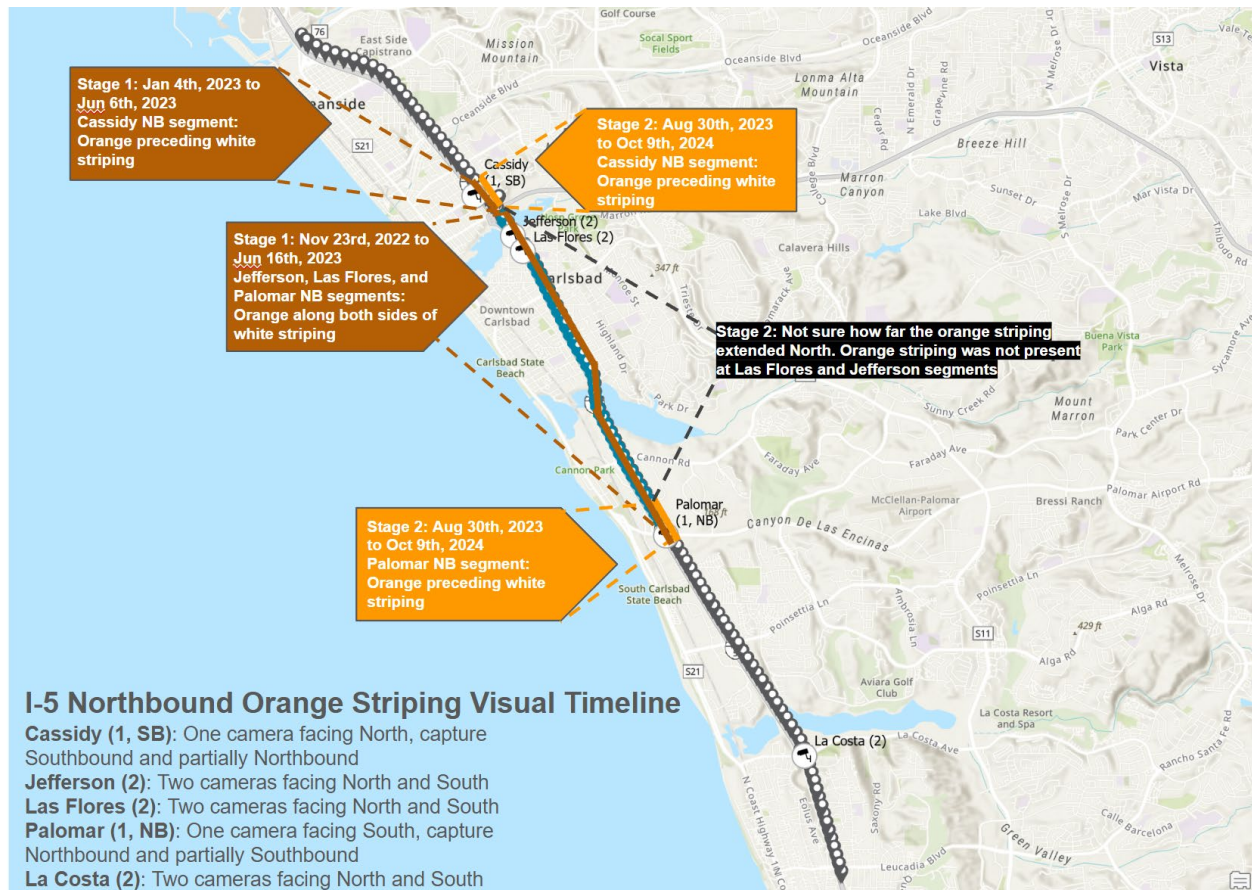
**Figure 1.3: I-5 NB Orange Striping Visual Timeline.** The blue segment is the projected work zone. The grey segments are the north and south of the work zone (or the non-work zone). Map generated using ArcGIS software by Esri.

Figure 1.3 shows the segments featuring orange striping on I-5 NB outlined in orange over a map of the area.

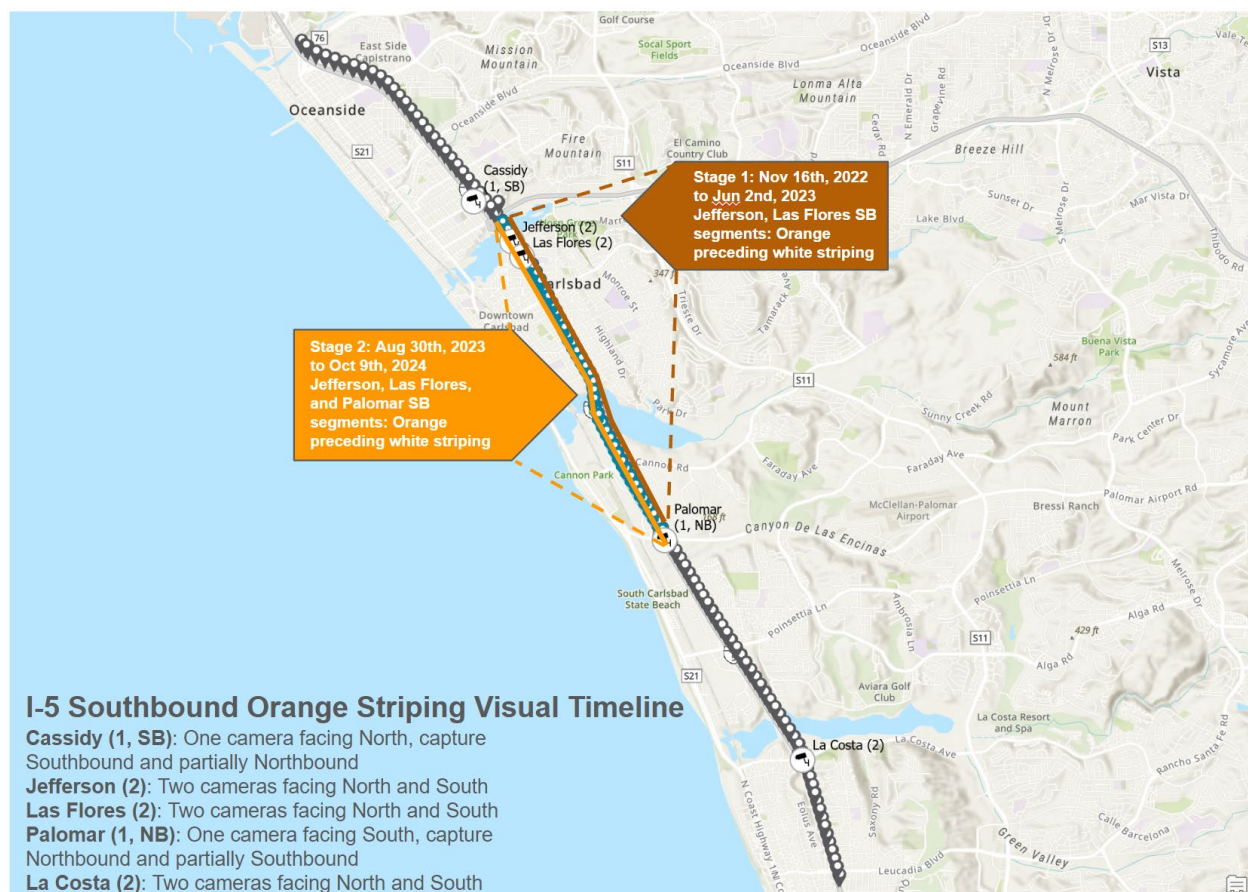
**Figure 1.4: I-5 SB Orange Striping Visual Timeline.** The blue segment is the projected work zone. The grey segments are the north and south of the work zone (or the non-work zone). Map generated using ArcGIS software by Esri.

Figure 1.4 shows where orange striping was installed on I-5 in the SB direction.

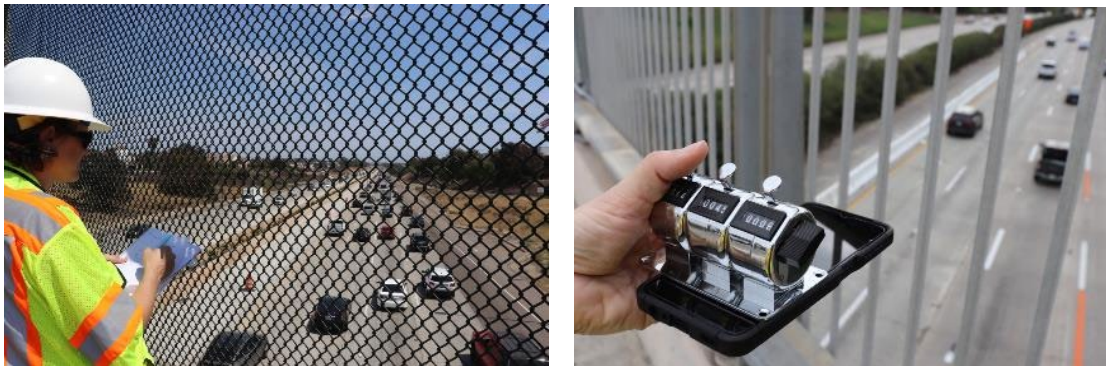
**Figure 2.1: Left: Visual observation of driver lane keeping on Palomar Airport Rd Overcrossing over I-5. Right: Using the three-part clicker for recording and smartphone as a timer on Las Flores Overcrossing over I-5.**

Initial visual observations of driver behavior were performed from Palomar Airport Road Overcrossing over I-5 with tally marks (Figure 2.1 left). This location was not yet a work zone but provided a good, safe observation location. A protocol to record lane keeping was developed by counting cars that were either in the middle, drifted to the left, or drifted to the right for a given time per lane with tally marks on paper. The initial protocol was refined with a longer recording time and the use of a clicker (Figure 2.1 right).

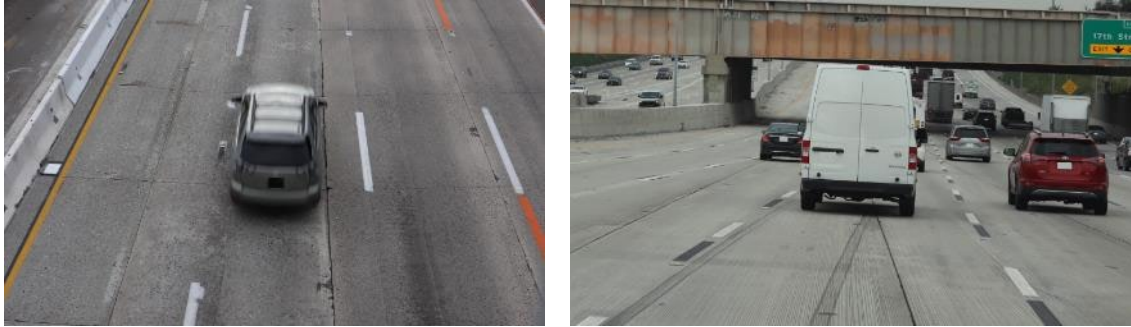
**Figure 2.5: Examples for lane keeping and pavement joints. Left: Las Flores, I-5 lane 2, SB traffic. Right: I-5, Tustin, CA, NB traffic. Both pictures taken on January 13, 2022**

The slabs of the concrete added additional features to the lanes and might have affected driver behavior. For example, a straight slab seam, as in Figure 2.5 left, tempted drivers to stay on one side, especially drivers in smaller cars. Figure 2.4 left shows a larger bias of drivers in lane 2 towards the K-rail than for all other lanes. Figure 2.5 right shows slab seams moving across lane markings, which might have confused drivers. No quantitative measurements were taken in this study, but the influence of pavement joints and vehicles ahead on driver behavior need to be considered.

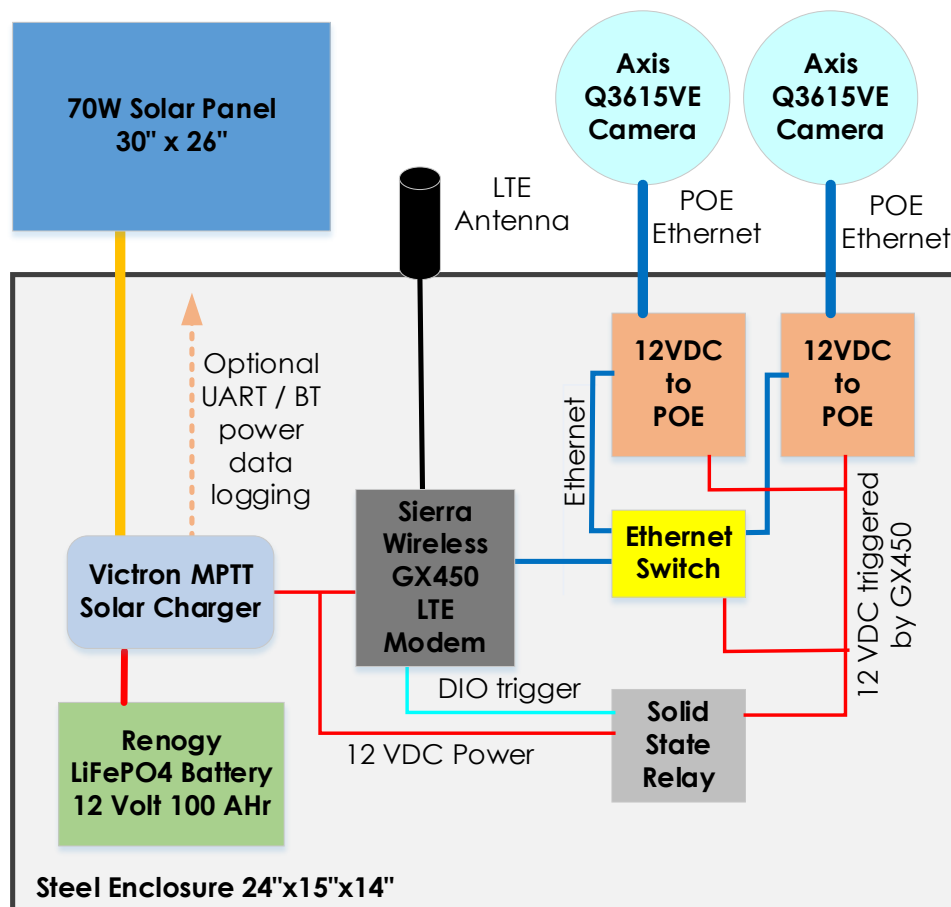
**Figure 2.6: Diagram of the camera system**

AHMCT researchers and Caltrans decided that the electronics box, solar panels, and cameras did not need to be on the same pole, which led to higher installation effort but increased flexibility for component placing. The camera location prioritized video information; the electronics box location prioritized accessibility for AHMCT researchers to trouble-shoot and download data; and the solar panel location prioritized maximum solar energy intake.

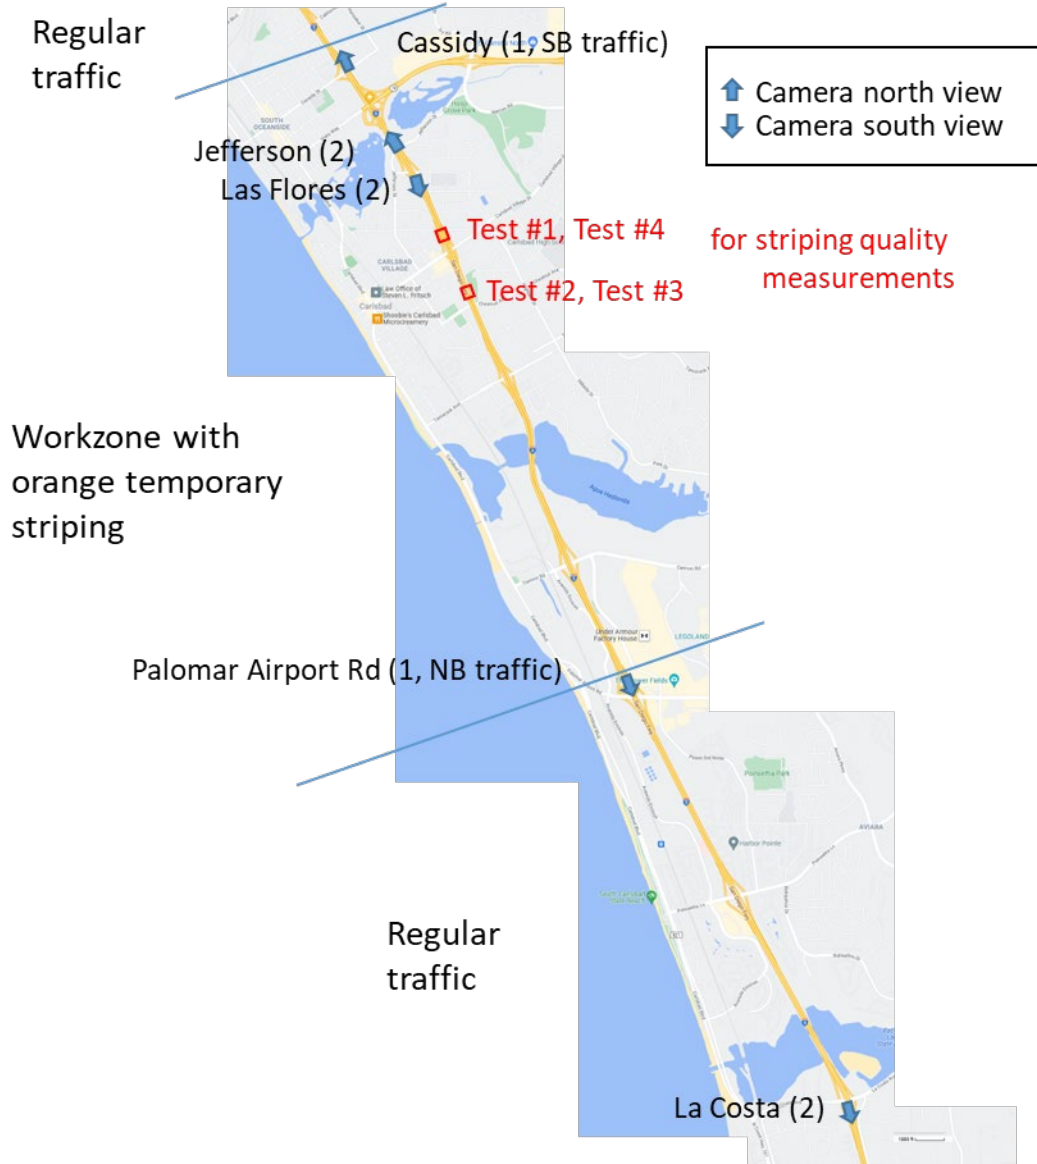
Figure 2.8: Camera locations on I-5 (map obtained from [www.google.com/maps](http://www.google.com/maps)).

The camera locations needed to have a large field of view and include important road features, such as curves, marking schemes, or ramps. Initially, observing vehicle behavior at on- or off-ramps was discussed but was omitted to focus on the striping effect within the work zone. It was decided to focus on the following general conditions and locations, as shown in Figure 2.8:

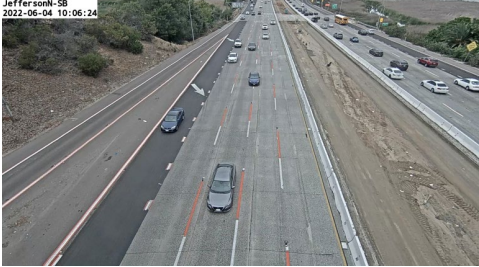
Location	Camera Installation Date	Road Condition	Camera Screenshot
Jefferson Overcrossing	January 2022	Straight part in work zone with orange temporary striping and white temporary striping	<p>Overcrossing W end, view N, SB traffic</p>

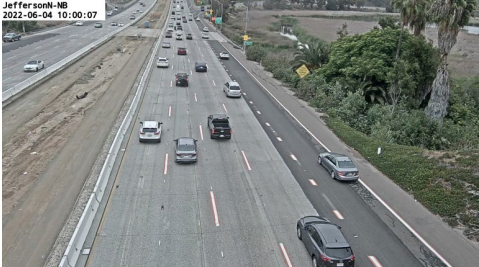
<p>Overcrossing E end, view N, NB traffic</p>

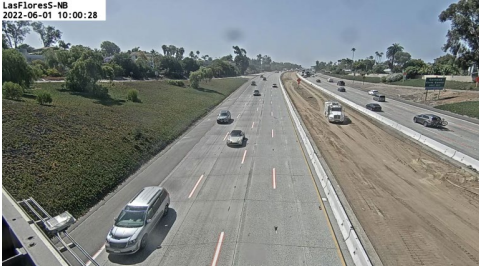
Las Flores Dr Overcrossing	January 2022	Curve in work zone with orange temporary striping and white temporary striping (SB traffic curves to the right)	<p>Overcrossing E end, view S, NB traffic</p>

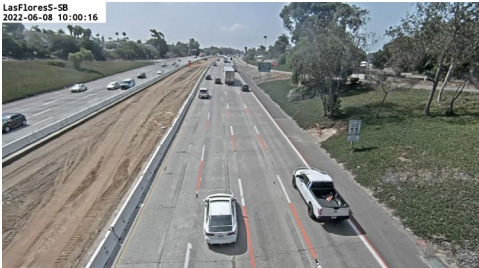
<p>Overcrossing W end, view S, SB traffic</p>

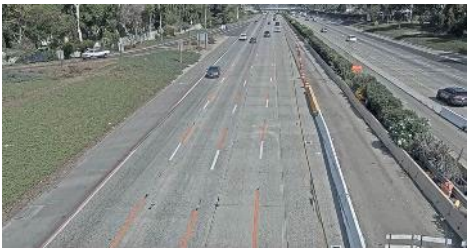
Location	Camera Installation Date	Road Condition	Camera Screenshot
Cassidy Overcrossing	June 2022	Taper shift between regular traffic zone and work zone with orange temporary striping	Overcrossing W end, view N, SB traffic

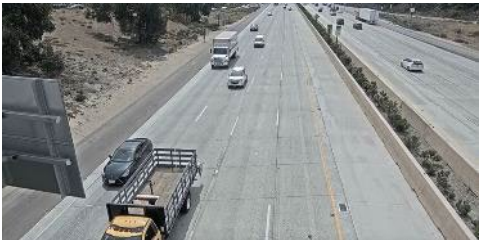
Palomar Airport Rd Overcrossing	June 2022	Taper shift between work zone with orange temporary striping and regular traffic zone	Overcrossing E end, view S, NB traffic

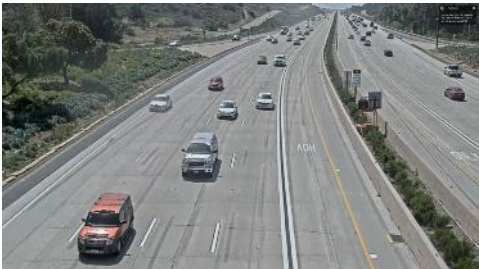
La Costa Overcrossing	June 2022	Curve in regular traffic zone (southbound traffic curves to the right)	Overcrossing E end, view S, NB traffic

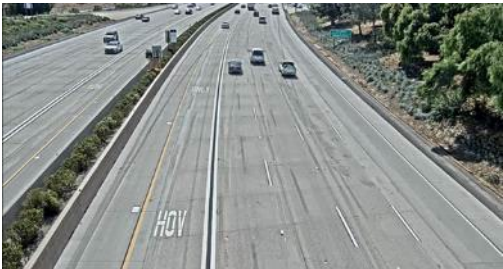
Overcrossing W end, view S, SB traffic

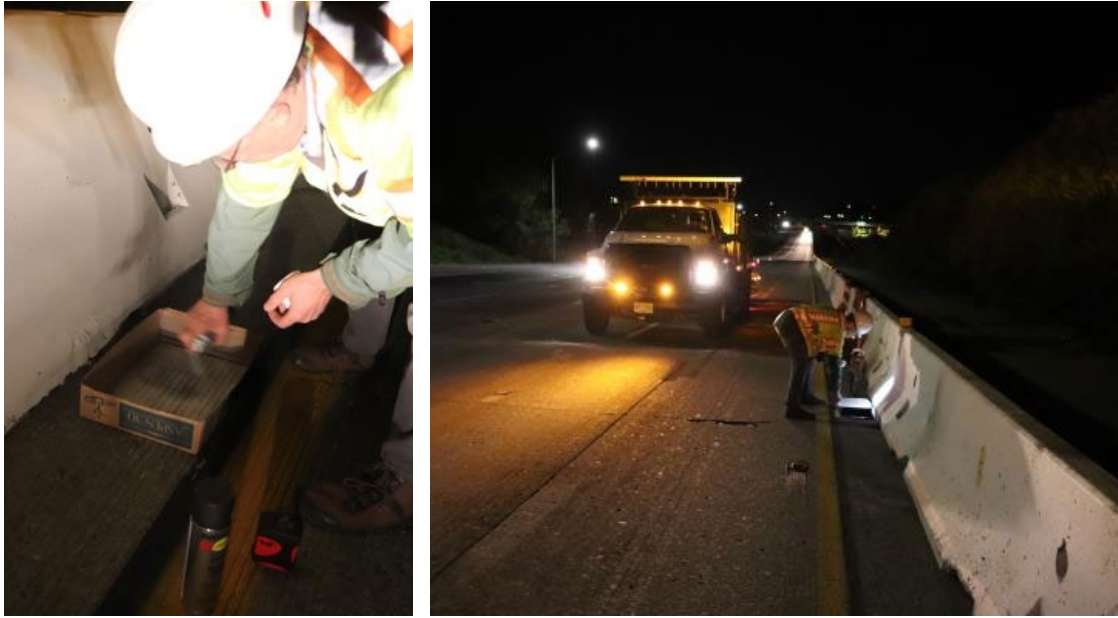
**Figure 2.10: Road marking application with spray paint**

cameras. The markings built a rectangle with the white stripes between lanes 3 and 4 (Figure 2.9, right). Figures 2.10 and 2.11 show installation and positioning. The marking closest to the overcrossing (0 ft) was followed by a second marking with  $y_i = 48$  ft. The next three markings were  $y_i = 3 \times 48$  ft = 192 ft apart so that five markings of up to 480 ft distance were visible from each camera. For the following camera installations, fewer road markings were installed closer together and by Caltrans personnel. The first marking was at 0 ft, the next at 48 ft, and the third at 96 ft.

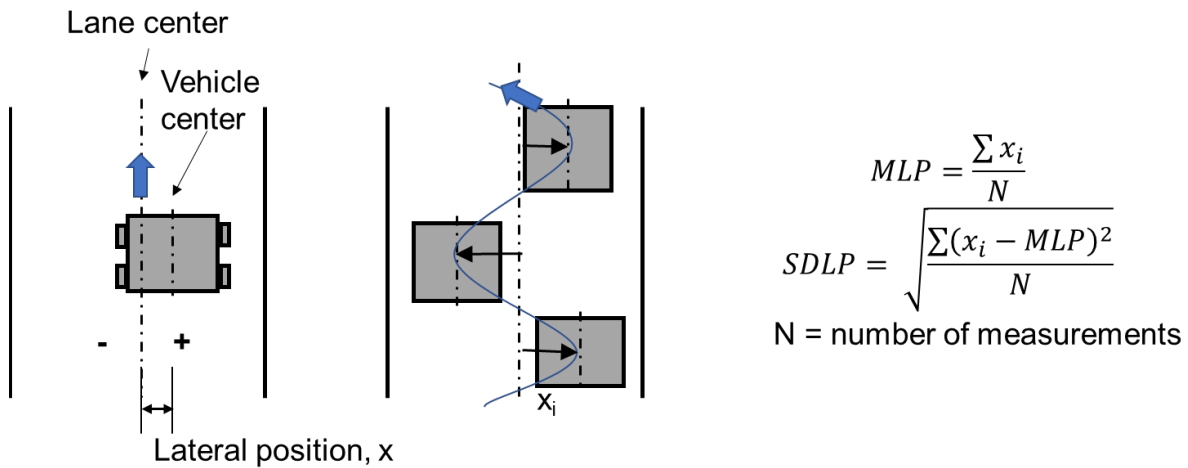
**Figure 2.12: Definition of mean of vehicle distance from lane center (MLP) and standard deviation of lateral position (SDLP)**

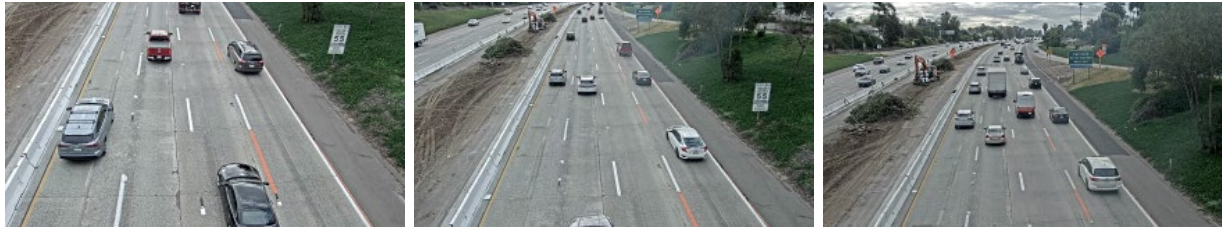
**Figure 2.13: Video screenshots with different views, from Las Flores Overcrossing, SB traffic. Left: Close view. Middle: Intermediate view. Right: Far view.**

Camera recordings were collected at different times of the day and at different time intervals. The accuracy of the measurements was strongly dependent on camera resolution, line of sight, and lighting conditions. The pan, tilt, and zoom options allowed for changing the camera view to see lane keeping behavior close-up or observe driver behavior and speeds over a longer stretch (Figure 2.13).

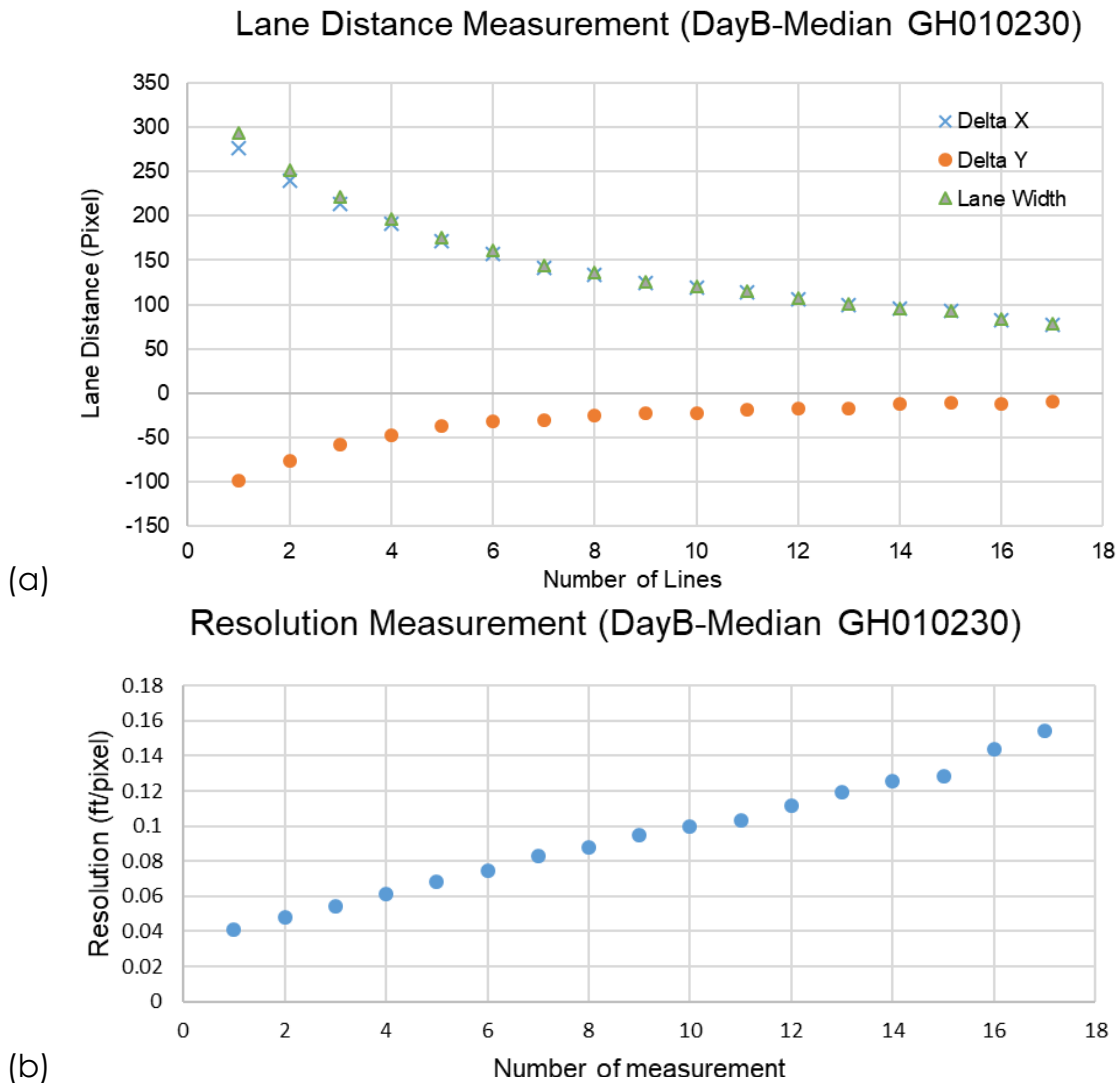
**Figure 2.17: Analysis of Figure 2.16 left measurements: (a) lane distance measurement in pixel and (b) resolution measurement for a lane width of 12 ft**

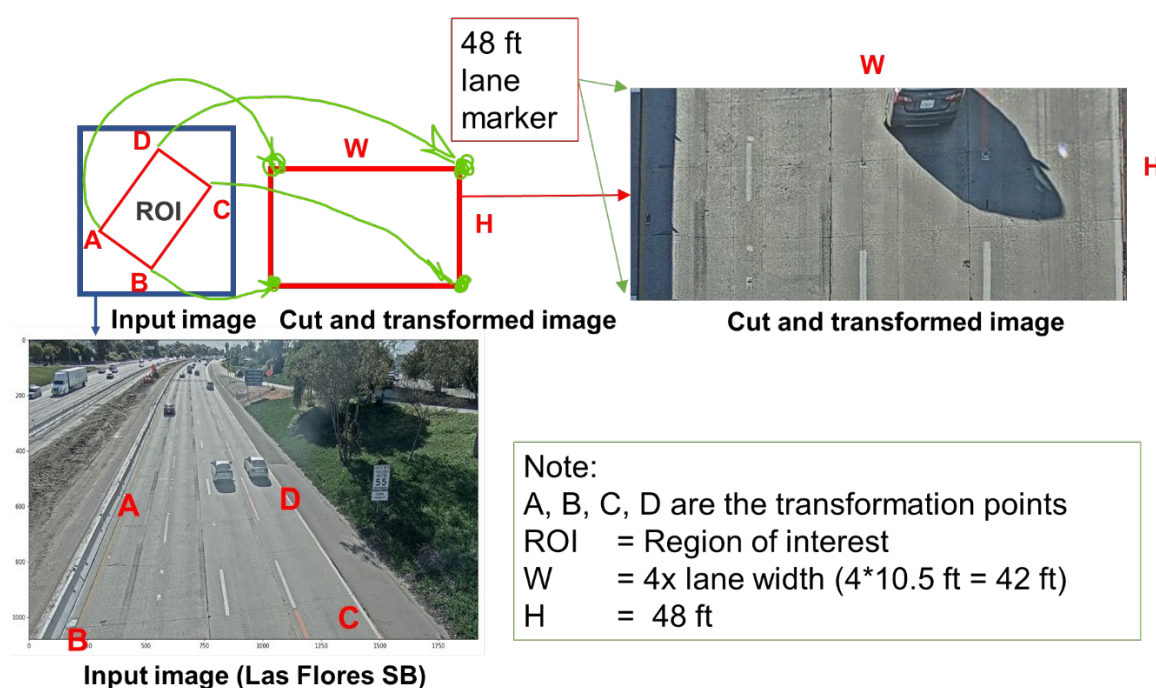
**Figure 2.18: Transformation of region of interest**

The video recordings were analyzed with analysis routines programmed in Python and automated vehicle detection through YOLOv5. YOLO is the abbreviation of “You Only Look Once” and is a popular open-source video processing algorithm. In the original CCTV video, YOLOv5 detected vehicles either as cars, trucks, and possibly busses. Busses were not found in this study. We also decided to ignore motor bikes. Each vehicle received a number and an estimated center point. From the camera input image, the region of interest was marked, which was then cut out and transformed into a bird's eye-view (Figure 2.18). With the transformed image, vehicles were counted per lane, speed was analyzed, and vehicle center distance from the respective lane center was calculated.

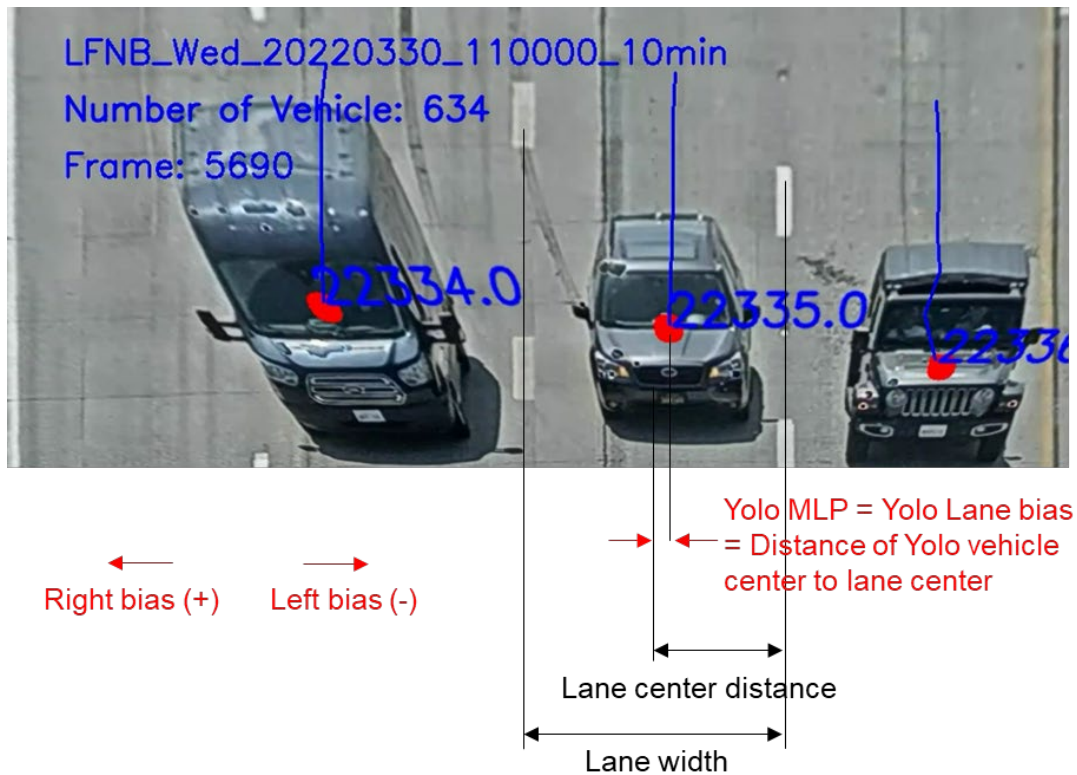
**Figure 2.19: Automated YOLO vehicle center analysis**

was derived from the left and right bumper distances to the lane stripes. As trucks were observed to have a higher MLP error, the manual evaluation intentionally considered a majority of cars instead of trucks and semi-trucks. This manual vehicle center to lane stripe distance was compared to the distance between lane stripe and the red marked vehicle center as determined by the YOLO vehicle center analysis routine on the same frame of the processed video.

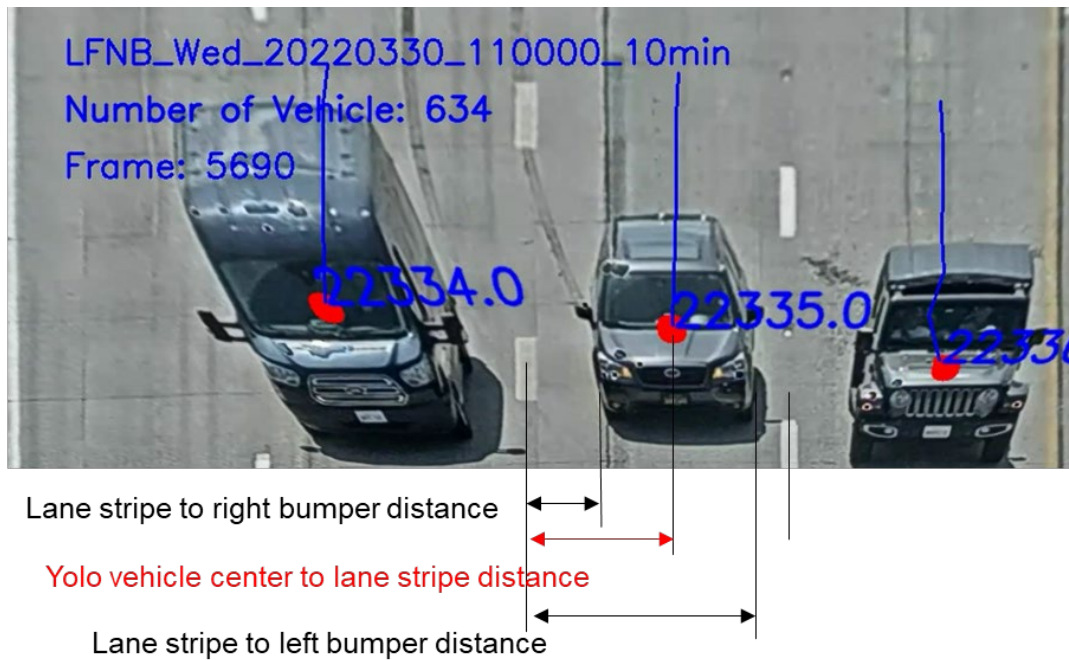
$$\text{Manual vehicle center to lane stripe distance} = 0.5 * (\text{Lane stripe to left bumper distance} + \text{Lane stripe to right bumper distance})$$

**Figure 2.20: Manual vehicle center measurement**

To evaluate the quality of the automatic YOLO MLP detection, the center positions of vehicles were manually obtained from processed video recordings. Figure 2.20 shows how the manual vehicle center to lane stripe measurement

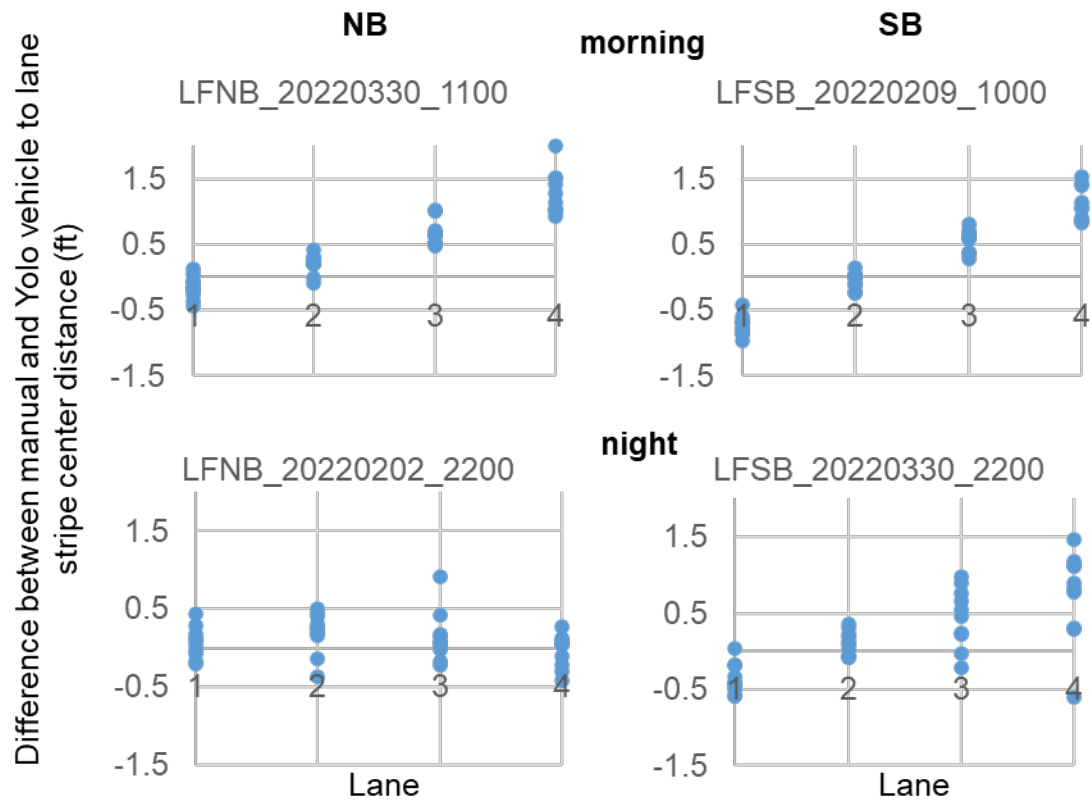
**Figure 2.21: Trendline of errors at Las Flores, NB and SB direction; in the morning (11 am and 10 am) and night (10 pm) for 10 cars each**

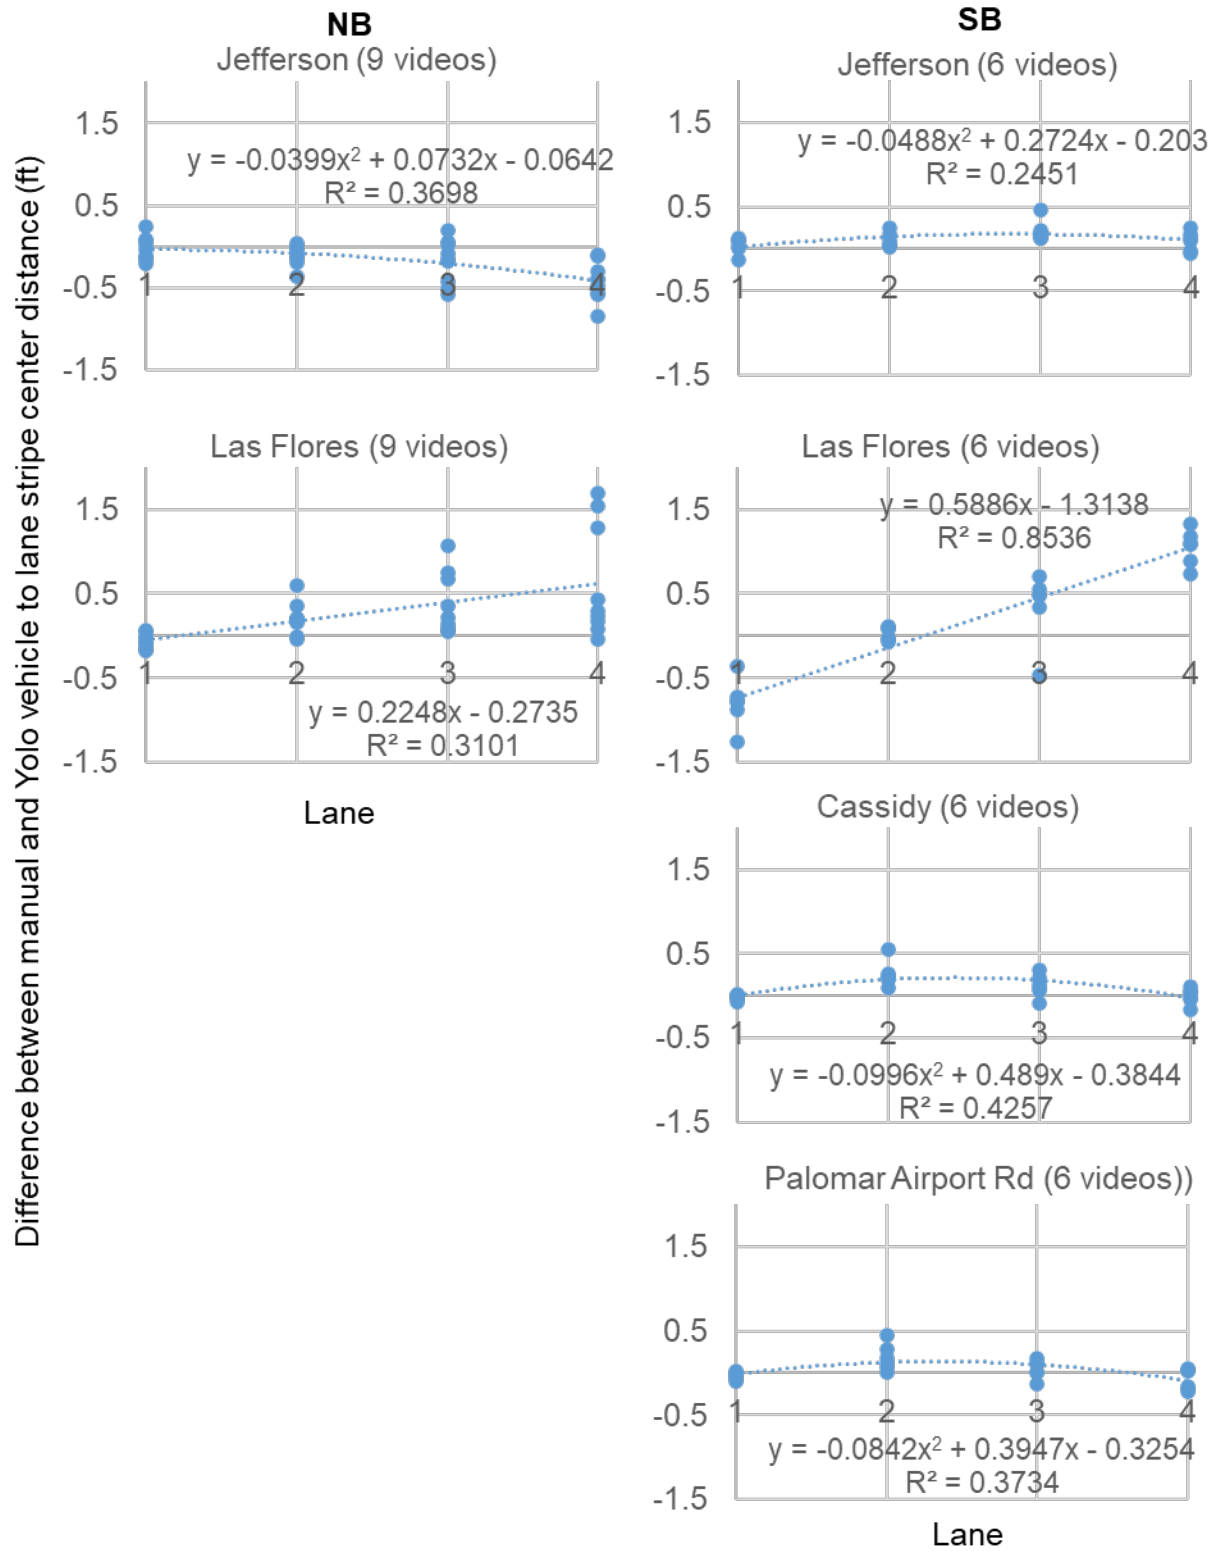
Figure 2.22: Trendlines of errors per CCTV camera (10 cars per video)

To increase the number of vehicles observed, six to nine videos for different day and night times and for 10 vehicles per video were evaluated. The averaged errors per CCTV camera and lane are shown in Figure 2.22. The CCTV cameras at Las Flores had the highest errors of up to 1.69 ft right bias for lane 4. The errors at Las Flores SB range from -0.18 ft to 1.69 ft in NB direction and -1.26 ft to 1.34 ft in SB direction. This high error might have resulted from the curved road and on-ramp merging behavior at Las Flores. The camera at Jefferson NB had errors between -0.84 ft to 0.24 ft, Jefferson SB between -0.14 ft to 0.47 ft, Cassidy between -0.17 ft to 0.56 ft, and Palomar Airport Rd between -0.23 ft to 0.44 ft.

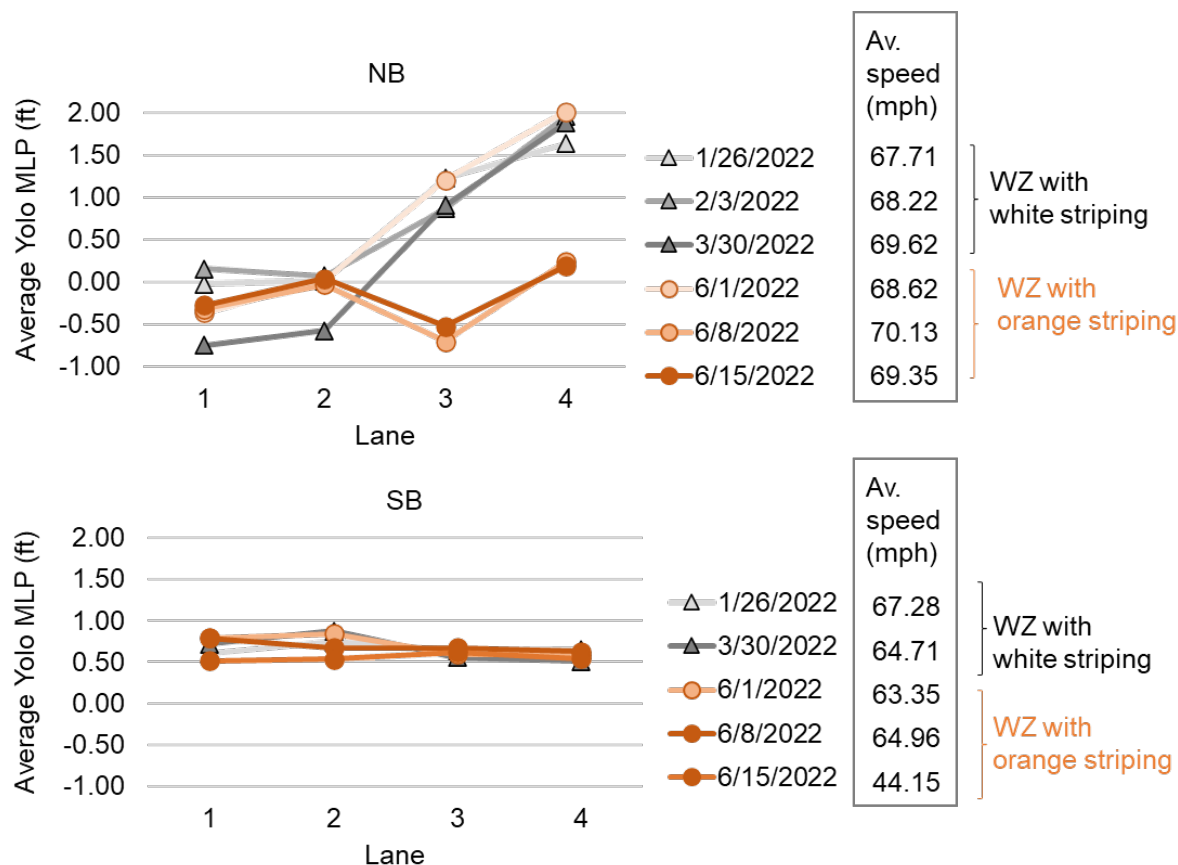
**Figure 2.24: Lane keeping behavior for lanes 1 to 4 from automated YOLO vehicle center analysis, Jefferson Overcrossing, selected weekdays at 10 am, 10-min videos; average speed from HERE Technologies data for 1 h at Las Flores Dr/Exit 51A (closest location to Jefferson Overcrossing)**

average MLP for five Wednesdays and one Thursday (February 3, 2022) were compared (Figure 2.24). In the NB direction, vehicles had varying left and right bias for the six observed dates. In the NB direction, vehicles had just passed an on-ramp to the auxiliary lane 5 (Table 2.1). Also, there is a stronger error from camera distortion on lanes 3 and 4 (Figure 2.22). The average speeds were obtained from Here Technologies data (the methodology is described Chapter 5). For the NB direction, all average speeds were between 67.71 mph and 70.13 mph.

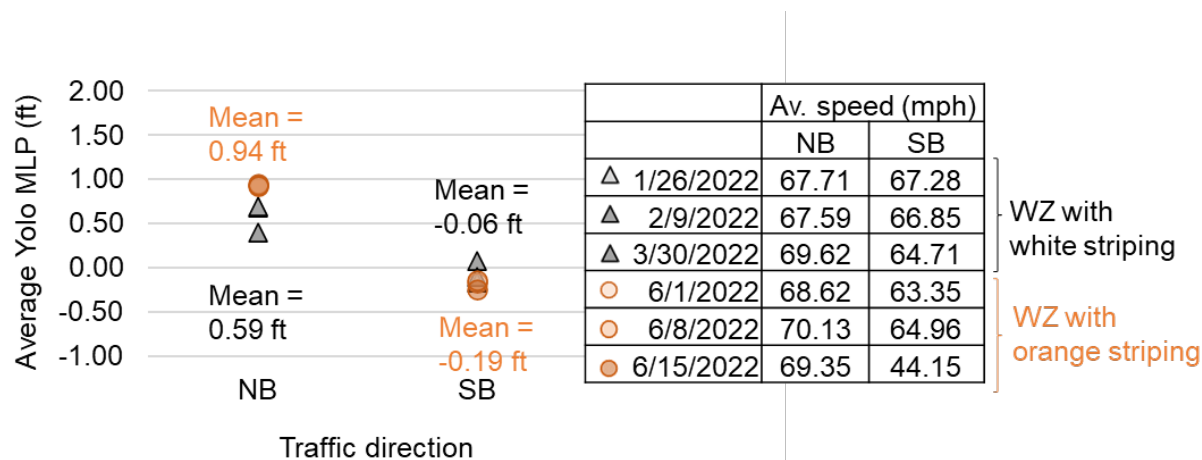
**Figure 2.25: Lane keeping behavior for lane 2 from automated YOLO vehicle center analysis, Las Flores Overcrossing, selected Wednesdays at 10 am, 10-min videos (mean is not weighted by car count); average speed from HERE Technologies data for 1 h at Las Flores Dr/Exit 51A**

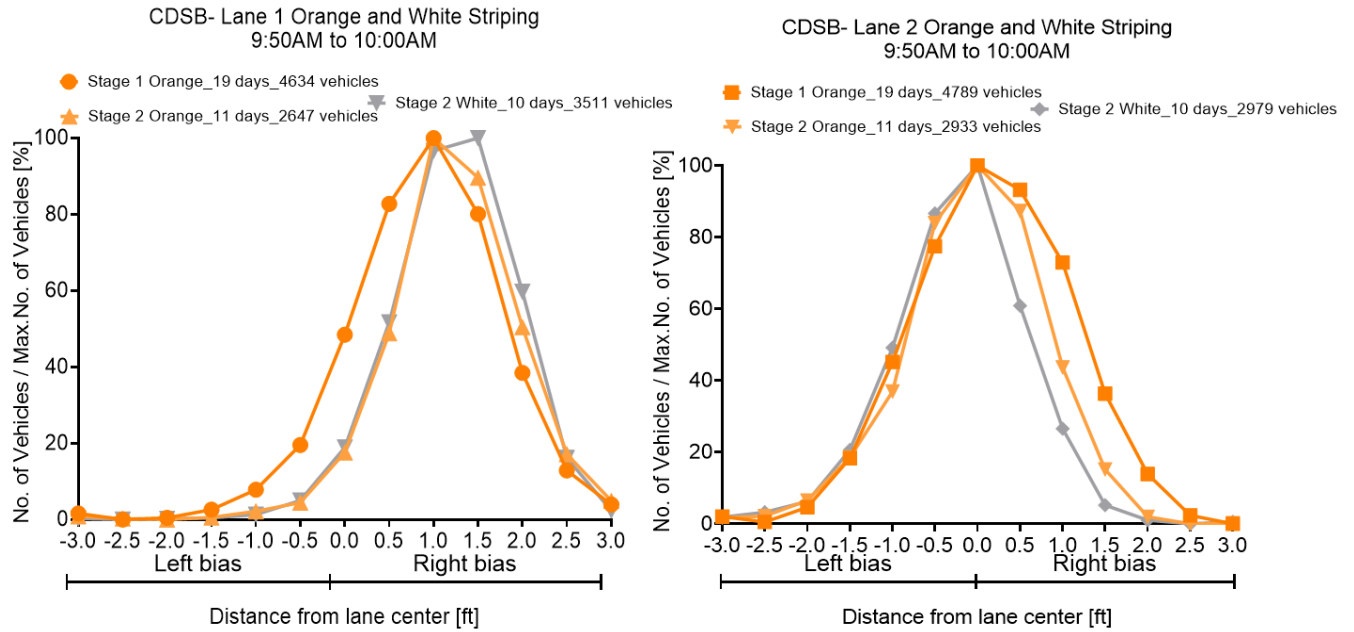
**Figure 2.32: Normalized histogram of vehicle center distance to lane center at Cassidy overcrossing, SB traffic in the morning (n = 21,493). Left: Lane 1. Right: Lane 2**

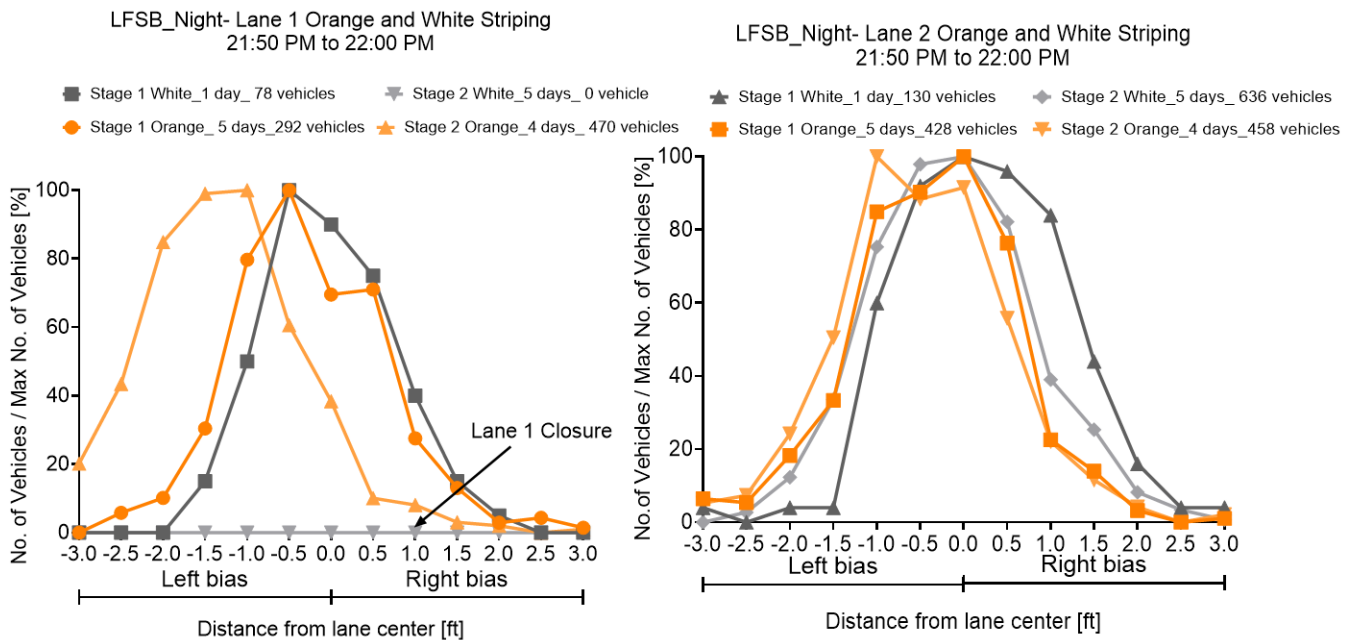
**Figure 2.33: Normalized histogram of vehicle center distance to lane center at Las Flores overcrossing, SB traffic at night (n = 2,492). Left: Lane 1. Right: Lane 2**

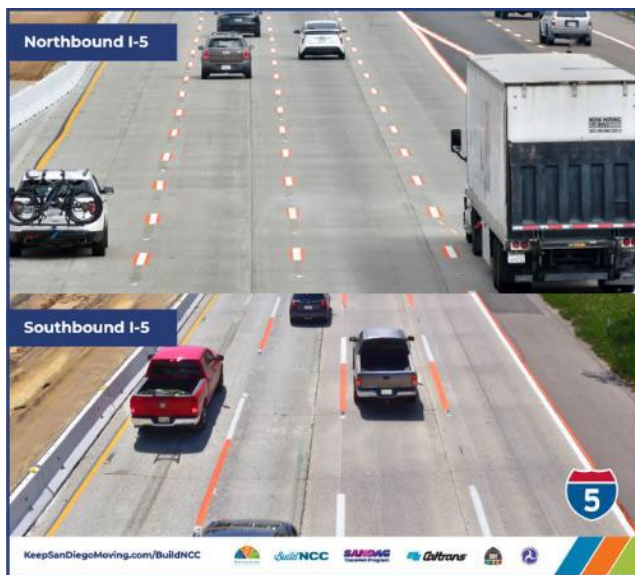
**Figure 3.1: Visual for Q5 on lane line pattern preference**

Of 1,087 people, 43.2% noticed a difference in the NB and SB orange contrasted lane line striping, but the majority (56.9%) did not (Q4, Appendix C). Only the respondents who noticed the difference were asked Q5 concerning which orange contrasted lane line striping they preferred. In addition, a picture with both striping patterns was shown (Figure 3.1). Of the 465 respondents, the majority (60.4%) preferred the orange along both sides of the white lane line in the NB direction, 22.8% preferred the orange preceding the white lane line in the SB direction, and 16.8% reported no preference (Q5, Appendix C).

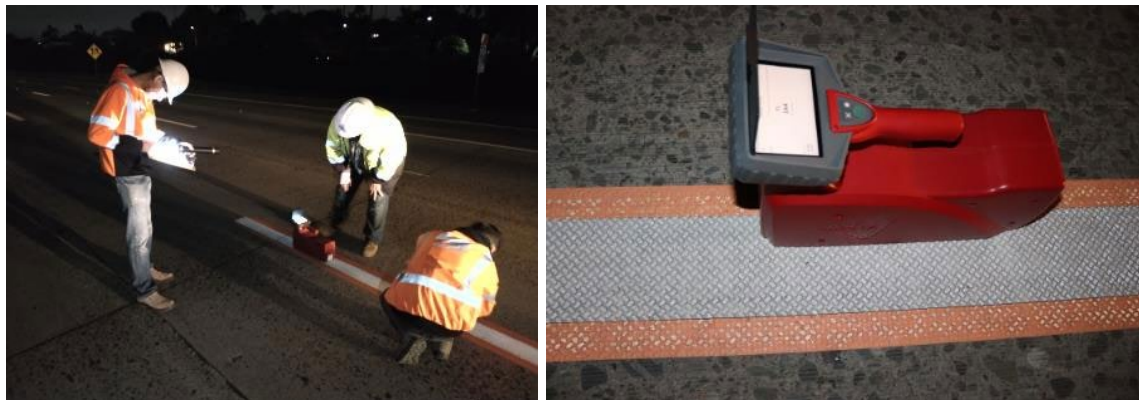
**Figure 4.2: Left: Striping quality measurements performed by AHMCT researcher and Caltrans staff days after orange striping installation. Right: Retroreflectivity and nighttime color measurements on tape striping on I-5 NB south of Las Flores Overcrossing**

The visibility of orange contrast delineation was quantified through direct measurements of retroreflectivity and color on the striping and through dashboard camera videos. Figure 4.2 shows the device to measure retroreflectivity and nighttime color. The spectrophotometer for daytime color measurements can be seen in Figure 4.8 (top right). Additional trials to assess striping quality were performed with a portable USB light microscope. Findings about temporary tape striping are reported in this chapter.

Measurements were performed with a stationary reflectometer LTL3000 (Delta Instruments), which collects the coefficient of retroreflected luminance, RL, and nighttime chromaticity (Figure 4.2, right). A spectrophotometer Spectro2guide, 45/0 (BYK-Gardner) collected daytime chromaticity values. The measurements are made within seconds, but the devices needed to be placed on top of the stripe. Due to safety concerns, measurements were only taken during lane closures, which occurred at night. Both devices had their own light sources for nighttime measurements and high consistency. The measurements were made shortly after the installation of the orange striping in the work zone in stage 1 (0 months) and six months after the installation by Caltrans and AHMCT. Further measurements were performed roughly every two months by Caltrans personnel.

Based on ASTM standard D7585/D7585M,<sup>3</sup> retroreflectivity and colors were measured on two 400 ft segments for each striping pattern (Figure 4.1). For safety reasons, data points were collected at night on the stripes between lanes 1 and 2 during freeway lane closures (Figure 4.2, left). The measurement routine per stripe pattern is shown in Figure 4.3. There were three measurements per stripe and color.
