1. REPORT NUMBER <b>CA25-3836</b>	2. GOVERNMENT ASSOCIATION NUMBER N/A	3. RECIPIENT'S CATALOG NUMBER N/A
4. TITLE AND SUBTITLE <b>Orange Contrasted Temporary Pavement Delineation in Construction Zones</b>		5. REPORT DATE <b>04-04-2025</b>

6. PERFORMING ORGANIZATION CODE AHMCT Research Center, UC Davis
7. AUTHOR Barbara Linke, Wilderich White, Kin Yen, Anh Duong, Felicia Fashanu, Nathan Byrd		8. PERFORMING ORGANIZATION REPORT NO. <b>UCD-ARR-25-03-31-01</b>

11. CONTRACT OR GRANT NUMBER <b>65A0749 Task 3836</b>
12. SPONSORING AGENCY AND ADDRESS <b>California Department of Transportation P.O. Box 942873, MS #83 Sacramento, CA 94273-0001</b>		13. TYPE OF REPORT AND PERIOD COVERED <b>Final Report 04/21 - 03/25</b>

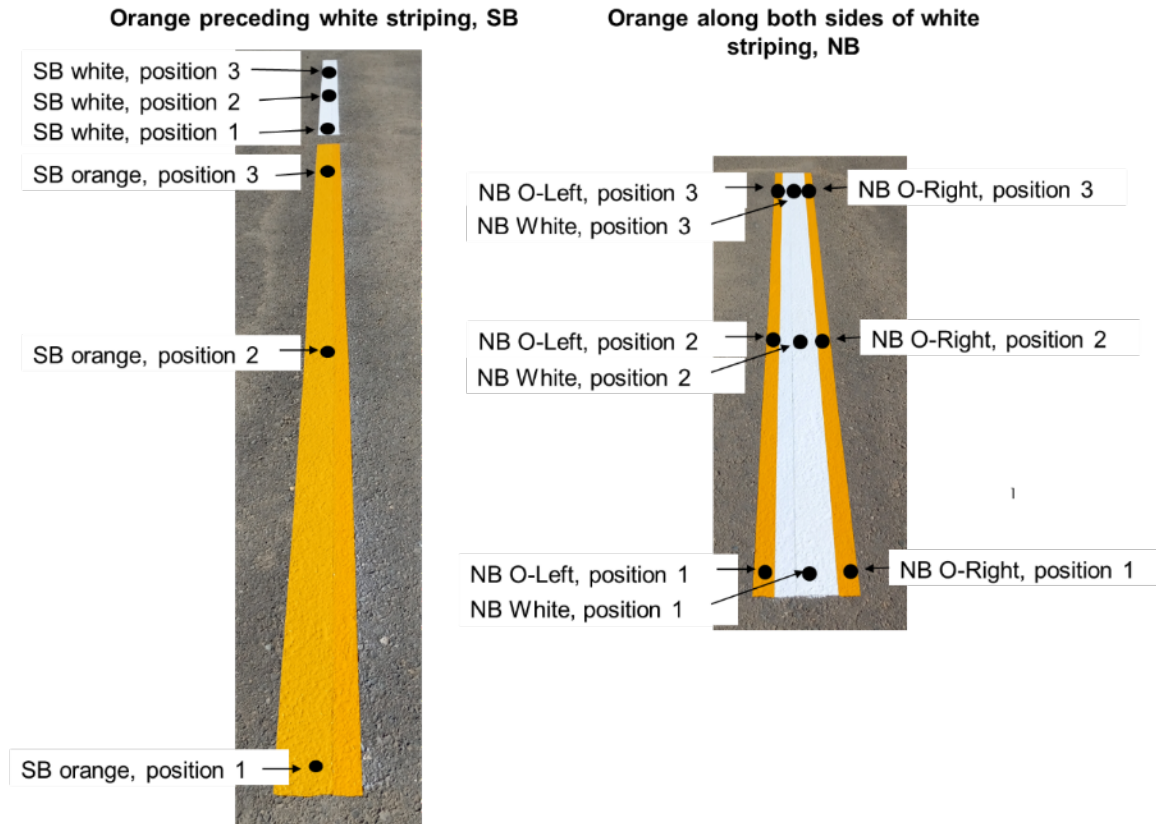
**Figure 4.3: Measurement routine per stripe pattern**

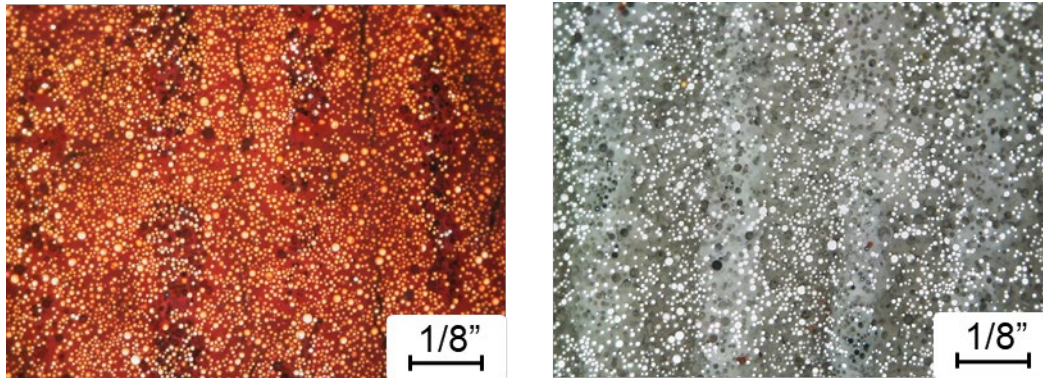
**Figure 4.6: Microscope pictures from orange (left) and white (right) temporary striping on November 14, 2022**

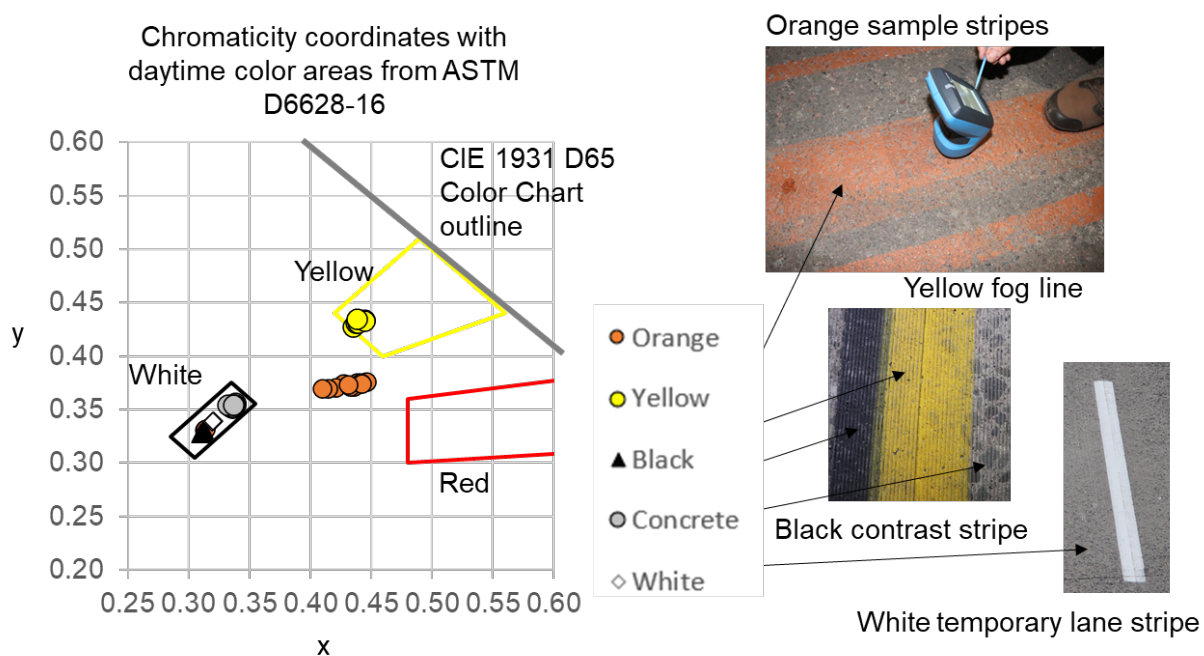
**Figure 4.8: Test daytime color measurements, n = 5 to 13 measurements per sample type**

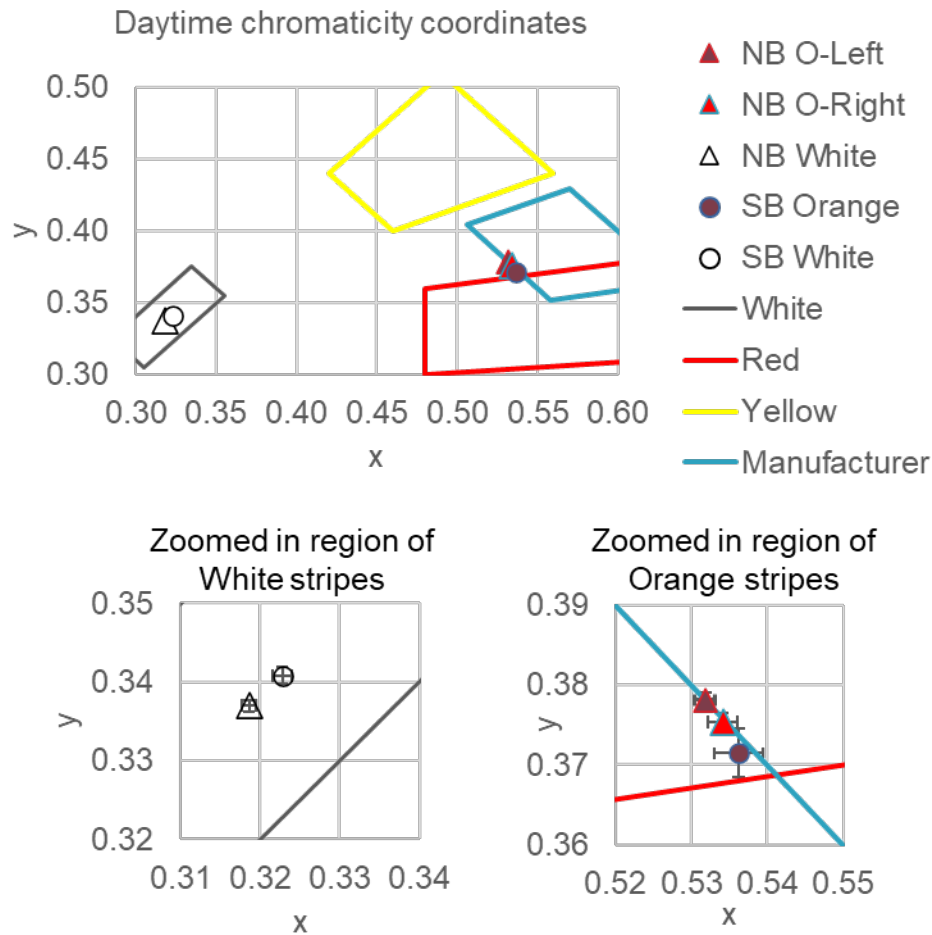
**Figure 4.10: Daytime color measurements on measurements at 0 months after orange striping installation in stage 1 compared with ASTM Standard D6628 (n = 48 measurements per stripe type)**

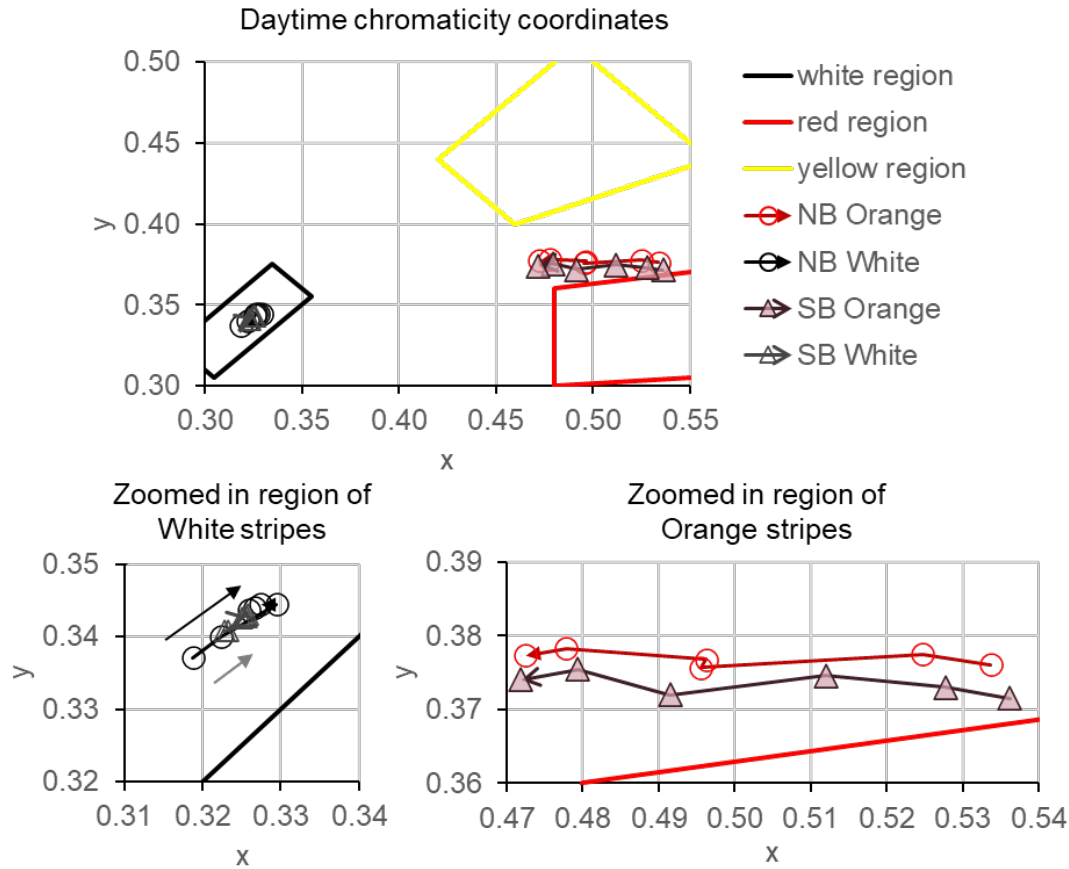
**Figure 4.12: Average daytime color coordinates over time after orange striping installation in stage 1 compared with regions in ASTM Standard D6628 (n = 48 measurements for NB White, SB Orange, SB White (except for 12.6 months,  $n_{SB\text{ Orange}} = 27$  and  $n_{SB\text{ White}} = 24$ ); n = 96 measurements for NB Orange). Arrows indicate increasing number of months**

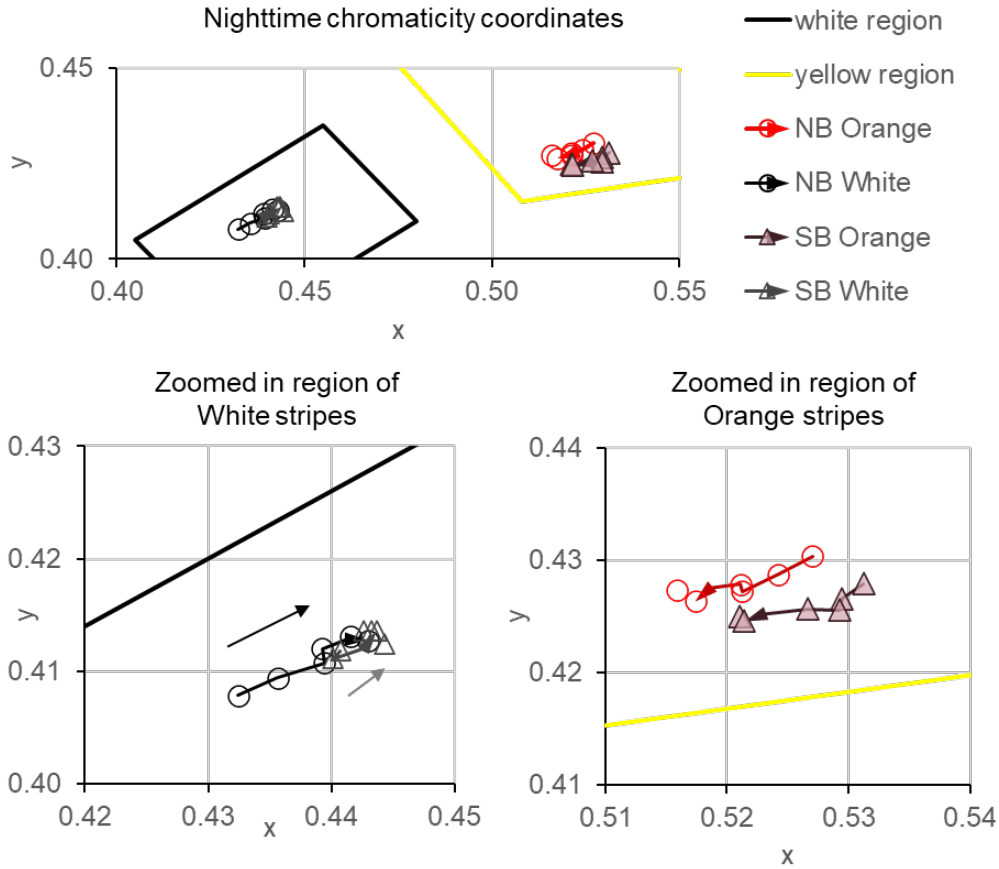
**Figure 4.13: Average nighttime color coordinates over time after orange striping installation in stage 1 compared with regions in ASTM Standard D6628 (n = 48 measurements for NB White, SB Orange, SB White; n = 96 measurements for NB Orange). Arrows indicate increasing number of months**

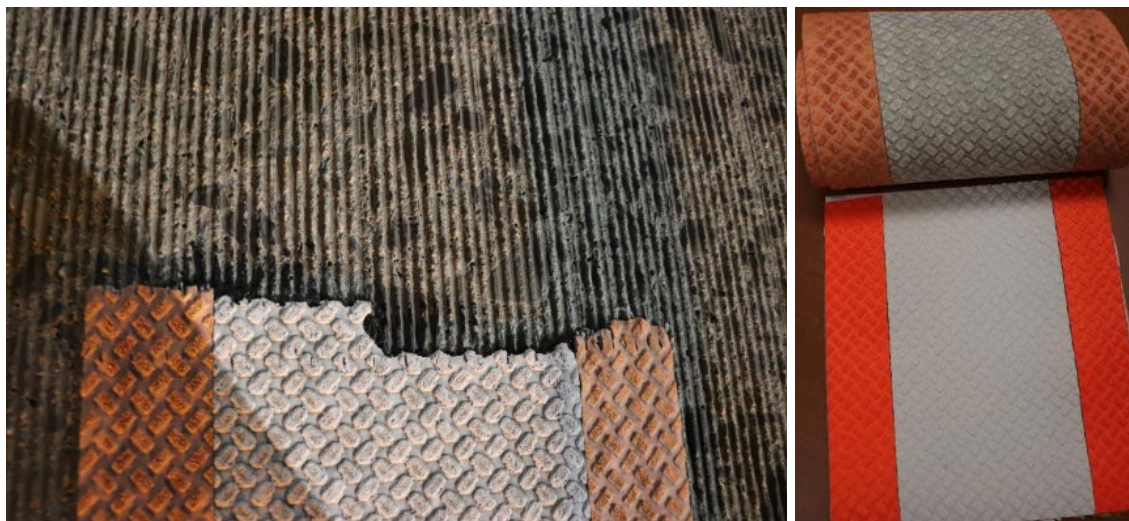
**Figure 4.17: Left: Tape on freeway concrete surface with grinding grooves and orange tape striping worn (at 5 months). Right: New orange striping tape**

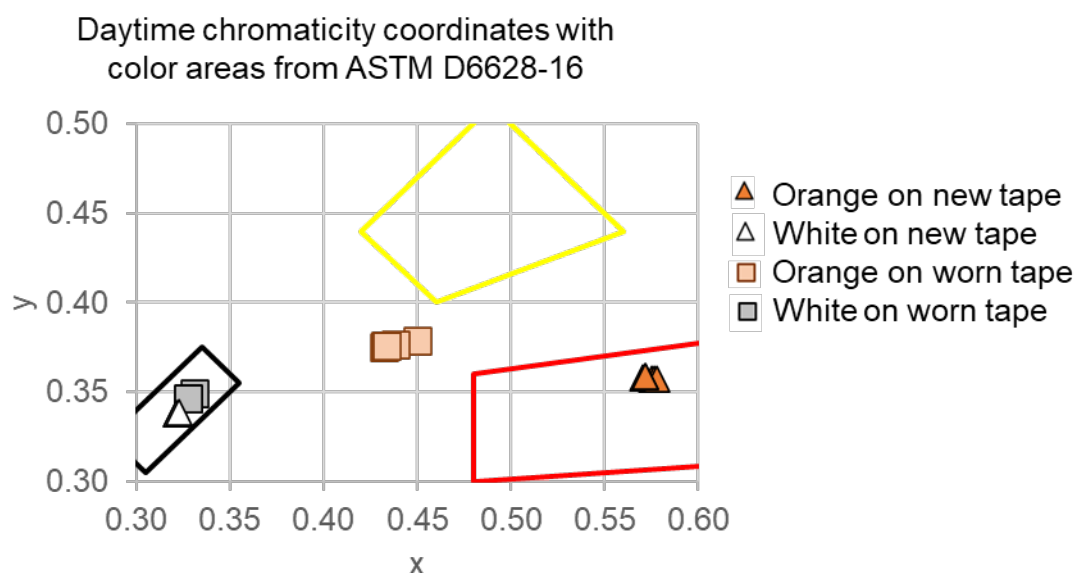
**Figure 4.18: Daytime color measurements on new and worn orange tape, 3 worn stripes after 5 months of installation, 1 new stripe**

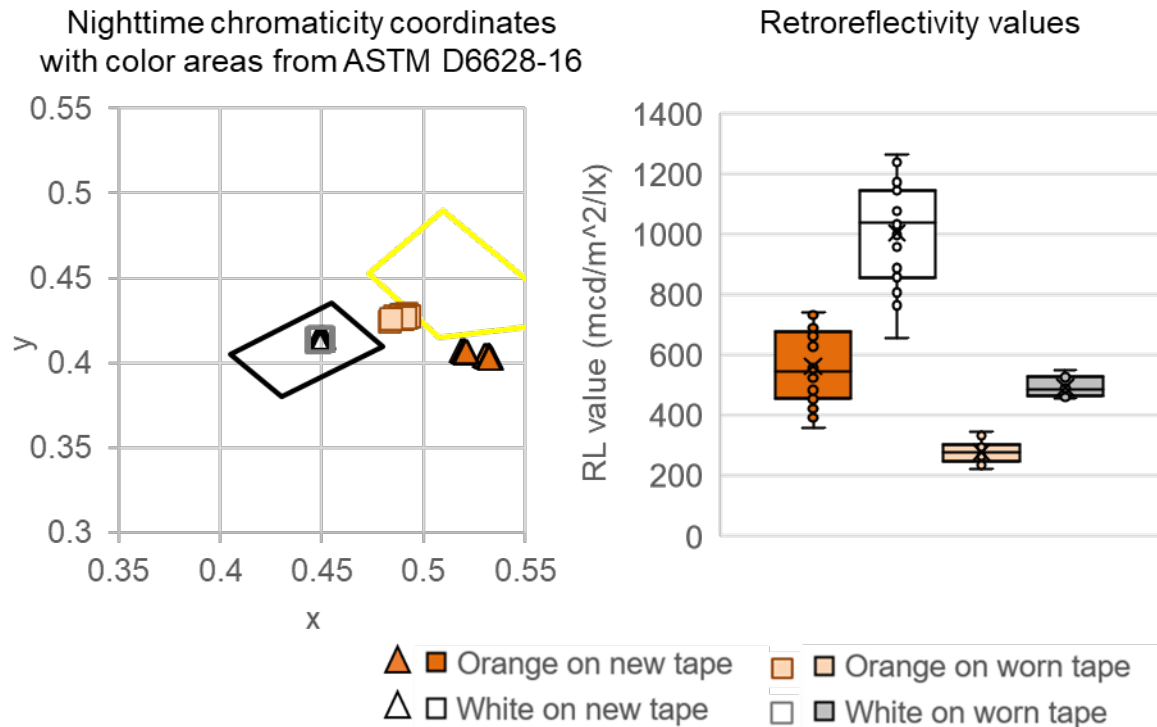
**Figure 4.19: Nighttime color and retroreflectivity measurements on new and worn orange tape, 3 worn stripes after 5 months of installation, 1 new stripe**

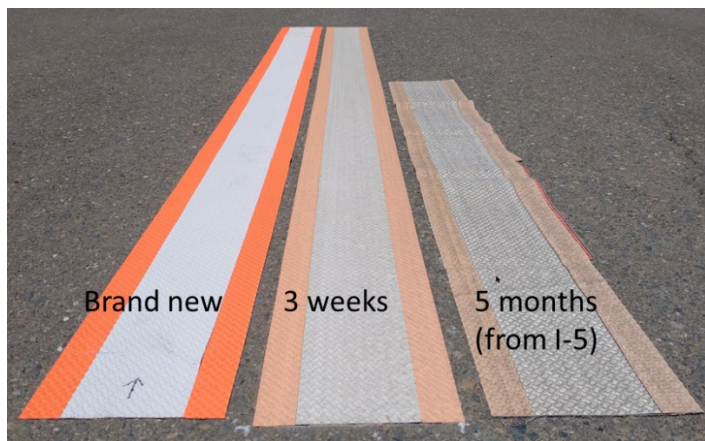
**Figure 4.20: Color degradation of orange along both sides of white tape after exposure to sunlight**

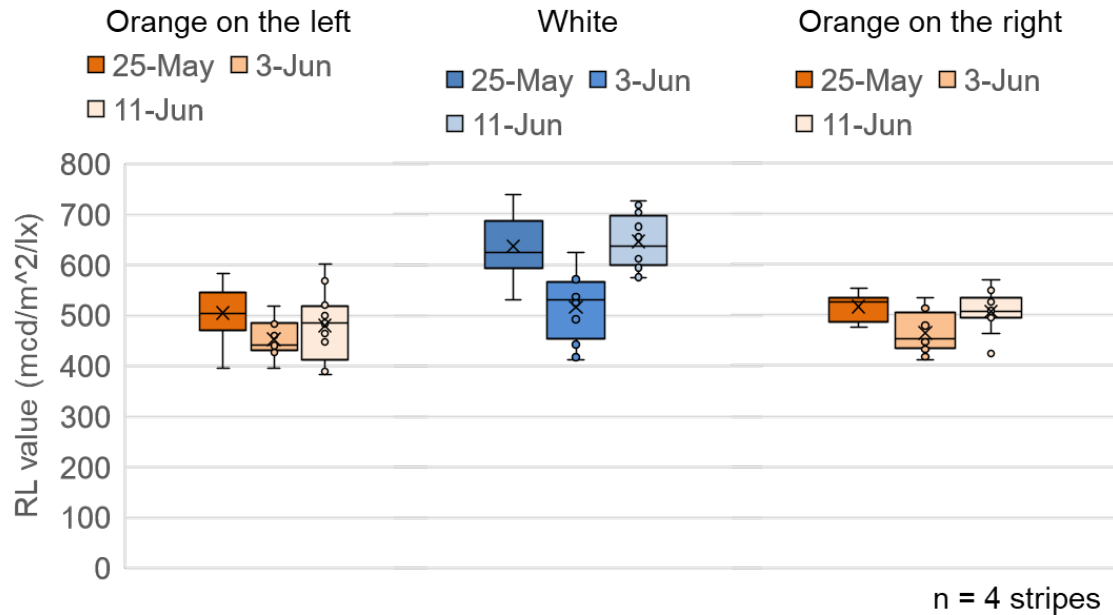
**Figure 4.21: Retroreflectivity measurements of orange tape, left in the sunshine after installation on May 22, 2022, 4 stripes, measured 3x each**

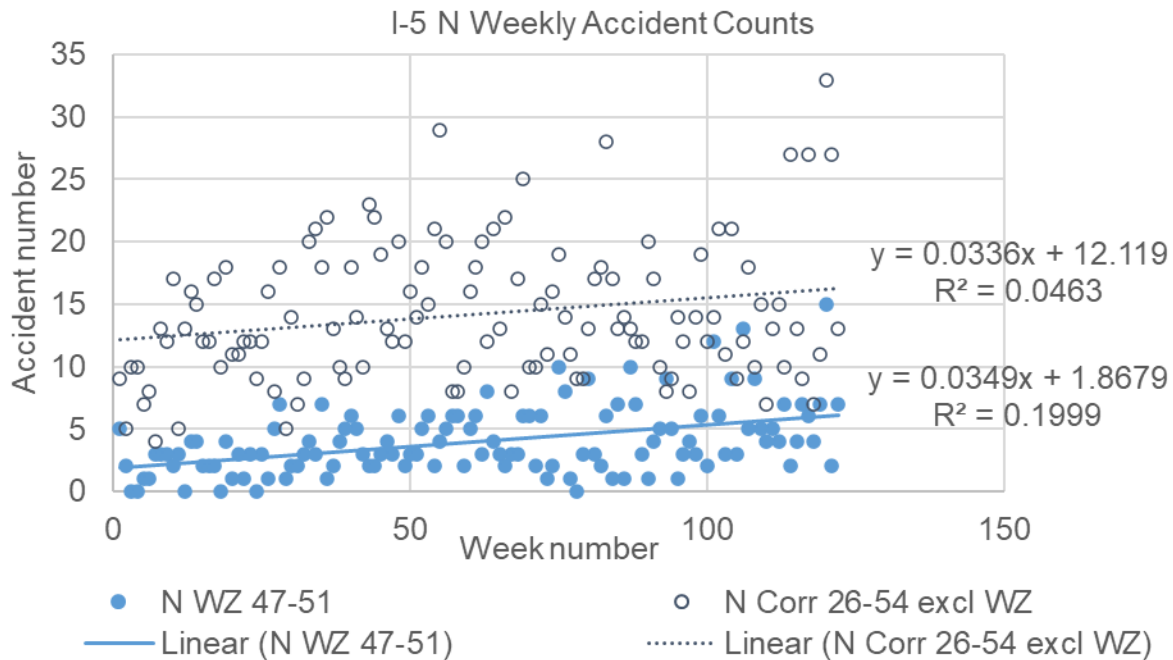
**Figure 5.5: NB accident counts with linear continuous trendlines in the work zone (WZ) and corridor excluding WZ, PeMS data, weeks of November 29, 2020 till April 1, 2023**

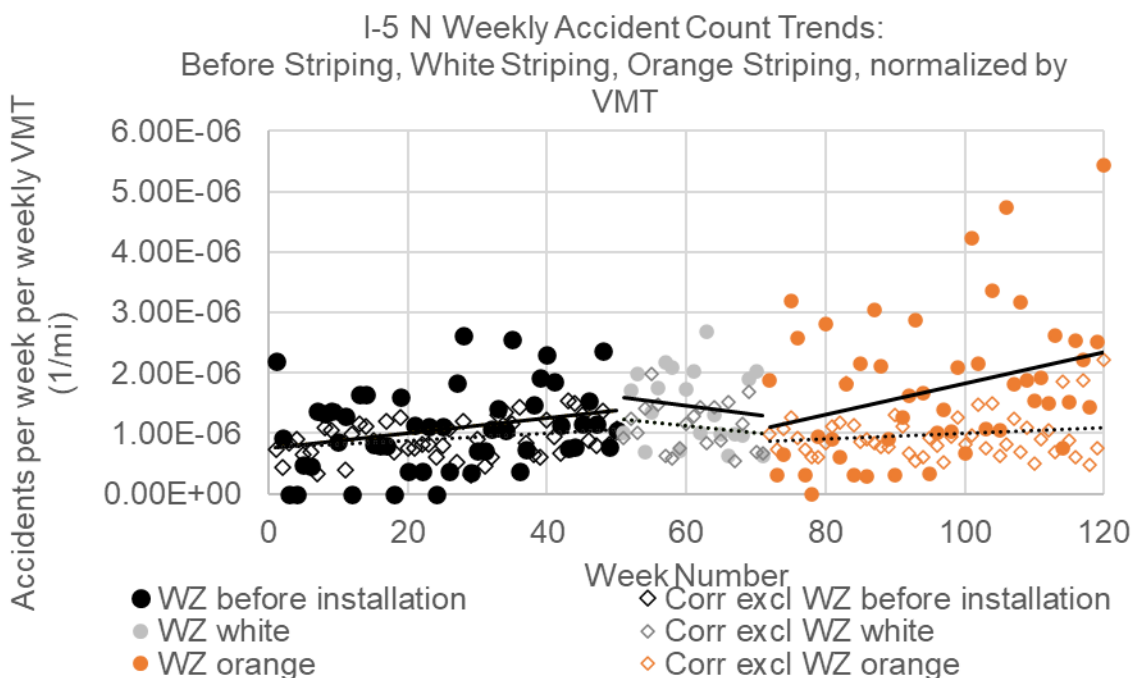
**Figure 5.7: NB weekly accidents normalized by the weekly VMT with linear trendlines (bold lines for WZ, dotted lines for corridor excluding WZ), divided into three time periods, PeMS data, weeks of November 29, 2020 till April 1, 2023**

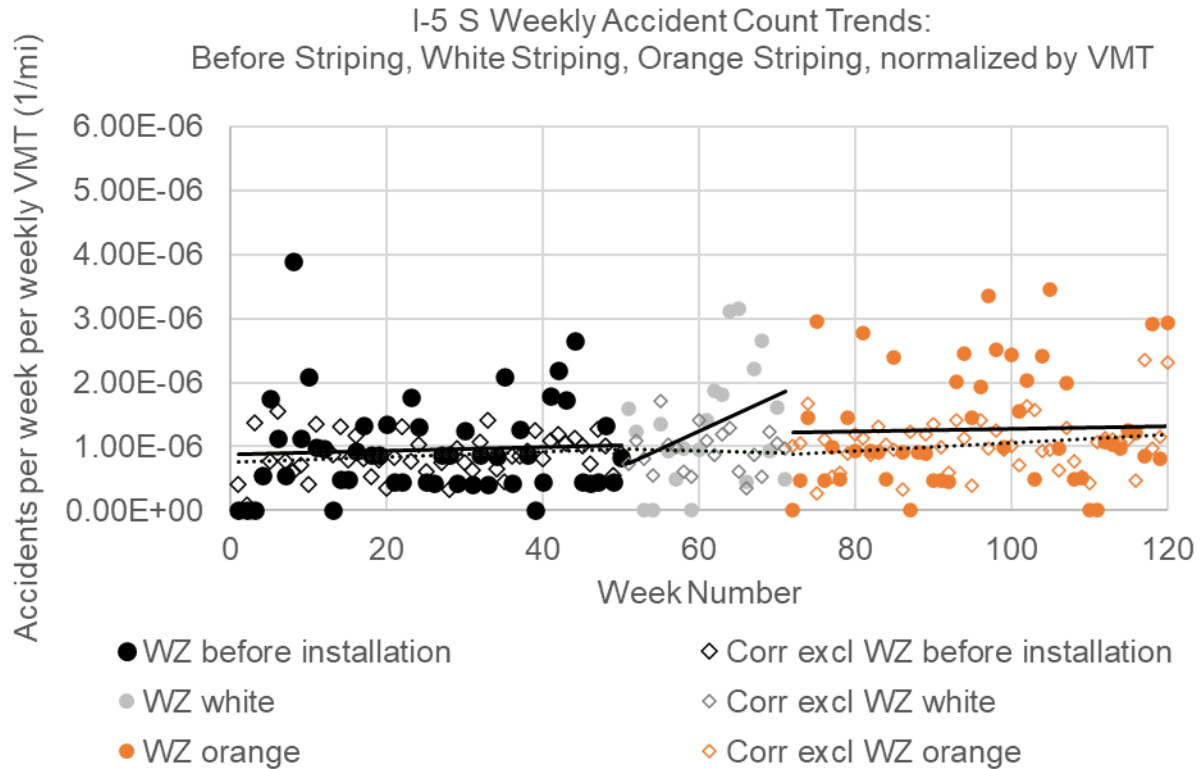
**Figure 5.8: SB weekly accidents normalized by the weekly VMT with linear trendlines (bold lines for WZ, dotted lines for corridor excluding WZ), divided into three time periods, PeMS data, weeks of November 29, 2020 till April 1, 2023**

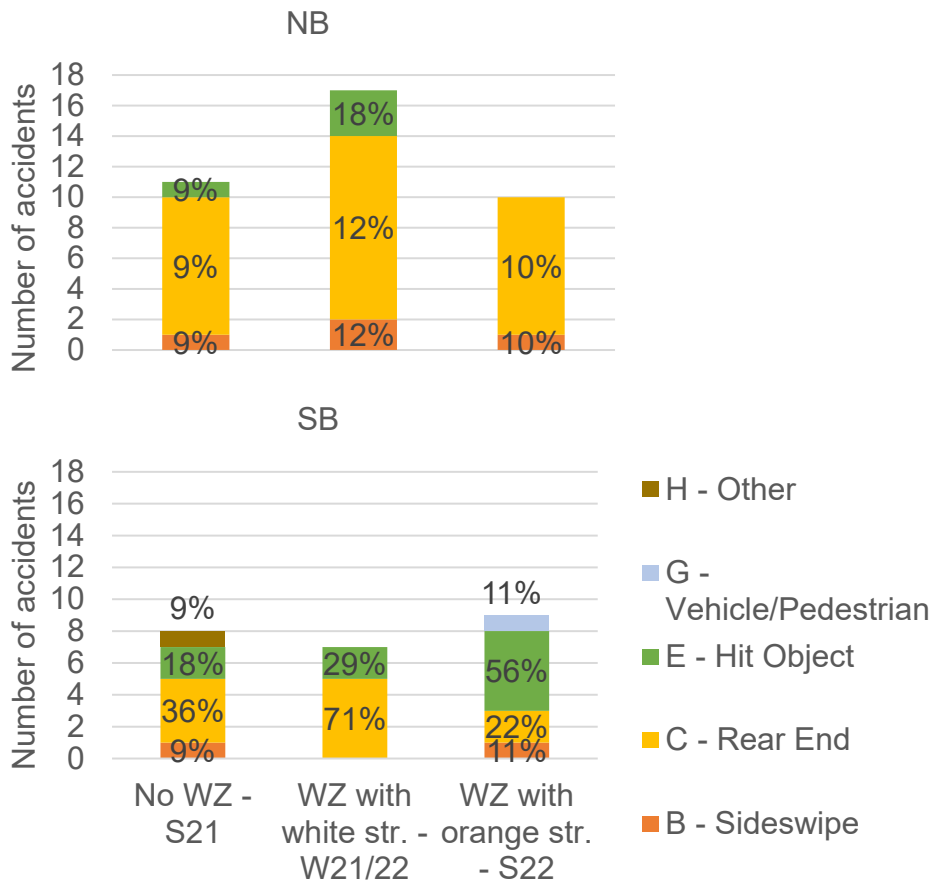
**Figure 5.9: TIMS accident type numbers and distribution for Abs PM 46 to 51 during selected 5-month periods (data downloaded on July 31, 2023)**

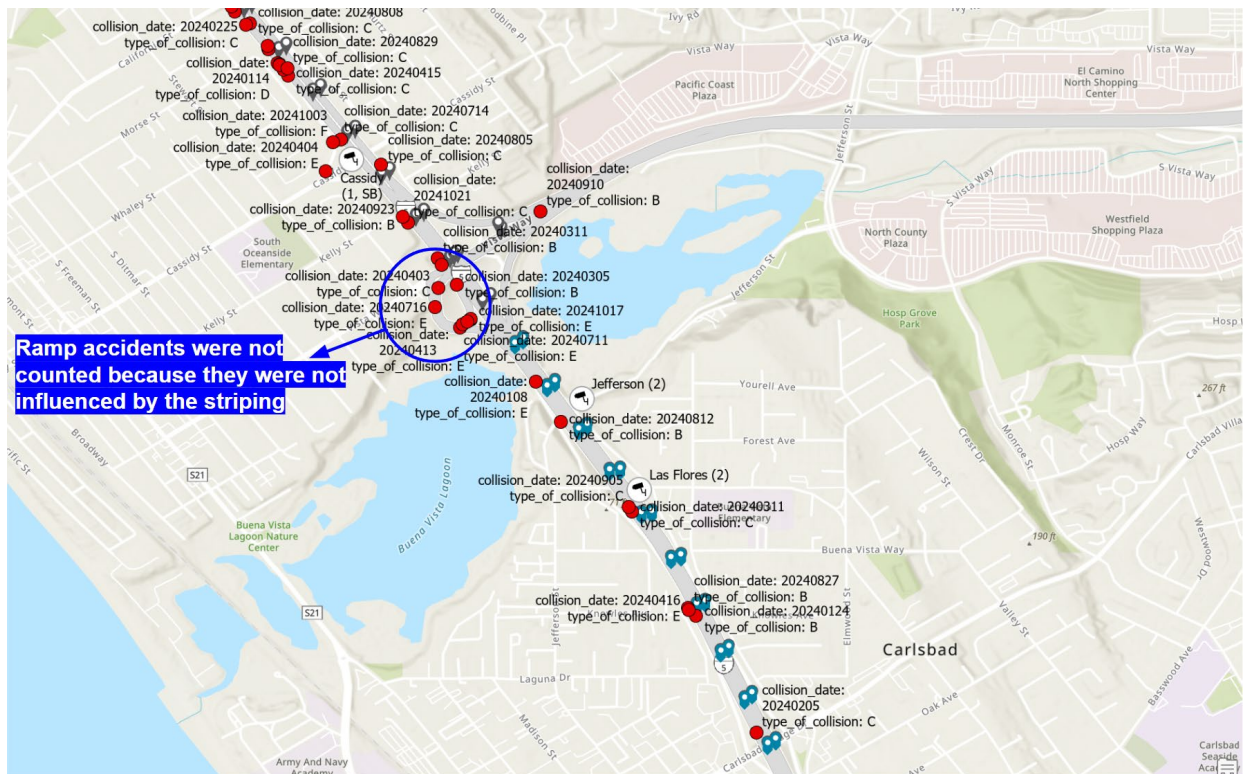
**Figure 5.11: The process of importing the data into ArcGIS, categorizing accident types, and counting the number of accidents occurring between PM 43 and 54, excluding the ramp accidents**

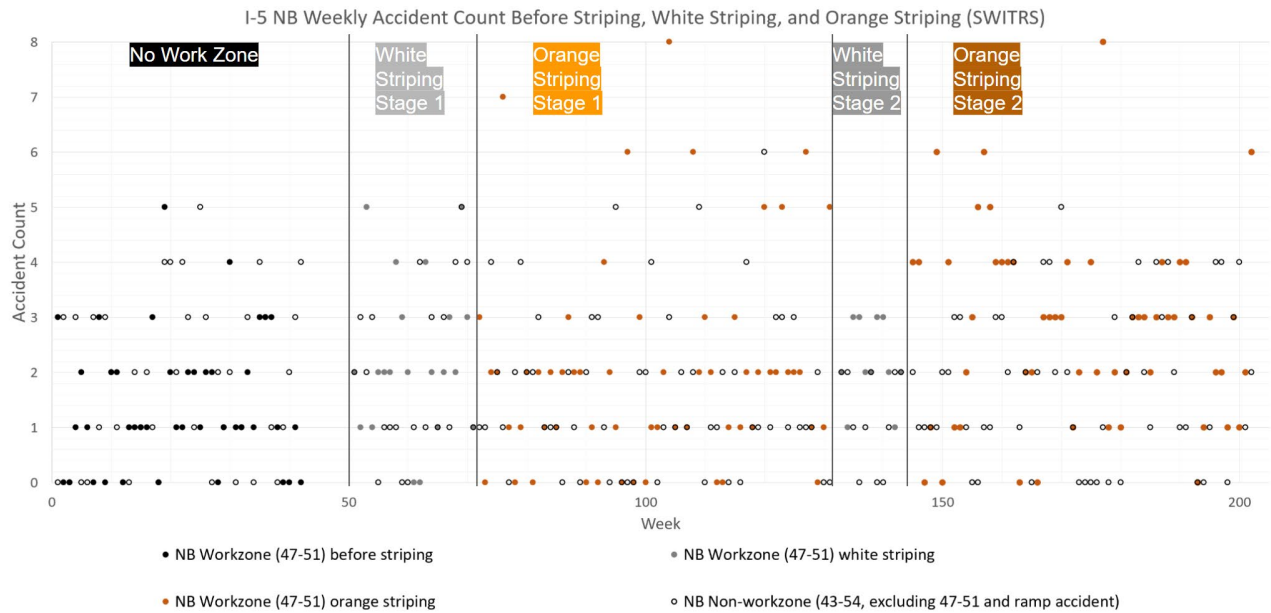
**Figure 5.12: Weekly number of accidents on I-5 NB from the week of November 29, 2020 to the week of October 6, 2024. The numbers in parentheses indicate the PM mark**

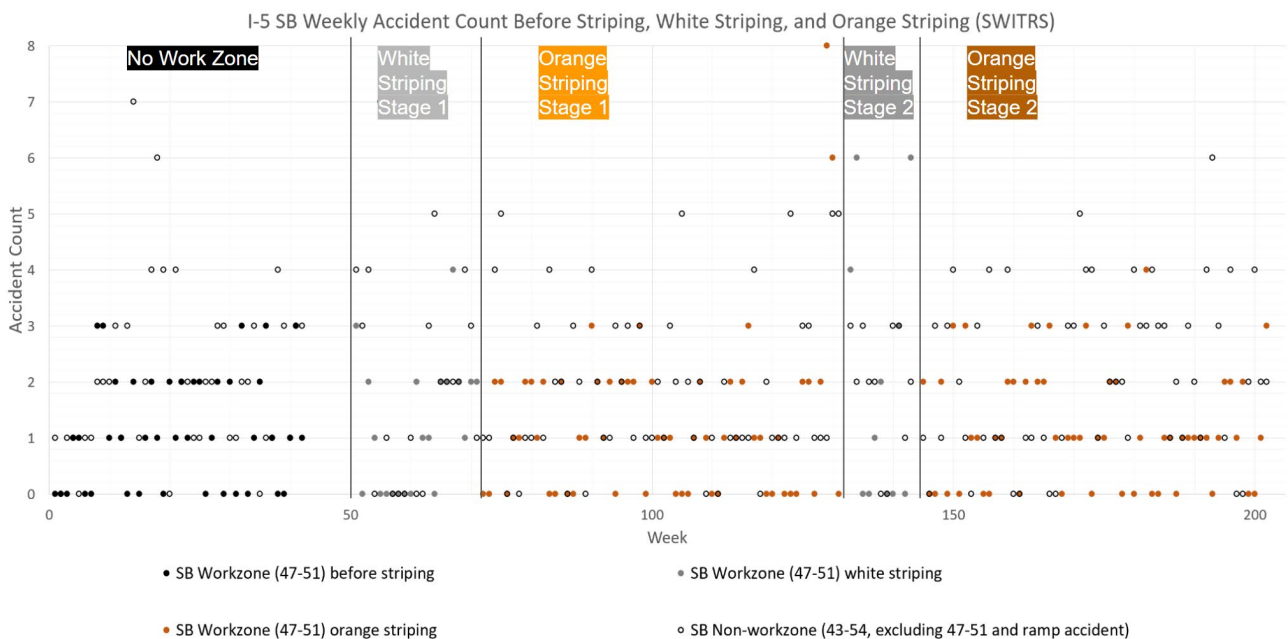
**Figure 5.13: Weekly number of accidents occurred on I-5 Southbound from the week of November 29, 2020 to the week of October 6, 2024. The numbers in parentheses indicate the PM mark**

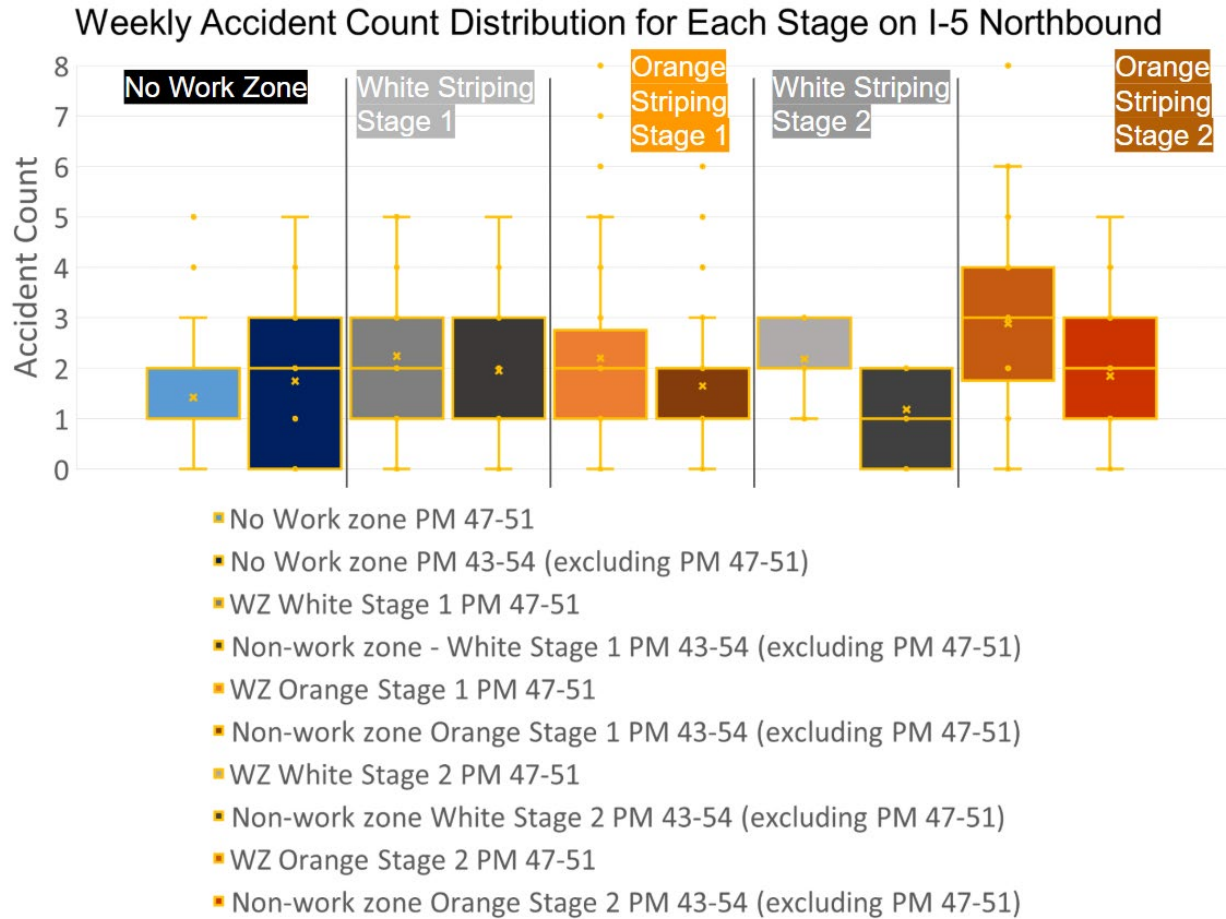
**Figure 5.14: Weekly accident count distribution for each stage of striping on I-5 NB, comparing the work zone (PM 47 to 51) with the non-work zone (PM 43 to 47, and 51 to 54).**

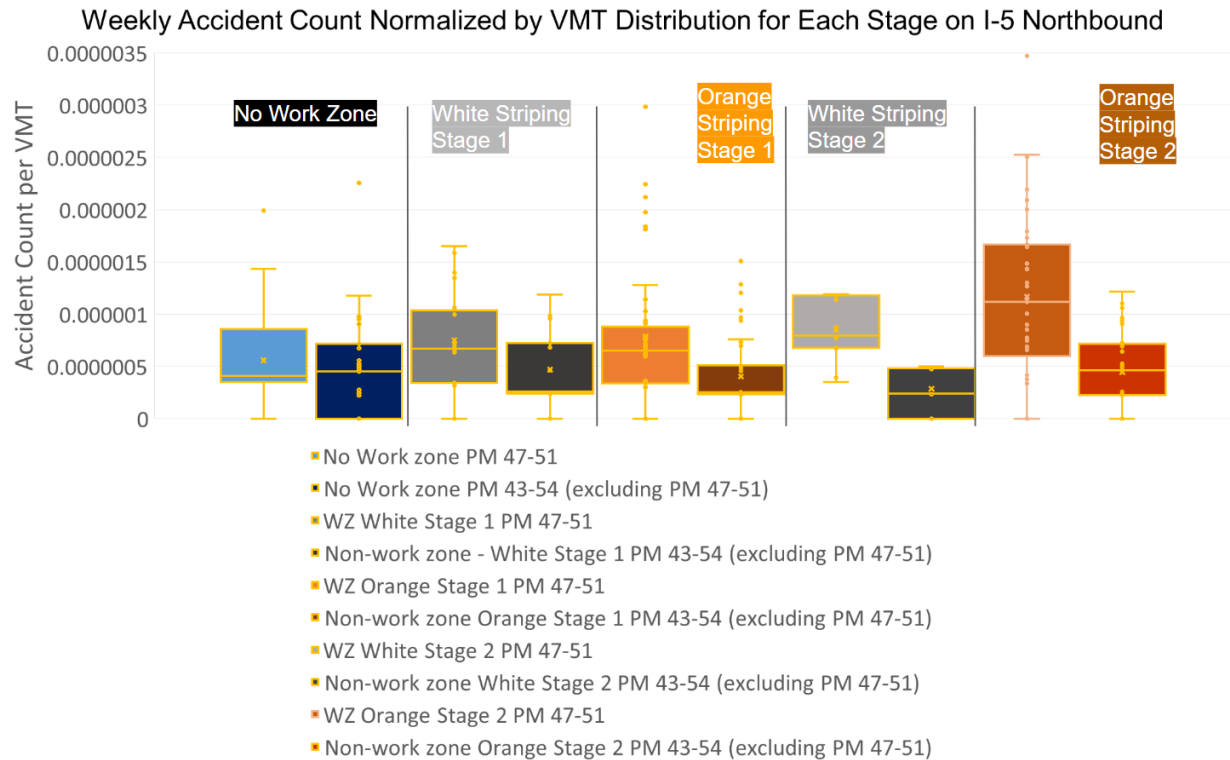
**Figure 5.15: Weekly accident count normalized by VMT distribution for each stage of striping on I-5 NB, comparing the work zone (PM 47 to 51) with the non-work zone (PM 43 to 47, and 51 to 54).**

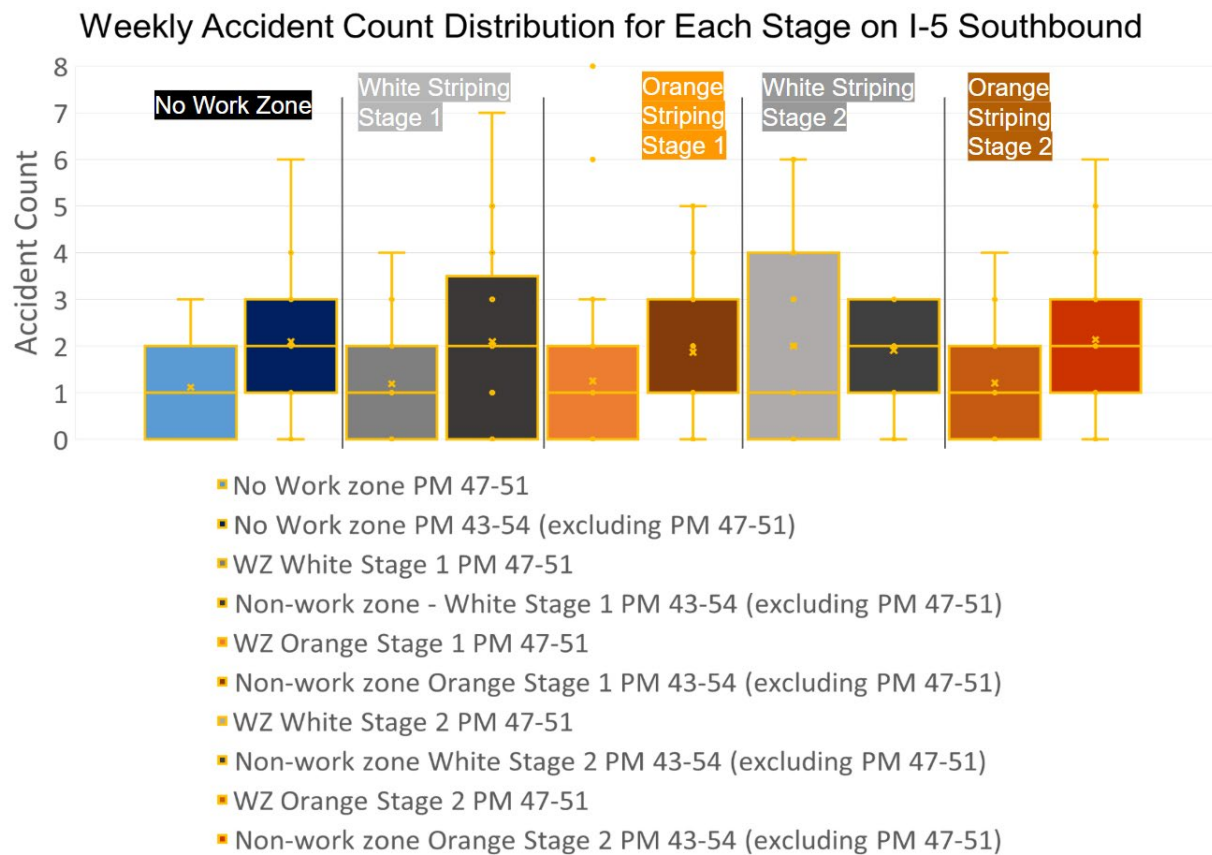
**Figure 5.16: Weekly accident count distribution for each stage of striping on I-5 SB, comparing the work zone (PM 47 to 51) with the non-work zone (PM 43 to 47, and 51 to 54)**

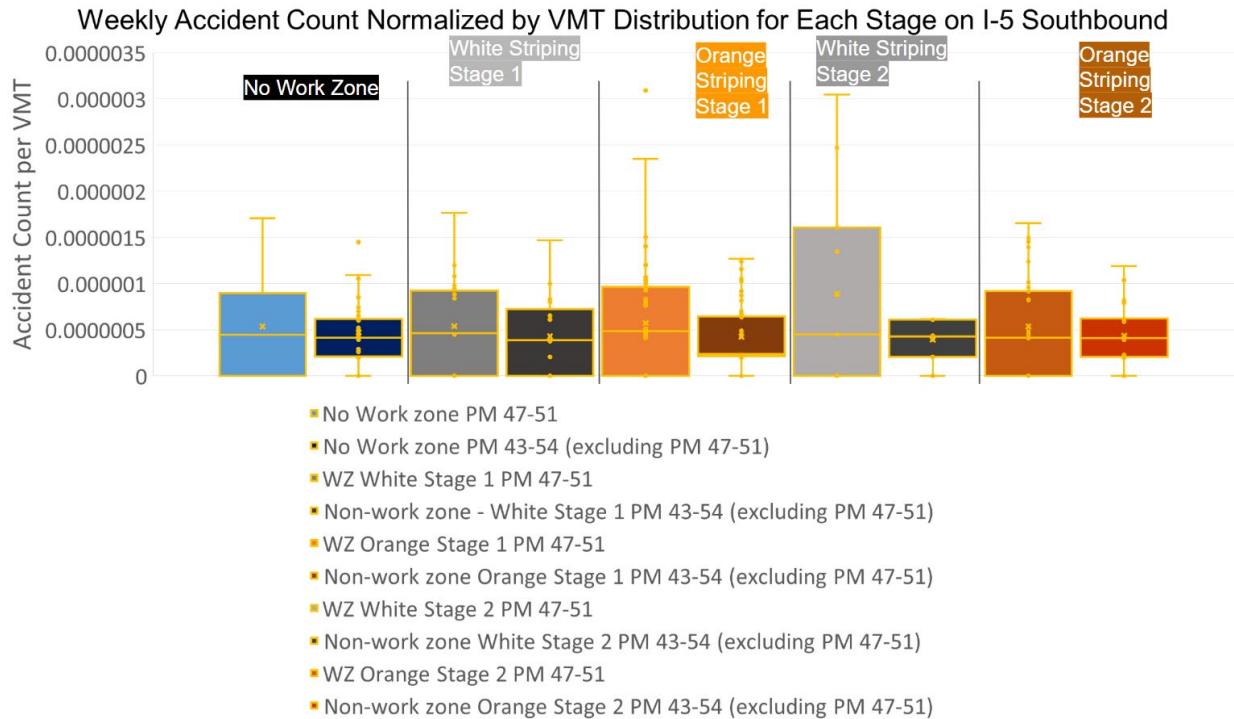
**Figure 5.17: Weekly accident count normalized by VMT distribution for each stage of striping on I-5 Southbound, comparing the work zone (PM 47 to 51) with the non-work zone (PM 43 to 47, and 51 to 54)**

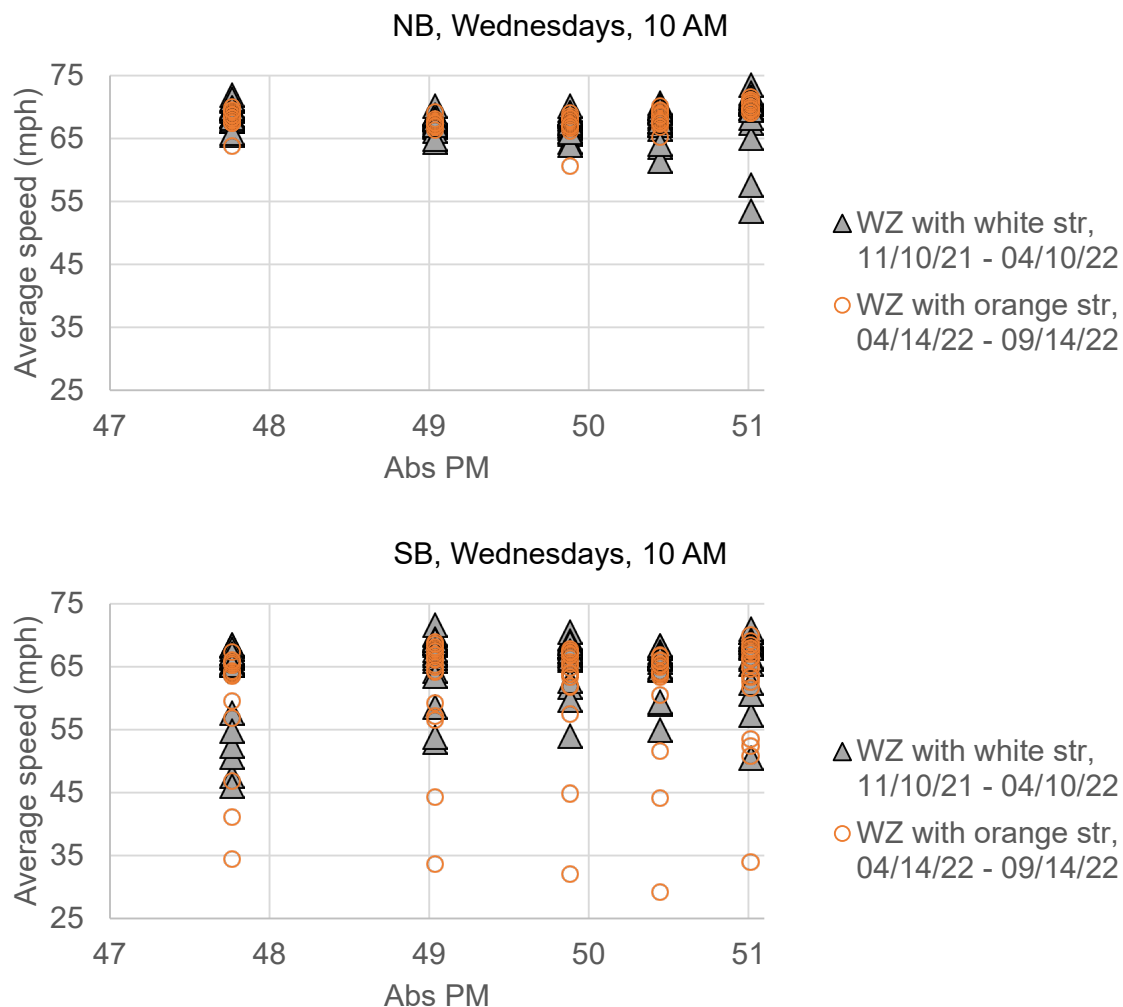
**Figure 5.24: HERE average speed data from 10:00 am to 10:59 am on Wednesdays from Abs PM 47 to 51**

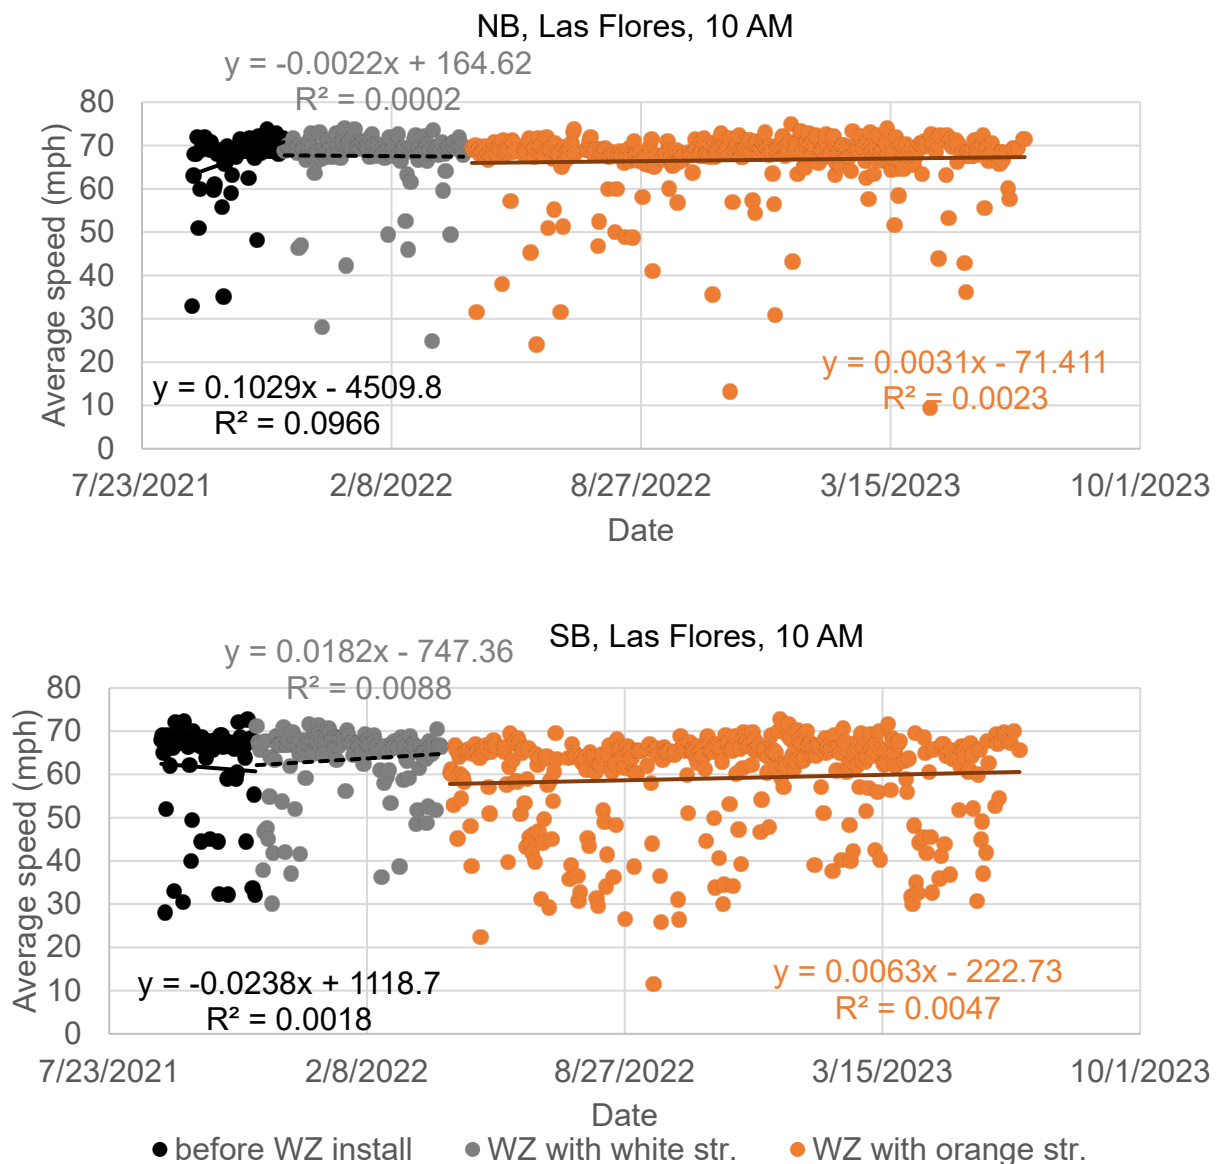
**Figure 5.25: Average speed from HERE data per day at 10:00 am at Las Flores ramps, with linear trendlines**

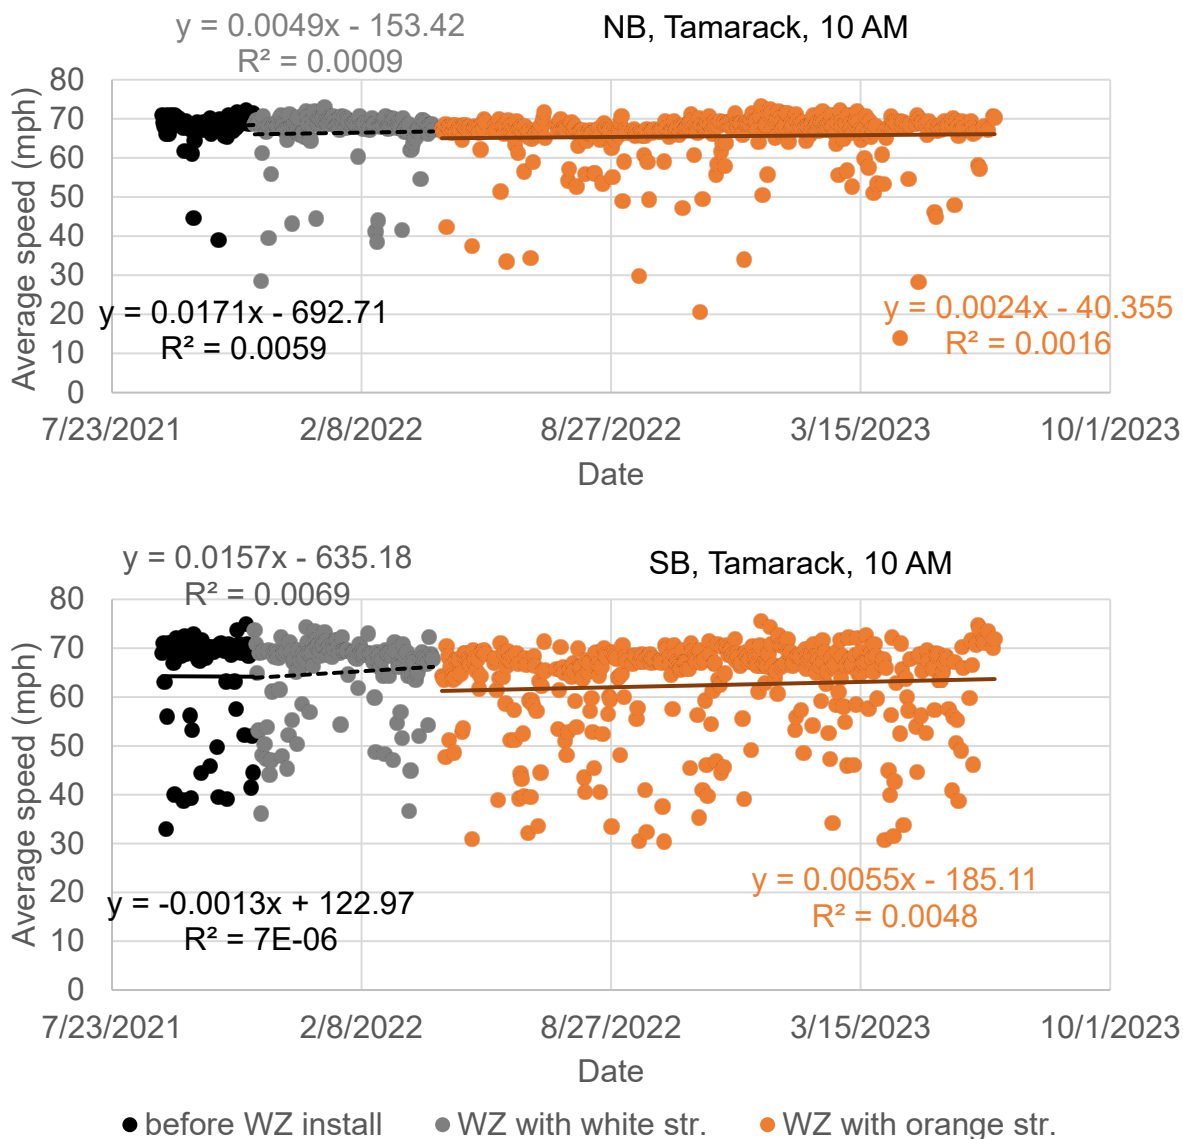
**Figure 5.26: Average speed from HERE data per day at 10:00 AM Tamarack ramps, with linear trendlines**
