1. REPORT NUMBER <b>CA25-3836</b>	2. GOVERNMENT ASSOCIATION NUMBER N/A	3. RECIPIENT'S CATALOG NUMBER N/A
4. TITLE AND SUBTITLE <b>Orange Contrasted Temporary Pavement Delineation in Construction Zones</b>		5. REPORT DATE <b>04-04-2025</b>

6. PERFORMING ORGANIZATION CODE AHMCT Research Center, UC Davis
7. AUTHOR Barbara Linke, Wilderich White, Kin Yen, Anh Duong, Felicia Fashanu, Nathan Byrd		8. PERFORMING ORGANIZATION REPORT NO. <b>UCD-ARR-25-03-31-01</b>

11. CONTRACT OR GRANT NUMBER <b>65A0749 Task 3836</b>
12. SPONSORING AGENCY AND ADDRESS <b>California Department of Transportation P.O. Box 942873, MS #83 Sacramento, CA 94273-0001</b>		13. TYPE OF REPORT AND PERIOD COVERED <b>Final Report 04/21 - 03/25</b>

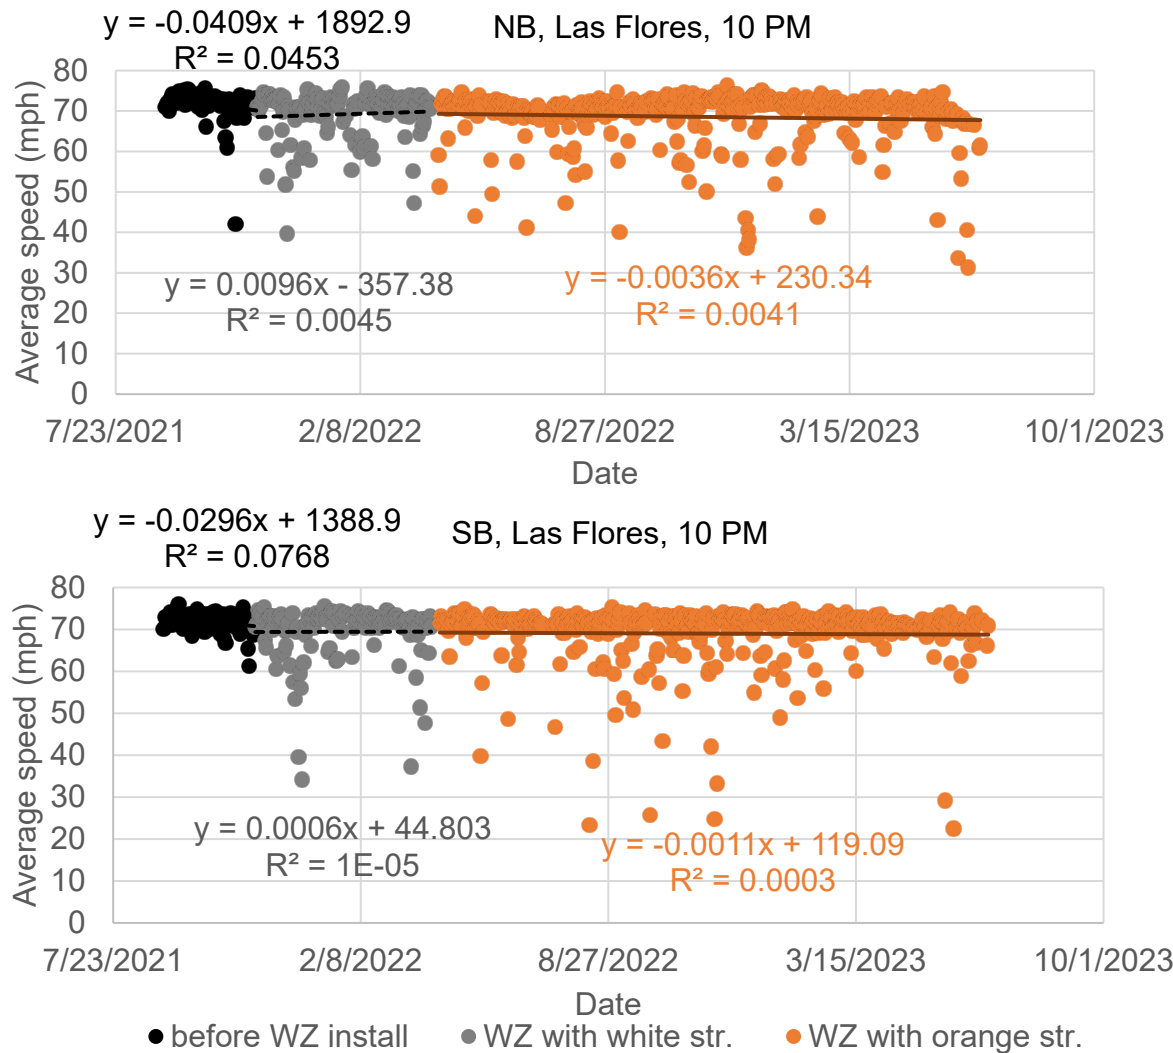
**Figure 5.27: Average speed from HERE data per day at 10:00 pm Las Flores ramps, with linear trendlines**

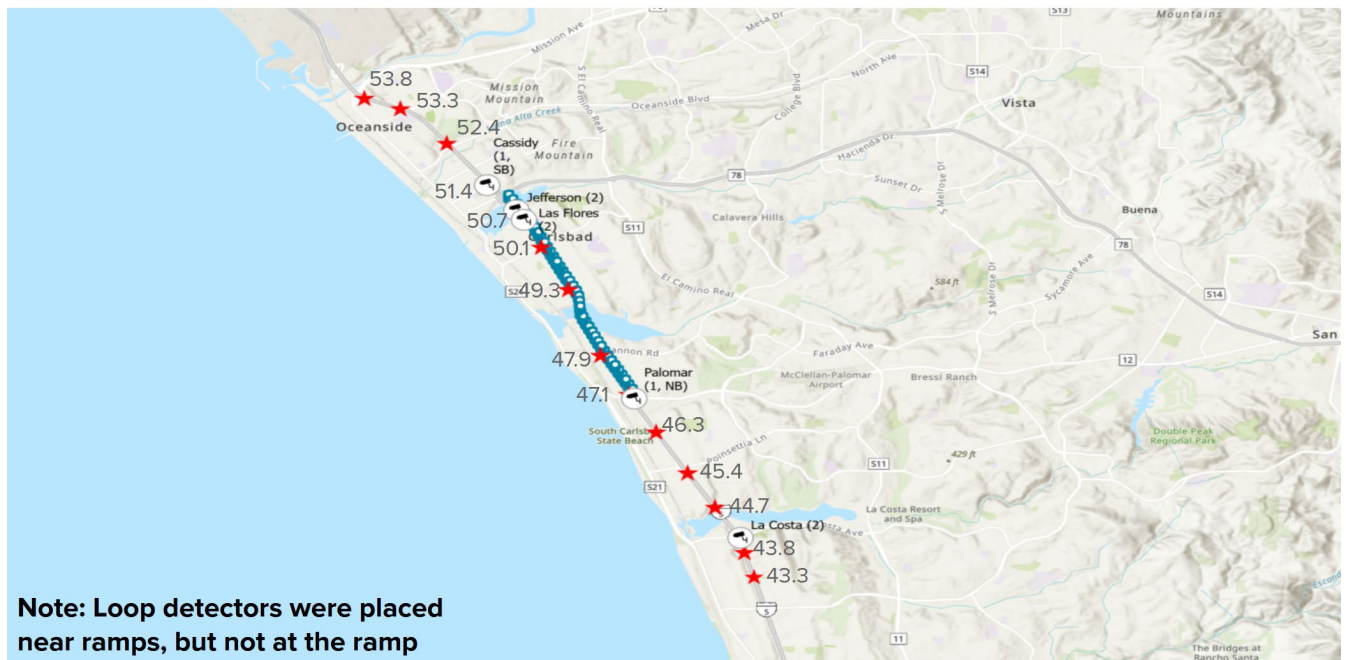
**Figure 5.29: The placements of the loop detectors highlighted with a star and a corresponding PM reading. When the camera icons overlap with the stars, the PM reading serves as an alternative indicator of the loop detector placements. The blue segment represents where striping activities took place.**

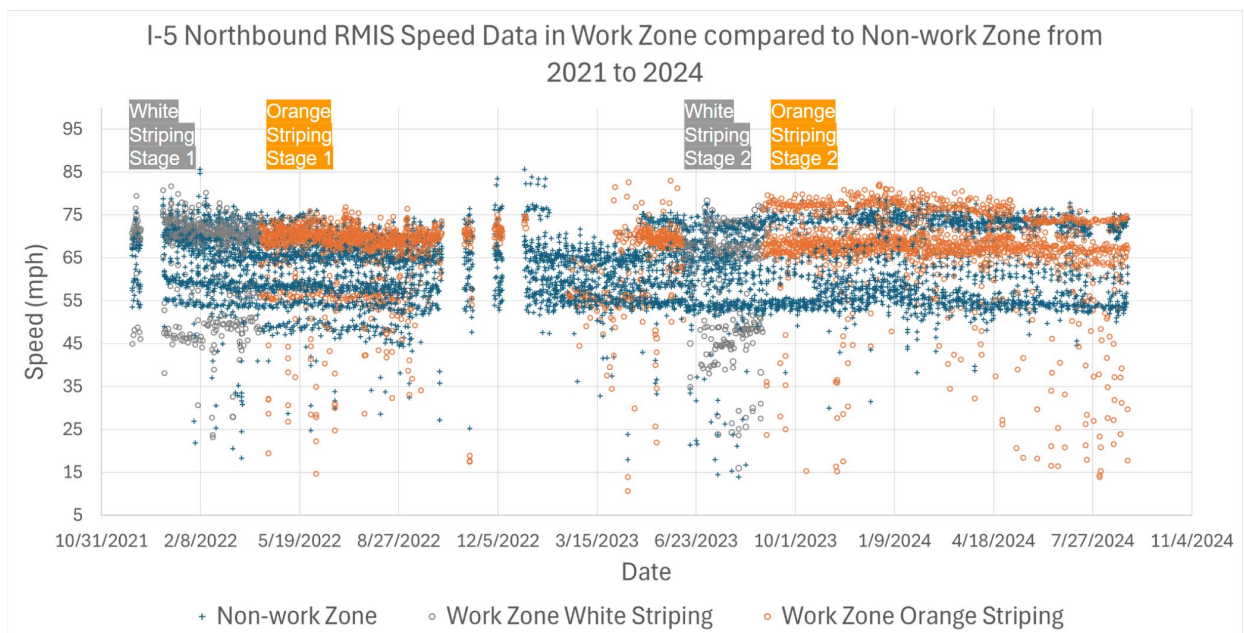
**Figure 5.30: Visualization of RMIS speed data on I-5 NB at different stages of striping for Figure 5.29 locations. Corrupted data (speed readings exceed 100 mph) was not included in the plot. Some of the data were unavailable, resulting in the gaps in between data.**

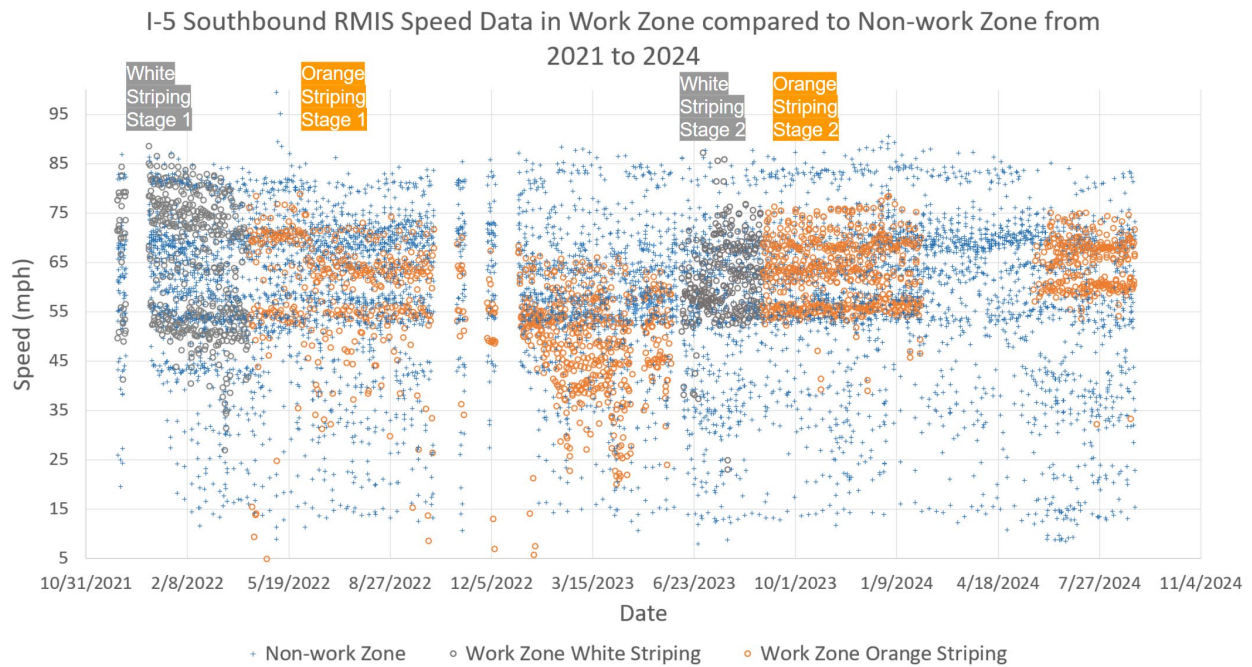
**Figure 5.31: Visualization of RMIS speed data on I-5 SB at different stages of striping for Figure 5.29 locations. Corrupted data (speed readings exceed 100 mph) were not included in the plot. Some of the data were unavailable, resulting the gaps in between data.**

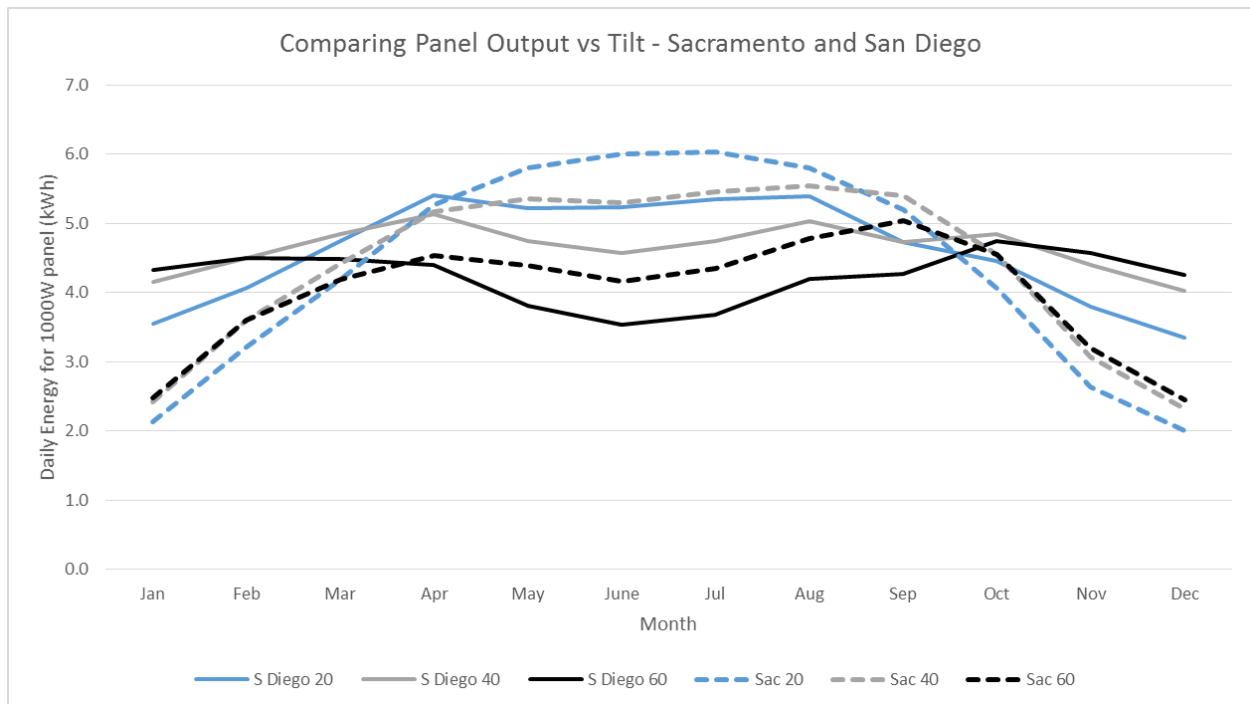
**Figure A1.1: Comparing the effect of panel tilt (20°, 40°, 60°) on energy output – San Diego and Sacramento**

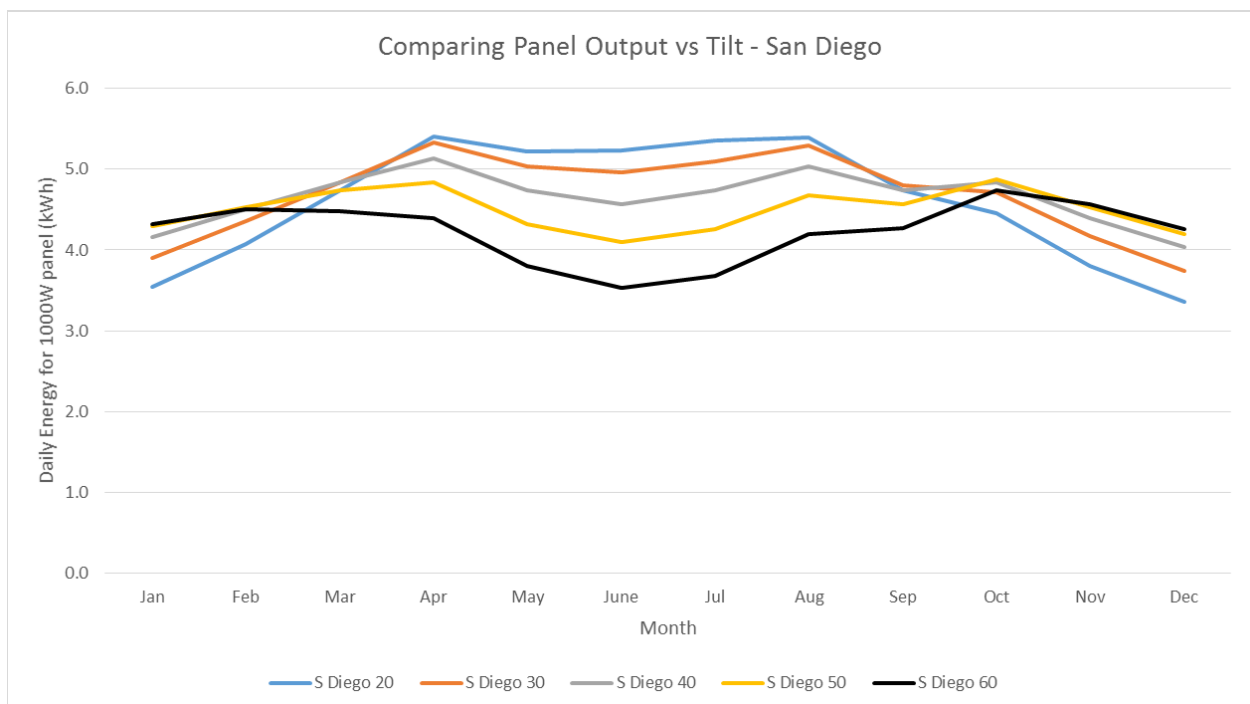
**Figure A1.2: Comparing the effect of panel tilt on energy output – San Diego**

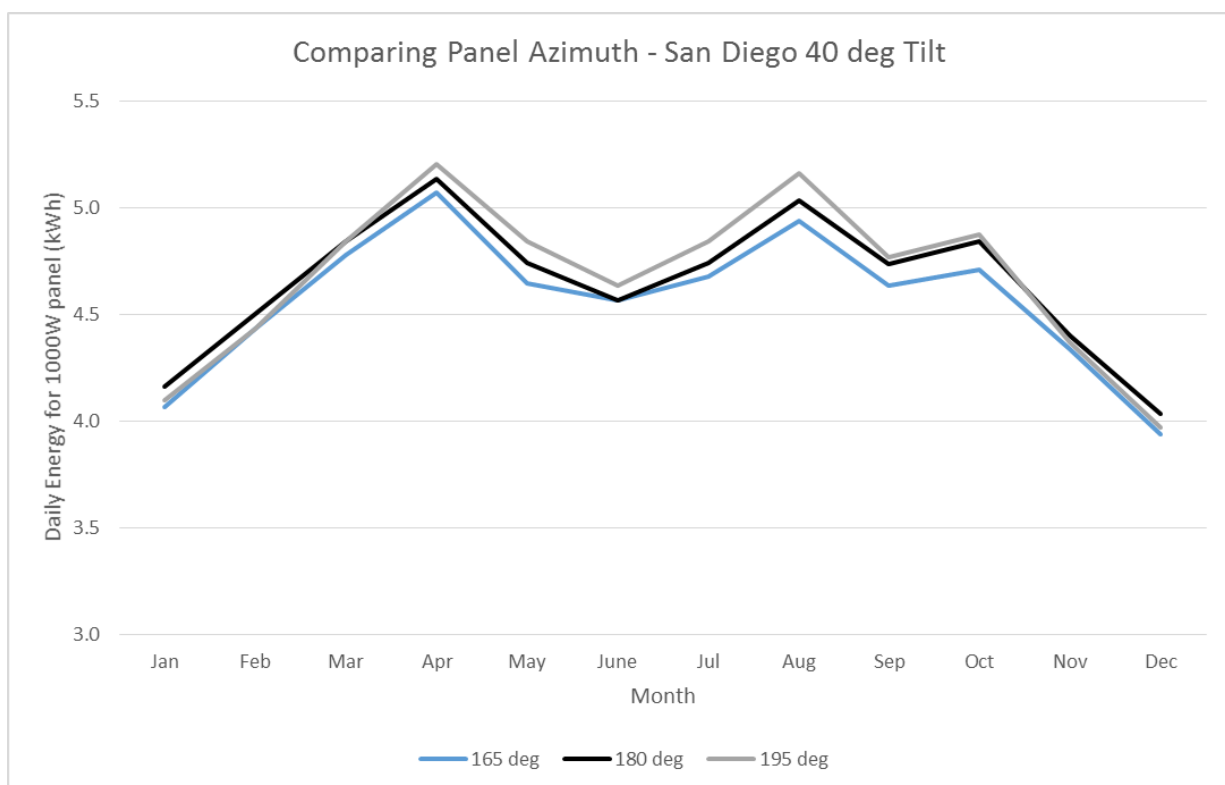
**Figure A1.3: Comparing the effect of azimuth angle (Vertical scale different than prior figures)**

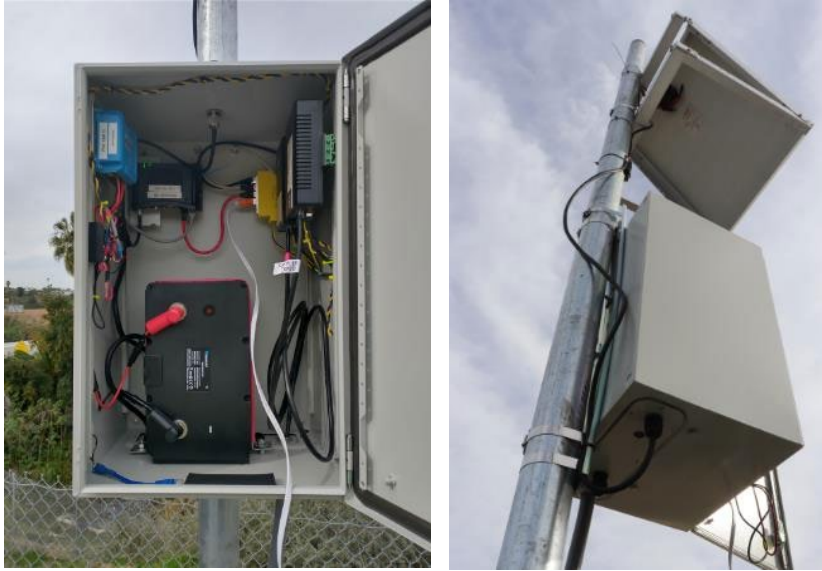
**Figure A1.5: Pictures of electronics box and solar panel**

The battery size was based on camera and modem power draw (non-continuous) with and without LiDAR sensor. Important features included a low temperature charge cut off and high temperature cut off. The cell phone modem allowed for remote camera access and data download. Initial calculations determined the need for about 3.5 GB per hour of video. Therefore, a local storage of 256GB would hold more than 70 hours of video. A direct download of data from the electronics box in certain intervals was preferred because the transmission by modem incurs high costs for cell phone plans. Reasonable data plans range between 5 GB to 35 GB of downloaded data per month. Figure A1.5 shows components inside the electronics box and its installation under the solar panel.

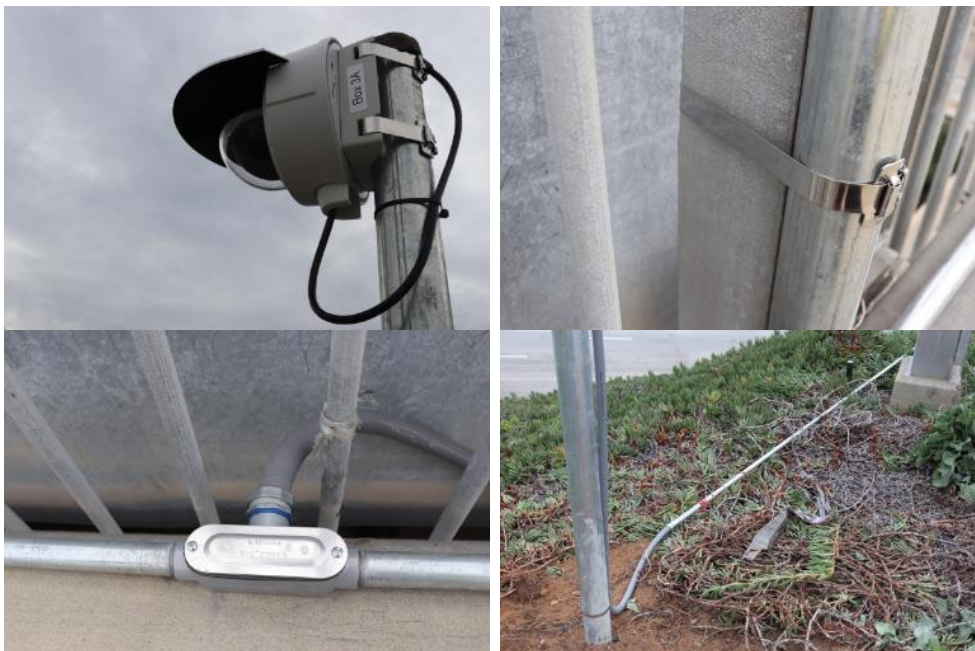
**Figure A1.7: Details of camera mounting and cabling at Las Flores Overcrossing**

Caltrans arranged for the temporary installation of the cameras onto overpass structures. The cameras were strapped to 2.5-in metal conduit poles, which were then strapped to existing overpass fencing poles. The overpass fence pole nearest to the ideal location of the camera was selected. The large and heavy hardware, made up by electronics box and solar panel, was installed on a 3.5-inch metal conduit pole near the end of the overpass. The cameras were connected with CAT 6 shielded Ethernet cable carrying power

and communications. This cable was run through the metal conduit along the bottom edge of the fencing and along the ground to the electronics box. The cable was buried a few inches deep in areas where there was danger of people stepping on it.

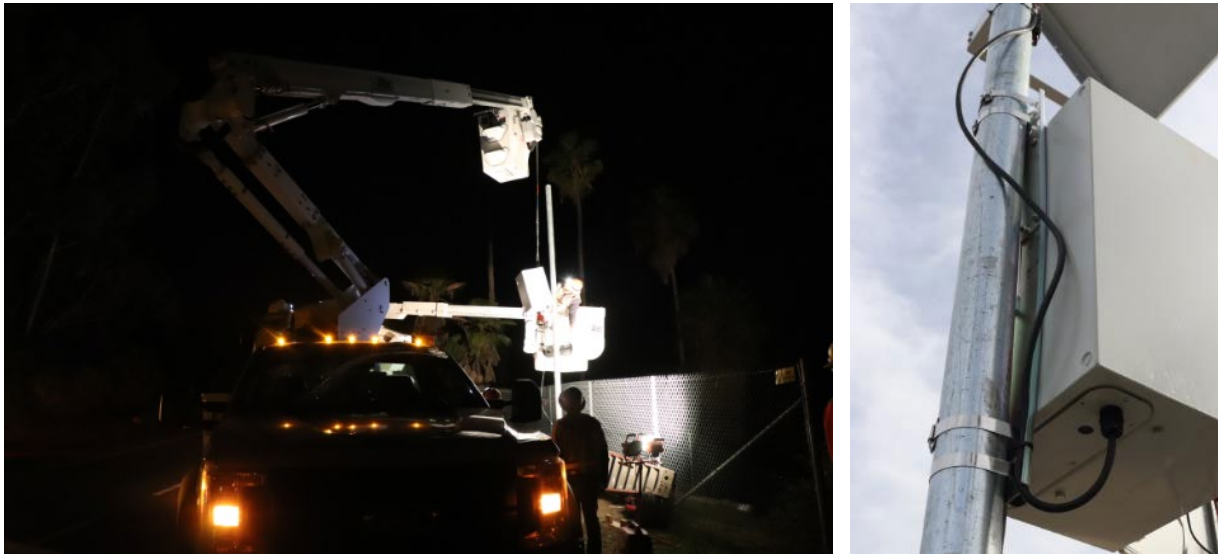
**Figure A1.8: Left: Installation of electronics box at Jefferson Overcrossing with a bucket truck. Right: Straps around the steel pole**

AHMCT researchers brought partially assembled components by truck and designed the system for easy installation. The on-site contractor crew became familiar with the installation and installed four cameras in two nights (Figure A1.8). AHMCT researchers made sure that the cameras and modems worked. One camera at Jefferson Overcrossing had to be re-wired by the contractor.

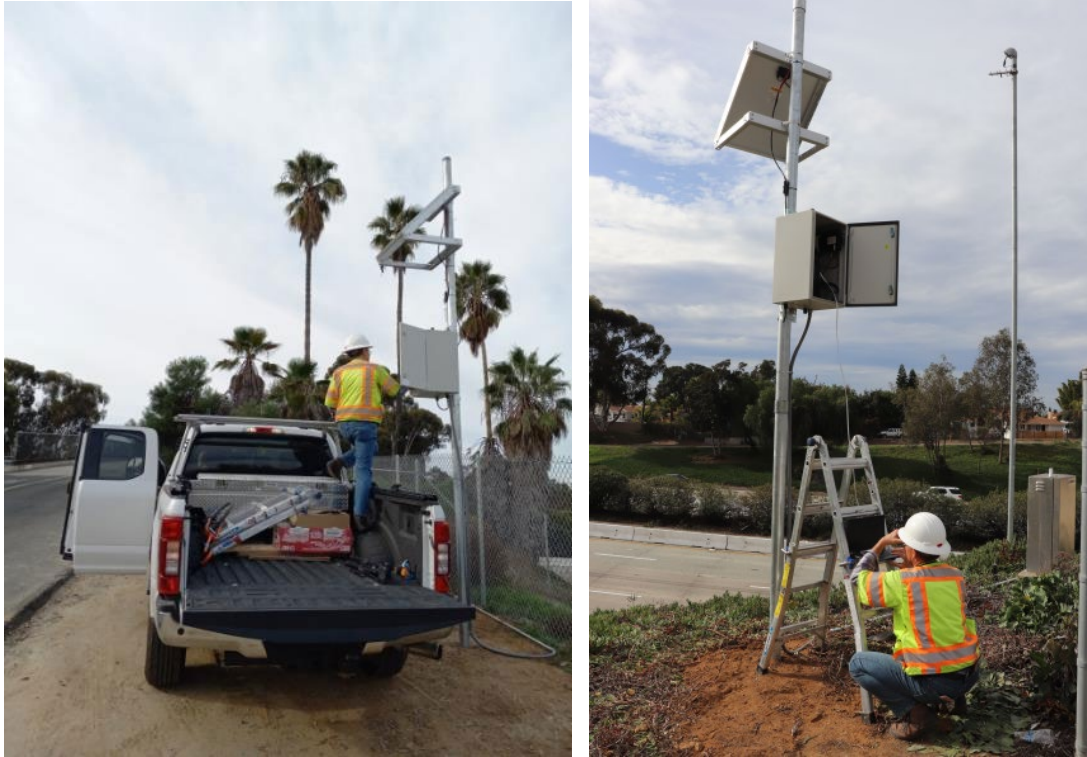
**Figure A1.9: Access to electronics box. Left: At Jefferson Overcrossing. Right: At Las Flores Overcrossing**

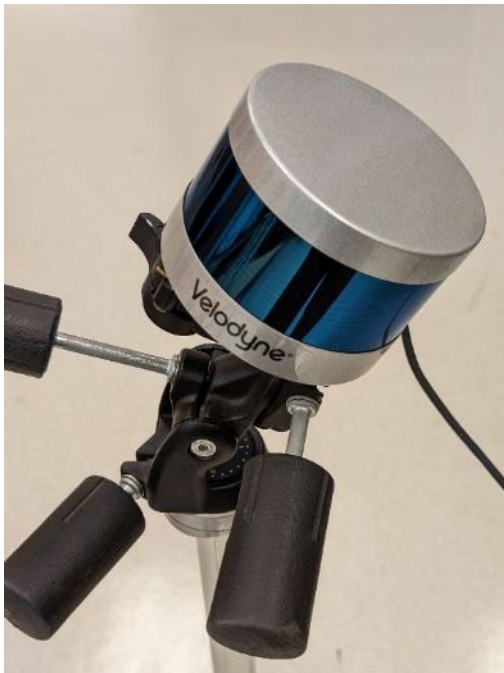
**Figure A2.1: Velodyne VLP16 LiDAR sensor with a 30 degree tilt from the horizon**

Experiments performed at UC Davis using different LiDAR sensor mounting heights and orientation with a Velodyne Lidar VLP16 sensor are shown in Figure A2.1. The experiment's objective was to determine the best LiDAR mounting location and orientation for estimating the vehicle lateral positions as well as achieving best coverage using a single sensor. The sample LiDAR data were collected for evaluation of various post-processing methods.

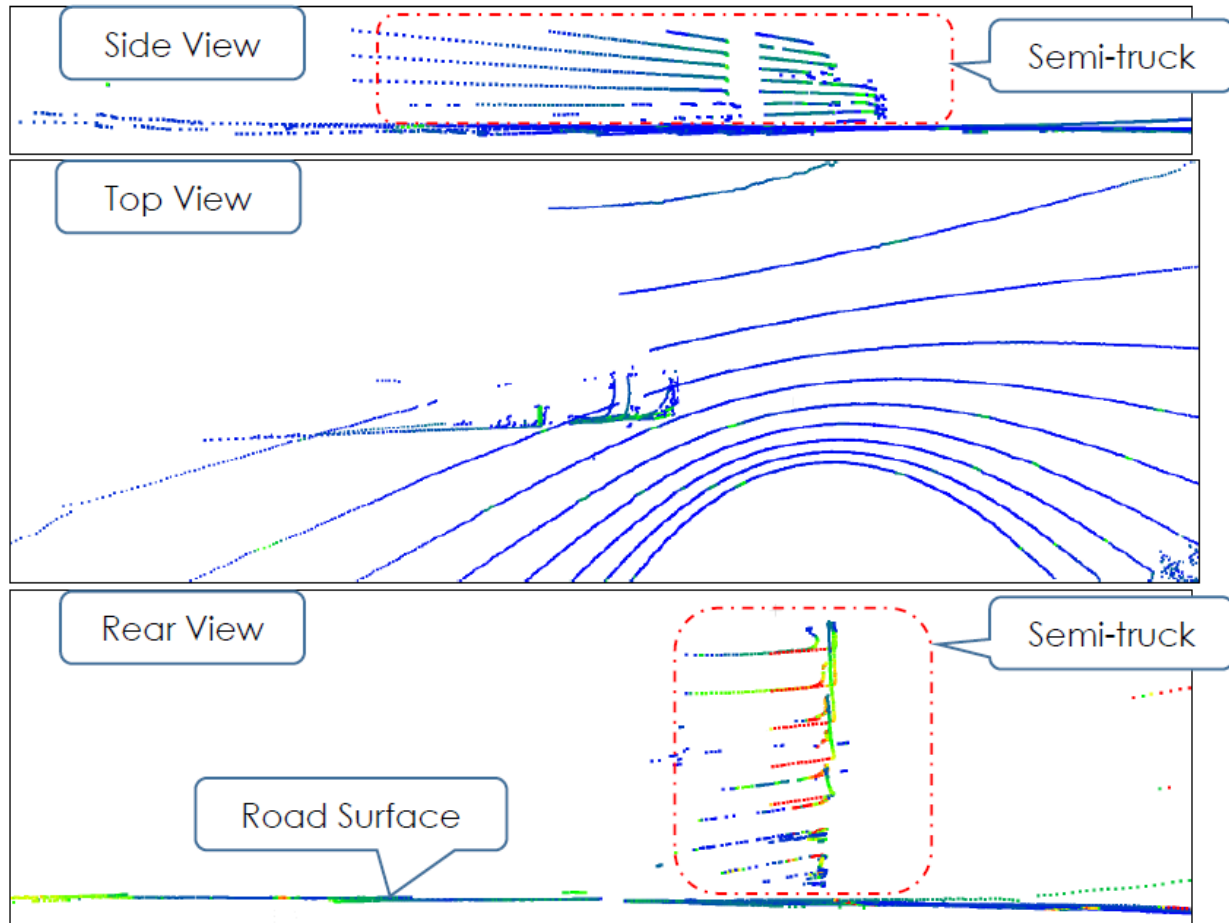
**Figure A2.2: Example of a single frame point cloud from the C1 configuration. Top: Roadside view. Middle: Top view. Bottom: Roadway view along the direction of vehicle travel)**

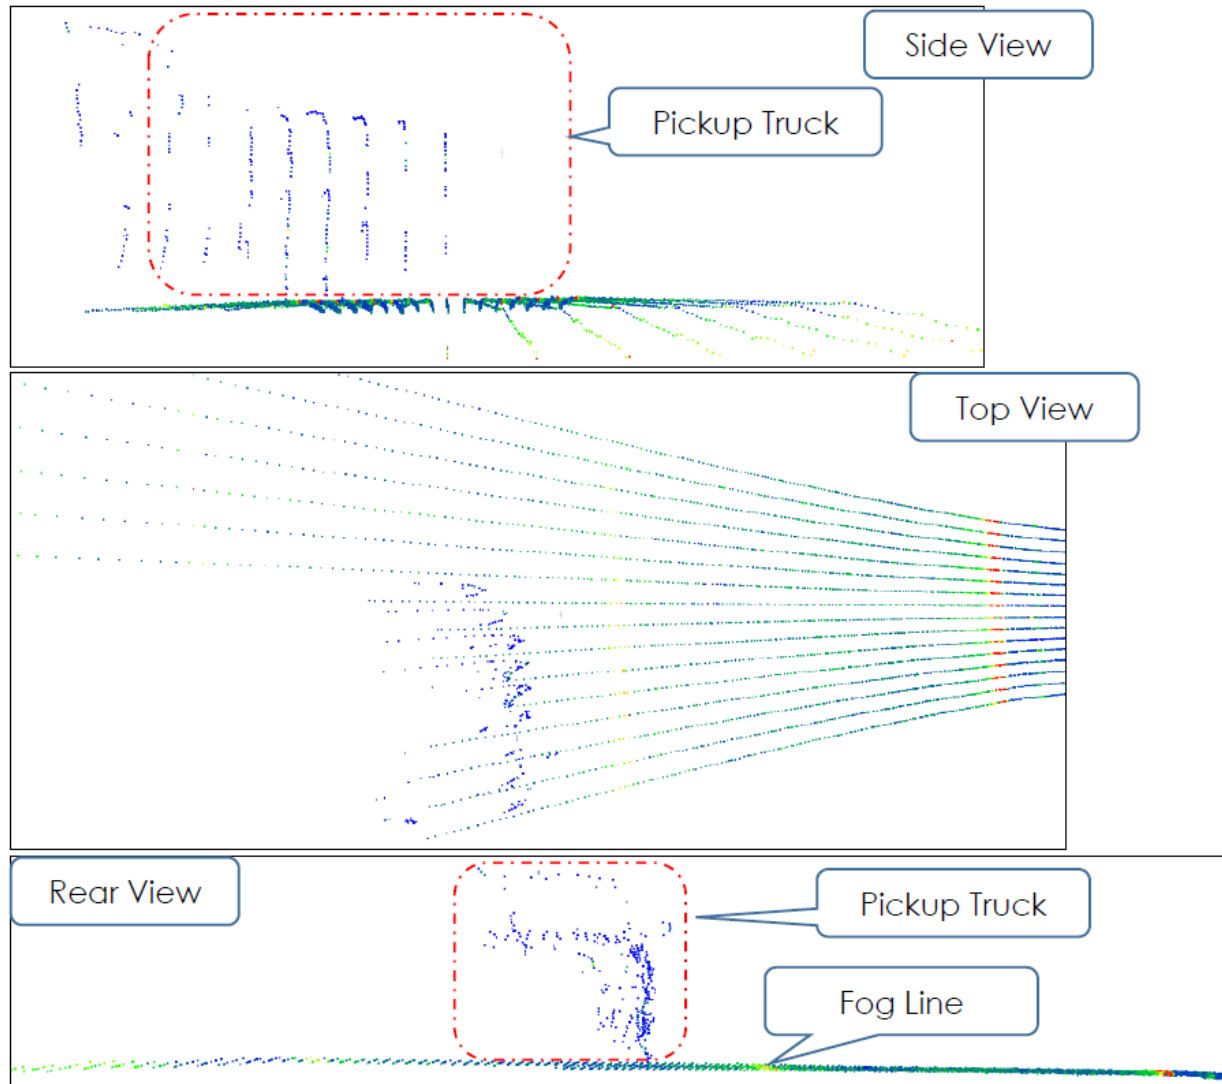
**Figure A2.3: Example of a single frame point cloud from the C3 configuration. Top: Roadside view. Middle: Top view. Bottom: Roadway view along the direction of vehicle travel)**

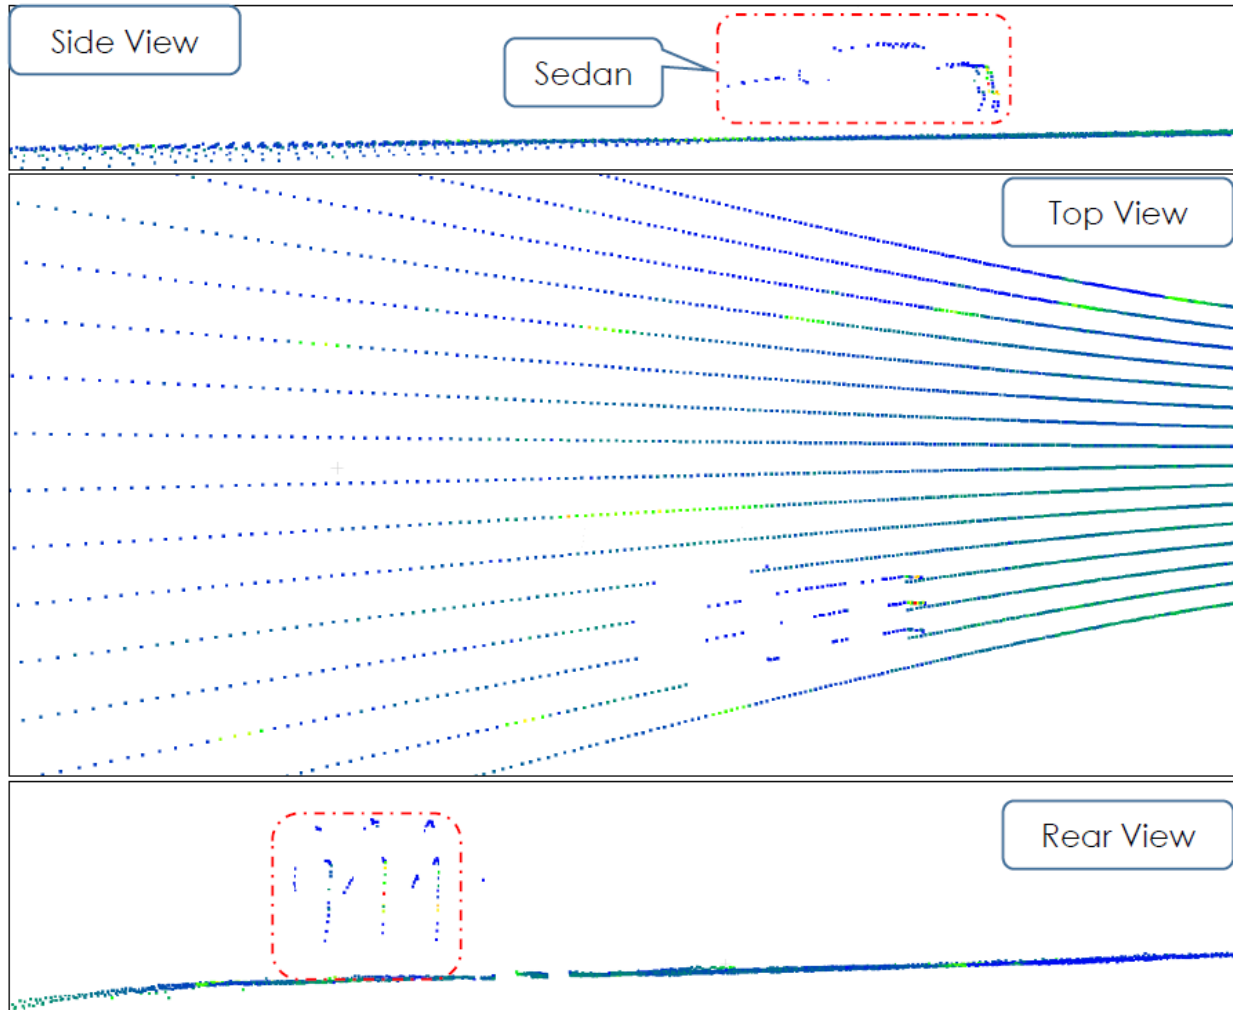
**Figure A2.4: Example of a single frame point cloud from the C3 configuration. Top: Roadside view. Middle: Top view. Bottom: Roadway view along the direction of vehicle travel)**

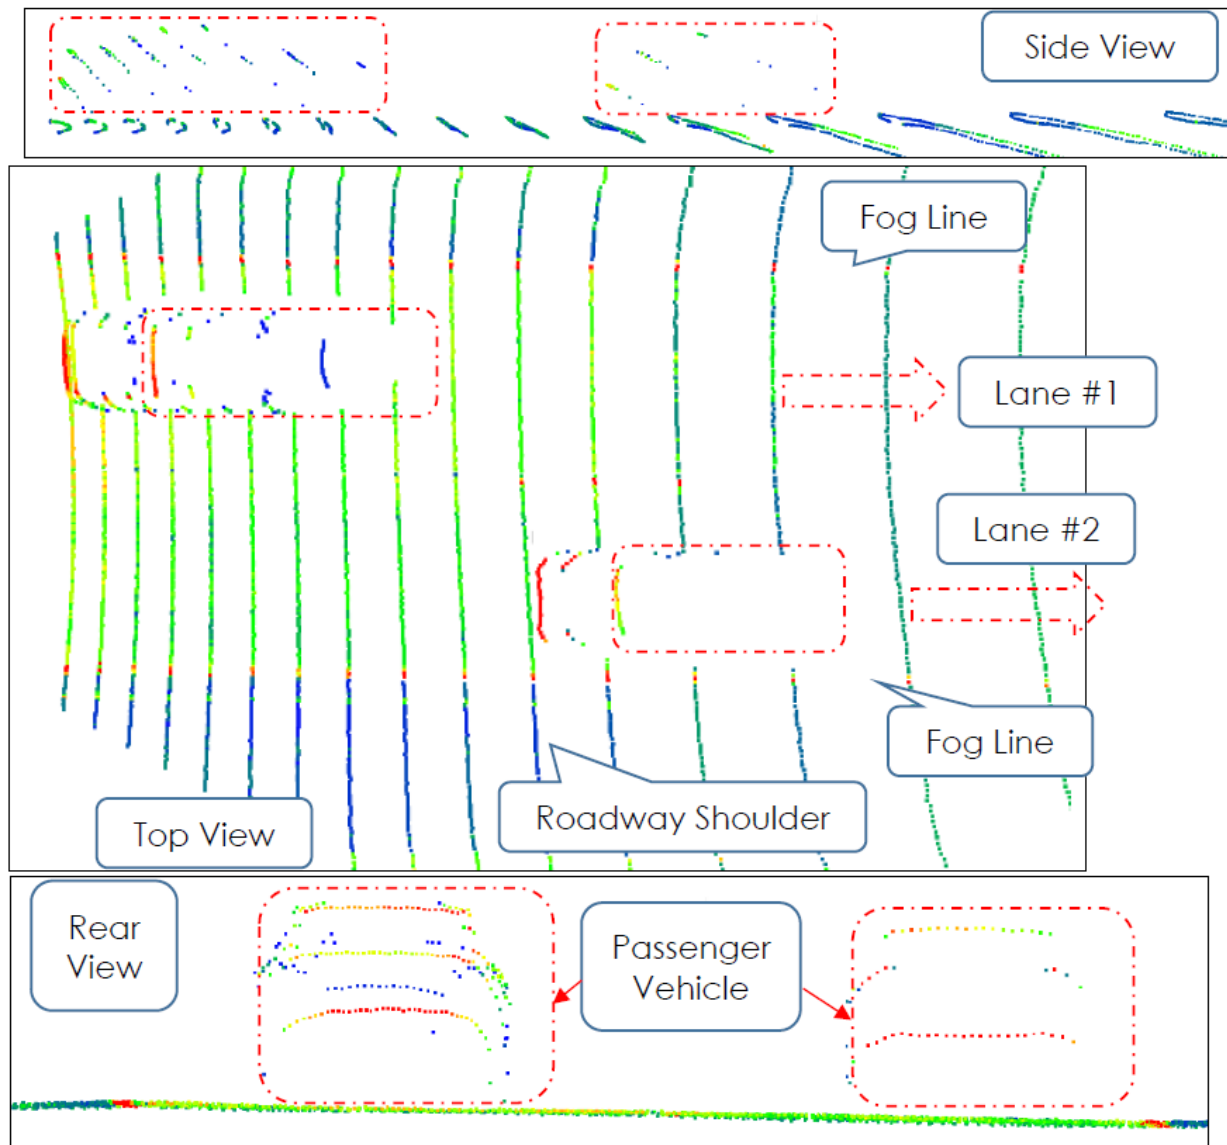
**Figure A2.5: Example of a single frame point cloud from the C4 configuration. Top: Roadside view. Middle: Top view. Bottom: Roadway view along the direction of vehicle travel.**

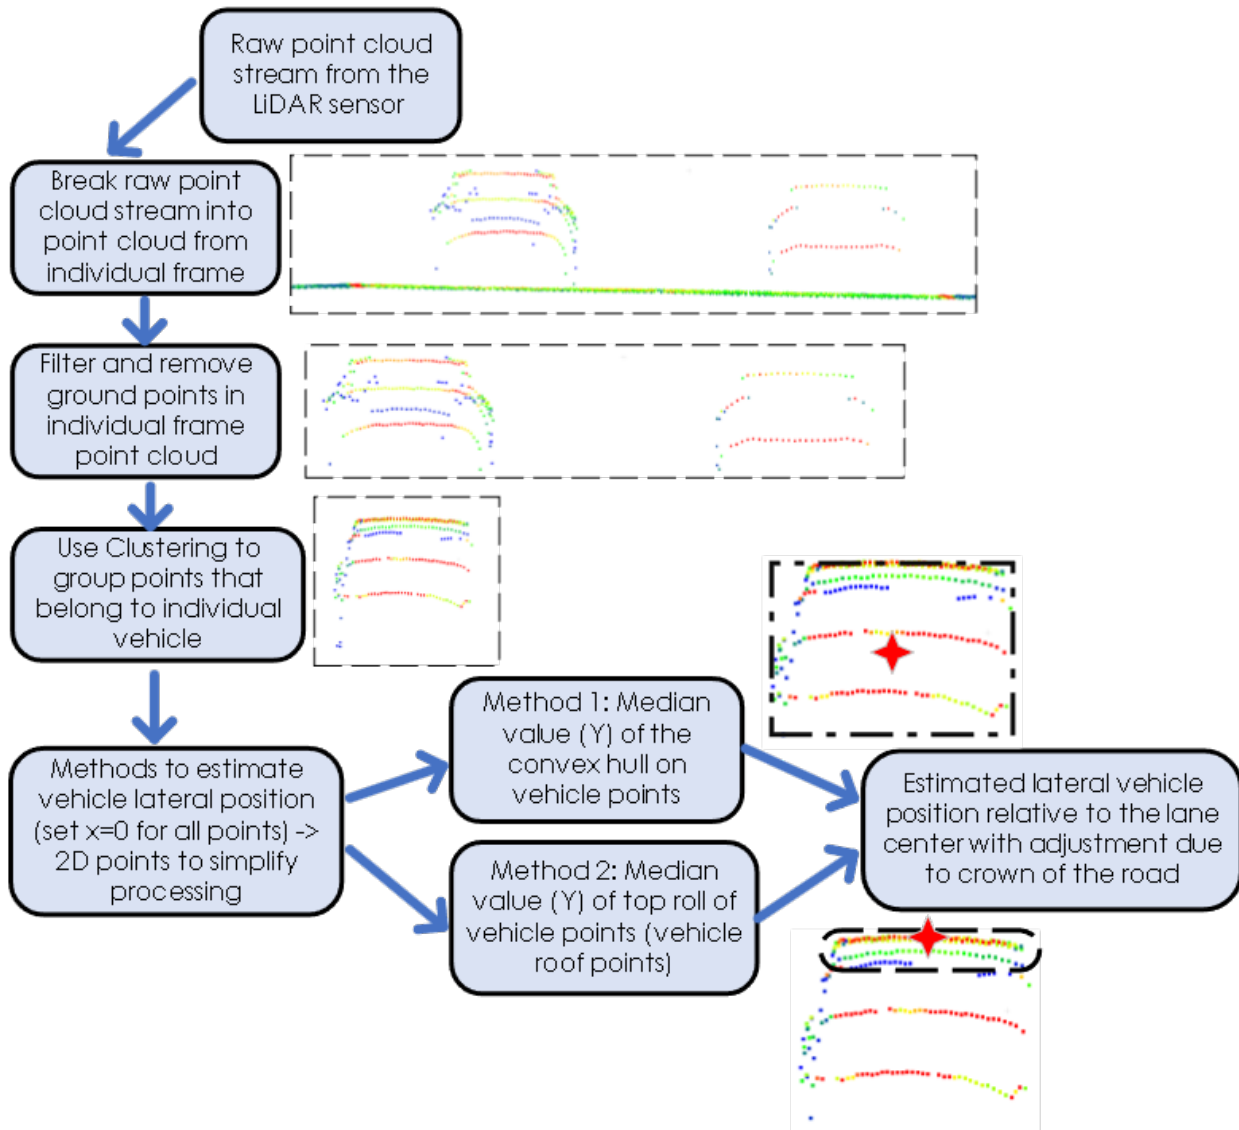
**Figure A2.6: High level conceptual point cloud post-processing steps**
