| 4. Title and Subtitle<br>Automated Vehicle (AV) Data Sharing and Data Analytics | | 5. Report Date<br><b>04/30/2026</b> | |
| 7. Author(s)<br>Xinwei Yang, Peggy Wang | | 8. Performing Organization Report Number<br>UCB-ITS-PRR-2026-01 | |
| 9. Performing Organization Name and Address<br>California PATH, University of California at Berkeley<br>1357 South 46th Street, Richmond, CA, 94804 | | 10. Work Unit Number | |

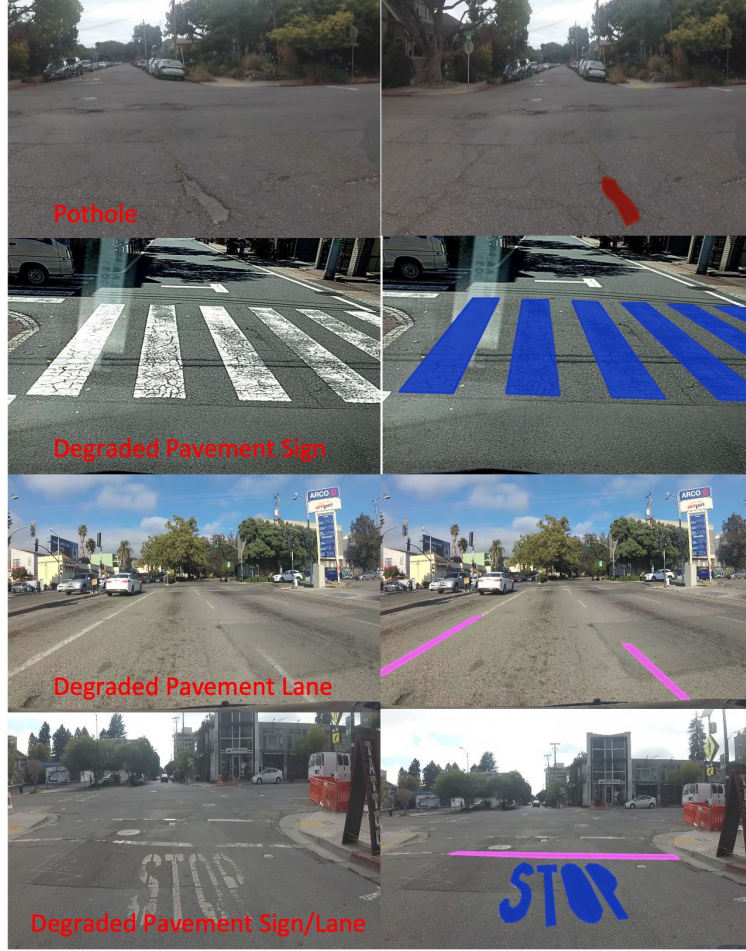
Therefore, all detection objects were labeled using semantic segmentation with mask annotations. An example of the annotation format is shown in Figure 1. All annotations were created and managed using the Label Studio platform.

**Figure 1. Illustration of Objects and Annotation**

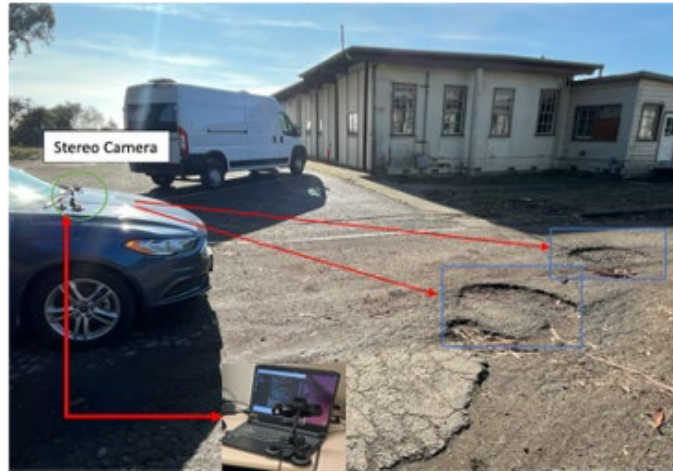
To ensure safety and avoid interference with live traffic, all experiments were conducted in a closed-course test track at Richmond Field Station. The test site contains enough pavement damage samples, making it suitable for validating the proposed method. The apparatus setup and testing field are illustrated in Figure 14.

**Figure 14. Apparatus and Testing Field**

The stereo camera was mounted on the vehicle hood and connected to a portable onboard computing unit. The system was implemented on a laptop equipped with an NVIDIA RTX 3050 GPU, a multi-core Intel i7-11800 CPU, and a Linux operating system. The trained YOLOv12m-seg ONNX model and the proposed size estimation algorithm were integrated into the system, enabling real-time pothole detection and extraction of physical size information during vehicle operation.

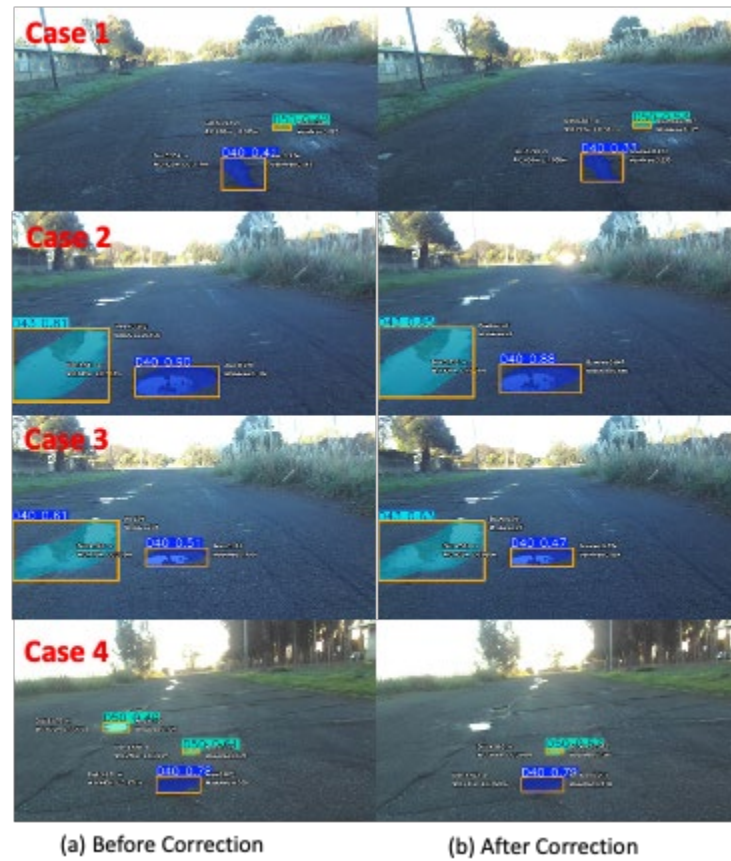
Figure 15 presents a visual comparison of the pothole size estimation results before and after correction. The corrected dimensions were much closer to the ground-truth values, indicating that

the proposed calibration-based correction method can effectively reduce estimation errors caused by distance-dependent nonlinear distortion.

**Figure 15. Pothole Size Estimation Before and After Correction**

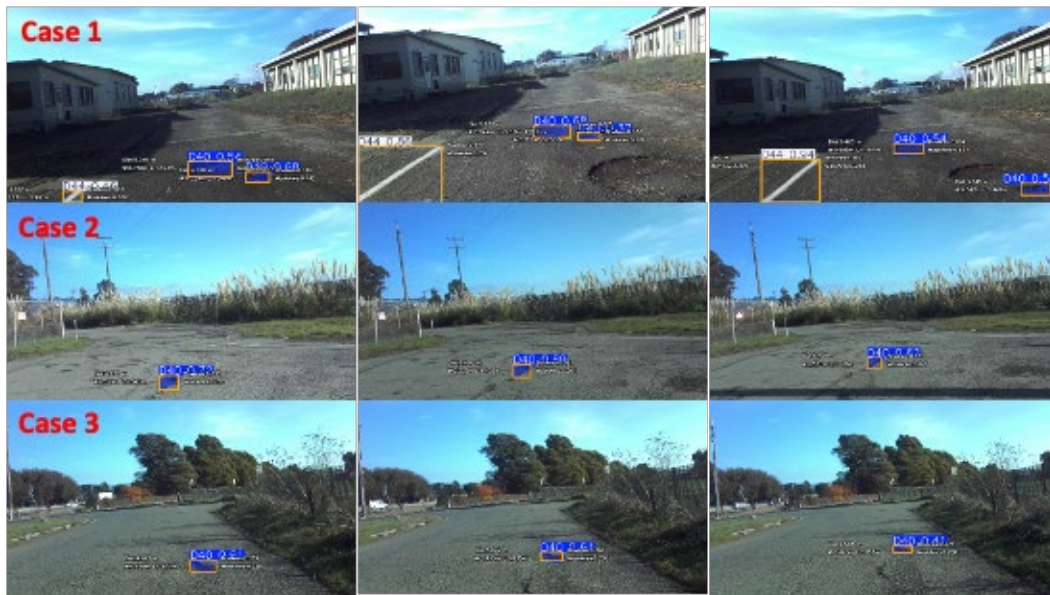
To further evaluate the performance of the proposed pothole size estimation algorithm, experiments were conducted using three representative pothole samples at different measurement distances. For each pothole, size estimation was performed at multiple distances ranging from 4.5 m to 7.0 m. The selected test samples and estimation results are illustrated in Figure 16, and the corresponding quantitative results are summarized in Table 9.

**Figure 16. Pothole Size Estimation with Different Distances**

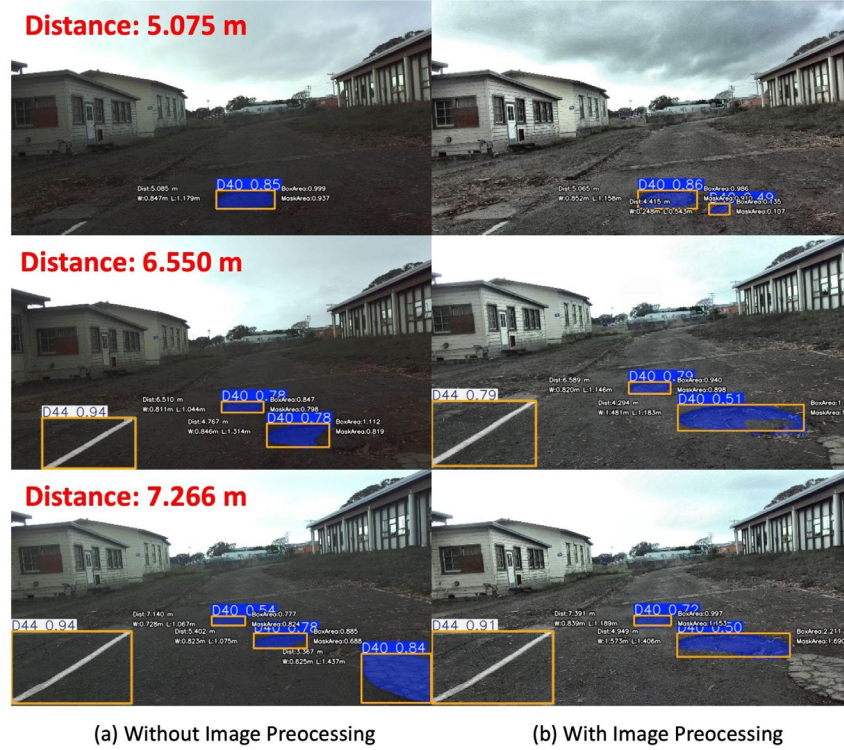
Figure 18 illustrates the pothole detection and size estimation results under low-light conditions at three different camera-to-pothole distances: 5.075 m, 6.550 m, and 7.266 m. For each distance, the left image shows the detection result without image enhancement, while the right image shows the corresponding result after applying image enhancement.

**Figure 18. Illustration of Low-Light Test**

Table 10 presents the pothole size estimation results under the low-light condition. Without image enhancement, the width estimation error increased rapidly as the measured distance increases, rising from 1.626% at 5.075 m to 5.698% at 6.550 m and 15.447% at 7.266 m. This was mainly because pothole edges become less distinguishable from the dark background as the image signal-to-noise ratio decreases. As a result, the detection confidence also decreased from 0.85 to 0.54.

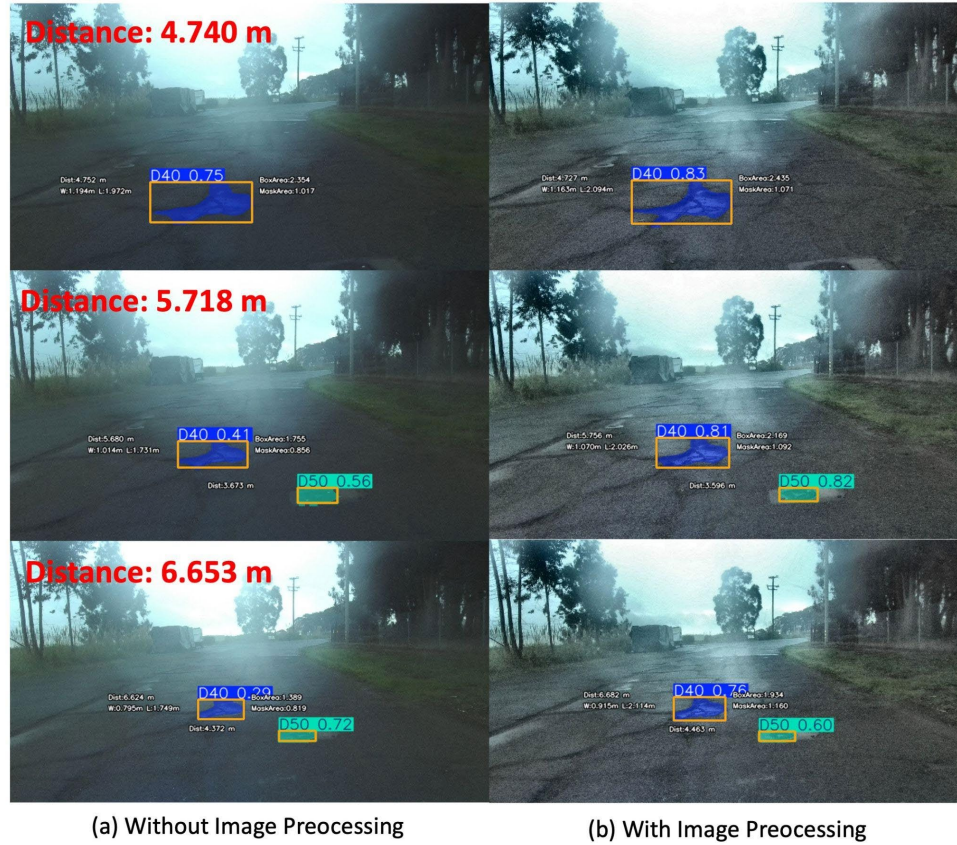
Figure 24 illustrates the pothole detection and size estimation results under rainy conditions with low light at three different camera-to-pothole distances: 4.740 m, 5.718 m, and 6.653 m. For each distance, the left image shows the detection result without image enhancement, while the right image shows the corresponding result after applying image enhancement.

**Figure 24. Illustration of Rainy and Low-light Test**

Table 13 summarizes the size estimation results for Case 4 under the rainy conditions with low light. Without image enhancement, the width estimation errors were 5.581%, 10.107%, and 29.521% at the three measured distances. The corresponding length errors were 2.617%, 14.519%, and 22.519%. As the distance increases, both the estimation error and detection instability become more pronounced. The confidence scores also decreased from 0.75 to 0.41 and 0.29, indicating that low-light rainy conditions made reliable detection more challenging, especially at longer distances.
