**DECEMBER 2015****Project Title:**Field Operations for GPS-assisted  
Winter Maintenance Vehicles  
(Avalanche Sensing)**Task Number:** 1810**Start Date:** June 29, 2009**Completion Date:** September 30, 2014**Product Category:** New or improved tool  
or equipment**Task Manager:**Larry Baumeister  
Transportation Engineer (Electrical)  
[larry.baumeister@dot.ca.gov](mailto:larry.baumeister@dot.ca.gov)

## Managing Avalanches Along Roadways

*Sensors can gather the needed data to initiate controlled avalanches and improve safety*

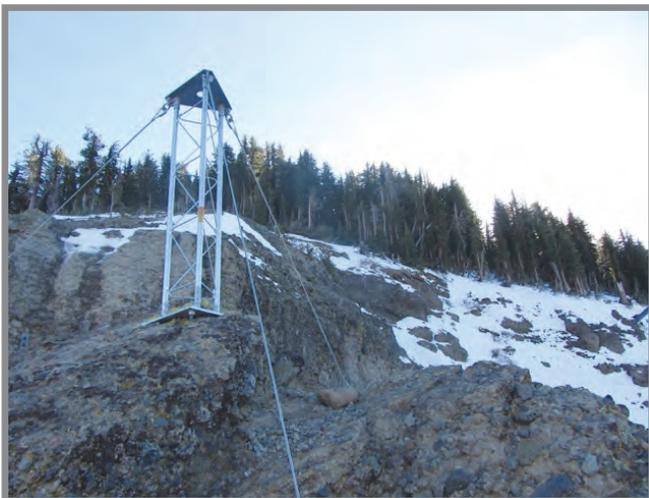
Tower installed on Carson Spur to hold the instrumentation equipment

The project involved several steps. To determine the best location to place the prototype, Caltrans Surveys measured the entire face of the Carson Spur using a stationary laser scanner. The researchers then installed a 5-foot tower to hold the instrumentation equipment on the rock face. The system included an outdoor network video camera to allow remote monitoring and visual corroboration of the sensor measurements. The wind speed sensor can detect wind speeds up to 224 mph, with an accuracy of 2.2 mph. The temperature sensor can detect temperatures down to -58°F, with an accuracy of 0.54°F. The equipment was powered by a wind generator that can supply up to 350 watts.

The instruments were successfully bench-tested, but installing the equipment was more challenging than anticipated. In particular, it was difficult to find a location for the tower that provided the right field of view for imaging and distance measurements as well as secure mounting and system survivability. For this reason, the system was not installed by the end of the project. Final system installation, field testing, and analysis are occurring in follow-up research.

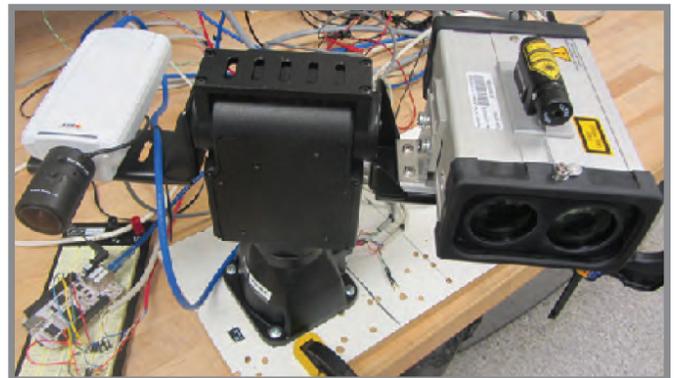
Prototype system in lab
