Implementation and Evaluation of the  
Snowplow Driver Assistance System

**Task Number:** 2167

## Implementation and Evaluation of the Snowplow Driver Assistance System

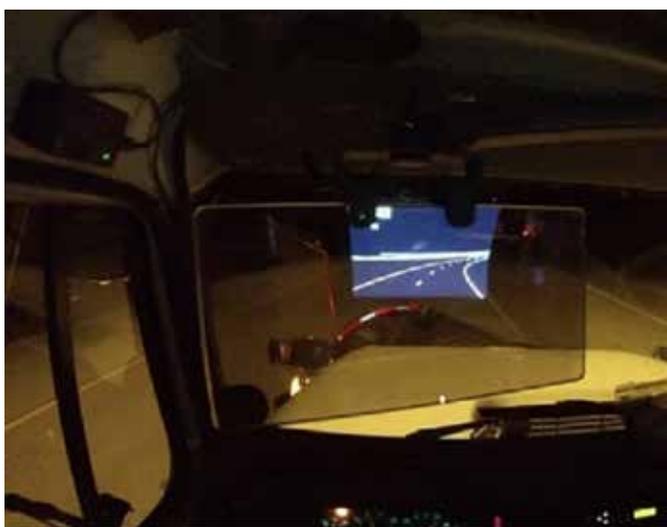
Figure 1: UM DAS HUD combiner

The snowplow DAS functions include lane position indication, lane departure warning, and forward collision warning. Lane lines, stored in a geospatial database, and lane position information are displayed on a head-up display (HUD), shown in Figure 1. This image is projected onto the HUD by an LCD imager (Figure 2). The DAS Collision Warning System uses a single radar, shown in Figure 3, to detect vehicles and other inorganic objects. Radar data allows the system to map detected obstacles to their lateral location, and projects these obstacles onto the HUD. The system also stores the location of fixed roadside objects in the geospatial database to eliminate false positive collision warnings. Vehicle position is provided by the GPS receiver, which has an accuracy of a few inches. The solution is calculated in real time by the snowplow's GPS when it receives the differential base station data in real time through a cellular radio modem, shown in Figure 3. The GPS and radar data is all processed by a DAS computer that is installed underneath the passenger seat, as shown in Figure 4.

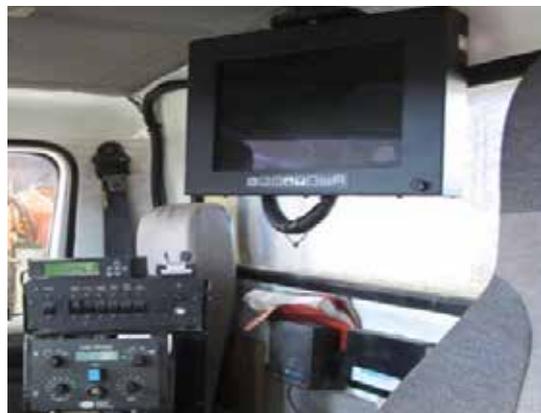
Figure 2: UM DAS HUD LCD imager

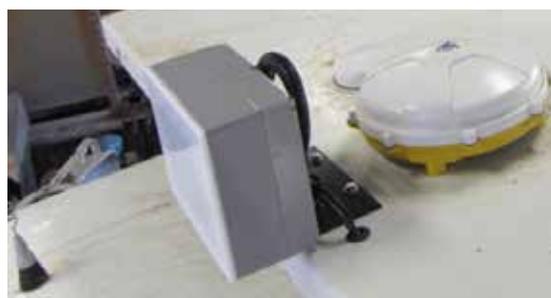
Figure 3: Radar, modem and GNSS antenna installed on top of a snowplow cab protector

During the initial testing of the DAS, there was occasional buildup of ice on the front fascia of the radar enclosure. The thin water layer trapped on the radar enclosure absorbed a majority of the radar signal, rendering the radar ineffective. This water layer buildup and signal attenuation problem was not reported by Alaska or Minnesota during their use of similar systems, and is attributed to the type of snow prevalent in the Sierras. The phenomenon was new and unexpected to UM, MTS, and AHMCT researchers.

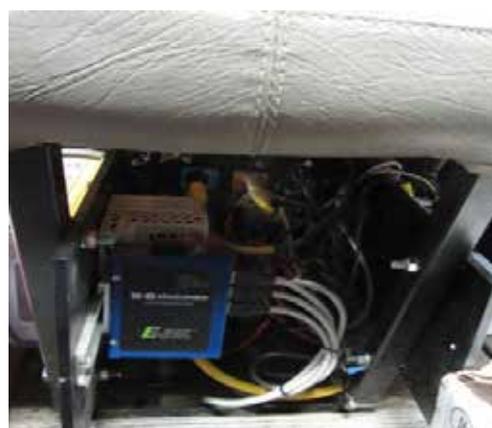
Figure 4: UM DAS computer installed underneath passenger seat
