Caltrans Division of Research,
Innovation and System Information

MAY 2019

Project Title:
Field Testing of the Snowplow Driver Assistance System

Field Testing of the Snowplow Driver Assistance System

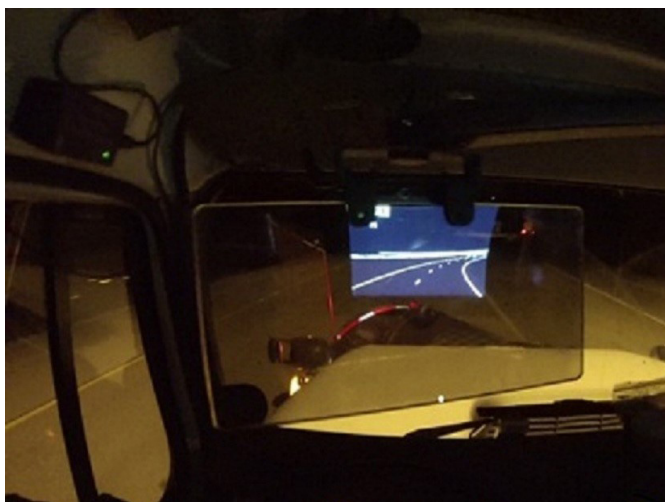
FIGURE 1: DAS HUD combiner

Install a Global Positioning System (GPS)-based Driver Assistance System (DAS) on two snowplows and one snow blower, to help with snow removal operations on the Donner Pass corridor of Interstate 80 (I-80). The system provides a high-accuracy GPS map of the roadway that is displayed on a head-up display (HUD) inside the cab of the vehicle.

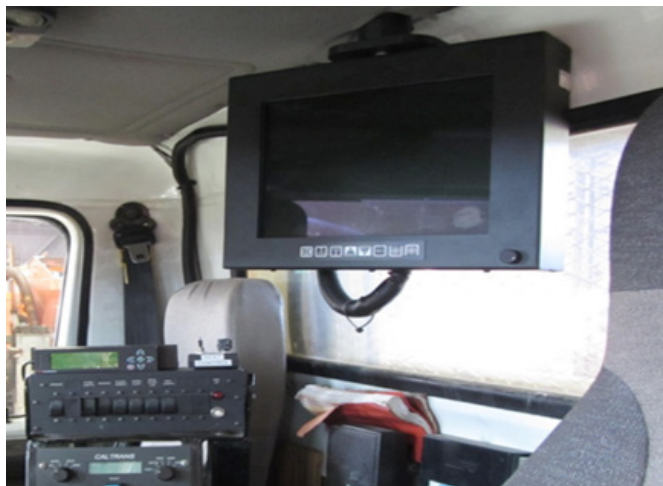
FIGURE 2: DAS HUD LCD imager

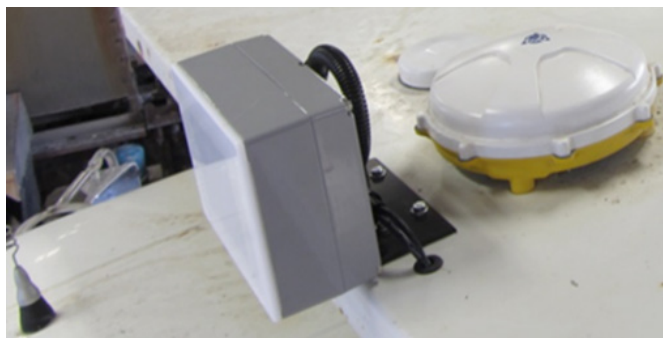
FIGURE 3: Radar, modem, and GNSS antenna installed on top of a snowplow cab protector

Under the previous task, the DAS encountered radar enclosure icing during heavy snowstorms, causing the radar to malfunction. A feasible solution was developed and tested towards the end of the previous task, but it still needed additional development and testing to confirm suitability. This research task completed the field testing of the DAS that was not finished under the previous task.

During the first field testing of the DAS in December 2015, the heated radar enclosure on one of the snowplows failed due to epoxy adhesive delamination from the aluminum housing and the plastic front cover. This failure, which did not occur under the previous task, hindered the operation of the radar that is used to detect oncoming vehicles. In January 2016, the heated radar enclosure on the second snowplow failed due to the same delamination issue. The research then evolved towards investigating methods to mitigate the

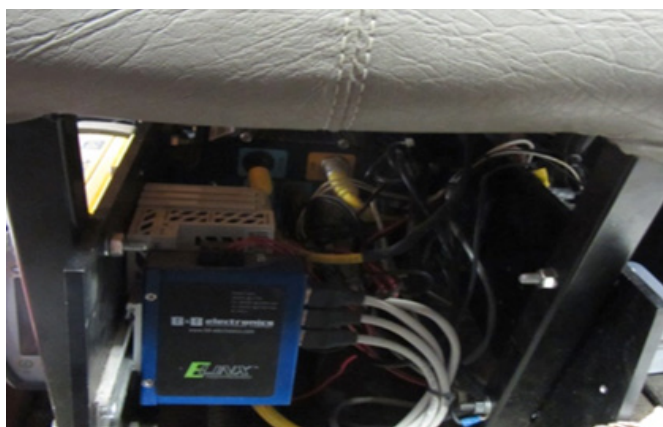
FIGURE 4: DAS computer installed underneath passenger seat
