Caltrans Division of Research,
Innovation and System Information

Integrating Color and Thermal Imaging IR cameras with Caltrans 3D-GPR and GNSS/INS System

Research to Integrate Color and Thermal Imaging IR cameras with Caltrans 3D-GPR and GNSS/INS System.

Integrating 3D-GPR, color and infrared cameras, and GNSS/INS to enable the detection of roadway substructure faults at highway speeds.

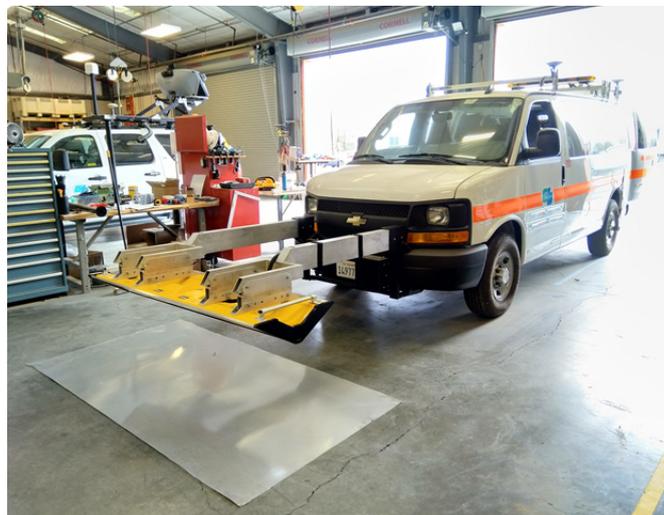
Figure 1: A frontal view of Caltrans' 3D Radar vehicle. The 3D-GPR antenna array (with a yellow top) is mounted on two racks at the front of the vehicle.

The GPR and its antenna (figure 1) and the unites shown above operate as an integrated system allowing multiple streams of digital and video data to be collected at highway speeds, without the need for closing lanes.

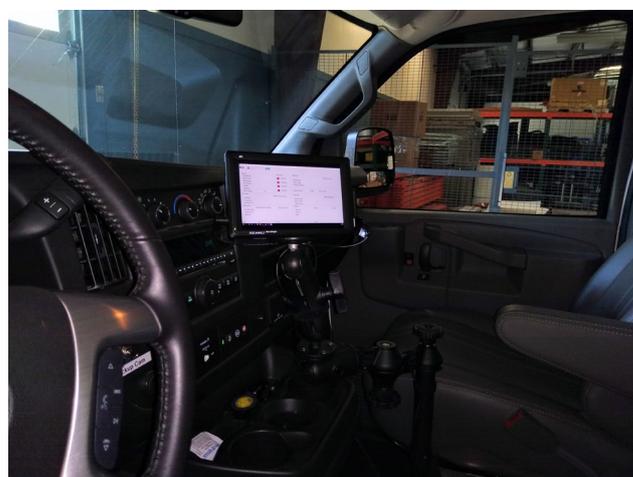
Figure 2: The driver's guidance display. It guides the driver to the proper location within the lane for complete and accurate data collection.

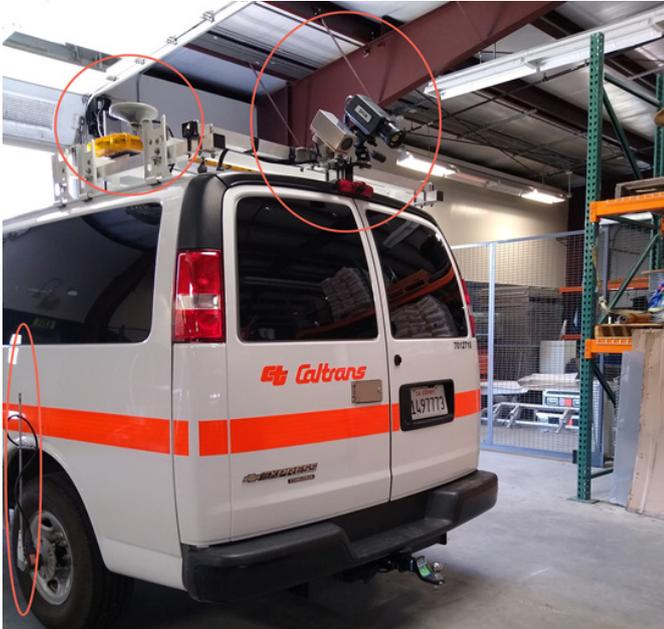
Figure 3: A rear view of Caltrans' 3D Radar vehicle. The dual GNSS antennas that provide accurate positioning are mounted near the center of the roof of the vehicle (a). Above the rear doors are the B/W camera (enclosed inside a stainless steel waterproof housing) and the FLIR IR Camera, both pointing towards the pavement (b). Mounted on the left rear wheel is the Distance Measurement Unit (DMI), which is connected to the Applanix GNSS/IMU system and GeoScope (c).

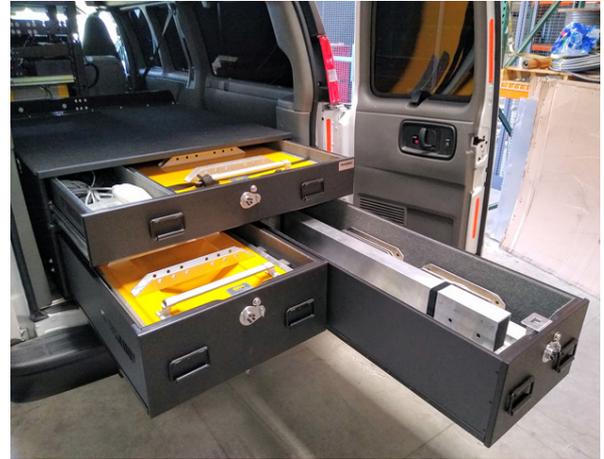
Figure 4: A lockable storage system mounted at the rear of the 3D vehicle. It provides secure storage and transportation for the 3D GPR antennas and sensor mount.

- The top drawer stores the ground couple 3D GPR antenna with tools and accessories.
- The lower left drawer stores the air couple GPR antenna.
- The lower right drawers stores the air couple GPR antenna mounts.

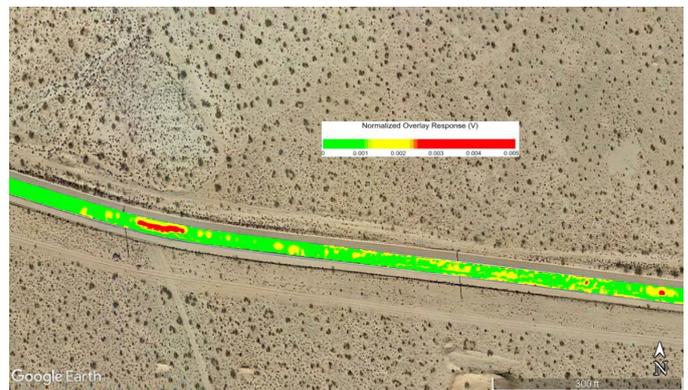
Image 5: A sample graphic of the Pavement Intralayer GPR Response. Intralayer GPR Response provides an indicator for overlay stripping or delamination.

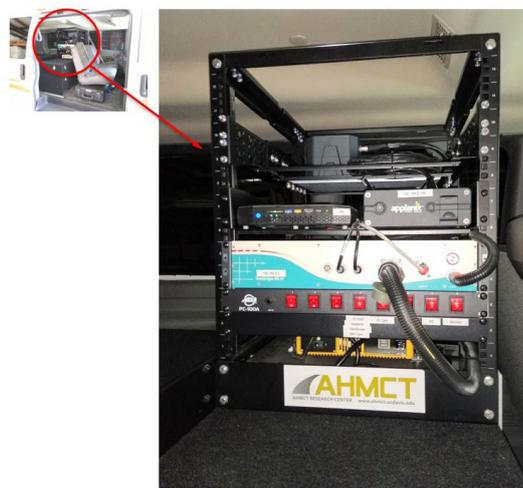
Figure 6: The equipment rack enclosure provides secure mounting of various 3D GPR electronic components including:

- Inverter (located at the bottom),
- GeoScope MK IV computer for 3D GPR data acquisition,
- Operator interface computer (labeled PC),
- Applanix GNSS/IMU computing system,
- The IMU (located on the very top)
- The power supplies (located behind the GeoScope).

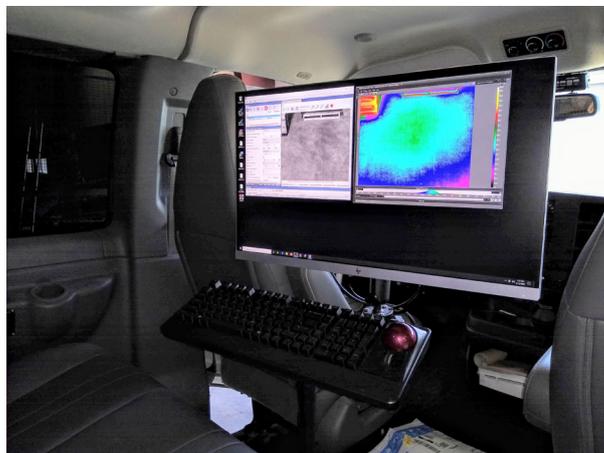
Figure 8: The 3D GPR operator's user interface. The interface enables the operator to monitor the proper functioning of sensors, cameras, and data collection.

The display shows the thermo-imaging from the FLIR IR camera (right screen) and pavement images from the B/W camera (left screen).

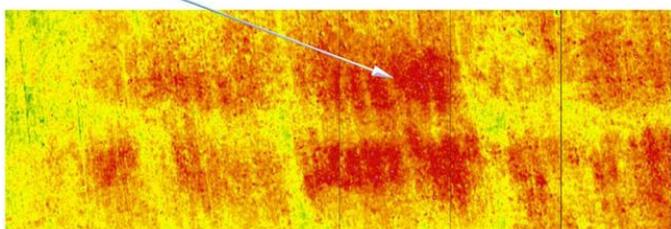
Color difference can indicate delamination

Image 7: A sample of a processed thermal image of a bridge deck where the color difference (red shade) can indicate delamination.
