Iconic Big Sur Route Reclaimed

Highway 1 Crews Have Realigned, Strengthened Section After Massive Slide

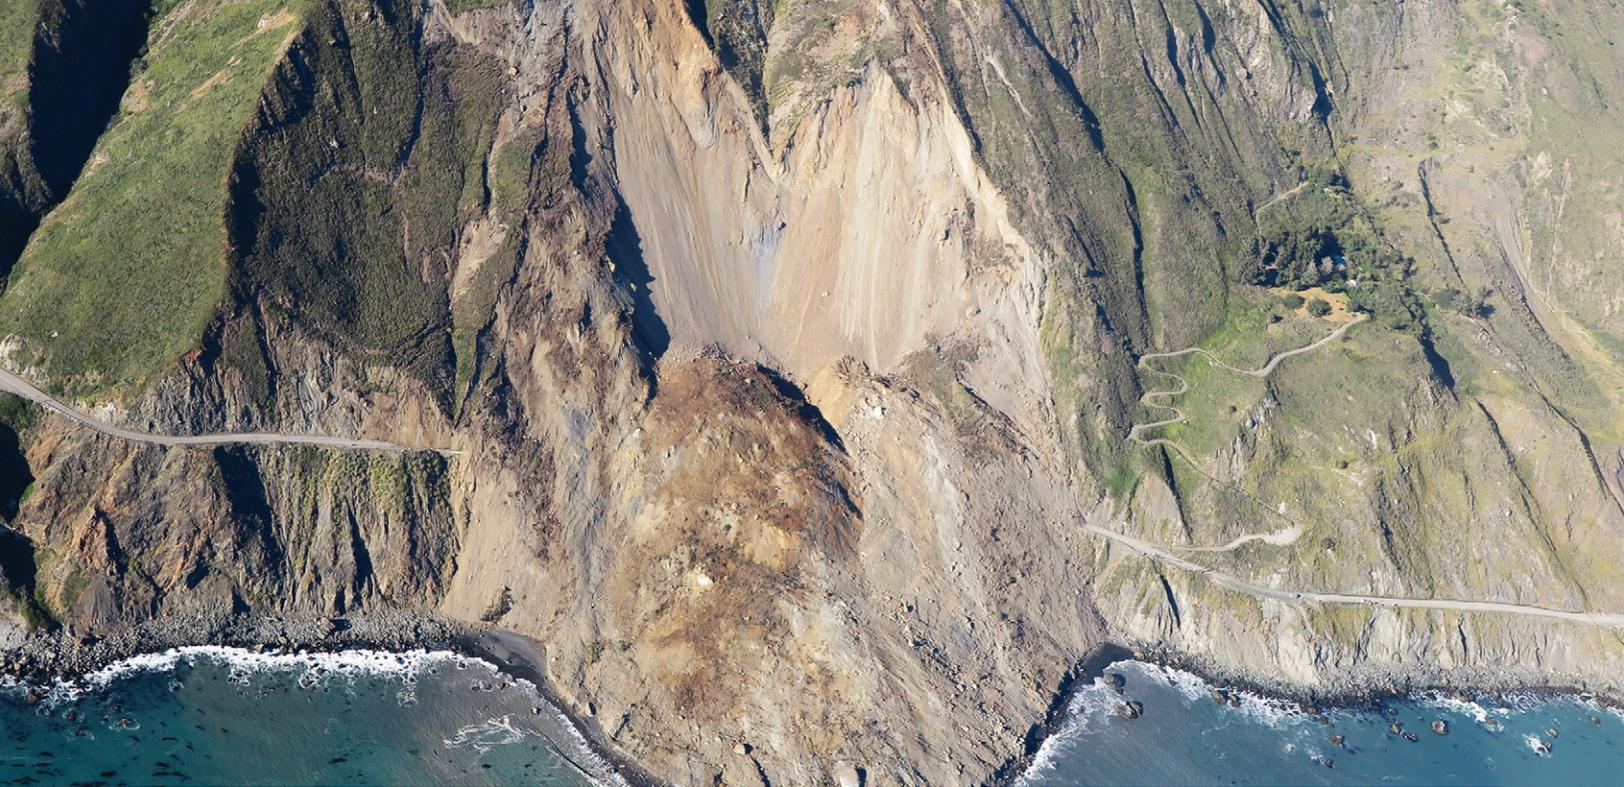
An aerial shot shows the massive landslide that, in an instant, wiped out all traces of a section of Highway 1, and dramatically changed the surrounding landscape along the Big Sur coast. Recognizing the highway's importance, Caltrans almost immediately began plans for rebuilding.

The slide that buried the highway on May 20, 2017 dumped more than 6 million cubic yards of material atop the roadway and into the ocean, adding 15 acres of new coastline. It occurred after one of the most severe winters on record battered the Central Coast, and the rest of California.

Miraculously, no one was injured or killed by the slide, but the collapsed cliff side obliterated a ¼-mile section of roadway.

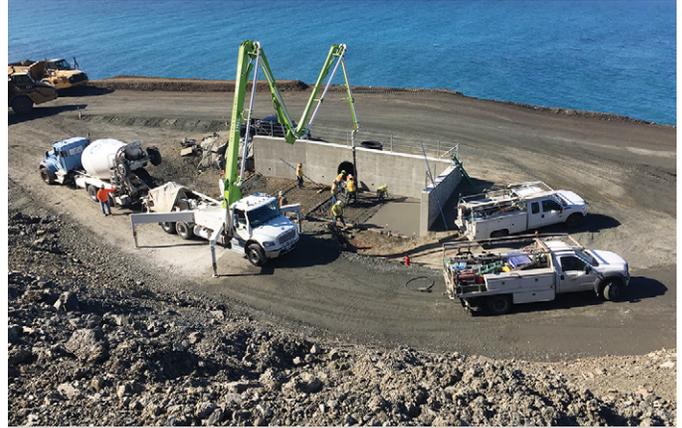
Crews pour a concrete drainage pad under the five-foot-plus diameter pipe that will drain excess water from the Mud Creek area.

A larger and more interconnected drainage system has been installed. The main feature is a 63-inch diameter pipe that will drain runoff from the southern portion of the project and Mud Creek, which is not a year-round water source but can rage during stormy periods. A four-foot diameter piping network also has been laid, and replaces a series of culverts that would regularly clog with mud and debris.

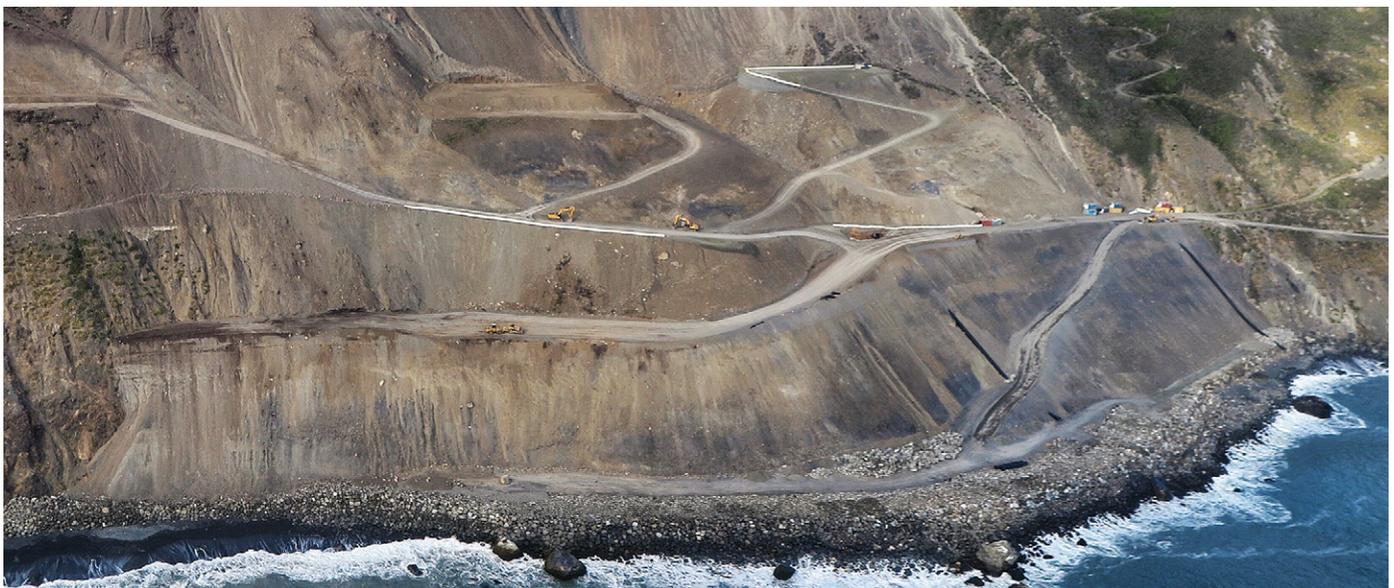
Construction crews create a new roadway base for the middle and north sections of the Mud Creek project. Access roads have been constructed for future maintenance of the site. A rock barricade, called a revetment, was built along the shoreline to keep the tide from eroding the embankments.
