Pitkins Curve

Rockin' & Rollin' an
ALL-AMERICAN ROAD

Highway 1 Pitkins Curve and Rain Rocks

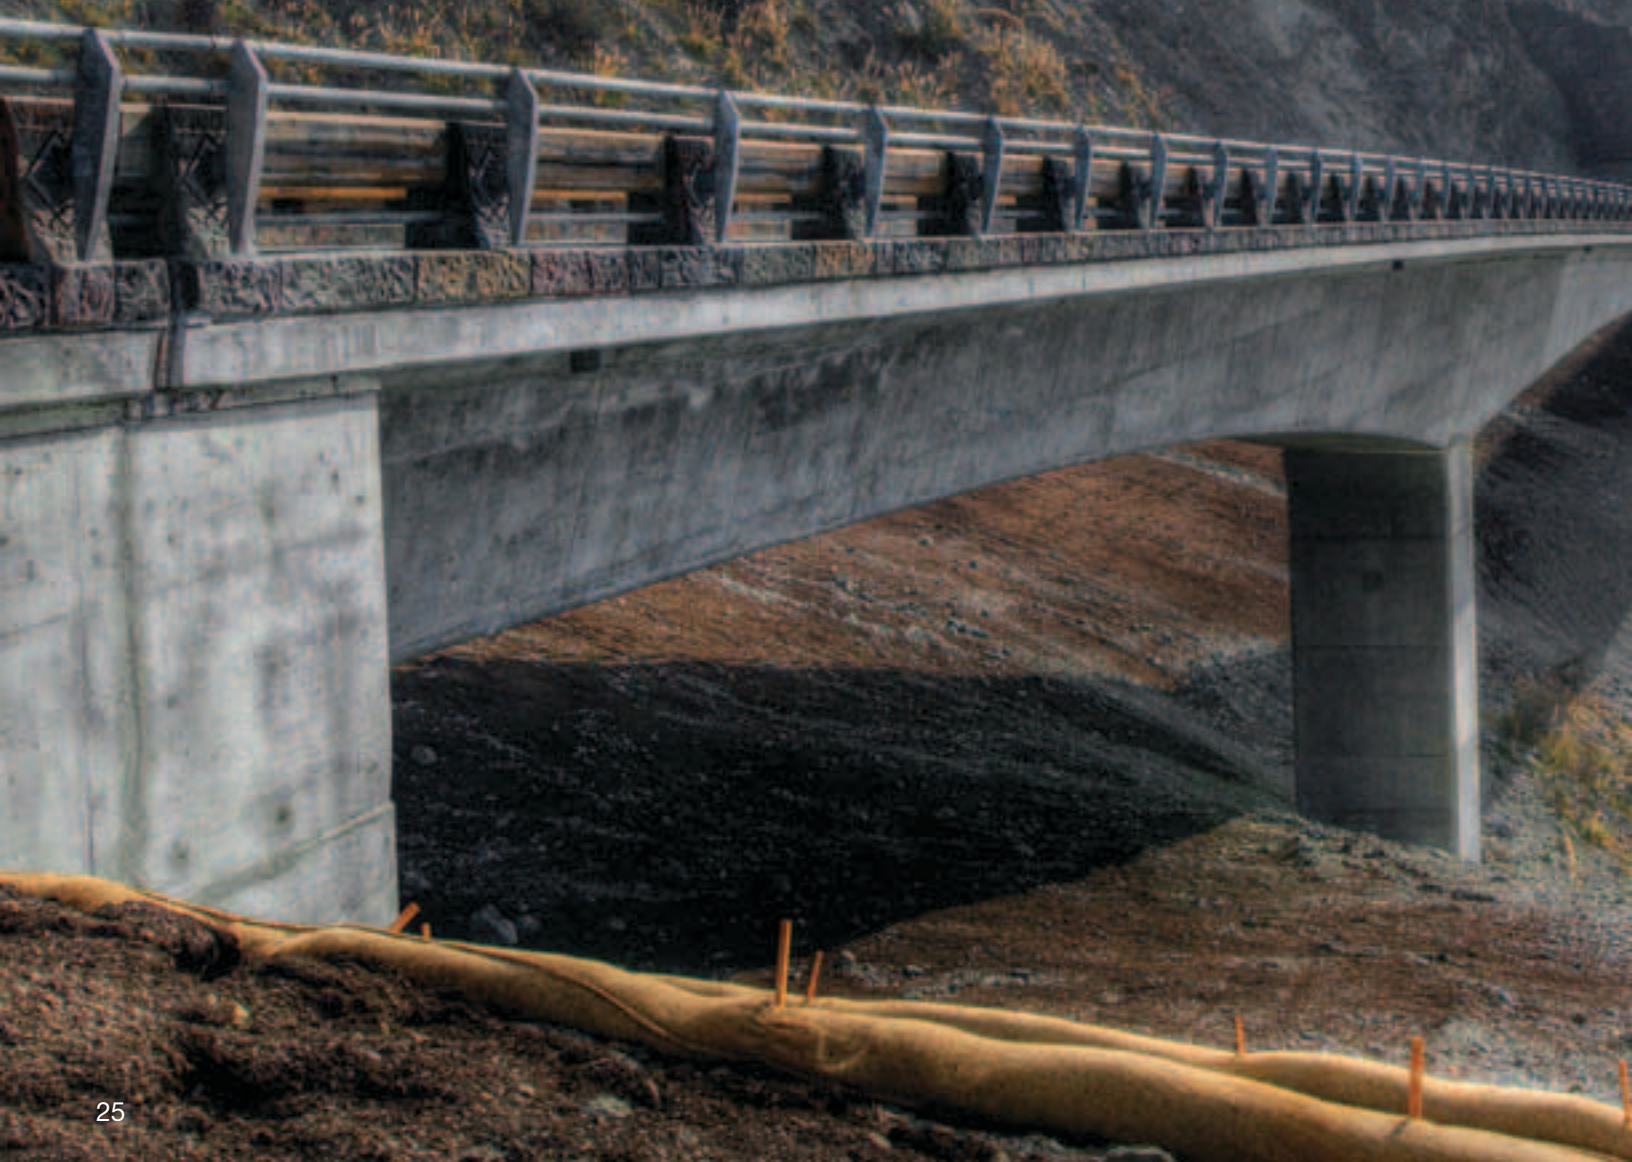
A scenic view of a coastal highway bridge overlooking the ocean. The bridge is a concrete structure with multiple arches, built on a steep, rocky cliffside. The ocean is a deep blue, with white-capped waves crashing against the shore. The sky is a clear, bright blue. The overall scene is a beautiful coastal landscape.

The Rain Rocks shed is the only roadway structure of its kind in the nation. It has a faux keystone finish, aqueduct-like arches, and a slanted roof that allows rocks to tumble into the ocean without affecting the highway or drivers. The Pitkins Curve Bridge spans over part of the ocean, allows rocks to fall under the bridge and into the water, and offers breathtaking views by bringing drivers closer to the water.
