**California Traffic Control Devices Committee (CTCDC)  
Agenda Item Report**

**Technical Report for Orange Contrast Temporary Pavement Delineation in Construction Zones**

1. REPORT NUMBER <b>CA23-3836</b>	2. GOVERNMENT ASSOCIATION NUMBER <b>N/A</b>	3. RECIPIENT'S CATALOG NUMBER <b>N/A</b>
4. TITLE AND SUBTITLE <b>Orange Contrasted Temporary Pavement Delineation in Construction Zones</b>		5. REPORT DATE <b>09/30/2023</b>

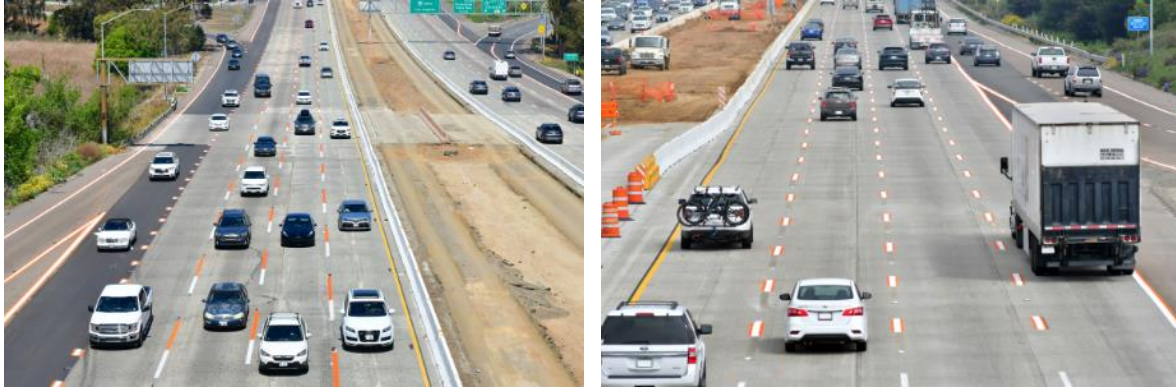
**Figure 1.2: Orange preceding white striping in southbound (SB) direction (left); orange along both sides of white striping in northbound (NB) direction (right) (photos: courtesy of Caltrans)**

This project assessed the influence of orange pavement delineation in a work zone in Caltrans District 11 in the Interstate 5 (I-5) North Coast Corridor (NCC) Construction Project in San Diego County (Figure 1.1). The construction started with standard temporary white striping and then temporary orange contrast striping was added later. The different time periods with white and orange temporary striping allowed the researchers to compare driver behavior and evaluate the effectiveness of the orange temporary delineation. There were two alternatives used for orange striping with lane lines. The southbound (SB) direction had orange preceding white temporary striping (Figure 1.2 left); the northbound (NB) direction had orange along both sides of white striping (Figure 1.2 right). The orange contrast with the right edge line, lane drop, and gores was the same in both directions.

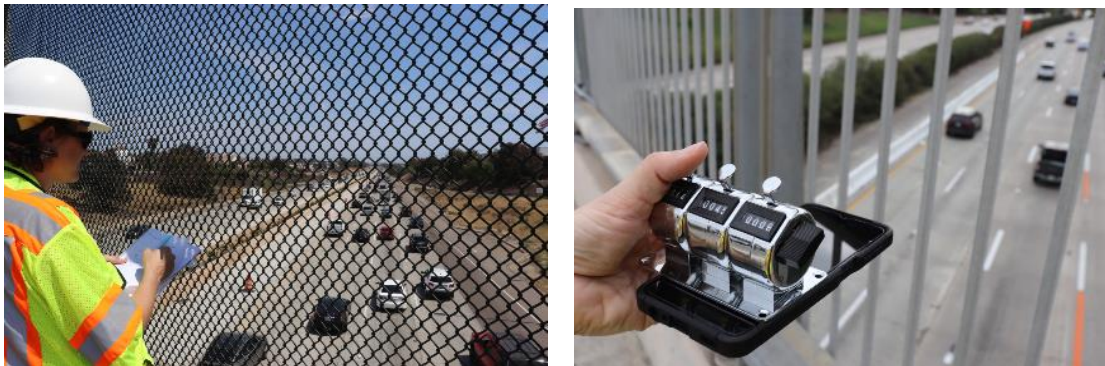
**Figure 2.1: Left: Visual observation of driver lane keeping on Palomar Airport Rd Overcrossing over I-5, south view on SB traffic. Right: Using the three-part clicker for recording and smartphone as timer on Las Flores Overcrossing over I-5, south view on SB traffic.**

Initial visual observations of driver behavior were performed from Palomar Airport Road Overcrossing over I-5 with tally marks (Figure 2.1 left). This location was not yet a work zone but provided a good and safe observation location. A protocol to record lane keeping was developed by counting cars that were either in the middle, drifted to the left, or drifted to the right for a given time per lane with tally marks on paper. The initial protocol was refined with a longer recording time and the use of a clicker (Figure 2.1 right).

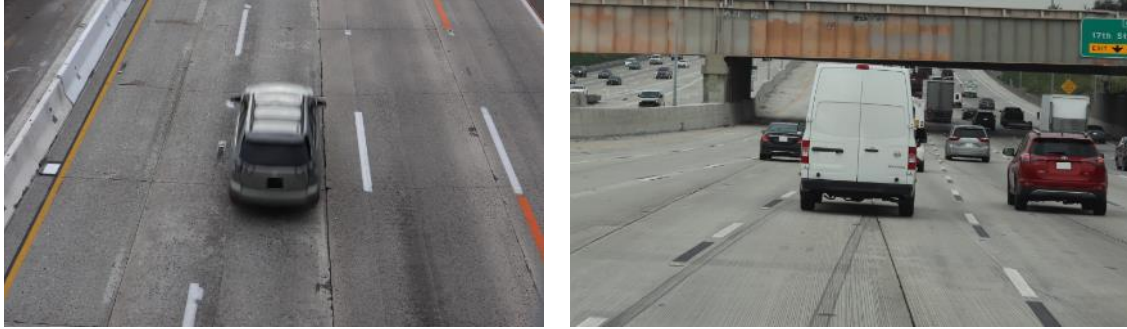
**Figure 2.5: Examples for lane keeping and pavement joints, left: Las Flores, I-5 south view, lane 2, SB traffic; right: I-5, Tustin, CA, NB traffic; both pictures taken on 1/13/2022**

The slabs of the concrete added additional features to the lanes and might have also affected driver behavior. For example, a straight slab seam, as in Figure 2.5 left, tempted drivers to stay on one side, especially drivers in smaller cars. Figure 2.4 left shows a larger bias of lane 2 towards the K-rail than for all other lanes. Figure 2.5 right shows slab seams moving across lane markings, which might have confused drivers. No quantitative measurements were taken in this study, but the influence of pavement joints and vehicles ahead on driver behavior need to be considered.

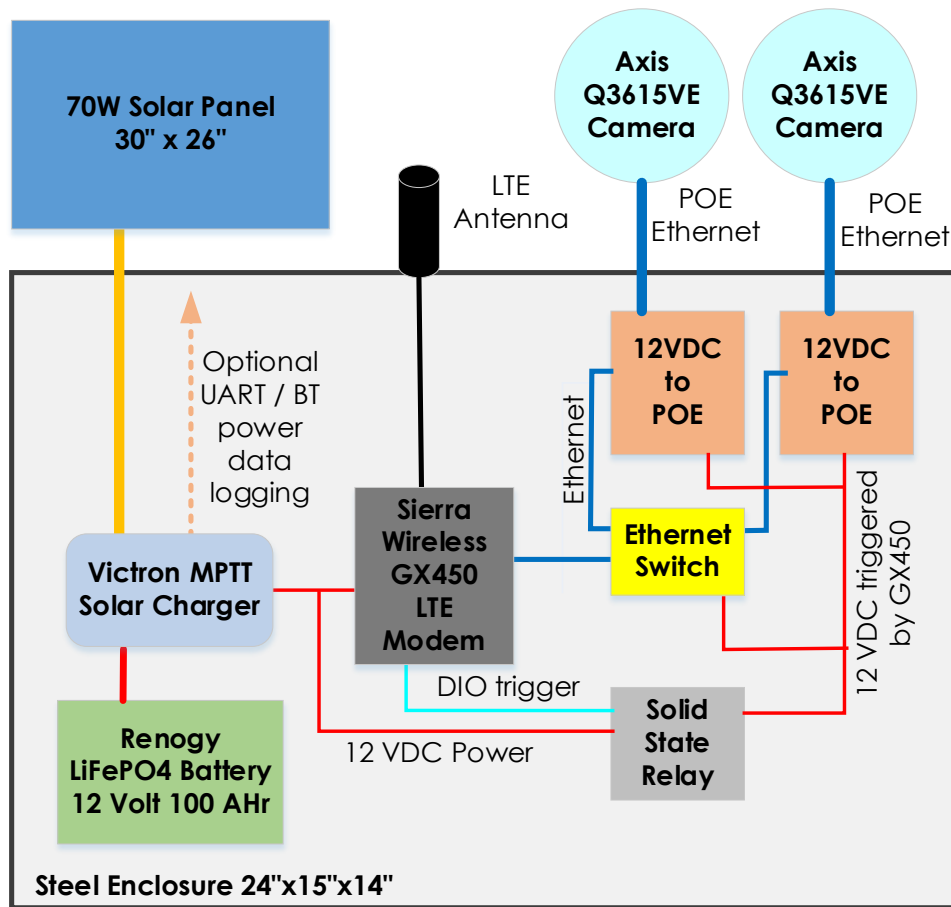
Figure 2.6: Diagram of the camera system.

AHMCT and Caltrans decided that the electronics box, solar panels, and cameras did not need to be on the same pole, which led to higher installation effort but increased flexibility for component placing. The camera location prioritized video information; the electronics box location prioritized accessibility for AHMCT researchers to trouble-shoot and download data; and the solar panel location prioritized maximum solar energy intake.

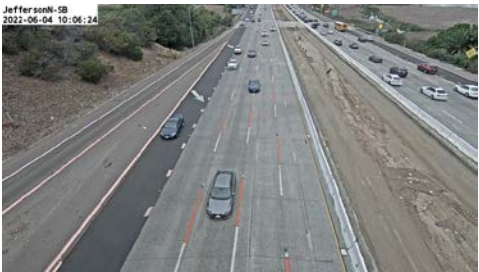
**Table 2.1: Cameras at Jefferson Overcrossing (installed January 2022)**

Condition	Straight part in work zone with orange temporary striping and white temporary striping	
Location	Jefferson Overcrossing	
Camera screen shot	Overcrossing W end, view N, SB traffic

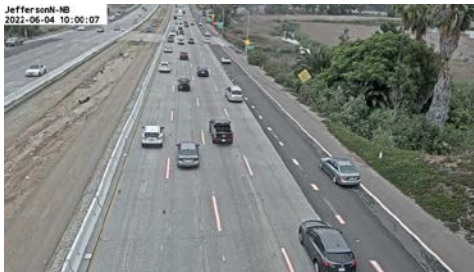
Overcrossing E end, view N, NB traffic

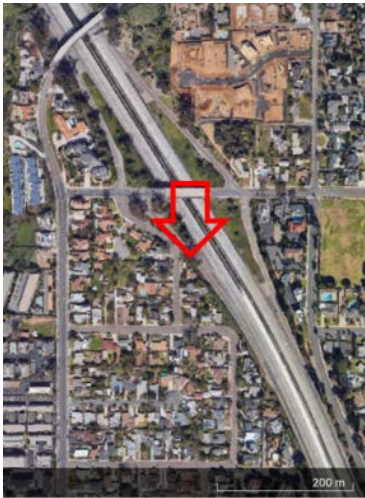
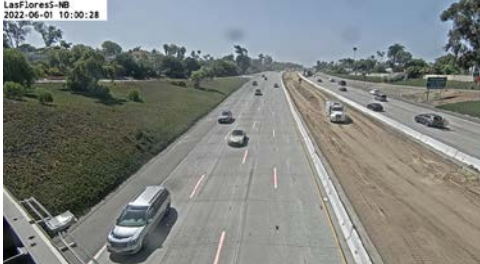
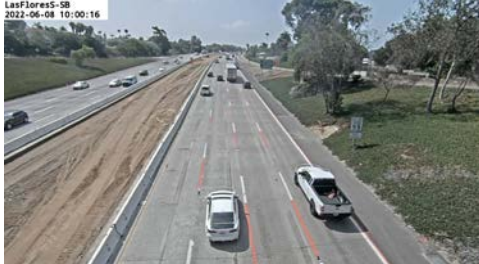
**Table 2.2: Cameras at Las Flores Overcrossing (installed January 2022)**

Condition	Curve in work zone with orange temporary striping and white temporary striping (southbound traffic curves to the right)	
Location	Las Flores Dr Overcrossing	
Curve overview (Google earth)

<p>about 380 ft to curve</p>	
Camera screen shot	Overcrossing E end, view S, NB traffic

Overcrossing W end, view S, SB traffic

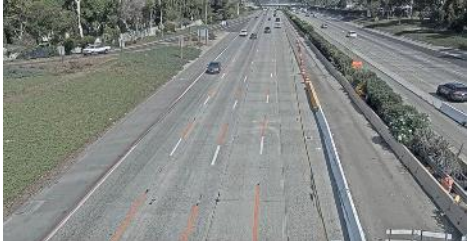
**Table 2.3: Camera at Cassidy Overcrossing (installed June 2022)**

Condition	Taper shift between regular traffic zone and work zone with orange temporary striping
Location	Cassidy St Overcrossing
Camera screen shot	Overcrossing W end, view N, SB traffic

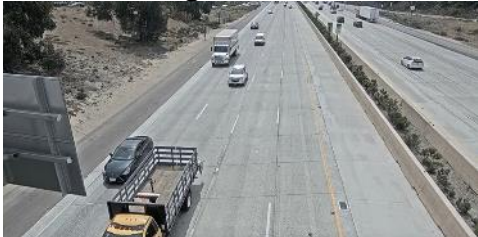
**Table 2.4: Camera at Palomar Airport Rd Overcrossing (installed June 2022)**

Condition	Taper shift between work zone with orange temporary striping and regular traffic zone
Location	Palomar Airport Rd Overcrossing
Camera screen shot	Overcrossing E end, view S, NB traffic

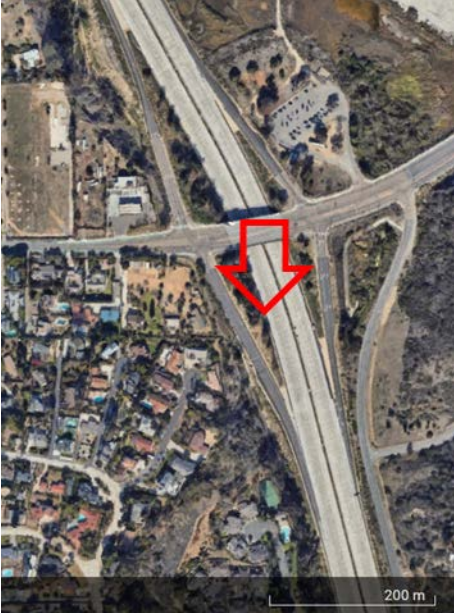
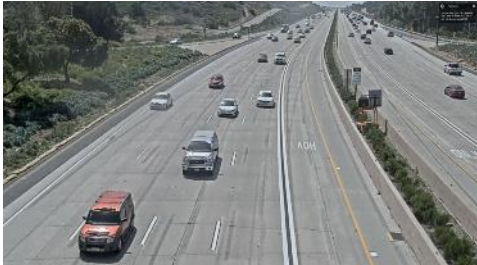
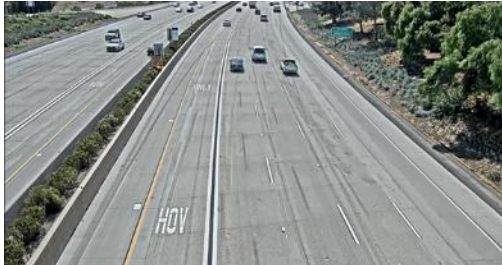
**Table 2.5: Cameras at La Costa Overcrossing (installed June 2022)**

Condition	Curve in regular traffic zone (southbound traffic curves to the right)	
Location	La Costa Overcrossing	
Curve overview (Google earth)

<p style="text-align: right;">about 280 ft to curve</p>	
Camera screen shot	<p>overcrossing E end, view S, NB traffic</p>

<p>overcrossing W end, view S, SB traffic</p>

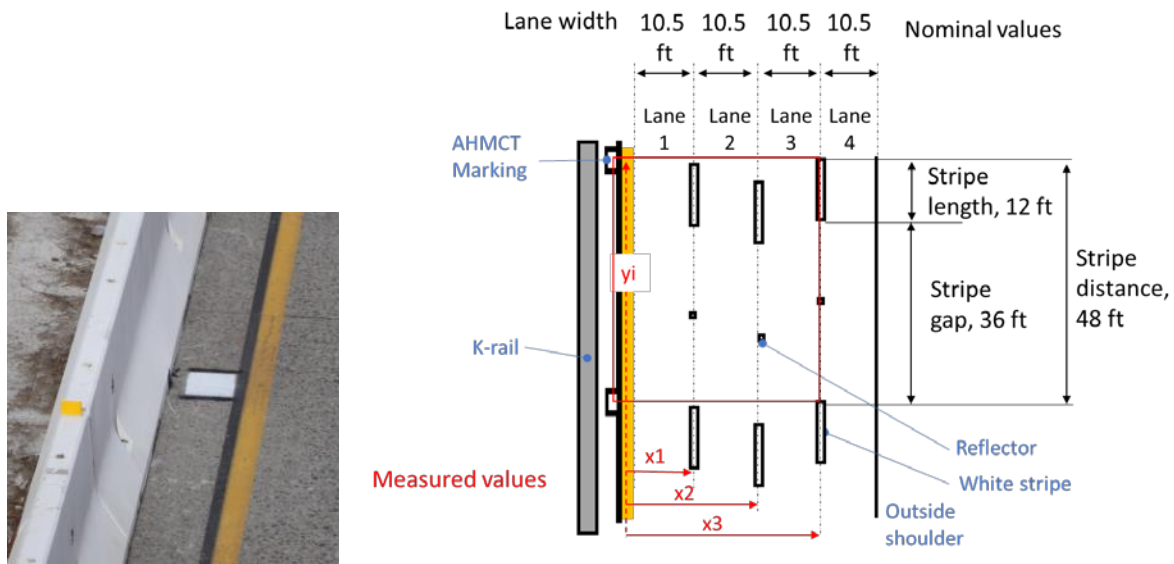
Figure 2.9: Road marking; Left: photo; Right: diagram of freeway and road markings with nominal values (black) and measured values (red)

Caltrans personnel. The first marking was at 0 ft, the next at 48 ft, and the third at 96 ft.

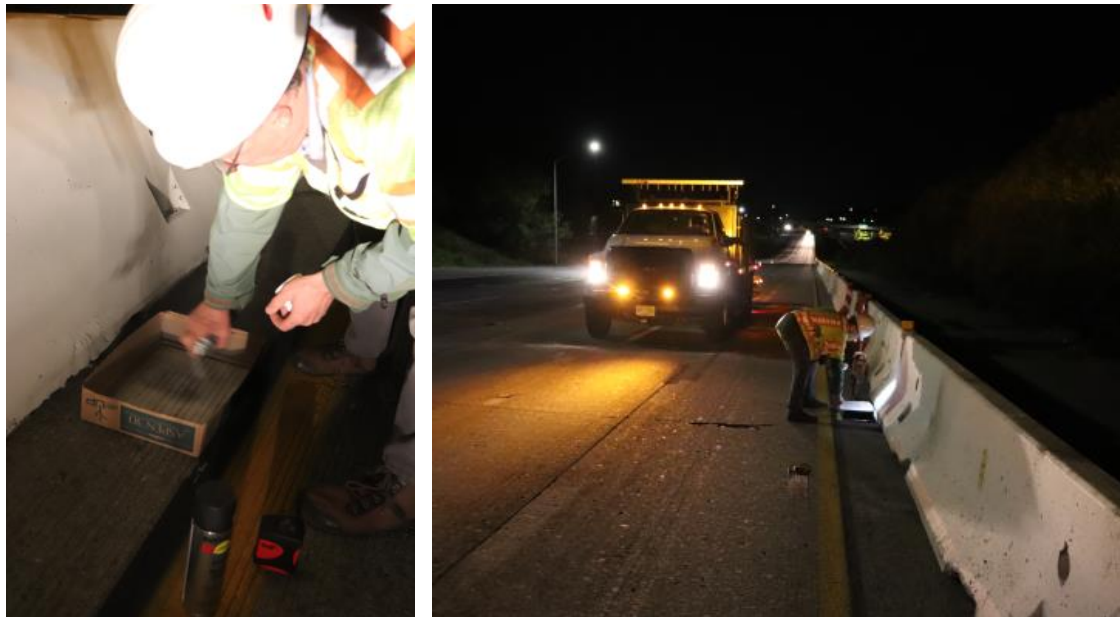
Figure 2.10: Road marking application with spray paint

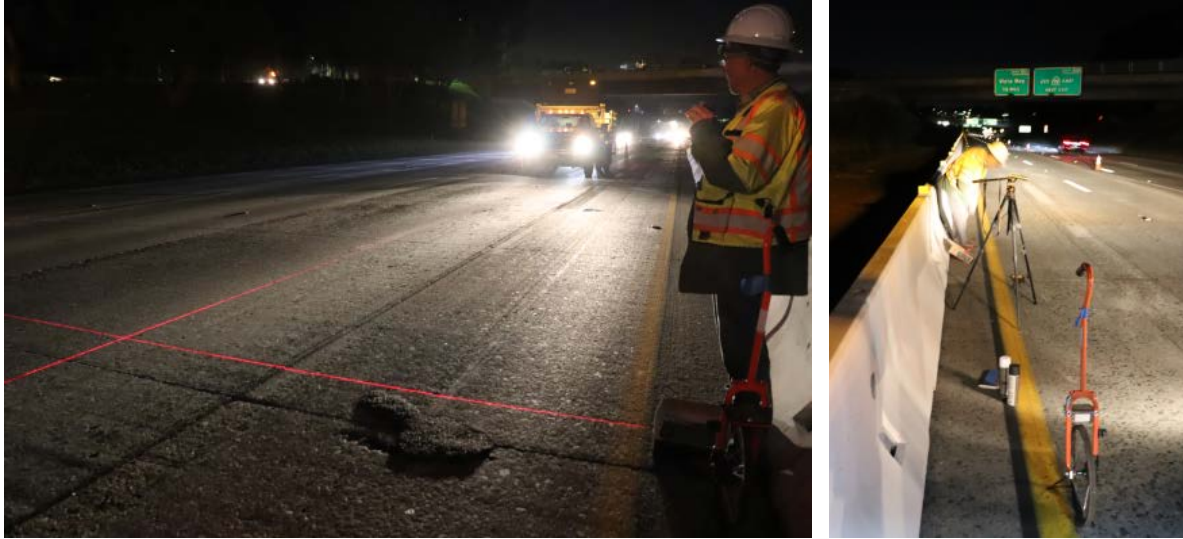
**Figure 2.11: Positioning of road markings; left: with laser perpendicular to road ( $x_1, x_2, x_3$ ); right: with wheel along the road ( $y_i$ )**

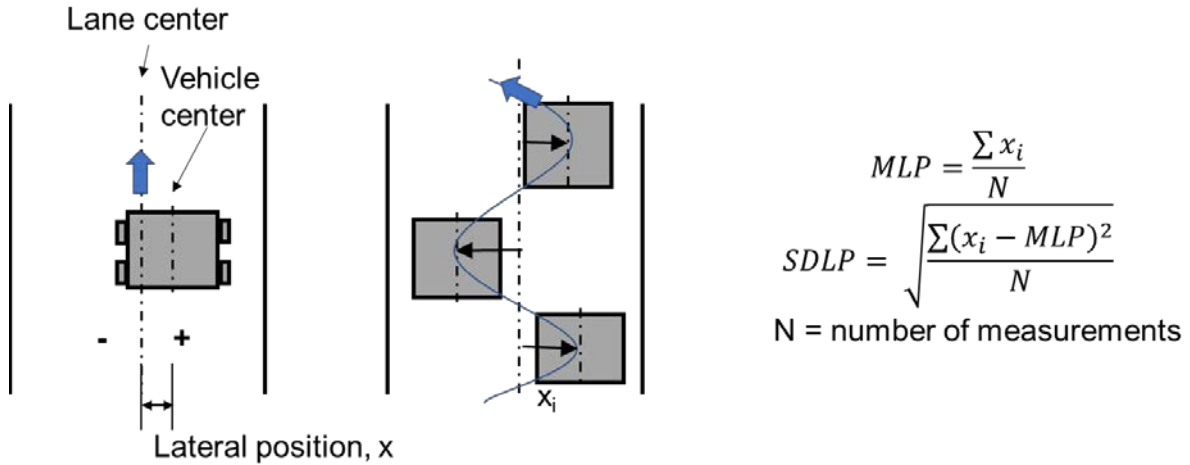
**Figure 2.12: Definition of Mean of vehicle distance from lane center (MLP) and Standard deviation of lateral position (SDLP)**

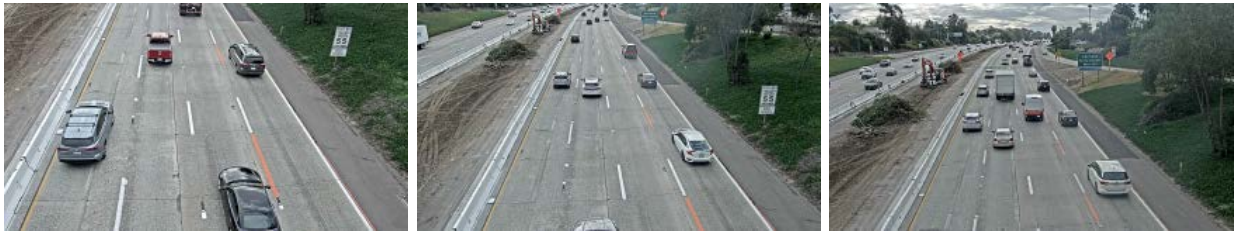
**Figure 2.13: Video screenshots with different views, from Las Flores Overcrossing, south view, SB traffic; left: close view; middle: intermediate view; right: far view**

Camera recordings were collected at different times of the day and at different time intervals. The accuracy of the measurements was strongly dependent on camera resolution, line of sight, and light conditions. The pan, tilt, and zoom options allowed for changing the camera view to see lane keeping behavior close-up or observe driver behavior and speeds over a longer stretch (Figure 2.13).

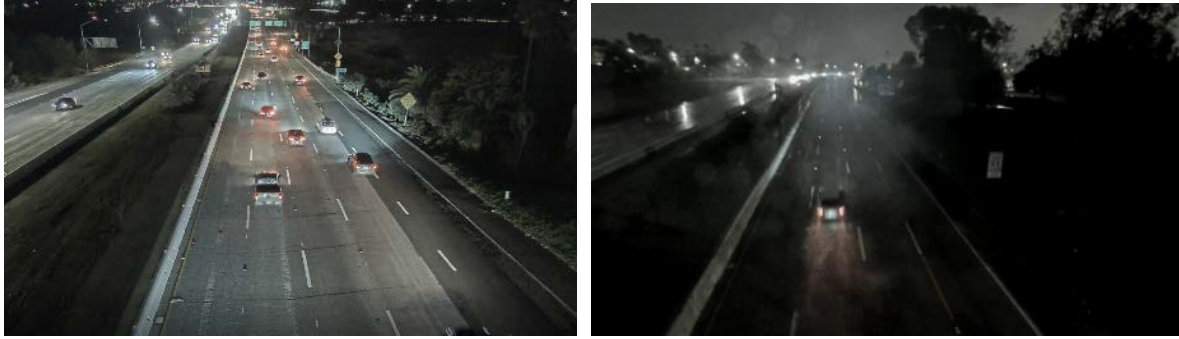
**Figure 2.14: Video screenshots at night with different numbers of cars, left: from Jefferson Overcrossing, north view, NB traffic, night time; right: from Las Flores Overcrossing, S view, SB traffic**

The night videos were well lit when multiple vehicles were on the road, but quite dark when there were single vehicles on the road (Figure 2.14). The camera automatically switched from color to black and white mode when there was not much light (Figure 2.15).

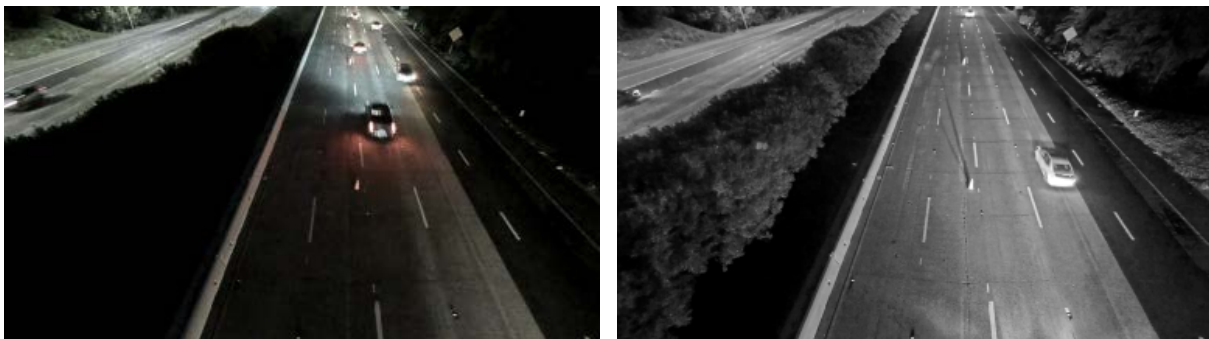
**Figure 2.15: Video screenshots at night from Jefferson Overcrossing, north view, NB traffic; left: color video; right black & white video**

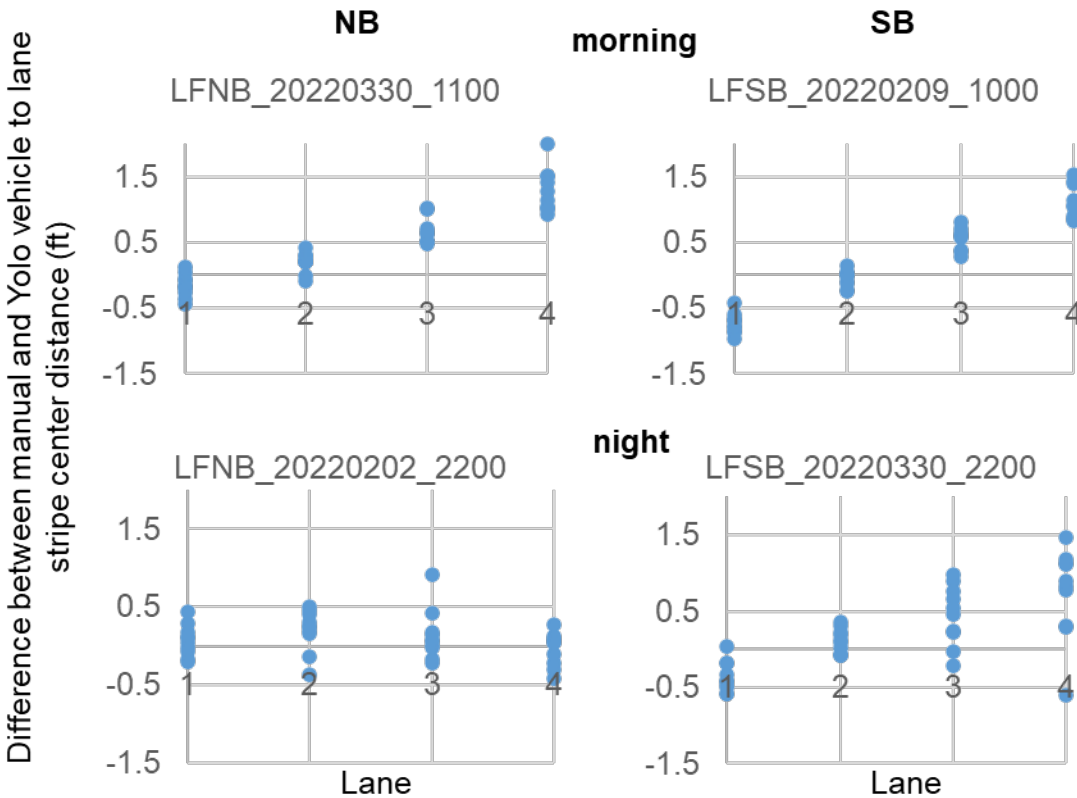
**Figure 2.21: Trendline of errors at Las Flores, NB and SB direction; in the morning (11 am and 10 am) and night (10 pm) for 10 cars each**

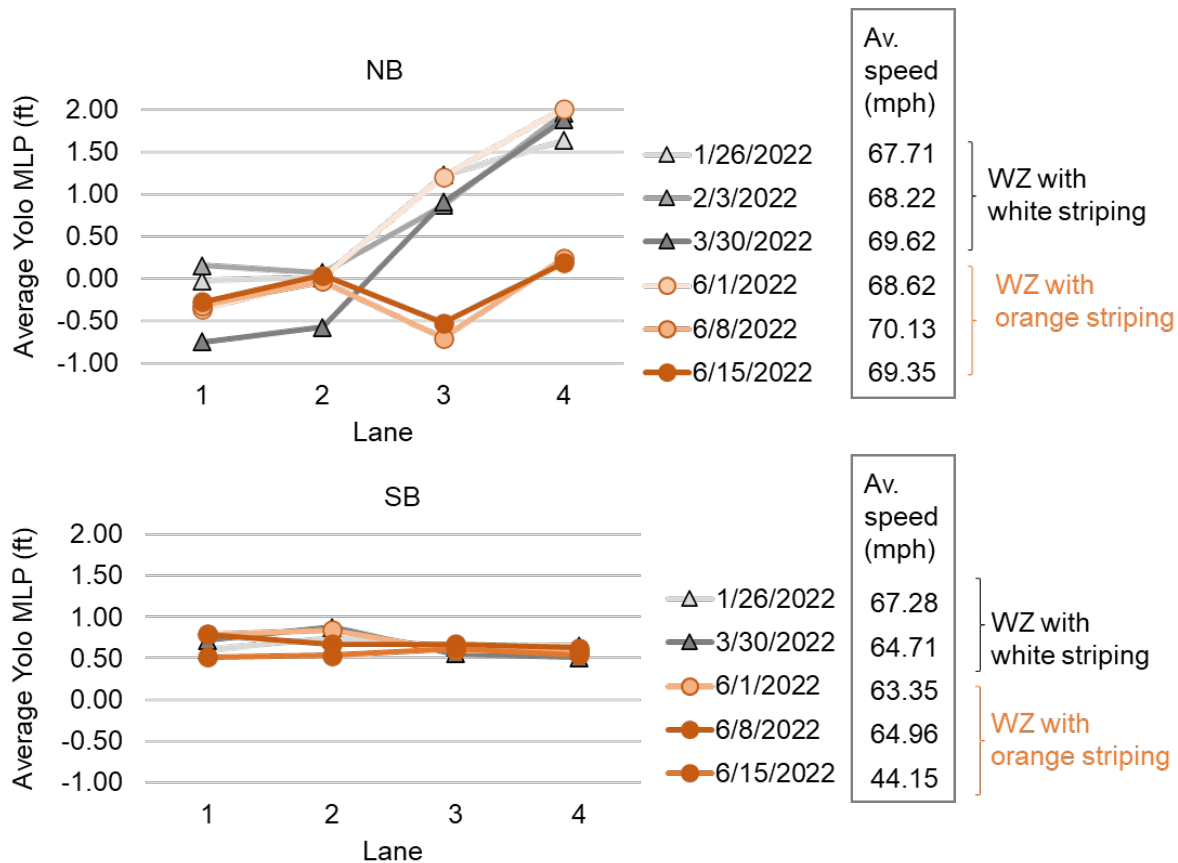
**Figure 2.24: Lane keeping behavior for lanes 1 to 4 from automated Yolo vehicle center analysis, Jefferson Overcrossing, selected weekdays at 10 am, 10-min videos; average speed from HERE Technologies data for 1 h at Las Flores Dr/Exit 51A (closest location to Jefferson Overcrossing)**

To compare the lane keeping behavior for W, with white temporary striping and WZ with orange temporary striping, the average MLP for five Wednesdays and one Thursday (2/3/2022) were compared (Figure 2.24). In the NB direction, vehicles had varying left and right bias for the six observed dates. In the NB direction, vehicles had just passed an on-ramp to the auxiliary lane 5 (Table 2.1). Also, there is a stronger error from camera distortion on the lanes 3 and 4 (Figure 2.22). The average speeds were obtained from Here Technologies data (the method is described Chapter 5). For the NB direction, all average speeds were between 67.71 mph and 70.13 mph.

The SB striping was white preceding orange whereas the NB striping was orange along white on both sides, but it cannot be said for sure that these different striping patterns affected the driver lane keeping behavior because of the different ramp, lane 5, and average speed conditions. In addition, the standard deviations of average Yolo MLP ranged between 0.72 ft to 2.03 ft as shown in Figure 2.24. With this large standard deviation and data scatter in the vehicle center position, there was high data uncertainty.

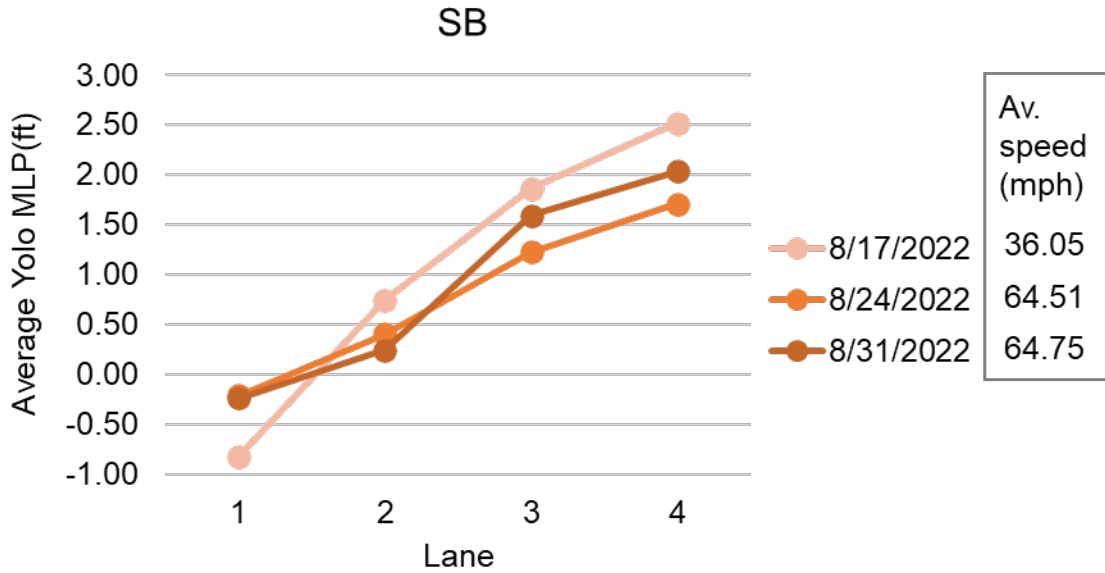
**Figure 2.26: Lane keeping behavior from automated Yolo vehicle center analysis, Cassidy Overcrossing, SB direction, selected Wednesdays at 10 am, 10-min videos; average speed from HERE Technologies data for 1 h at Cassidy St/Exit 51C**

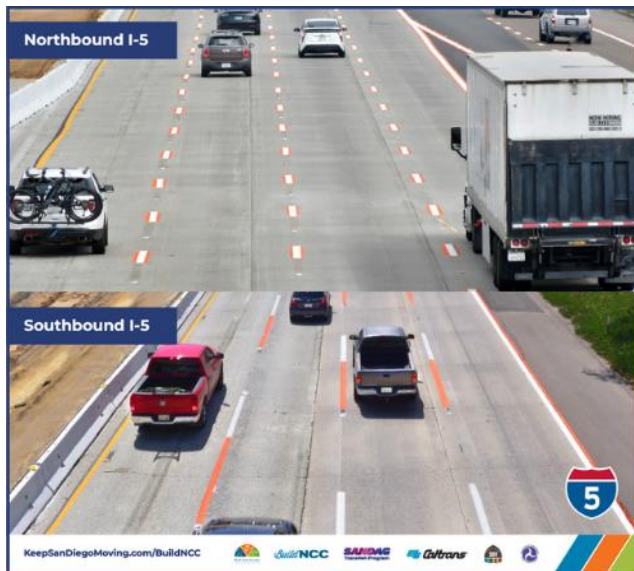
**Figure 3.1: Visual for question Q5 on pattern preference.**

Of 1,087 people, 43.2% noticed a difference in the NB and SB orange contrasted lane line striping, but the majority (56.9%) did not (Appendix C, Q4). Only the respondents who noticed the difference were asked Q5 concerning which orange contrasted lane line striping they preferred. In addition, a picture with both striping patterns was shown (Figure 3.1). Of the 465 respondents, the majority (60.4%) preferred the orange along both sides of the white lane line in the NB direction, 22.8% preferred the orange preceding the white lane line in the SB direction, and 16.8% reported no preference (Appendix C, Q5).

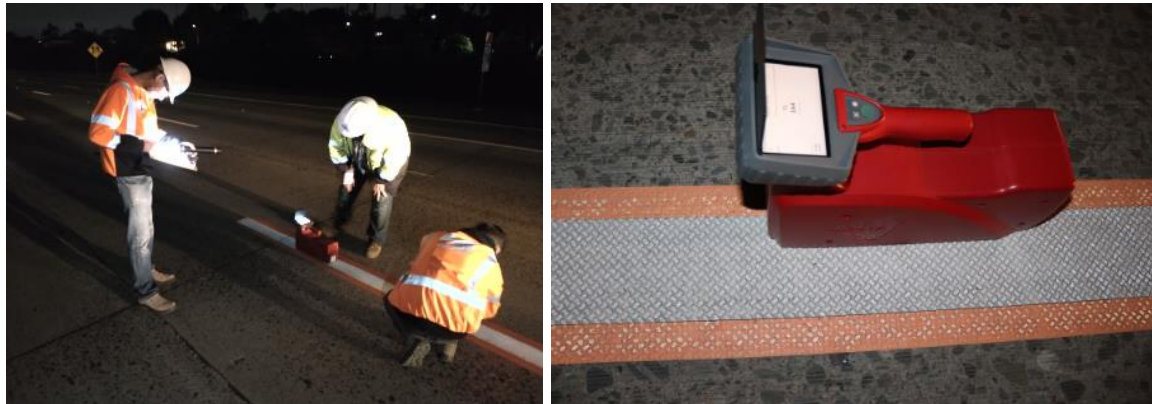
Figure 4.2: Left: Striping quality measurements performed by AHMCT researcher and Caltrans staff days after orange striping installation; Right: Retroreflectivity and nighttime color measurements on tape striping on I-5, northbound traffic, south of Las Flores Overcrossing

Measurements were performed with a stationary reflectometer LTL3000 (Delta Instruments), which collects the coefficient of retroreflected luminance, RL, and nighttime chromaticity (Figure 4.2, right). At the same time, a spectrophotometer Spectro2guide, 45/0 (BYK-Gardner) collected daytime chromaticity values. The measurements were made within seconds, but the devices needed to be placed on top of the stripe. Due to safety concerns, measurements were only taken during lane closures, which occurred at night. Both devices had their own light sources for nighttime measurements and high consistency. The measurements were made shortly after the installation of the work zone (0 months) and six months after the installations by Caltrans and AHMCT. Further measurements were performed roughly every two months by Caltrans personnel.

Based on ASTM standard D7585/D7585M,<sup>3</sup> retroreflectivity and colors were measured on two 400 ft segments for each striping pattern (Figure 4.1). For safety reasons, data points were collected at night on the stripes between lanes 1 and 2 during freeway lane closures (Figure 4.2, left). The measurement routine per stripe pattern is shown in Figure 4.3. There were three measurements per stripe and color.

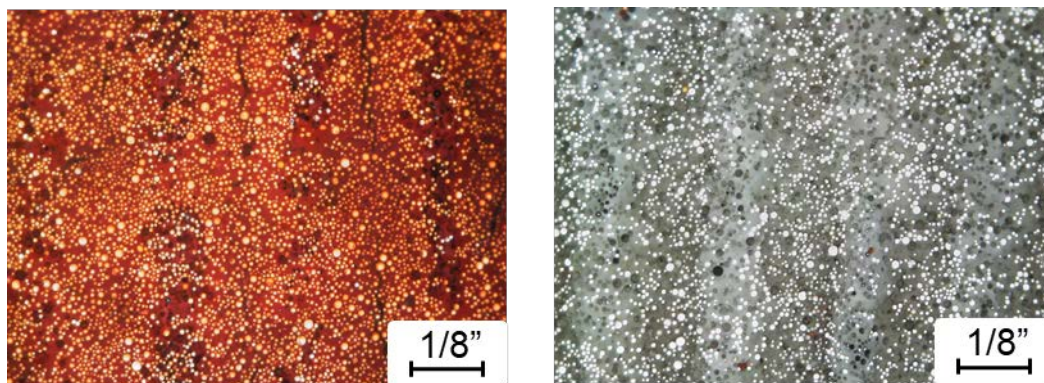
**Figure 4.6: Microscope pictures from orange (left) and white (right) temporary striping on Nov. 14, 2022**

A simple portable USB microscope was used to examine the glass bead embedding. Figure 4.6 shows orange and white temporary striping about 6.5 months after installation. The pavement grooves were visible. These microscope pictures were strongly influenced by lighting conditions so that a standardized and robust recording setup should be proposed for future measurements.

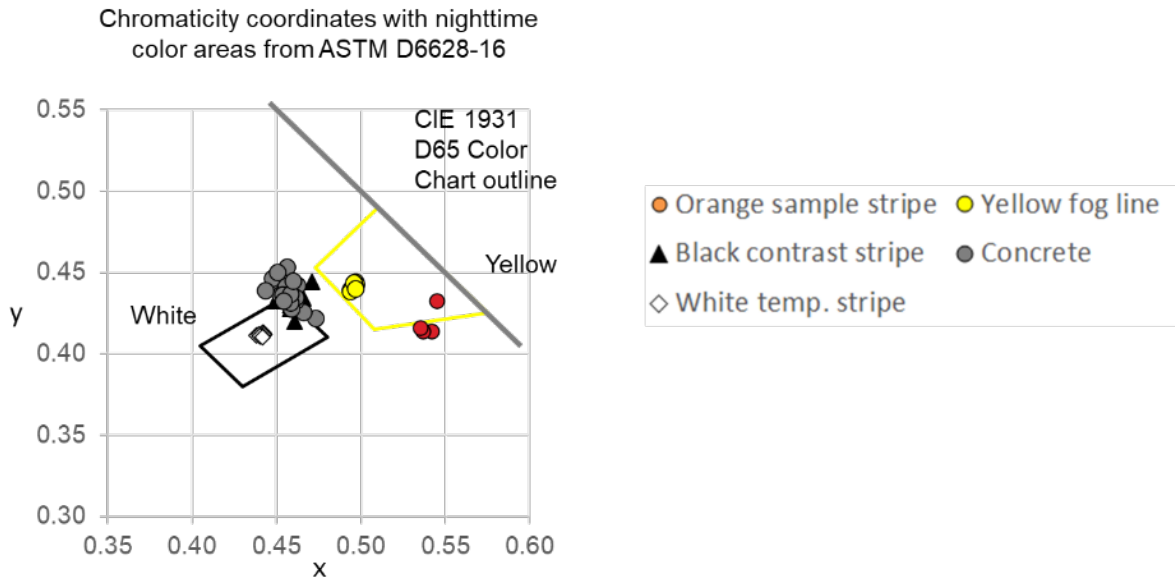
**Figure 4.9: Test nighttime color measurements, n= 6 to 20 measurements per sample type**

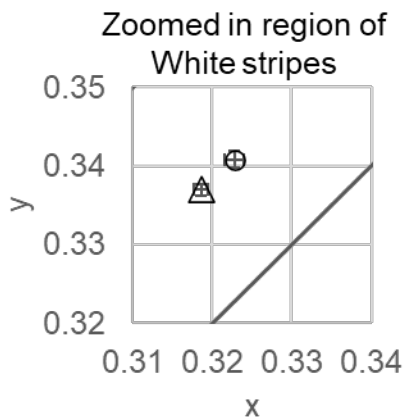
average x-coordinate	average y-coordinate	standard deviation of x-coordinate		standard deviation of y-coordinate	
<b>NB O-Left</b>	0.5318	0.3781	0.00135	0.25%	0.00102	0.27%
<b>NB O-Right</b>	0.5342	0.3754	0.00198	0.37%	0.00113	0.30%
<b>NB White</b>	0.3186	0.3370	0.00092	0.29%	0.00075	0.22%
<b>SB Orange</b>	0.5362	0.3715	0.00322	0.60%	0.00301	0.81%
<b>SB White</b>	0.3228	0.3408	0.00116	0.36%	0.00106	0.31%

**Figure 4.10: Daytime color measurements on measurements at 0 months after orange striping installation, compared with ASTM Standard D6628 (n =48 measurements per stripe type)**

In the following, daytime and nighttime chromaticity coordinates are displayed in relation to colors defined in standard ASTM Standard D6628<sup>8</sup>. At 0 months, the NB and SB white stripes were in the white color region for daytime chromaticity coordinates (Figure 4.10). The daytime colors for the NB and SB orange stripes had color coordinates outside of the red color region in close proximity to each other. The SB orange chromaticity values had the largest deviation from 0.6 – 0.81% in both coordinate values.

Table 4.1 specifies the color coordinate range by the manufacturer. The daytime orange striping color values were all close to the manufacturer's color line (Figure 4.10).

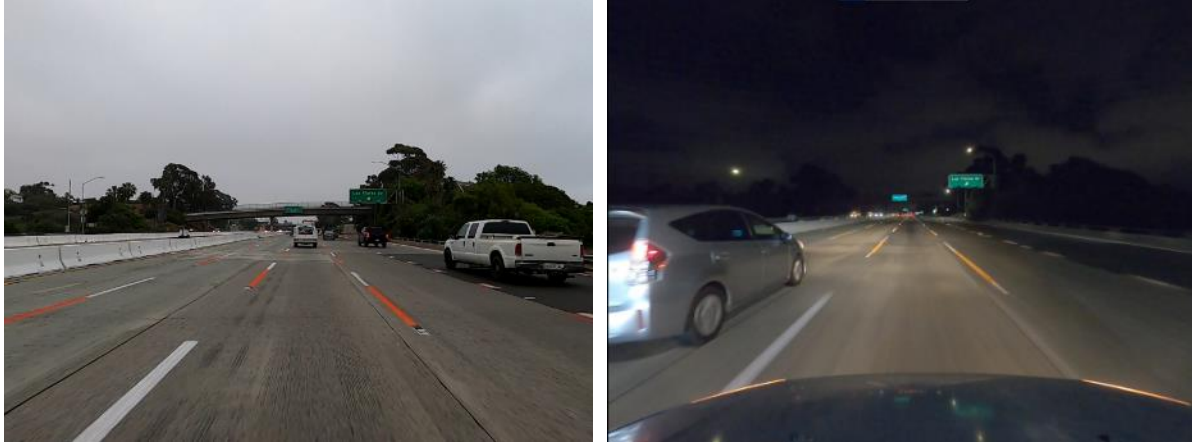
**Figure 4.15: Screenshots from dashboard camera videos in southbound direction, at Las Flores exit, daytime versus nighttime, lane 3, May 2022**

Figure 4.15 shows the same location on the I-5 in the SB direction at Las Flores exit at daytime versus nighttime. The orange appeared less intense at night and more yellow than orange. Figure 4.16 shows orange along both sides of white striping in northbound direction. The yellow appearance at night aligned with the quantitative measurements (Figure 4.14). However, the automatic camera white balancing and the car head lights contributed to the color appearance on the pictures. In addition, there was a difference in head light quality and color for different vehicles used to drive through the work zone.

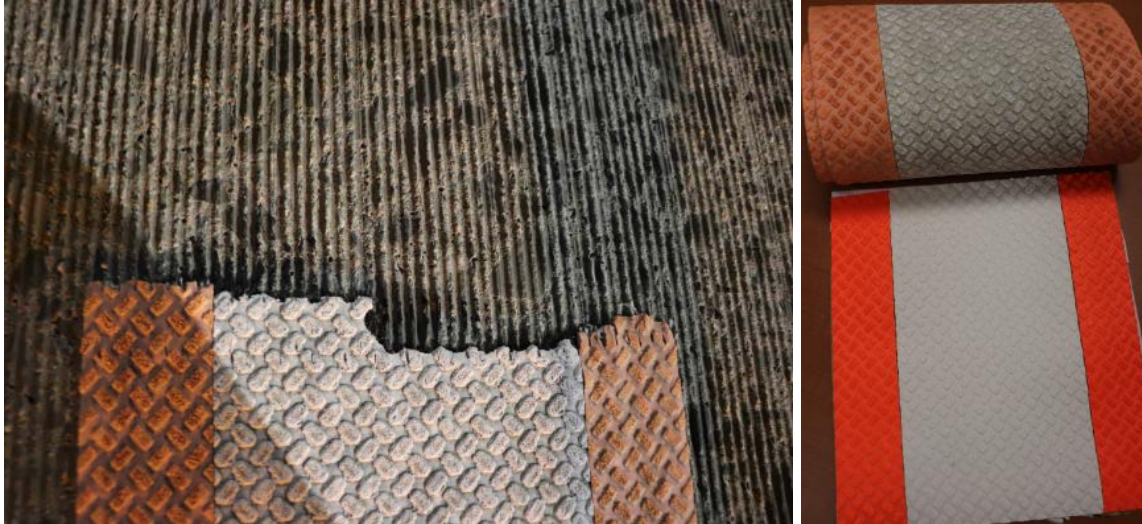
**Figure 4.17: Tape on freeway concrete surface with grinding grooves (left); Orange tape striping worn (at 5 months) and new**

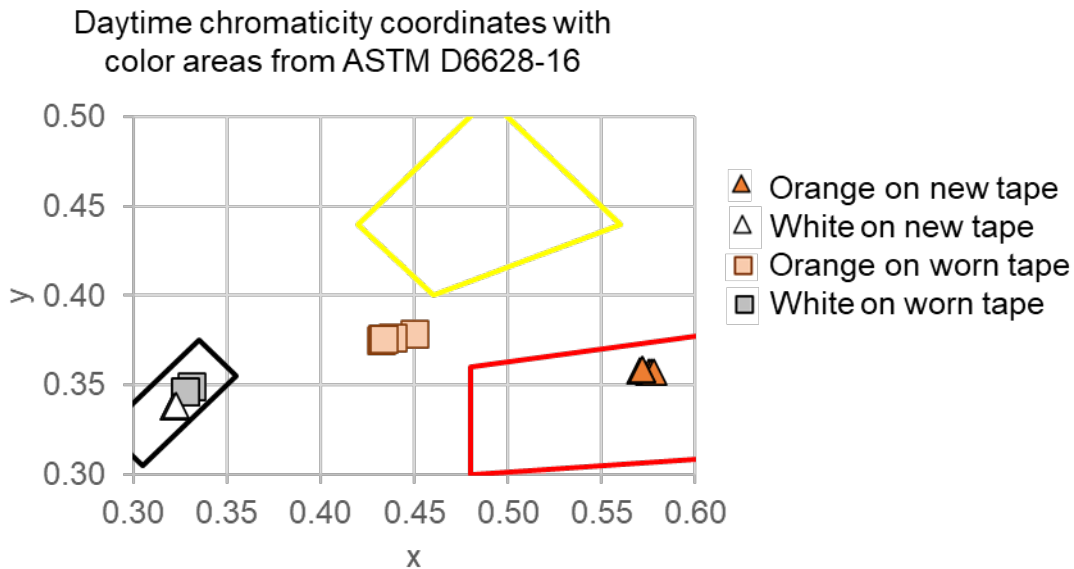
**Figure 4.18: Daytime color measurements on new and worn orange tape, 3 worn stripes after 5 months of installation, 1 new stripe**

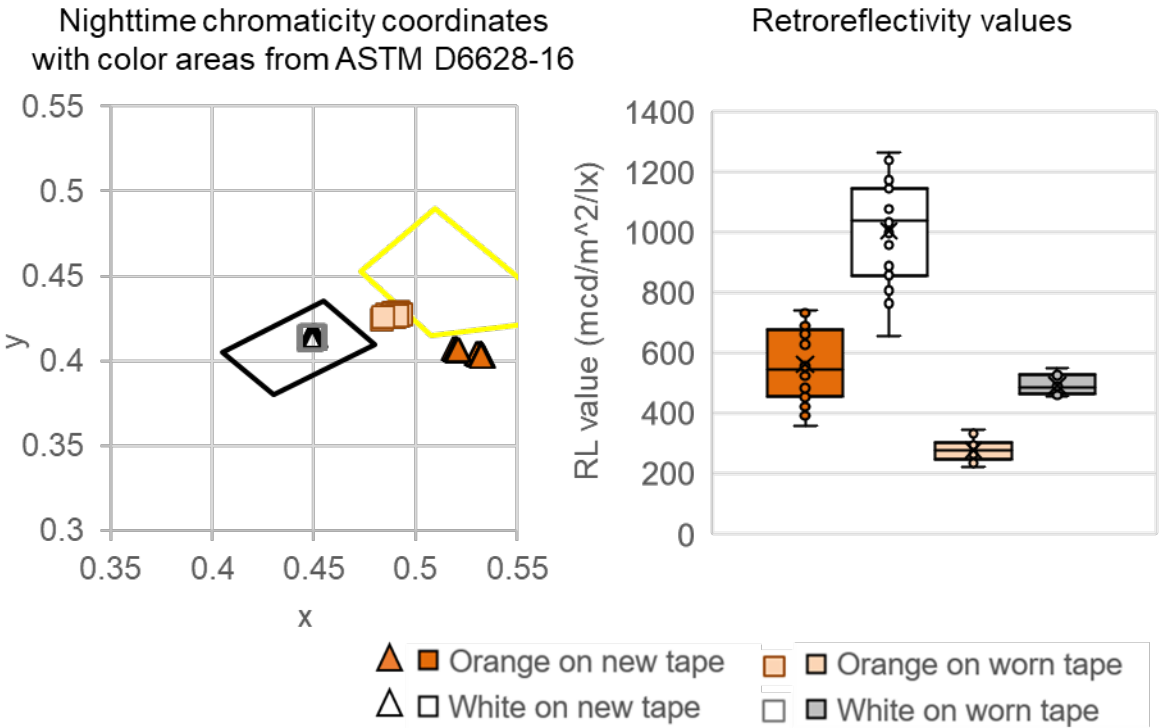
**Figure 4.19: Nighttime color and retroreflectivity measurements on new and worn orange tape, 3 worn stripes after 5 months of installation, 1 new stripe**

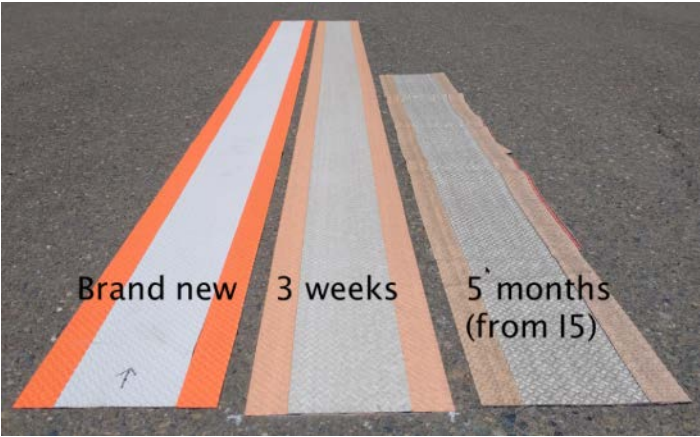
**Figure 4.20: Color degradation of orange along both sides of white tape after exposure to sunlight**

To study the color degradation in more detail, new orange tape stripes (Figure 4.20, left) were installed at AHMCT on asphalt in the sunshine on May 22, 2022. Measurements on May 25, June 3, and June 11, 2022 showed no significant changes in retroreflectivity (Figure 4.21). The orange stripes (left and right) have slightly lower retroreflectivity (average of 479 mcd/m<sup>2</sup>/lx for the left stripe and 496 mcd/m<sup>2</sup>/lx for the right stripe) than the white stripes (average of 599 mcd/m<sup>2</sup>/lx).

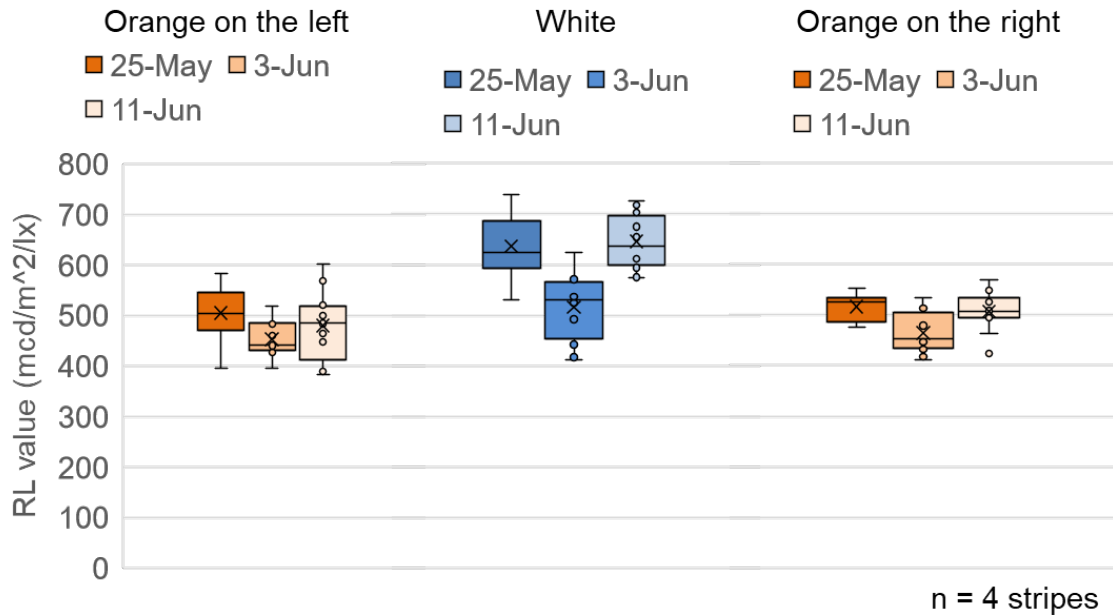
**Figure 4.21: Retroreflectivity measurements of orange tape, left in the sunshine after installation on May 22, 2022, 4 stripes, measured 3x each**

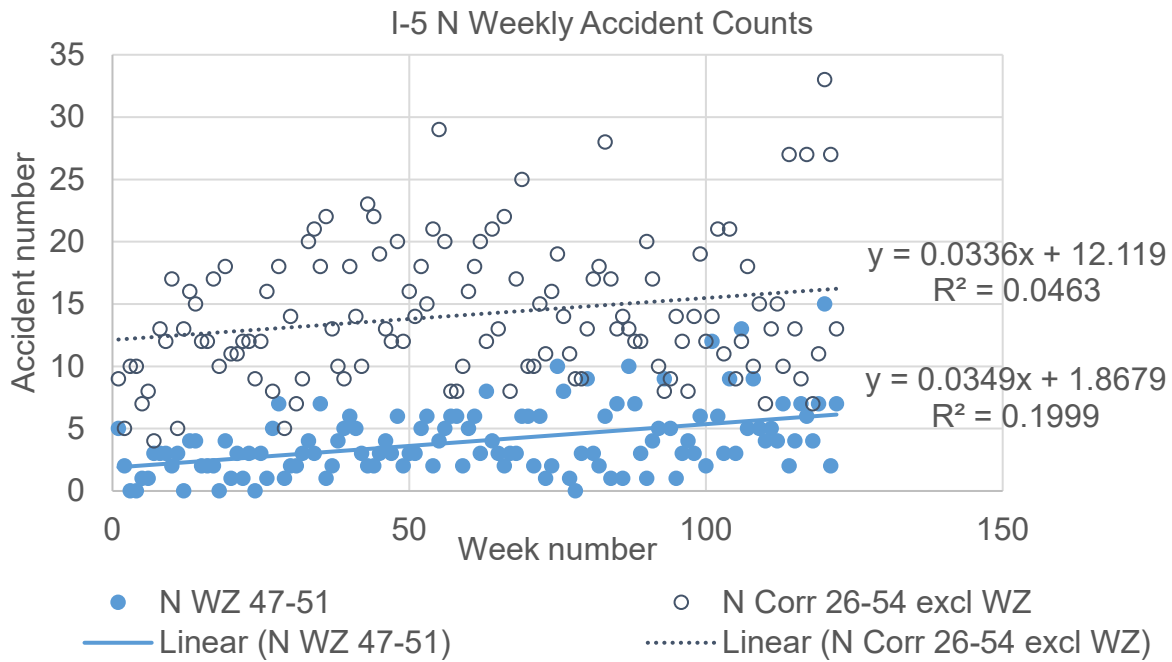
**Figure 5.5: Northbound accident counts with linear continuous trendlines in WZ and corridor excluding WZ, PeMS data**

Counts for the WZ area and for the corridor excluding the WZ were plotted with linear trendlines for absolute accident numbers in the NB direction in Figure 5.5 and in the SB direction in Figure 5.6. The trendlines show a generally slowly increasing trend for accidents over the whole 122 weeks observed, which can be explained by increasing traffic rates after the COVID-19 pandemic shutdowns. However, the data scatter was very large, and trendlines for the shorter time periods were not statistically significant. It does appear that there was generally an upward trend for all accidents which was expected as the traffic returned to normal after the reduction caused by the pandemic shutdowns. The SB WZ accident rate (Figure 5.6) does seem to be flat, whereas the NB WZ stretch tends to track the overall increase (Figure 5.5).

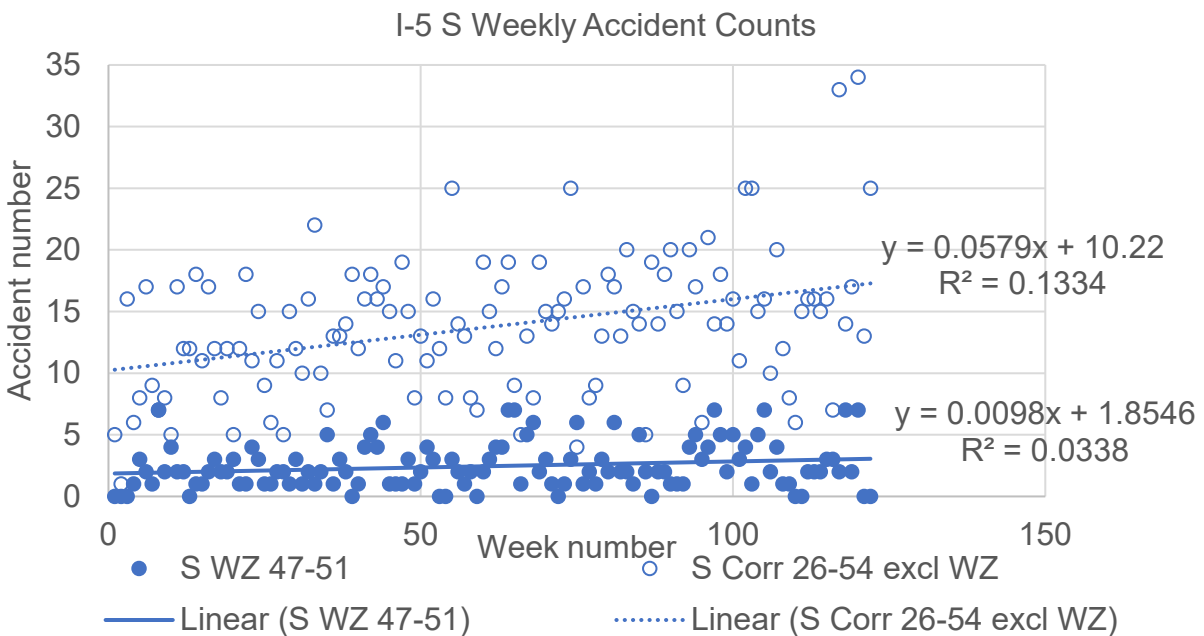
**Figure 5.6: Southbound accident counts with linear continuous trendlines in WZ and corridor excluding WZ, PeMS data**

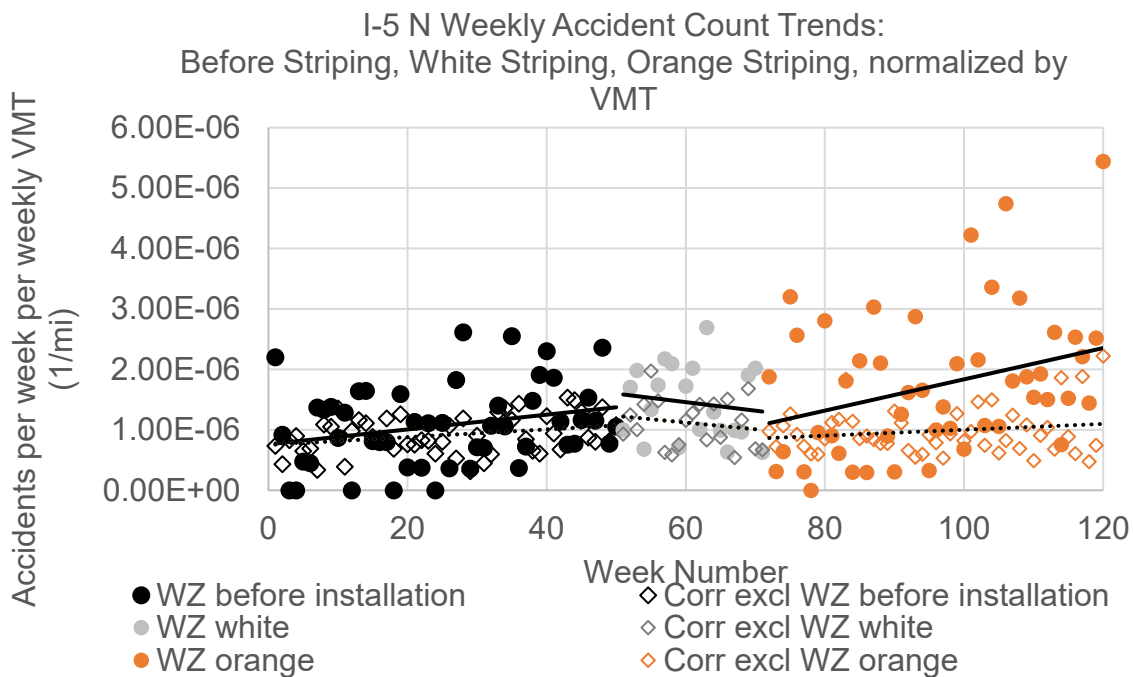
**Figure 5.7: Northbound weekly accidents normalized by the weekly VMT with linear trendlines (bold lines for WZ, dotted lines for corridor excluding WZ), divided into three time periods, PeMS data**
