**California Traffic Control Devices Committee (CTCDC)  
Agenda Item Report**

**Technical Report for Orange Contrast Temporary Pavement Delineation in Construction Zones**

1. REPORT NUMBER <b>CA23-3836</b>	2. GOVERNMENT ASSOCIATION NUMBER <b>N/A</b>	3. RECIPIENT'S CATALOG NUMBER <b>N/A</b>
4. TITLE AND SUBTITLE <b>Orange Contrasted Temporary Pavement Delineation in Construction Zones</b>		5. REPORT DATE <b>09/30/2023</b>

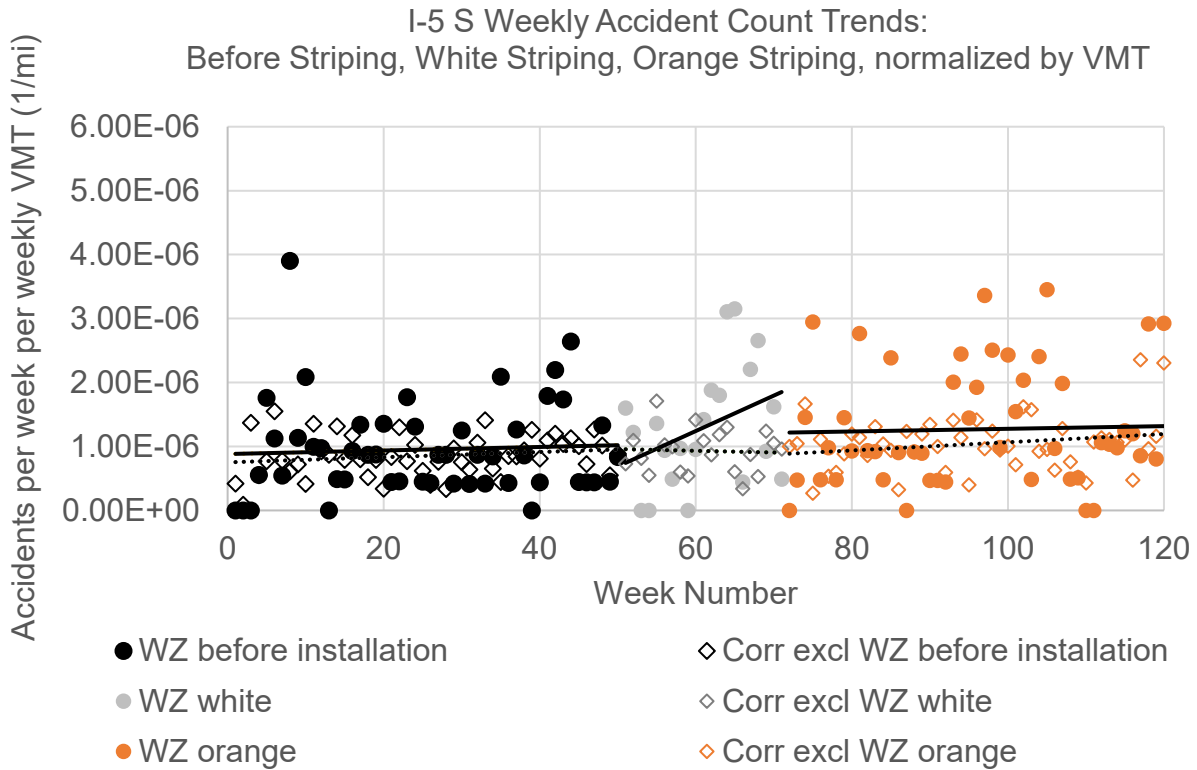
**Figure 5.8: Southbound weekly accidents normalized by the weekly VMT with linear trendlines (bold lines for WZ, dotted lines for corridor excluding WZ), divided into three time periods, PeMS data**

Southbound traffic also behaved similarly with a very slight increasing trend before WZ installation in both road stretches, in the WZ, and in the corridor excluding WZ (Figure 5.8 and Table 5.6). There were relatively few accidents per week over the observed corridor (1 to 41 accidents per week in SB direction), and large data scatter leading to low coefficients of determination  $R^2$  for the accident trend lines.

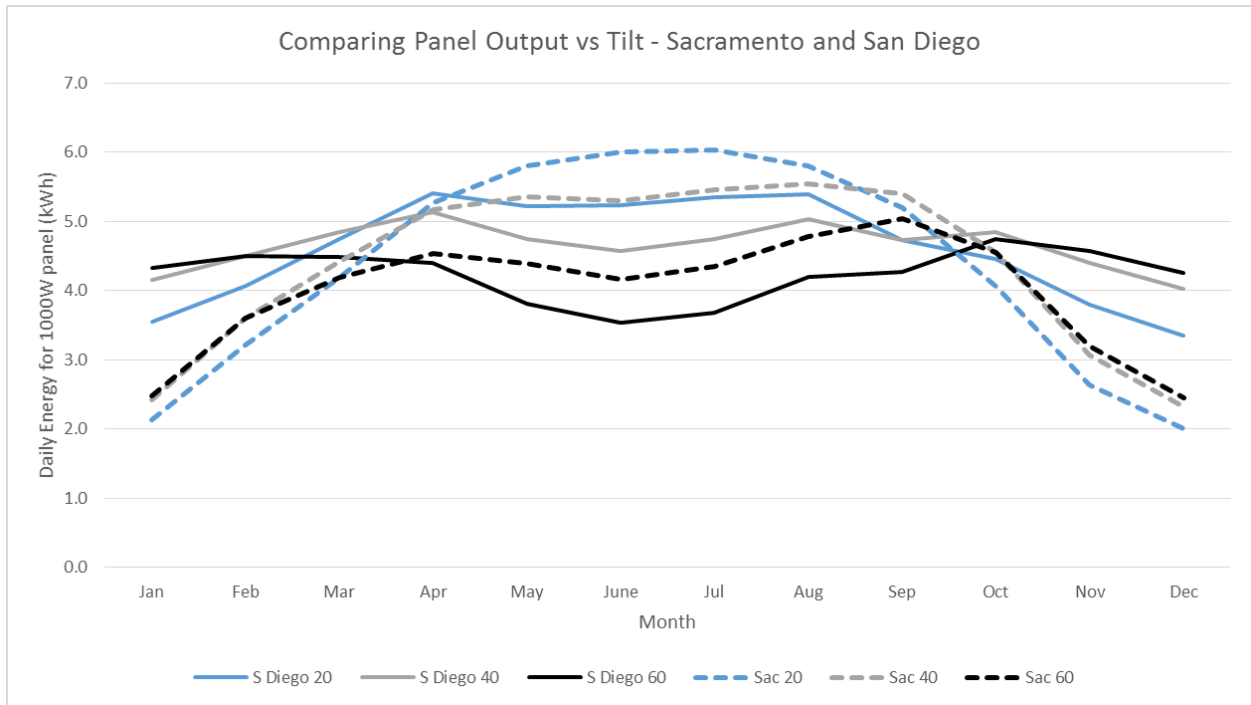
**Figure A1.1: Comparing the effect of panel tilt (20°, 40°, 60°) on energy output – San Diego and Sacramento**

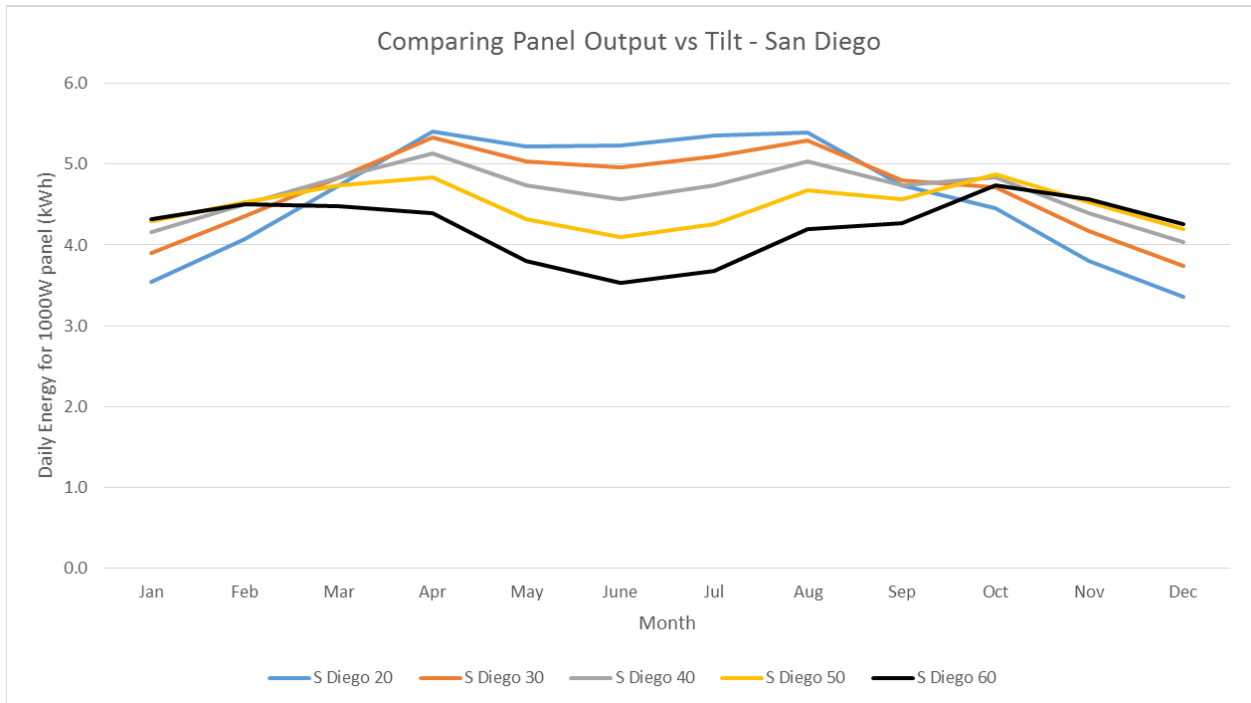
**Figure A1.2: Comparing the effect of panel tilt on energy output – San Diego**

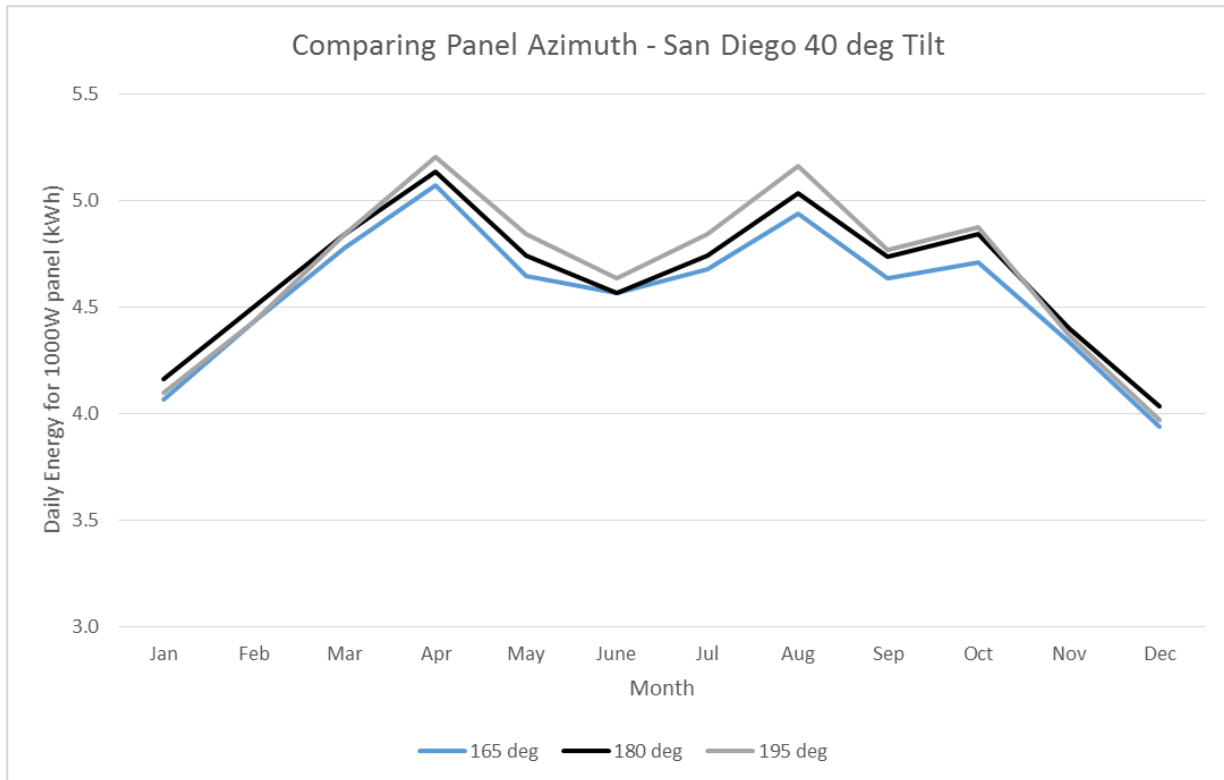
**Figure A1.3: Comparing the effect of azimuth angle (Vertical scale different than prior figures)**

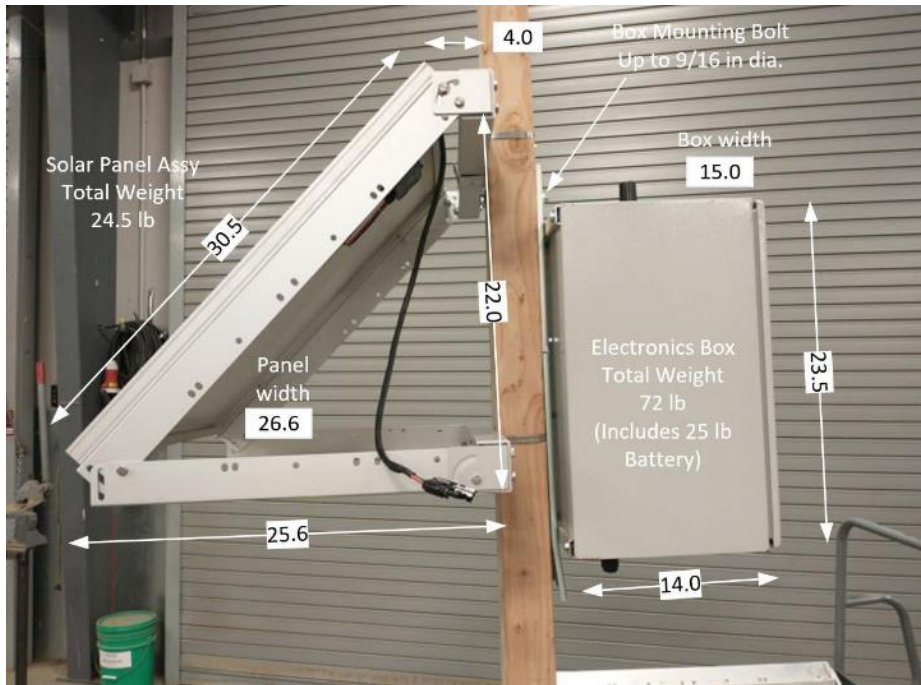
**Figure A1.4: Solar panel and electronics box installation**

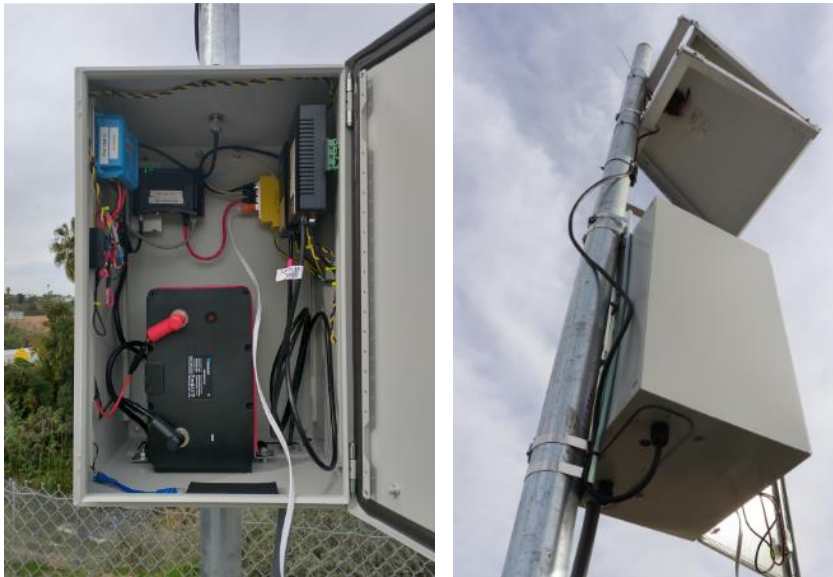
**Figure A1.5: Pictures of electronics box and solar panel**

The cell phone modem allowed for remote camera access and data download. Initial calculations determined about 3.5 GB per hour of video. Therefore, a local storage of 256GB would hold more than 70 hours of video. A direct download of data from the electronics box in certain intervals was preferred because the transmission by modem incurs high costs for cell phone plans. Reasonable data plans range between 5 GB to 35 GB download data

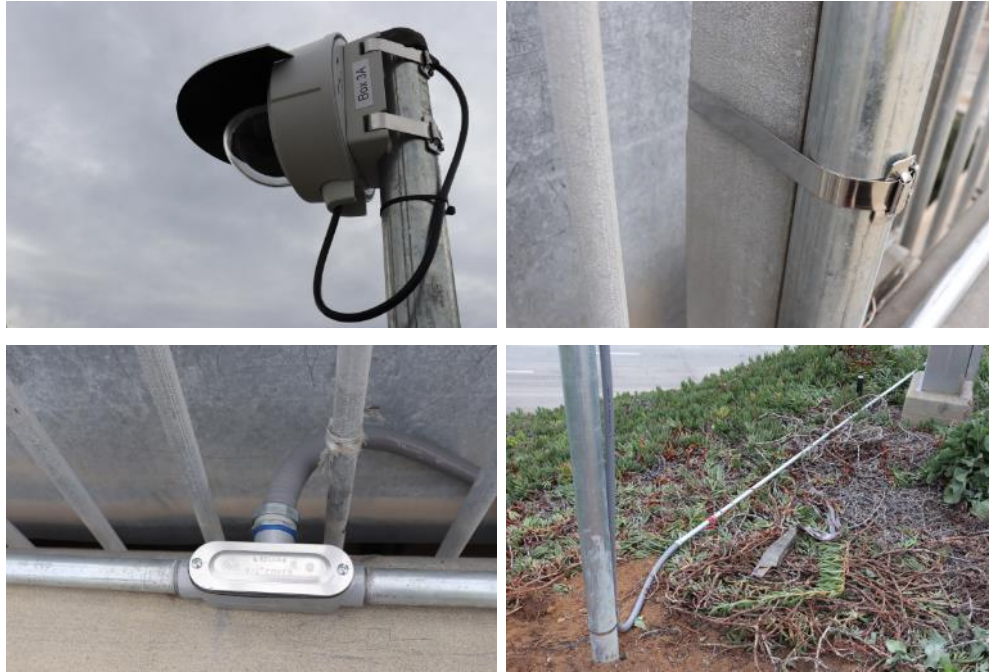
**Figure A1.7: Details of camera mounting and cabling at Las Flores Overcrossing**

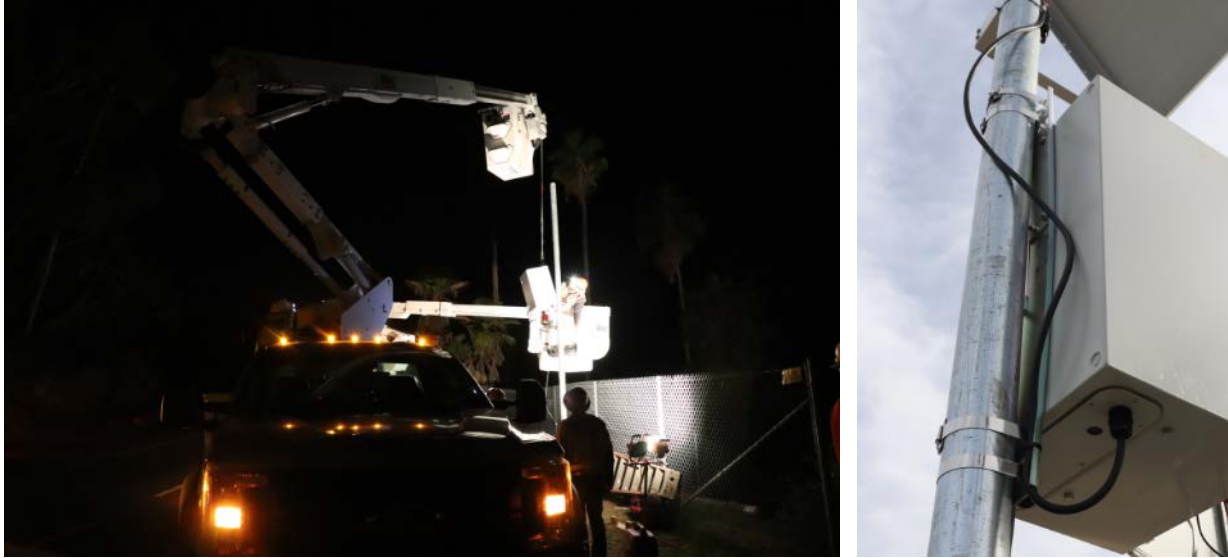
**Figure A1.8: Left: Installation of electronics box at Jefferson Overcrossing with a bucket truck; right: straps around the steel pole.**

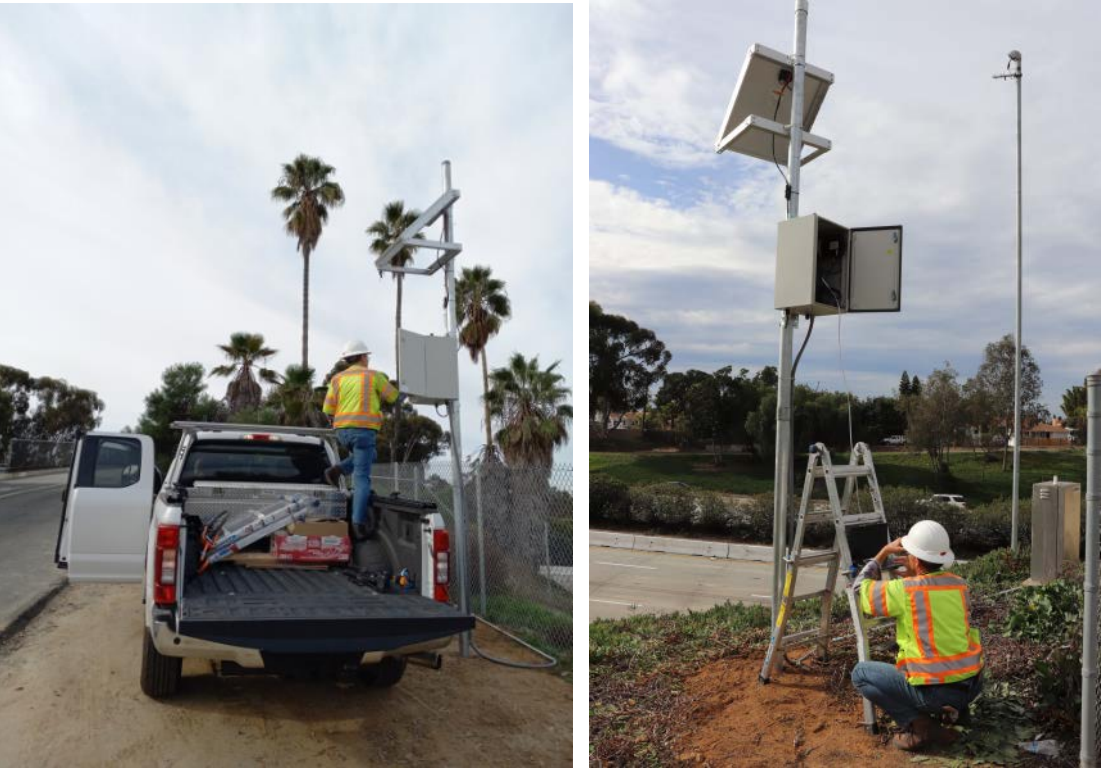
**Figure A1.9: Access to electronics box: Left: at Jefferson Overcrossing, Right: at Las Flores Overcrossing.**

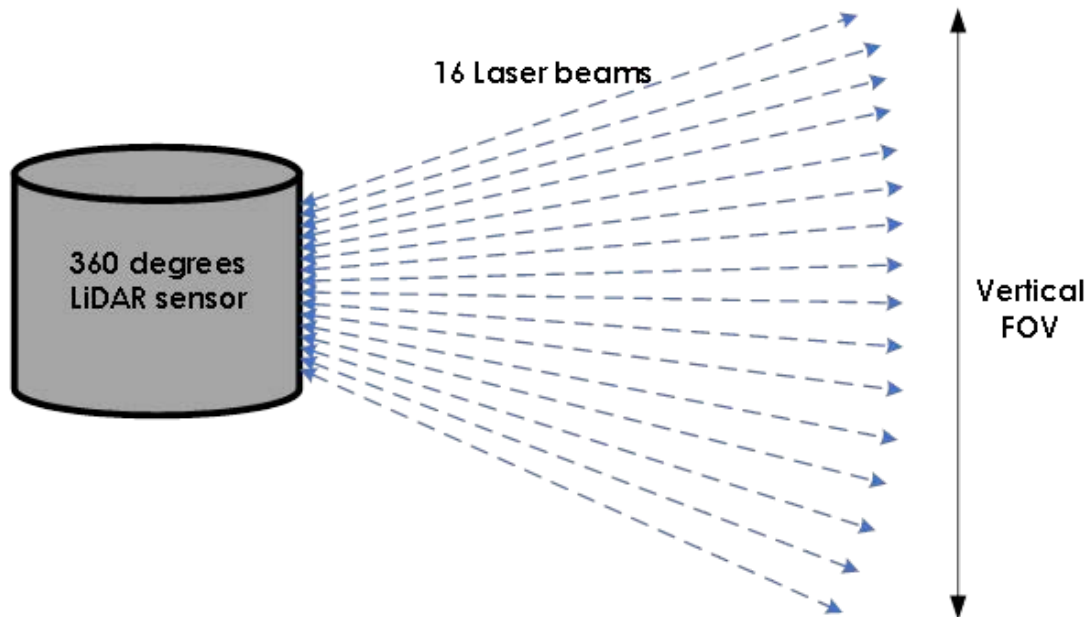
**Figure A2.1: Multi-beams 360 degree LiDAR sensor**

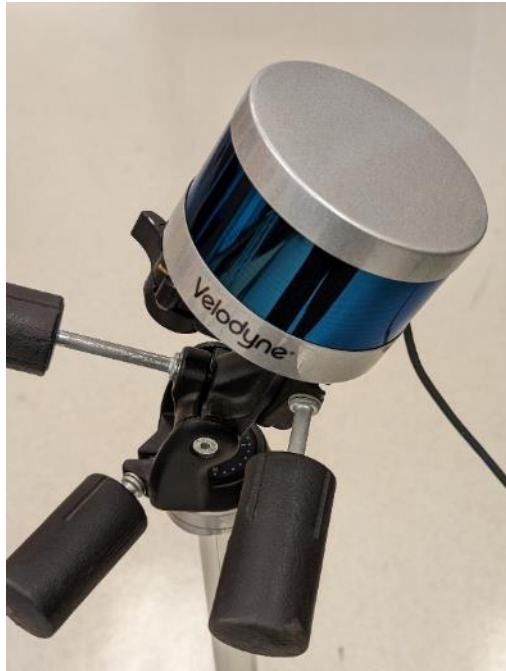
**Figure A2.1: Velodyne VLP16 LiDAR sensor with a 30 degree tilt from horizontal**

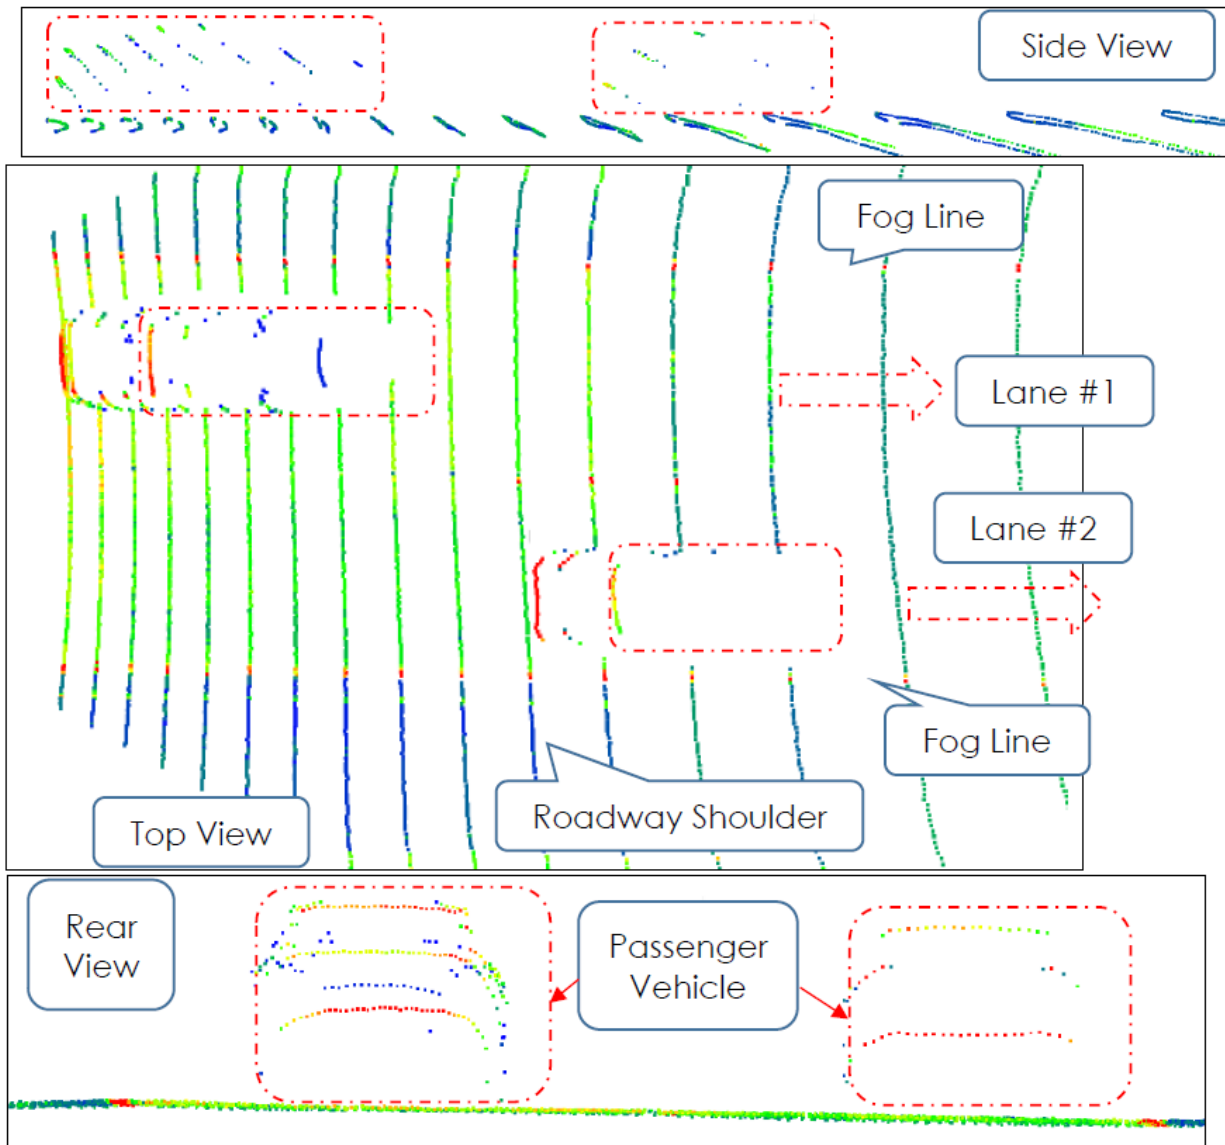
**Figure A2.5: Example of a single frame point cloud from C4 (Top image shows roadside view; middle image shows top view; bottom image shows roadway view along the direction of vehicle travel)**

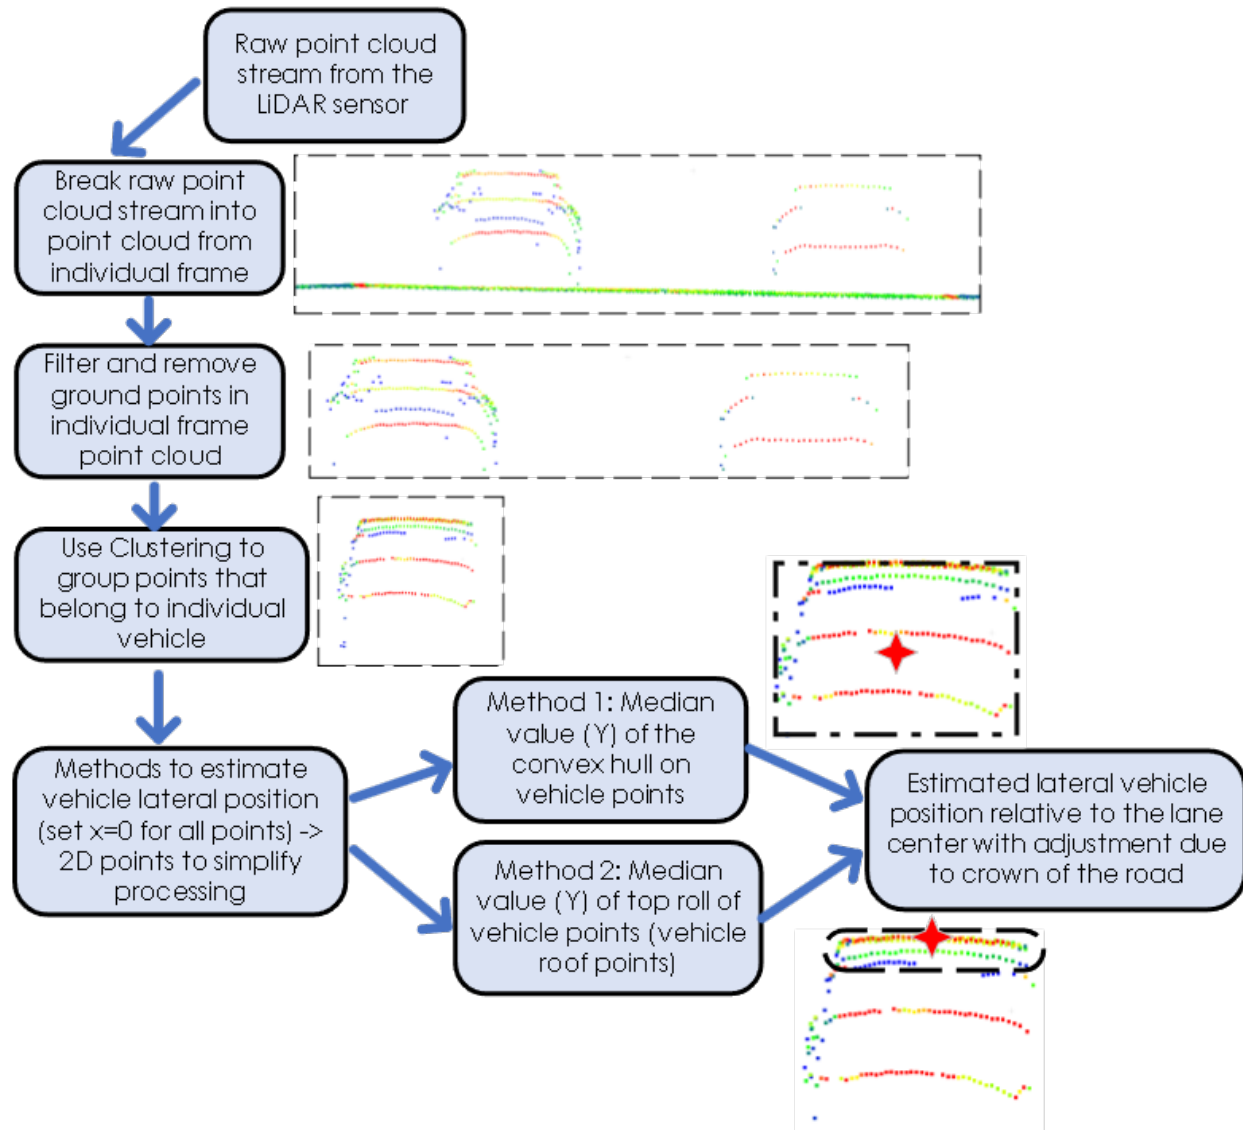
**Figure A2.6: High level conceptual point cloud post-processing steps**
