Yellow LED Border on Pedestrian Signal

An Evaluation to Determine the Effectiveness of Adding an Actuated Yellow LED Border to Standard Pedestrian Signals in the City of Redding, CA.

FHWA Experiment: 4(09)-13 (E) Yellow LED Border on Ped Signal – Caltrans

Prepared by:
Robert Stinger, P.E.
California Department of Transportation
District 2 – Traffic Engineering & Operations

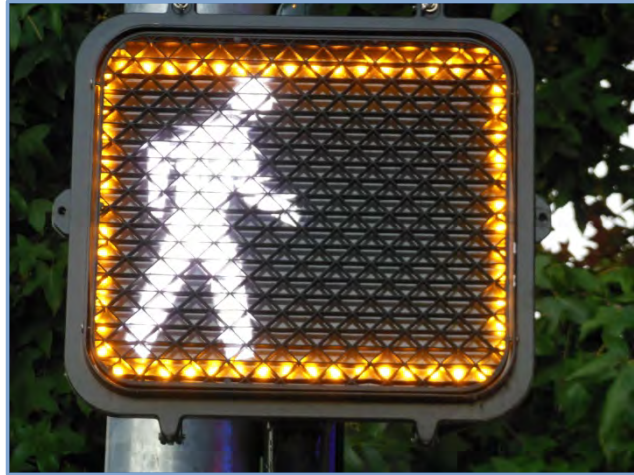
Figure 2 – Final prototype module with 1-inch LED spacing.

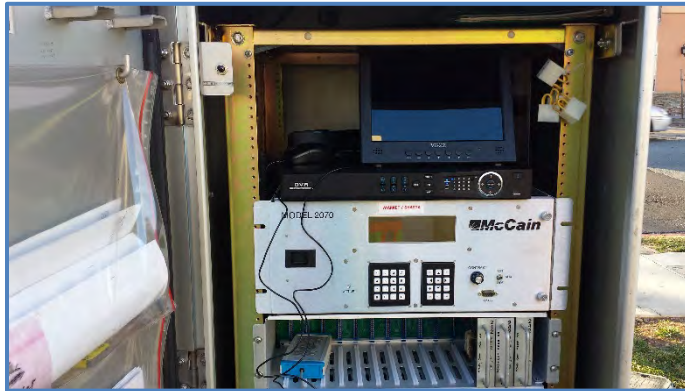
Figure 3 – DVR and monitor placed in signal controller cabinet at Location 4.

During data collection, each location was observed in the before and after condition using digital video recording equipment. Video data was recorded for seven consecutive days, 24-hours per day. As much as possible, each recording period was completed during fair weather conditions to capture the greatest amount of pedestrian activity. Also, because Location 1 is near two schools, the before/after data was collected while the schools were in session.

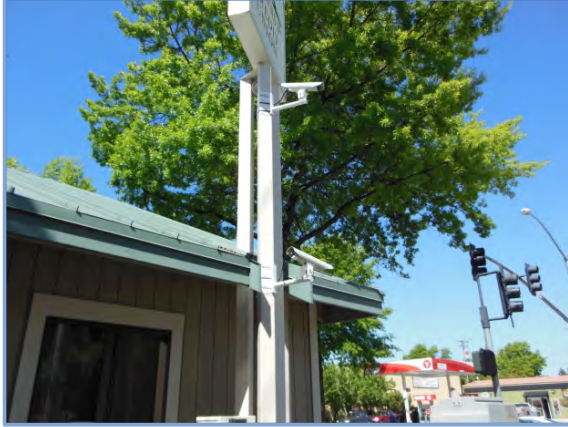
Figure 6 – Cameras placed on business sign post.

Two cameras were placed at the northwest corner of the intersection to collect video data for the two crosswalks. The cameras were mounted on a sign post for the credit union building located at the corner of the intersection. The power source and storage for the DVR was provided by the

signal controller cabinet located in the same corner of the intersection. The cameras provided excellent visibility of the two crosswalks and most of the pushbuttons. The only exception was the view of the pushbutton in the northwest corner of the intersection that is used by pedestrians heading south across Shasta Street. This part of the intersection was too close to the camera facing to the south to be included in the view.

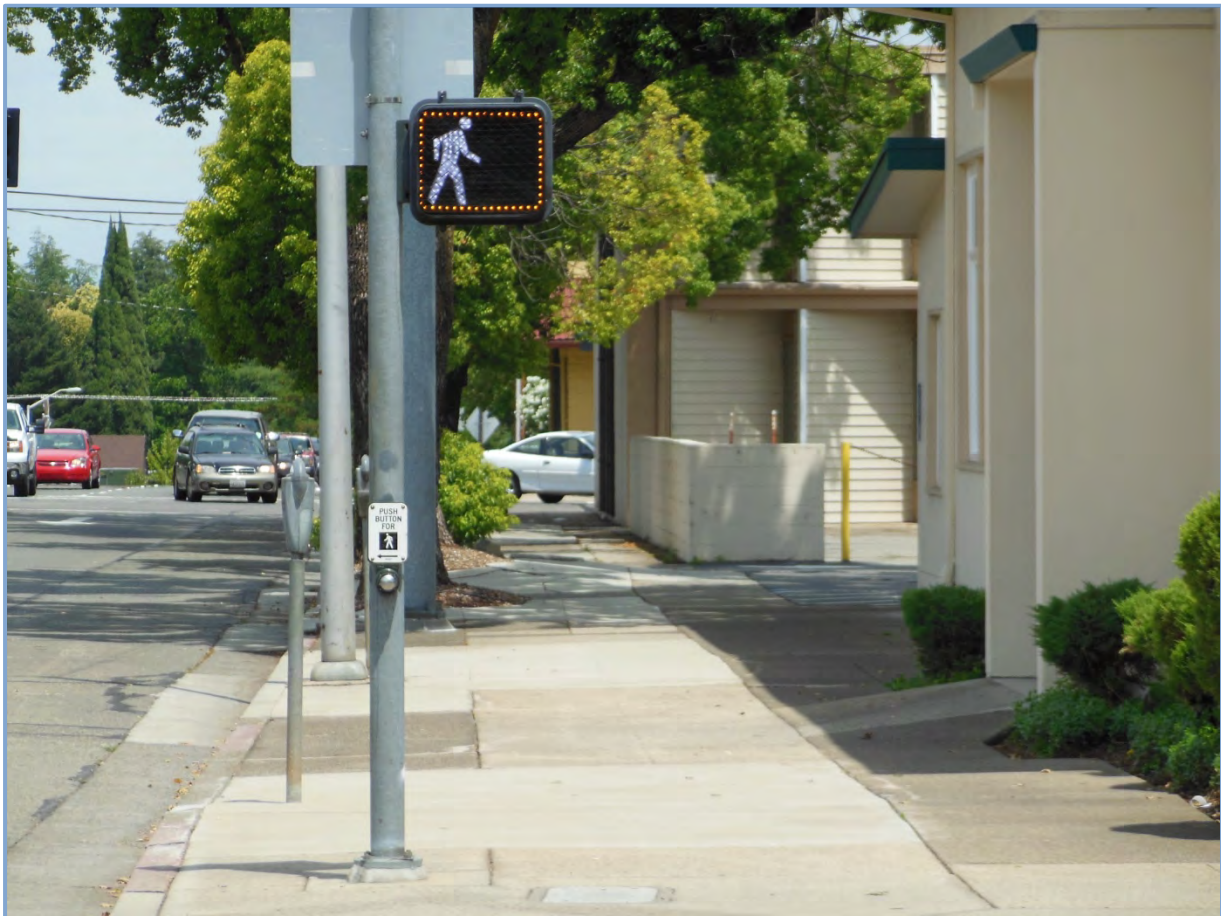
Figure 7 – YPB signal in the southeast corner of Location 2, looking east.

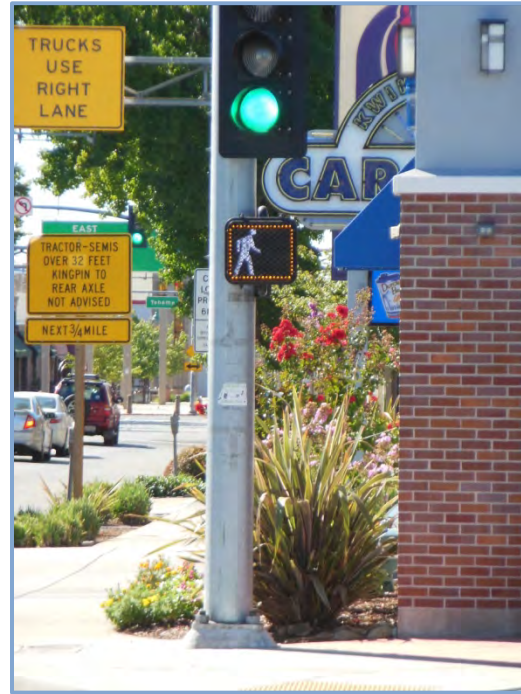
Figure 8 – YPB signal in the southwest corner of Location 3, facing south.

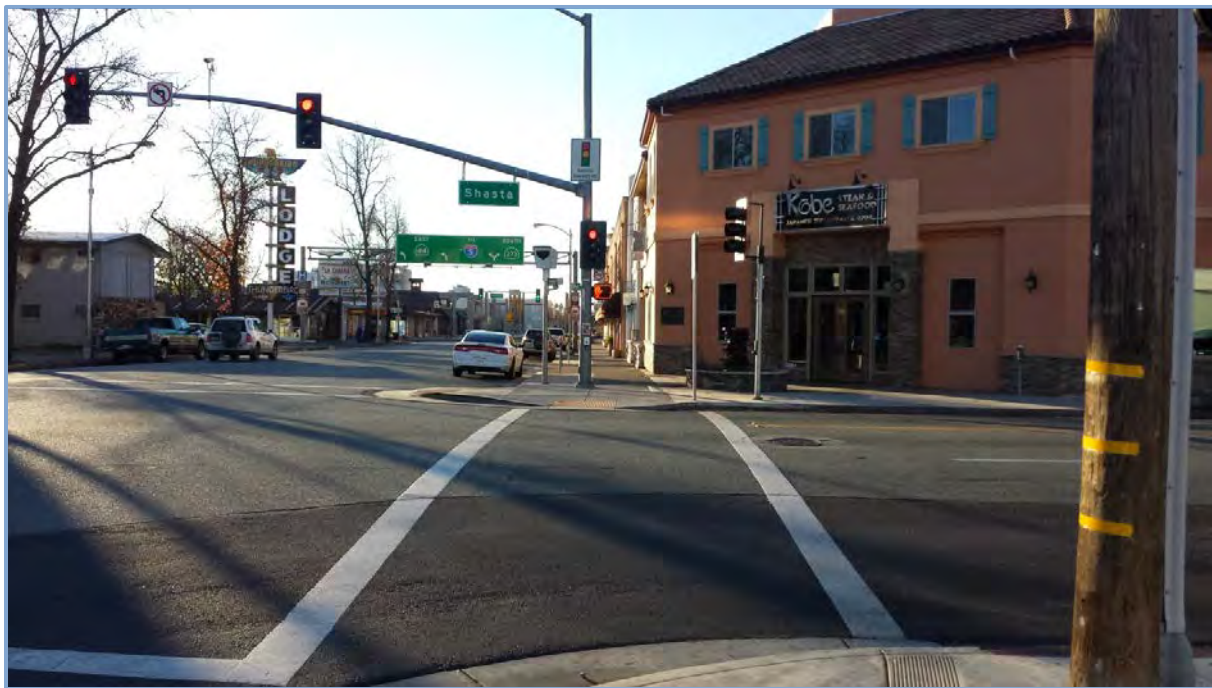
Figure 9 – Looking at the southwest corner of Location 4.

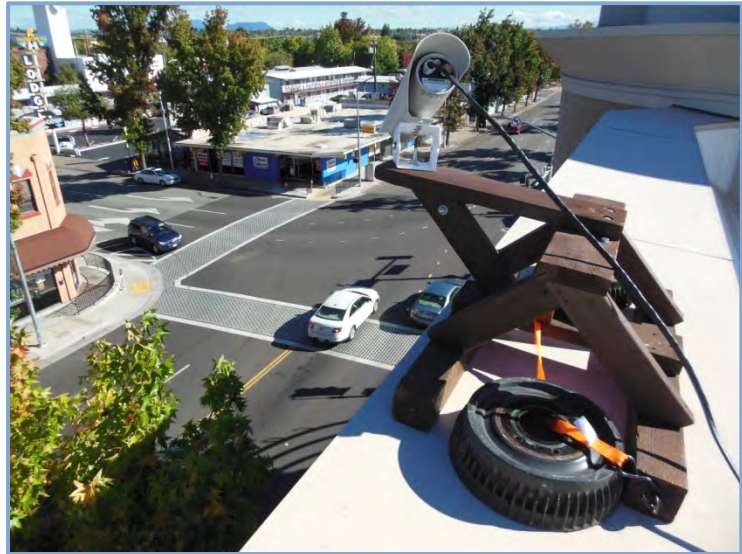
Figure 10 – Camera placement on the 2-story Downtown Health Sciences Building for Shasta College.
