CALIFORNIA  
**NATIONAL CITY**  
1887  
INCORPORATED

# Bike Box

## Post-Implementation Report

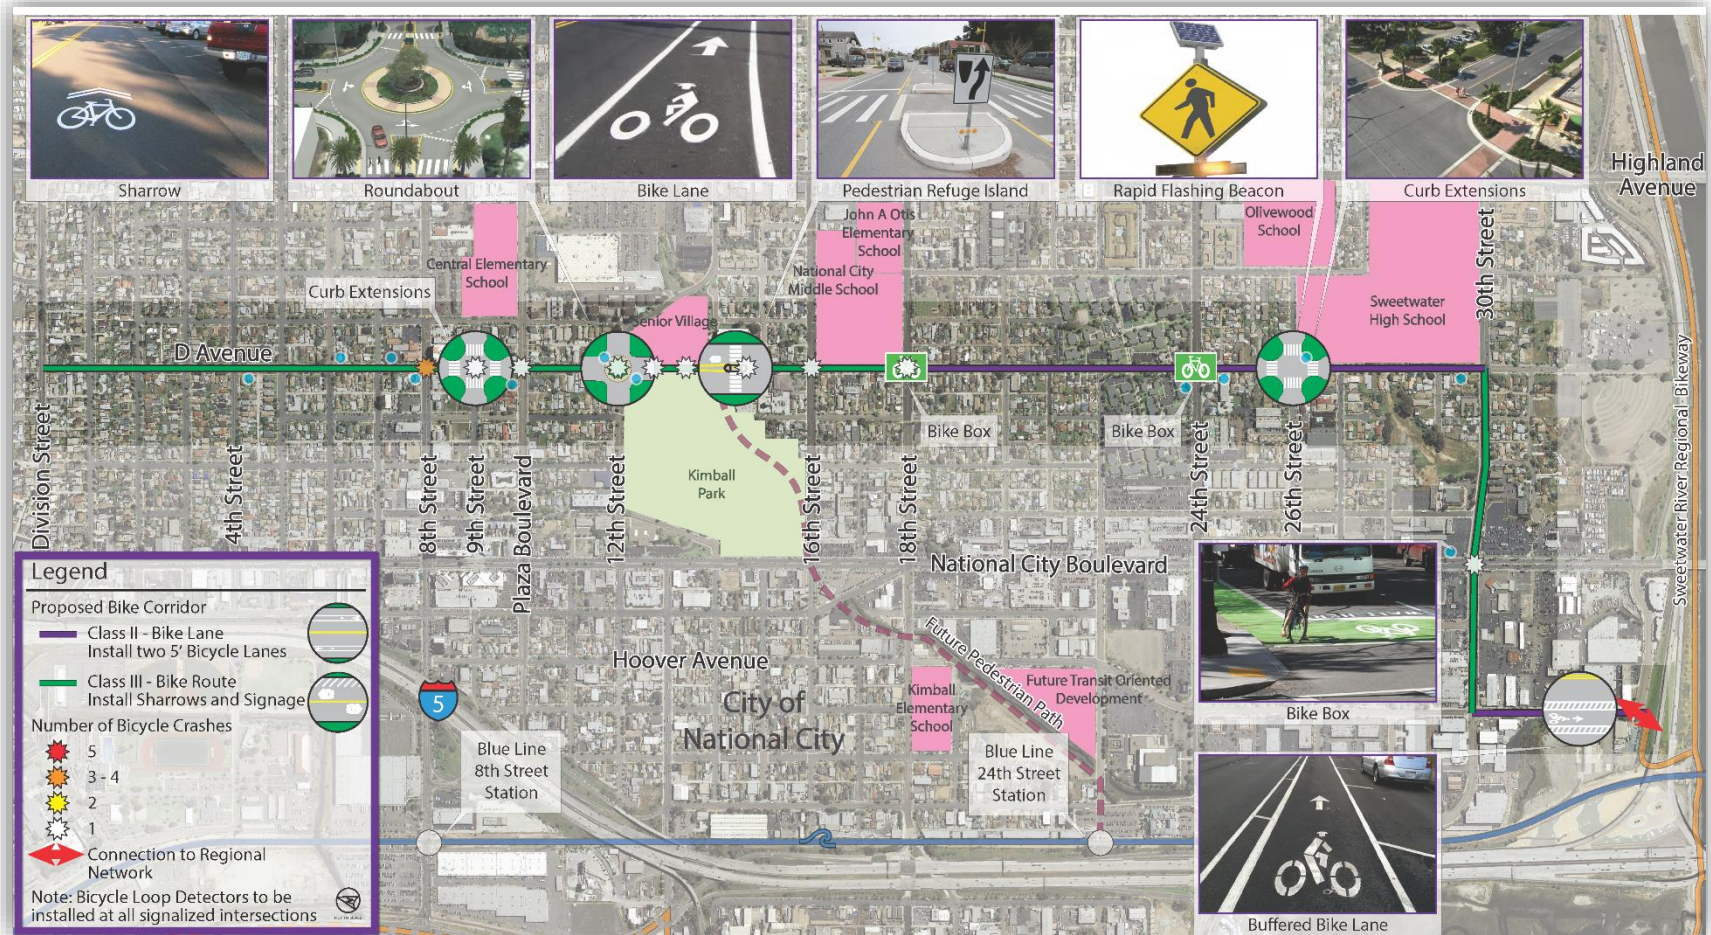
Figure 6 – D Avenue Community Corridor

**Figure 6** shows the D Avenue Community Corridor improvement plan including the location of improvements along with schools, parks and transit lines.

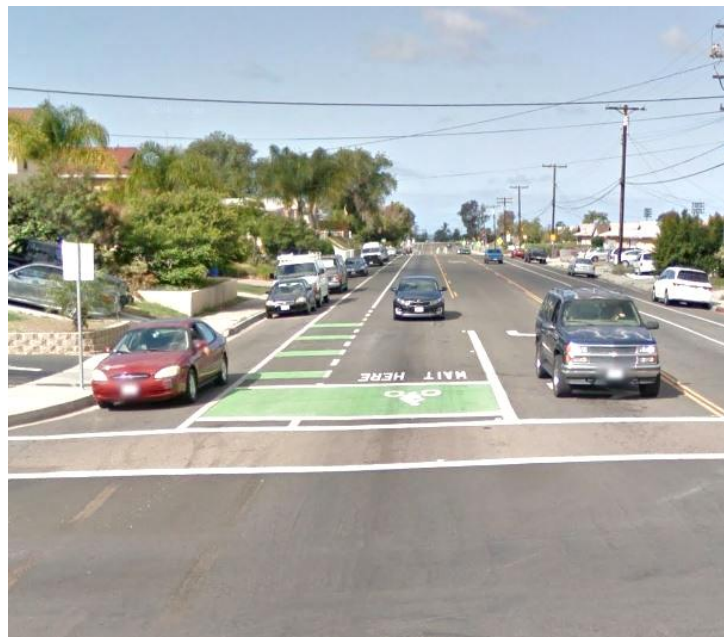
**Figure 7 - 4th Street Bike Box**

**Figure 7** displays the implemented Bike Boxes. **Figure 8** shows the 4<sup>th</sup> Street Community Corridor improvement plan including the location of improvements along with schools, parks and transit lines.
