**Subject:** REQUEST TO EXPERIMENT:

- (1) NON-STANDARD STRIPING DETAIL - 6" WHITE SKIP STRIPE NEXT TO 6" WHITE SOLID STRIPE
- (2) NEW STRIPING DETAIL – 6" DOUBLE WHITE SOLID STRIPE

SR-91 CORRIDOR IMPROVEMENT PROJECT  
TYPICAL INTERMEDIATE WEAVE  
SIGNING & STRIPING EXHIBIT

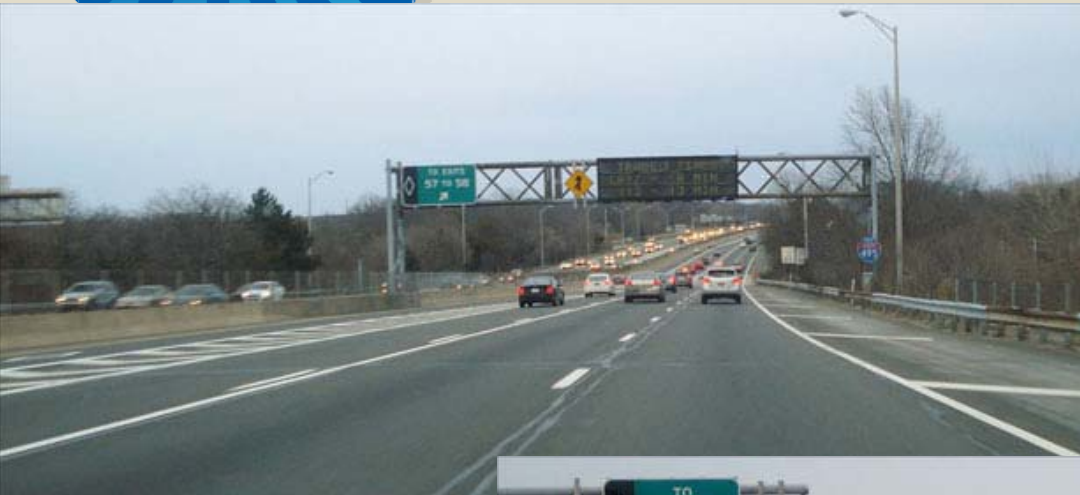
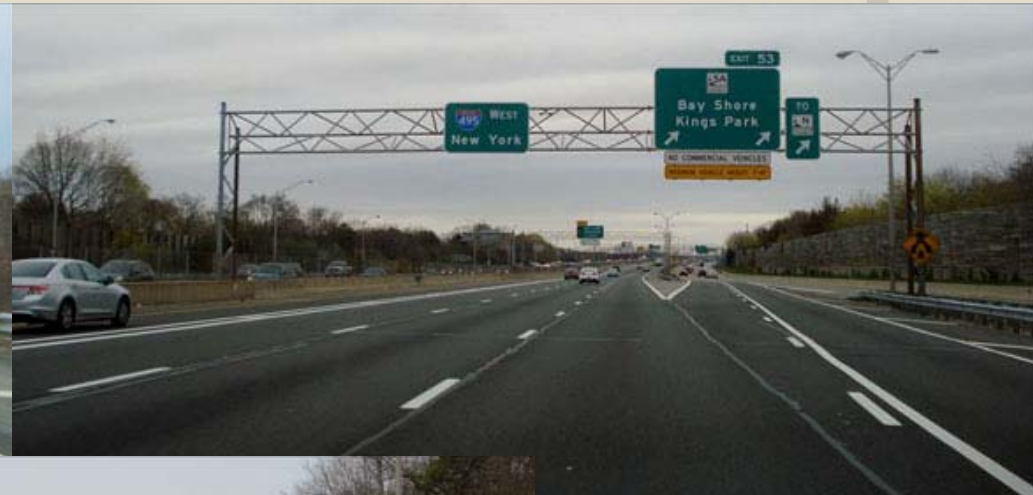
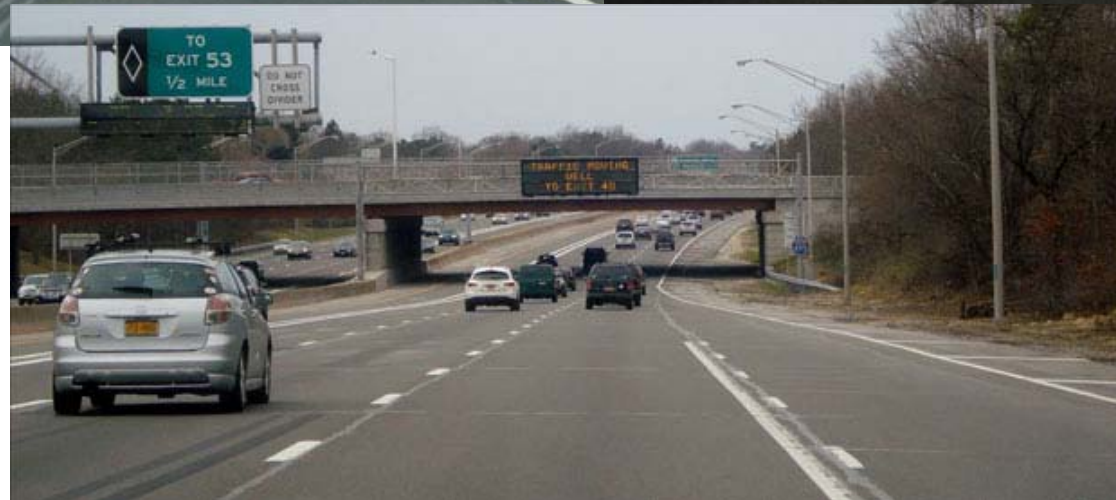
# I-495 Long Island Expressway, NY

The non-standard striping detail, 6-inch white skip stripe next to 6-inch white solid stripe, further enhances the egress only condition by signifying that an allowable movement across this stripe can only be in the egress direction. A similar striping detail exists in a few limited locations identified in the United States and one instance overseas as follows (see attached photos):

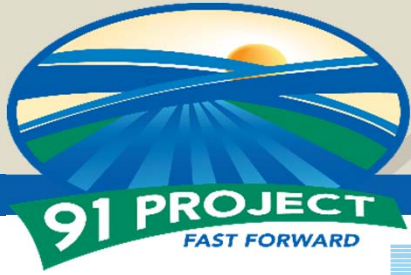
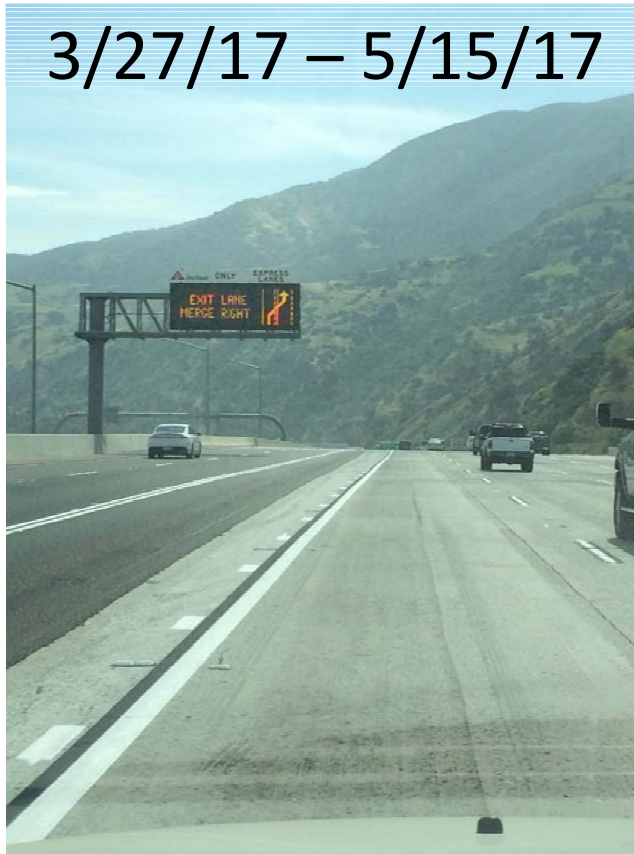
3/27/17 – 5/15/17

An additional feature was implemented one week after opening day. On March 27, 2017, toll information changeable message sign (CMS) located approximately 1300 feet downstream from the beginning of the eastbound egress lane displayed a message to help inform motorists when exiting the Express Lanes. The message displayed “EXIT LANE MERGE RIGHT”. The CMS sign also included an image of an arrow crossing over the experimental skip/stripping line merging into the general purpose lane. This image of the arrow crossing over indicated the preferred egress movement to the motorist. A photo of the CMS special sign is shown in Photo 5. The message and arrow image were displayed until May 15, 2017.

In order to determine the effect of the CMS special sign and the experimental skip/solid stripe, Express Lanes customer actions were observed. Evaluation of Express Lanes customer actions for eastbound SR-91 were monitored periodically in 2017 and 2018 and are shown in tables 3a and 3b. As shown in Table 3a, a vast majority of vehicles exiting the eastbound Express Lanes waited until the end of the exit zone before merging into the general purpose lanes. A very small portion of the vehicles crossed over the experimental skip/solid stripe. The two time periods, 4/20/2017 and 4/22/2017 (CMS special sign was displayed) provide almost identical percentages as the various other time periods shown in Tables 3a and 3b. It appears the CMS special sign message did not alter driver behavior. Drivers continued to the end of the exit zone and did not cross over into the general purpose lanes as displayed on the CMS special sign. Therefore, providing a special sign for exiting Express Lanes does not appear beneficial.
