## Transit Mall Survey Analysis 2018-2021

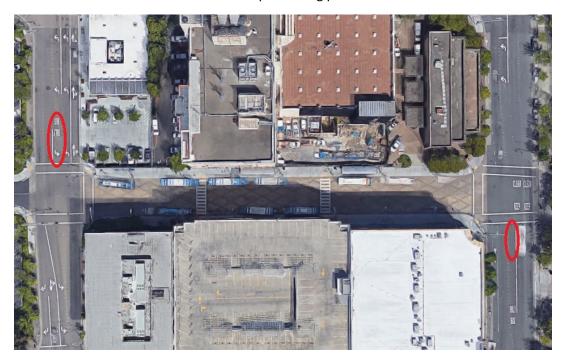
Above is an aerial view of the Transit Mall. The lanes circled in red indicate "no turn" lanes or "transit only" lanes installed to deter private vehicles from entering the Transit Mall. Prior to the 2018 surveys, BUS ONLY legends on the roadway had be installed and had little effect on driver behavior and private vehicles entered the Transit Mall throughout the day. The data collected in 2017 reflects this condition. In 2018, prior to the 2018 surveys red lanes were installed into the left turn pocket to enhance the visibility and prohibition of the turning movement for private vehicles. The right turns into the Transit Mall from at both intersections lack the equivalent markings to prevent unauthorized entry due to the current roadway lane assignments.
