SPOT INSPECTION REPORT

Building Name: Oaktown Parking

Street Address: 5th Street and Castro Street

Lot Number: ALA880-0035

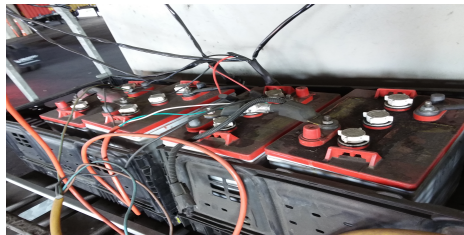
Violation # 697509

Comments: In close proximity to the center column of the lot, there is waste motor oil and hydraulic fluid accumulating in five-gallon containers and large volume steel caged polyethylene mobile totes. In addition, there is no secondary spill containment under any of the containers. The waste material shall be immediately removed from the premises.

Comments: Battery wires

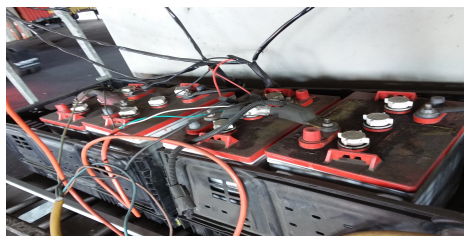
Violation # 697509

Comments: In close proximity to the center column of the lot, there is waste motor oil and hydraulic fluid accumulating in five-gallon containers and large volume steel caged polyethylene mobile totes. In addition, there is no secondary spill containment under any of the containers. The waste material shall be immediately removed from the premises.

Comments: Battery wires
