4. TITLE AND SUBTITLE	5. REPORT DATE
COMPLIANCE CRASH TESTING OF THE TYPE 60 MEDIAN BARRIER, Test 140MASH3C16-04 TYPE 60 MEDIAN BARRIER	May 2018 6. PERFORMING ORGANIZATION CODE

COMPLIANCE CRASH TESTING OF THE TYPE 60 MEDIAN BARRIER

(TEST 140MASH3C16-04)

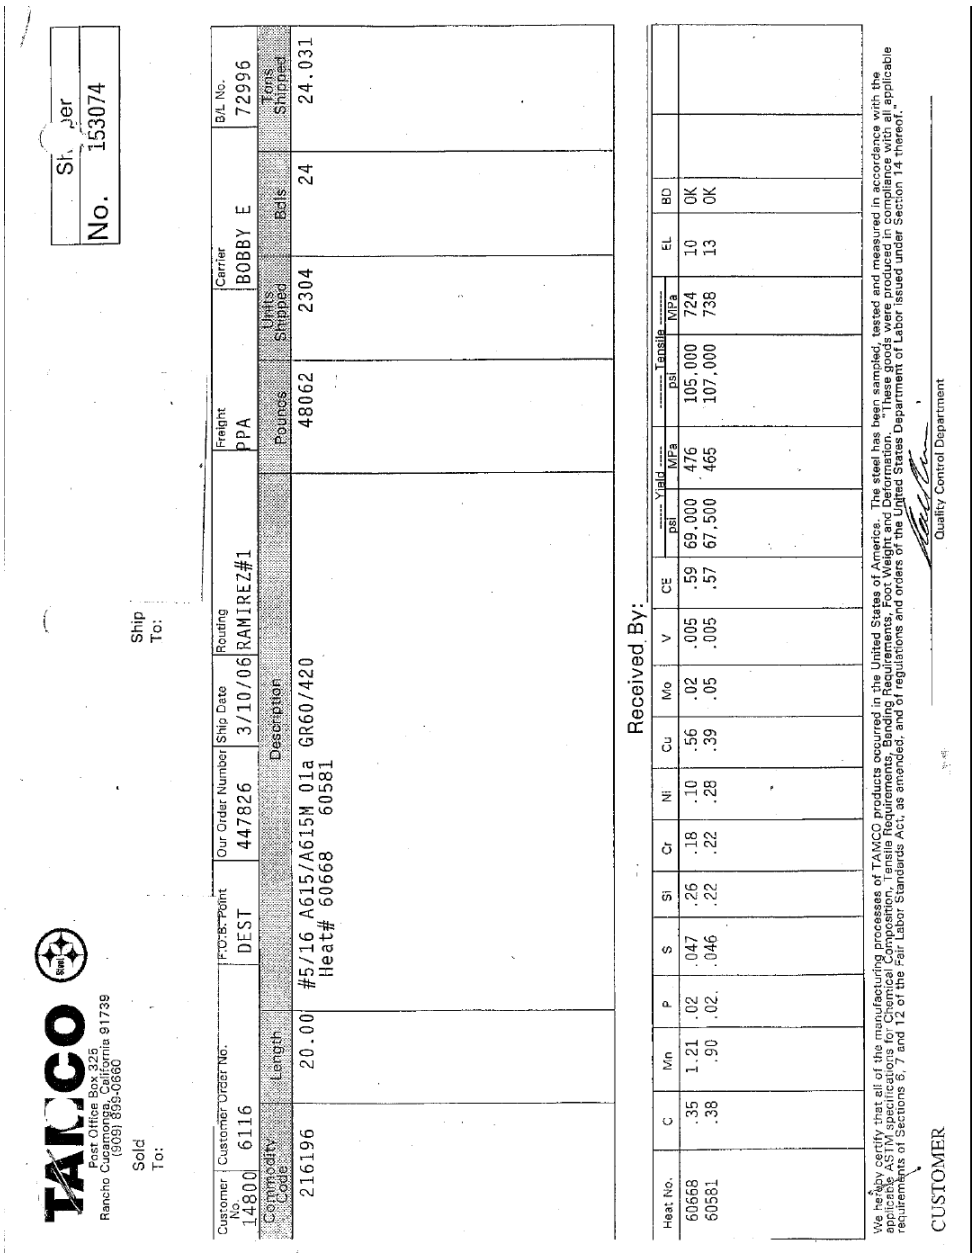
Figure 2-10 Rebar Tensile Strength

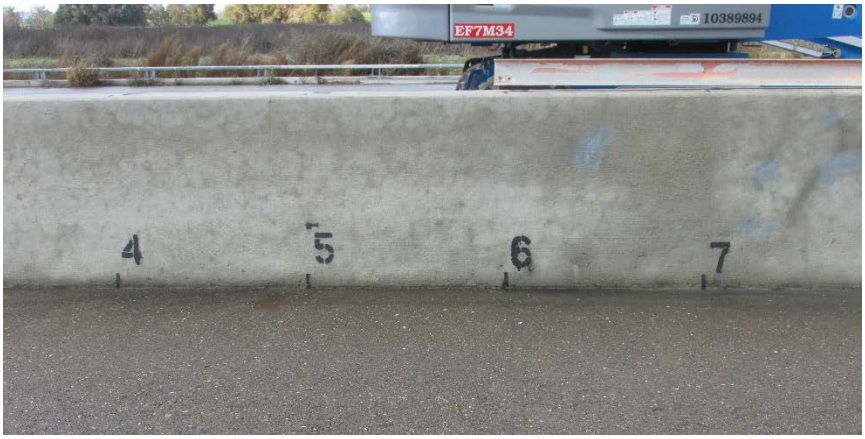
Figure 5-2 Type 60 Barrier Point of Impact (I-beam on barrier was removed prior to test)

The point of impact was approximately 6.25 meters from the upstream barrier end. The impact angle of 25° was set with a Total Station. The intended impact speed was 100 kph.

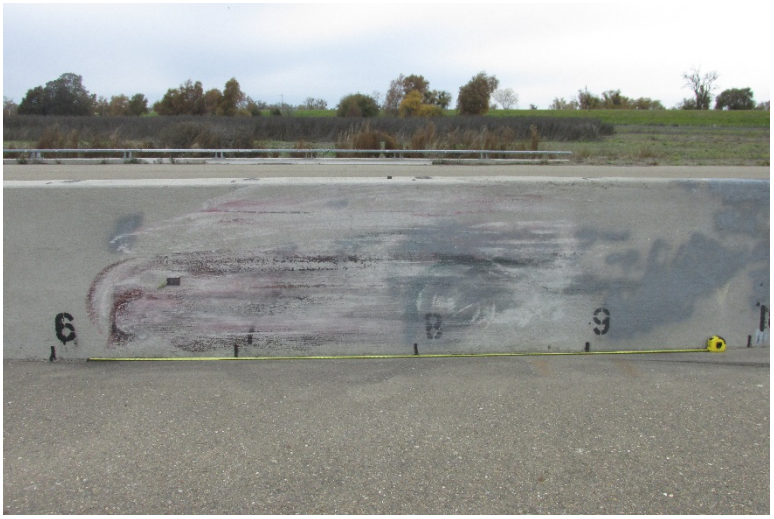
Figure 5-6 Vehicle Marks on Type 60 Barrier

There was no significant damage to the barrier. The only damage was extremely minor surface scrapes and gouges (see Figure 5-6, Figure 5-7, and Figure 5-8). The red contact marks are from the front left tire. The green contact marks are from the rear left tire. The barrier did not move.

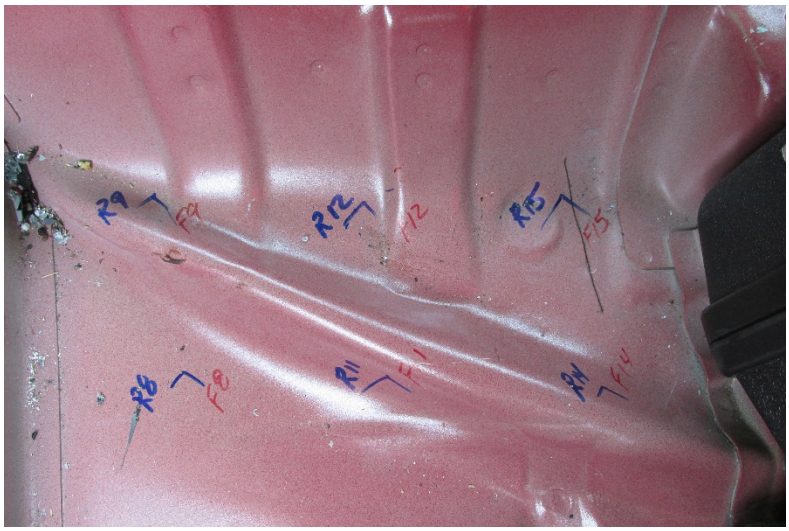
Figure 5-14 140MASH3C16-04 Kia Rio Floorboard Crease with Maximum Deformation

Vehicle Damage ..... Moderate
- VDS 11-FL-3, LD-1, 9-LP-1, 7-LBQ-3
- CDC 10LYMK2, 09LBEK2
- Maximum Deformation ..... Approx. 2.6 in (66 mm) at floorboard[2]

The occupant risk was acceptable. The maximum interior dashboard, roof, and floorboard measured deformations were 1.6 inches (41 mm), 0.5 inches (13 mm), and 2.5 inches (63 mm), respectively. As mentioned previously, the maximum floorboard measurement was estimated to be 2.6 inches because the point of greatest deformation did not appear to occur at a predefined point. There was no occupant compartment intrusion or potential for it. The occupant compartment was not compromised. The dummy head protruded slightly beyond the plane of the driver's side window when it was broken but did not show potential for striking any portion of the barrier. The yaw, pitch, and roll of the vehicle were within acceptable limits.

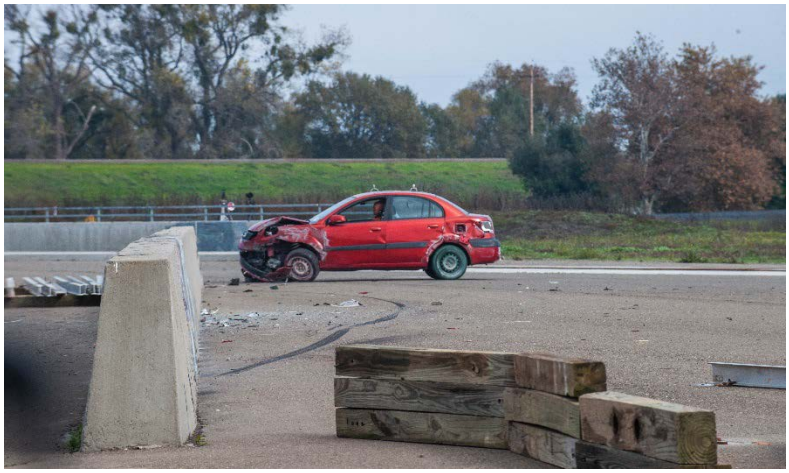
Figure 5-15 Trajectory after Impact

The vehicle was towed up to the intended target speed of 100 km/hr. The vehicle impacted the Type 60 barrier at approximately 6.25 meters from the upstream end at a speed of 61.2 mph (98.5 kph) and angle of 25.7°. The vehicle impacted on the driver's side; the front corner of the hood and front panel contacted the barrier and crumpled. The vehicle began to redirect and slide along the face of the barrier. The buckling of the front panel appears to cause the driver door to separate from the vehicle (as if it were opening and then quickly closing) at approximately 0.04 seconds to 0.05 seconds after impact. The buckling forces on the driver's side of the vehicle appear to cause the driver's side-window to spider-crack and shatter at approximately 0.066 seconds after impact. The dummy's head subsequently hit the glass fragments at approximately 0.076 seconds after impact. The vehicle continued to redirect and became parallel to the rail at approximately 0.168 seconds after impact. At approximately 0.276 seconds after impact, the rear of the vehicle lost contact with the barrier. There were approximately 3 meters of contact with the barrier. The exit speed and angle were measured to be 39.6 mph (63.8 kph) and 8.6°, respectively. The brakes were applied approximately 1.0 seconds after the initial impact and while the vehicle was moving away from the barrier. The braking action caused the car to yaw back toward the barrier, resulting in a secondary impact with the barrier. The vehicle came to a stop with the front end of the vehicle facing the barrier, approximately 2.7 feet (0.82 m) from the face of the barrier and approximately 139 feet (42.4 m) downstream from the initial point of impact.

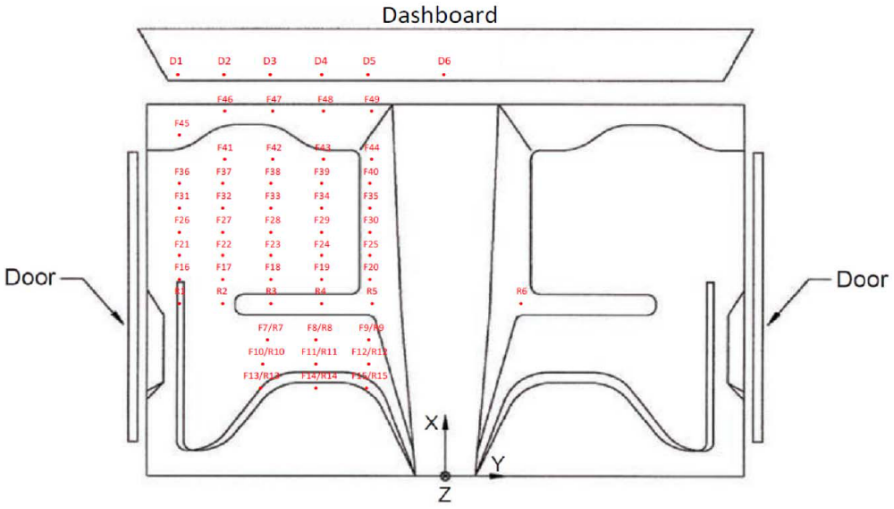
NOTE: CNBM stands for "Could Not Be Measured" due to loss of the measured mark.
