PRELIMINARY SITE INVESTIGATION
ASBESTOS AND LEAD-BASED PAINT SURVEY
CENTENNIAL CORRIDOR PROJECT
BAKERSFIELD, CALIFORNIA

06-48460
KER-58 (PM T31.7/R55.6)
KER-99 (PM 21.2/26.2)

January 6, 2015
Group Delta Project No. EN047

Subject: Preliminary Site Investigation - Asbestos and Lead-Based Paint Survey
Centennial Corridor Project
Bakersfield, California

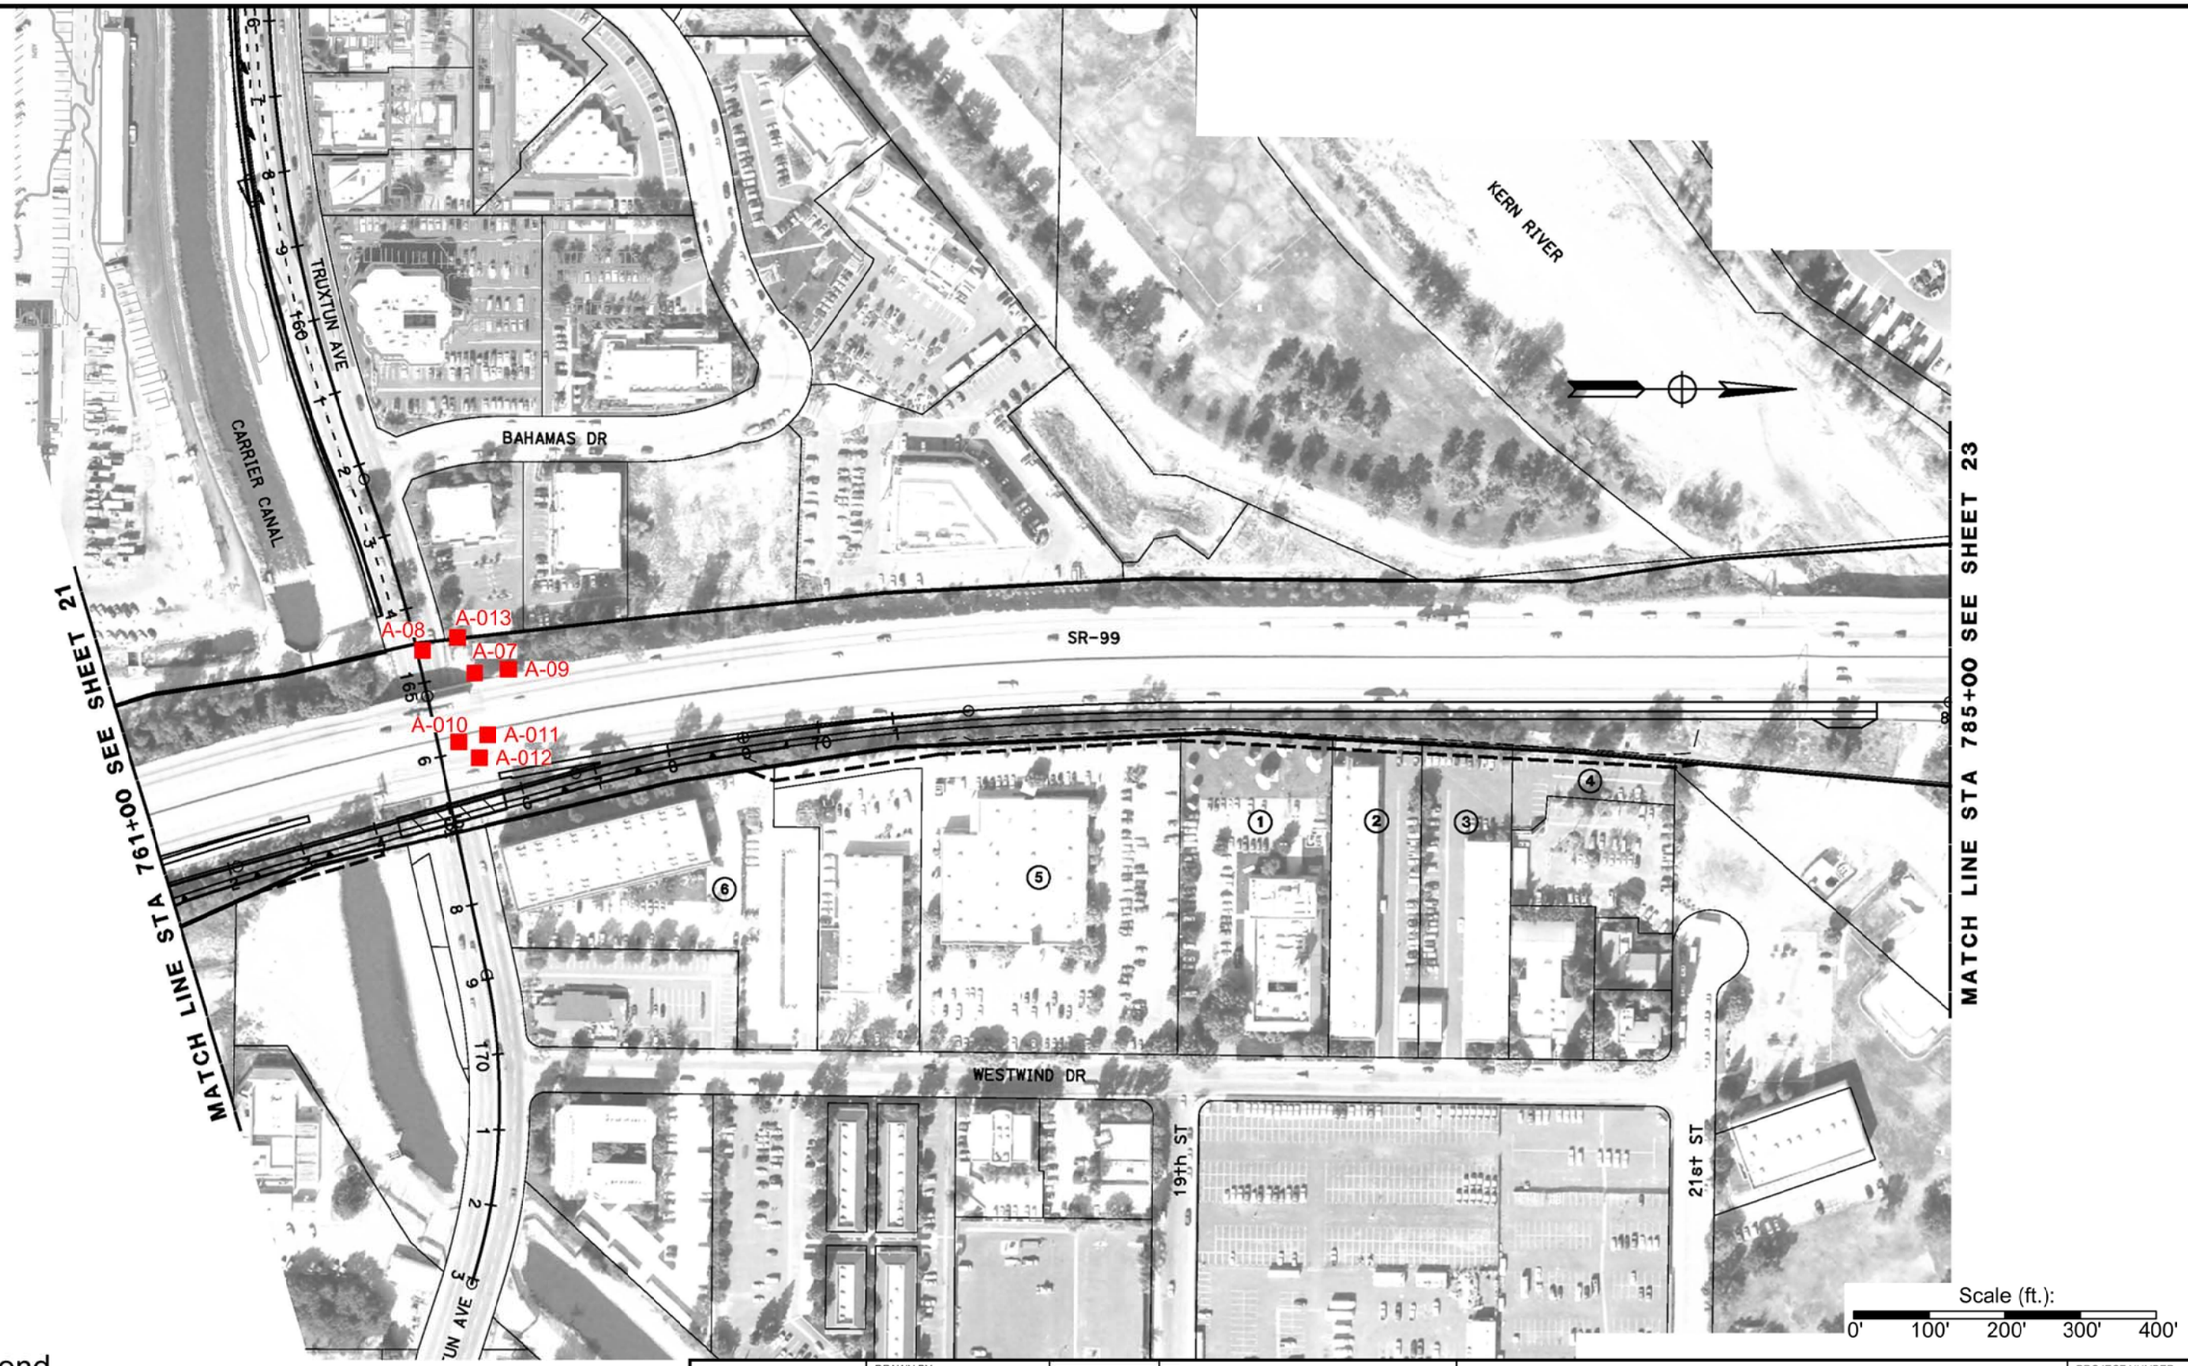
PROJECT NUMBER: EN047
SCALE: AS SHOWN
FIGURE NUMBER: 2a

Asbestos was detected in one sample, A-09, collected from the Truxtun Avenue UC (Table B). Additional PLM 1,000 point count method sample analysis was conducted on sample A-09 in accordance with the Work Plan. The reported sample result was 0.10% non-friable asbestos.

Table B Detected ACCM					
Sample ID	Location	Color, Substrate, Component	Approx. Quantity	Method/Concentration	Determination
A-09	Truxtun Avenue UC	White Bolt Sealant at Rail Base	40 SF	PLM: <1% Point Count: 0.10%	ACCM

Asbestos was not detected above 1% on any of the structures. However, the results of the asbestos survey indicate that ACCMs are present on the Truxtun Avenue UC, in the railing bolt sealant, which may be impacted by construction activities and summarized in Table B.

At no time should the identified ACCMs be drilled, cut, sanded, scraped or otherwise disturbed by untrained personnel. These materials should be removed prior to any activities which will impact these materials. Asbestos disturbance and/or removal operations must be conducted by a Cal/OSHA-registered and State licensed asbestos removal contractor. Disturbance and/or abatement operations should be performed under the direct observation of a California CAC.

Construction activities involving the potential for impacting ACCMs should be conducted in accordance with the requirements of Title 8 of the California Code of Regulations, Section 1529 (8 CCR 1529).

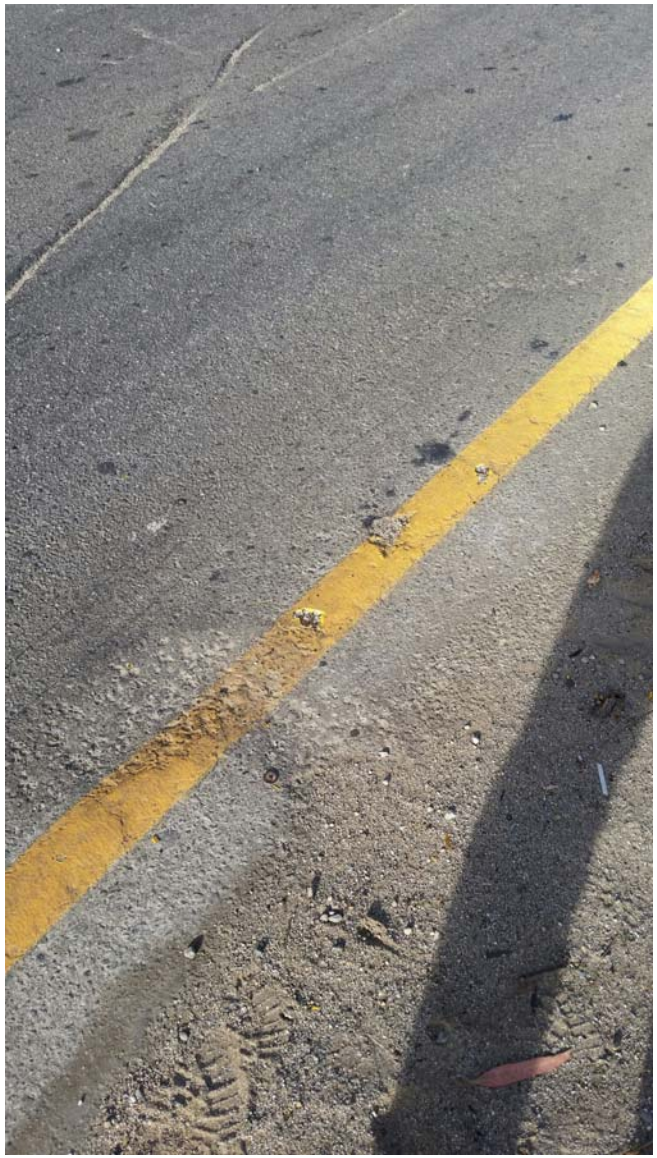
The lead testing results revealed that LBP was found in yellow roadway striping at the Kern Valley River Bridge and may be impacted by the proposed bridge replacement or retrofit. LCSC was found in yellow roadway striping at the Westbound SR-58 over SR-99 and may be impacted by the proposed bridge replacement or retrofit and summarized in Table C. Lead concentrations at these two locations exceeded thresholds for LBP/LCSC and the TTLC, but TCLPs were below 5 mg/L. Therefore, if removed, paint would be considered a non-RCRA hazardous waste.

Site: Kern River Bridge & Westbound SR-58 over SR-99
View: Representative view of yellow striping

There is no current state or federal regulation requiring mandatory lead removal or abatement prior to disturbance or demolition of structures with identified lead materials. However, there are applicable Cal/OSHA worker protection and training requirements; California Environmental Protection Agency (Cal/EPA) waste disposal requirements, California Department of Public Health (CDPH) requirements for public and residential buildings, and Senate Bill (SB) 460 lead hazard regulations that apply to lead-related construction activities, abatement activities and their associated wastes.

Written notification to Cal/OSHA must be accomplished should LBP activities involve more than 100 square or linear feet of removal in accordance with the requirements of 8 CCR 1532.1. Proper written notification to CDPH may be required, depending upon the nature of the activity.

Proper waste characterization and disposal of lead-containing materials and lead-contaminated debris should be conducted in accordance with Title 22 of the California Code of Regulations and the California Health and Safety Code, Section 25157.8.
