STATE OF CALIFORNIA
DEPARTMENT OF PUBLIC WORKS
DIVISION OF HIGHWAYS

Progress Report

STUDIES ON THE CAUSES AND PREVENTION OF ERRATIC CRACKING IN CONCRETE PAVEMENTS

November 1, 1961

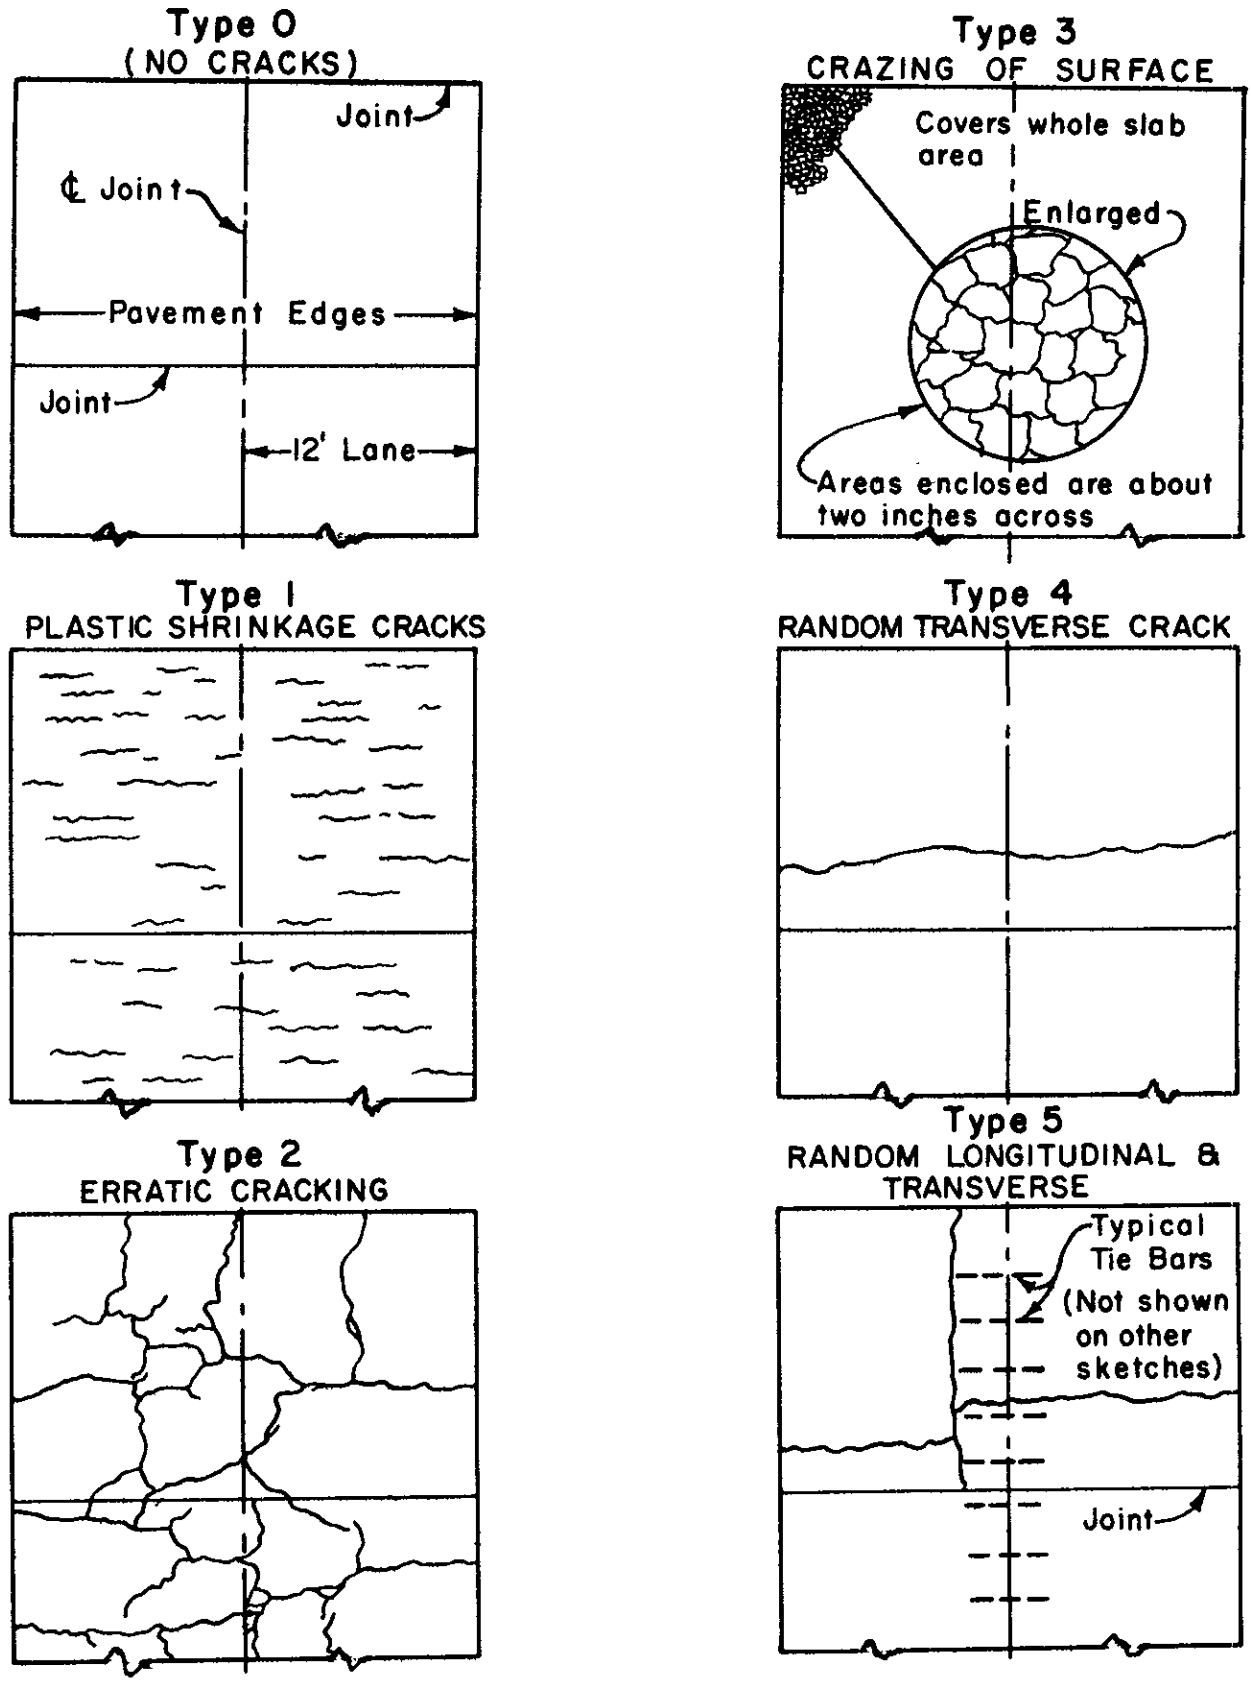
Figure 1

This investigation is being conducted in accordance with verbal instructions from Mr. J. W. Trask, Assistant State Highway Engineer, Operations, in August, 1959. The investigation is financed in part with Federal funds. For the purpose of this study, "erratic" cracking is defined as deep seated cracking having no pronounced orientation with respect to the margins of the pavement. The areas enclosed by the cracks, and/or the pavement margin usually being from about 10 to 75 square feet. For convenience in discussion, erratic cracking is designated as Type 2. See Figure 1.

Most of the pavements contain cracking of some type. The different types are broadly classified and illustrated in Figure 1, and the occurrence of the type of cracking found in each pavement is shown in Table 1.

GENERAL CLASSIFICATION OF CRACKING IN PCC PAVEMENTS
