CALIFORNIA PAVEMENT FAULTING STUDY

INTERIM REPORT

RESEARCH REPORT

NO. M & R 635167-1

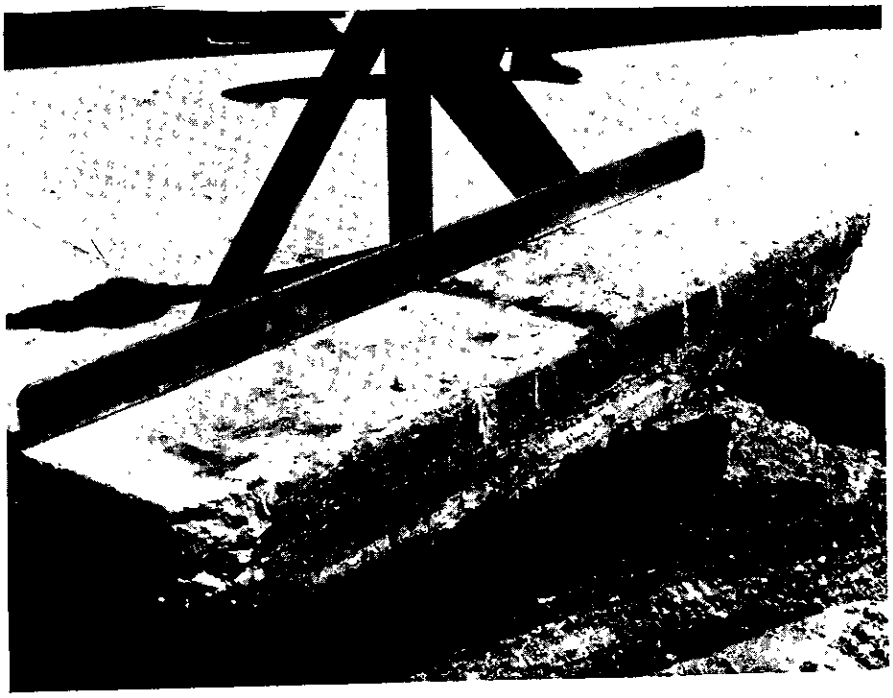
Figure 1

Since this was a new pavement, no significant findings were expected, nor were any found. However, it did serve the valuable purpose of familiarizing field personnel with the techniques of testing and slab removal before moving to locations under traffic. It was noted that there was no evident bond between the CTB and PCC (see Figure 1) and no cracks were found in the CTB. This site may be re-examined in the future, in which case, conditions before and after traffic can be compared.
