State of California
Transportation Agency
Division of Highways
Materials and Research Department

FAULTING OF PORTLAND CEMENT CONCRETE PAVEMENTS

REFERENCE: Spellman, D. L., Woodstrom, J. H., and Neal, B. F., "Faulting of Portland Cement Concrete Pavements", State of California, Transportation Agency, Department of Public Works, Division of Highways, Materials and Research Department, Research Report No. M&R 635167-2, January 1972.

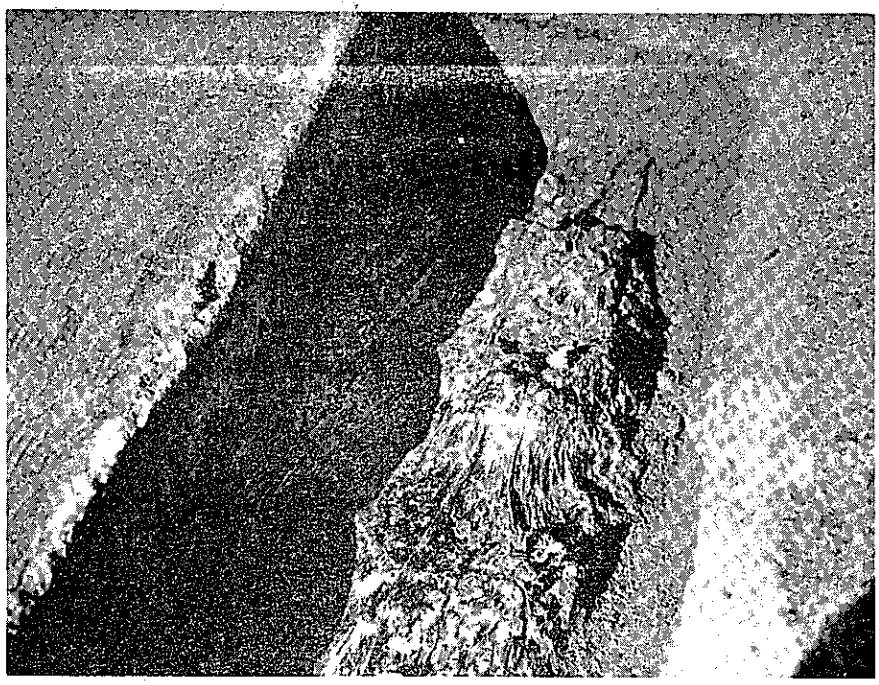
Some difficulty was also encountered in placing the membranes. Although an asphalt emulsion was satisfactory as an adhesive for the membranes on flat surfaces, it would not hold them for a sufficient time on vertical surfaces. As a result, it was necessary to hold the membrane against the slab by hand while aggregate base was being placed against it. Finished placement was proven satisfactory, at least for the plastic, by opening up the shoulder about 8 months later for examination. The material was found to be solidly stuck to the concrete and CTB, and had conformed to all irregularities caused by excess concrete left on the edge during pavement construction. (See Figure 5.) The material cost for fiberglass reinforced plastic was about $600 per mile, while the cost of the layered coal tar and fiberglass was about three times as much. The underground life of the plastic is unknown, but if the theory of its use is proven, it would probably be sufficient to at least delay faulting for many years.

Fig. 5 Shoulder opening showing plastic conforming to irregularities

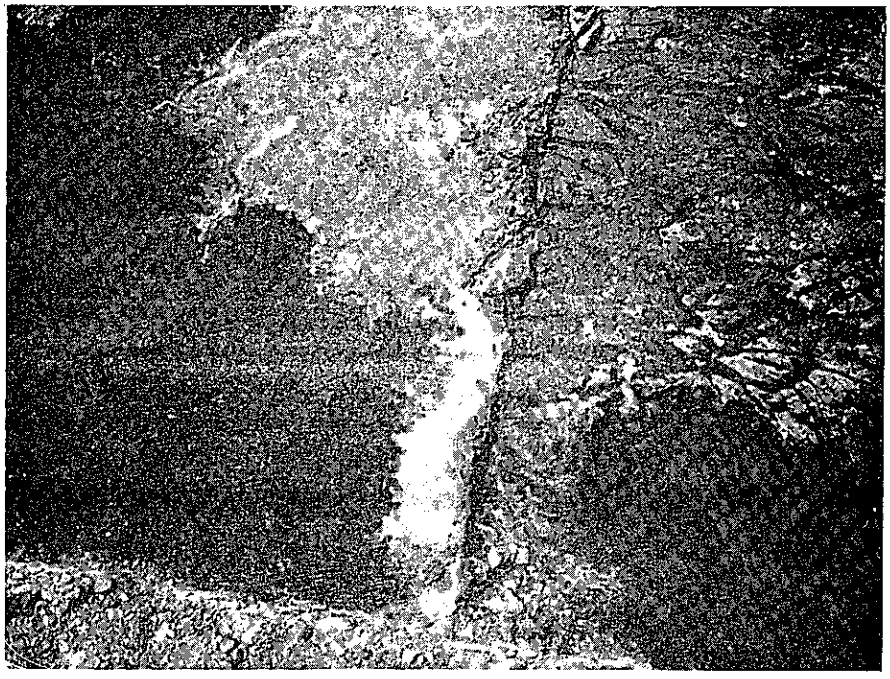
Although base settlement has long been suspected as a cause of faulting, there was no evidence found during the field investigation of any such settlement. (All pavements opened had cement treated base - CTB.) There was, however, positive evidence of erosion of the base surface under the leave slab. The evidence was in the form of rivulets caused by water movement and might result in some lack of uniform support but would not allow the slab to be depressed (see Figure 6). The top portion of the CTB at many locations has been found to be loosely cemented and readily erodable. While drying of the surface before curing may be responsible for part of the problem, much is felt to be due to the trimming operation used to conform to grading tolerances. Since a high base will result in thin pavement for which a Contractor is penalized, and a low base results in the use of excessive concrete, considerable effort is exerted in obtaining the proper grade. Trimming is usually done about an hour or more after original placement. The surface material, once loosened, is never fully rebonded and so does not form a monolithic erosion resistant base.

Fig. 6 Channels indicating water movement on cement treated base surface

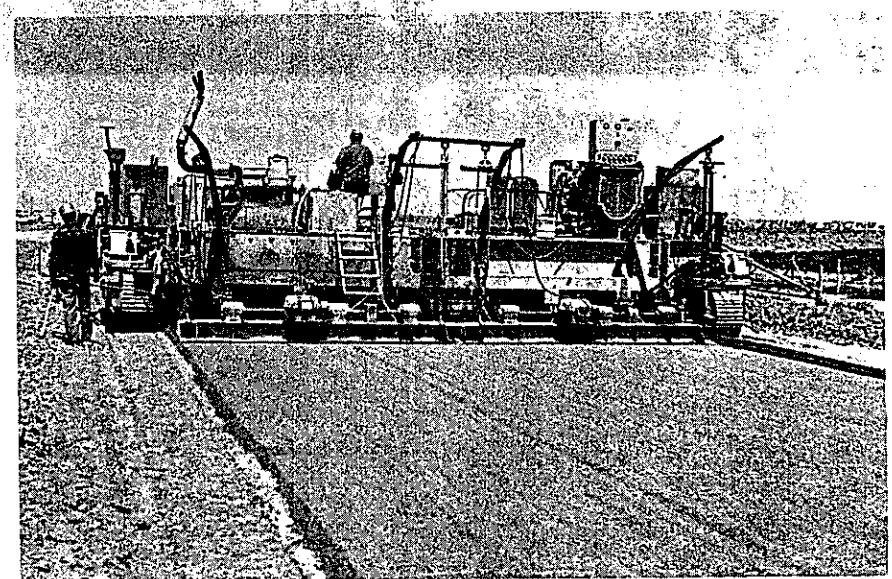
Recently it has been noted that a few contractors are changing their CTB placing methods. They have gone to central mixing, whether required or not, and to placing with a slipform paver. Instead of a wet mix and internal vibration, they use the regular dry mix and a vibrating screed behind the paver, followed by rollers. This results in a much harder appearing surface and trimming is seldom if ever necessary. Unfortunately, there is no test method available for measuring abrasion resistance of CTB in place. If the trend to this type of construction continues, our objection to CTB due to trimming may be overcome (see Figure 7).

Fig. 7 Placing cement treated base with slipform paver
