A COMPARISON OF TRANSVERSE WEAKENED PLANE JOINTS FORMED BY SAWING AND BY PLASTIC INSERT

INTERIM REPORT

RESEARCH REPORT

CA-DOT-TL-5254-1-73-26

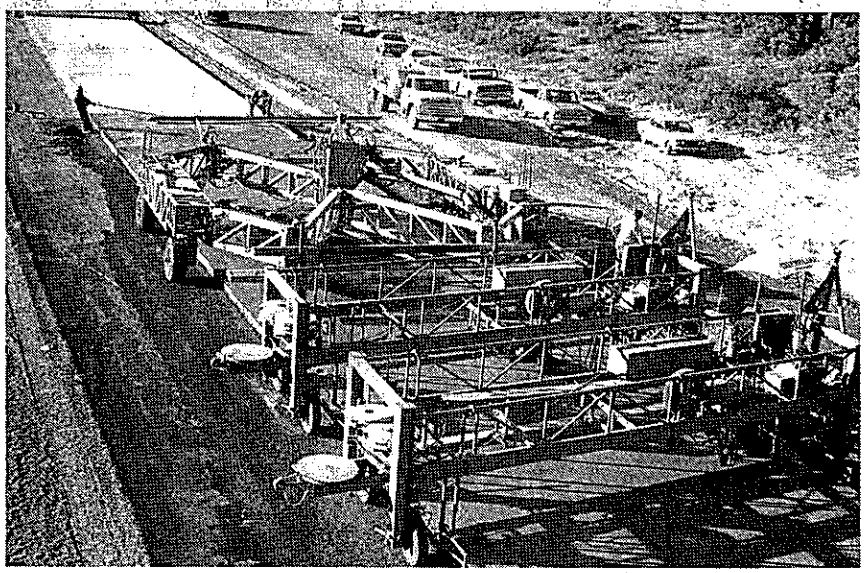
Figure 1. Two plastic joint machines followed by pipe float.

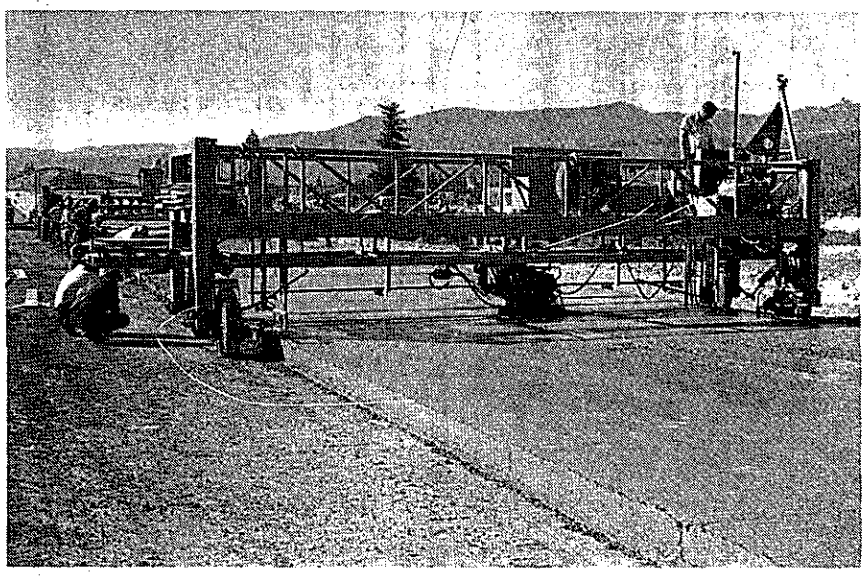
Figure 2. Plastic joint machine in operation.

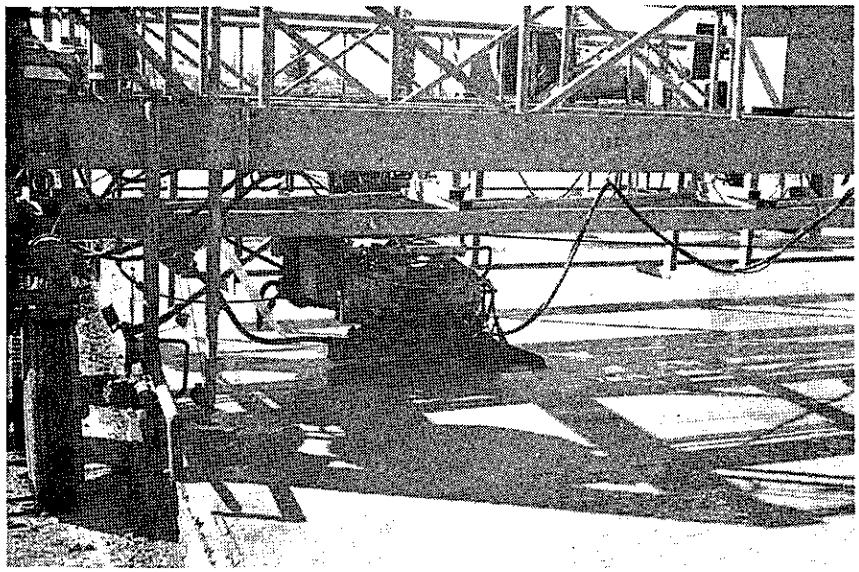
Figure 3. Inserting head on joint machine.

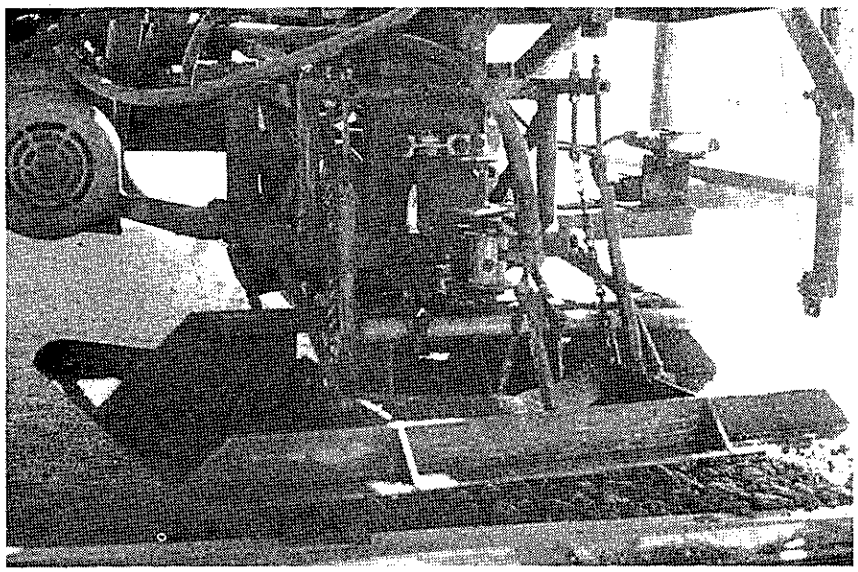
Figure 4. Vibrator and pan float on inserting head.

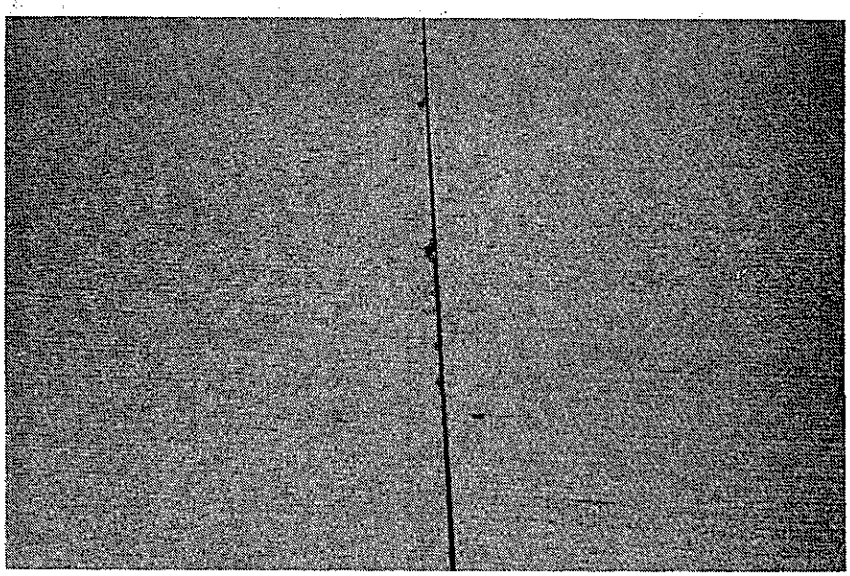
Figure 6. Rating "1". Minor spalling.

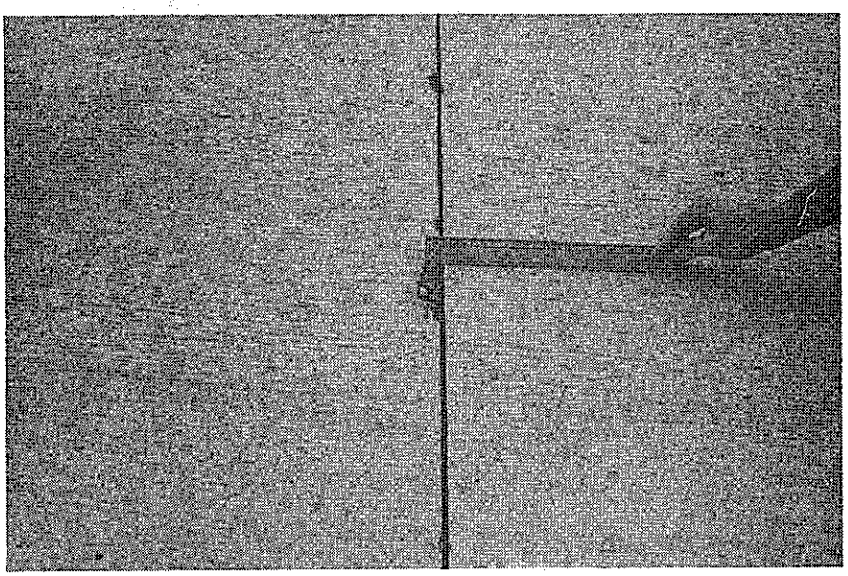
Figure 7. Rating "2". Moderate spalling.

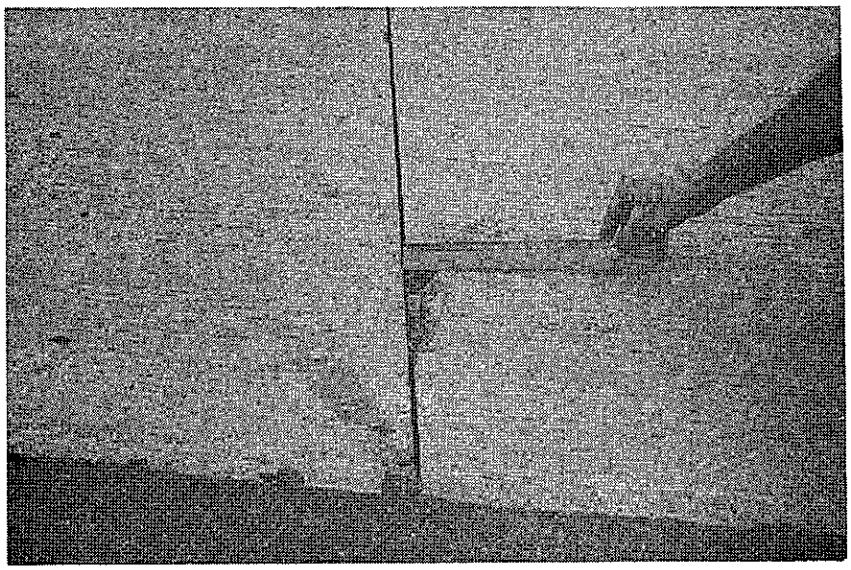
Figure 8. Rating "3". Major spalling.

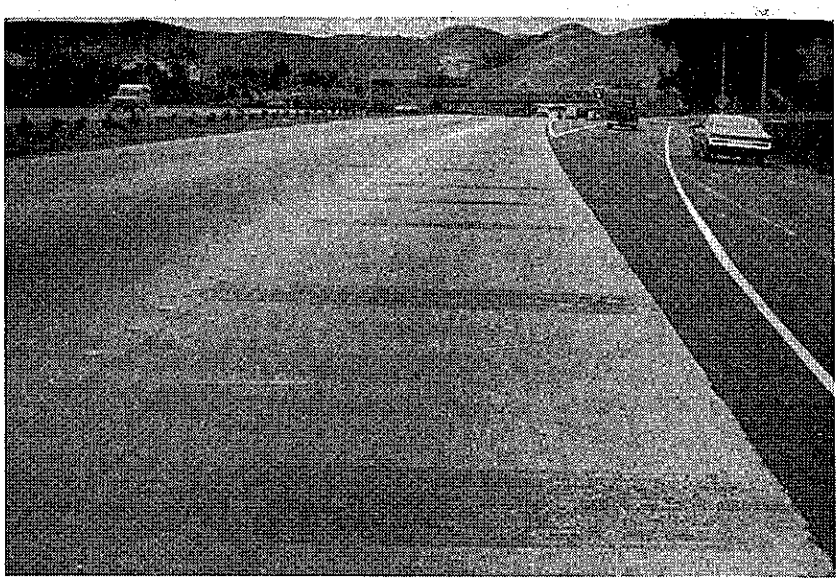
Roughness put in by the joint inserter caused the Contractor to grind transversely on the low side of almost every joint on grades. (See Figure 10.) This still did not improve the ride to any great extent.

Figure 10. Grinding at transverse plastic insert joints.

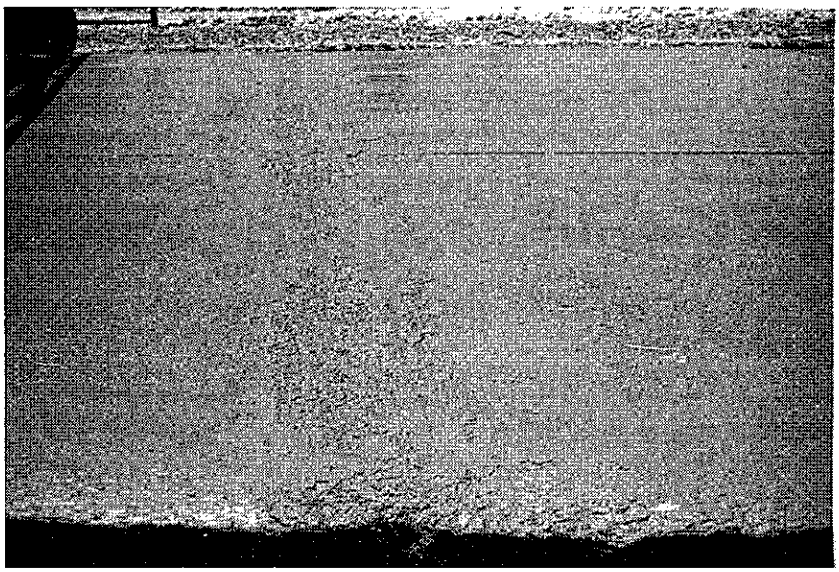
Joint inserter caused bowing of longitudinal tape and edge slump that could not be corrected. Very harsh mix contributed to troubles. (See Figure 11.) Use of inserter was discontinued.

Figure 11. Edge slump at transverse plastic insert joint.

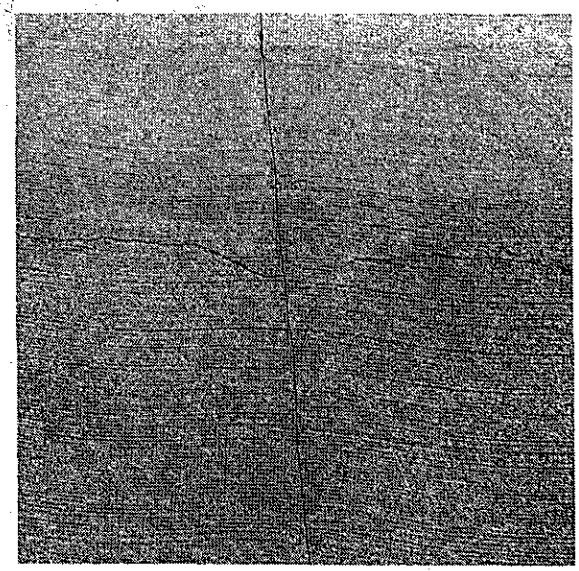
Excessive displacement of the longitudinal joint insert at the intersection with the transverse insert has occurred in about half of the joints surveyed. (See Figure 13.) While this can cause a small triangle of weakness prone to spalling, only a small percentage of those surveyed had spalled to any degree.

Figure 13. Displacement of longitudinal insert.

On several projects where displacement of the longitudinal plastic insert was a problem, changing to a less elastic type plastic for the longitudinal joint and keeping it at the proper elevation has been of considerable help in alleviating the problem. On other projects, edge slump has been reduced by careful adjustment of the movable side forms. No real effort has gone into trying to reduce the inequalities in the pavement surface caused by the inserter as most of these bumps or depressions are within the present specification limit.

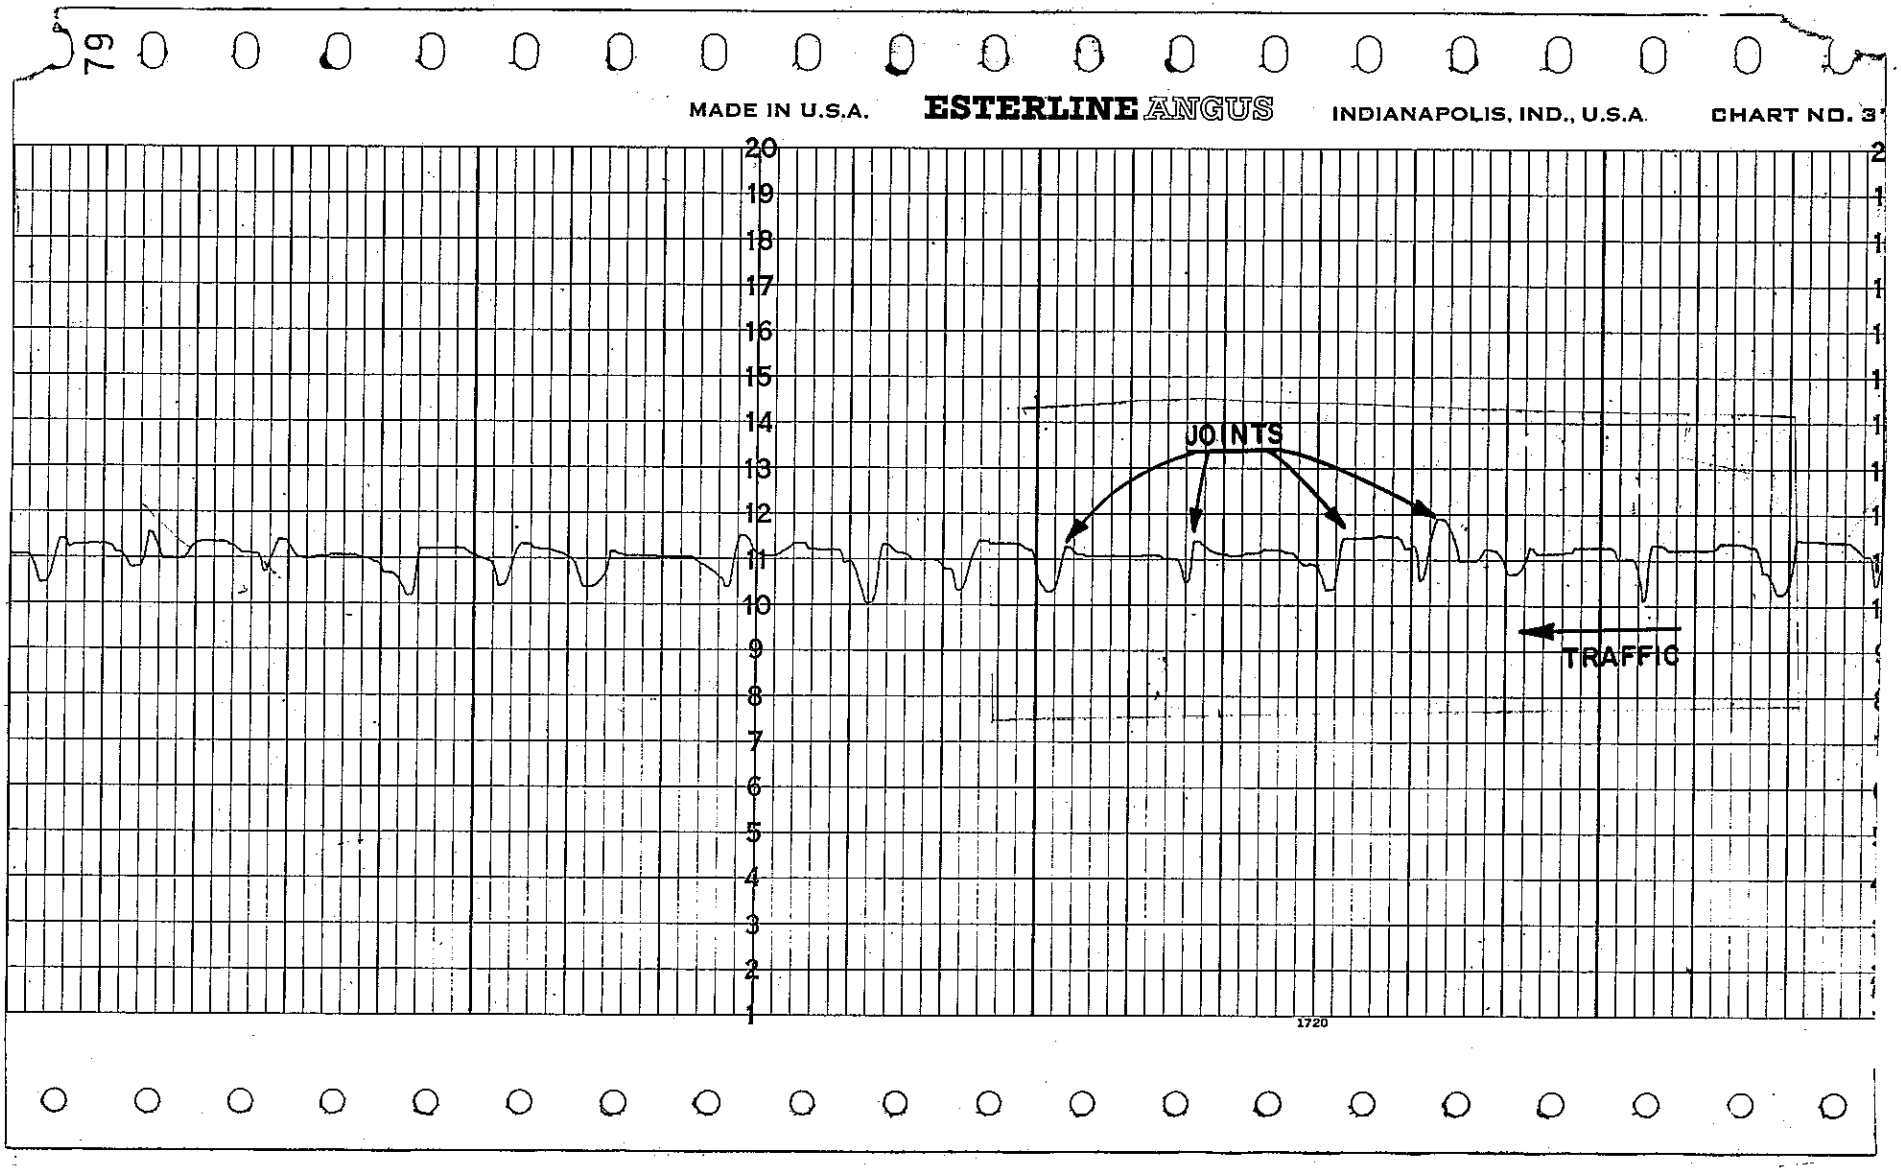
Figure 14. Graph of pavement showing roughness caused by joint inserter

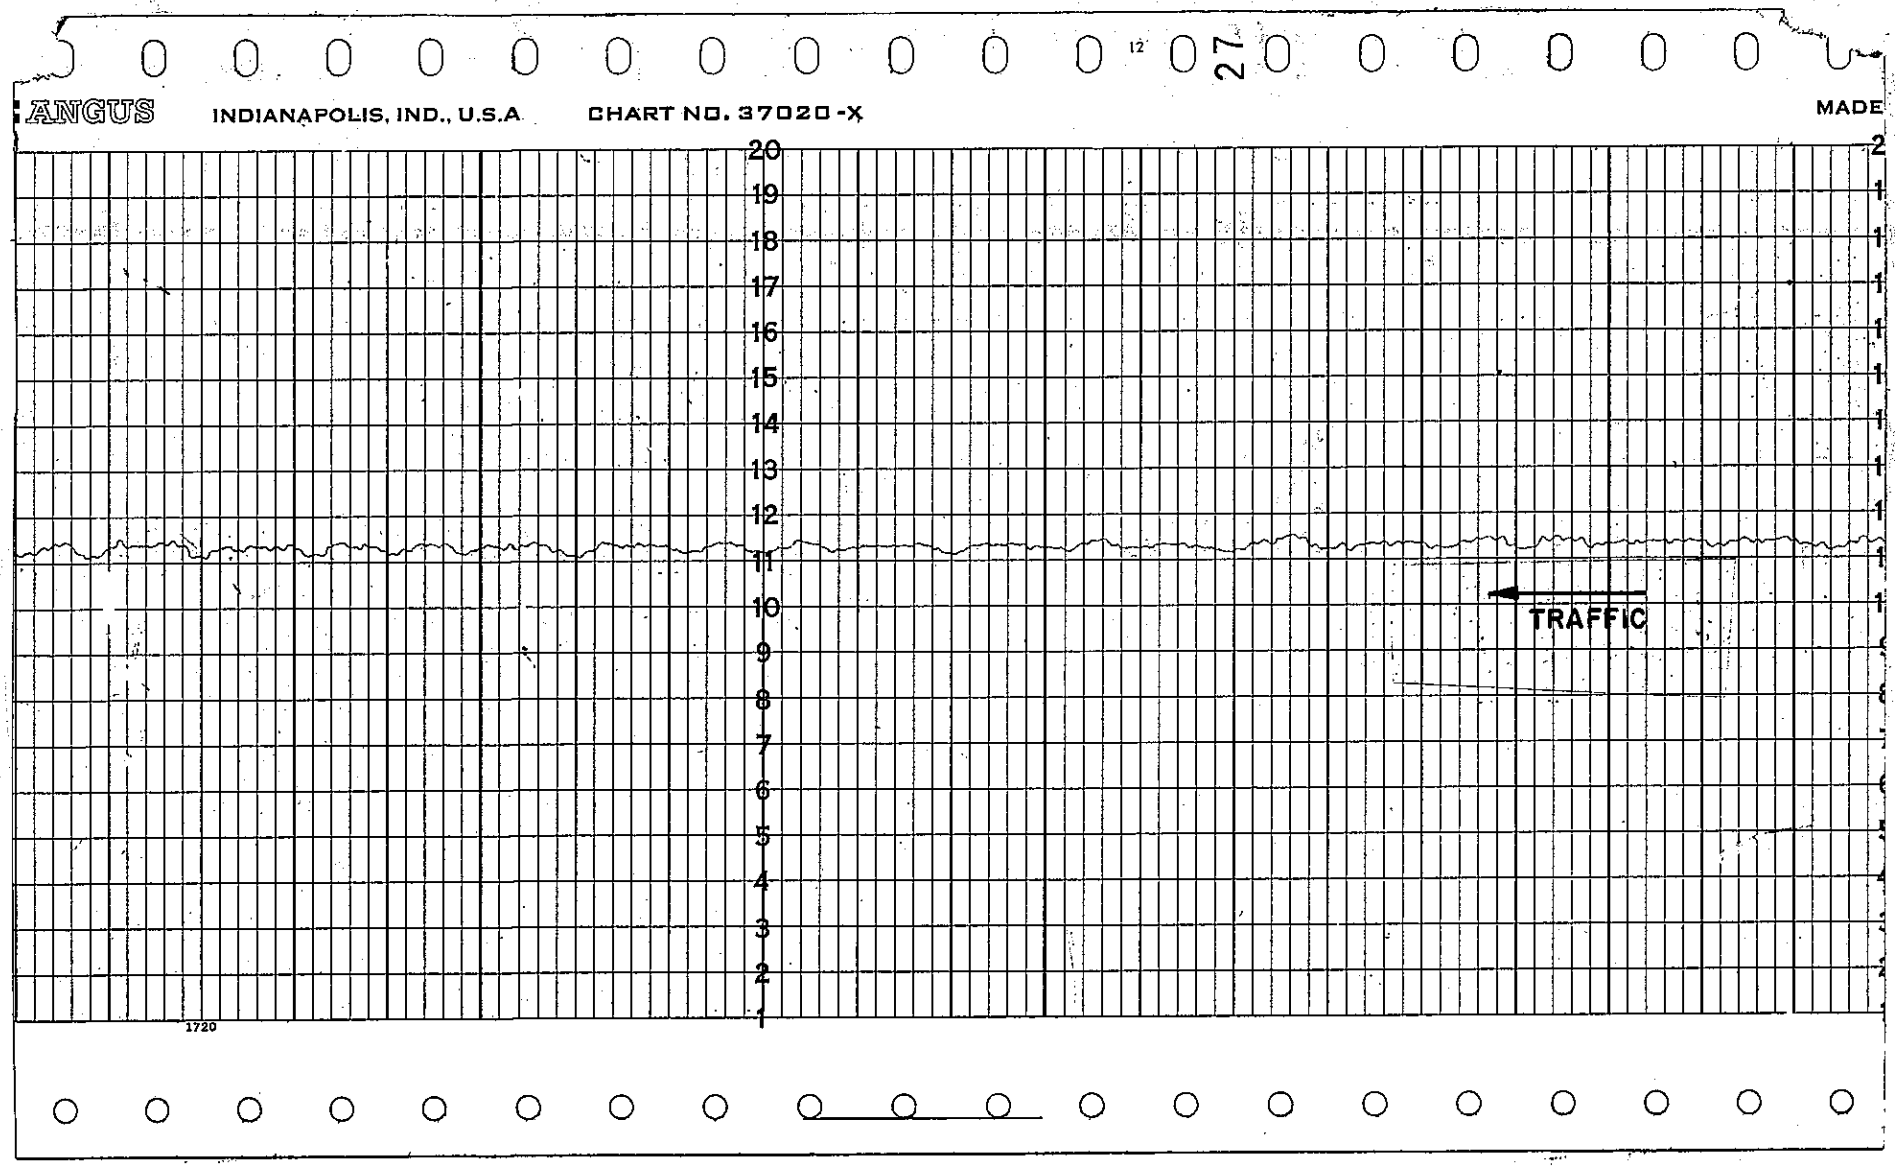
Figure 15. Graph of smooth pavement.

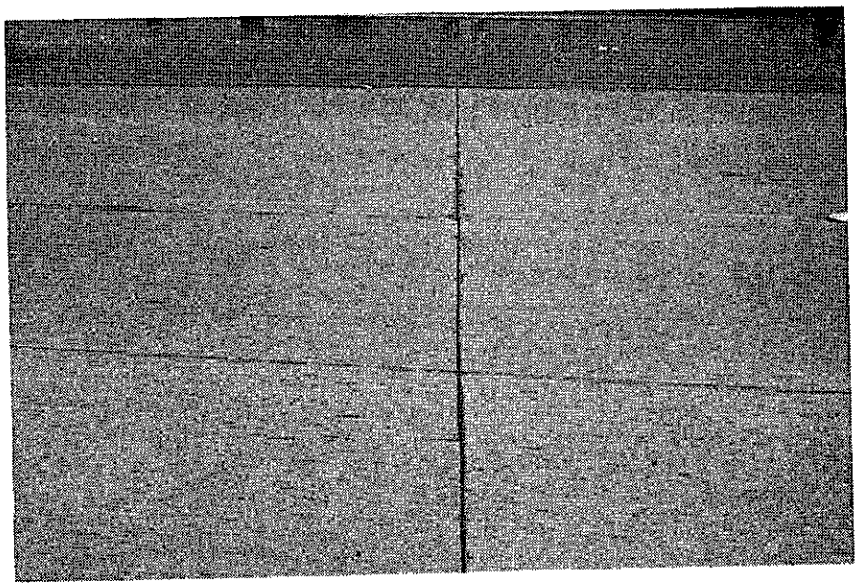
The proper time for sawing is the most critical aspect of the operation. Concrete that is too green when sawed will have unsightly ravelling (see Figure 16) or lead to later ravelling and spalling due to disturbance of the partially hardened concrete. Concrete that is left too long before sawing may develop random cracking. (See Figure 17.) Under certain climatic conditions, large areas of the pavement will crack before sawing can be completed. Mismatch of multiblade saws where they overlap occasionally occur. This results in extra wide openings at that point. These joints cannot be satisfactorily sealed with

Figure 16. Ravelling of sawed joint.

Excessive ravelling or tearing of the concrete adjacent to the saw cut, caused by sawing when the concrete is too green, will be repaired as specified in Section 40-1.08B (3). Excessive ravelling shall be defined as more than one foot of ravelling which exceeds 0.04-foot in width in a 12-foot lane, or more than three feet of ravelling which exceeds 0.01-foot in width in a 12-foot lane.

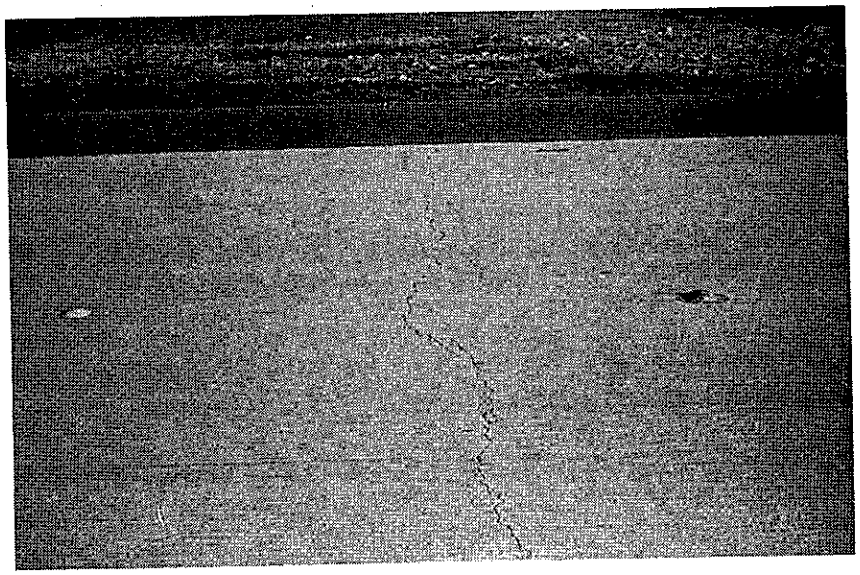
Random cracking in pavements using plastic insert joints is practically nonexistent. A pavement constructed with sawed joints and having no random cracking is the exception rather than the rule. This can and does lead to costly repairs, sometimes even before the project is open to public traffic.

Figure 17. Random crack on sawed joint project.

Volunteer cracks that do not cross planned weakened plane joints or that cross such planned joints but do not follow their alignment, shall be repaired by injecting with epoxy under pressure except as provided herein. Where the volunteer crack crosses a planned joint, protective measures must be taken to prevent the entry of epoxy into the planned joint. Where a volunteer crack meets a planned weakened plane joint and proceeds along the joint, only the volunteer crack portion of the joint shall receive the injected epoxy and protective measures must be taken to prevent entry of injected epoxy into the working portion of the planned joint. Epoxy injection shall be completed within 30 working days from the date pavement is placed.
