4. TITLE AND SUBTITLE	5. REPORT DATE
REHABILITATION OF FAULTED PAVEMENTS BY GRINDING	February 1976
	6. PERFORMING ORGANIZATION CODE
7. AUTHOR(S)	8. PERFORMING ORGANIZATION REPORT NO
B. F. Neal, J. H. Woodstrom	19503-635167
9. PERFORMING ORGANIZATION NAME AND ADDRESS Office of Transportation Laboratory California Department of Transportation Sacramento, California 95819	10. WORK UNIT NO.
	11. CONTRACT OR GRANT NO D-3-32
12. SPONSORING AGENCY NAME AND ADDRESS California Department of Transportation Sacramento, California 95807	13. TYPE OF REPORT & PERIOD COVERED Interim 1965-75
	14. SPONSORING AGENCY CODE

STATE OF CALIFORNIA
DEPARTMENT OF TRANSPORTATION
DIVISION OF STRUCTURES & ENGINEERING SERVICES
OFFICE OF TRANSPORTATION LABORATORY

REHABILITATION OF FAULTED PAVEMENTS
BY GRINDING

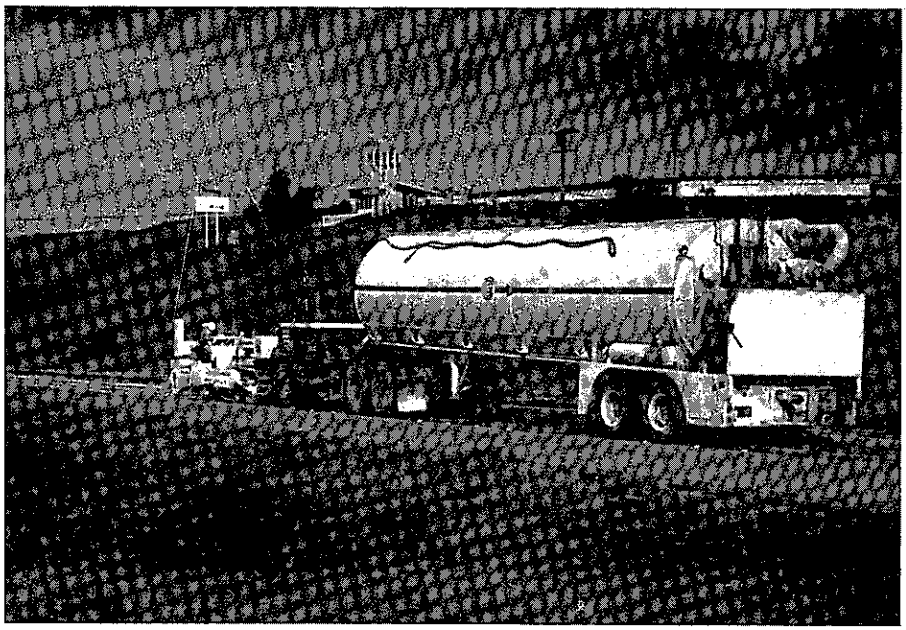
Fig. 1

Grinding equipment with tank for both cooling water and waste water.

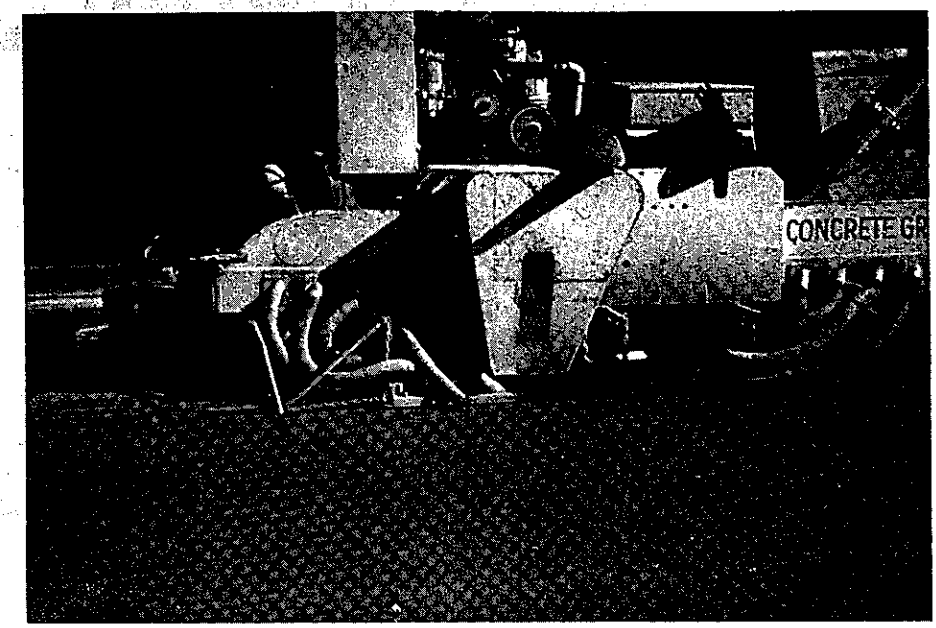
Fig. 3

Vacuum equipment for removing water and residue from grinding.

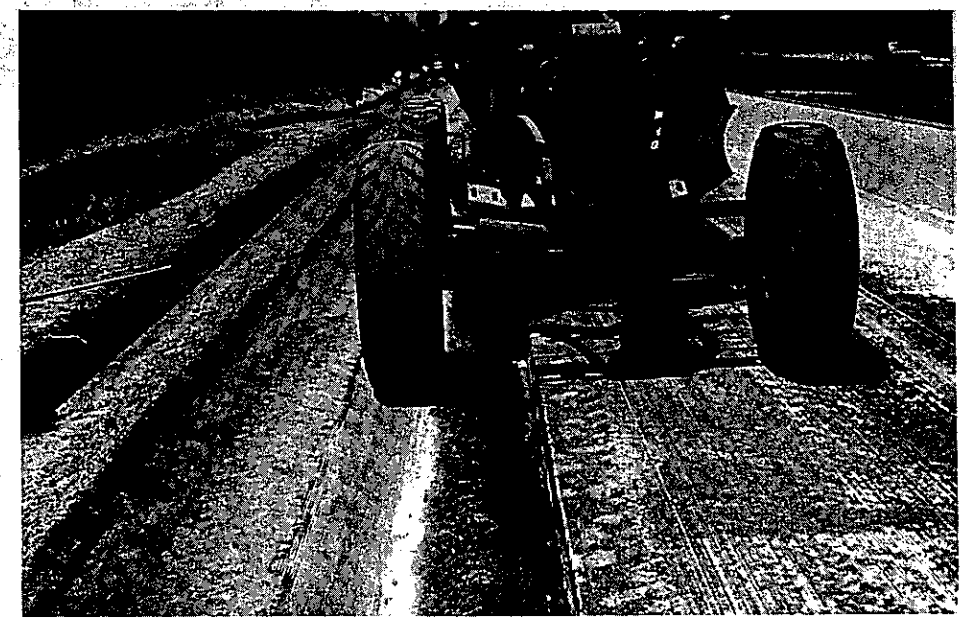
Fig. 11
Covering pipe with removed shoulder material.

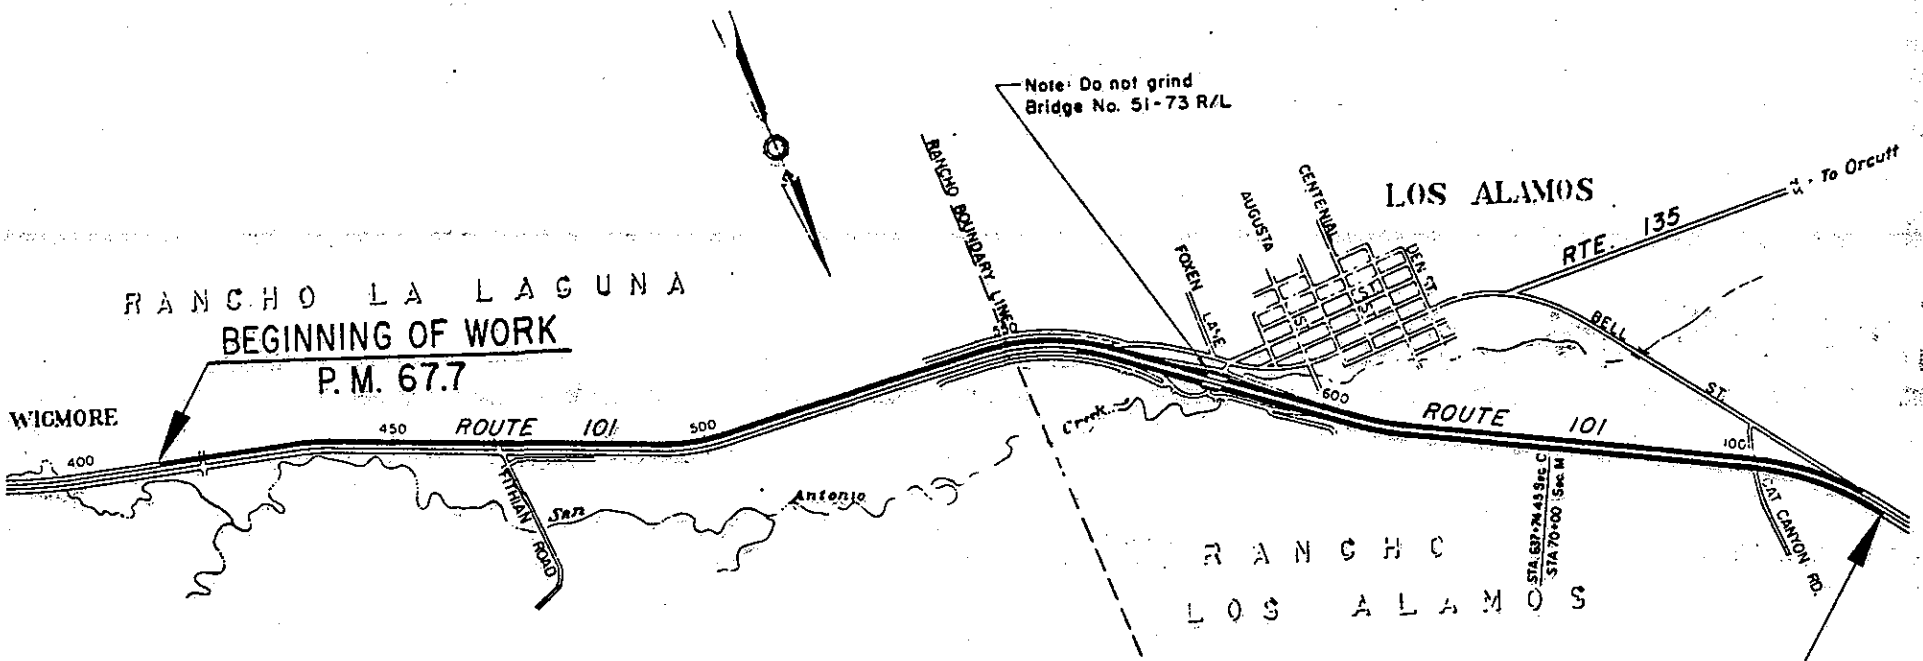
CONCRETE PAVEMENT GRINDING

Location	Width	Sq Yds.
Right Lane		
P.M. 70.5 to 73.0	12'	17,600
Left Lanes		
P.M. 67.7 to 72.9	12'	36,608
Less Area of Bridge		
51-73 Right		- 300
51-73 Left		- 300
Total		53,608
