REPORT NO. FHWA-CA-TL-78-29

PERFORMANCE OF EXPERIMENTAL PCC PAVEMENT SECTIONS

FINAL REPORT

SEPT., 1978

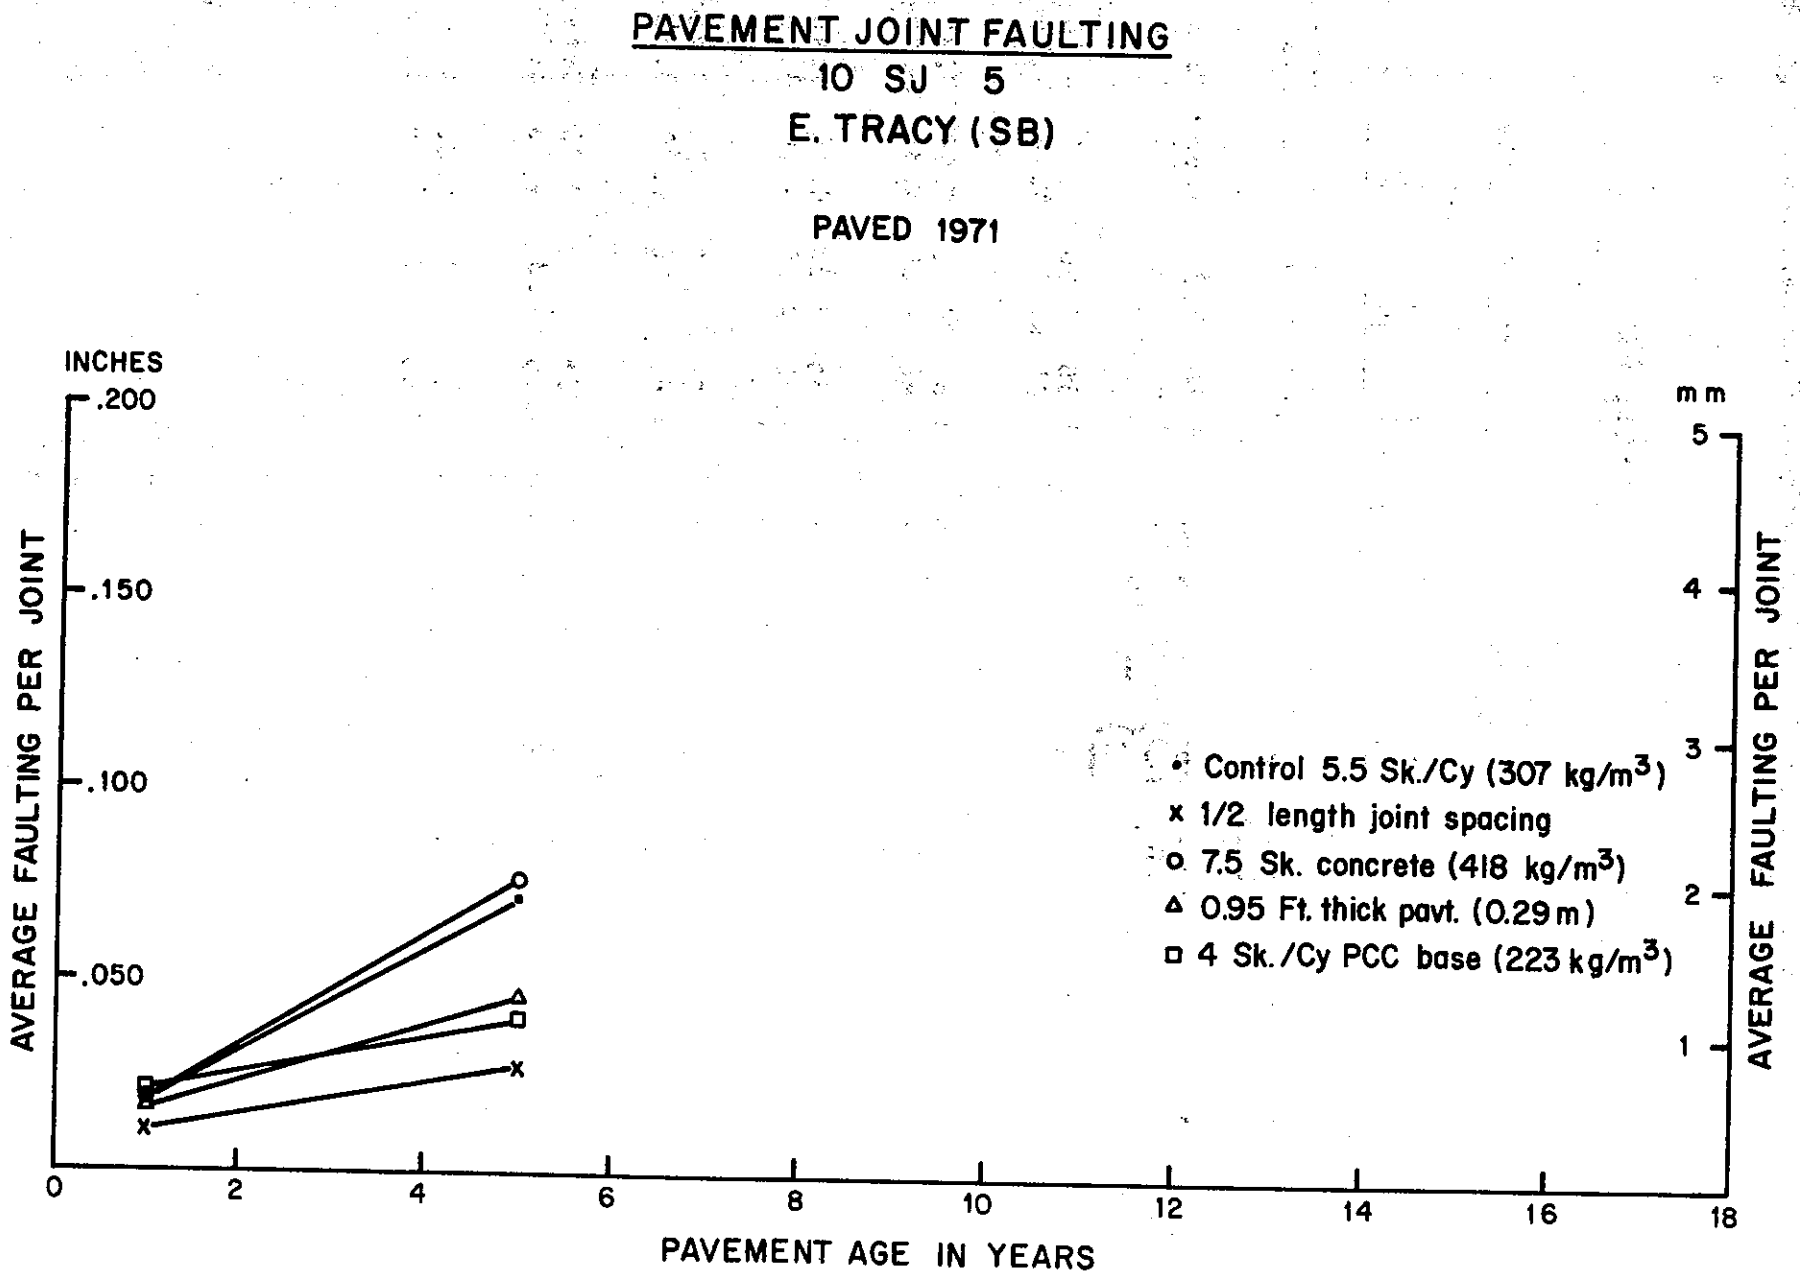
Figure 2

Figures 2 and 3 show average faulting per joint of the various non-reinforced sections about 5 years after construction. These averages were calculated from periodic measurements of the same 25 consecutive joints in each of the test sections. The sections with 1/2 length slabs and those with concrete base show the least increase in average faulting. The improved faulting performance of short slabs can only be attained if practically all transverse weakened plane joints are made to crack. This requires applying a load to the pavement while the concrete still has relatively low strength. It might be pointed out that total faulting per given length of pavement will probably be approximately that of normally spaced joints. Concrete base or lean concrete base (LCB) is presently being promoted in California as a means of helping the faulting problem. However, it is also considered necessary to eliminate untreated shoulder material adjacent to the pavement which was not done on this project.
