STATE OF CALIFORNIA
DEPARTMENT OF TRANSPORTATION
DIVISION OF CONSTRUCTION
OFFICE OF TRANSPORTATION LABORATORY

June 1980

FHWA No. F-7-33
TL No. 633170

MODEL SLAB FAULTING STUDY

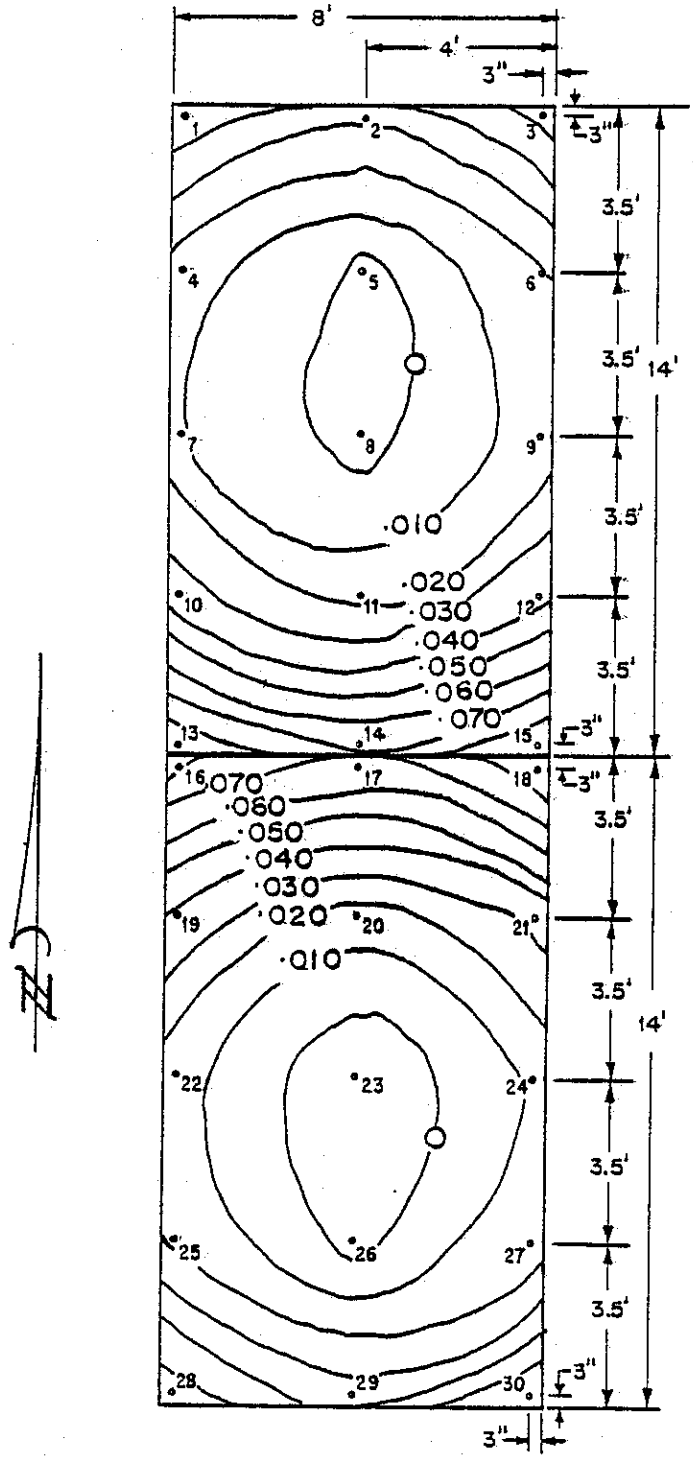
ISOGRAM OF CURL

During the approximately 7 month period between completion of the test slab and equipment installation, temperature and curl gages were monitored periodically. The circulating hot water effectively raised the temperature at the bottom of the slab. However, due to the high thermal conductivity of concrete, it also raised the temperature throughout the slab. This reduced the thermal gradient and the amount of induced curl. During the monitoring period, the water temperature was held to about 110°F and slab temperature was not raised above about 90°F. When the water was not circulating, temperatures throughout the structural section were uniform and approximately the same as ambient. As the concrete dried, upward curl increased daily, with a maximum of 0.03 inch after 7 days, 0.05 inch after 14 days, and a peak of about 0.10 inch in 3 months, although total curl varied with changes in temperature. An isogram of the curl after 6 months with uniform temperature of 56°F is shown in Figure 8, at which time maximum curl was about 0.085 inch.

SIX MONTHS DRYING - NO LOADING

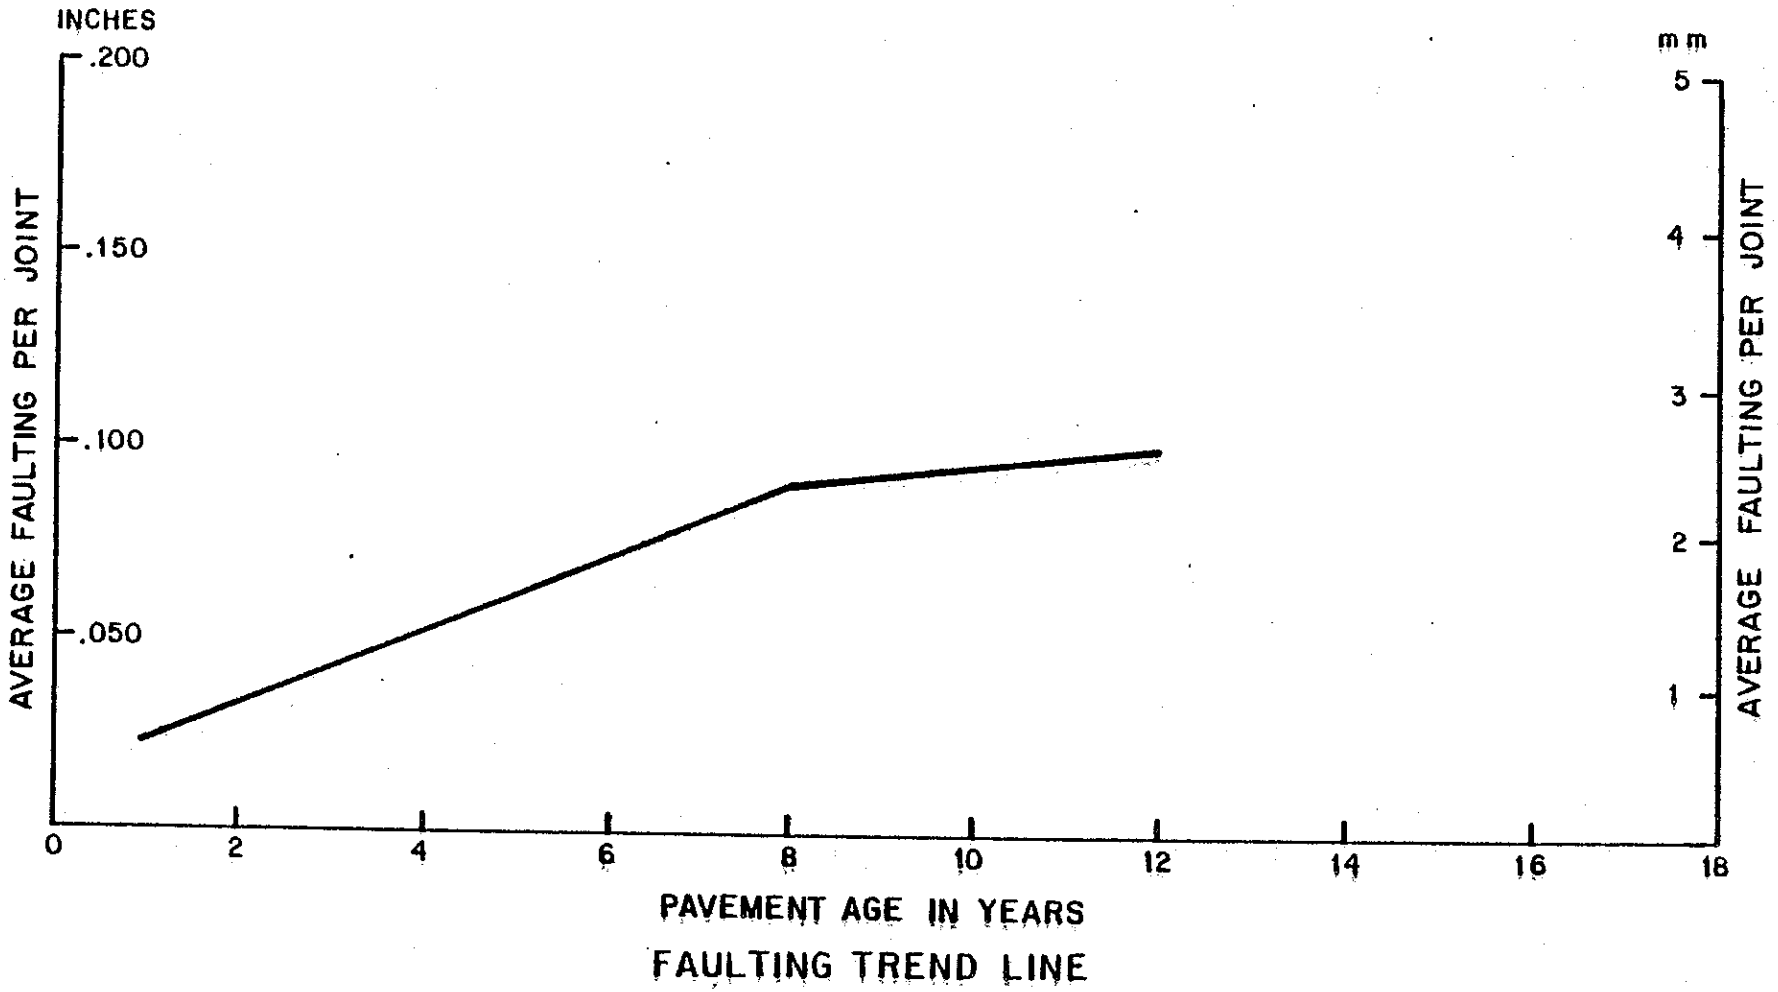
Figure B-1

07 LA 14
ROSAMOND

PAVED 1968
CT BASE
(CT = Cement Treated)

FAULTING TREND LINE

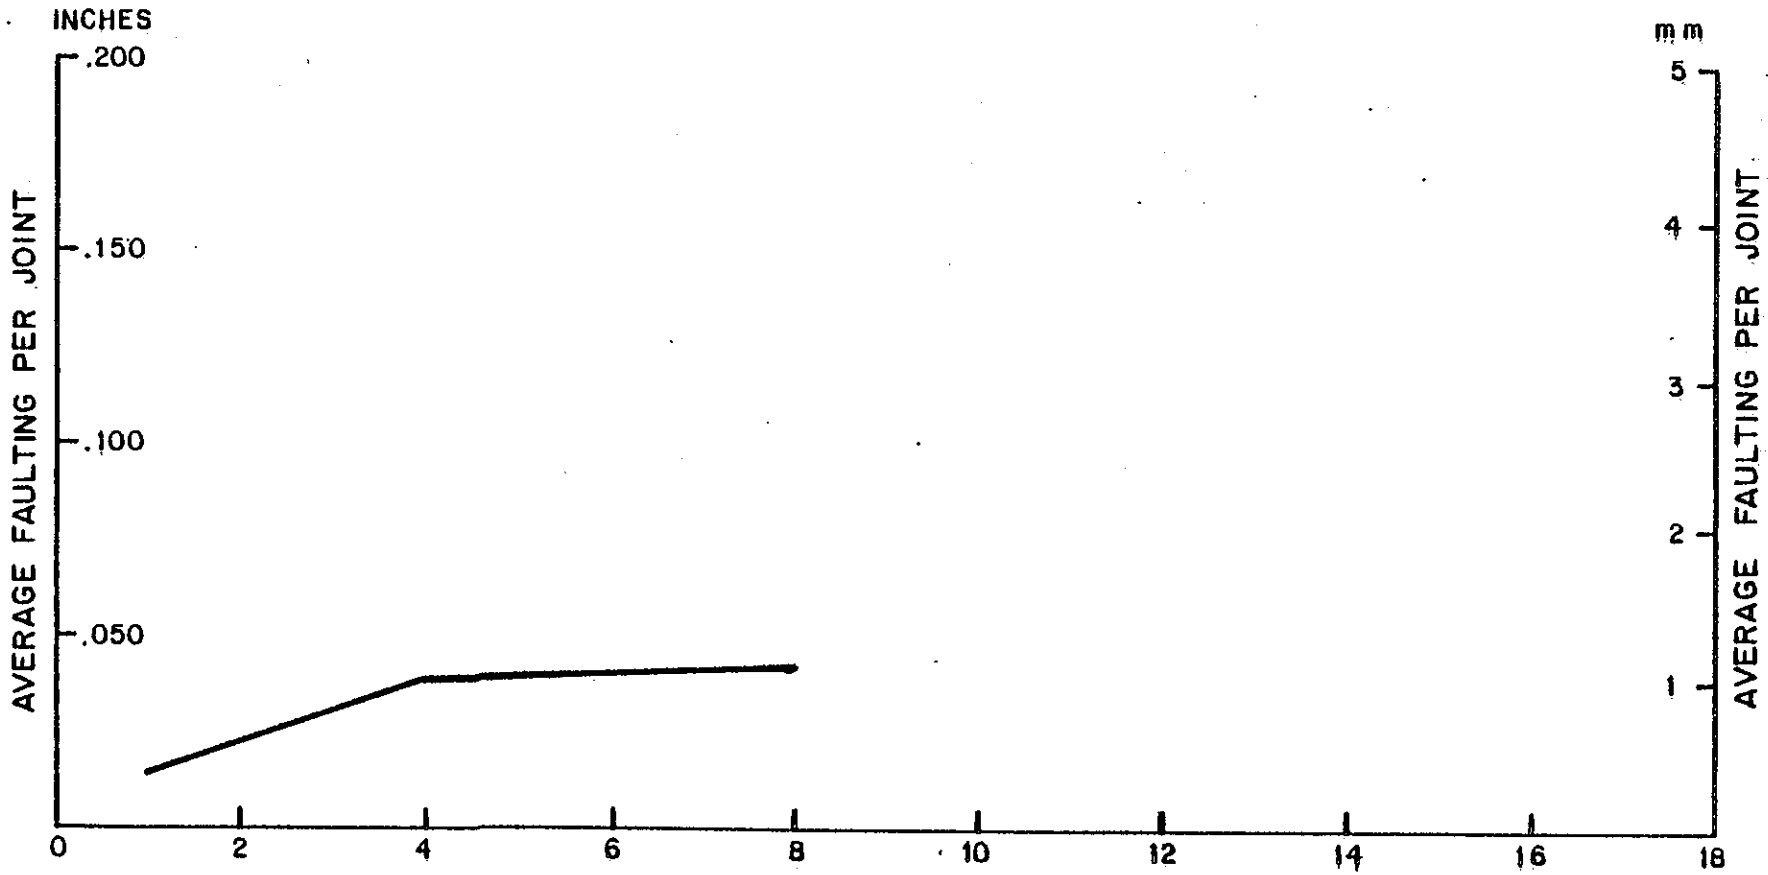
Figure B-2

11 Riv 10
INDIO

PAVED 1972
CT BASE

FAULTING TREND LINE

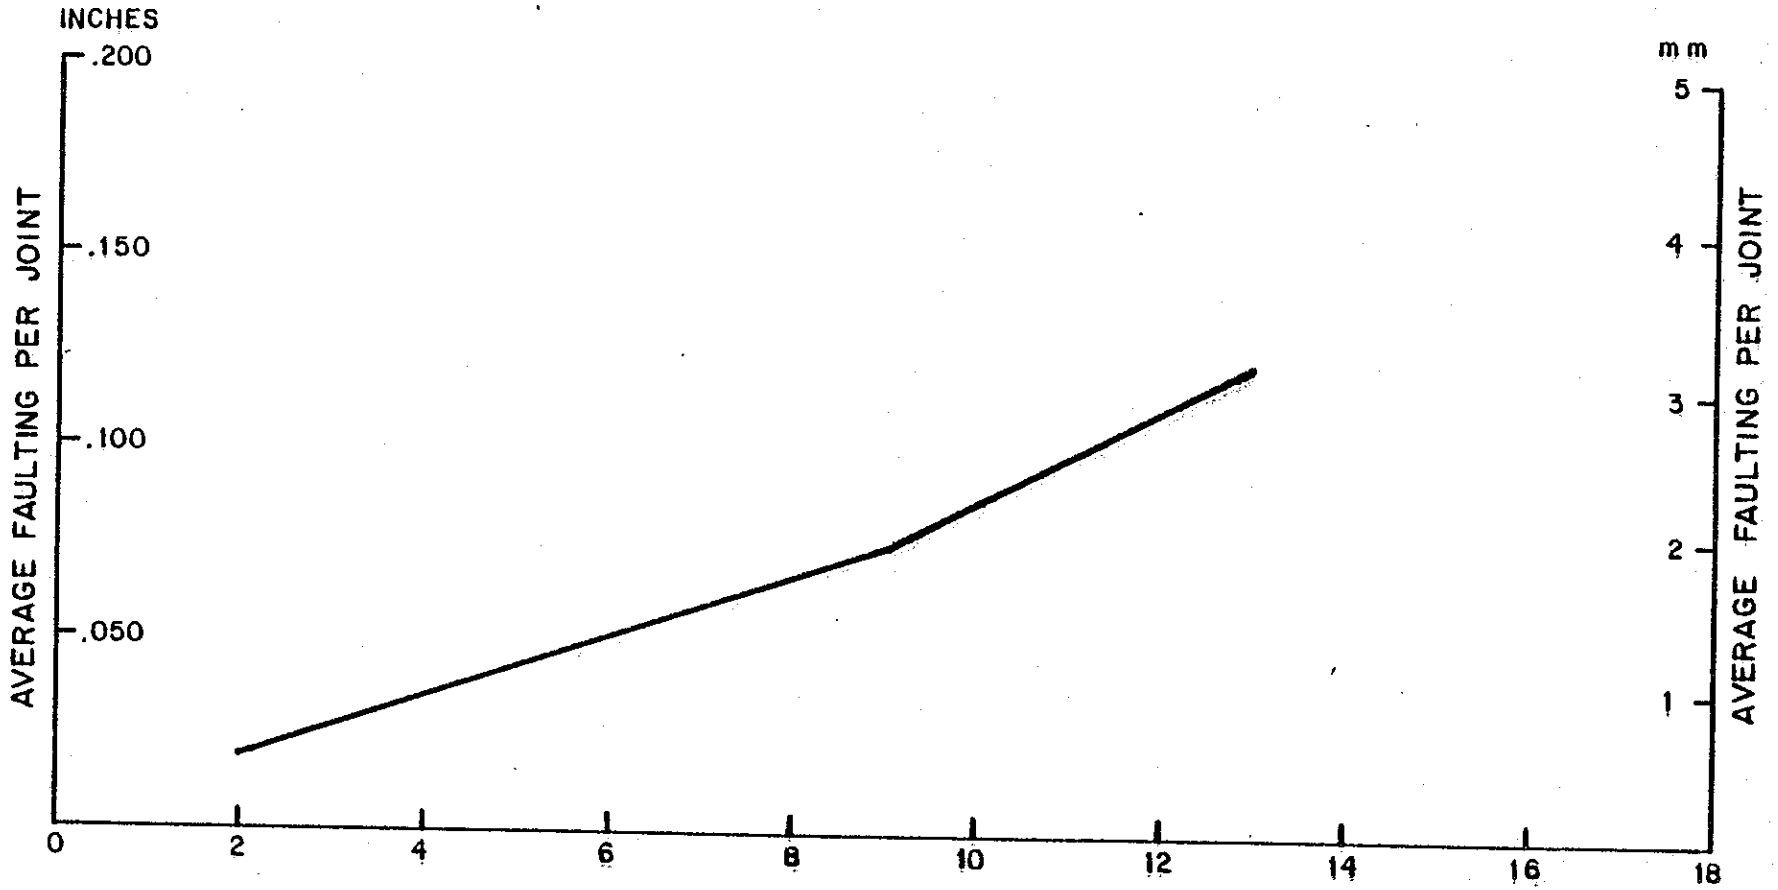
Figure B-3

02 Sha 5
REDDING

PAVED 1967
AC BASE
(AC = Asphalt Concrete)

FAULTING TREND LINE

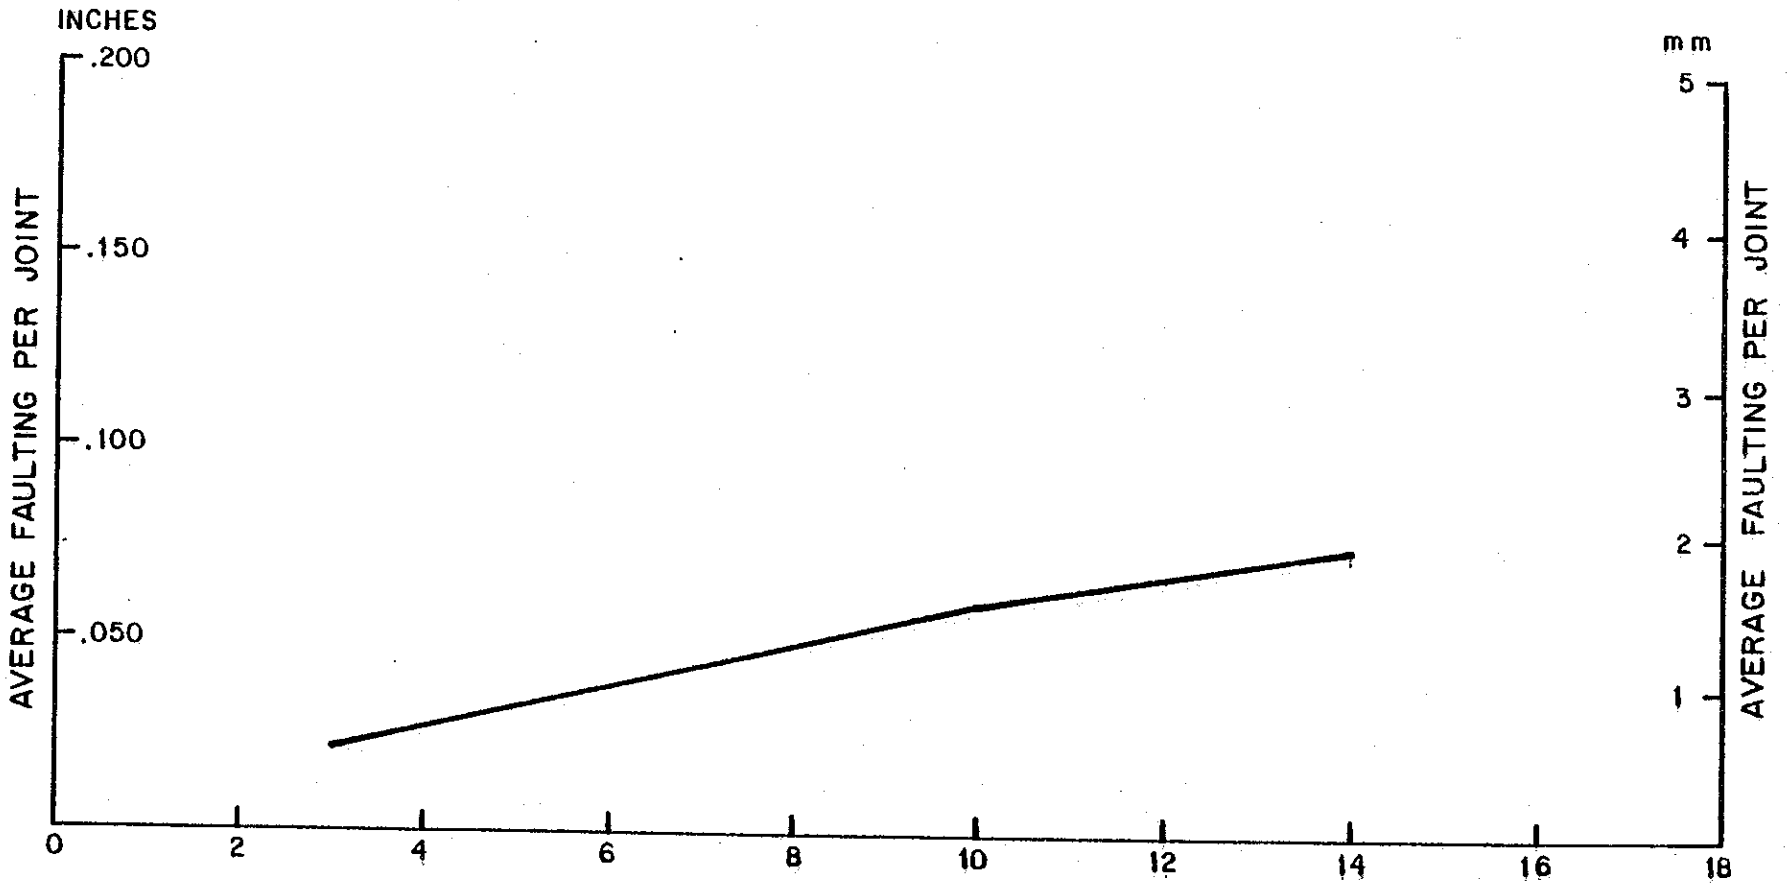
Figure B-5

10 SJ 580
VERNALIS

PAVED 1966
CT BASE

FAULTING TREND LINE

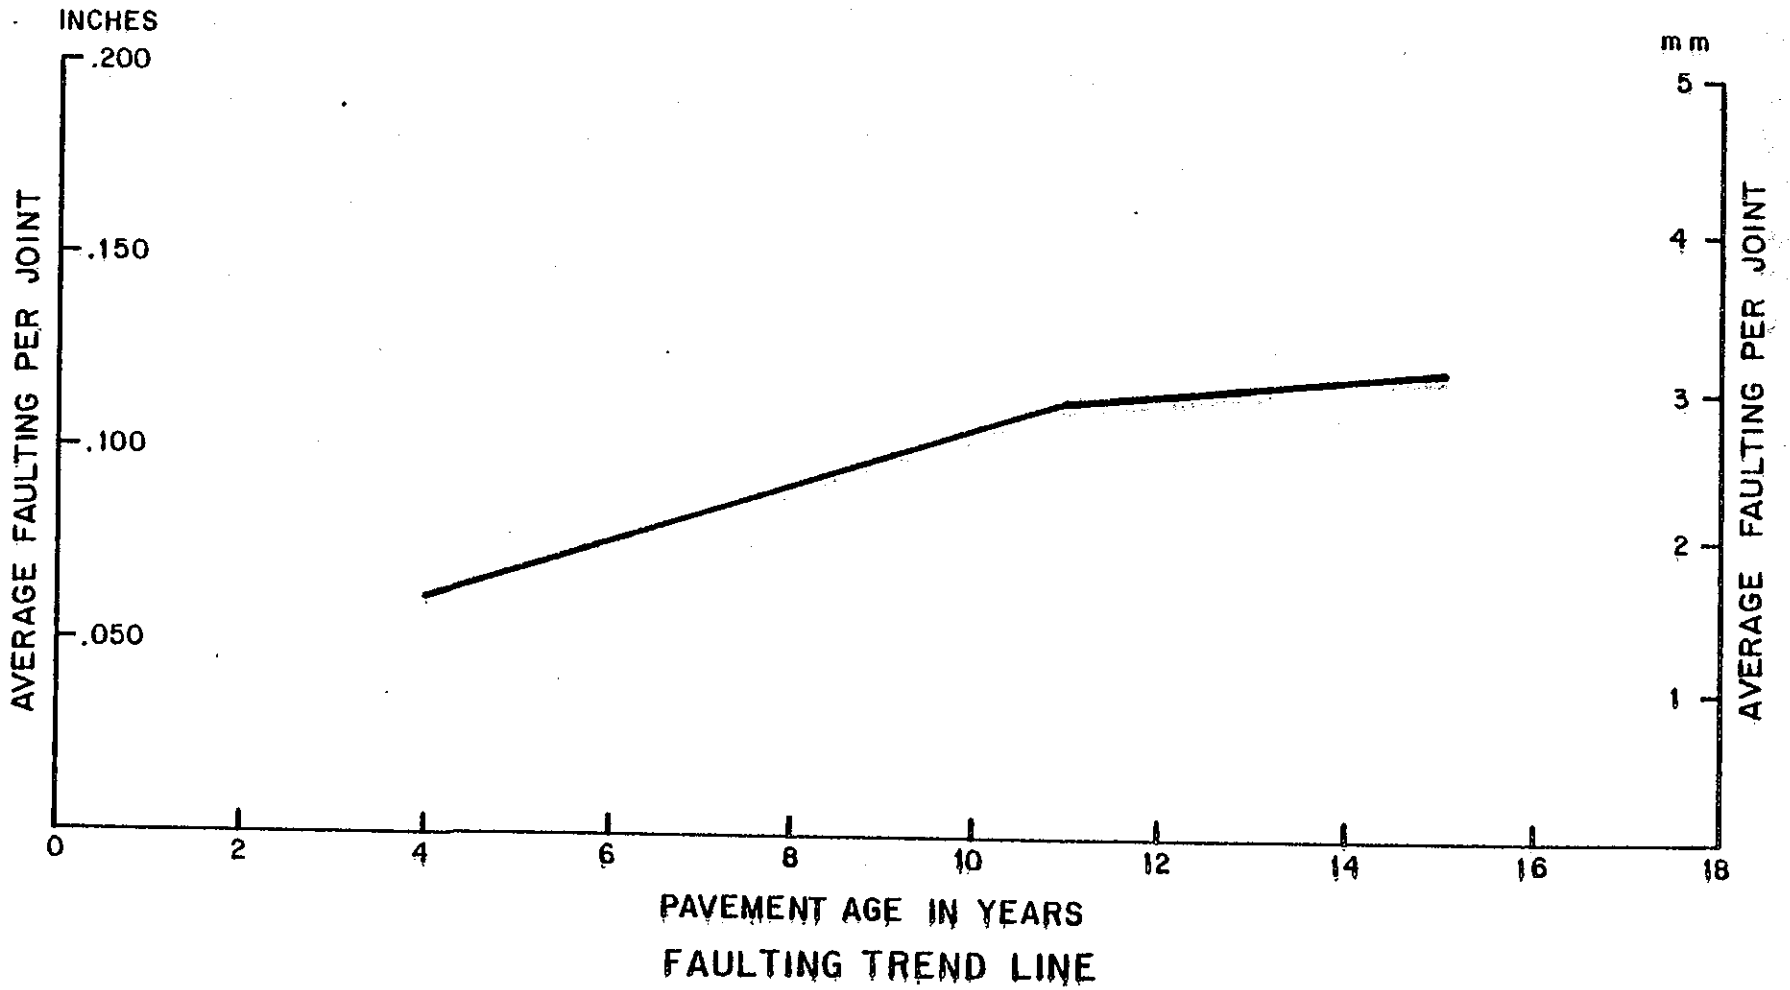
Figure B-6

10 Mer 152
PACHECO PASS

PAVED 1965
CT BASE

FAULTING TREND LINE

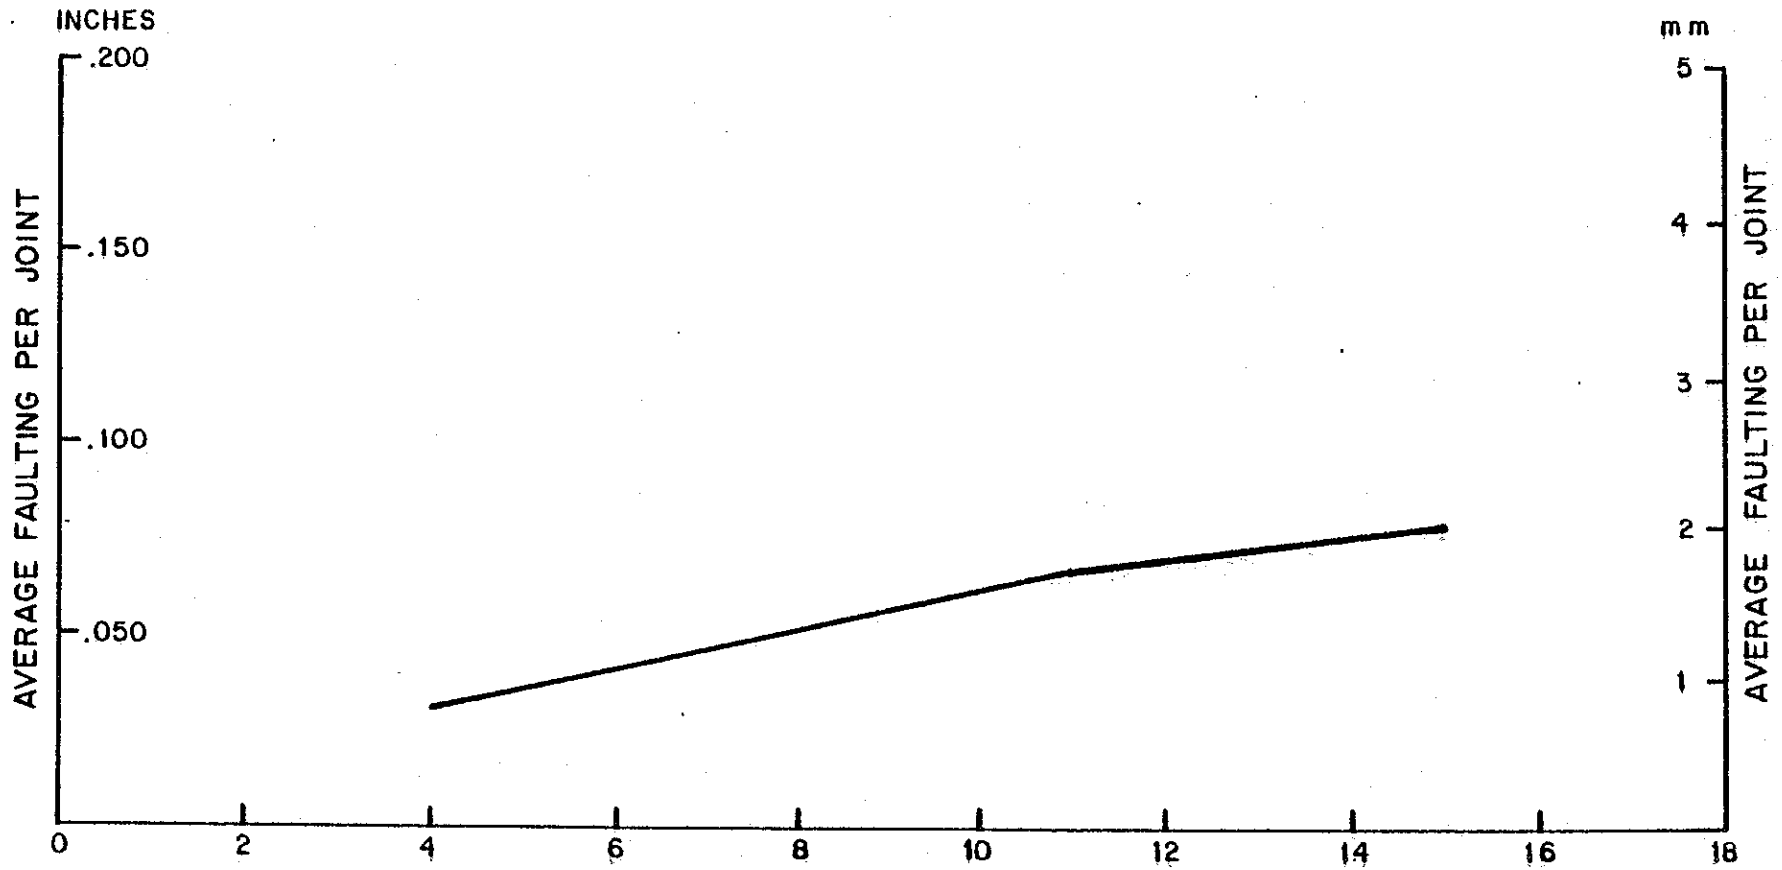
Figure B-7

08 SBd 15
CAJON PASS

PAVED 1965
CT BASE

FAULTING TREND LINE

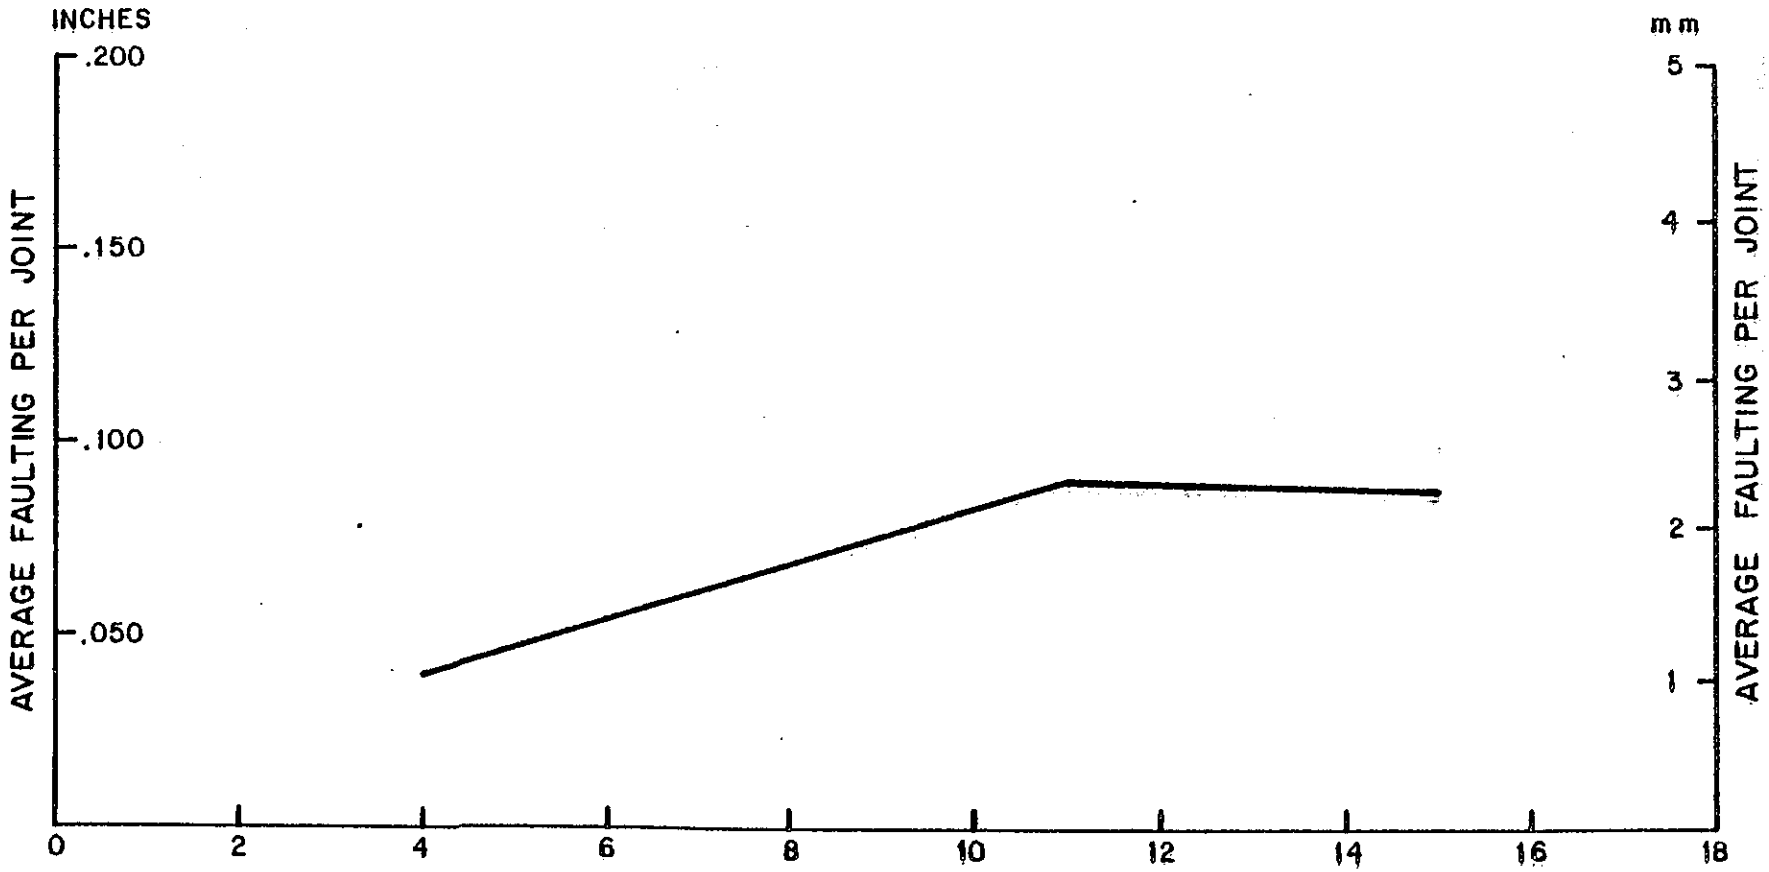
Figure B-8

09 Ker 58
TEHACHAPI WB

PAVED 1965
AC BASE

FAULTING TREND LINE

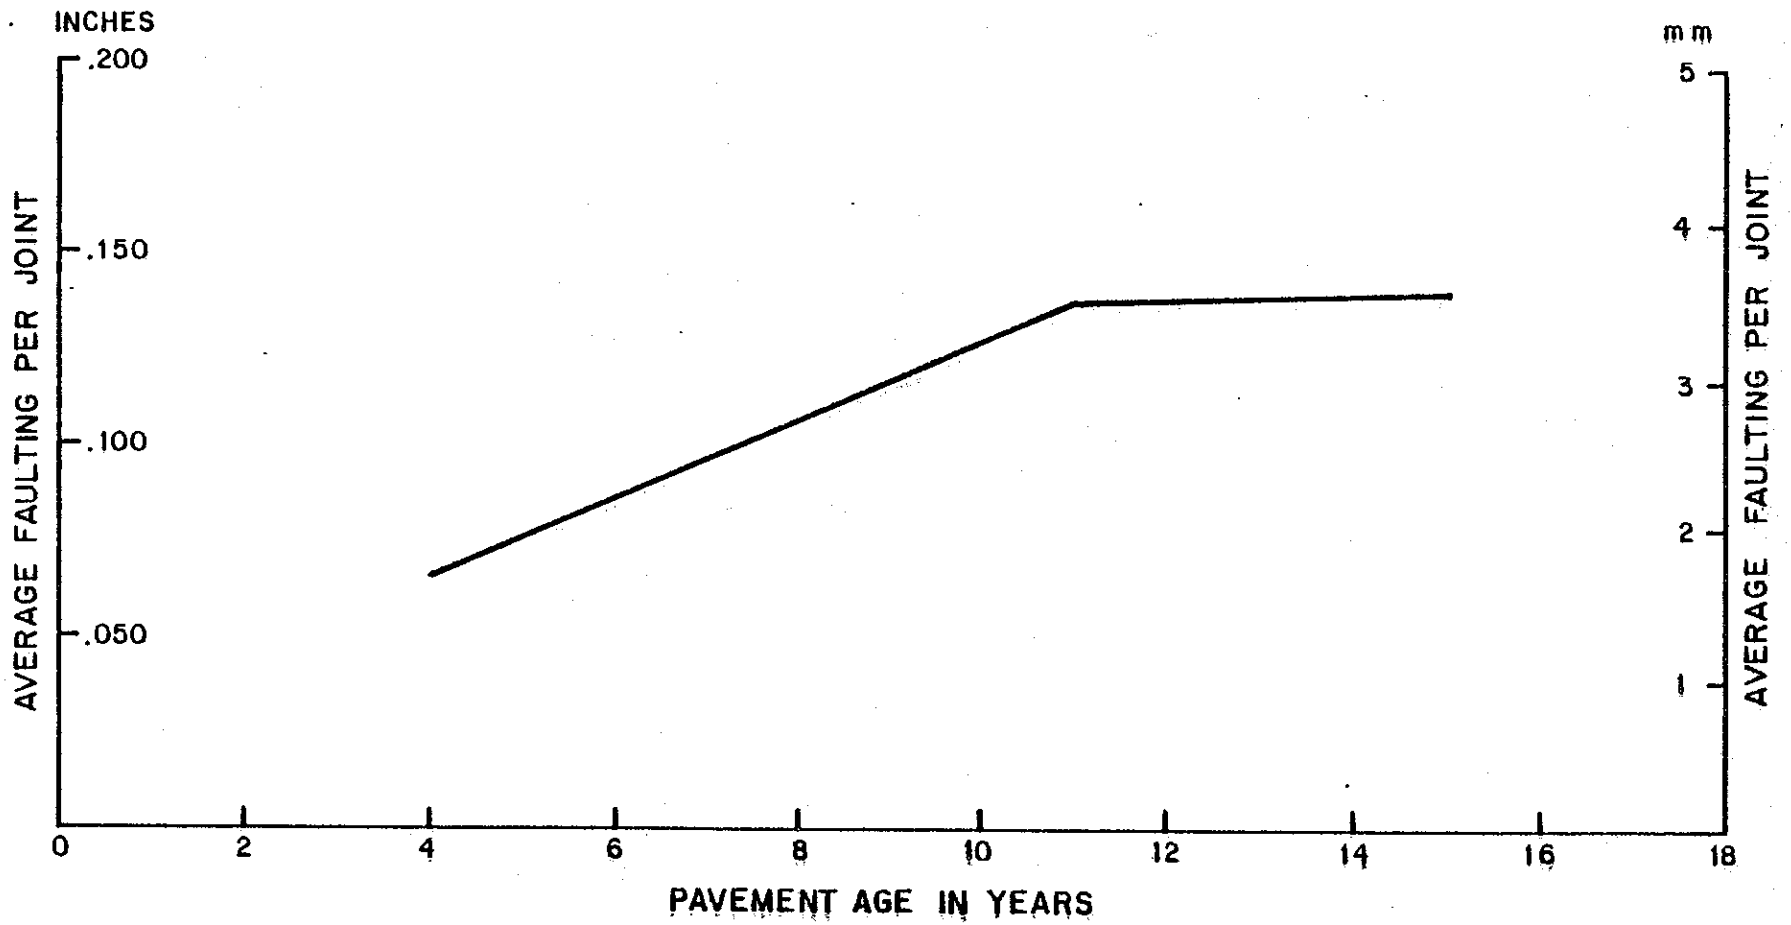
Figure B-9

09 Ker 58
TEHACHAPI EB

PAVED 1965
CT BASE

FAULTING TREND LINE

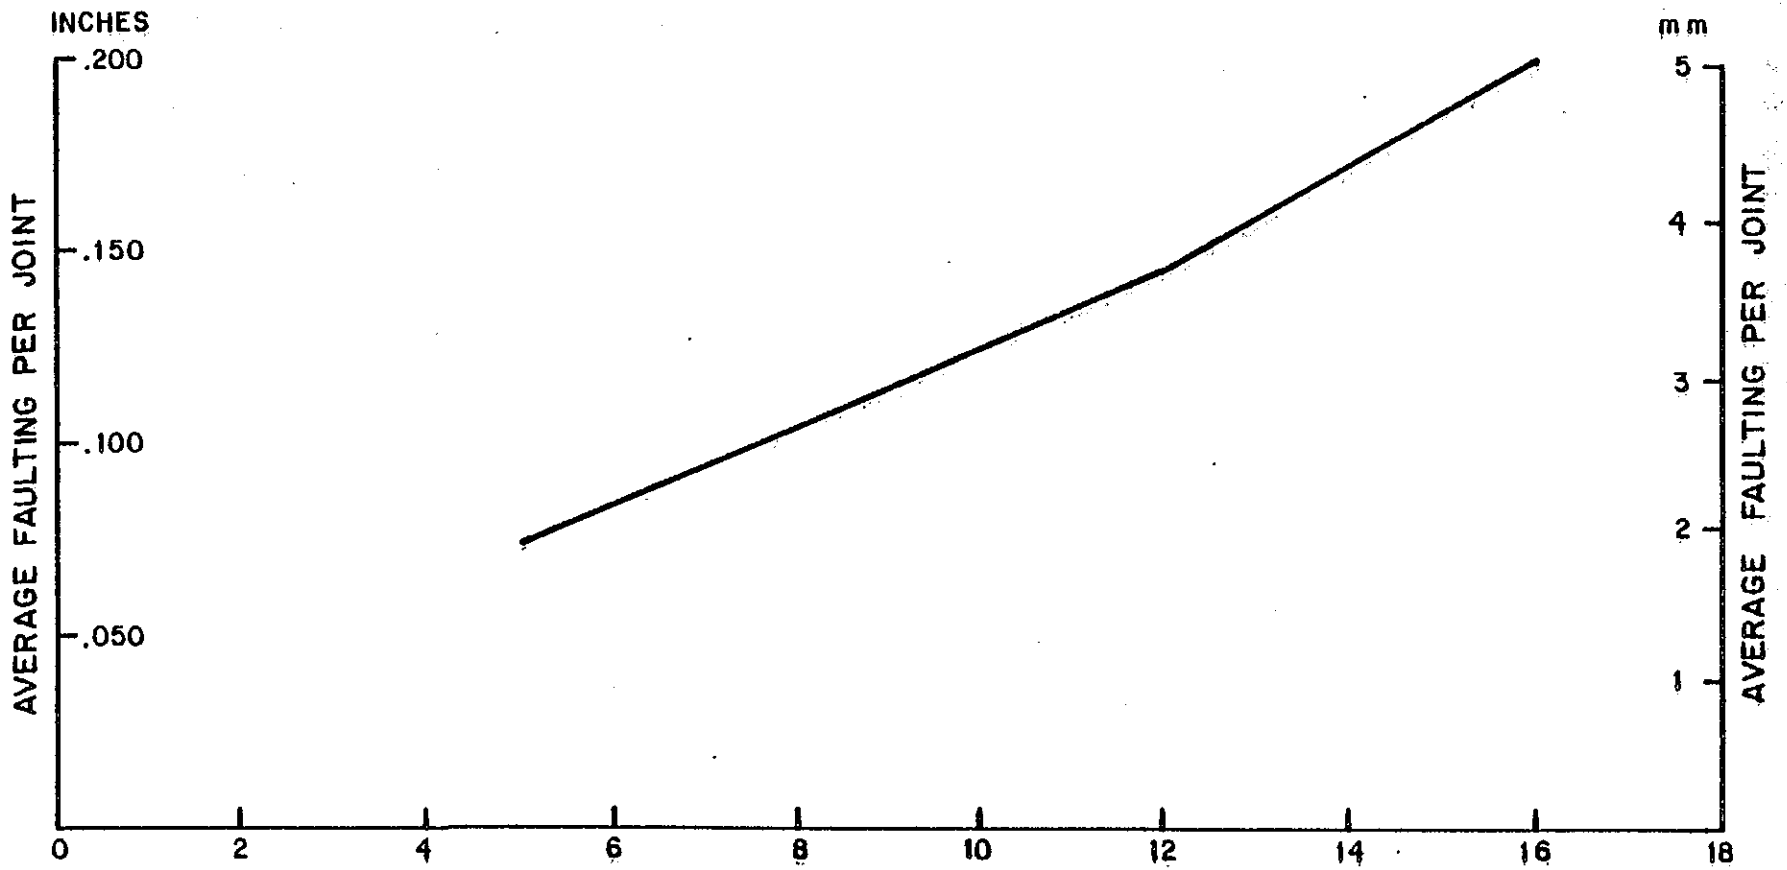
Figure B-10

02 Sis 5
MT SHASTA

PAVED 1964
CT BASE

FAULTING TREND LINE

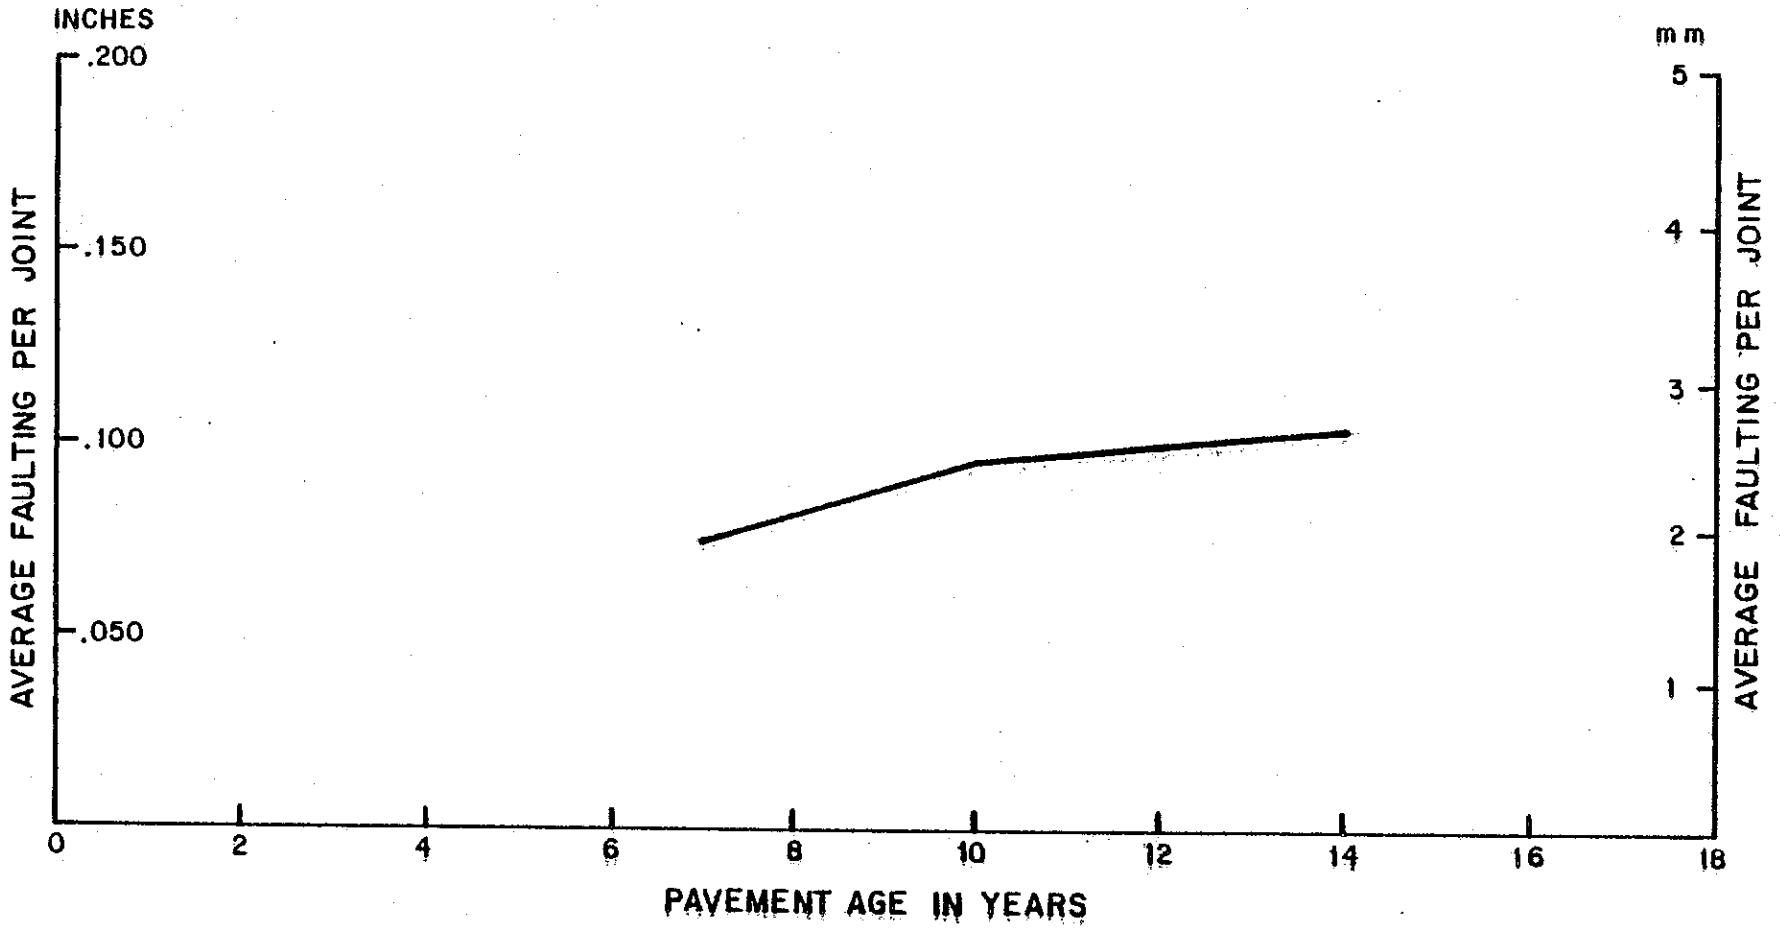
08 Riv 10
CABAZON

PAVED 1966
CT BASE

FAULTING TREND LINE
Figure B-11

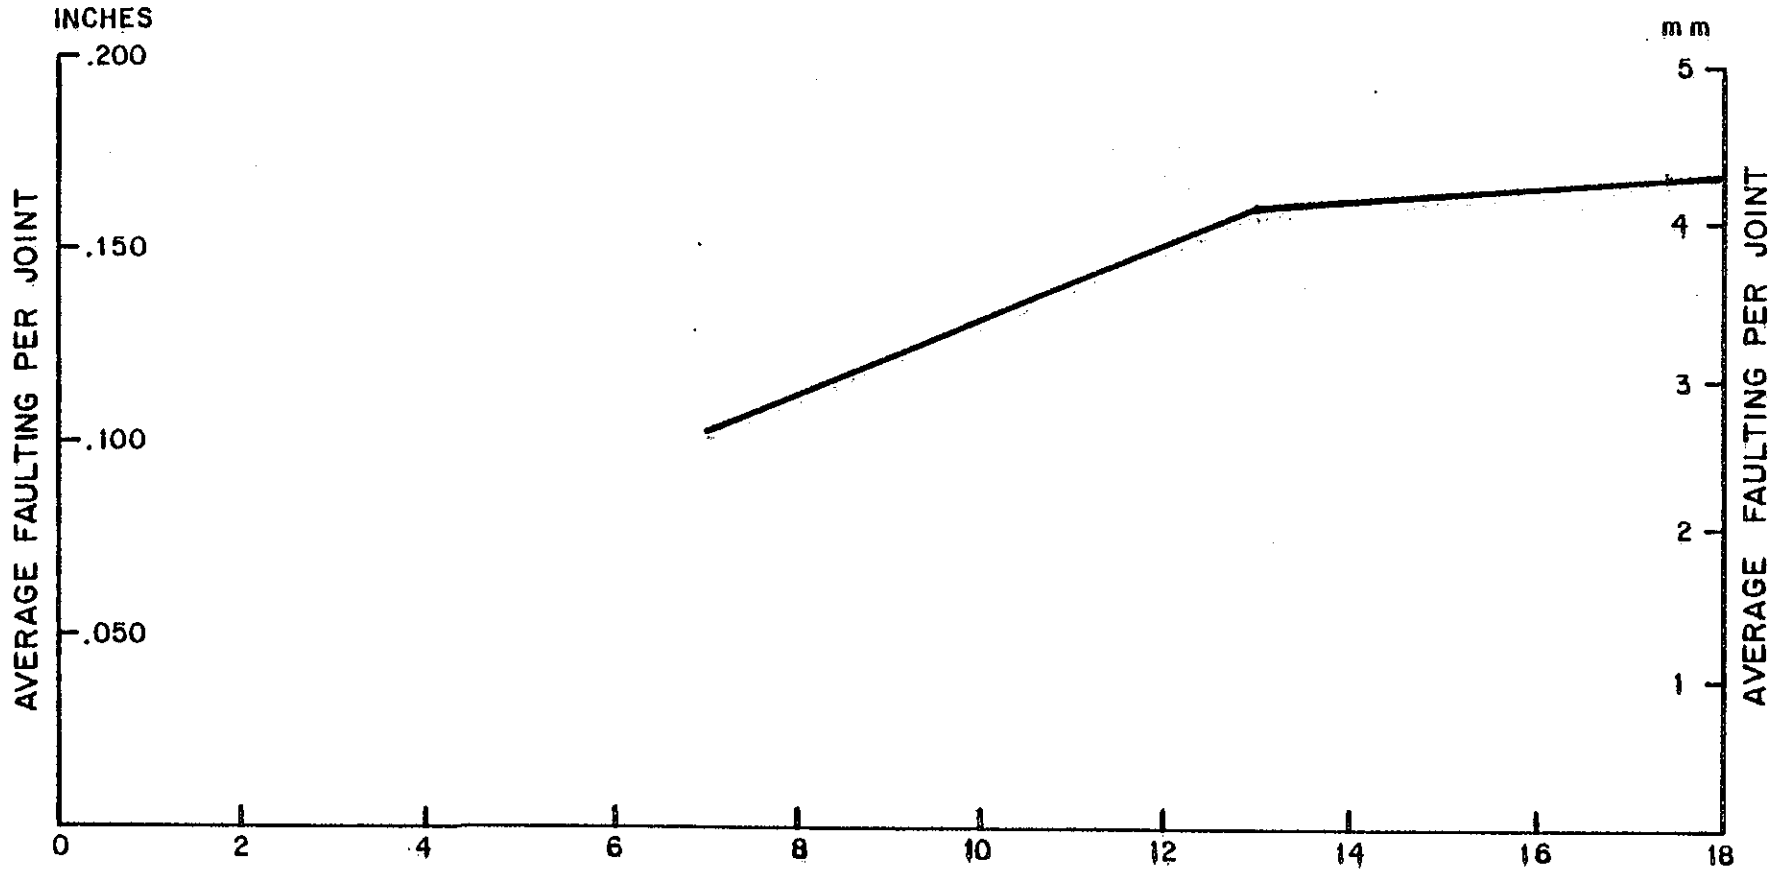
Figure B-12

03 Nov 80
YUBA GAP

PAVED 1962
CT BASE

FAULTING TREND LINE

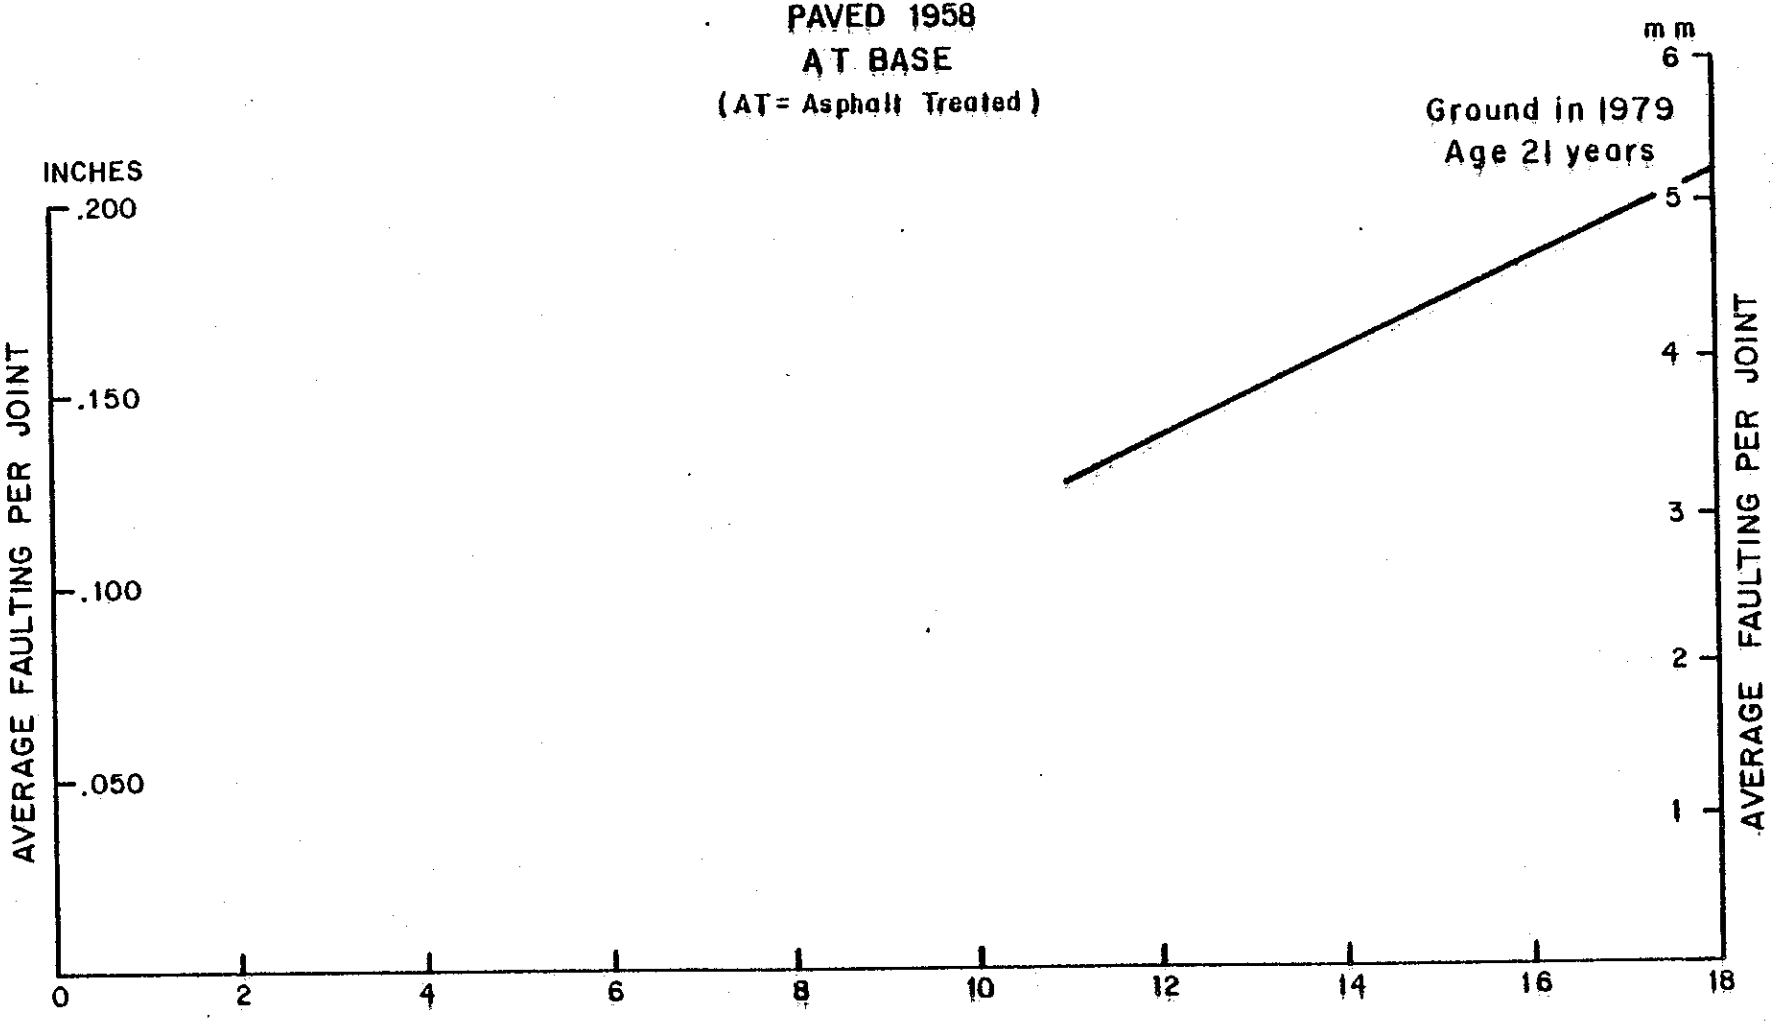
Figure B-13

05 SB 101
ORELLA

PAVED 1958
AT BASE
(AT = Asphalt Treated)

FAULTING TREND LINE

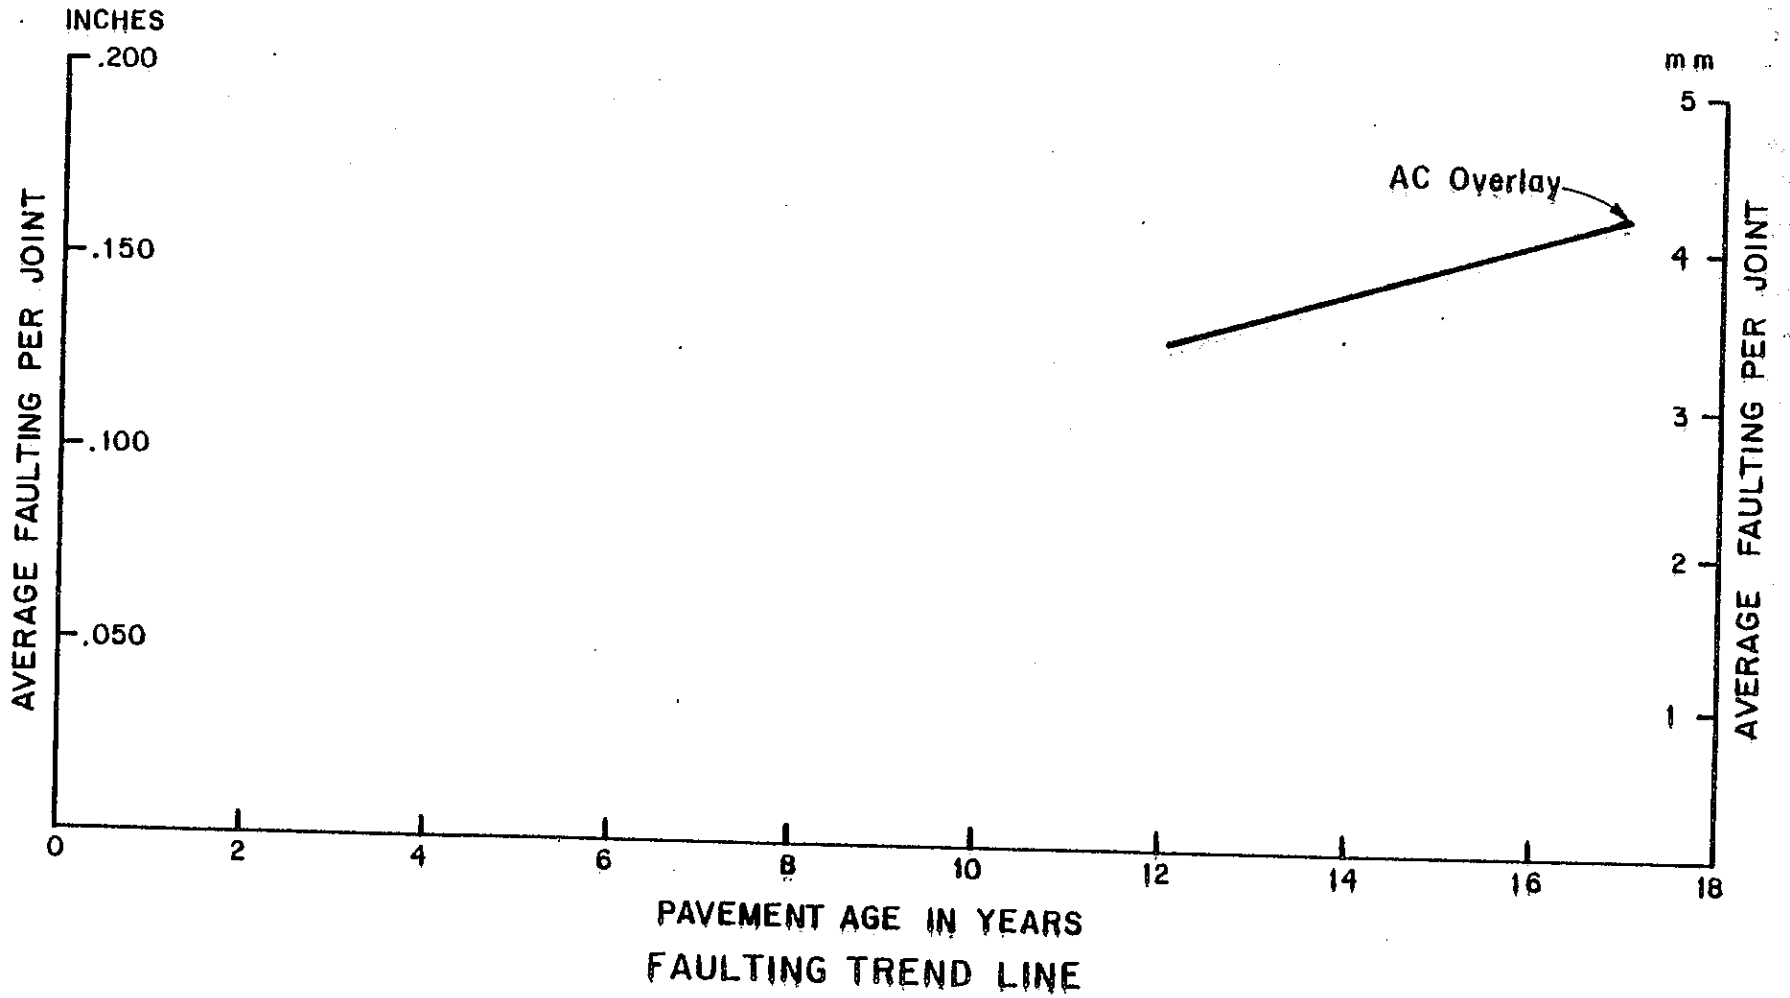
Figure 8-14

05 SLO 101
NIPOMO

PAVED 1957
CT BASE

FAULTING TREND LINE
