STATE OF CALIFORNIA
DEPARTMENT OF TRANSPORTATION
DIVISION OF CONSTRUCTION
OFFICE OF TRANSPORTATION LABORATORY

June 1980

FHWA No. F-7-33
TL No. 633170

MODEL SLAB FAULTING STUDY

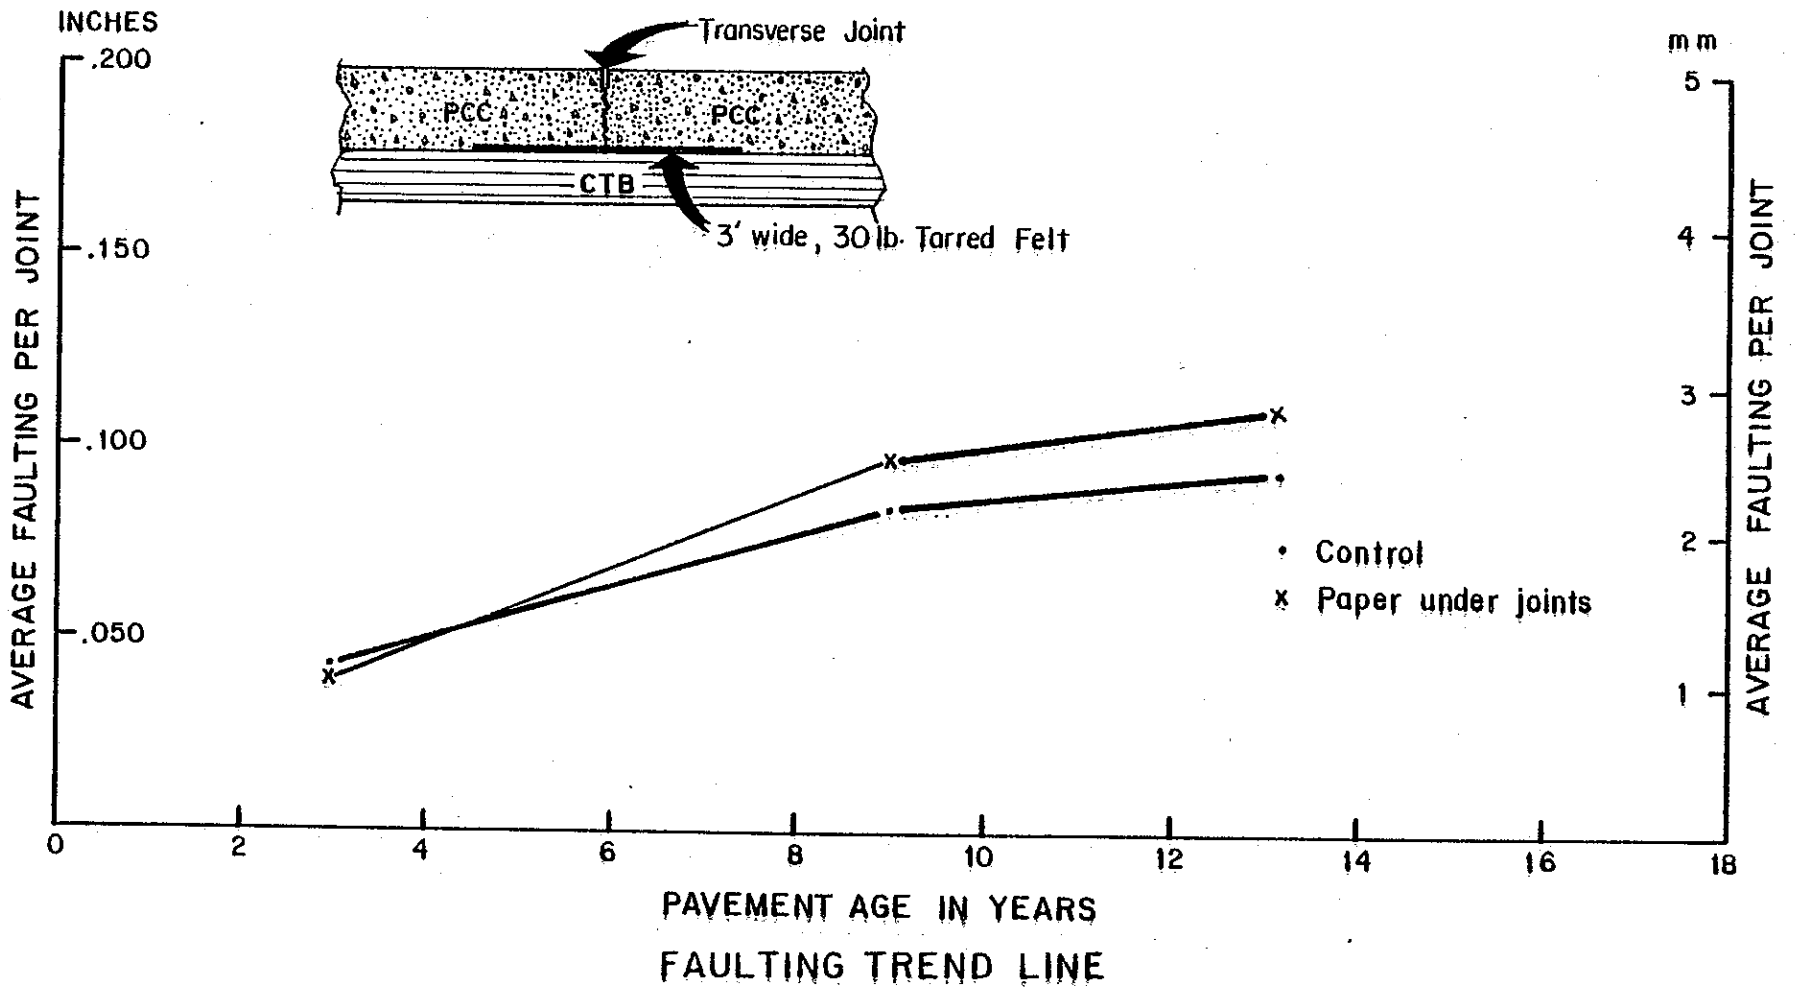
Figure B-15

04 Ala 680
SUNOL

PAVED 1967
CT BASE

FAULTING TREND LINE

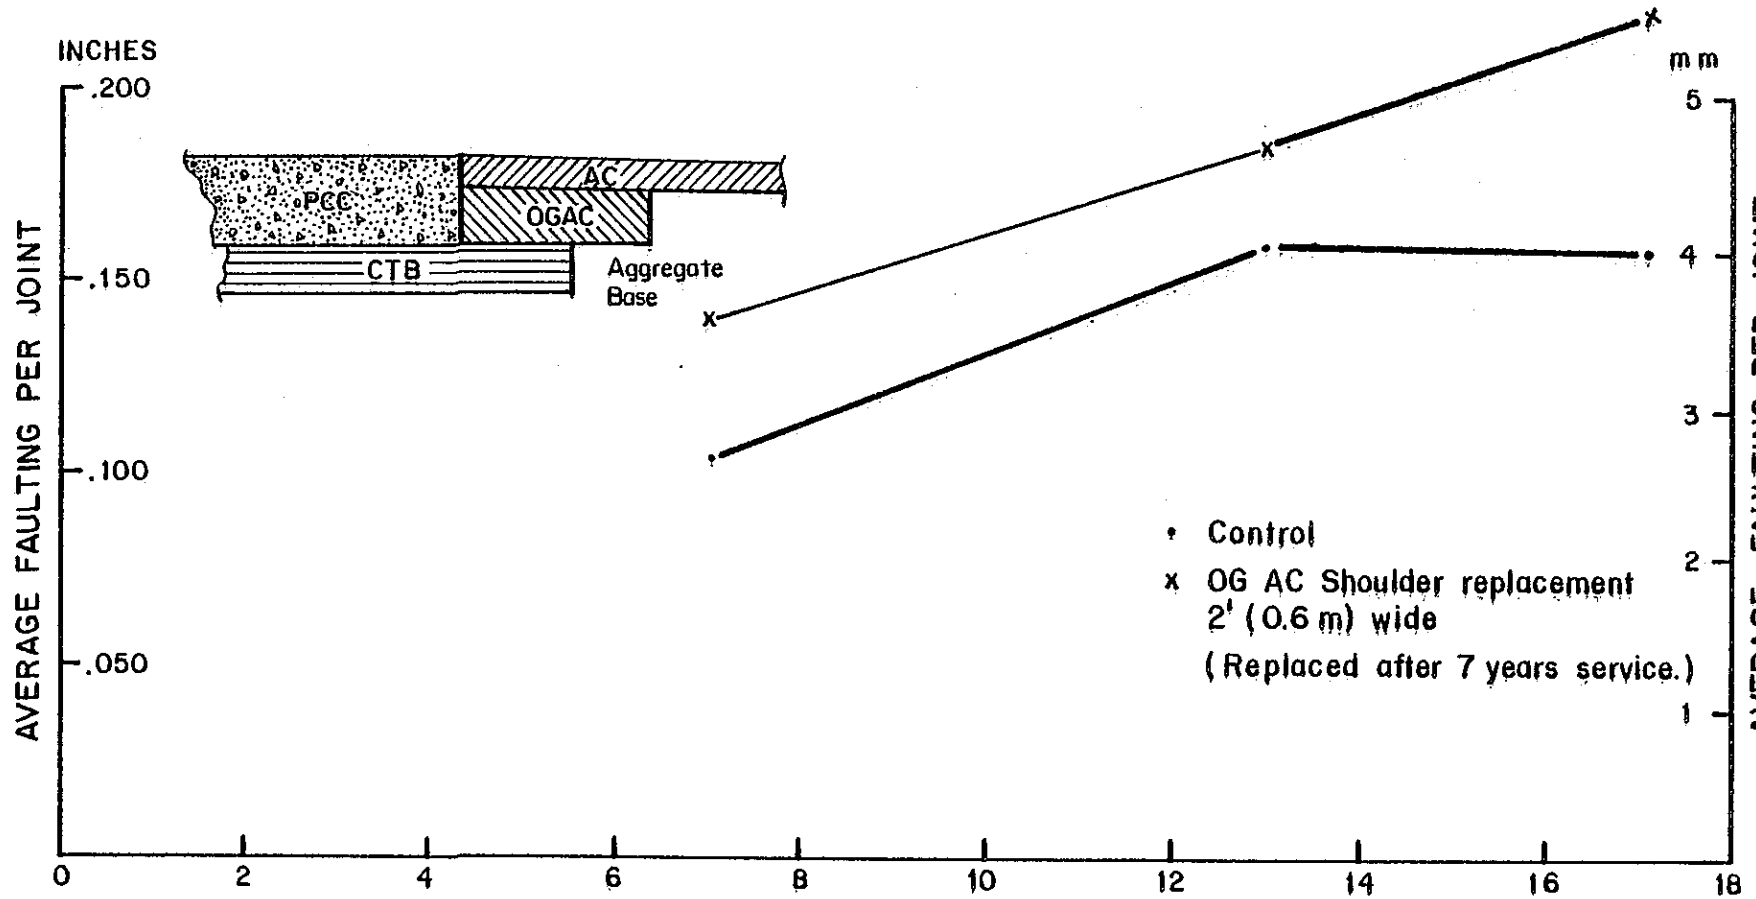
Figure B-16

10 Sol 80
VACAVILLE EB

PAVED 1963
CT BASE

FAULTING TREND LINE

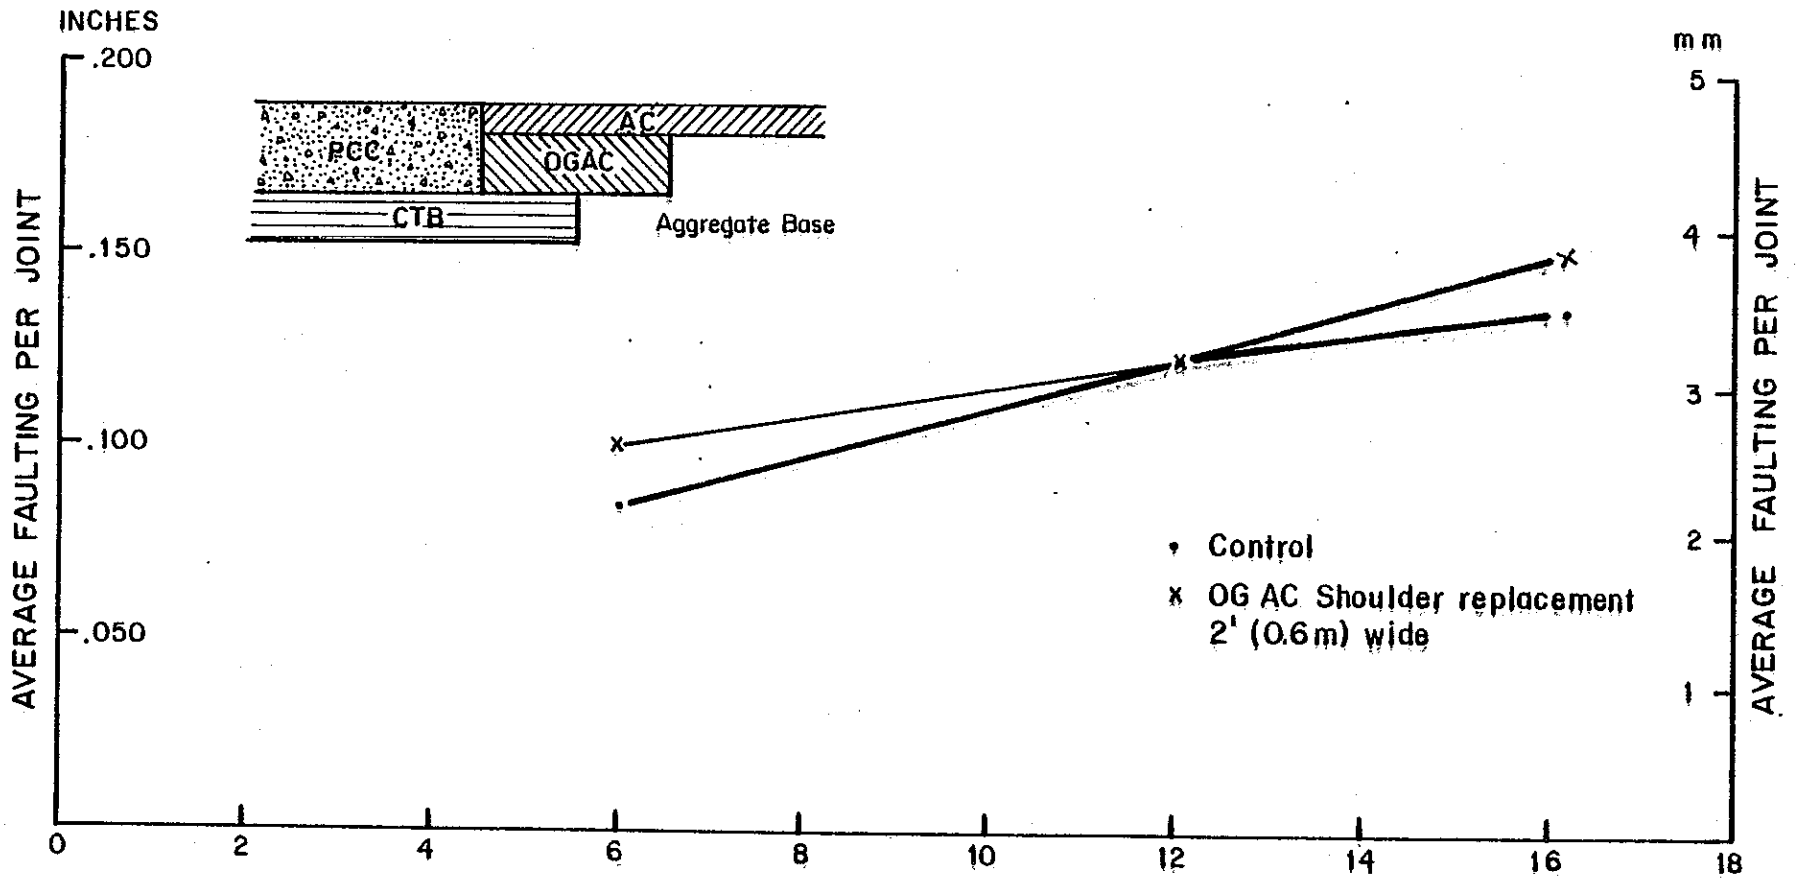
Figure B-17

10 Sol 80
VACAVILLE WB

PAVED 1964
CT BASE

FAULTING TREND LINE

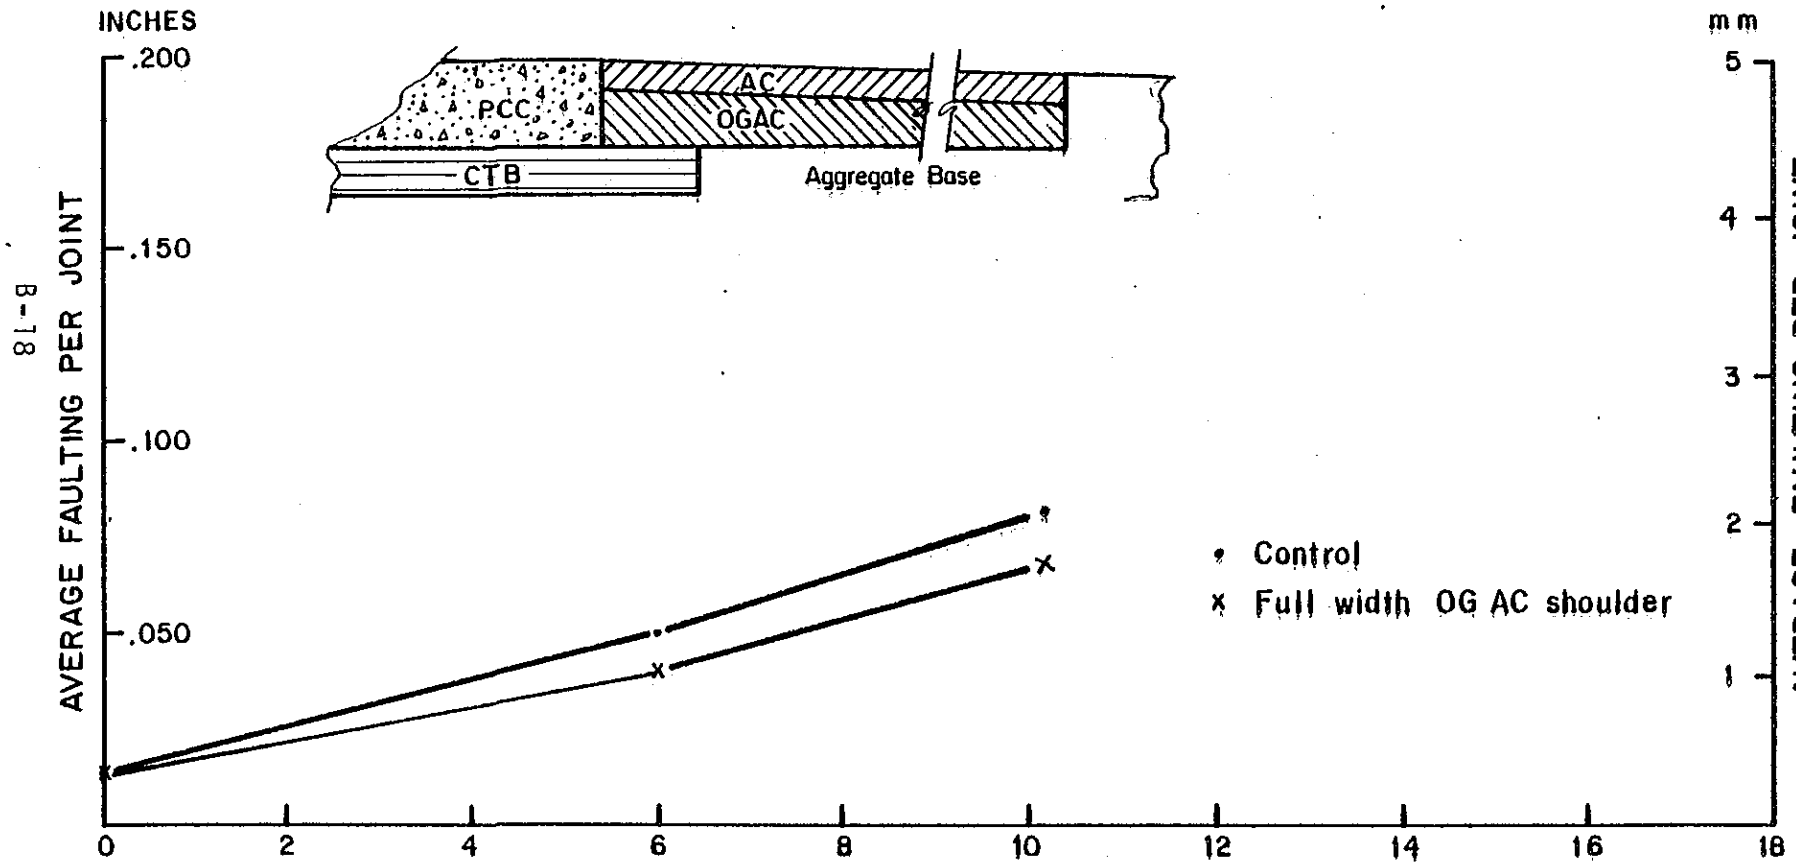
Figure B-18

03 Col 5
WILLOWS

PAVED 1970
CT BASE

FAULTING TREND LINE

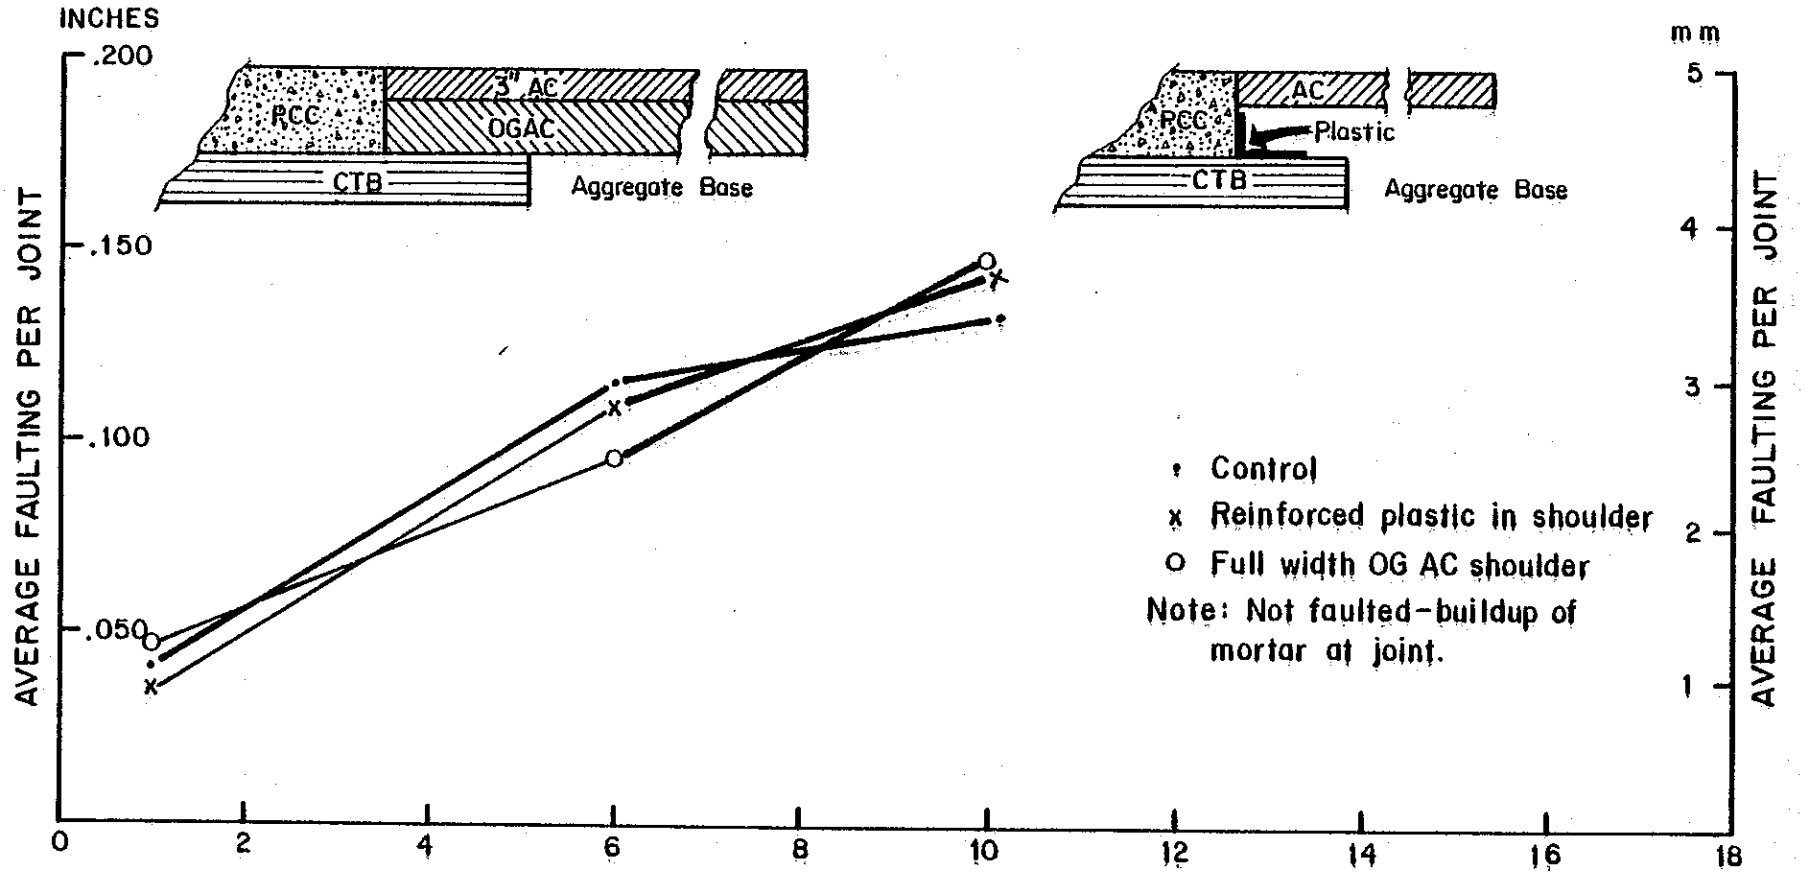
Figure B-19

10 Sta 99
SALIDA

PAVED 1970
CT BASE

FAULTING TREND LINE

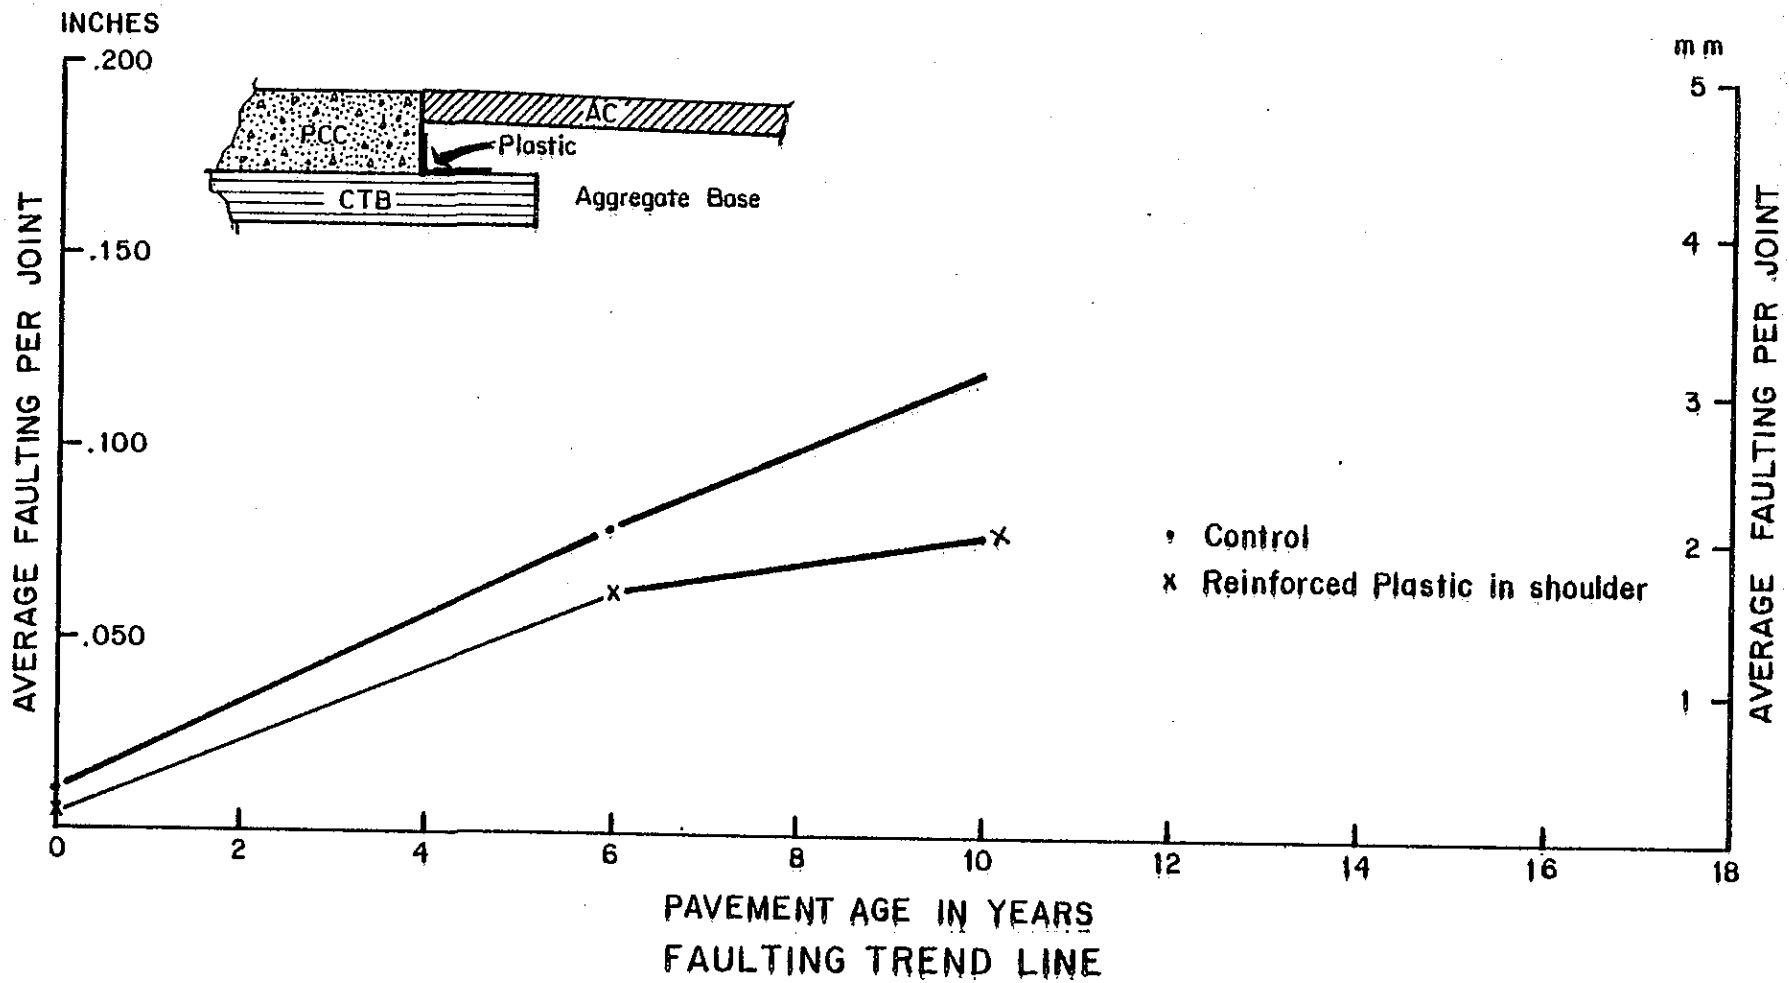
Figure B-20

10 SJ 205
N. TRACY

PAVED 1970
CT BASE

FAULTING TREND LINE

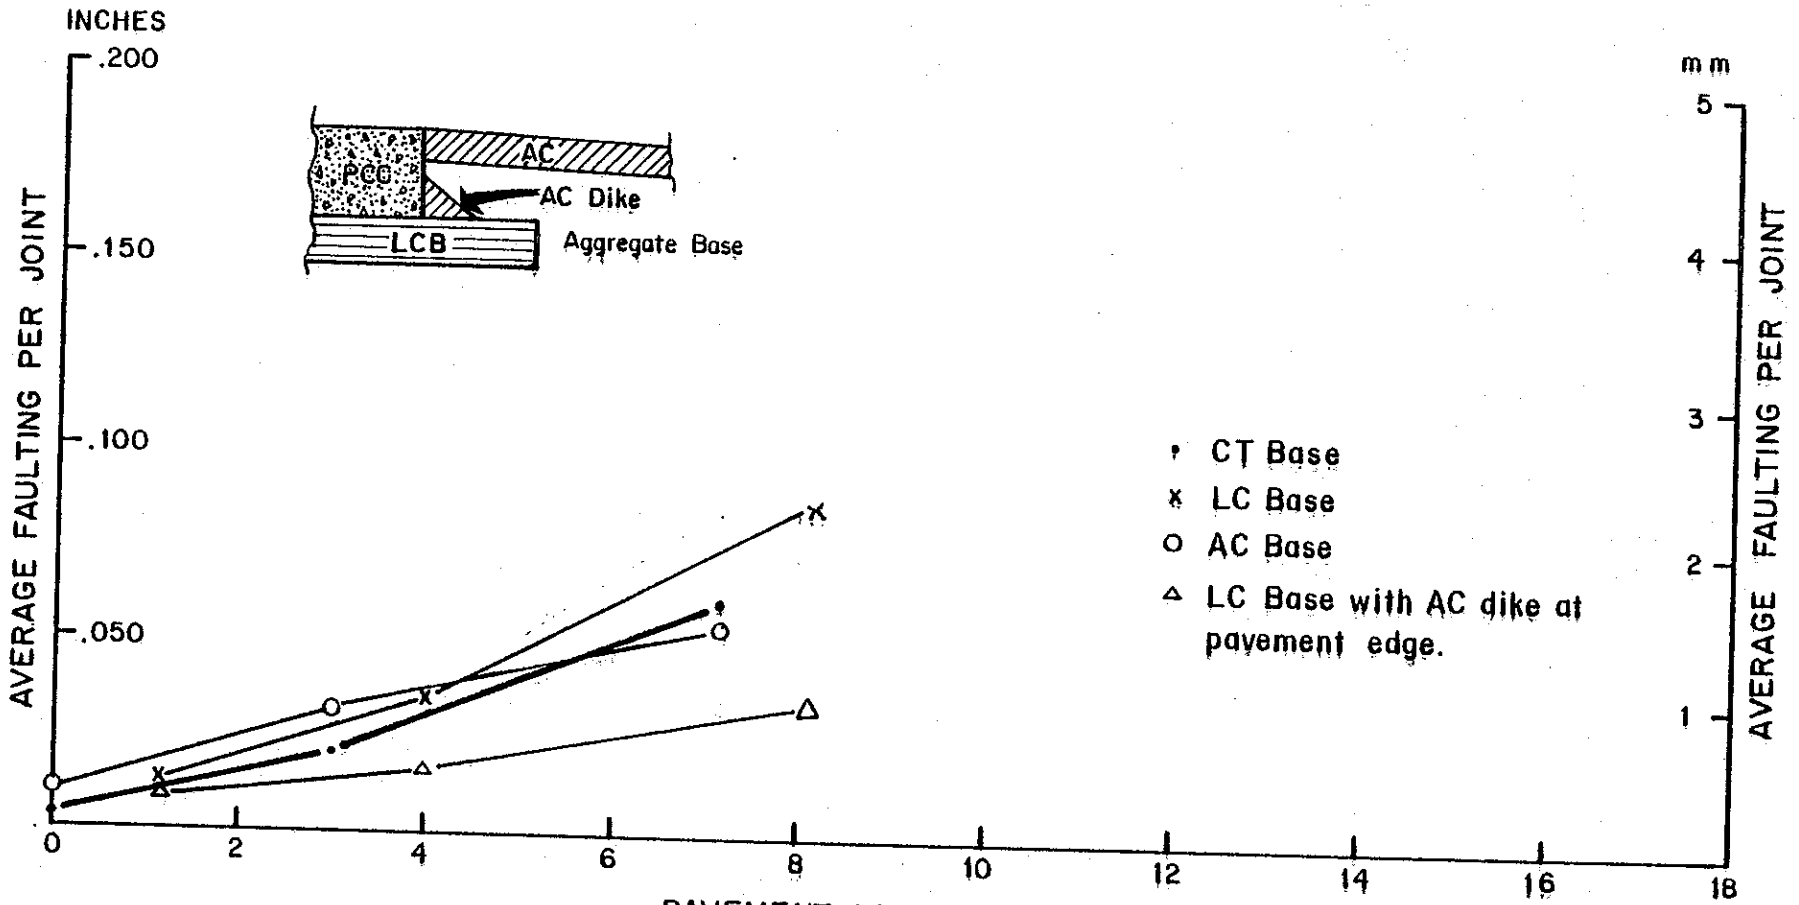
Figure B-21

05 Mon 1
FORT ORD

PAVED 1972 & 1973

FAULTING TREND LINE

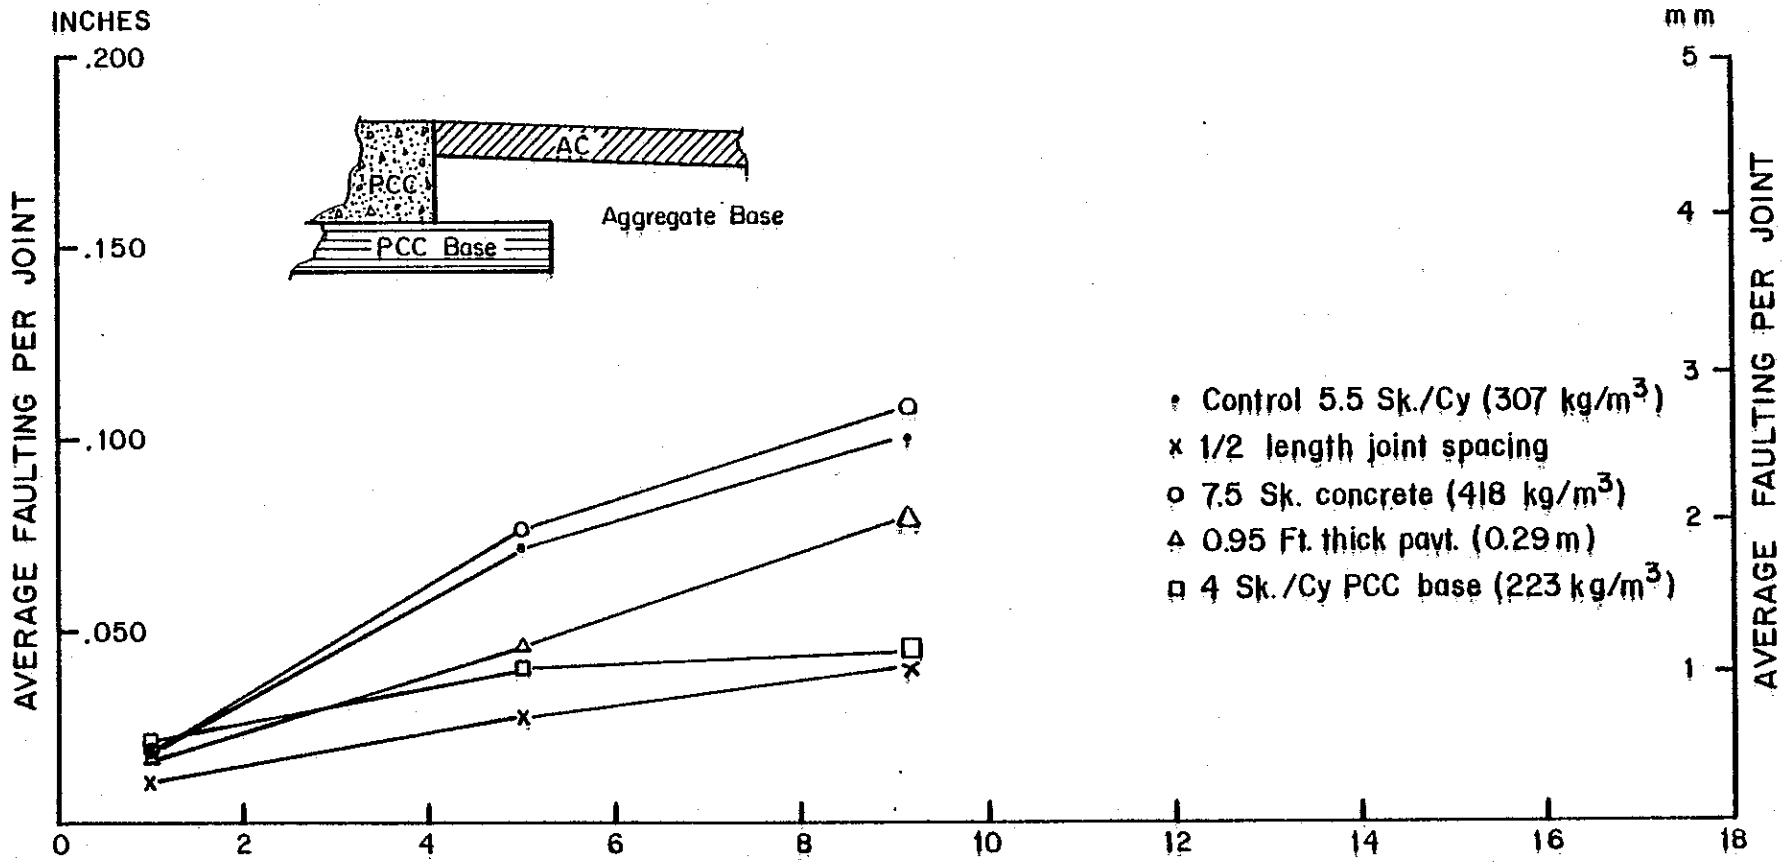
Figure B-23

PAVED 1971

CT BASE

FAULTING TREND LINE
