Investigation of Integrity and Effectiveness of RC Bridge Deck Rehabilitation Using CFRP Composites

Final Report

Report No. CA04-0112

November 2008

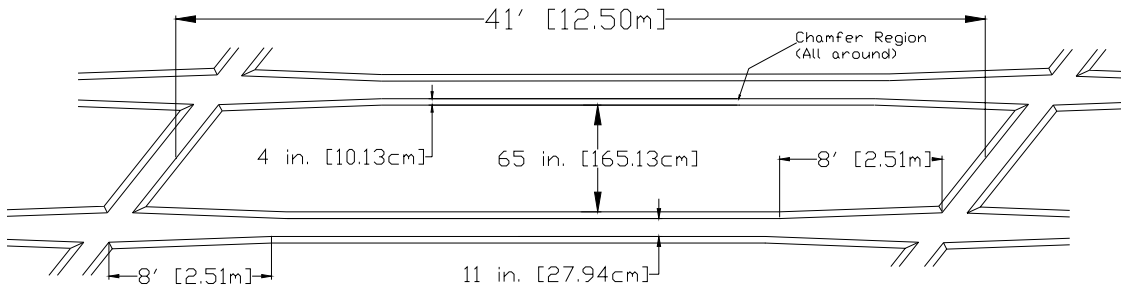
Figure 5.4. Typical Interior Bay of Watson Wash Bridge

A visual inspection of the Watson Wash Bridge reveals a significant number of transverse cracks in the soffit of the bridge deck. The spacing of these cracks is approximately 14 cm (5.5 inches) corresponding to the average spacing of the transverse reinforcement in the deck of the bridge. Figure 5.4 shows transverse cracking on the bridge deck soffit.

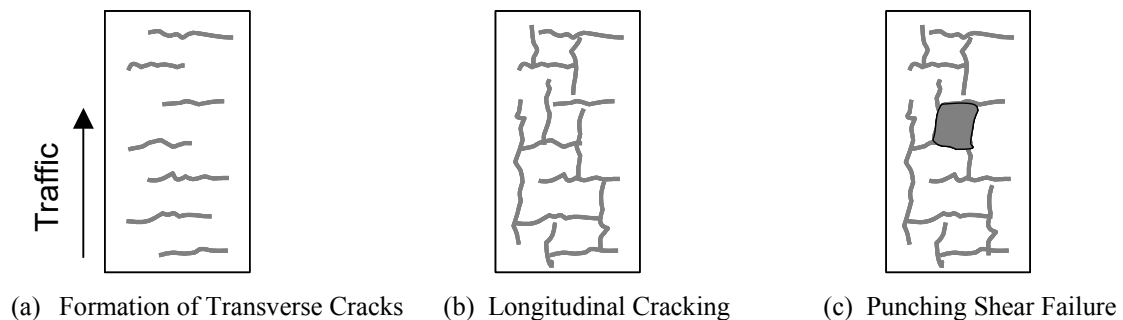
Figure 5.7. Flexural Cracking Patterns Leading to Punching Shear

(a) Formation of Transverse Cracks   (b) Longitudinal Cracking   (c) Punching Shear Failure

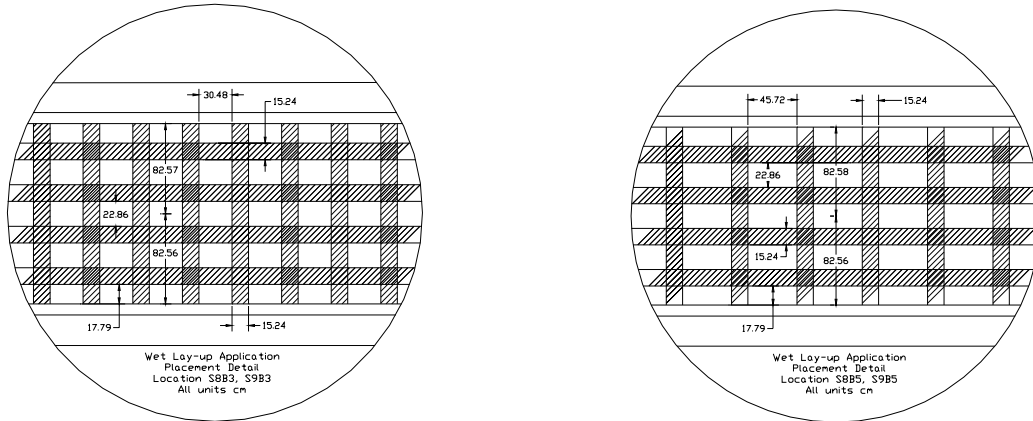
Figure 6.5. Placement of Wet Lay-up CFRP

Spacing of the CFRP rehabilitation is governed by the punching shear criterion as reported earlier in section 4.5.2. CFRP strips are placed such that punching shear perimeters are unable to develop, which translates into a nominal spacing of 60.96 cm (24 inches) center-to-center (c-to-c) for the transverse CFRP wet lay-up strips. The longitudinal CFRP wet lay-up strips are applied with consideration for the existing longitudinal steel reinforcement in the deck slab and thus placed at 22.86 cm (9 inches) c-to-c. The 22.86 cm (9 inches) c-to-c minimizes the overlap between composite and longitudinal steel reinforcement in the bridge slab. The spacing dimensions of the transverse and longitudinal reinforcement at the locations for the wet lay-up CFRP are provided in the following figure.

(a) CFRP Spacing for locations S8B5 and S9B5   (b) CFRP Spacing for locations S8B3 and S9B3

Table 6-11 provides a summary of the rehabilitation design using wet lay-up manufactured CFRP by location. For purposes of comparison, locations S8B3 and S9B3 are rehabilitated for the Permit Truck load condition. Locations S8B5 and S9B5 employ the Permit Truck load rehabilitation, with a nominal safety factor of 1.2 applied for transverse strips and a safety factor of 1.56 applied for longitudinal CFRP strips. Figure 6.7 identifies rehabilitation location by design requirement.

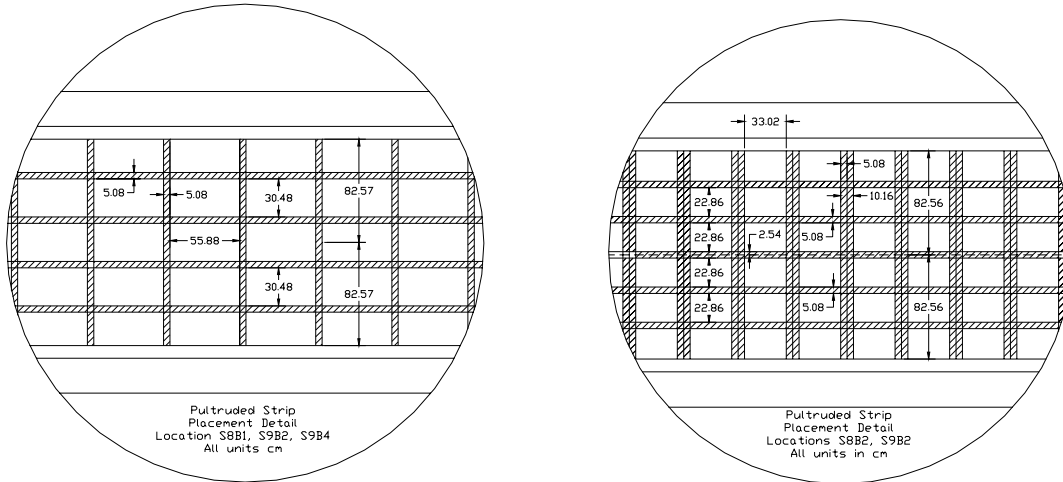
Figure 6.6. Placement of Pultruded CFRP Strips

As with the wet lay-up manufactured CFRP composites, the spacing of the unidirectional composites is governed by the punching shear criterion resulting in a nominal spacing of 60.96 cm (24 inches) c-to-c. Similarly, the longitudinal CFRP strips are bonded to the bridge deck soffit such that the bonded pultruded strips alternate between existing steel reinforcement. The spacing of the longitudinal and transverse strips for both the punching shear and permit load requirements is shown in Figure 6.6.

(a) CFRP Spacing at S8B1, S9B1, and S9B4   (b) CFRP Spacing at S8B2 and S9B2

The rehabilitation design in locations S8B1, S9B1 and S9B4 utilize the punching shear condition as the governing load condition, while locations S8B2 and S9B2 are rehabilitated for the Permit Truck Load Condition. Locations S8B2 and S9B2 are strengthened with 29 pairs of transverse strips and 5 longitudinal strips. A transverse strip pair is two 50.8 mm (2 inches) wide CFRP pultruded strips applied adjacent to each other, which is effectively a 101.6 mm (4 inches) wide single strip of CFRP. Locations S8B1 and S9B1 are strengthened to prevent punching shear failure and thus have 21 transverse strips and 4 longitudinal strips.   Table 6-13 provides a summary of the rehabilitation design using pultruded CFRP strips with respect to location

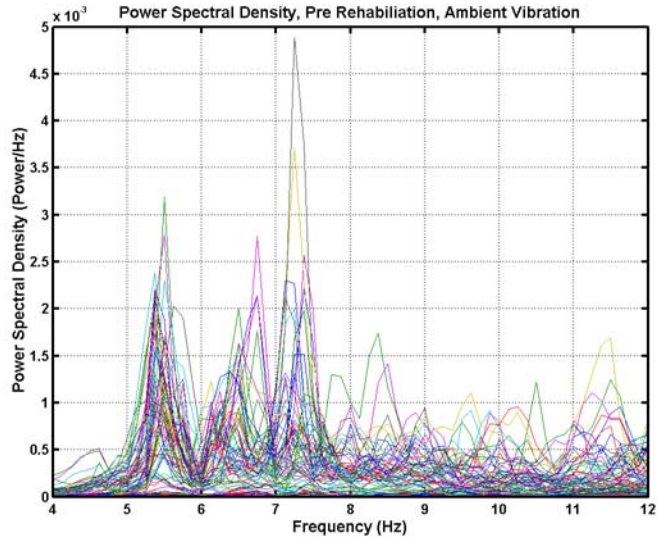
Figure 7.14. Power Spectral Density of All Signals, July 2001

In Figure 7.14, peaks in the PSD plots are observed between 5 and 6 Hz, 6 and 7 Hz, and between 7 and 8 Hz prior to rehabilitation of the bridge structure. A closer examination of the PSD plot reveals that a number of frequency bands contain peaks which may correspond to vibration modes of the bridge structure. Therefore, a wide array of frequency bands is used as input into the experimental modal analysis procedure for each time period. For each ambient modal vibration test, the same array of frequency bands is used to extract mode shapes from the recorded time history data of the bridge. The upper and lower bounds of the frequency bands used in the modal extraction procedure are shown in Table 7-2.

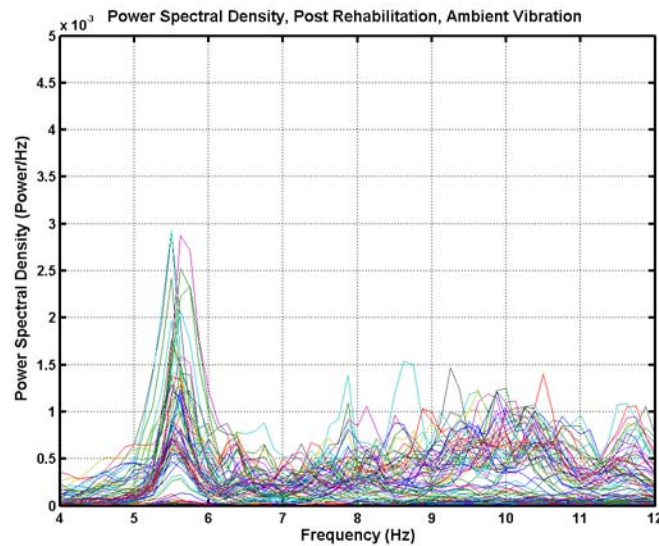
Figure 7.15. Power Spectral Density of All Signals, November 2001

Figure 7.15 shows the PSD plot for acceleration time history data recorded after FRP rehabilitation of the bridge deck. It is noted that besides the peak observed between 5 and 6 Hz, the PSD plot does not indicate any consistency among sensors for vibration modes in the frequency ranges specified in Table 7-2. Similar observation are made for Figure 7.16 and Figure 7.17, which are PSD plots for modal tests 1 year after FRP rehabilitation and prior to demolition, respectively. The frequency bands specified in Table 7-2 are applied when extracting the mode shapes from the measured acceleration time history of the bridge structure. While the PSD plots potentially indicate that only one vibration mode between 5 and 6 Hz is detected consistently in all data sets, mode shapes are validated between modal tests with the use of the modal assurance criteria (MAC) values (Ewins, 2000).

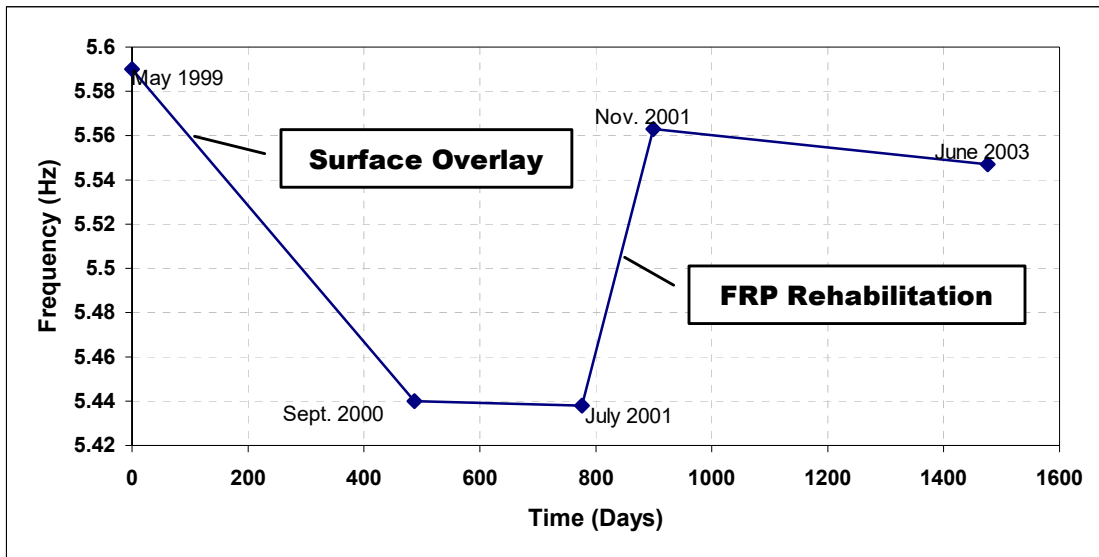
Figure 7.22. First Mode Frequency Results

A preliminary evaluation of mode 1 frequencies provides indications as to the change in structural performance relative to two distinct maintenance actions. First, the asphalt overlay applied to the structure in May 1999, increases the mass of the structure while providing negligible changes in the stiffness. On the other hand, the mode 1 frequencies indicate that rehabilitation of approximately two spans of Frame S-3 (2 of 4 spans, or 9 of 20 bays) with CFRP composites contributes to an increase in the stiffness of the frame. A summary of the maintenance measures and first mode frequency results is illustrated in the following figure.

An independent evaluation of the Watson Wash Bridge Structure of Frame S-3 showed that a mass density increase of 11.9% occurs following the application of the asphalt overlay from 2.42 g/cc (4.7 lb-s^2/ft^4) to 2.71 g/cc (5.26 lb-s^2/ft^4) (Stubbs et al, 2001) between May 1999 and September 2000. The mass density increase correlates with the experimentally measured frequency decrease since no stiffness increase is observed with the addition of the asphalt surface overlay.

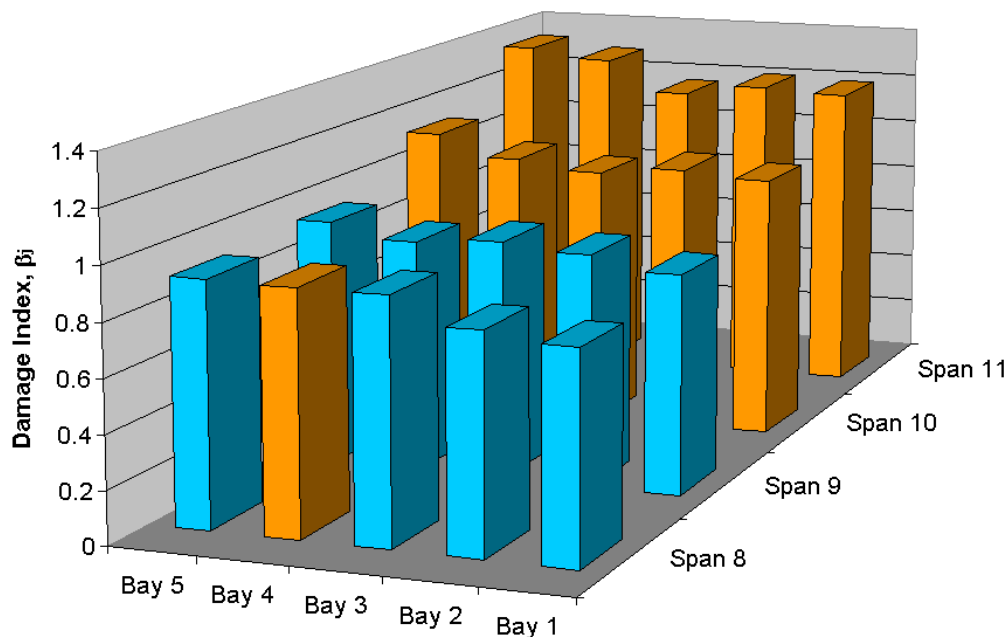
Figure 7.24. Damage Indices After CFRP Construction

Figure 7.24 shows damage index results from equation 8.10, comparing mode shapes measured before and after rehabilitation of spans 8 and 9 with CFRP composites. A damage index, β_j, value less than one indicates that stiffness has increased in a location or element; a β_j value greater than one indicates that a decrease in stiffness in a location has occurred. In Figure 7.24, damage index values less than one are measured in spans 8 and 9 as expected since CFRP composite rehabilitations are constructed in those locations. A damage index value less than one in S8B4, an unrehabilitated location, is attributed to the stiffening effects in adjacent locations. In the unrehabilitated locations of spans 10 and 11, damage index values greater than one are observed, indicating stiffness losses in the region.

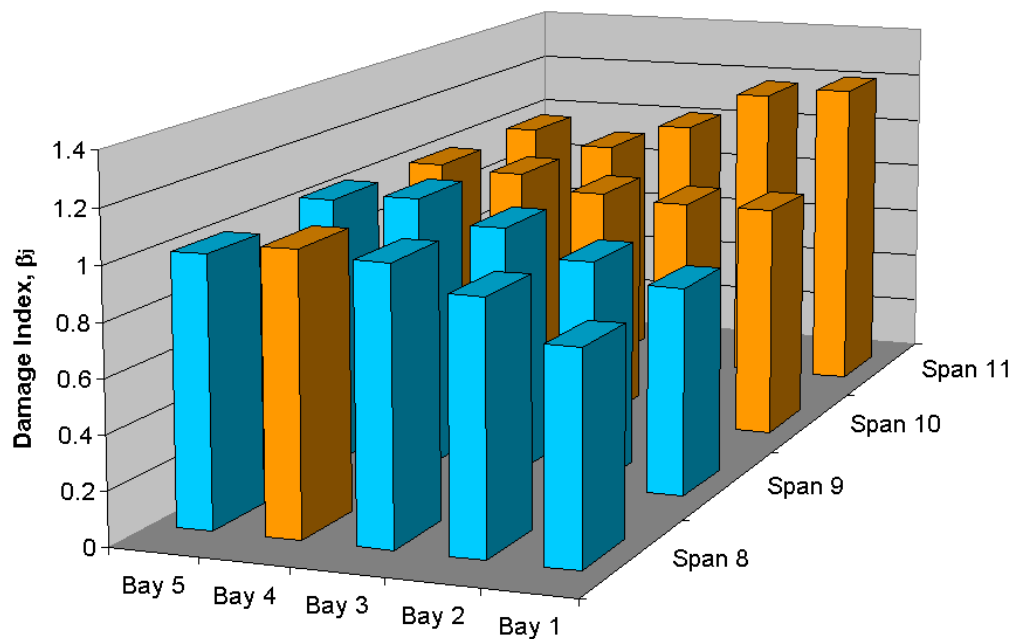
Figure 7.25. Damage Indices 12 Months After FRP Construction

In bays 1 and 2 of spans 8 thru 12, the damage index results show a similar pattern as compared to Figure 7.24. The rehabilitated locations S8B1, S8B2, S9B1, and S9B2 continue to show damage index values less than one, indicating the stiffness increase is maintained at 12 months. S8B1, S8B2, S9B1 and S9B2 are rehabilitated using pultruded CFRP composites.

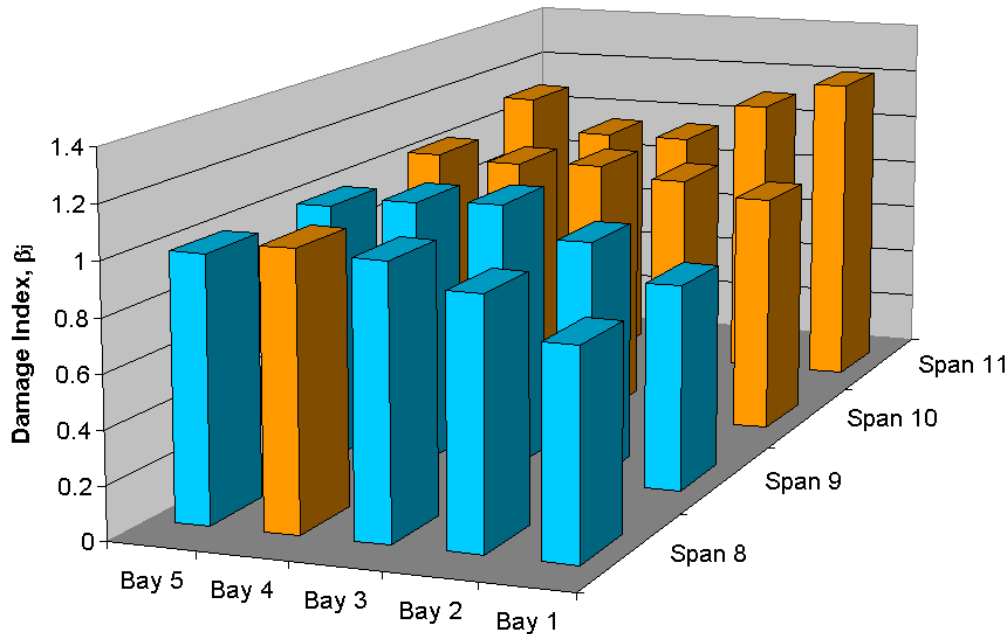
Figure 7.26. Damage Indices 20 Months After FRP Construction

Figure 7.26 shows damage index results comparing mode shapes measured before and 20 months after rehabilitation. Bays 3, 4 and 5 of spans 8 thru 12 show similar results as compared to Figure 7.25. Furthermore, bays 1 and 2 of spans 8 thru 12 also show similar damage index results. At twenty months, damage index results in spans 10 and 11, compared to Figure 7.24 indicate stiffness increases have occurred although no rehabilitation measures were conducted in the regions.

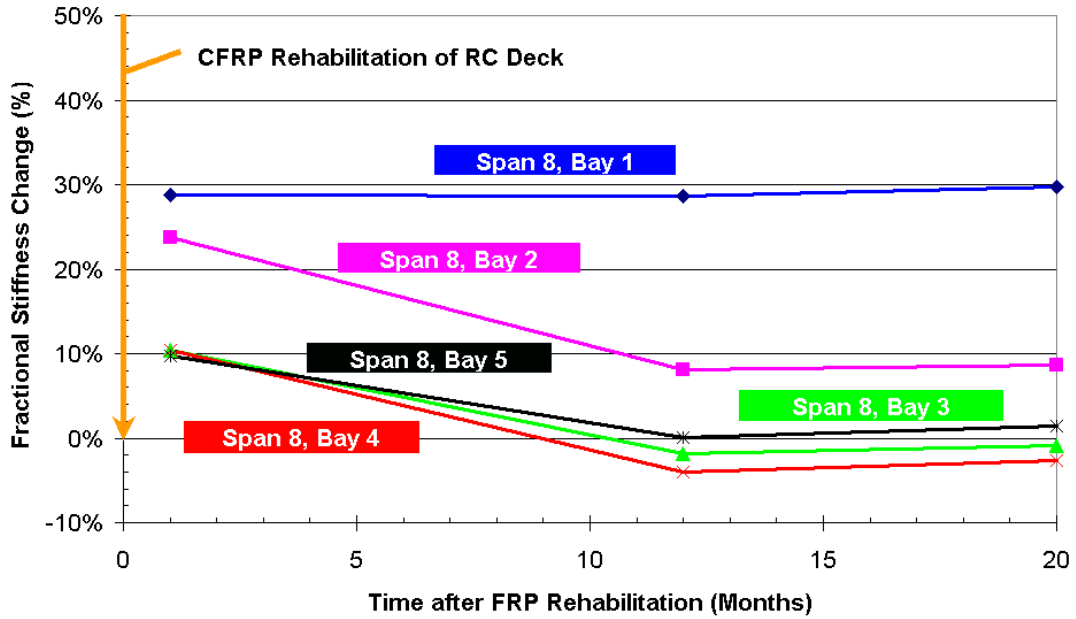
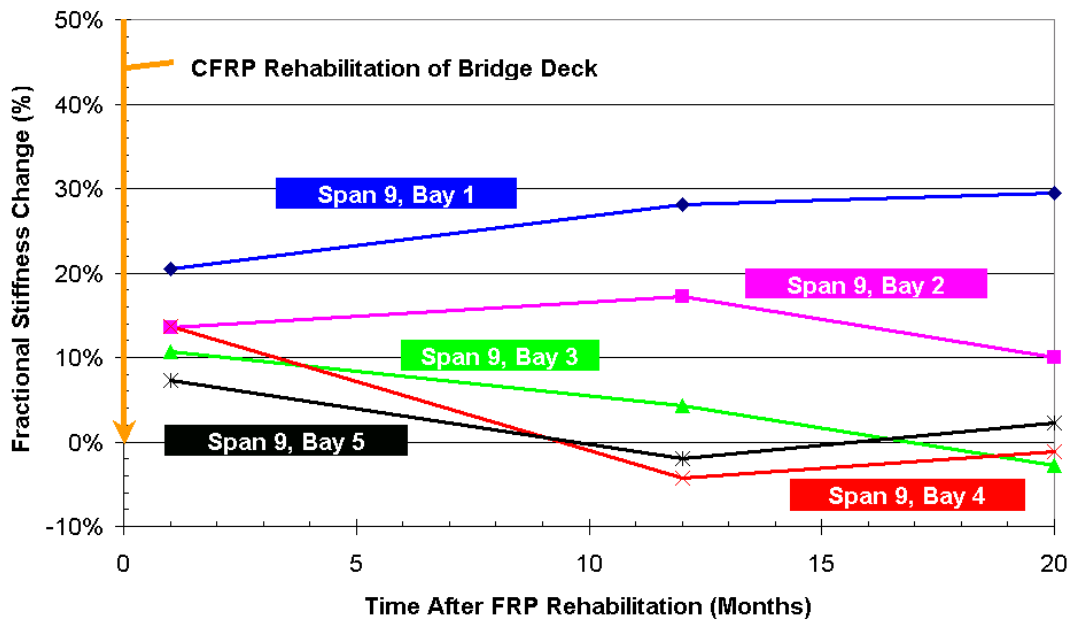
Figure 7.27 and Figure 7.28 illustrate stiffness changes in spans 8 and 9 after rehabilitation with CFRP composites. As observed previously, a decrease in stiffness occurs in locations adjacent to S8B4 at 12 months and 20 months after rehabilitation.

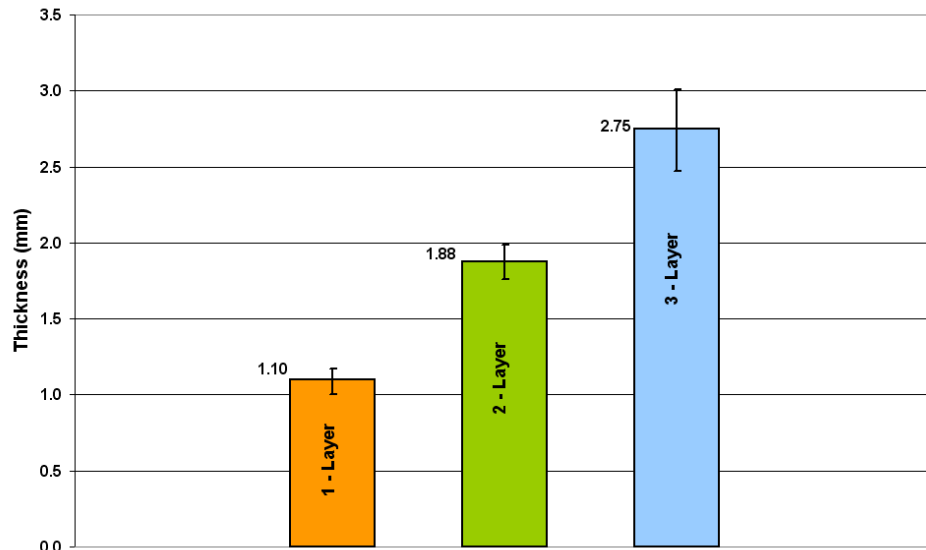
Figure 8.12. Thickness Scatter of Wet Lay-up CFRP Composites

The nominal thickness of a single ply of carbon fabric is 1.016 mm (0.040 in). An average thickness of 1.10 mm (0.043 in) is measured from a one-layer CFRP composite, where the thickness increase compared to the nominal thickness is attributed to the impregnation of resin.

Nominal thickness for two layers of carbon fabric is 2.032 mm (0.080 in), while the measured average thickness of the two-layer CFRP composite specimens is 1.88 mm (0.074 in). The difference in nominal and measured thicknesses indicates that compaction of the fibers is taking place during the manufacturing process.

An average thickness of 2.75 mm (0.108 in) is measured for the three-layer CFRP composite. The measured thickness is less than the nominal thickness of 3.048 mm (0.120 in) for three layers of carbon fabric, indicating the effect of compaction.

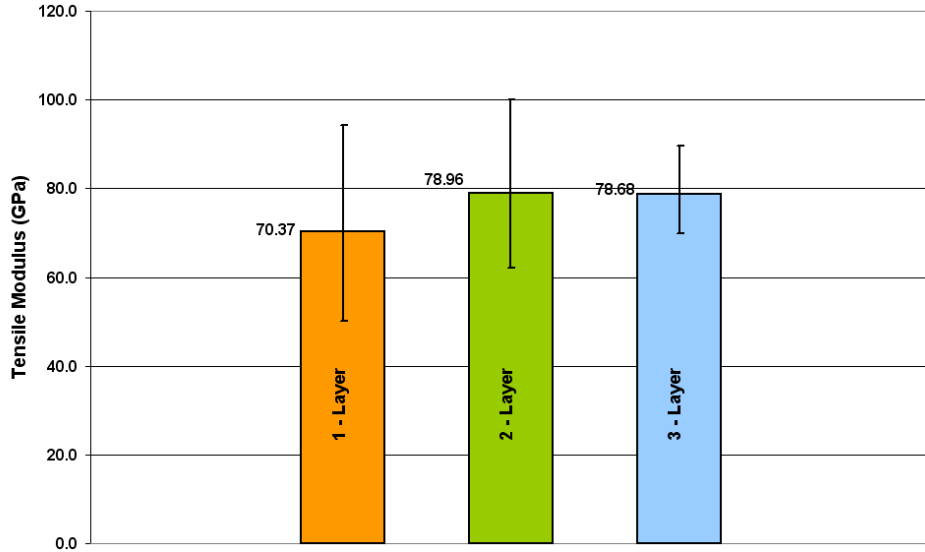
Figure 8.13. Tensile Modulus Scatter of Wet Lay-up CFRP Composites

A comparison of the average tensile modulus between the one, two, and three layer CFRP composites shows that tensile modulus increases by 12.21% from 70.37 GPa (10.21 msi) to 78.96 GPa (11.45 msi) between the one and two layer CFRP composites, while remaining steady for the three layer composite at 78.68 GPa (11.41 msi).

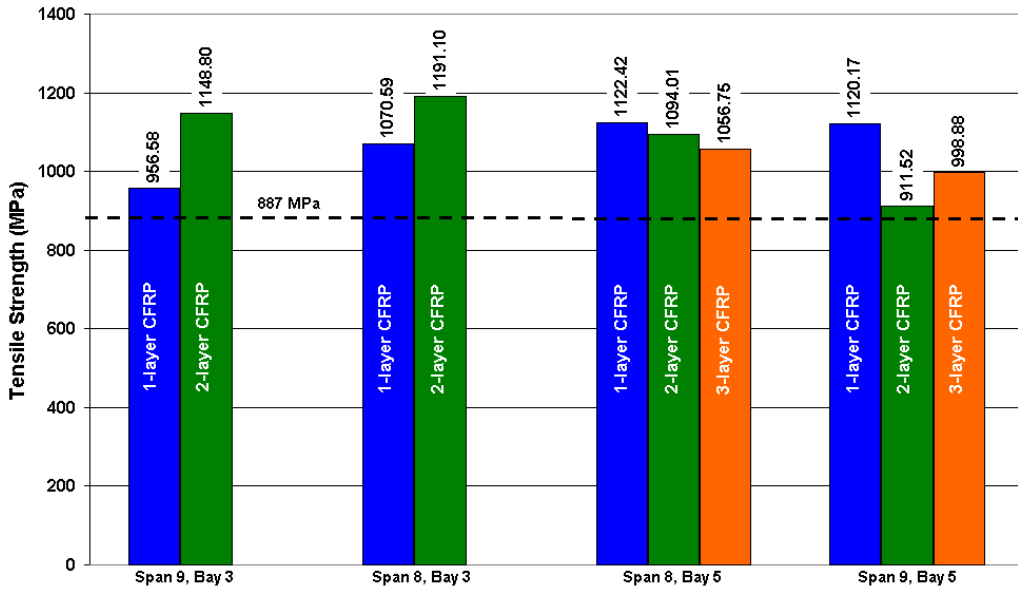
Figure 8.15. Tensile Strength of CFRP Composites by Location

Figure 8.15 and Figure 8.16 illustrate the average tensile strength and average tensile modulus obtained by pooling of data from the wet lay-up specimens. The average tensile strength and average tensile modulus results exceed the assumed design values of 0.89 GPa (128.66 ksi) and 64.92 GPa (9.42 msi), respectively.

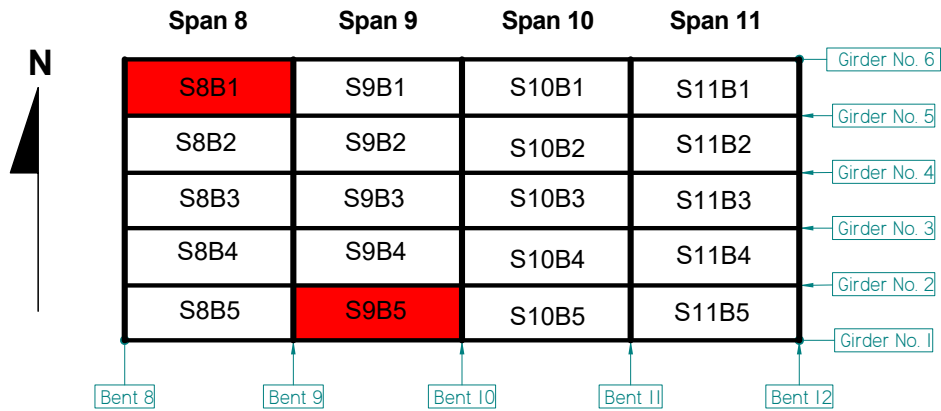
Figure 10.1. Locations for Progressive Damage Testing

Damage scenarios were applied to two locations of the structure, one of which was rehabilitated using pultruded CFRP strips in Span 8, Bay 1 (S8B1), which is the northernmost bay of Span 8 and is a design intended to prevent the occurrence of punching shear failure, which in effect is a minimum deck rehabilitation using CFRP

composites. The other inflicted damage location was Span 9, Bay 5 rehabilitated with wet lay-up manufactured CFRP strips. Progressive damage locations are identified in red in Figure 10.1.

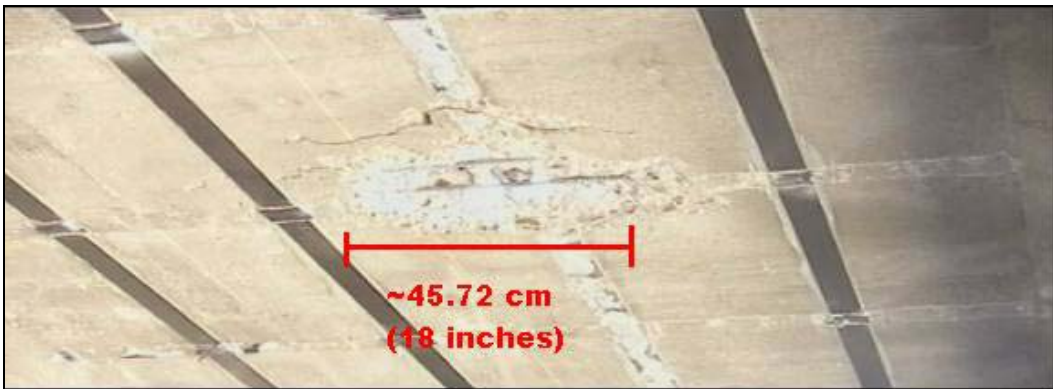
Figure 10.4. Punch Out of Bridge Deck in S8B1

The investigations related to progressive damage were initiated with a baseline modal test which provided parameters that could be used as the intial state characteristics of the structure. In the case of the pultruded strip rehabilitation in Span 8 Bay 1 (S8B1), the first damage state was represented by the removal of a single longitudinal strip (Figure 10.2). Care was taken to ensure that the removal did not result in damage to concrete beyond the level anticipated through debonding and transverse crack opening. Once modal data were obtained for this state, 4 adjoining transverse strips were removed from the central span region (Figure 10.3). Again modal data was obtained and then a punching shear failure was simulated through impact loading on the top surface of the deck. This resulted in a damage area of about 46 cm by 25 cm, which is representative of punch through under normal service conditions (Figure 10.4), after which modal characterization was again repeated.

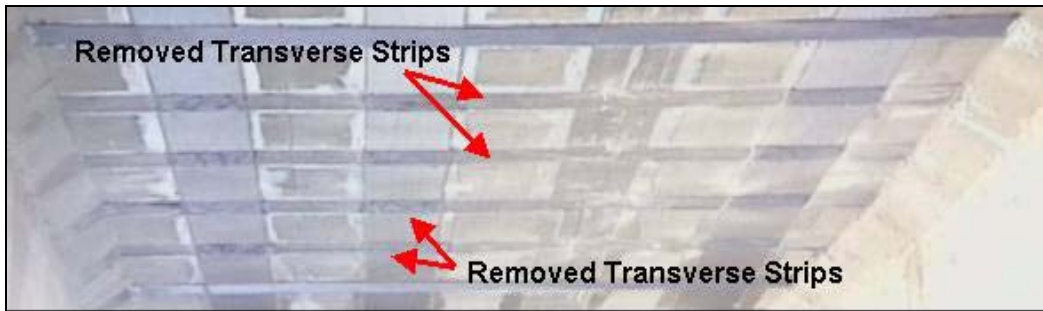
Figure 10.6. Removal of Four Transverse CFRP Strips in Location S9B5

A similar procedure was followed in S9B5 which had been rehabilitated using the wet lay-up procedure. The sequence of damage is illustrated in Figure 10.5, Figure 10.6, and Figure 10.7.

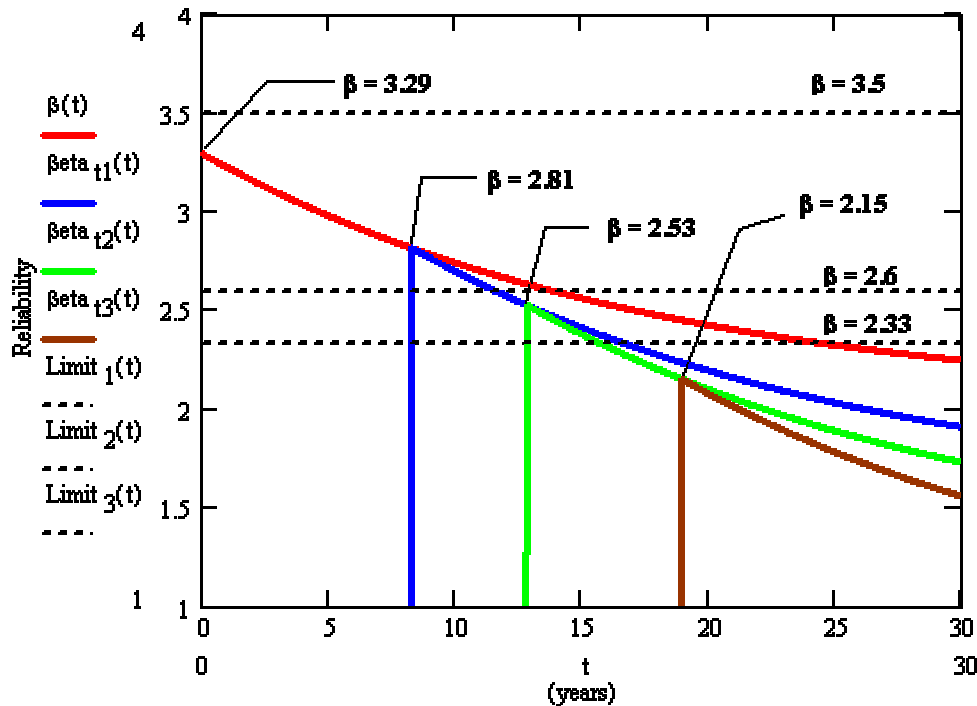
Figure 10.8. Span 8, Bay 1, Longitudinal, HS20

Prior to rehabilitation the reliability indices of the deck slab are 2.07 and 5.92 in the longitudinal and transverse slab directions, respectively. The reliability index of span 8, bay 1 increases to 3.29 with rehabilitation and decreases to 2.81, 2.53, and 2.15 corresponding to damage cases B1, B2, and B3, respectively in the longitudinal direction. The reliability index in the transverse direction increases to 6.61 with rehabilitation then decreases to 6.19, 5.94, and 5.59, respectively for damage cases B1, B2, and B3. The inclusion of these instantaneous measurements for the reliability of the deck slab into the time-dependent reliability formulation provides an estimate of the remaining service life of a structure. A time based superposition of the reliability index assuming degradation in CFRP composites following damage provides the change in reliability with respect to time as shown in Figure 10.8.

For the HS20 load demand level, the CFRP composite rehabilitation in location S8B1 is predicted to provide a service life of 11.54 years and 15.7 years corresponding to the limit reliabilities of 2.6 and 2.33, respectively.

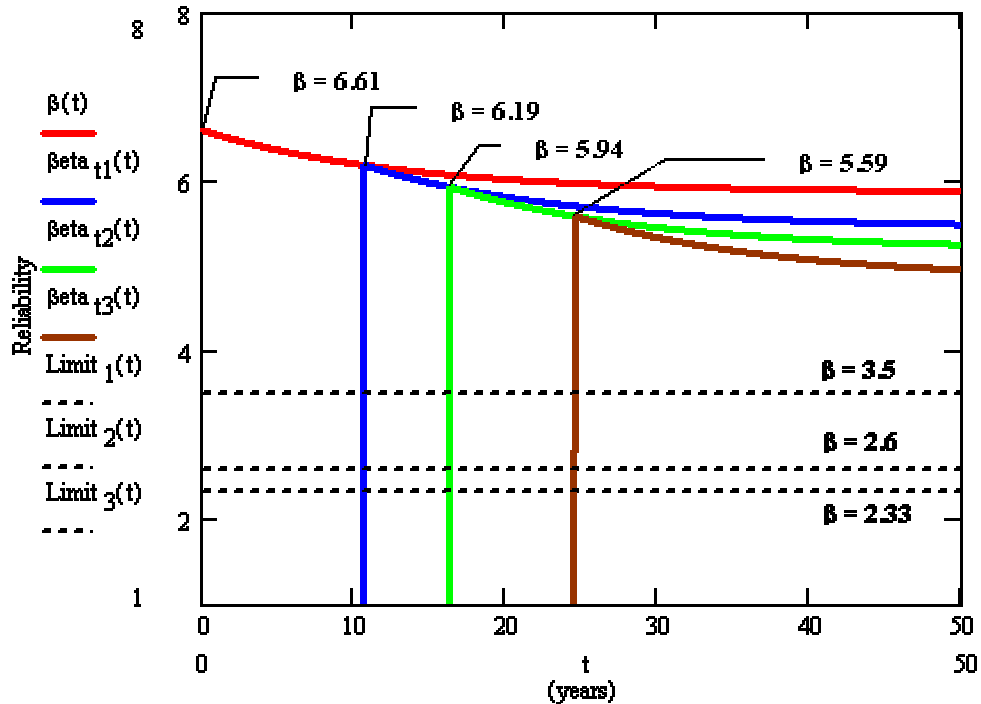
Figure 10.9. Span 8, Bay 1, Transverse, HS20

The change in reliability index versus time is shown for the transverse direction in Figure 10.9 for location S8B1 for the HS20 wheel load. Transverse CFRP rehabilitation continues to sustain a reliability index greater than 3.5 following successive damage to the deck slab and degradation of the CFRP composite.

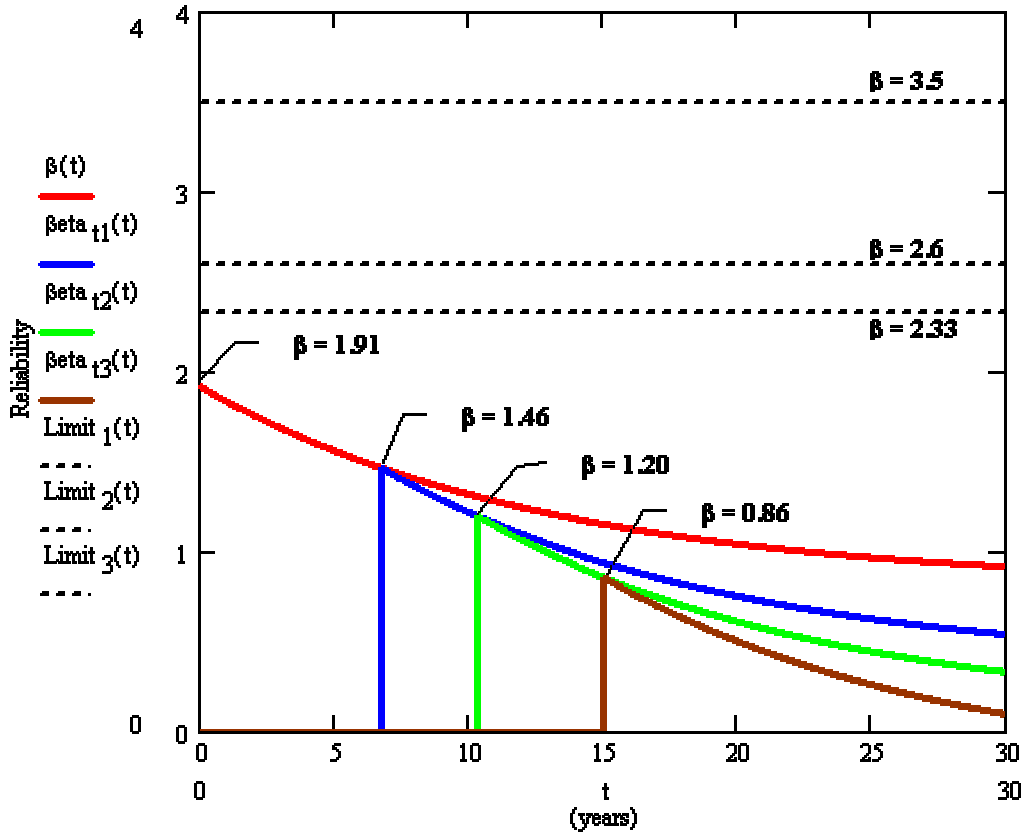
Figure 10.10. Span 8, Bay 1, Longitudinal, Permit

From Figure 10.10, the longitudinal CFRP rehabilitation design does not provide a service life extension for the permit load condition. A FRP rehabilitation design must provide a post rehabilitation reliability index greater than the allowable reliability level in order to provide a service life extension.

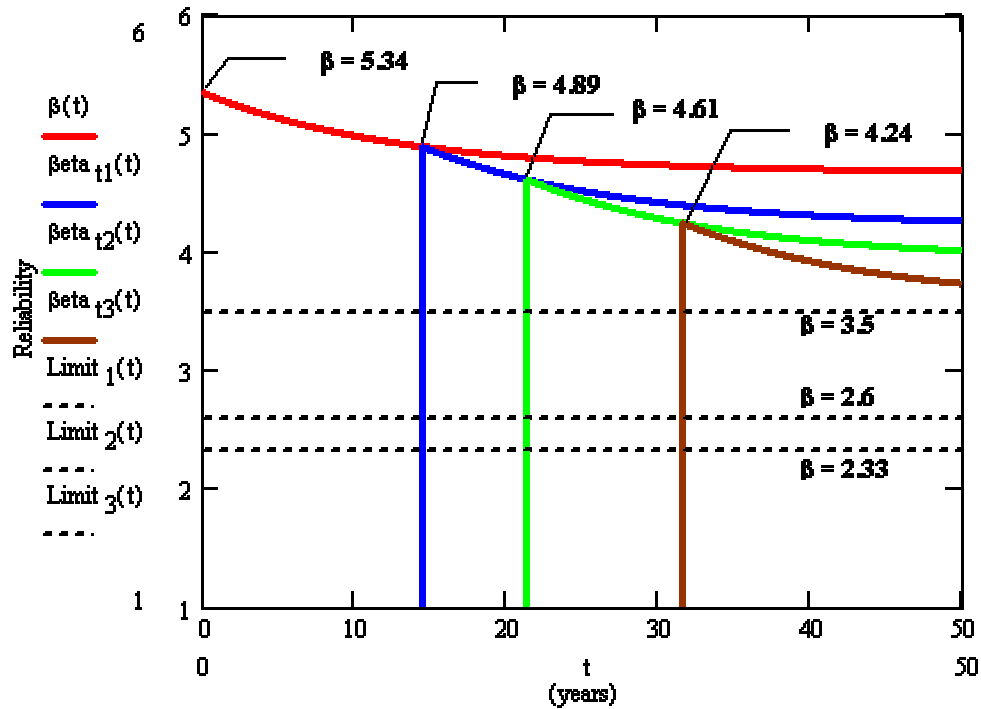
Figure 10.11. Span 8, Bay 1, Transverse, Permit

The change in reliability index as a function of time is shown for the transverse direction in Figure 10.11 for location S8B1 for the permit wheel load. Transverse CFRP rehabilitation continues to sustain a reliability index above 3.5 following successive damage to the deck slab and degradation of FRP composite parameters.

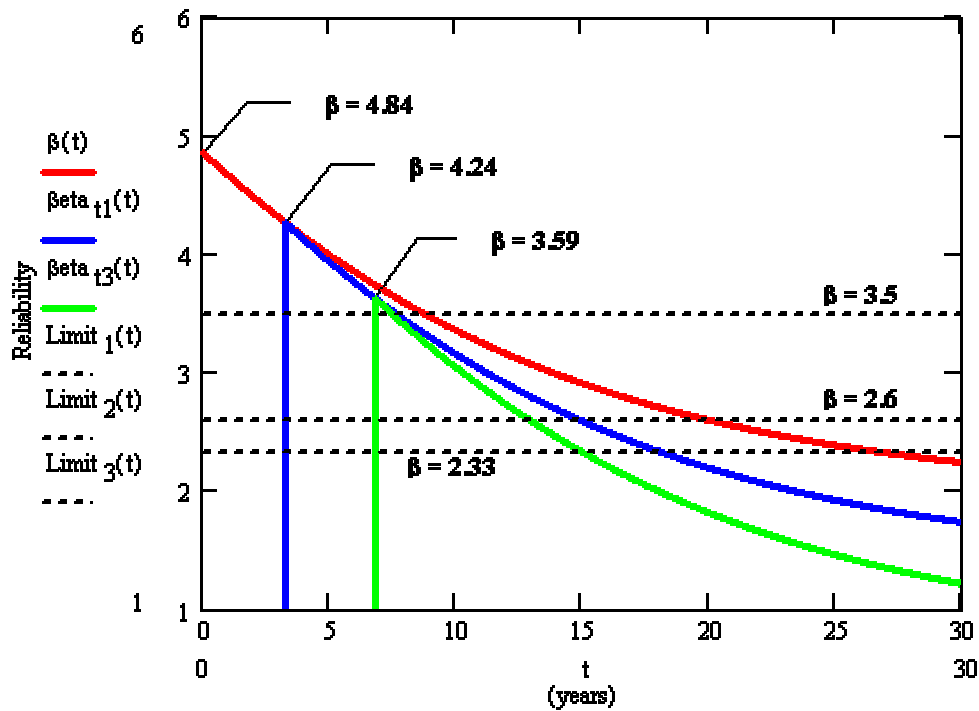
Figure 10.12. Span 9, Bay 5, Longitudinal, HS20

Figure 10.12 shows the change in reliability index as a function of time for location S9B5 in the longitudinal slab direction with the HS20 load condition. For the HS20 load demand level, the CFRP composite rehabilitation in location S9B5 is predicted to provide a service life of 7.5 years, 12.9 years, and 15.0 years for limit reliabilities of 3.5, 2.6, and 2.33.

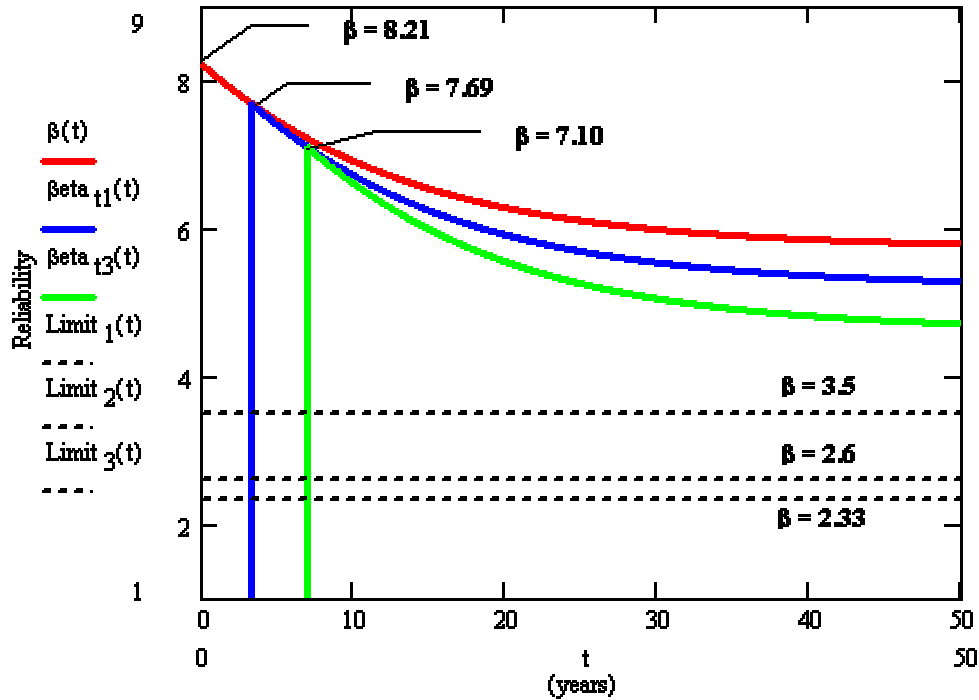
Figure 10.13. Span 9, Bay 5, Transverse, HS20

As in the transverse reinforcement in location S8B1, the application of CFRP composites assists in sustaining a level of reliability above 3.5 for following successive damage to the deck slab and degradation of the CFRP composite.

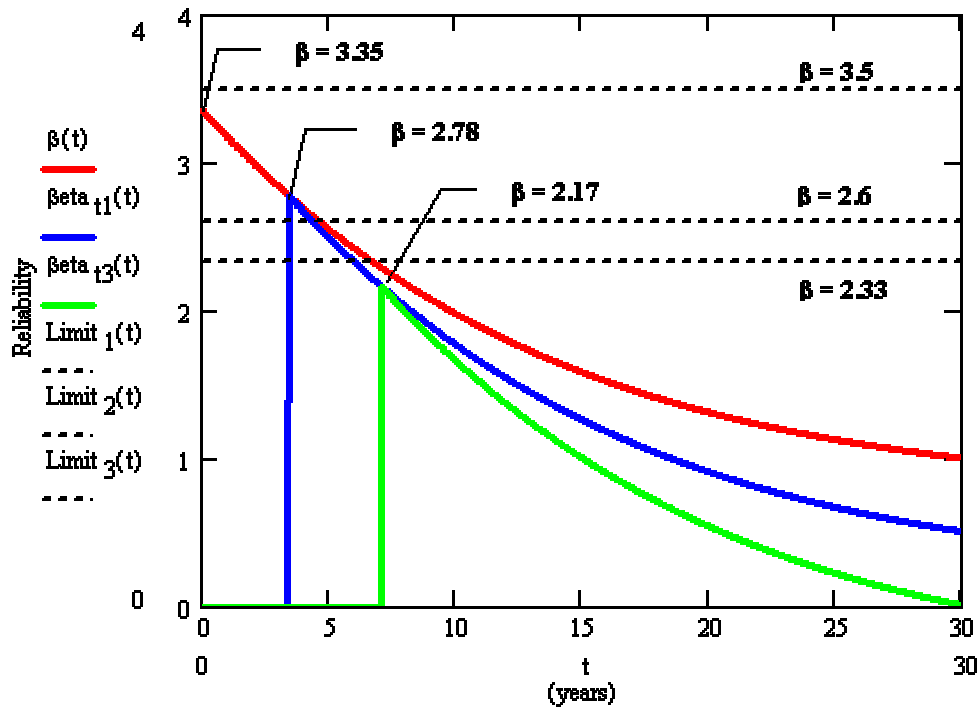
Figure 10.14. Span 9, Bay 5, Longitudinal, Permit

The change in reliability index as a function of time is shown for the longitudinal direction in Figure 10.14. For the Permit load level in S9B5, the CFRP composite rehabilitation provides a service life of 4.4 years and 6.0 years for the limits of 2.6 and 2.33, respectively.

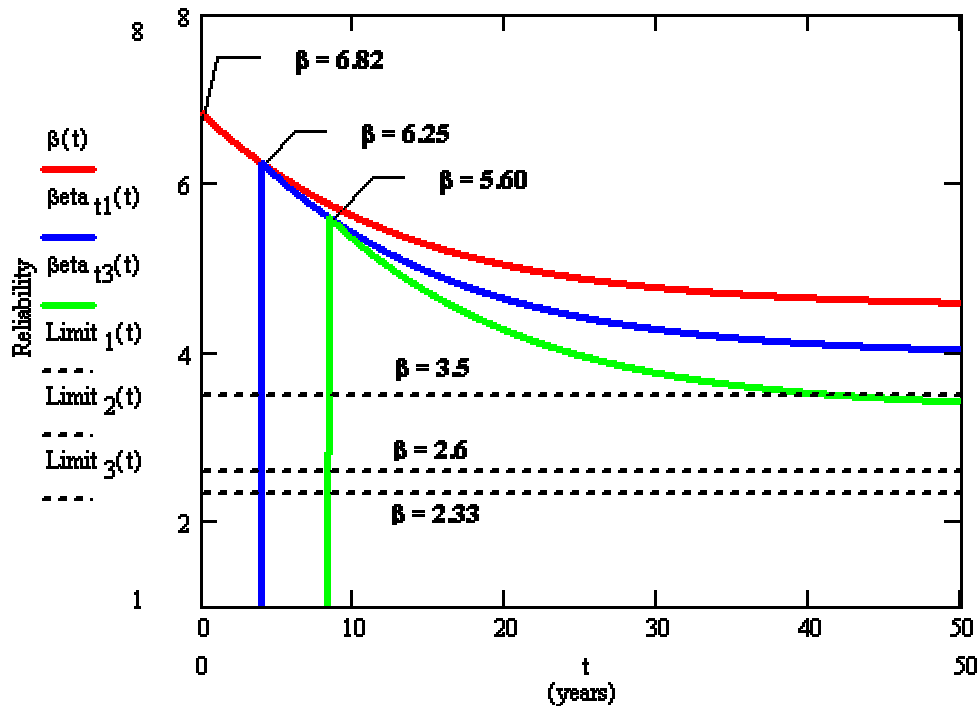
Figure 10.15. Span 9, Bay 5, Transverse, Permit

For the transverse slab direction in location S9B5 for the permit load level, a service life of 41.5 years for a limit of 3.5. The reliability index does not violate the limits of 2.6 and 2.33 with the successive damage cases and assumed material parameter predictions.
