4. TITLE AND SUBTITLE	5. REPORT DATE
Full-Depth Recycling Study: Test Track Construction and First-Level Analysis of Phase 1 and Phase 2 HVS Testing, Forensic Investigation, and Phase 1 Laboratory Testing	07/11/2016
	6. PERFORMING ORGANIZATION CODE

7. AUTHOR(S)	8. PERFORMING ORGANIZATION REPORT NO.
D. Jones, S. Louw, and R. Wu	UCPRC-RR-2015-02

Full-Depth Recycling Study:
Test Track Construction and First-Level Analysis of Phase 1 and Phase 2 HVS Testing, Forensic Investigation, and Phase 1 Laboratory Testing

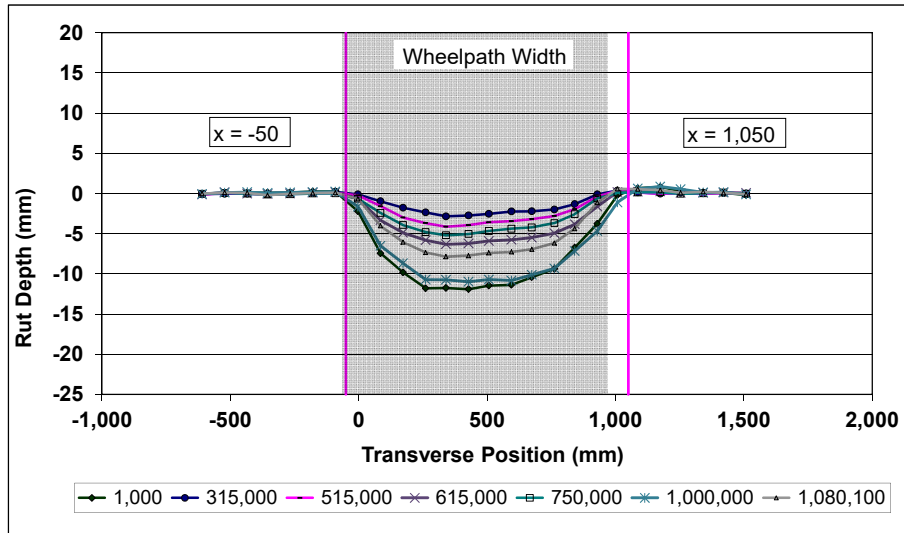
Figure 5.21: 677HC: Profilometer cross section at various load repetitions.

Figure 5.21 shows the average transverse cross section measured with the laser profilometer at various stages of the test and illustrates the increase in rutting and deformation over time. The plot shows that most of the deformation was in the form of a depression rather than upward and outward displacement of the material above the zero elevation point.

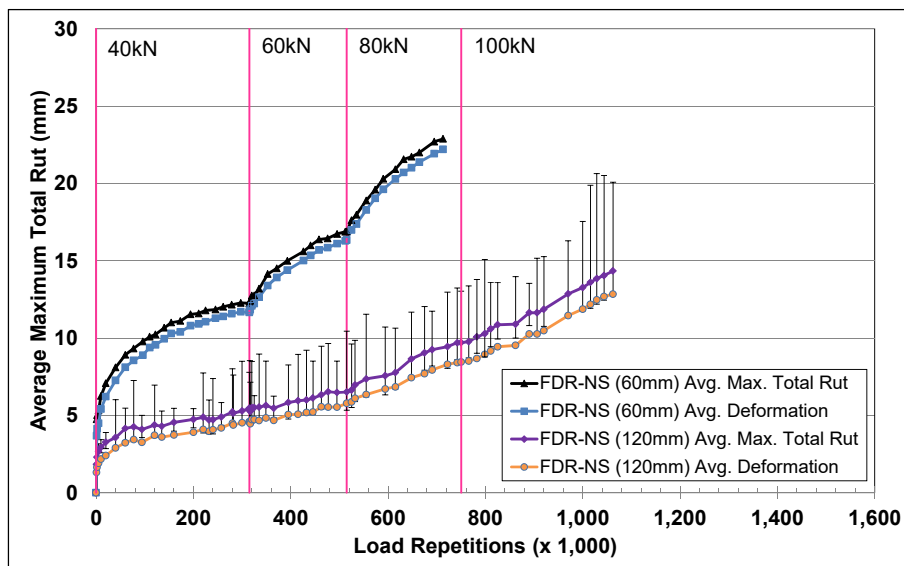
Figure 5.22: 677HC: Average maximum total rut and average deformation.

Figure 5.22 shows the development of permanent deformation (average maximum rut and average deformation) with load repetitions for the test section. The results for the FDR-NS (60 mm) section (Section 672HB) are shown for comparison.

The embedment phase on the FDR-NS (120 mm) section was of a similar duration to that on the FDR-NS (60 mm) section in terms of the number of load repetitions (i.e., ± 5,000), but ended with significantly less rutting compared to Section 672HB. The average maximum total rut at the end of the embedment phase was about 3.5 mm (0.13 in.). The rate of rut depth increase after the embedment phase was also considerably slower than that on Section 672HB, which was attributed to the generally stiffer structure resulting from the thicker asphalt concrete surfacing. Increases in the applied load (to 60 kN and then to 80 kN and 100 kN) did not result in any noticeable embedment phases after each event. However, the rate of rut depth increase did accelerate slightly after each load change. Error bars on the average maximum total rut reading indicate that there was some variation along the length of the section. Analysis of the data showed that variability was across the entire section and not confined to one half as with the rut on Section 672HB.

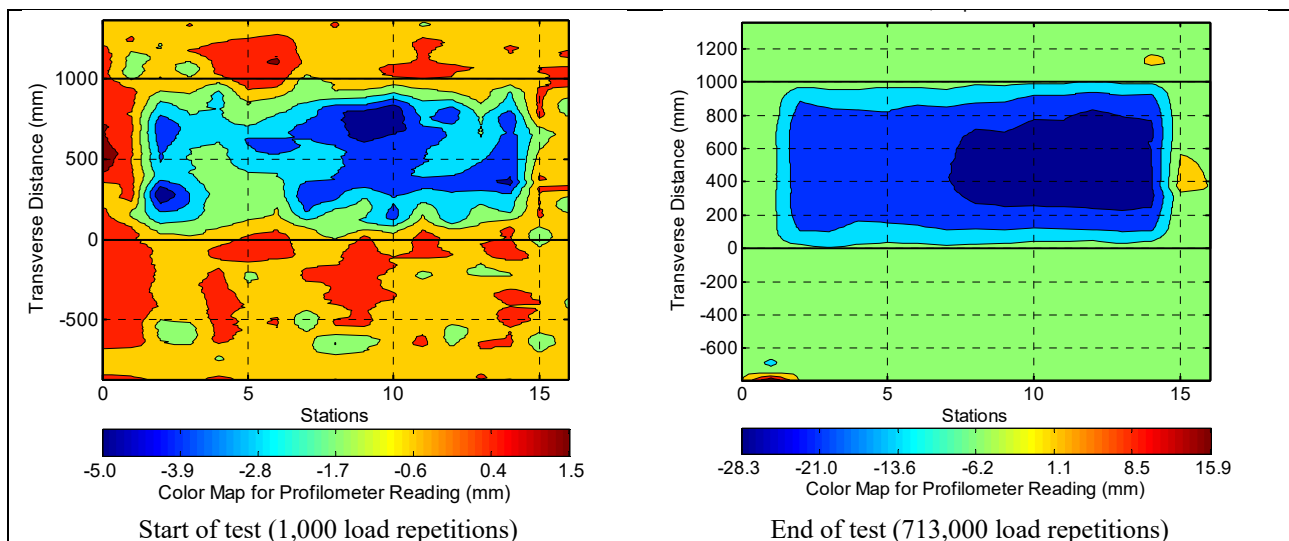
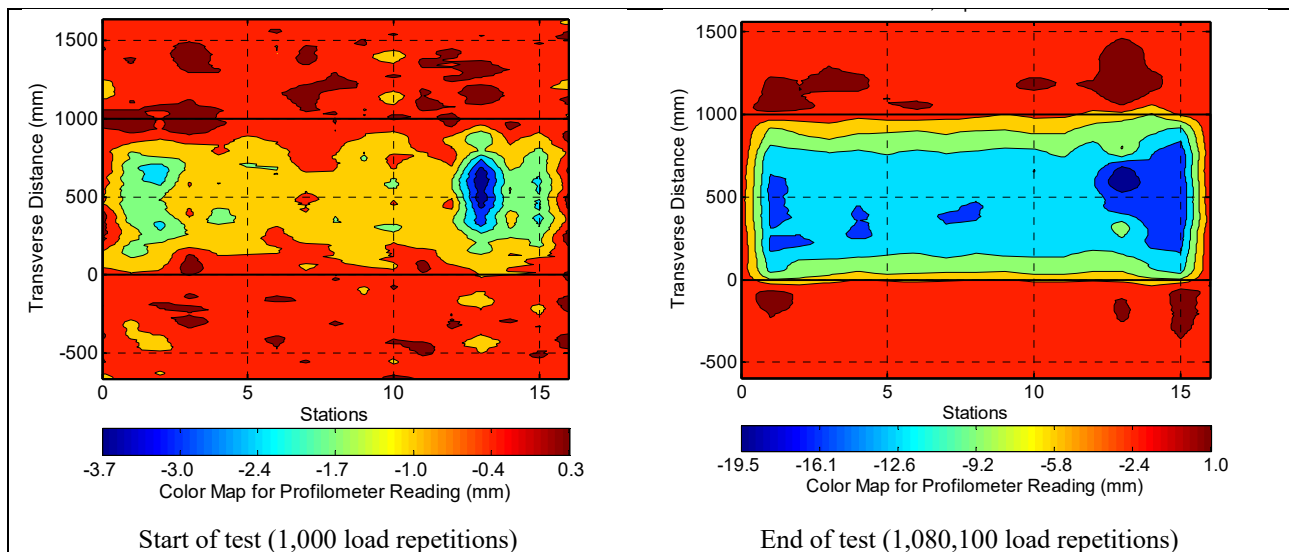
Figure 5.23: 677HC: Contour plots of permanent surface deformation.
(Note different scales in legends.)

Figure 5.23 shows contour plots of the pavement surface at the start and end of the test (1,080,100 load repetitions). The plot indicates that the deepest ruts were at the start and end of the test section where the wheel changed direction. Terminal rut (12.5 mm [0.5 in.]) was reached after approximately 950,000 load repetitions (~ 14.7 million ESALs). After completion of trafficking, the average maximum total rut depth and the average deformation were 14.3 mm (0.56 in.) and 12.8 mm (0.50 in.), respectively. The maximum rut depth measured on the section was 19.4 mm (0.76 in.), recorded at Station 13.

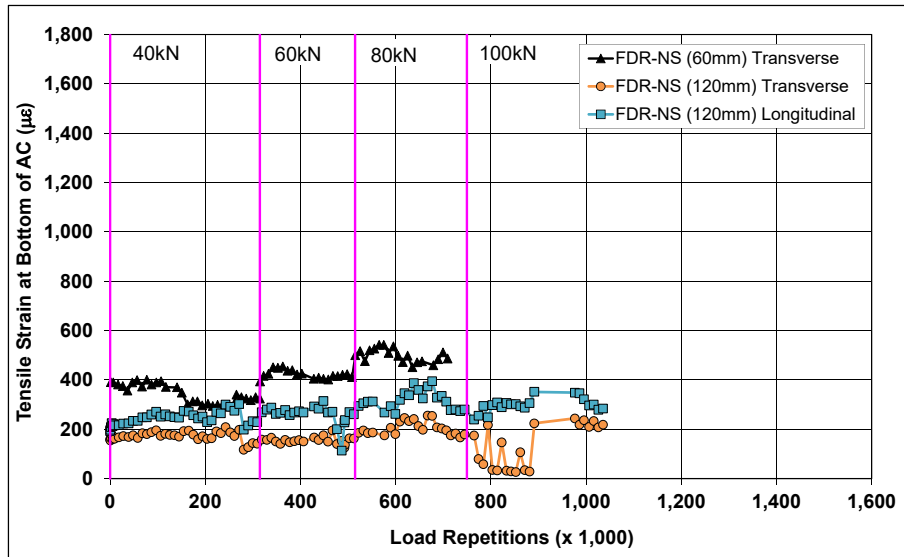
Figure 5.25: 677HC: Tensile strain at the bottom of the asphalt concrete layer.

Figure 5.25 shows the peak traffic-induced tensile strain at the bottom of the asphalt concrete layer. Transverse strain measurements from the FDR-NS (60 mm) section are included in the figure for comparison.

Longitudinal strains were slightly higher than the transverse strains on the FDR-NS (120 mm) section, the opposite of that recorded on the FDR-NS (60 mm) section. Transverse strains on the FDR-NS (120 mm) section were lower than those measured on the FDR-NS (60 mm) section as expected, this being attributed to the thicker asphalt concrete surfacing layer. Transverse and longitudinal strains showed similar trends on the FDR-NS (120 mm) section. Strains increased in the initial stages of the test, and then stabilized or decreased slightly, suggesting gradual layer stiffening resulting from densification caused by the HVS trafficking. Strains increased after each load change but then showed similar decreasing trends, indicating continued densification under loading. It is not clear what caused the variations in the transverse strain measurements after the load change to 100 kN and no specific factors that may have influenced the measurements were observed during the forensic investigation. Apart from the permanent deformation discussed in Section 5.4.4 and Section 5.4.5, no other surface distresses associated with the increase in strain measured in the recycled layer were noted during the course of the study.

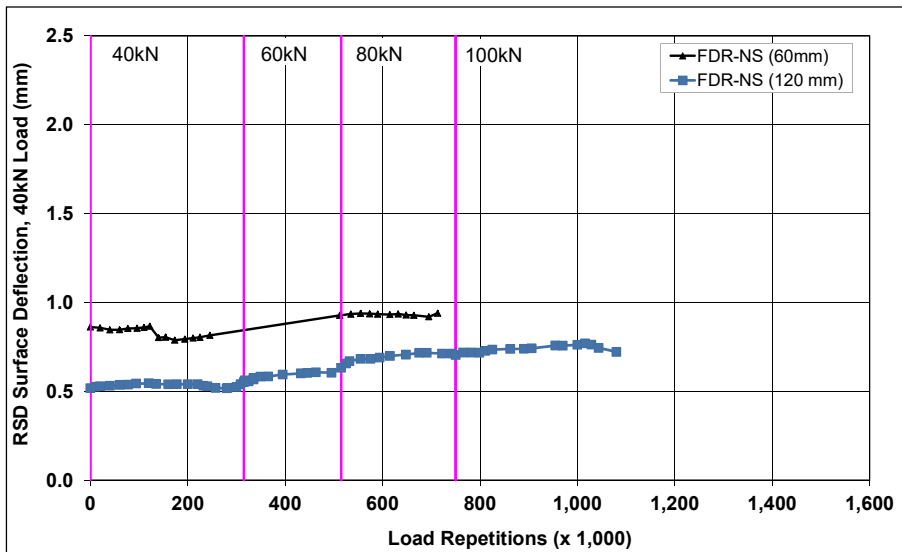
Figure 5.27: 677HC: Surface deflection (RSD).

Figure 5.27 compares elastic surface deflections measured with an RSD on the FDR-NS (120 mm) and FDR-NS (60 mm) sections under a 40 kN half-axle load. Deflections were notably lower on the FDR-NS (120 mm) section, as expected. Slight increases in absolute surface deflection were recorded after each load change, but it stabilized after initial embedment, indicating that there was no significant change in the stiffness of the pavement structure over time.

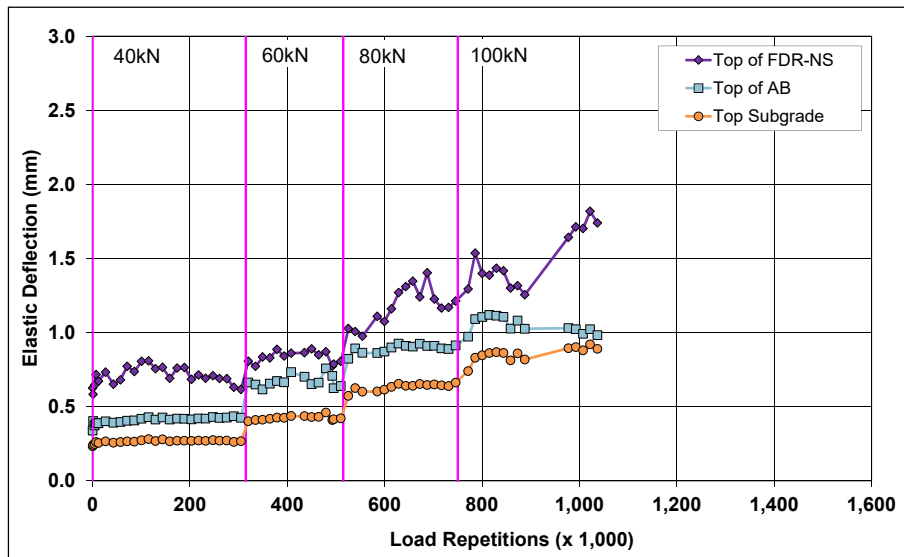
Figure 5.28: 677HC: Elastic deflection in the underlying layers.

Figure 5.28 shows the history of in-depth elastic deflections measured by the LVDTs in the multi-depth deflectometer in the FDR-NS (120 mm) section. These readings are consistent with the surface

deflections measured with the RSD and those recorded on the FDR-NS (60 mm) section. However, initial deflection on the top of the recycled layer was lower on the FDR-NS (120 mm) section, as expected, due to the additional confinement provided by the thicker asphalt concrete surfacing and its effect on load distribution. Deflections increased with increased load, as expected, but stabilized after the embedment phase with increasing number of load repetitions, which suggests some stiffening/densification in the recycled layer attributable to HVS trafficking. Deflections decreased with increasing depth, but the LVDTs at the different depths all showed similar trends over the course of the test.

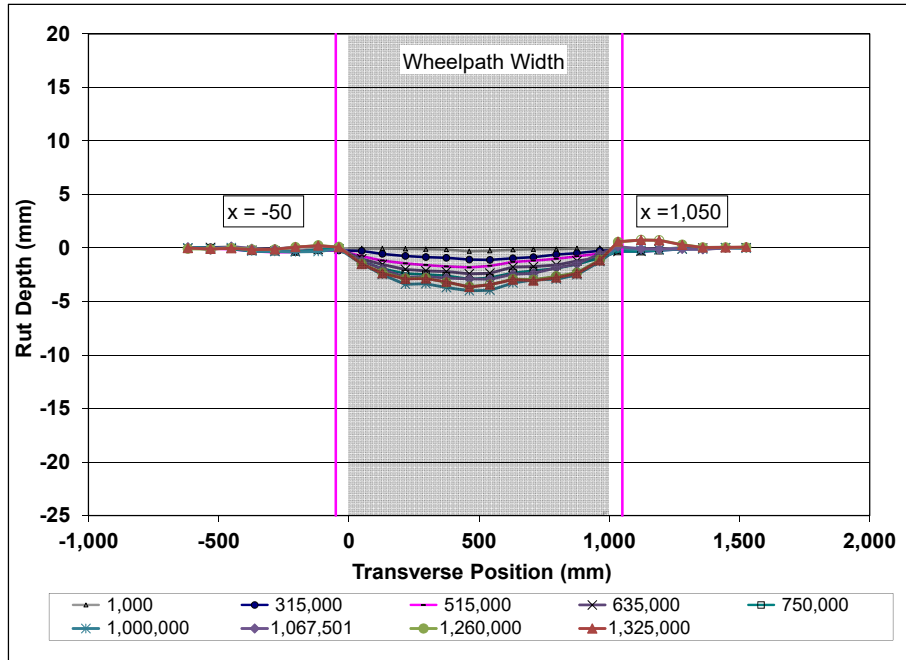
Figure 5.39: 673HB: Profilometer cross section at various load repetitions.

Figure 5.39 shows the average transverse cross section measured with the laser profilometer at various stages of the test and illustrates the increase in rutting and deformation over time. The plot shows that

most of the deformation was in the form of a depression rather than upward and outward displacement of the material above the zero elevation point. Figure 5.40 shows the development of permanent deformation (average maximum rut and average deformation) with load repetitions for the test section. The results for the FDR-NS (60 mm) section are shown for comparison.

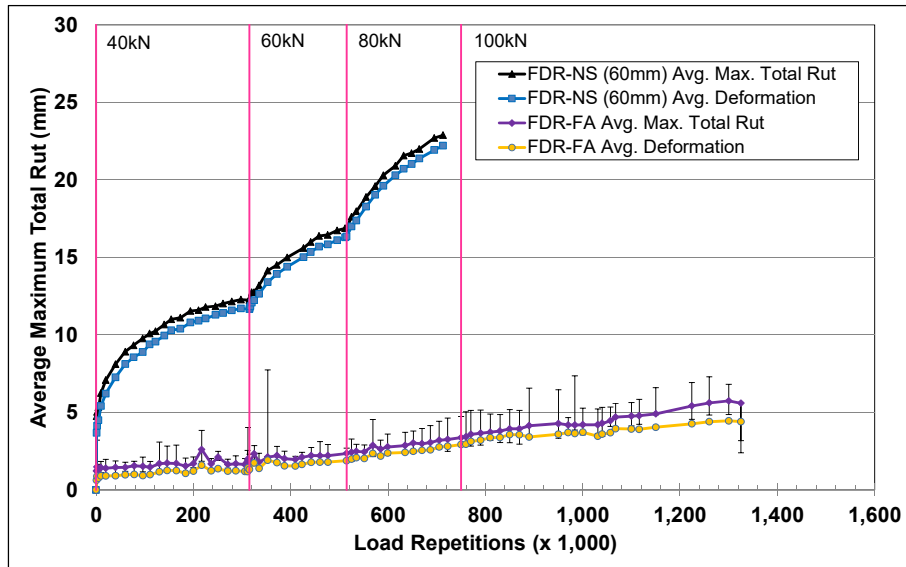
Figure 5.40: 673HB: Average maximum total rut and average deformation.

The embedment phase on the FDR-FA section was of a similar duration to that on the FDR-NS (60 mm) section in terms of the number of load repetitions (i.e., ± 5,000), but ended with significantly less rutting. The average maximum total rut at the end of the embedment phase was about 1.1 mm (0.04 in.). The rate

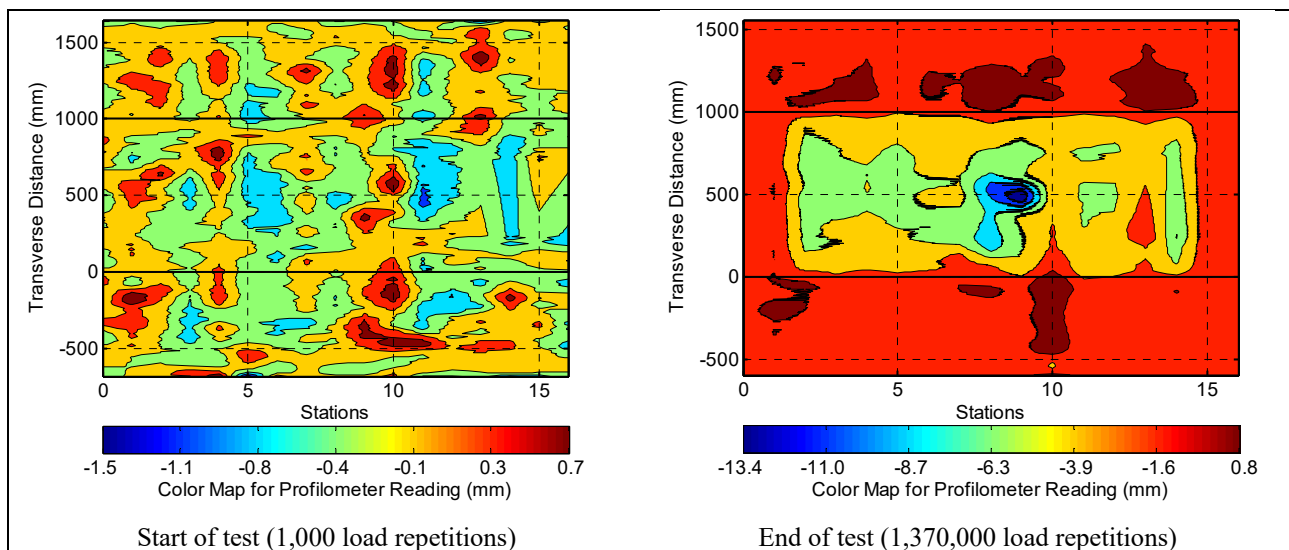
Figure 5.41: 673HB: Contour plots of permanent surface deformation.
(Note different scales in legends.)

Figure 5.41 shows contour plots of the pavement surface at the start and end of the test (1,370,000 load repetitions). The plot shows the relative uniformity of the rut depth over the length of the section. The small area of distress at Station 8 was attributed to some mechanical damage on the surface and not to rutting (see Section 5.5.11). After completion of trafficking (~ 34 million ESALs), the average maximum rut depth and the average deformation were 5.6 mm (0.22 in.) and 4.4 mm (0.17 in.), respectively. The maximum total rut depth measured on the section was 14.5 mm (0.57 in.), recorded at Station 8 and Station 9 in the area of mechanical damage on the surface.

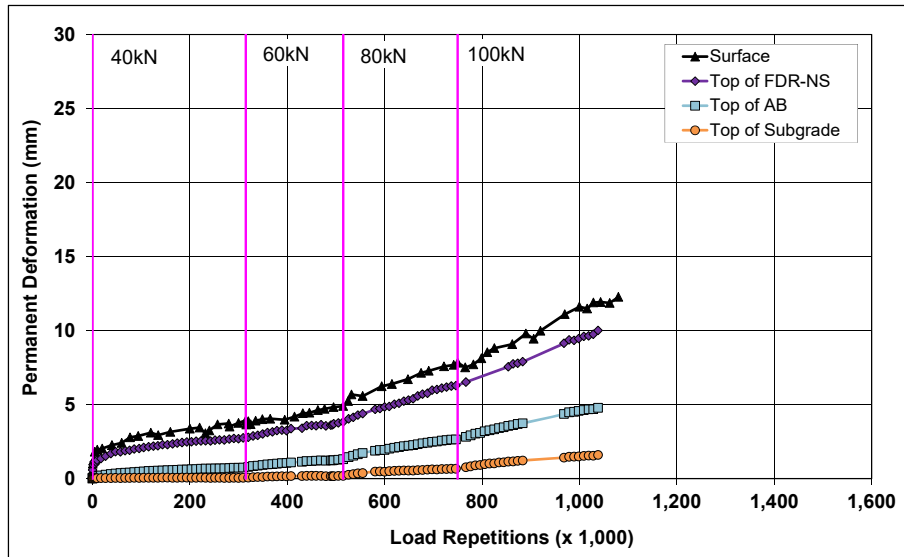
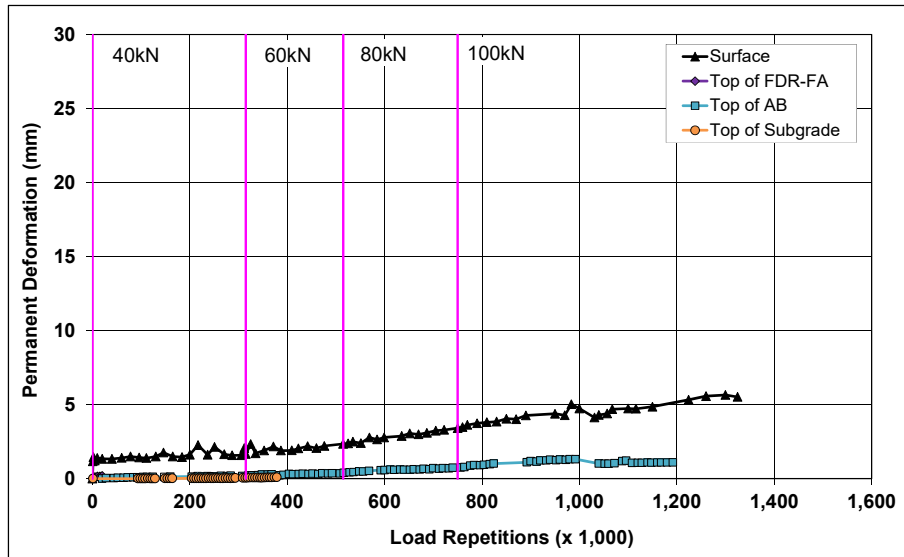
Figure 5.42: 673HB: Permanent deformation in the underlying layers.

Permanent deformation in the underlying layers, recorded with a multi-depth deflectometer (MDD) at Station 13 and compared to the surface layer laser profilometer measurements is shown in Figure 5.42.

The LVDT at the top of the FDR layer failed early in the test and consequently there were no measurements for this layer. The LVDT in the subgrade failed after approximately 400,000 load repetitions, leaving only one functioning LVDT at the top of the aggregate base, which failed during the second round of testing after 1.2 million load repetitions. No deformation was recorded in the subgrade up to the point that the subgrade LVDT failed. Deformation at the top of the existing aggregate base reached 1.2 mm (0.05 in.) after 1.2 load repetitions. Based on the results obtained from the two unstabilized sections (Sections 672HB and 677HC), it was assumed that most of the remaining deformation occurred in the asphalt concrete surfacing, with very little deformation in the FDR-FA and subgrade layers. Deformation in each of the layers is summarized in Table 5.6 with assumptions made for the recycled and subgrade layers (results for the FDR-NS [60 mm] section are included for comparison). Observations and measurements during the forensic investigation (see Section 8.7.3) confirmed these assumptions.

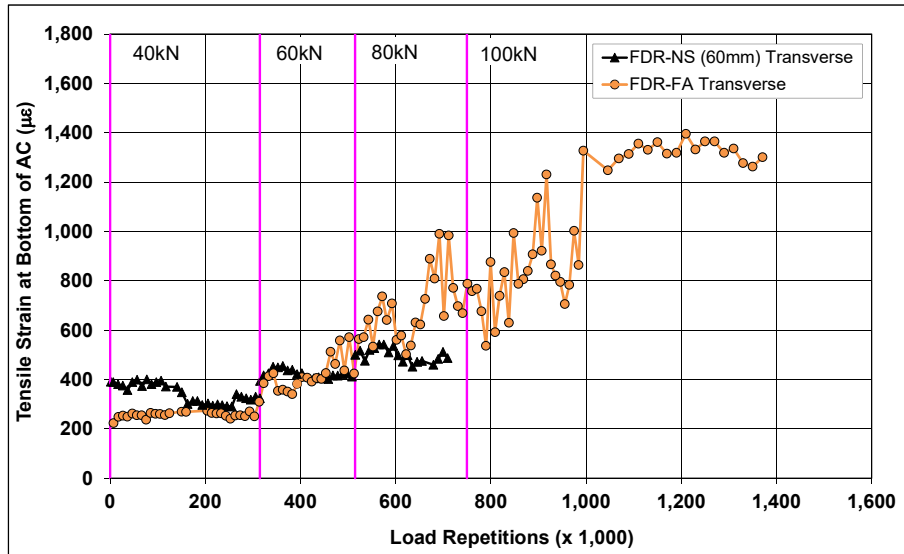
Figure 5.43: 673HB: Tensile strain at the bottom of the asphalt concrete layer.

Figure 5.43 shows the peak traffic-induced transverse tensile strain at the bottom of the asphalt concrete layer. The strain gauge installed to measure longitudinal strain was damaged during placement of the asphalt concrete surfacing and therefore no readings were obtained. Transverse strain measurements from the FDR-NS (60 mm) section are included in the figure for comparison.

Trends in the transverse strains measured on the FDR-FA section differed from those measured on the FDR-NS sections.   Initial transverse strains were significantly lower than those recorded on the unstabilized section, but they showed a relatively sharp increase in the first 50,000 load repetitions attributable to initial breakdown of the portland cement bonds. The strains stabilized thereafter at similar levels to those recorded on the FDR-NS (60 mm) section for the remainder of the 40 kN wheel load trafficking. The increase in strain immediately after the load change was not as sharp as that recorded on the FDR-NS section, but it continued to increase for the remainder of the test suggesting further weakening of the structure (probably attributed to microcracking in the recycled base) caused by trafficking. Variability in the strain measurements recorded in the latter part of the first round of testing was attributed to a combination of temperature changes and their effect on microcracks under the strain gauge. In the second round of testing (1,000,000 to 1,371,000 load repetitions), the strain measurements appeared to be more consistent. No surface distresses associated with the increase in strain measured in the recycled layer were noted during the course of the study.

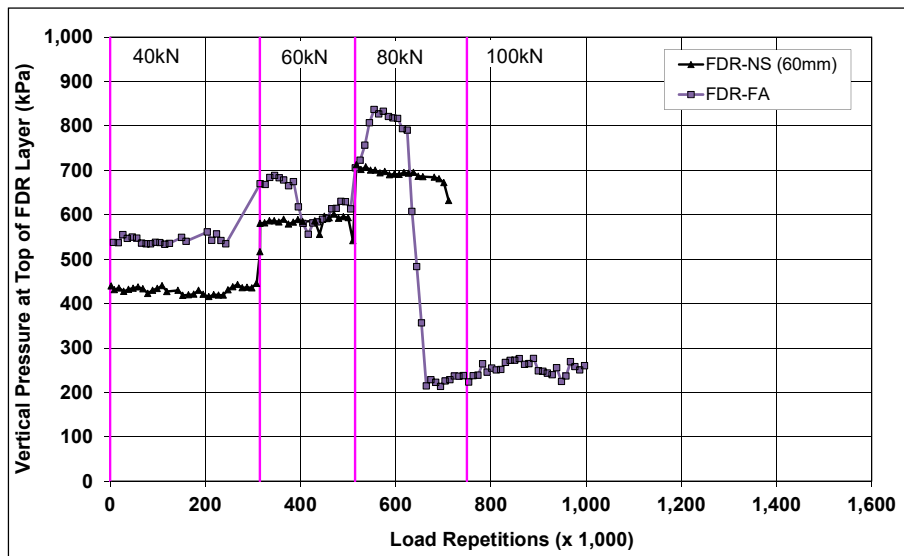
Figure 5.44: 673HB: Vertical pressure at the top of the recycled layer.

Figure 5.44 shows the comparison of traffic-induced vertical pressure at the top of the recycled base layer for the FDR-NS (60 mm) and FDR-FA sections. Pressure readings were stable and sensitive to load

changes for most of the FDR-FA test. Initial pressure was higher on the FDR-FA section compared to the FDR-NS section, which was expected based on layer elastic theory and considering the much higher stiffness of the FDR-FA section. Increases in recorded pressures occurred after the load changes, as expected. A rapid increase followed by a significant drop in pressure was recorded on the section between 520,000 and 620,000 load repetitions. The reason for this is unclear, but it is assumed that either the instrumentation was damaged or that support conditions under the pressure cell changed, given that no evidence of distress was observed on the section and that similar abrupt changes in measurements were not recorded on the other instruments. In the second round of testing, circular cracks mirroring the location of the pressure cell appeared on the surface confirming that the pressure cell was rocking under the asphalt concrete.

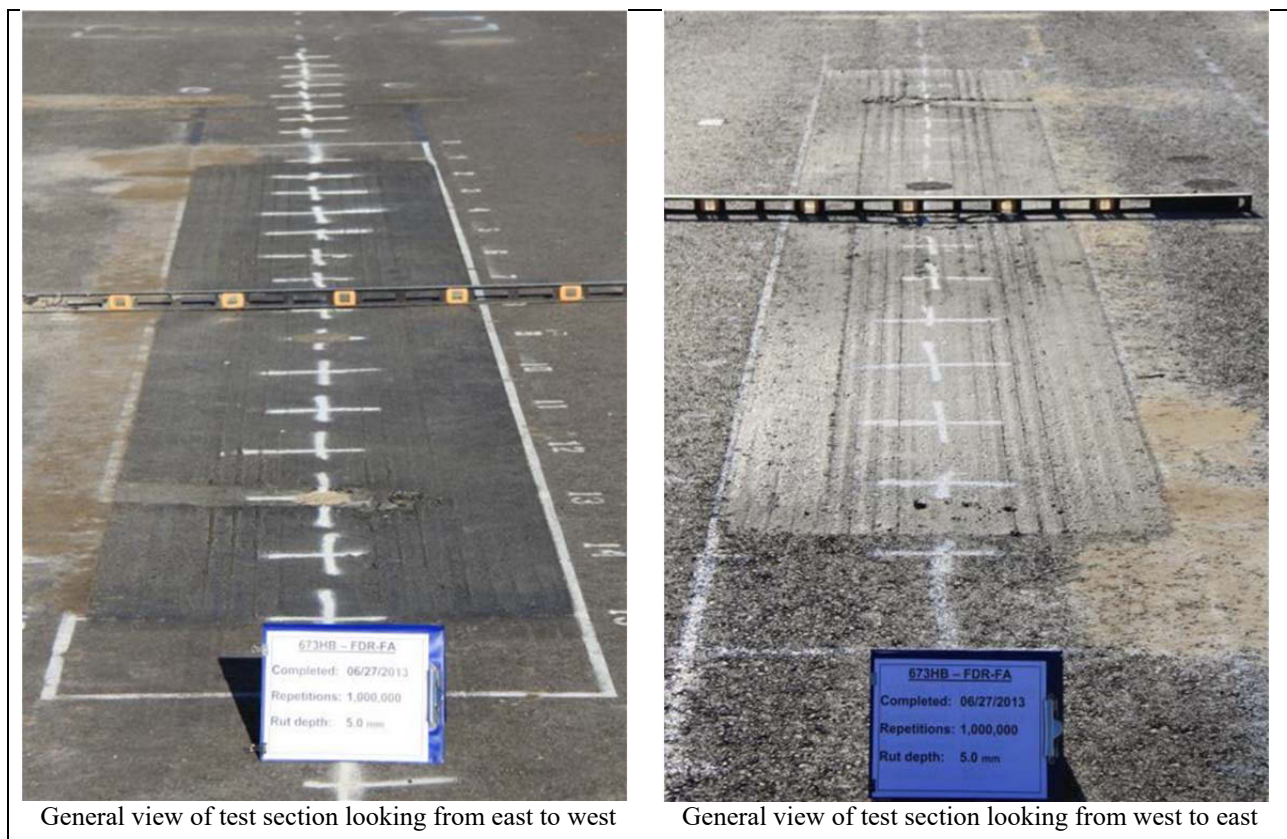
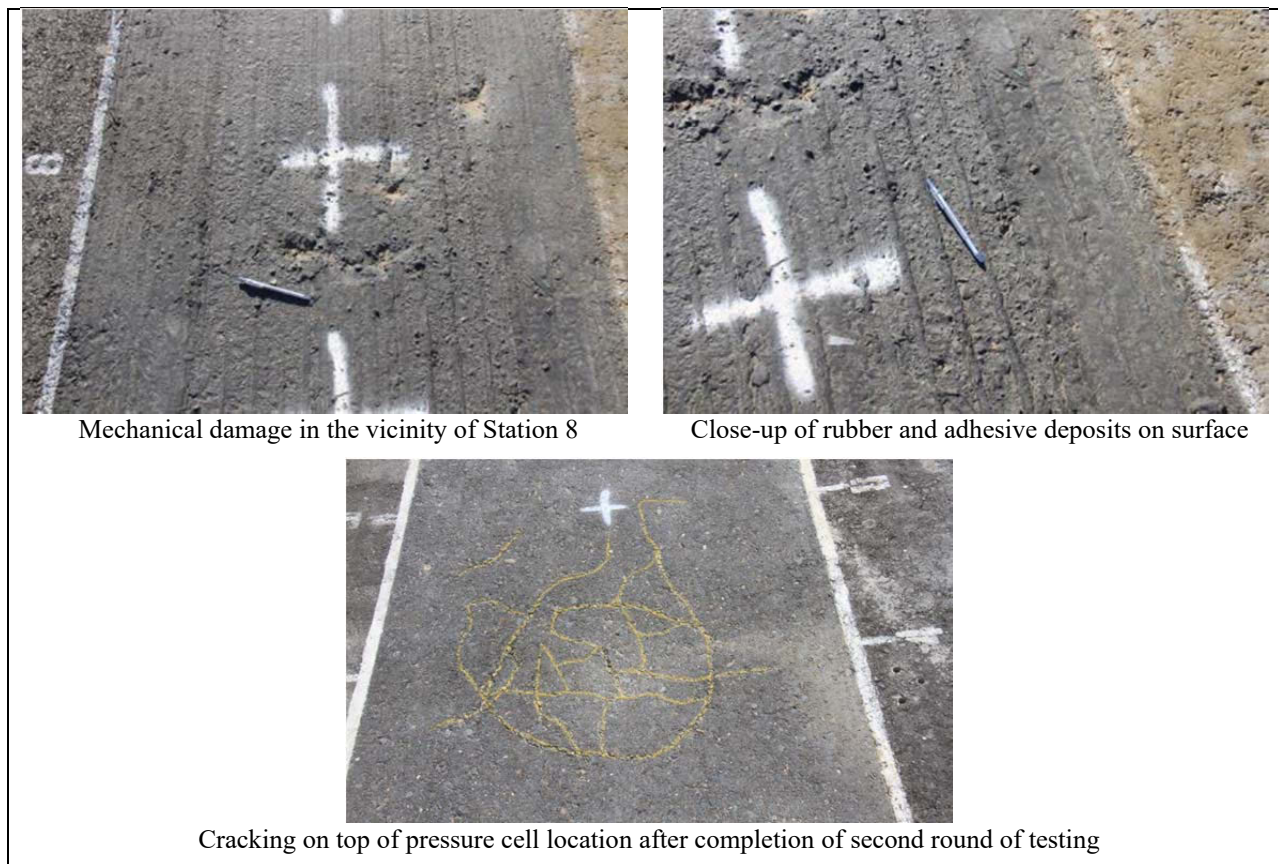
Figure 5.49: 673HB: Test section photographs *(continued)*.

Photographs of the test section after the first round of HVS testing are shown in Figure 5.49. Apart from rutting, no other distress was recorded on the section after the first round of testing. Some isolated circular cracks were observed in the immediate vicinity of the pressure cell and were not considered related to the performance of the pavement structure, but rather to debonding of the pressure cell from the surface of the FDR layer, causing it to move during wheel loading.

Cracking on top of pressure cell location after completion of second round of testing

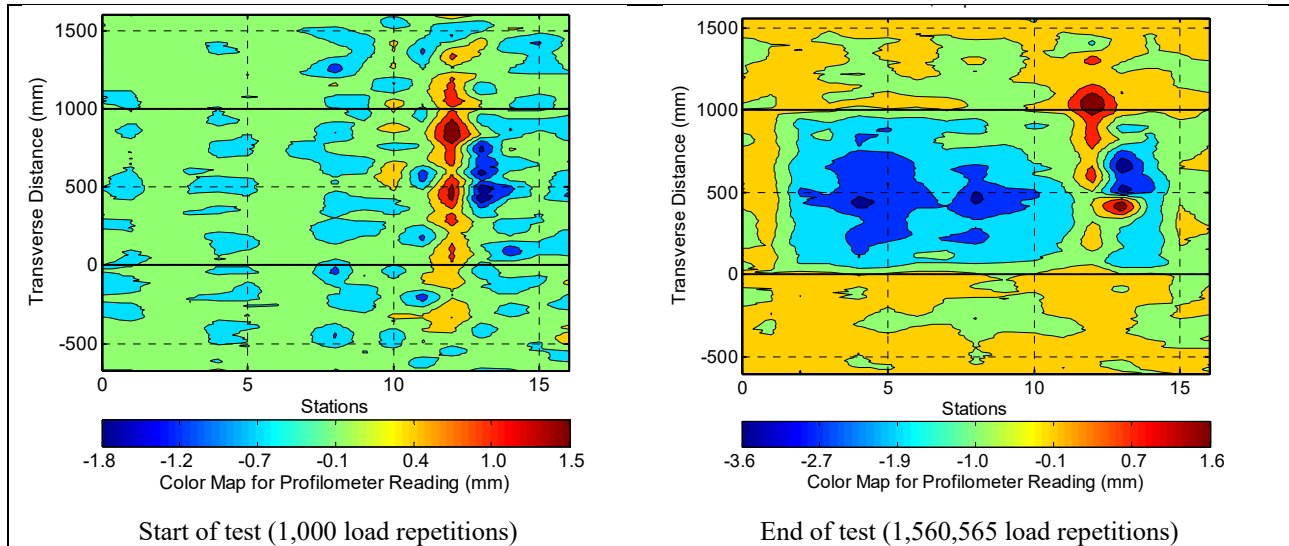
Figure 5.56: 674HB: Contour plots of permanent surface deformation.
(Note different scales in legends.)

Figure 5.56 shows contour plots of the pavement surface at the start and end of the test (1,560,565 load repetitions). The plot shows the relative uniformity of the rut depth over the length of the section. After completion of trafficking (~ 43.3 million ESALs) the average total maximum rut depth and the average deformation were 3.0 mm (0.12 in.) and 2.2 mm (0.09 in.), respectively. The maximum rut depth measured on the section was 5.9 mm (0.23 in.), recorded at Station 13, close to the wheel stop/start location.

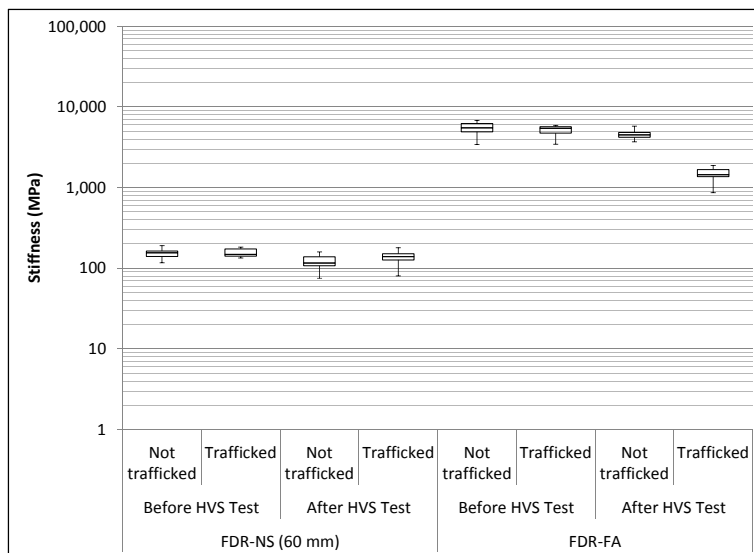
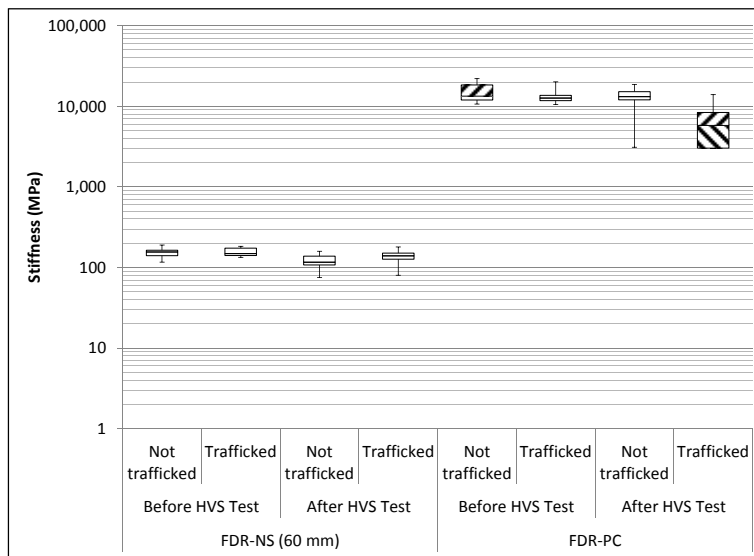
Figure 5.63: 674HB: Backcalculated stiffness of recycled layer (FWD).

The stiffness of the cement-stabilized layer was an order of magnitude stiffer than the unstabilized layer in the FDR-NS (60 mm) section. There was, however, a notable drop (~ 7,000 MPa) in the stiffness of the recycled layer after HVS trafficking, which was attributed to breaking of the cement bonds under loading and consequent damage in the form of microcracking. However, the recycled layer stiffness was still significantly higher compared to the recycled layer in the FDR-NS (60 mm) section after completion of trafficking (~ 6,000 MPa compared to ~ 150 MPa) despite the significantly higher number of equivalent single axle loads applied on the FDR-PC section (43.3 million compared to 5 million). The presence of the recycled asphalt concrete material did not appear to affect the stiffness of the layer. The stiffness of the untrafficked areas at either end of the test section did not change over time.

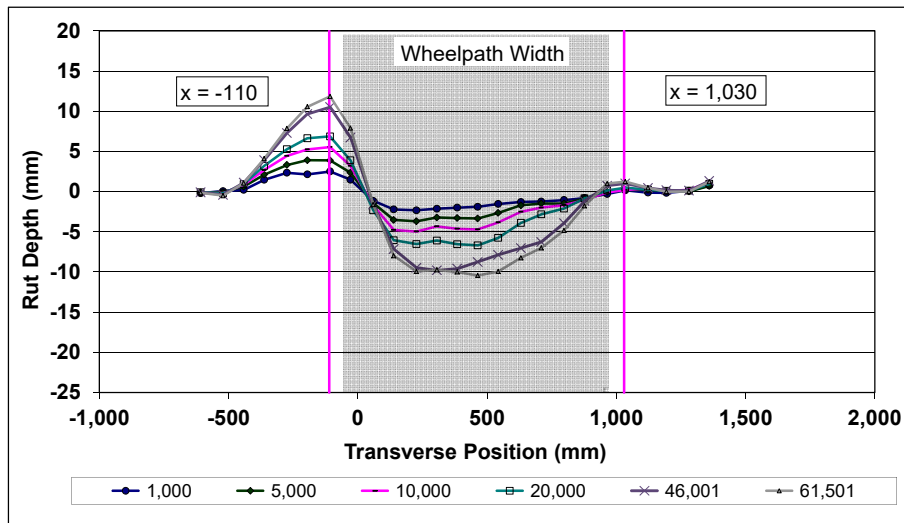
Figure 5.69: 675HC: Profilometer cross section at various load repetitions.

Figure 5.69 shows the average transverse cross section measured with the laser profilometer at various stages of the test and illustrates the rapid increase in rutting and deformation over the short duration of trafficking that was attributed to the construction problems (excess fluids and poor distribution of asphalt emulsion which led to poor compaction, and then the slow rate of curing after compaction) discussed in Section 3.5.2. The plot shows that depression and upward and outward displacement (shear) both contributed to the average maximum total rut depth.

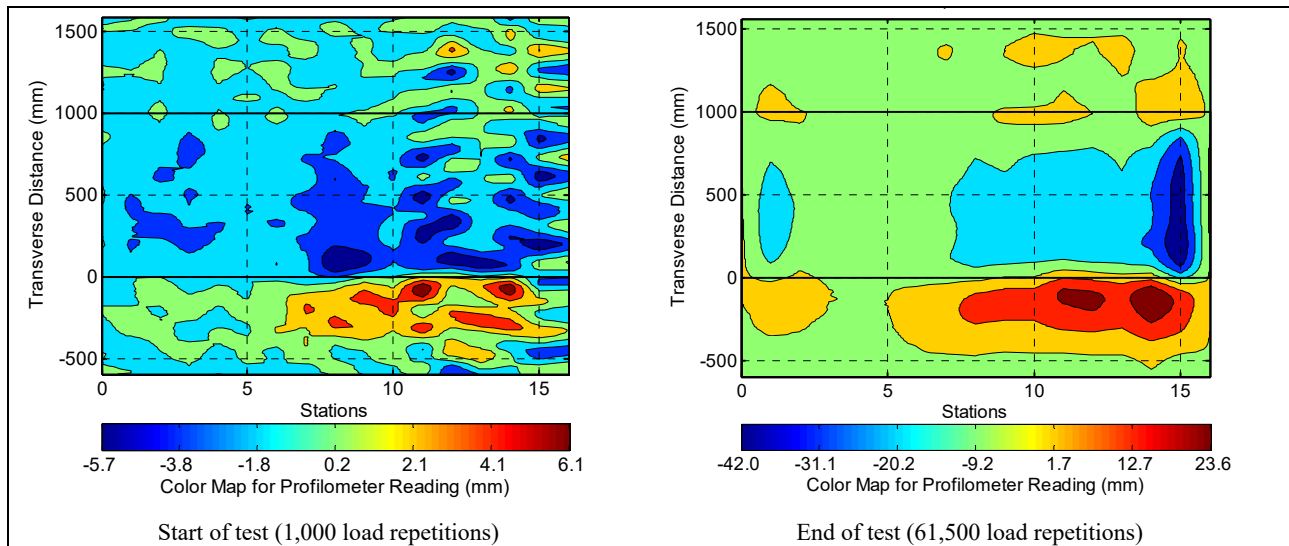
Figure 5.71: 675HC: Contour plots of permanent surface deformation.
(Note different scales in legends.)

Figure 5.71 shows contour plots of the pavement surface at the start and end of the test (61,500 load repetitions). The plot indicates that the deepest rut and area with the most sheared material were between Stations 8 and 16. Terminal rut (12.5 mm [0.5 in.]) was reached after just 14,000 load repetitions. After completion of trafficking, the average maximum total rut depth and the average deformation were 24.4 mm (0.96 in.) and 11.4 mm (0.45 in.), respectively. The maximum rut depth measured on the section was 44.6 mm (1.76 in.), recorded at Station 13. The maximum height of displaced material was 26.6 mm (1.05 in.), also measured at Station 13.

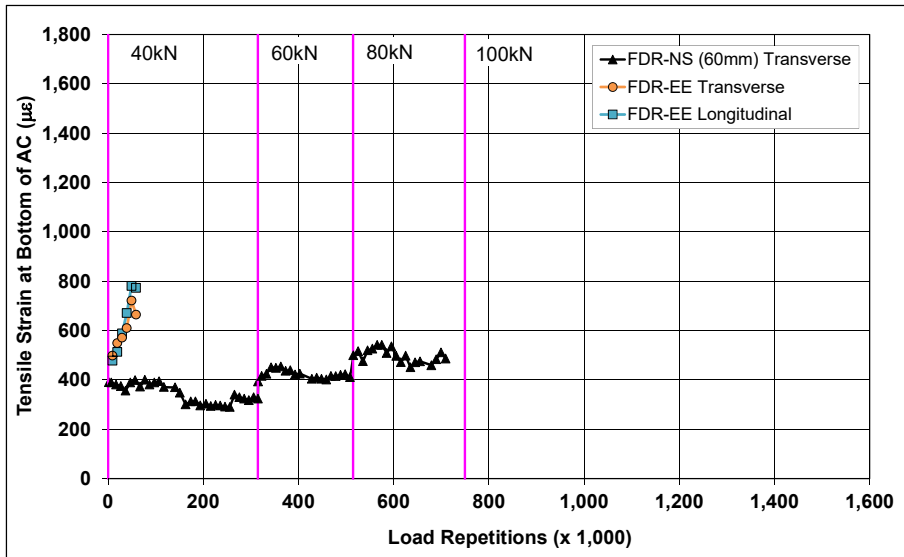
Figure 5.73: 675HC: Tensile strain at the bottom of the asphalt concrete layer.

Figure 5.73 shows the peak traffic-induced tensile strain at the bottom of the asphalt concrete layer. Transverse strain measurements from the FDR-NS (60 mm) section are included in the figure for comparison. Strains increased significantly from the start of the test and were consistent with the early severe deformation that was measured on the section and which is discussed in Sections 5.7.4 and 5.7.5. These problems were attributed to the construction issues discussed in Section 3.5.2.

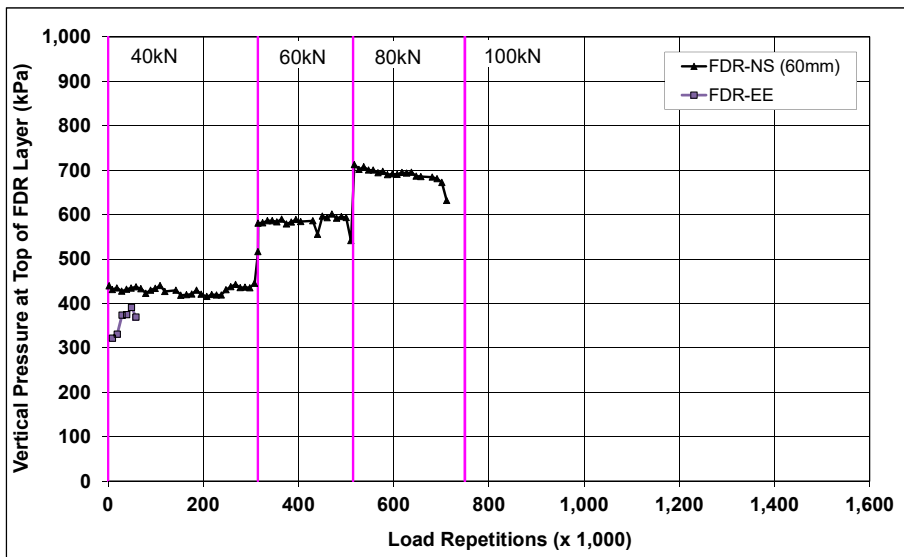
Figure 5.74: 675HC: Vertical pressure at the top of the recycled layer.

Figure 5.74 shows the comparison of traffic-induced vertical pressure at the top of the recycled base layer for the FDR-NS (60 mm) and FDR-EE sections. Pressure readings increased significantly from the start of the test on the FDR-EE section and were consistent with readings from the other instruments and with the surface deformation observed. This performance was attributed to the construction problems discussed in Section 3.5.2.

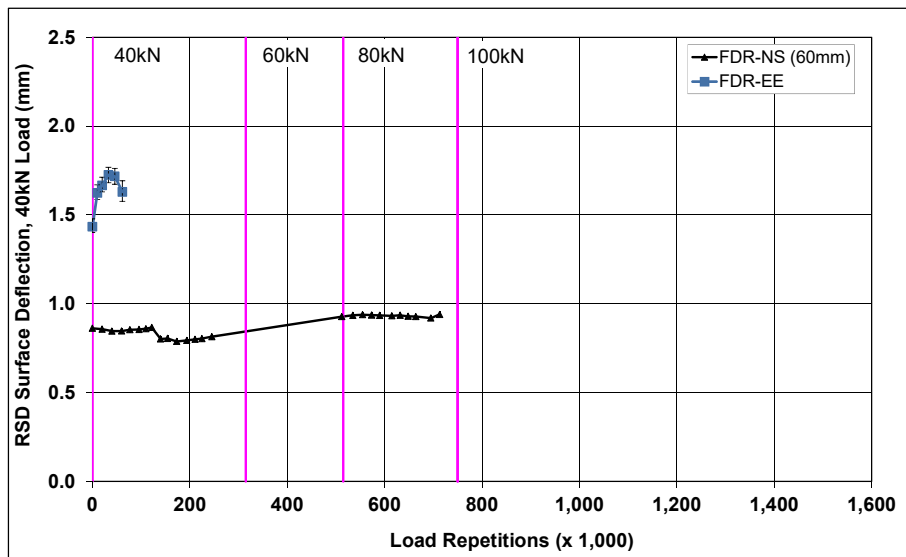
Figure 5.75: 675HC: Surface deflection (RSD).

Figure 5.75 compares elastic surface deflections measured with an RSD on the FDR-EE and FDR-NS (60 mm) sections under a 40 kN half-axle load. Deflections were significantly higher on the FDR-EE section, as expected, this being attributed to the lower stiffnesses associated with the construction problems discussed in Section 3.5.2.

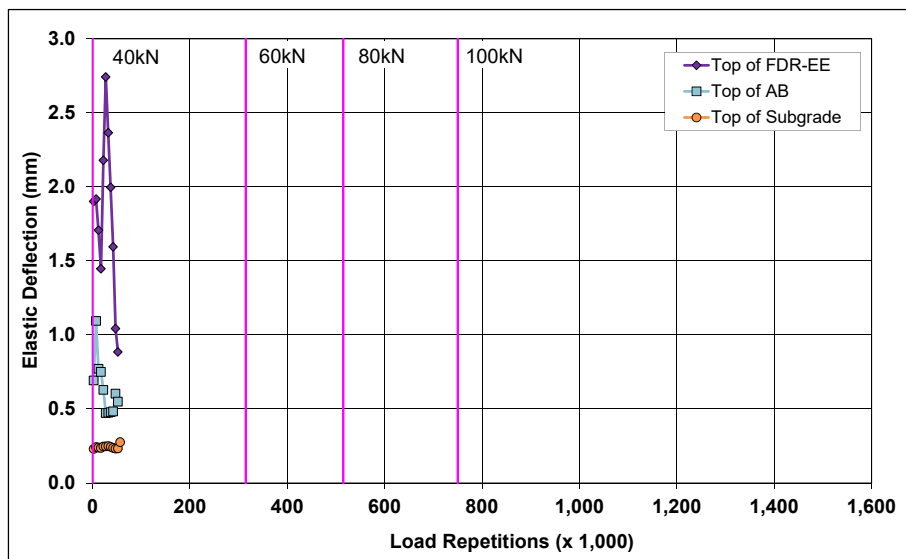
Figure 5.76: 675HC: Elastic deflection in the underlying layers.

Figure 5.76 shows the history of in-depth elastic deflections measured by the LVDTs in the multi-depth deflectometer in the FDR-EE section.   The high deflections recorded are consistent with other

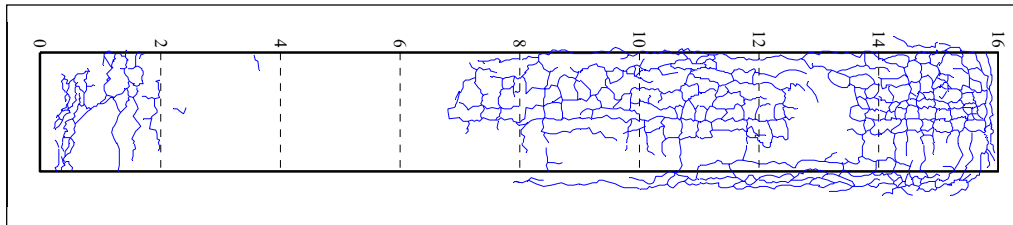
Figure 5.79: 675HC: Crack location and pattern.

Both rutting and fatigue cracking were recorded on the section. Severe alligator cracking was present between Station 7 and Station 16, with variation attributed to the construction problems discussed in Section 3.5.2. The total length of the cracks was 63.2 m (207.4 ft), which equates to an average crack density of 7.9 m/m^2 (2.4 ft/ft^2) on the test section at the end of the test, an amount considerably higher than

the failure criterion of 2.5 m/m² (0.75 ft/ft²) set for the study. The total length of the cracks between Station 7 and Station 16 was 53.2 m (174.5 ft), which equates to a crack density of 11.8 m/m² (3.6 ft/ft²). The location of the cracks and the crack pattern are shown in Figure 5.79. Photographs of the test section after HVS testing are shown in Figure 5.80.

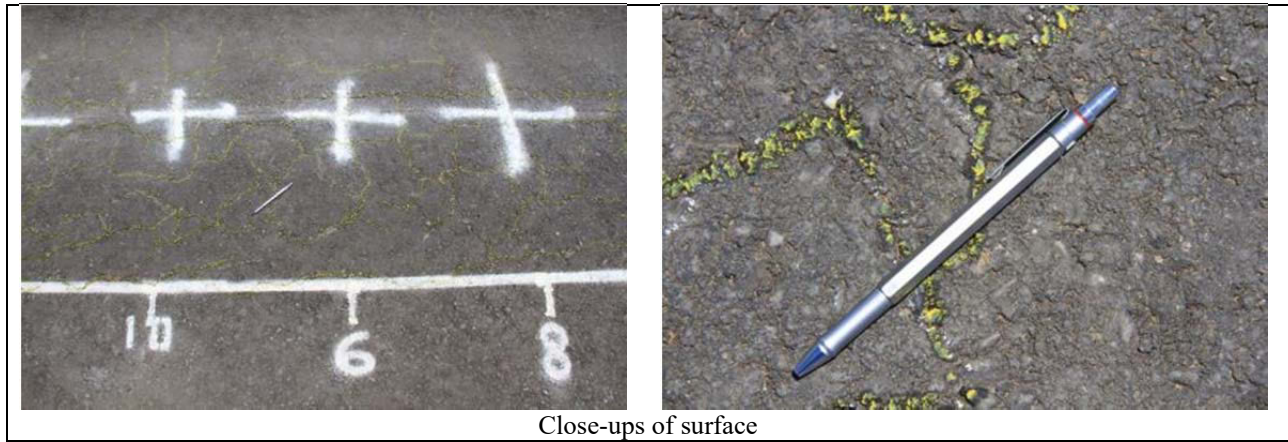
Figure 5.80: 675HC: Test section photographs *(continued)*.

Close-ups of surface

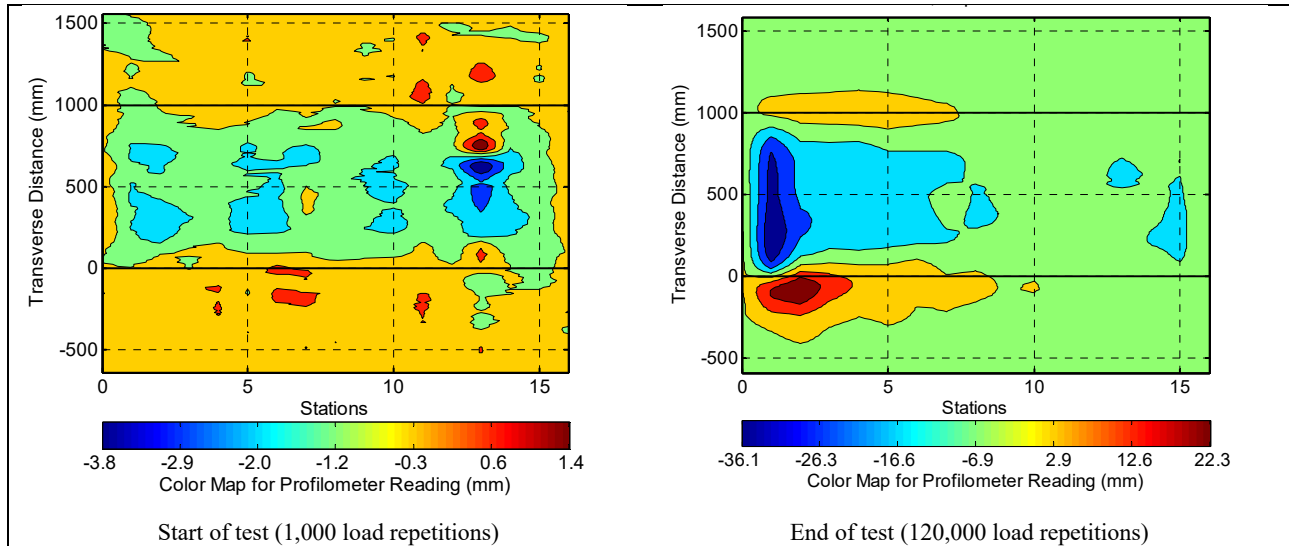
Figure 5.87: 676HC: Contour plots of permanent surface deformation.
(Note different scales in legends.)

Figure 5.87 shows contour plots of the pavement surface at the start and end of the test (120,000 load repetitions). The plot indicates that the deepest rut and the area with most sheared material were between Stations 0 and 8, opposite to that recorded on Section 675HC. Terminal rut (12.5 mm [0.5 in.]) was reached after about 80,000 load repetitions.

After completion of trafficking, the average maximum rut depth and the average deformation were 15.6 mm (0.61 in.) and 9.0 mm (0.35 in.), respectively. The maximum rut depth measured on the section was 24.8 mm (0.98 in.), recorded at Station 13. The maximum height of displaced material was 12.4 mm (0.49 in.) measured at Station 12.

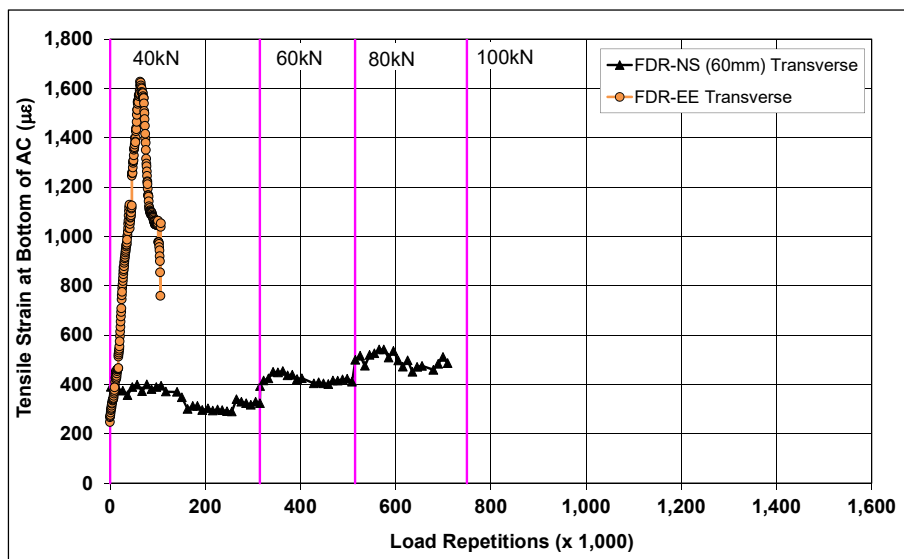
Figure 5.89: 676HC: Tensile strain at the bottom of the asphalt concrete layer.

Figure 5.89 shows the peak traffic-induced transverse tensile strain at the bottom of the asphalt concrete layer. The strain gauge installed to measure longitudinal strain was damaged during placement of the asphalt concrete surfacing and no data was recorded from this instrument.

Transverse strain measurements from the FDR-NS (60 mm) section are included in the figure for comparison. Transverse strains increased significantly from the start of the test and were consistent with the early severe deformation that was measured on the section and attributed to the construction issues discussed in Section 3.5.2. The significant reduction in strain measured in the latter part of the test was attributed to movement of the gauge associated with the depth of rutting in the vicinity of the gauge.

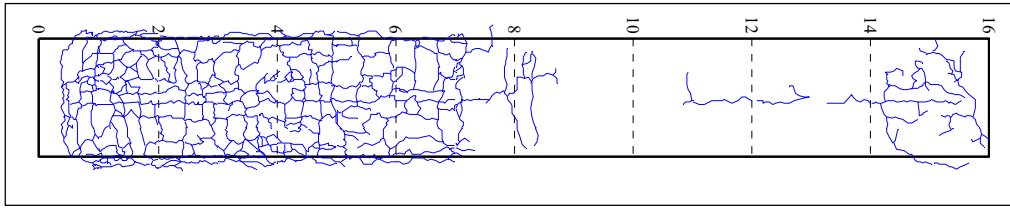
Figure 5.95: 676HC: Crack location and pattern.

Both rutting and fatigue cracking were recorded on the section. Severe alligator cracking was present between Station 0 and Station 8, with variation attributed to the construction problems discussed in Section 3.5.2. The total length of the cracks was 64.1 m (210.3 ft), which equates to an average crack density of 8.0 m/m^2 (2.4 ft/ft^2) on the test section at the end of the test, similar to that recorded on the FDR-EE#1 section and considerably higher than the failure criterion of 2.5 m/m^2 (0.75 ft/ft^2) set for the study. Total length of cracks between Station 0 and Station 8 was 55.7 m (182.7 ft), which equates to a crack density of 12.4 m/m^2 (3.8 ft/ft^2). The location of the cracks and the crack pattern are shown in Figure 5.95. Photographs of the test section after HVS testing are shown in Figure 5.96.
