4. TITLE AND SUBTITLE	5. REPORT DATE
Full-Depth Recycling Study: Test Track Construction and First-Level Analysis of Phase 1 and Phase 2 HVS Testing, Forensic Investigation, and Phase 1 Laboratory Testing	07/11/2016
	6. PERFORMING ORGANIZATION CODE

7. AUTHOR(S)	8. PERFORMING ORGANIZATION REPORT NO.
D. Jones, S. Louw, and R. Wu	UCPRC-RR-2015-02

Full-Depth Recycling Study:
Test Track Construction and First-Level Analysis of Phase 1 and Phase 2 HVS Testing, Forensic Investigation, and Phase 1 Laboratory Testing

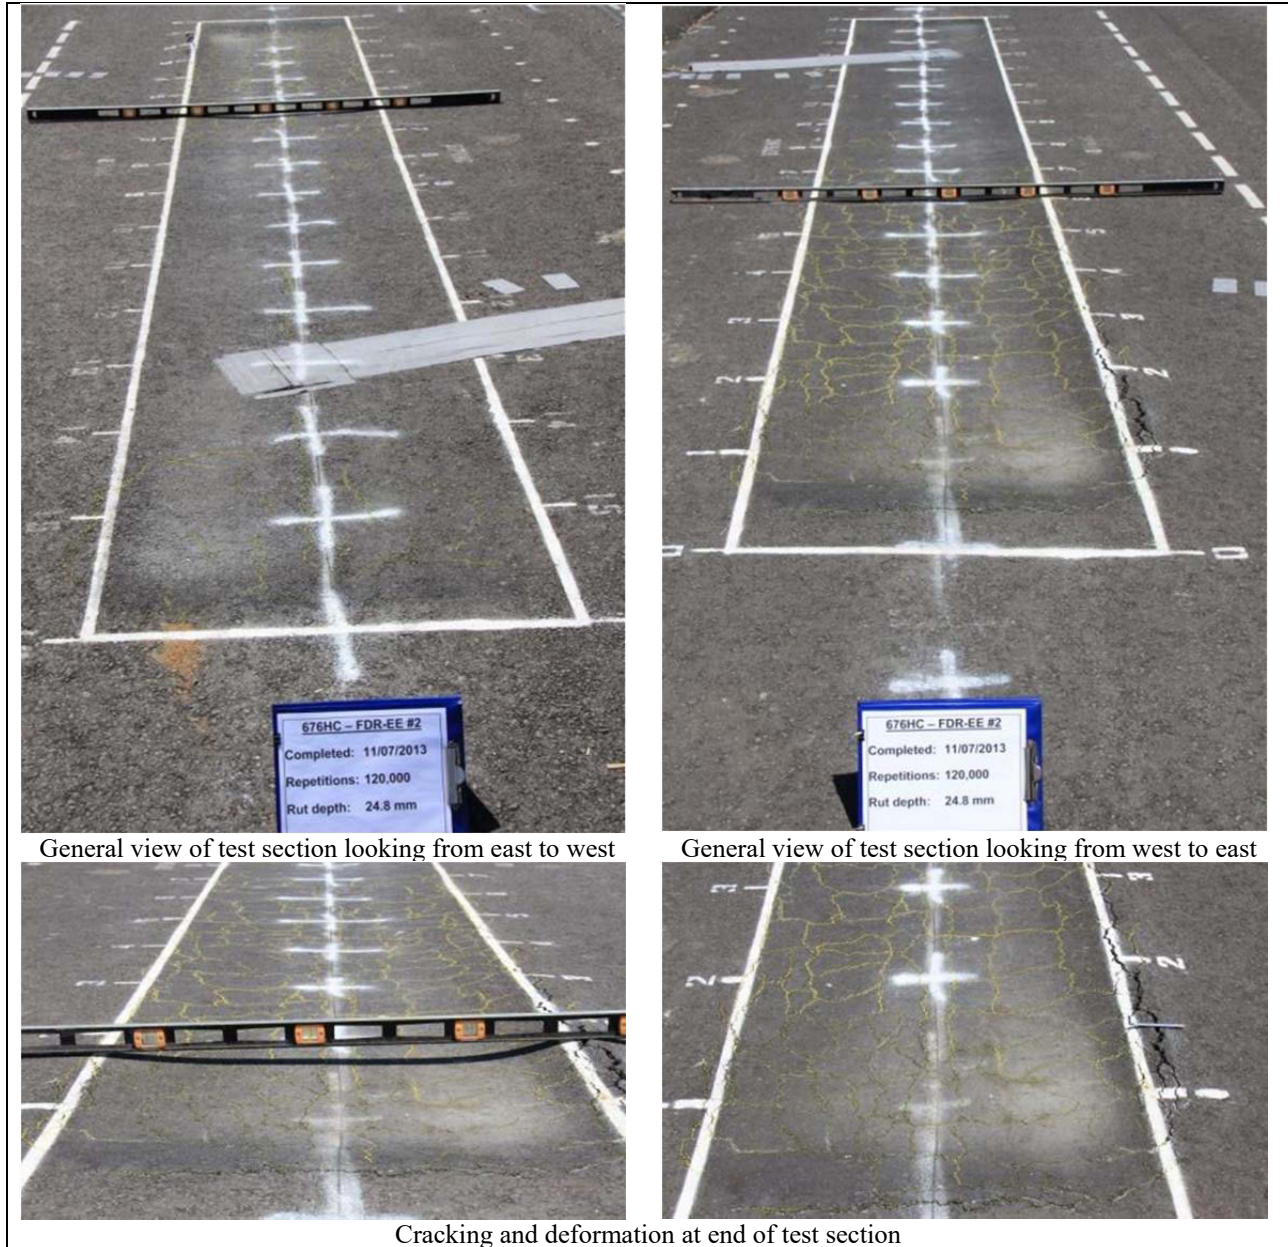
Figure 5.96: 676HC: Test section photographs.

General view of test section looking from east to west | General view of test section looking from west to east

Cracking and deformation at end of test section

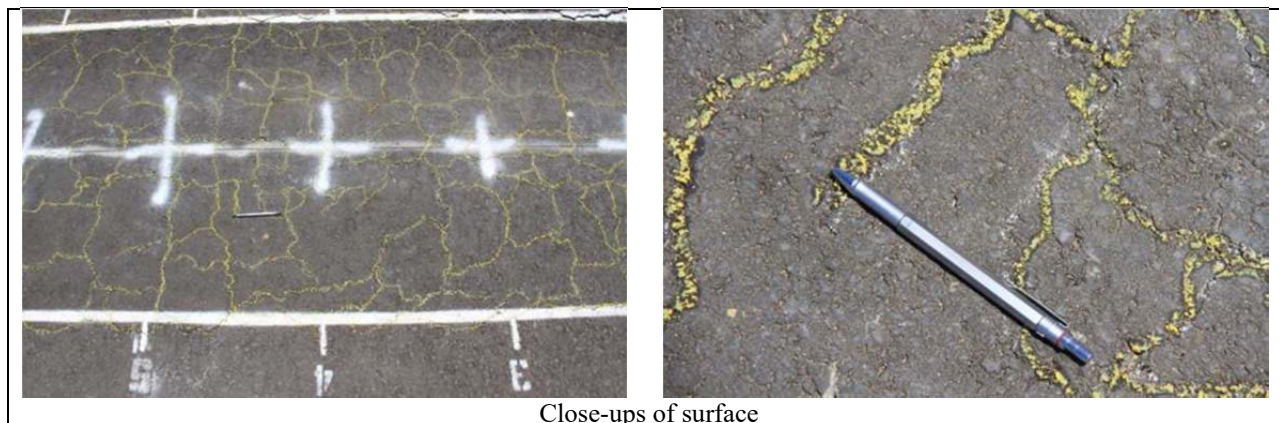
Figure 5.96: 676HC: Test section photographs *(continued).*

Close-ups of surface

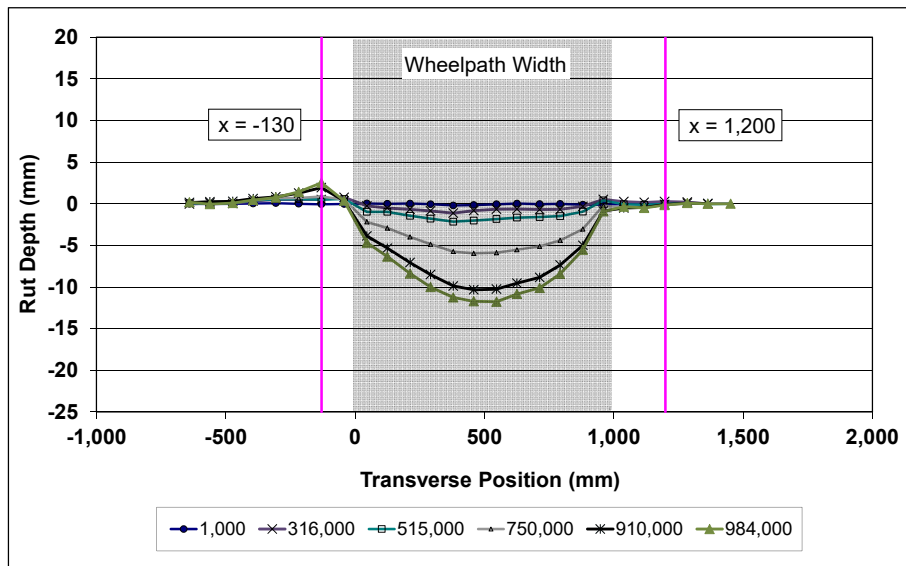
Figure 6.6: 685HB: Profilometer cross section at various load repetitions.

Figure 6.6 shows the average transverse cross section measured with the laser profilometer at various stages of the test and illustrates the increase in rutting and deformation over time. The plot shows that most of the deformation was in the form of a depression rather than upward and outward displacement of the material above the zero elevation point.

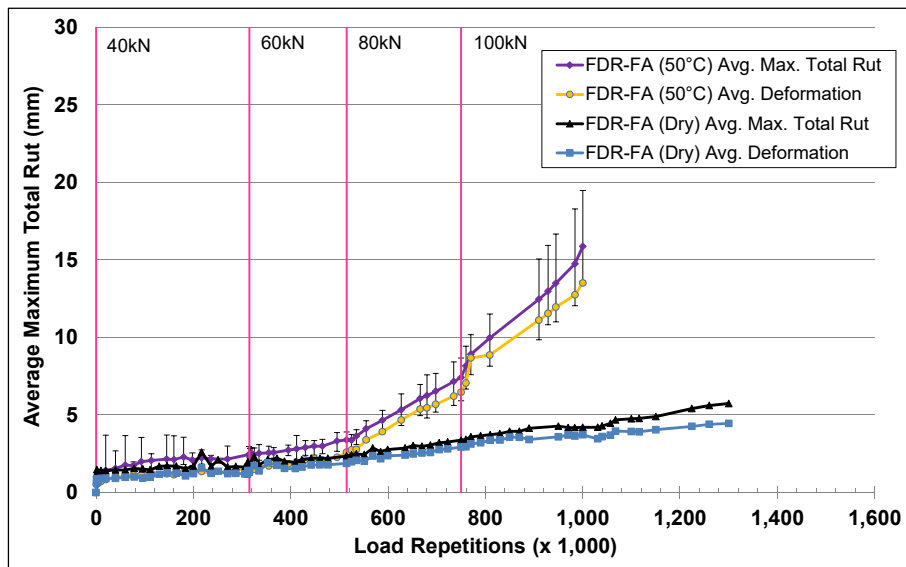
Figure 6.7: 685HB: Average maximum total rut and average deformation.

Figure 6.7 shows the development of permanent deformation (average maximum rut and average deformation) with load repetitions for the test section. The results for the Phase 1a FDR-FA dry test are shown for comparison. The embedment phase on this test was similar to that on the Phase 1a FDR-FA section tested at 30°C under dry conditions (673HB) both in terms of the number of load repetitions and

the rut depth. The average maximum total rut at the end of the embedment phase was about 1.4 mm (0.06 in.). The rate of rut depth increase for the remainder of the 40 kN wheel loading after the embedment phase was also similar to that recorded on Section 673HB. It had been expected that this rate would have been higher given the higher temperatures; however, the similar rate of rutting was attributed to the additional aging and consequent stiffening of the asphalt concrete in the two years between the different tests.

No clear embedment phases were evident after the 60 kN and 80 kN load changes, but one was clearly noticeable after the 100 kN load change. The rate of rut depth increased after each load change, with the severity of the change increasing with increasing load. This behavior was notably different from that

recorded on Section 673HB and was attributed to the combined effects of the high temperature and higher wheel loads, as well as to the high moisture contents in the FDR and original base layers caused by the testing under wet conditions on adjacent test sections. Error bars on the average maximum total rut reading indicate that there was limited variation along the length of the section. Observations on the section indicated that severe rutting had occurred at one end of the section in the zone where the wheel starts and stops at the beginning and end of a load repetition. Terminal rut 12.5 mm (0.5 in.) was reached after 910,000 load repetitions (~12.8 million ESALs), but trafficking was continued to monitor changes in rut rate and to monitor cracking behavior. The test was eventually halted when the average maximum rut depth was 16 mm (0.63 in.).

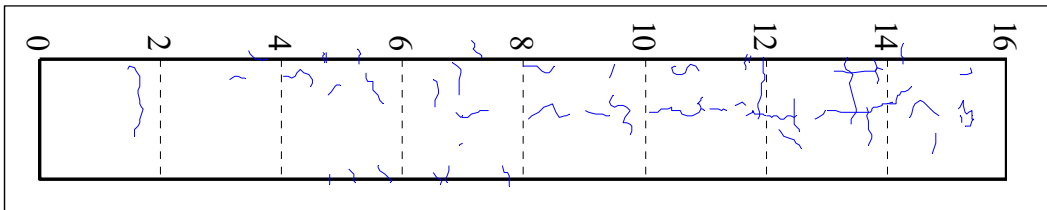
Figure 6.13: 685HB: Crack location and pattern after 1,000,000 load repetitions.

Rutting and limited cracking were recorded on the section. Cracks only started to appear towards the end of the test (first observed after 859,200 load repetitions had been applied) and were mostly longitudinal in nature. Some transverse cracks, associated with early signs of fatigue cracking attributed to the higher deflections, were also recorded in the last 20,000 load repetitions between Station 12 and Station 16. The total length of all cracks at the end of the test was 12.6 m (41.3 ft), which equates to an average crack density of 1.6 m/m^2 (0.5 ft/ft^2, well below the failure criterion of 2.5 m/m^2 (0.75 ft/ft^2) set for the study. The location of the cracks and the crack pattern at the end of the test are shown in Figure 6.13. Apart from the rutting and cracking, no other distresses were recorded on the section. Photographs of the test section after HVS testing are shown in Figure 6.14.

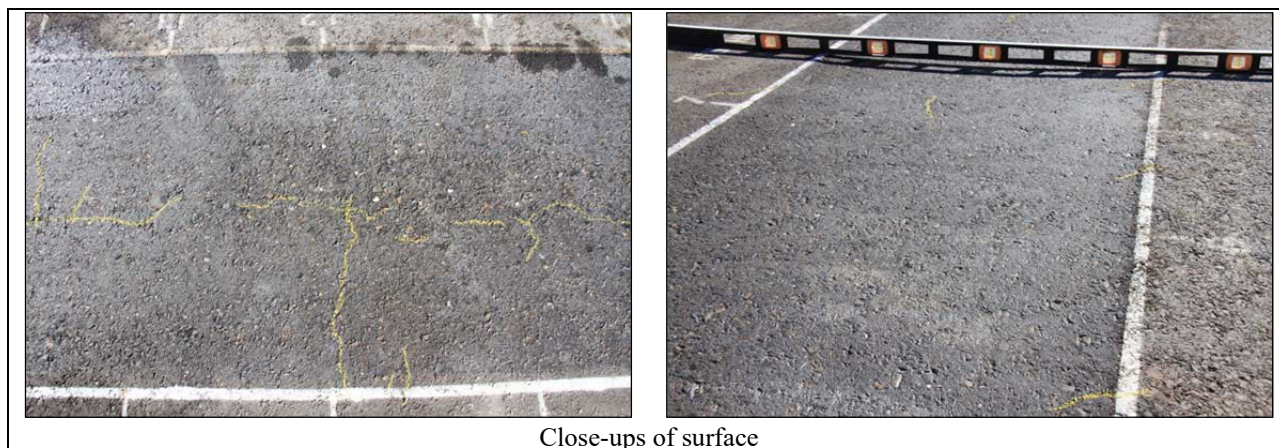
Figure 6.14: 685HB: Test section photographs *(continued).*

Close-ups of surface

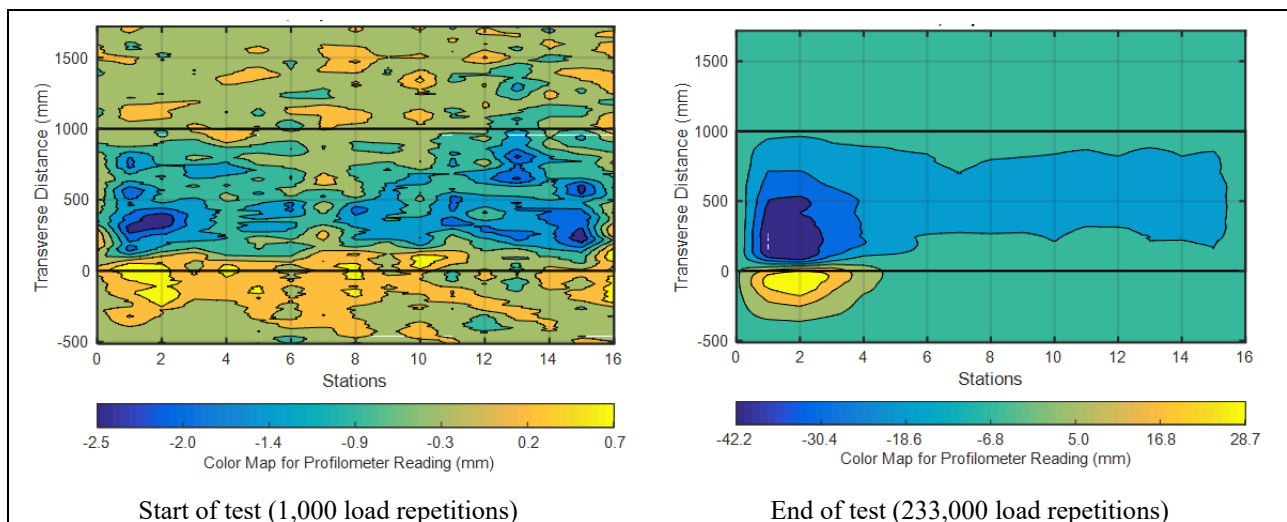
Figure 7.8: 683HC: Contour plots of permanent surface deformation.
(Note different scales in legends.)

Figure 7.8 shows contour plots of the pavement surface at the start and end of the test (233,000 load repetitions) that also indicate the deeper rut at one end of the section. Terminal rut (12.5 mm [0.5 in.]) was reached after approximately 215,000 load repetitions. However, testing was continued for approximately 20,000 additional load repetitions to further assess rutting and cracking trends.

After completion of trafficking, the average maximum rut depth and the average deformation were 17.5 mm (0.69 in.) and 13.3 mm (0.52 in.), respectively. The maximum rut depth measured on the section was 27.5 mm (1.08 in.), recorded at Station 3.

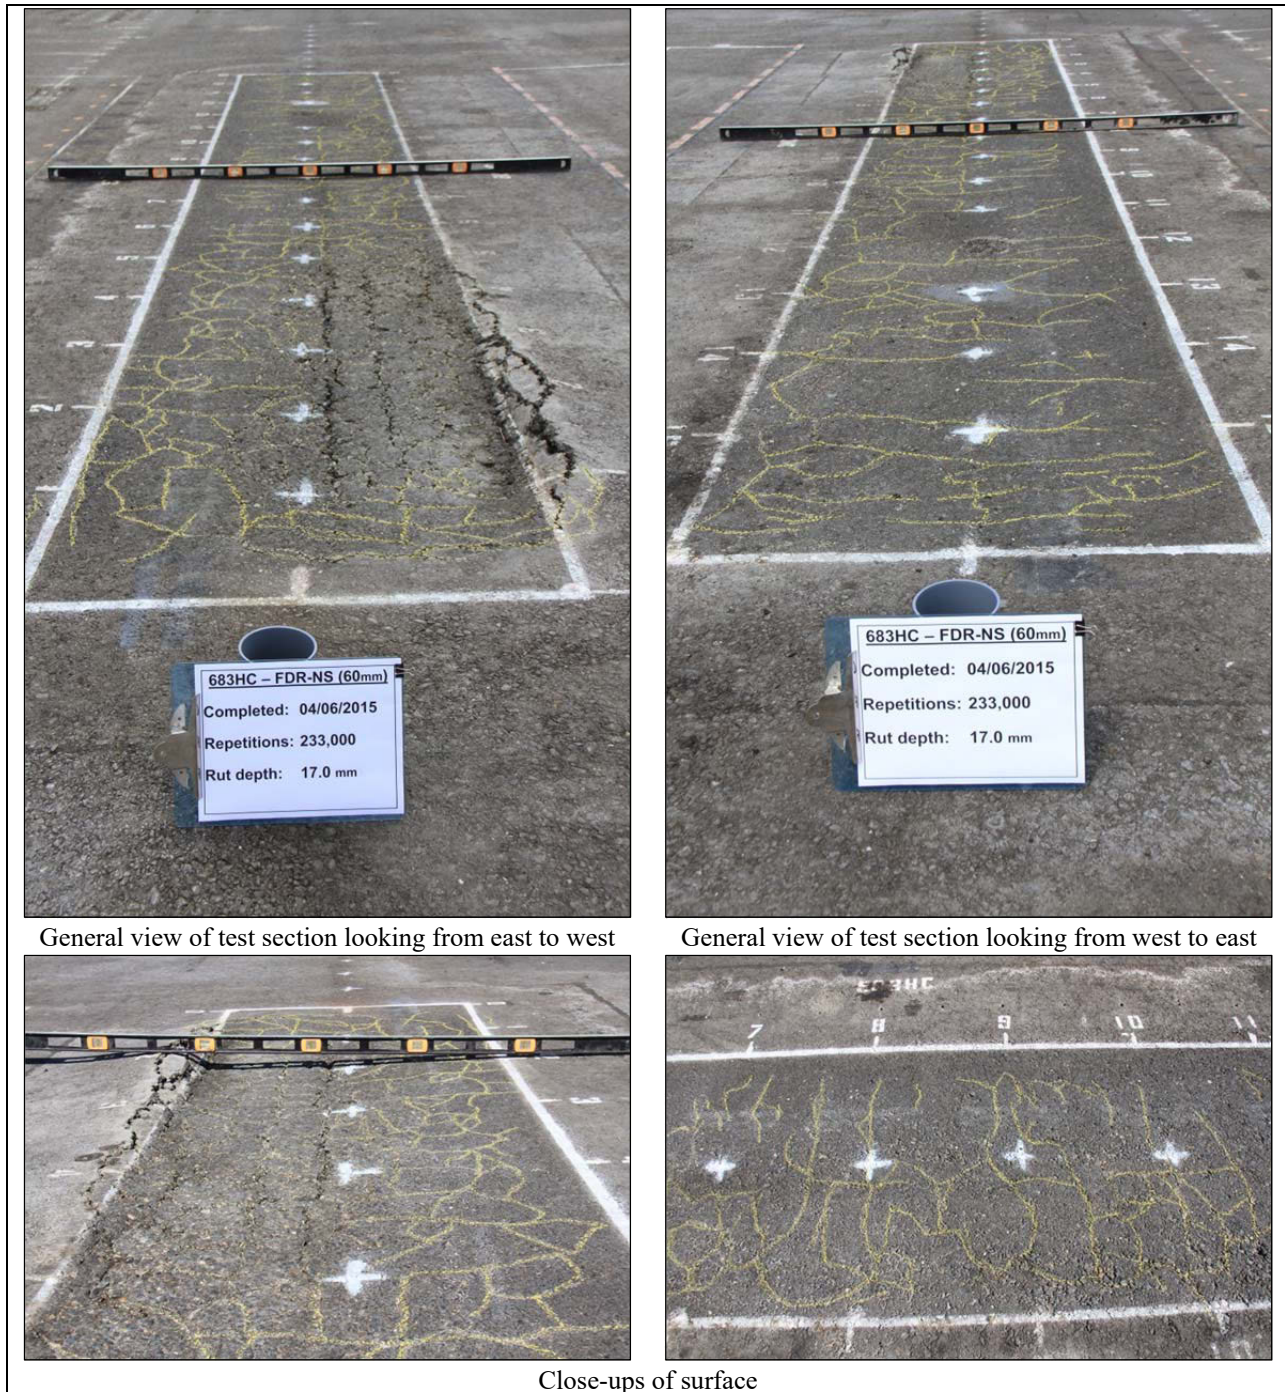
Figure 7.13: 683HC: Test section photographs.

Rutting and severe fatigue cracking were recorded on the section. Cracks were first observed after 20,000 load repetitions (wheel load at 40 kN) and continued to propagate for the remainder of the test. Terminal cracking (2.5 m/m^2 [0.75 ft/ft^2]) was reached after approximately 80,000 load repetitions. The total length of all cracks at the end of the test (233,000 load repetitions) was 95.7 m (314.0 ft), which equates to an average crack density of 11.9 m/m^2 (3.6 ft/ft^2) on the test section, well above the failure criterion set for the study. The location of the cracks and the crack pattern at 80,000 load repetitions and at the end of the test are shown in Figure 7.12. Crack density was highest between Stations 0 and 6, in the area of severe deformation. Photographs of the test section after HVS testing are shown in Figure 7.13.

| General view of test section looking from east to west | General view of test section looking from west to east |

Close-ups of surface

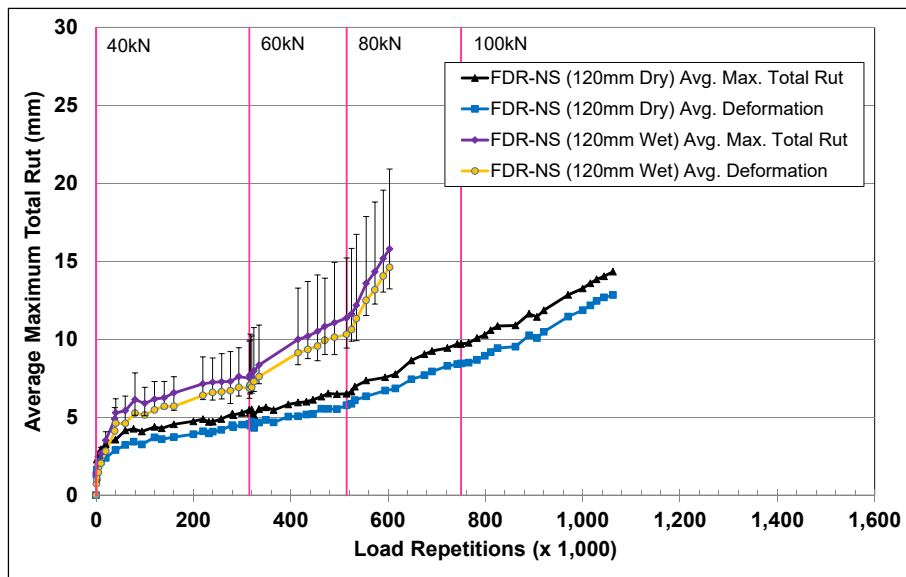
Figure 7.19: 684HB: Average maximum total rut and average deformation.

Figure 7.19 shows the development of permanent deformation (average maximum rut and average deformation) with load repetitions for the test section.   The results for the Phase 1a dry test (Section 677HC) are shown for comparison. The embedment phase on the wet test was of similar duration to that on the Phase 1a dry test (Section 677HC) in terms of the number of load repetitions (i.e., ± 5,000), but ended with a deeper rut. The average maximum total rut at the end of the embedment phase was about 5.3 mm (0.21 in.). The rate of rut depth increase after the embedment phase was also faster than that on Section 677HC, and this was attributed to the wet, weaker underlying layers. Increases in the

applied load to 60 kN and then to 80 kN and 100 kN resulted in observable embedment phases and increases in the rate of rut depth after each event. Error bars on the average maximum total rut reading indicate that there was some variation along the length of the section, specifically towards the end of the test. Rutting performance on this section was considerably better than that recorded on the FDR-NS (60 mm) test (Section 683HC); this was attributed to the additional 60 mm-thick asphalt concrete layer.

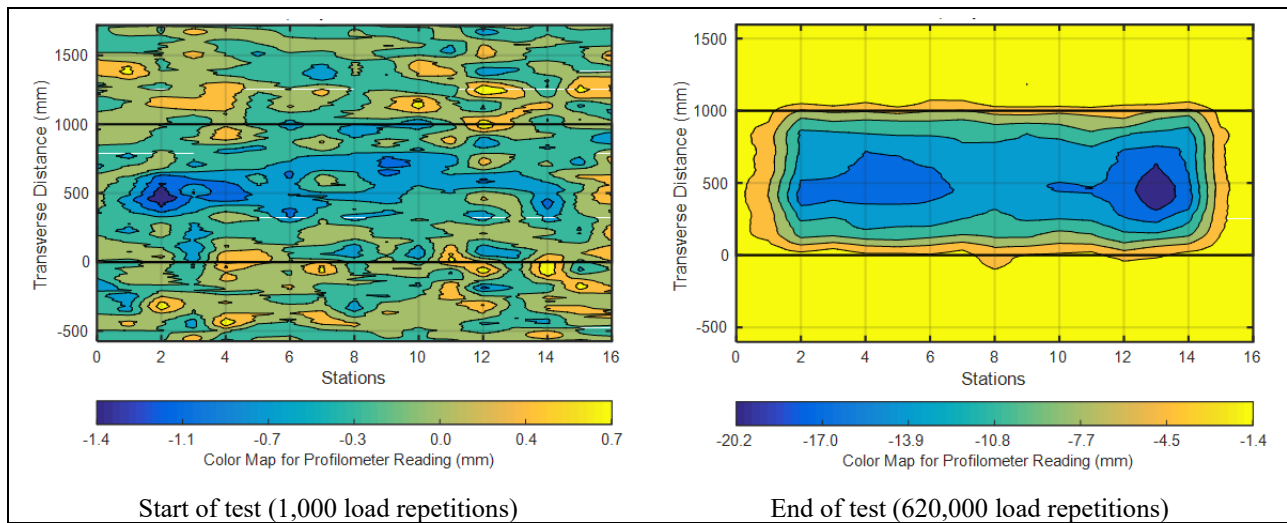
Figure 7.20: 684HB: Contour plots of permanent surface deformation.
(Note different scales in legends.)

Figure 7.20 shows contour plots of the pavement surface at the start and end of the test (620,000 load repetitions). The plot indicates that the deepest ruts were at the start and end of the test section, where the wheel changed direction. Terminal rut (12.5 mm [0.5 in.]) was reached after approximately 540,000 load

After completion of trafficking, the average maximum total rut depth and the average deformation were 15.7 mm (0.62 in.) and 14.6 mm (0.57 in.), respectively. The maximum rut depth measured on the section was 20.9 mm (0.82 in.), recorded at Station 13.

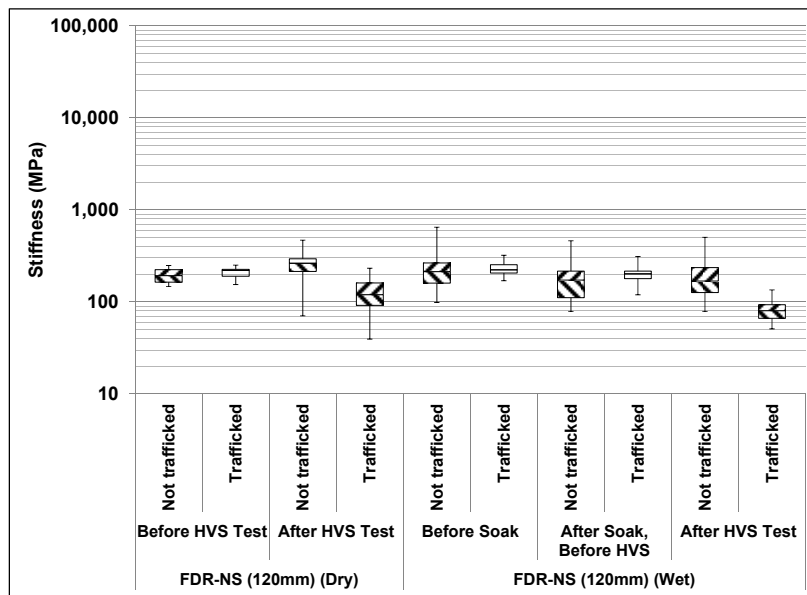
Figure 7.23: 684HB: Backcalculated stiffness of recycled layer (FWD).

The recycled layer stiffness was backcalculated from the deflection measurements using the *CalBack* software package, and the results are summarized in Figure 7.23. Stiffness of the recycled layer dropped immediately after soaking, indicating that the presoak process had allowed water to infiltrate the recycled layer. The stiffness of the wet unstabilized recycled layer showed a noticeable decrease compared to the dry section after completion of HVS testing. At the end of the HVS test, average stiffness measured along the length of the test section had dropped by about 150 MPa, consistent with the loading that had been applied (~ 3.3 million ESALs). The presence of the recycled asphalt concrete material did not appear to affect the stiffness of the layer. There was a slight reduction in the stiffness of the untrafficked areas on either side of the test section after testing was completed, indicating some impact of the prolonged water soaking of the recycled layer, which would also affect its the shear strength.

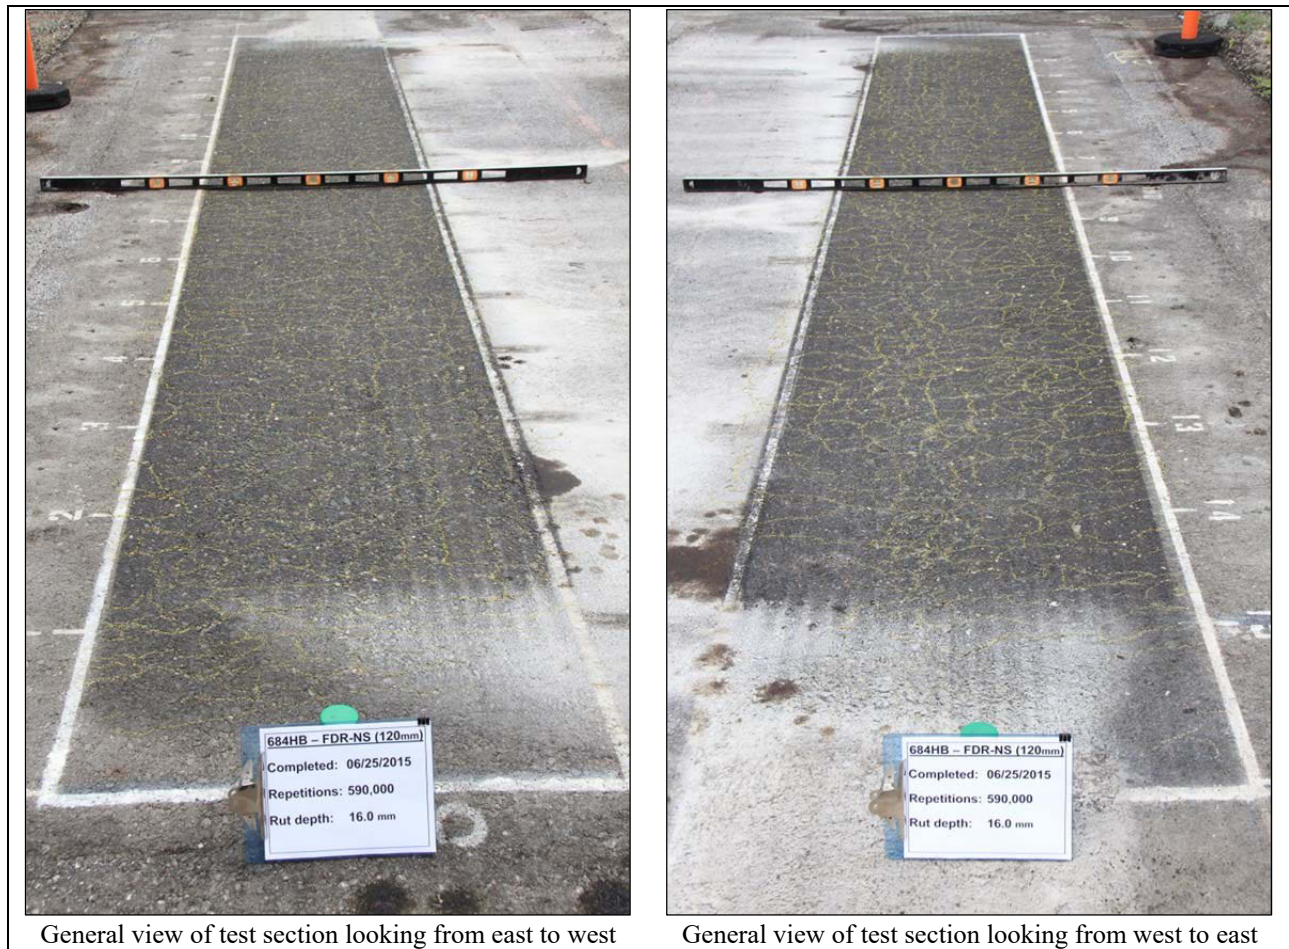
Figure 7.25: 684HB: Test section photographs.

Rutting and fatigue cracking were recorded on the section. Short and narrow transverse cracks were first observed after just 10,000 load repetitions and they continued to propagate into a dense matrix of fine fatigue cracks over the remainder of the test. Terminal cracking (2.5 m/m^2 [0.75 ft/ft^2]) was reached after approximately 40,000 load repetitions, significantly quicker than recorded on the FDR-NS (60 mm) test and attributed to debonding between the two lifts of asphalt. The total length of all cracks at the end of the test (620,000 load repetitions) was 192.8 m (632.5 ft), equating to an average crack density of 24.1 m/m^2 (7.3 ft/ft^2), significantly higher than the failure criterion. The cracks were much finer and more dense than those observed on the FDR-NS (60 mm) section. The location of the cracks and the crack pattern after

| General view of test section looking from east to west | General view of test section looking from west to east |

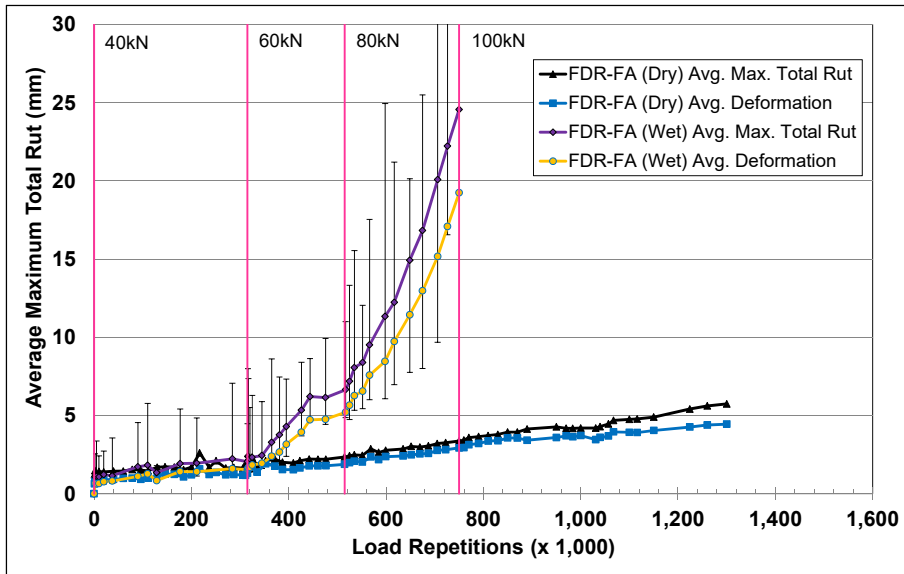
Figure 7.31: 681HC: Average maximum total rut and average deformation.

Figure 7.31 shows the development of permanent deformation (average maximum rut and average deformation) with load repetitions for the test section. The results for the Phase 1a dry test (Section 673HB) are included for comparison. Rutting behavior on this Phase 2 wet test was very similar to that recorded on the Phase 1a dry test for the duration of testing under the 40 kN wheel load. Minimal embedment was recorded in this part of the test. However, the rut rate increased dramatically after the changes to the 60 kN and 80 kN wheel loads, indicating some reduction in the shear strength of the underlying materials under the wet conditions. This observation was consistent with field and laboratory test results *(2)*. Error bars on the average maximum total rut reading indicate that there was considerable variation along the length of the section, with deepest ruts in the vicinity of the multi-depth deflectometer, pressure cell, and strain gauges, an indication that moisture damage was highest in these locations.

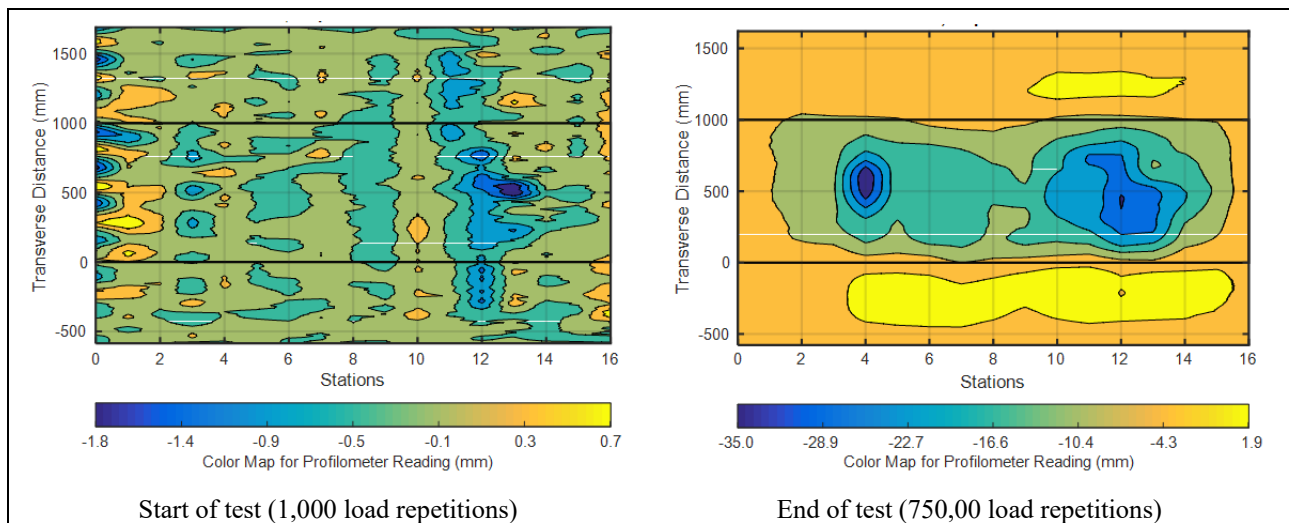
Figure 7.32: 681HC: Contour plots of permanent surface deformation.
(Note different scales in legends.)

Figure 7.32 shows contour plots of the pavement surface at the start and end of the test (750,000 load repetitions). The plot shows the two distressed areas at Stations 4 and 12 in the vicinity of the instrumentation. Terminal rut (12.5 mm [0.5 in.]) was reached after approximately 625,000 load repetitions. However, testing was continued for approximately 125,000 additional load repetitions to further assess rutting and cracking trends. After completion of trafficking, the average maximum rut depth and the average deformation were 22.2 mm (0.87 in.) and 17.1 mm (0.67 in.), respectively. The maximum total rut depth measured on the section was 35.0 mm (1.38 in.), recorded at Station 12, close to the multi-depth deflectometer.

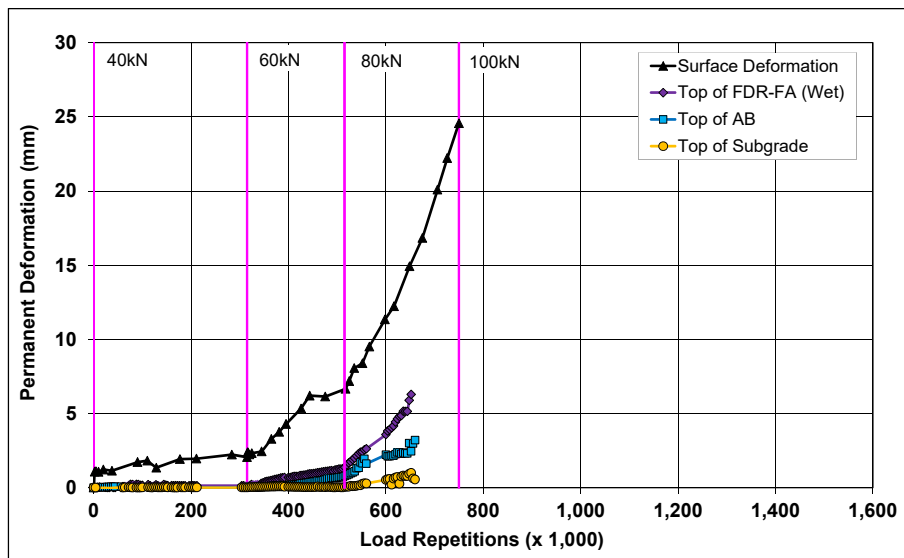
Figure 7.33: 681HC: Permanent deformation in the underlying layers.

Permanent deformation in the underlying layers, recorded with a multi-depth deflectometer (MDD) at Station 13 and compared to the surface layer laser profilometer measurements is shown in Figure 7.33. The MDD system failed after approximately 650,000 load repetitions as a result of water damage to electrical connections on the LVDT. Prior to the failure, the results show that no permanent deformation was recorded in the underlying layers until the load change to 60 kN (315,000 load repetitions), after which some deformation started in the FDR and original aggregate base layers. Deformation continued at a constant rate through to the 80 kN load change, after which the rate of deformation increased in both layers. Deformation at the top of the subgrade was first recorded after the 80 kN load change. Deformation in each of the layers is summarized in Table 7.4 (results for the Phase 1a dry test [Section 673HB] are included for comparison).

Deformation at the top of the FDR-FA layer, top of the existing aggregate base layer, and top of the subgrade had reached 2.9 mm, 2.1 mm, and 0.9 mm after 650,000 load repetitions when the MDD failed,

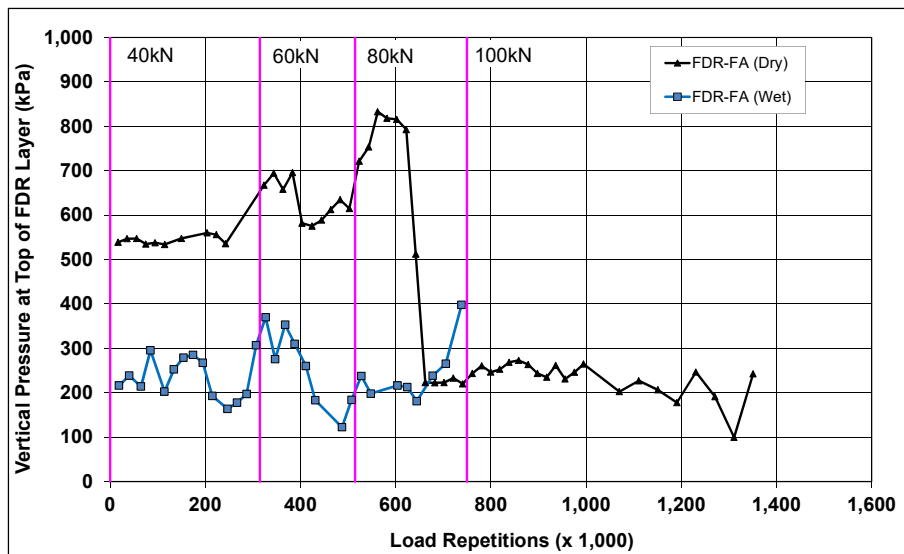
Figure 7.34: 681HC: Vertical pressure at the top of the recycled layer.

Figure 7.34 shows the comparison of traffic-induced vertical pressure at the top of the recycled base layer for the Phase 1a dry and Phase 2 wet tests. Pressure readings were inconsistent and significantly lower than expected. Early circular cracking and a depression in the asphalt concrete in the vicinity of the pressure cell (see Figure 7.40) suggested that the support conditions under the pressure cell and the bonding of the pressure cell to the asphalt concrete and FDR layers had been compromised by the water soaking conditions. Consequently, no conclusions were drawn with regard to vertical pressure at the top of the recycled layer in this test.

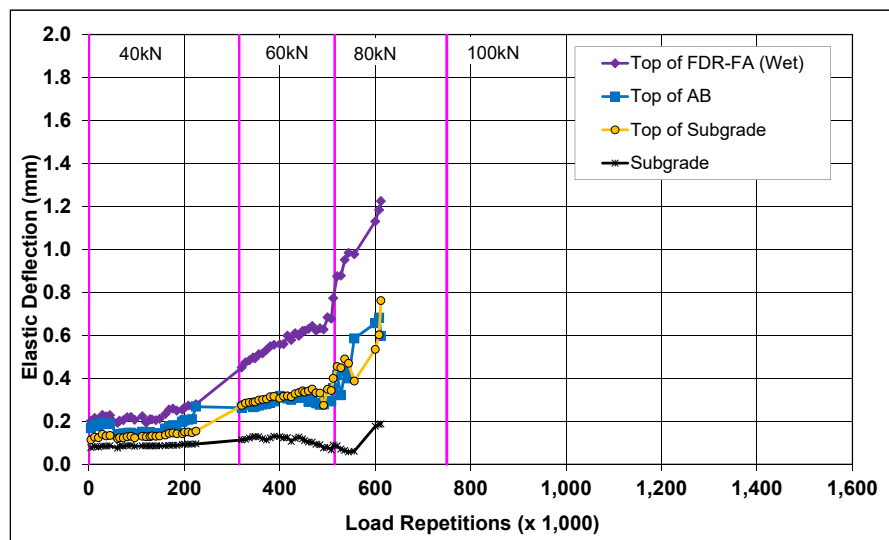
Figure 7.36: 681HC: Elastic deflection in the underlying layers.

The MDD failed after approximately 650,000 load repetitions as a result of moisture damage to the electrical connections in the LVDTs. Measurements at the top of the original aggregate base and top of

the subgrade were consistent with the measurements recorded in the Phase 1a test (Section 673HB). Deflections increased with increased load, as expected, but unlike the Phase 1a test, they did not stabilize after each embedment phase and continued to increase with increasing number of load repetitions, which suggests weakening of the layers as the distresses associated with the higher moisture content increased.

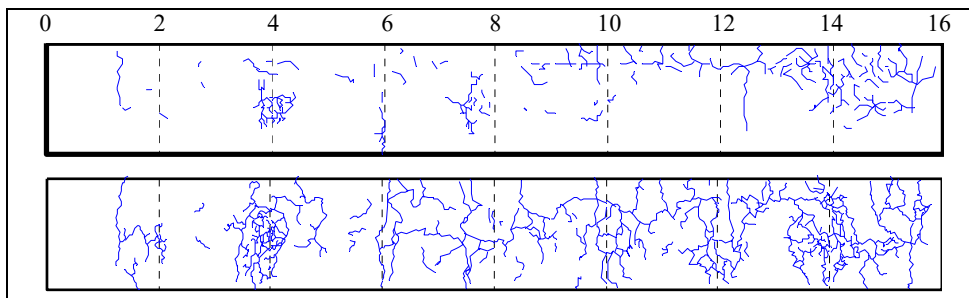
Figure 7.39: 681HC: Crack location and pattern after 625,000 and 750,000 load repetitions.

Rutting and cracking were recorded on the section. Transverse, longitudinal, and fatigue cracks were all recorded, with most of the fatigue cracking in the vicinity of the pressure cell (Station 4) and MDD (Station 14). Transverse cracks were first observed at these two locations after approximately 365,000 load repetitions when the wheel load was at 60 kN and they continued to propagate and spread for the remainder of the test. Terminal cracking (2.5 m/m^2 [0.75 ft/ft^2]) was reached after approximately 625,000 load repetitions when the wheel load was at 80 kN. The total length of all cracks at the end of the test (750,000 load repetitions) was 95.7 m (314.0 ft), which equates to an average crack density of 11.9 m/m^2 (3.6 ft/ft^2) on the test section, indicating that most cracks propagated under the heavier wheel loads. The location of the cracks and the crack pattern at 625,000 load repetitions and at the end of the test are shown in Figure 7.39. Photographs of the test section after HVS testing are shown in Figure 7.40.

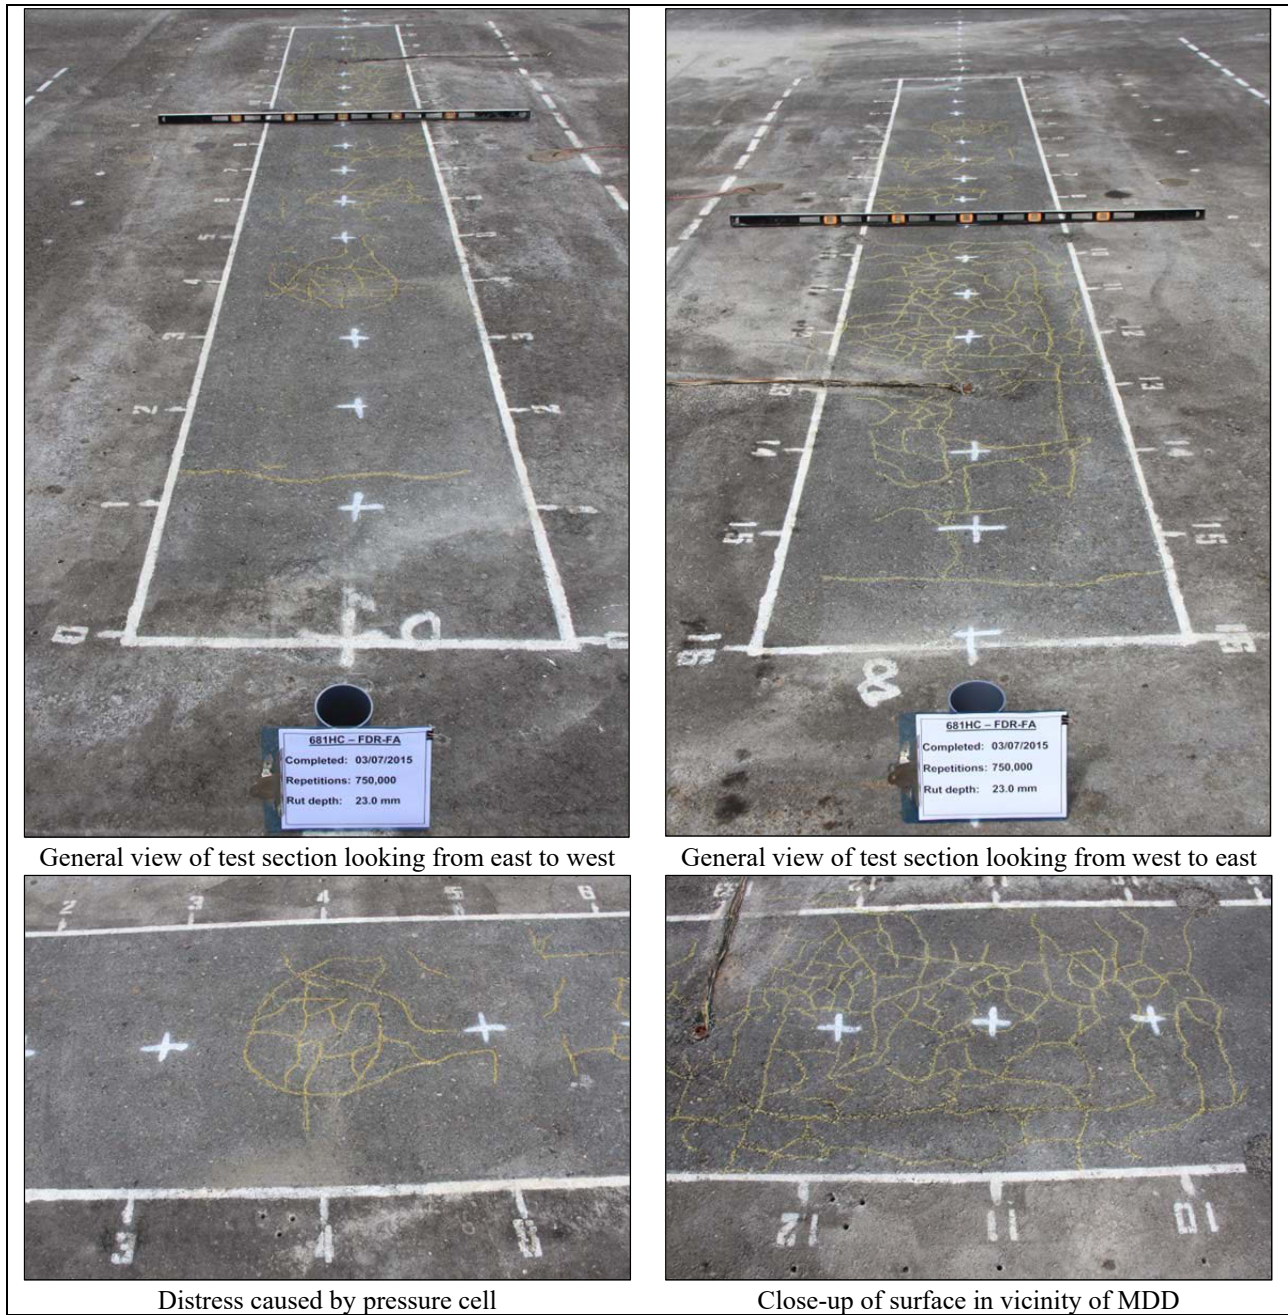
Figure 7.40: 681HC: Test section photographs.

| Distress caused by pressure cell | Close-up of surface in vicinity of MDD |

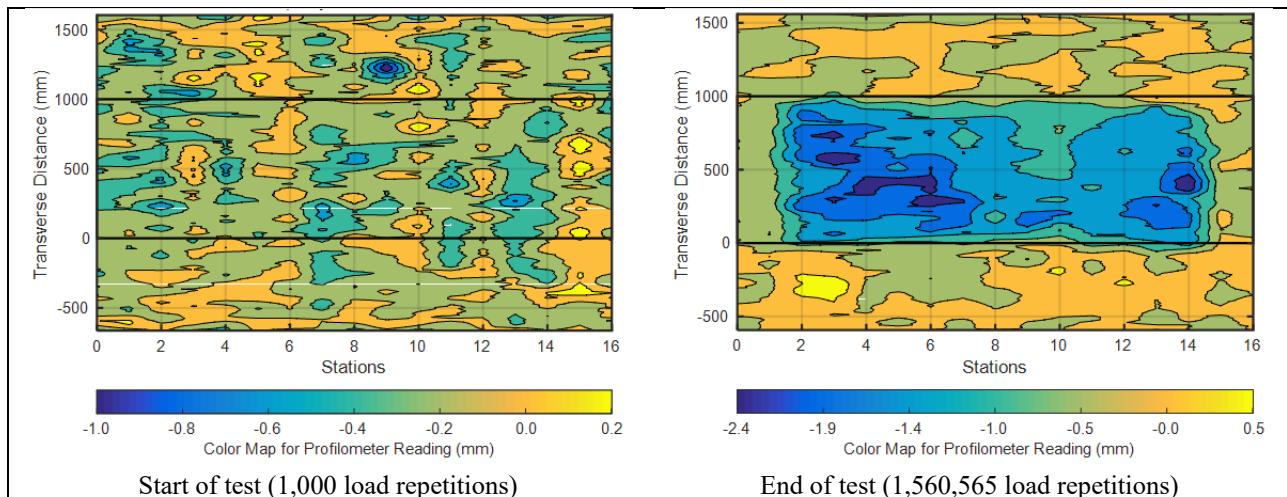
Figure 7.47: 682HB: Contour plots of permanent surface deformation.
(Note different scales in legends.)

Figure 7.47 shows contour plots of the pavement surface at the start and end of the test (1,000,000 load repetitions). The plot shows the relative uniformity of the rut depth over the length of the section, with the single area of distress at Station 13. The test was halted long before the terminal rut (12.5 mm [0.5 in.]) was reached.

After completion of trafficking, the average total maximum rut depth and the average deformation were 3.1 mm (0.12 in.) and 2.7 mm (0.11 in.), respectively. The maximum rut depth measured on the section was 12.2 mm (0.48 in.), recorded at Station 13.

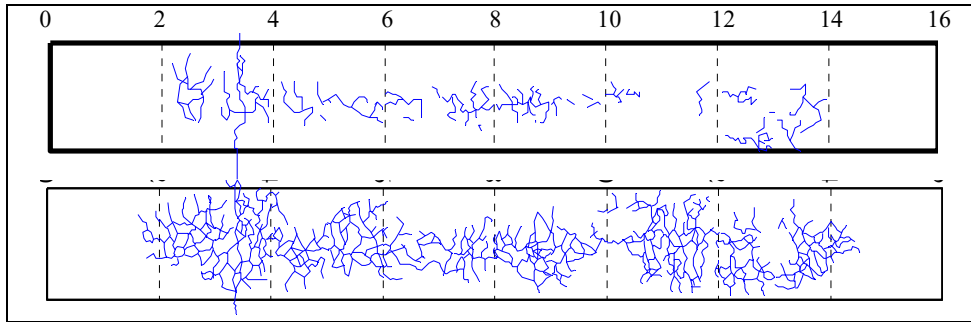
Figure 7.53: 682HB: Crack location and pattern after 530,000 and 1,000,000 load repetitions.

Rutting and cracking were observed on the section. Some raveling, attributed to the prolonged trafficking on the continuously wet section, was also recorded. Transverse cracks that had reflected through the asphalt concrete above shrinkage cracks in the underlying cement treated material were visible between Station 3 and Station 4 long before the start of Phase 2 HVS testing (first observed during the latter part of Phase 1a testing on Section 674HB). The first signs of new transverse cracks were observed after approximately 100,000 load repetitions with the wheel load at 40 kN. These eventually developed into fatigue cracks covering most of the section during the remainder of HVS testing. Terminal cracking (2.5 m/m^2 [0.75 ft/ft^2]) was reached after approximately 530,000 load repetitions when the wheel load was at 80 kN. The total length of all cracks at the end of the test (1,000,000 repetitions) was 63.3 m (207.7 ft), which equates to an average crack density of 7.9 m/m^2 (2.4 ft/ft^2). The location of the cracks and the crack pattern at 530,000 load repetitions and at the end of the test are shown in Figure 7.53. Photographs of the test section after HVS testing are shown in Figure 7.54.

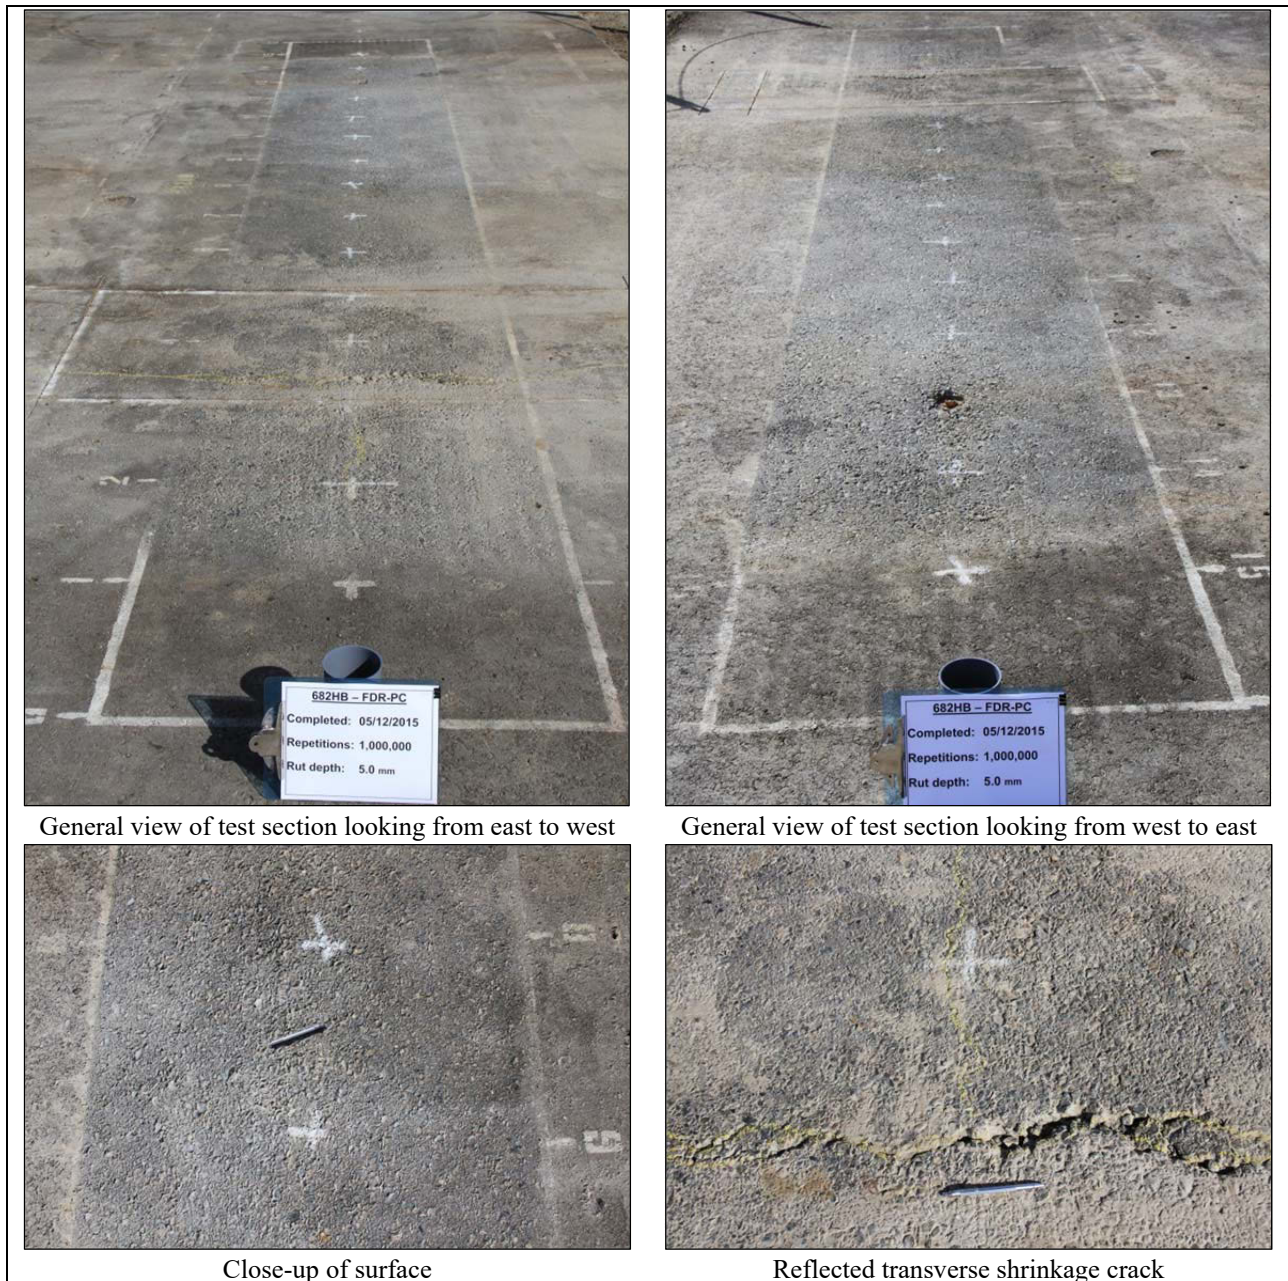
Figure 7.54: 682HB: Test section photographs.

| Close-up of surface | Reflected transverse shrinkage crack |
