4. TITLE AND SUBTITLE	5. REPORT DATE
Full-Depth Recycling Study: Test Track Construction and First-Level Analysis of Phase 1 and Phase 2 HVS Testing, Forensic Investigation, and Phase 1 Laboratory Testing	07/11/2016
	6. PERFORMING ORGANIZATION CODE

7. AUTHOR(S)	8. PERFORMING ORGANIZATION REPORT NO.
D. Jones, S. Louw, and R. Wu	UCPRC-RR-2015-02

Full-Depth Recycling Study:
Test Track Construction and First-Level Analysis of Phase 1 and Phase 2 HVS Testing, Forensic Investigation, and Phase 1 Laboratory Testing

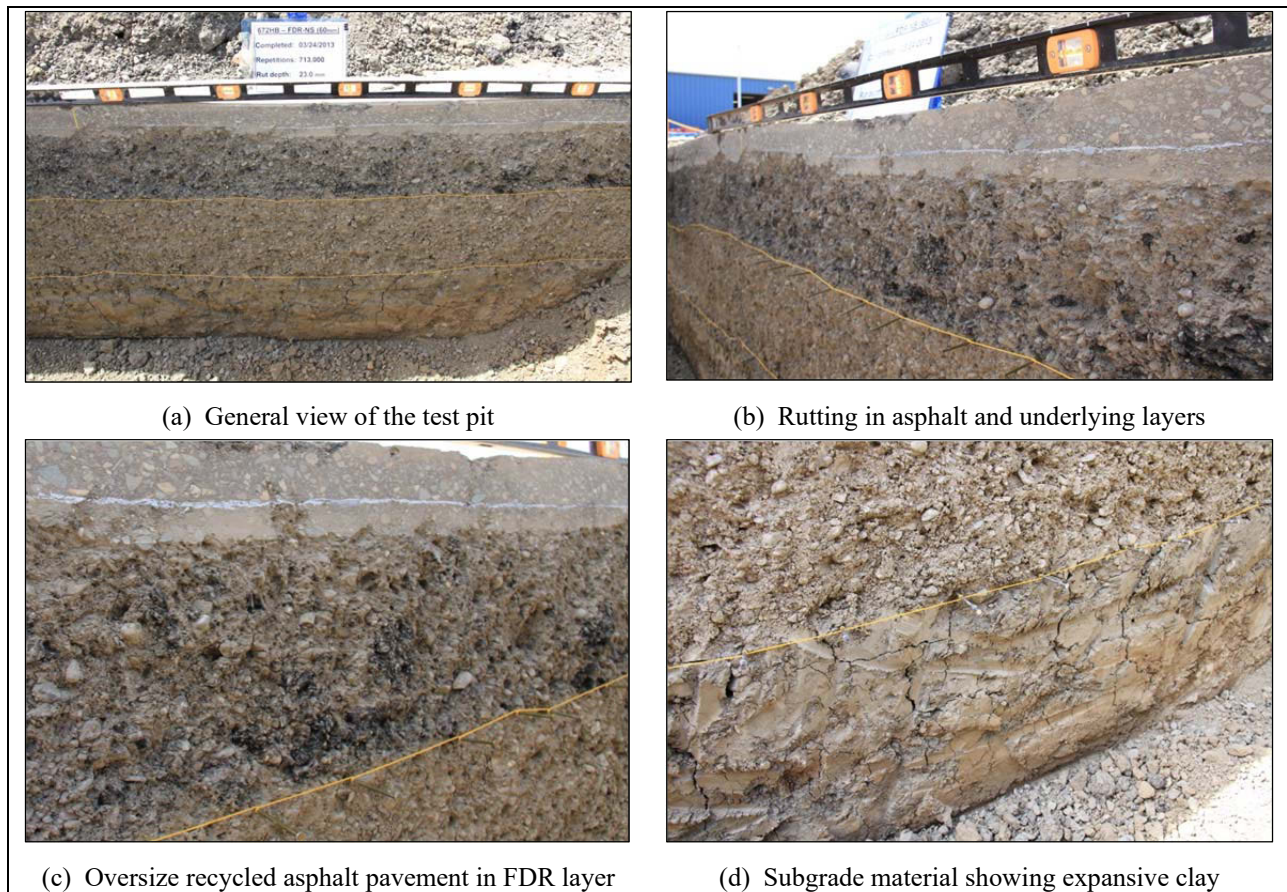
Figure 8.2: 672HB: Test pit photographs.

- The average thickness of the asphalt concrete was marginally thicker (68 mm [0.23 ft.]) than the design thickness (60 mm [0.2 ft.]).
- Rutting was measured in the asphalt concrete, FDR, and original base layers and at the top of the subgrade (Figure 8.2a and Figure 8.2b), confirming the measurements recorded during HVS testing (Table 5.2). Minor displacement was recorded on either side of the trafficked area in the asphalt concrete layer and in the top of the FDR layer. Apart from rutting, no other distresses were noted in the asphalt layer.
- The asphalt concrete layer was well bonded to the FDR layer, and the FDR layer was well bonded to the aggregate base. The prime coat appeared to have penetrated between 5 mm and 10 mm (0.2 in. and 0.4 in.) into the top of the FDR layer (Figure 8.2b).

(a) General view of the test pit	(b) Rutting in asphalt and underlying layers
(c) Oversize recycled asphalt pavement in FDR layer	(d) Subgrade material showing expansive clay

- FDR layer thickness showed very little variation across the profile. The material was well graded and aggregates were mostly rounded (little evidence of crushing) with some elongation. Some large pieces of recycled asphalt pavement were visible in the FDR layer (Figure 8.2c), indicating that

- Some variation was noted in the thickness at the bottom of the original base layer. The material was well graded and aggregates were mostly rounded with some flakiness. No oversize material was observed, and the material properties appeared to be consistent (Figure 8.2a). The material was rated as dense throughout the layer. No organic matter was observed.

- The layer definition between the original base and subgrade was clear. Some punching of the base into the subgrade was noted.

- The subgrade was moist, silty-clay material (Figure 8.2d). Consistency was rated as soft and some shrinkage and slickenslides were observed. Some evidence (hydrochloric acid reaction) of the lime treatment during the original site preparation for construction of the UCPRC facility in 2008 was noted. No organic matter was observed.

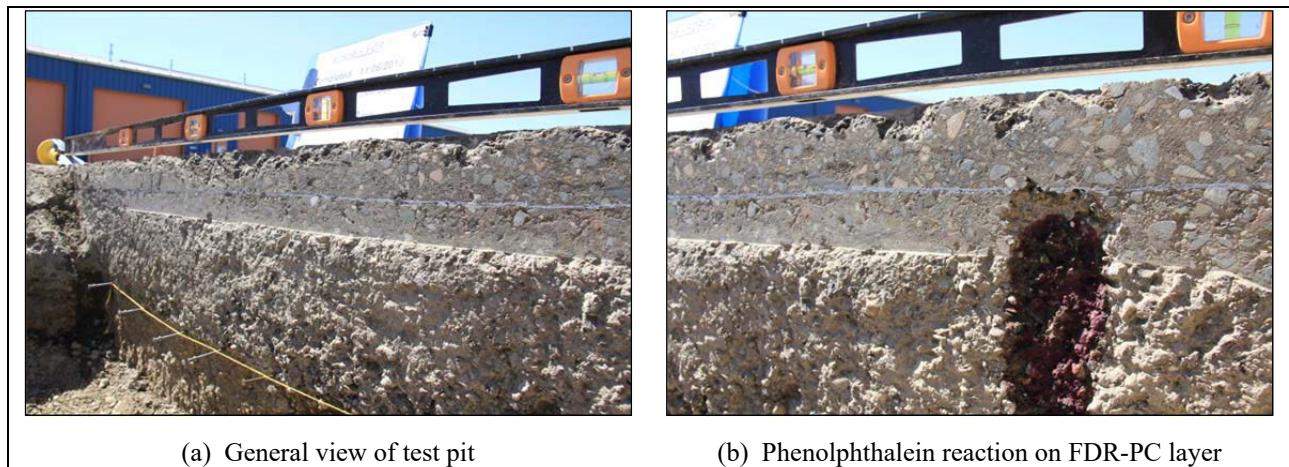
Figure 8.5: 674HB: Test pit photographs.

- The average thickness of the asphalt concrete was marginally thinner (57 mm [0.19 ft.]) than the design thickness (60 mm [0.2 ft.]).
- Limited rutting was measured in the asphalt concrete layer. No rutting could be distinguished in the FDR and original base layers or at the top of the subgrade (Figure 8.5a), confirming the measurements recorded during HVS testing (Table 5.8). No visible displacement was recorded on either side of the trafficked area in the asphalt concrete layer. Apart from rutting, no other distresses were noted in the asphalt layer.

- There was very little variation in the FDR layer thickness across the profile. The material was well graded and aggregates were mostly rounded (little evidence of crushing) with some flakiness. The stabilized material was consistent and rated as extremely dense throughout the layer, indicating that satisfactory stabilization had occurred. A strong phenolphthalein reaction (i.e., pH >12) was observed in the FDR layer (Figure 8.5b) confirming the stabilization reaction and that no carbonation had occurred. No large pieces of recycled asphalt pavement were visible, indicating that complete pulverization of the original pavement was achieved.

| (a) General view of test pit | (b) Phenolphthalein reaction on FDR-PC layer |

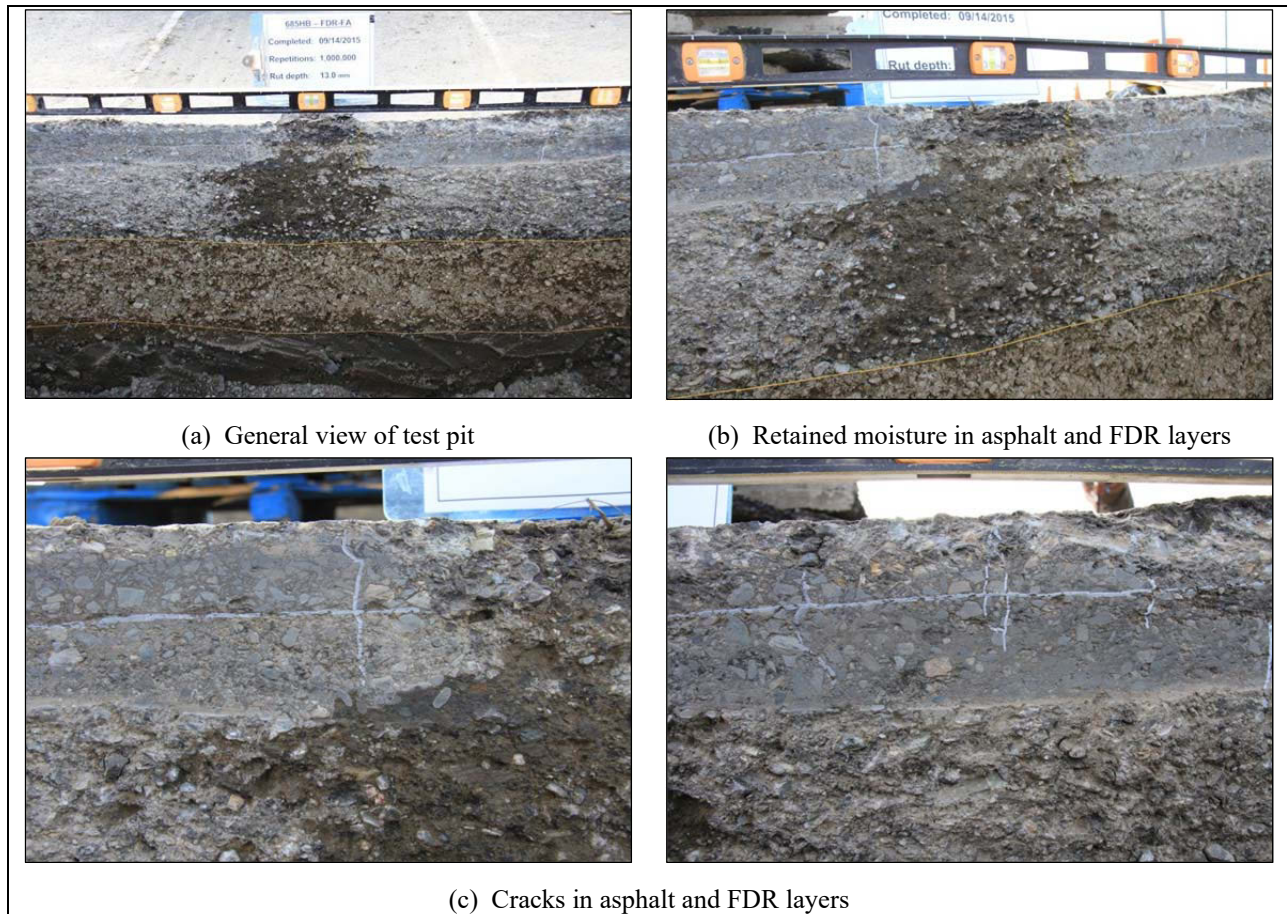
Figure 8.7: 685HB: Test pit photographs.

(c) Cracks in asphalt and FDR layers

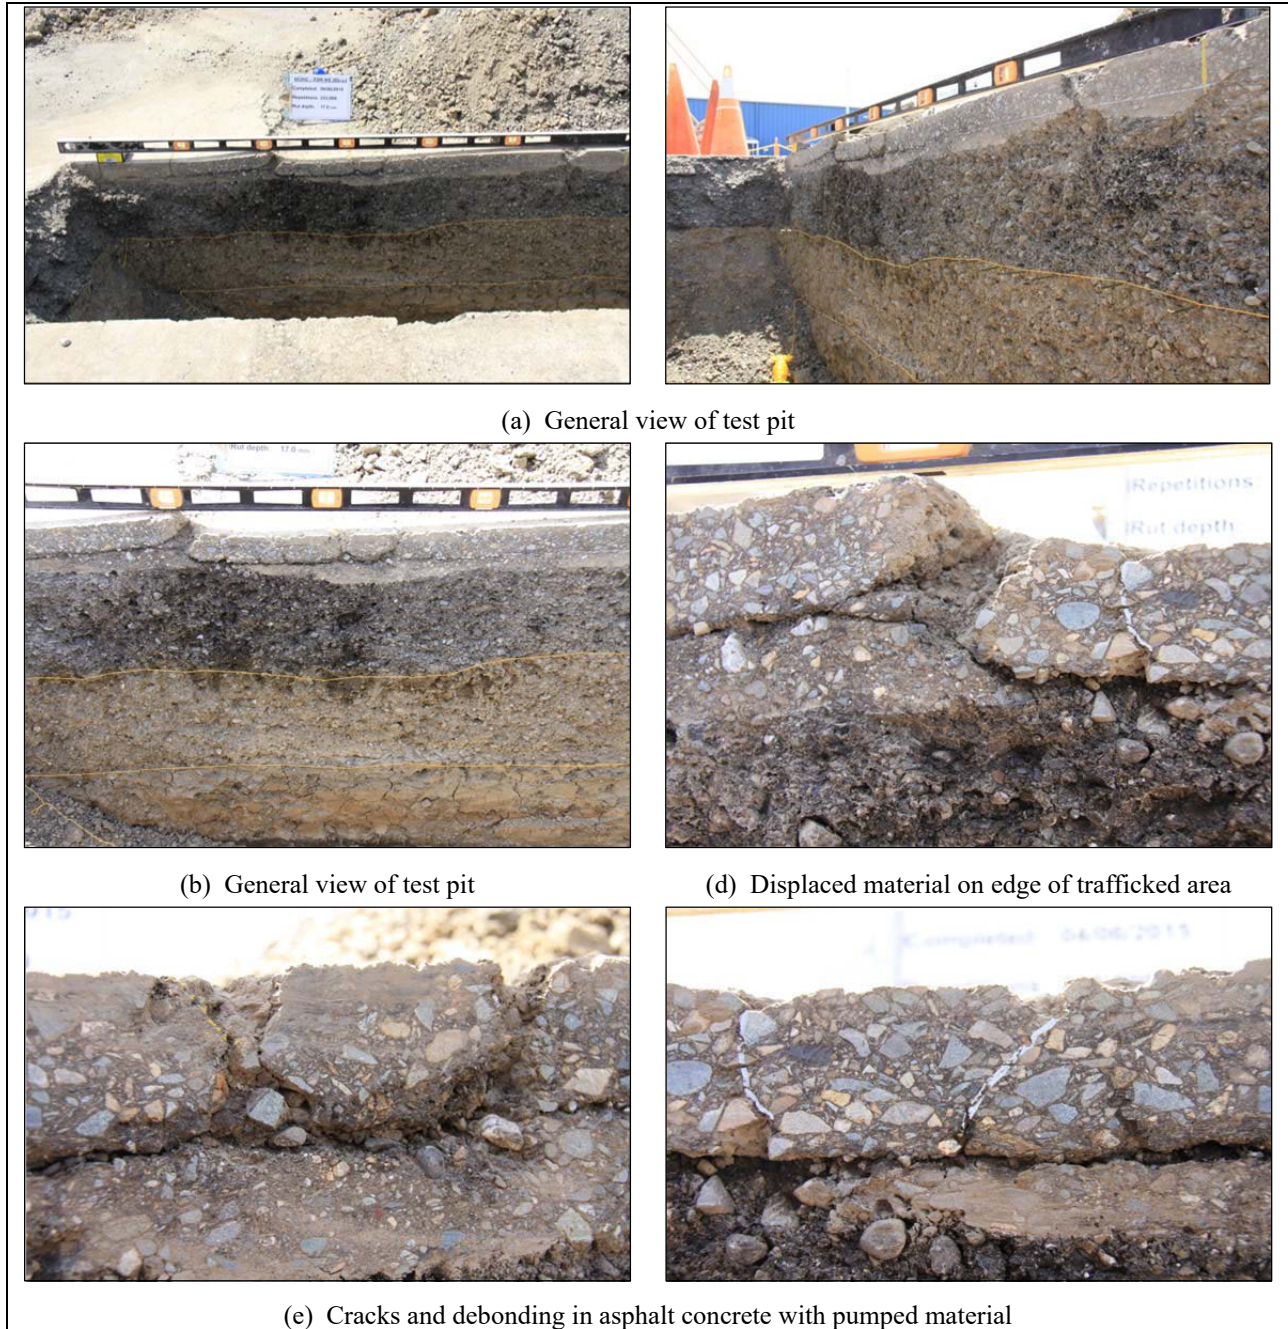
Figure 8.8: 683HC: Test pit photographs.

(d) Displaced material on edge of trafficked area

(e) Cracks and debonding in asphalt concrete with pumped material

- Rutting was measured in all layers in the test pit (Figure 8.8a and Figure 8.8b). Major displacement was recorded on either side of the trafficked area in the asphalt concrete layer and in the top of the FDR layer. Severe alligator cracking was also observed in the asphalt layer. Pumping of fine material from the FDR layer through the asphalt concrete was also observed.

- The asphalt concrete layer had debonded from the FDR layer and a void between the two layers was clearly visible (Figure 8.8). Prime coat penetration could not be determined. The FDR layer was well bonded to the aggregate base.

- Apart from the distressed areas, there was very little variation in the thickness of the FDR layer across the profile. The material was well graded and aggregates were mostly rounded (little evidence of crushing) with some flakiness. Some large pieces of recycled asphalt pavement were visible in the FDR layer (Figure 8.8a), similar to those observed in the test pit on Section 672HB, indicating that complete pulverization of the original pavement was not achieved. The material was rated as dense throughout the layer.

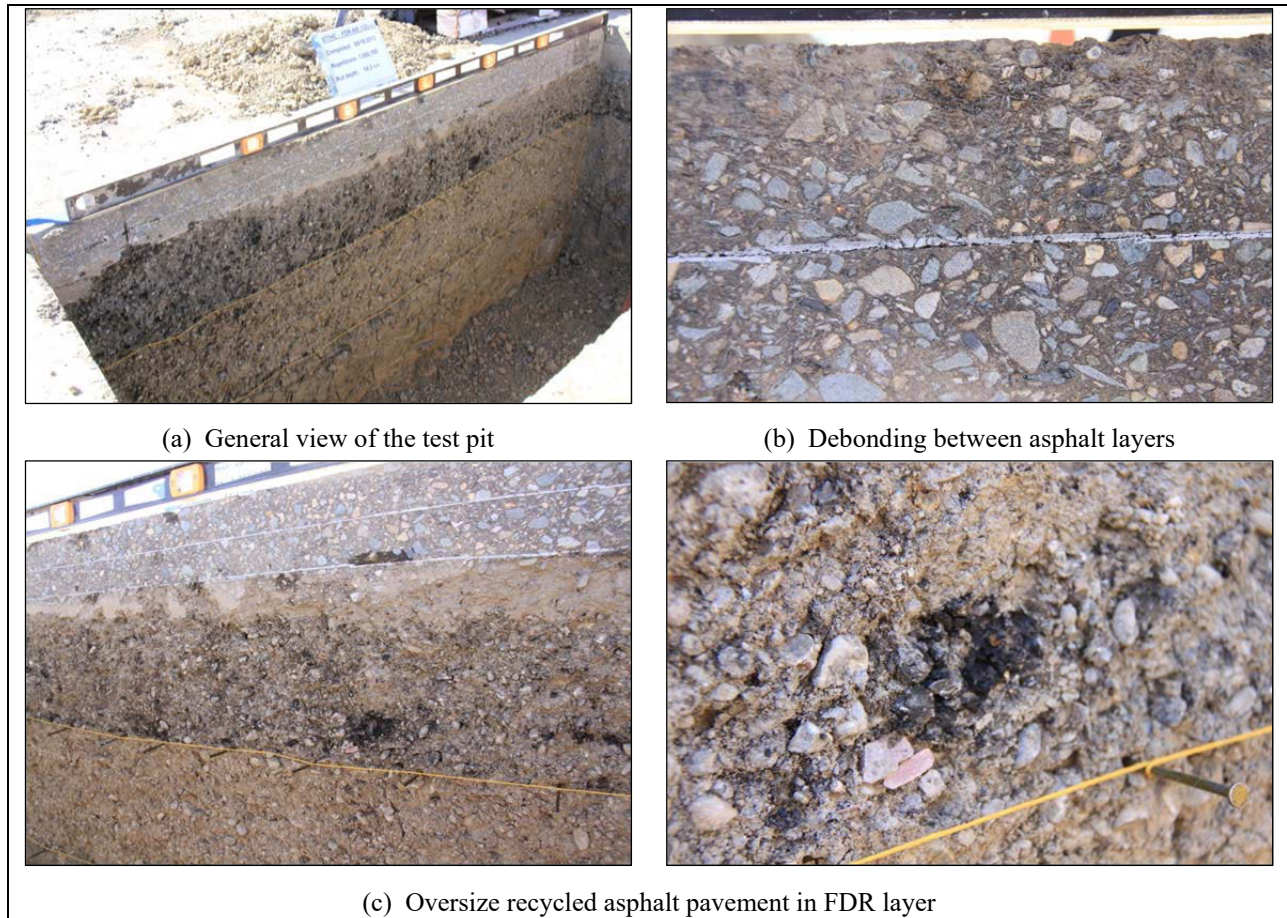
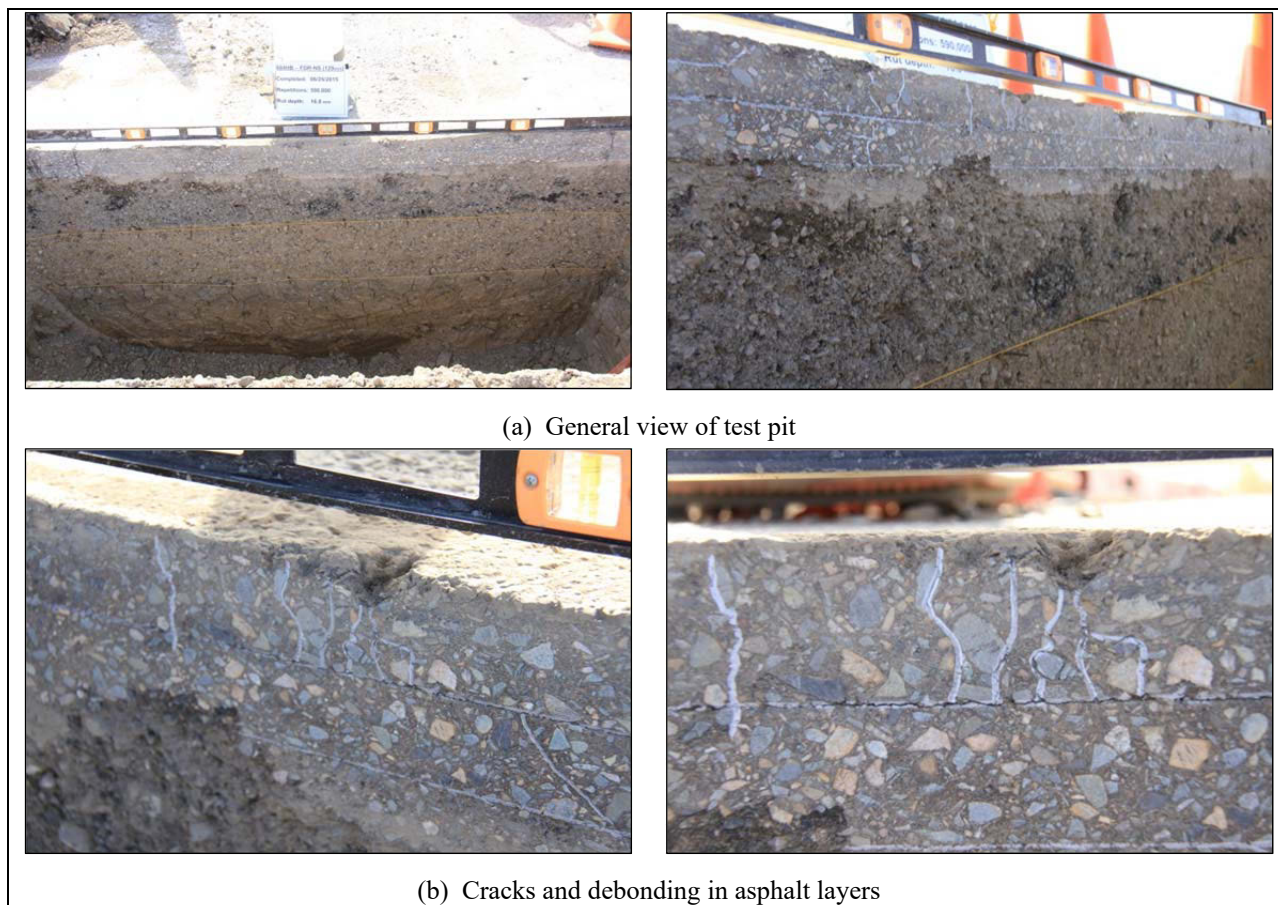
Figure 8.9: 684HB: Test pit photographs.

- Moisture content in the FDR and original base layers was rated as moist, with moisture content appearing to increase near the subgrade. There was no indication of higher moisture content at the interfaces between the asphalt concrete, FDR, and original base layers.

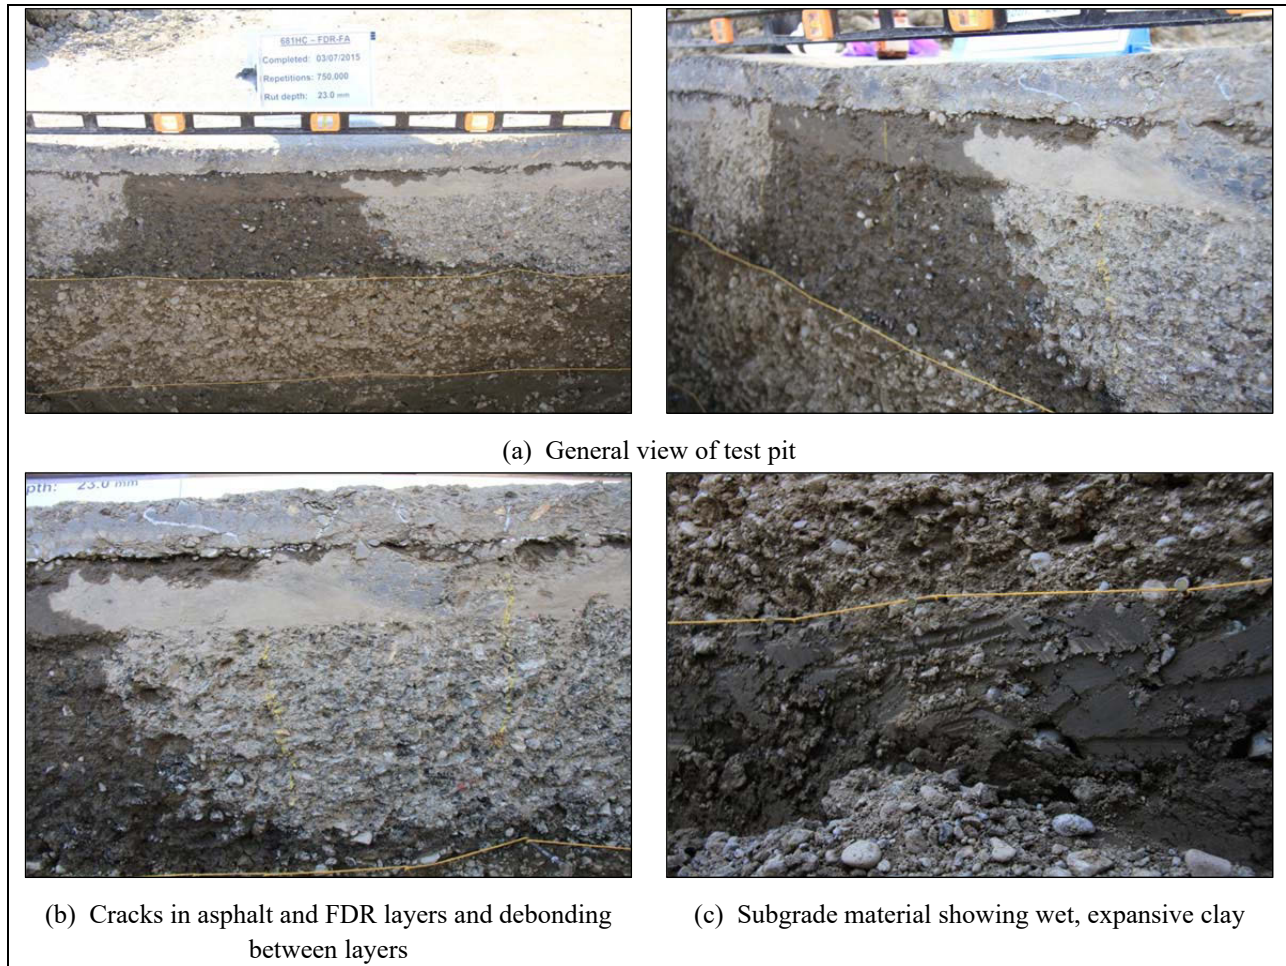
Figure 8.10: 681HC: Test pit photographs.

- The average thickness of the asphalt concrete was consistent with the design thickness (60 mm [0.2 ft.]).
- Rutting was measured in the asphalt concrete layer. No rutting could be distinguished in the FDR and original base layers, or at the top of the subgrade (Figure 8.10a), confirming the measurements recorded during HVS testing (Table 7.4). Some displacement was observed on either side of the trafficked area in the asphalt concrete layer. Cracks were observed in the asphalt concrete and FDR layers (Figure 8.10b). No other distresses were noted in the asphalt layer.
- The asphalt concrete layer had debonded from the FDR layer in the trafficked area and a small void attributed to pumping during trafficking was noted between the two layers. Prime coat penetration into the FDR layer could not be distinguished. The FDR layer was well bonded to the aggregate base.

(b) Cracks in asphalt and FDR layers and debonding between layers

(c) Subgrade material showing wet, expansive clay

- Observations with regard to the layer thicknesses and materials in the FDR and original base layers were consistent with observations in the test pit on the Phase 1a FDR-FA section tested under dry conditions (Section 673HB).
- Moisture content in the FDR and original base layers was rated as wet in the trafficked area and moist in the untrafficked areas, with moisture content appearing to increase near the subgrade. This retained moisture was attributed to the wet testing on this and the adjacent test sections.
- The layer definition between the original base and subgrade was clear. Some punching of the base into the subgrade was noted.
- The subgrade was wet, silty-clay material (Figure 8.10c). Consistency was rated as soft. No organic matter was observed.

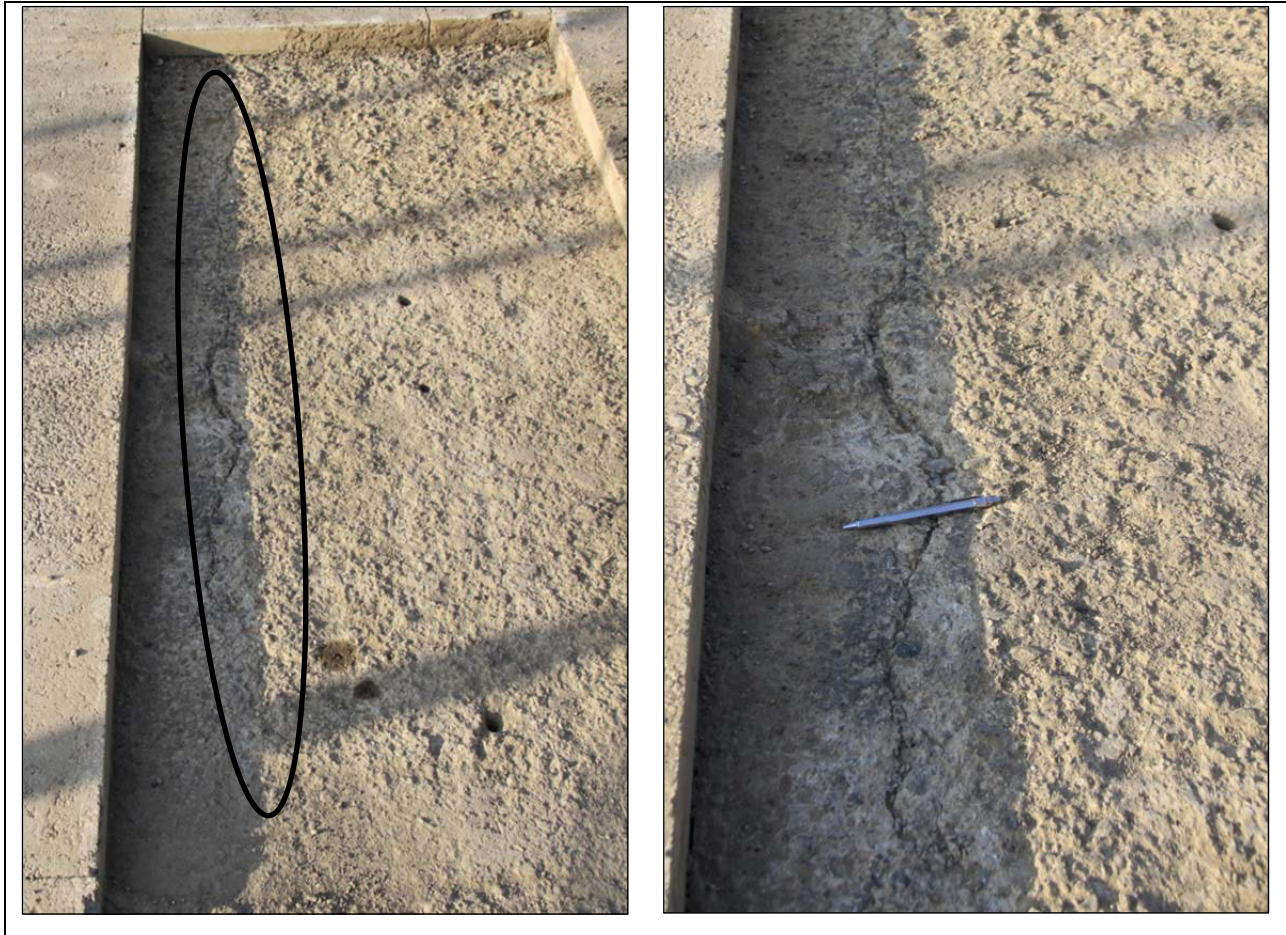
Figure 8.11: 682HB: Test pit photographs.

A test pit was not excavated on this test section due to the extremely cemented nature of the material. However, the asphalt concrete was removed to observe the shrinkage crack on the top of the FDR layer (Figure 8.11). The asphalt concrete appeared to have debonded from the FDR-PC layer during testing under soaked conditions, and was easily removed without damaging the underlying layer. The crack was

clearly visible and some spalling had occurred in the trafficked area, consistent with the observations of pumping during testing.
