4. TITLE AND SUBTITLE	5. REPORT DATE
Caltrans Field Trials of the Intelligent Truck-Mounted Attenuator (ITMA)	January 30, 2026
	6. PERFORMING ORGANIZATION CODE
	AHMCT Research Center, UC Davis

7. AUTHOR	8. PERFORMING ORGANIZATION REPORT NO.
Dave Torick, Dinesh Kumar, Anh Duong, & Shima Nazari	UCD-ARR-26-01-30-01

Caltrans Field Trials of the Intelligent Truck-Mounted Attenuator (ITMA)
Dave Torick, Dinesh Kumar, Anh Duong & Shima Nazari: Principal Investigator Report Number: CA26-4159 AHMCT Research Report: UCD-ARR-26-01-30-01 Final Report of Contract: 65A0749 Task 4159 DATE: January 30, 2026

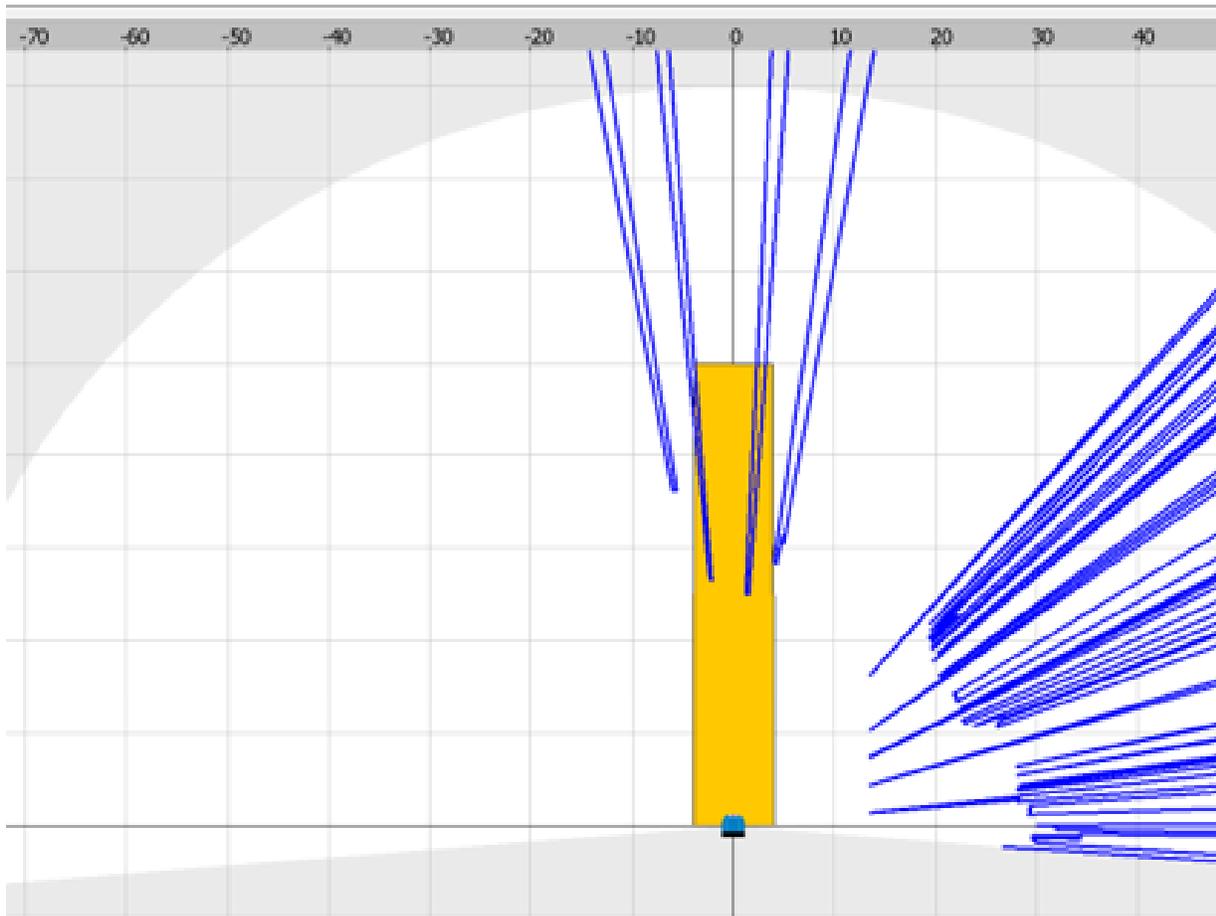
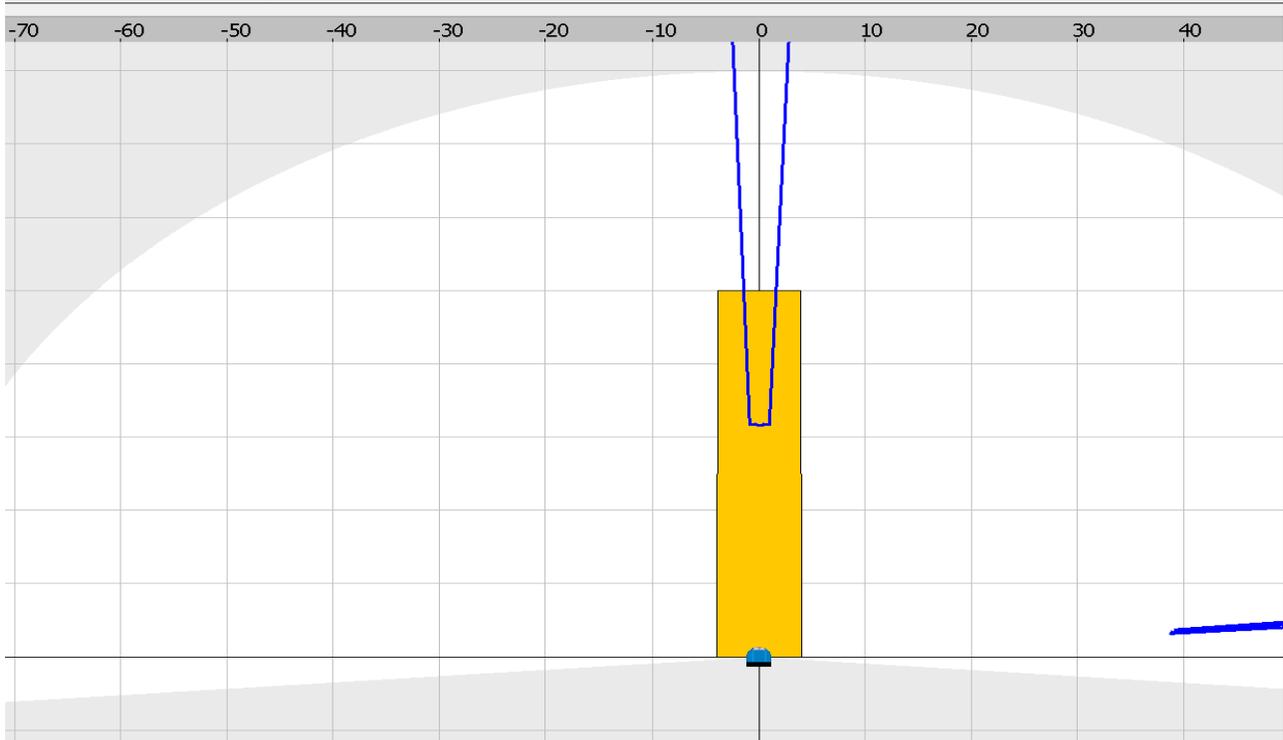
The false detections occurred on roadway segments with a slight depression and perpendicular drainage, which created geometric conditions that the front LiDAR misinterpreted as obstacles. As a result, an A-Stop was triggered and continued even after the vehicle cleared the affected area. The system repeatedly detected a non-existent obstacle and was unable to resume forward motion, preventing normal semi-intelligent operation along that segment.

**Figure 3.2: Ground reflections after adjusting LiDAR. (Each square represents 20 feet vertically and 10 degrees horizontally, the front of the truck is located at the small blue rectangle.)**

Following the adjustment, system performance was validated by confirming that the LiDAR could detect an average adult at 100 feet and by traversing the same highway section three times without further false detections. As shown in Figure 3.2, the only return within the planned travel path after adjustment was the LV, demonstrating that the correction successfully eliminated false obstacle

readings. These results highlight the importance of proper sensor alignment, particularly on highways with non-level vertical profiles.
