Report No.
SSRP-16/12

**Evaluation of Durability and Wear Characteristics of
Viscous Fluid Dampers for Seismic Bridge Retrofits
with Significant & Sustained Traffic Loadings**

Santiago Creek Damper Tests

May 2017

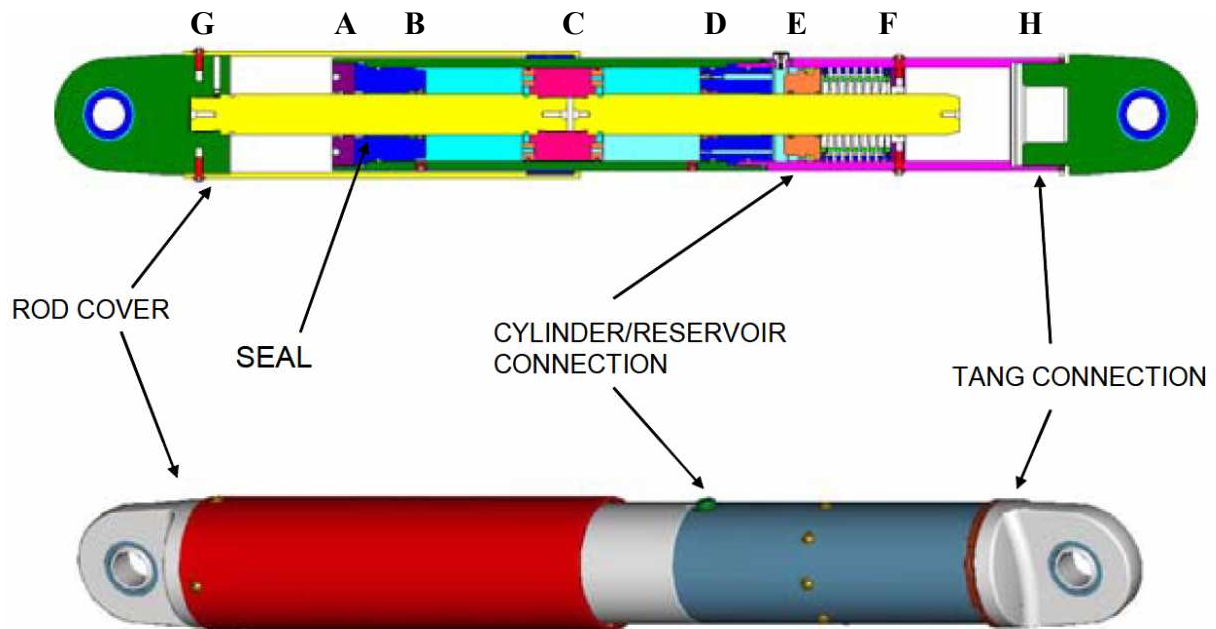
Figure 3. Schematic of a telescoping damper with the operating silicon fluid.

Figure 3 outlines the basic construction of the dampers installed on the Santiago Creek Bridge. It is a telescoping piston type device which incorporates flow of an appropriate high viscosity silicon fluid through orifices in the piston head to absorb energy. A fluid reservoir extension, attached via a threaded connection, providing additional fluid if needed. Since the device is only designed to dissipate energy, it is not intended to carry compressive or other loads. The operating high viscosity silicon fluid is located in the primary chamber, partitioned into two cavities by the piston head. The orifices in the piston head allow constrained fluid flow back and forth during piston movements under live-load conditions or seismic events – thereby providing the resistive force to external events. The energy dissipation is intrinsically linked to the filled fluid chamber and any loss creates operational dead zones where the force versus displacement hysteresis loop indicates negligible resistance and/or energy dissipation.

The damper includes a total of five seals identified in Figure 3 as – labeled **A, B** housed in the front bearing, labeled **D** housed in the rear bearing, and labeled **E, F** in the spring retainer. It is worth noting that the combination of rear bearing and the spring retainer with the three seals **D, E, F** provide a greater bearing support length for the piston rod. Looking ahead to the next

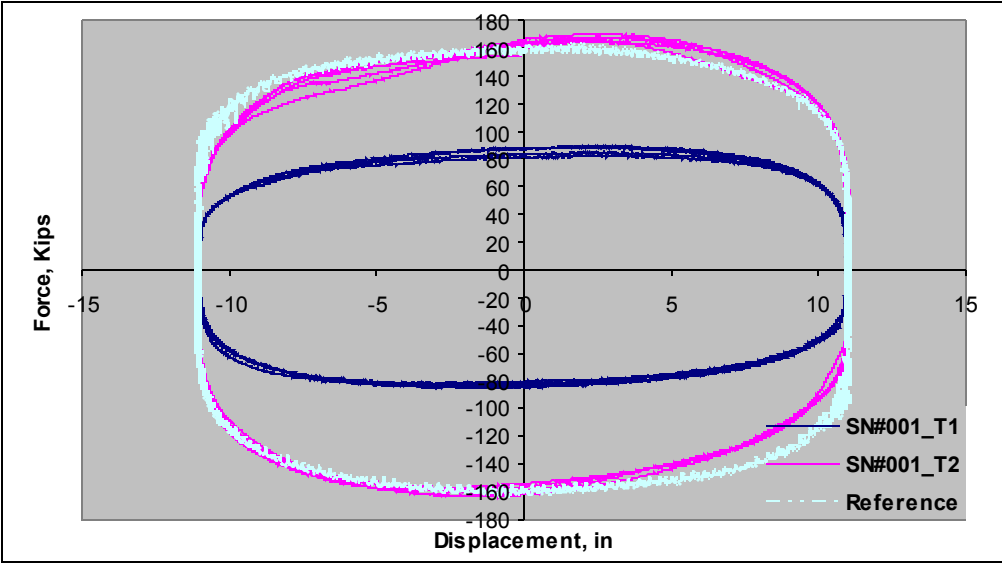
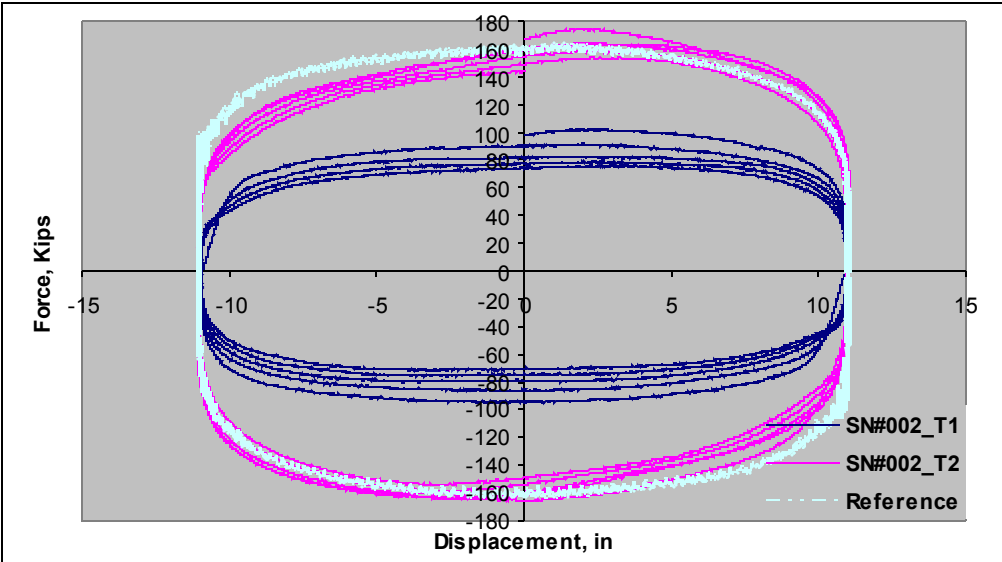
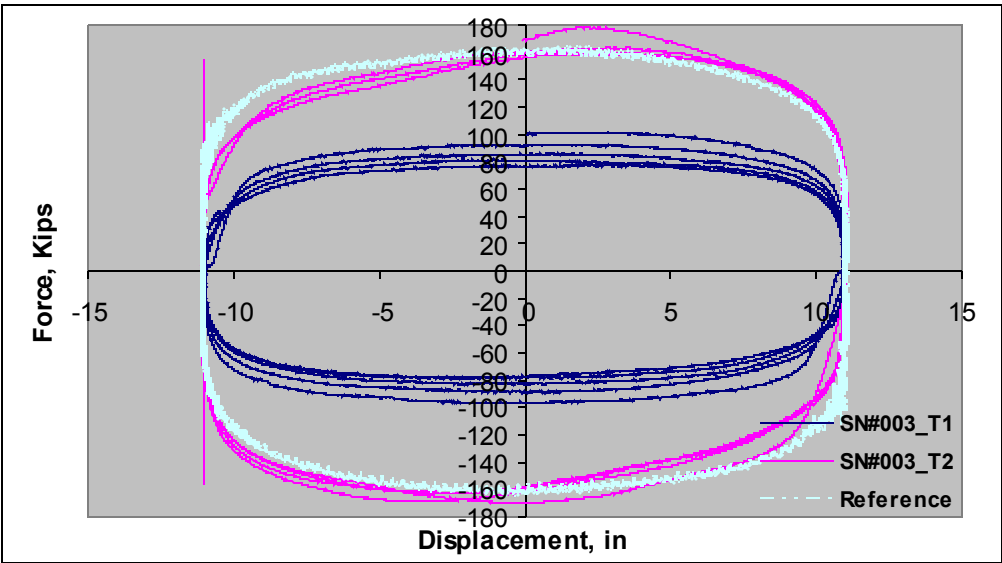
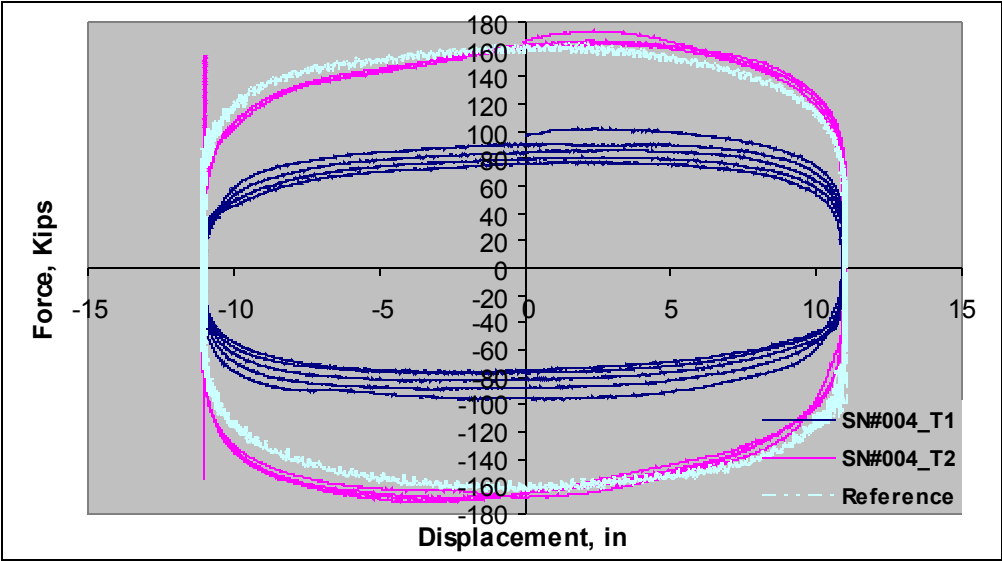
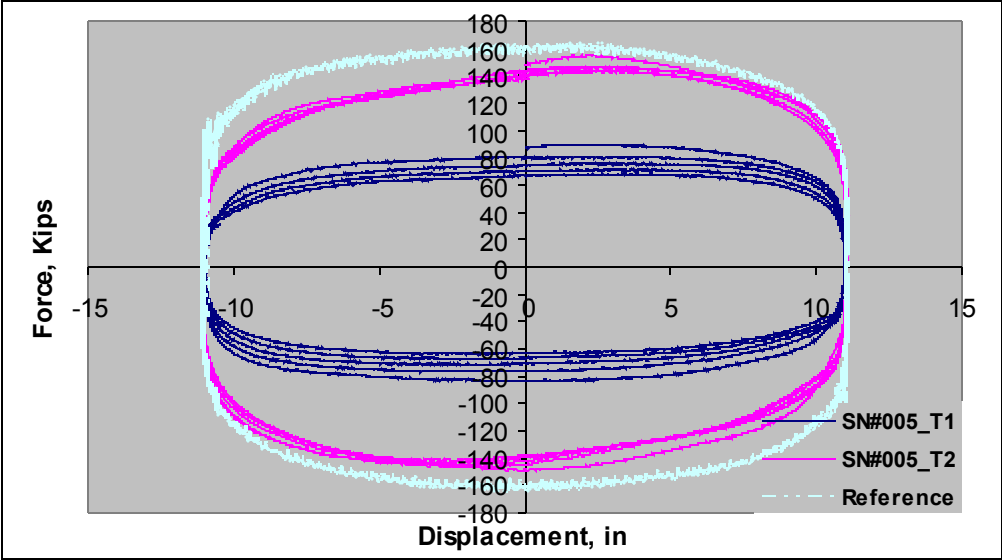
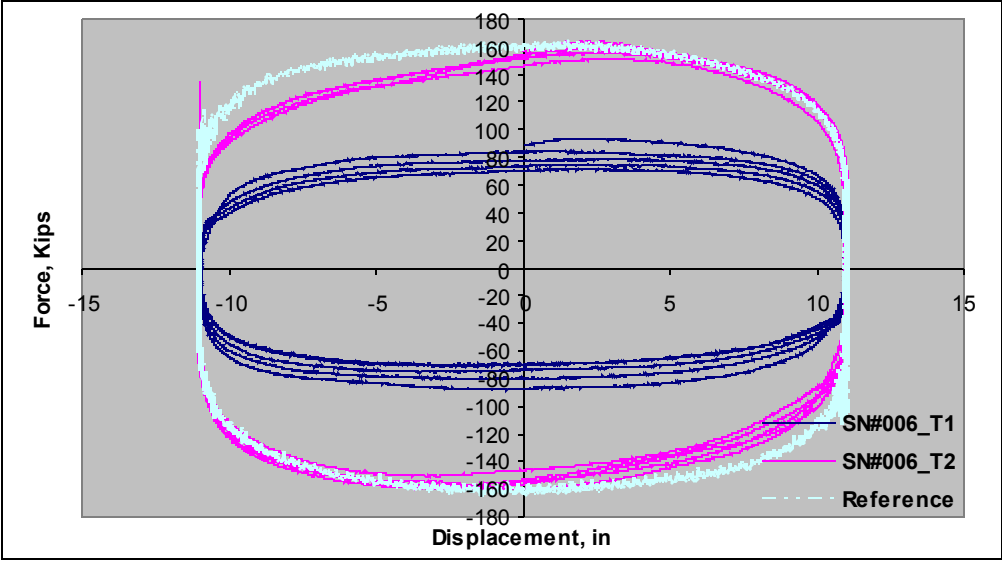
Figure 9. Load displacement plots for the 5 cycle proof testing for SN#001 – #006 dampers.

The principal results of Stage I (test velocity 10.5 in/sec) and Stage II (test velocity 42 in/sec) testing are presented in Figure 9. A brief overview of Stage I (blue curves) and Stage II (pink curves) test results indicate that dampers exhibit satisfactory Force-Displacement characteristics at the requisite test velocity. To illustrate this graphically, a reference Force-Displacement curve (Light Blue) for the stage II testing is superimposed on Figure 9. A quick visual examination shows fairly consistent overlap of the reference curve over the Stage II test data for SN#001, 002, 003, 004, 006. A quick examination also reveals that the Stage II test curve for SN#005 consistently underperforms the reference curve. As shown later, damper SN#005 indeed failed the current acceptance criterion outlined by Caltrans.

A brief description of the test loops follows: SN#001 exhibits an extremely tight loop with force vs. displacement performance fairly consistent over the 1st -5th cycles. SN#002 – SN#006 all show similar performance with 1st cycle exhibiting high peak force and decaying over the 2nd – 5th cycle. A rather negligible dead zone is observed for SN#002 and SN#003 in the first cycle which disappears in the subsequent cycles. Nonetheless, both SN#002 and SN#003 exhibit performance similar to the rest of the dampers. Figure 10 shows a comparative look of the 1st complete cycle response of all the dampers. We note that SN#003 and SN#004 exhibited marginally higher peak force; the rest have a slightly lower, and similar, peak force. The dead zone is clearly visible for SN#002 (small) and SN#003 (larger).

A comparison between the experimental test loops at $V=42$ in/sec (pink curves) and the ideal reference force curve (light blue) is illustrated graphically in Figure 9. A visual examination shows fairly consistent overlap of the reference curve over the Stage II test data for SN#001, 002, 003, 004, 006. The experimental force curves underperform slightly at force reversals (i.e., corresponding to stroke reversals at the +/- 11in displacement) for SN#001, #002, #003, #004, #006 and approach or exceed ideal performance at peak velocity at mean displacement=0. Similarly, a quick examination also reveals that the Stage II test curve for SN#005 consistently underperforms the reference curve, never approaching the ideal curve during any stage of the +/-

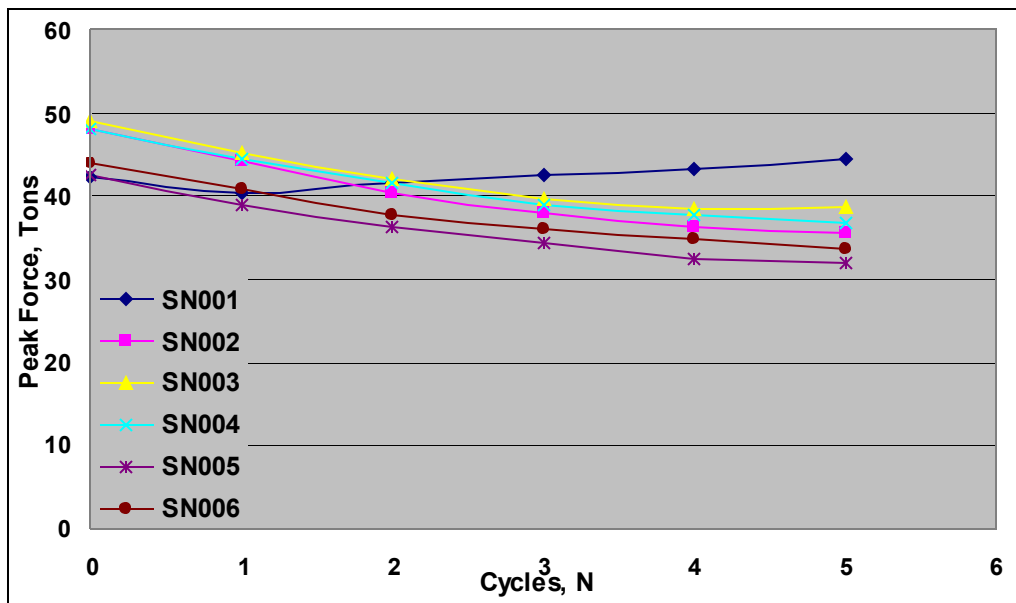
Figure 11. Stage I Peak force decay in 1st – 5th extension cycle for SN#001–SN#006 dampers.

The peak force data, as recorded at displacement = 0 is further recorded in Table 2, with +value denoting the pull cycle (i.e. damper extension) and -value denoting the push cycle (damper compression). The tabulated peak forces of Table 2 are further illustrated graphically in Figure 11. SN#001 indicates stable to mildly increasing peak force in what is clearly noted as anomalous behavior at variance with the remaining dampers. SN#002 – SN#005 indicate nearly similar response of gradually decaying peak force. The range of force drop is 10.6-13.21 short tons (21.2 – 26.42 kips), with the largest drop exhibited by SN#002 and the smallest drop exhibited by SN#006.

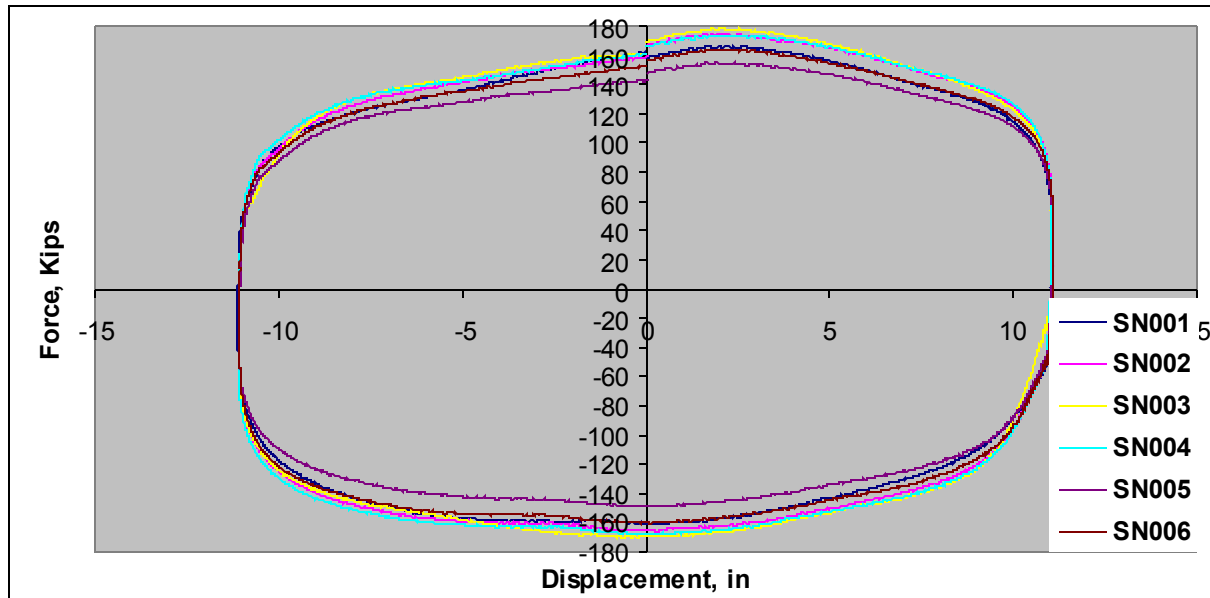
Figure 12. Stage II test performance of 1st Cycle behavior for SN#001 - #006 Dampers

Figure 12 shows a comparative look of the 1st complete cycle response of all the dampers. We note that contrary to stage I testing, no dead zone is observed for SN#002, SN#003 during the first cycle. We also note, as before, that SN#003 (yellow) and SN#004 (light blue) exhibit marginally higher peak force; the rest have a slightly lower, and similar, peak force. Once again SN#005 has the lowest peak force.

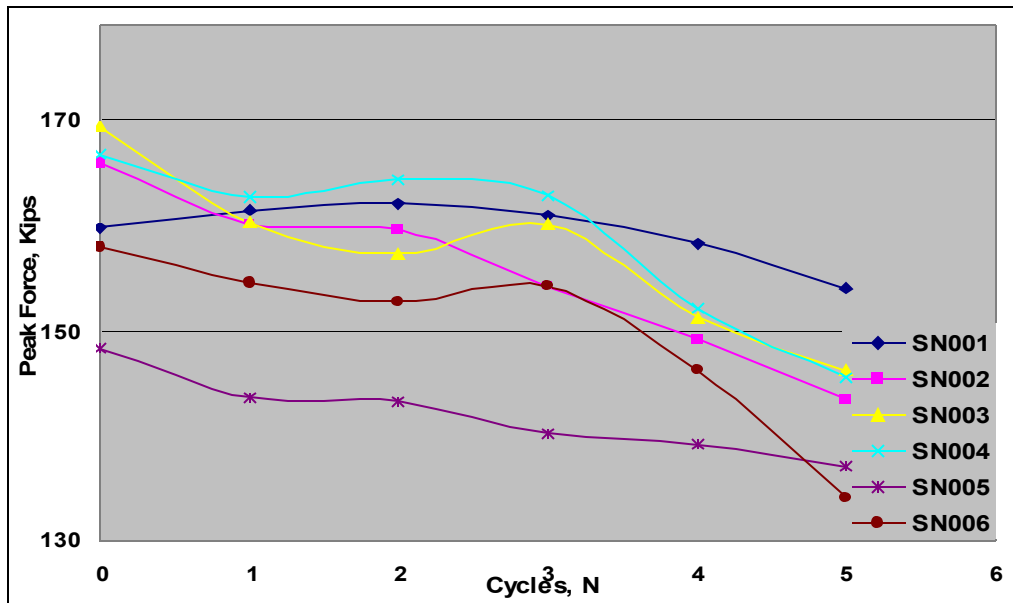
Figure 15. Stage II Peak force decay observed for cycles 1-5 for SN#001–SN#006 dampers.

The peak force data, as recorded at displacement = 0 is recorded in Table 3, with +value denoting the pull cycle (i.e. damper extension) and –value denoting the push cycle (damper compression). The tabulated peak forces of Table 3 are further illustrated graphically in Figure 15. SN#001 indicates very consistent peak force over 5 cycles of testing with minimal variation of about 10kips. We note that dampers with stripped sleeves (i.e., SN#003, SN#004, SN#006) show larger peak force drops in the later 4th and 5th cycles.
