<p>16. ABSTRACT</p> <p>The Type 732SW bridge rail is an updated version of the Type 26 bridge rail and was tested for compliance to the Manual for Assessing Safety Hardware (MASH 09) as a part of this research project.</p> <p>The 732SW is a taller, stronger version of the Type 26 with a sidewalk. It is comprised of a sidewalk, vertical concrete wall, and steel handrail for pedestrians. The barrier tested was about 24 m (79 ft) long and was constructed at the Caltrans Dynamic Test Facility in West Sacramento, California.</p> <p>Three crash tests were conducted under MASH 09: Test 3-11 (the 2270P pickup at TL-3), Test 3-10 (the 1100C small car at TL-3), and Test 2-10 (the 1100C small car at TL-2) because Test 3-10 resulted in a ridedown acceleration that was outside of the MASH 09 limits. The results of Tests 3-11 and 2-10 were within the limits of the MASH 09 guidelines.</p> <p>The Type 732SW bridge rail is recommended for approval on California highways requiring TL-2 bridge rails with pedestrian traffic. Since it is symmetric, the Type 732SW is also recommended in locations where a reverse hit is possible.</p>

**COMPLIANCE CRASH TESTING OF
THE TYPE 732SW BRIDGE RAIL**

DEPARTMENT

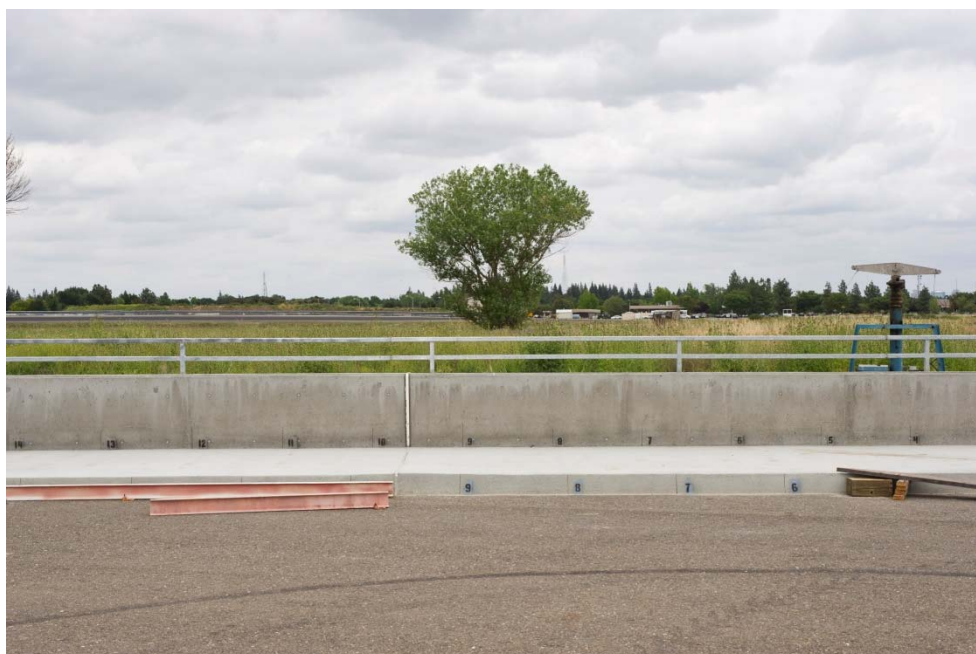
Figure 3-1 – Test article prior to Test 130MASH3P13-01

There was only minimal permanent damage to the barrier during Test 130MASH3P13-01. There was only very minor scraping of the concrete barrier face and scraping of the steel handrail. There was no structural damage to warrant immediate repair. There was no permanent deflection in the concrete curb or steel rail. As the vehicle impacted the barrier, the dynamic deflection in the steel rail was 1 inch (25 mm), as measured from the overhead camera.

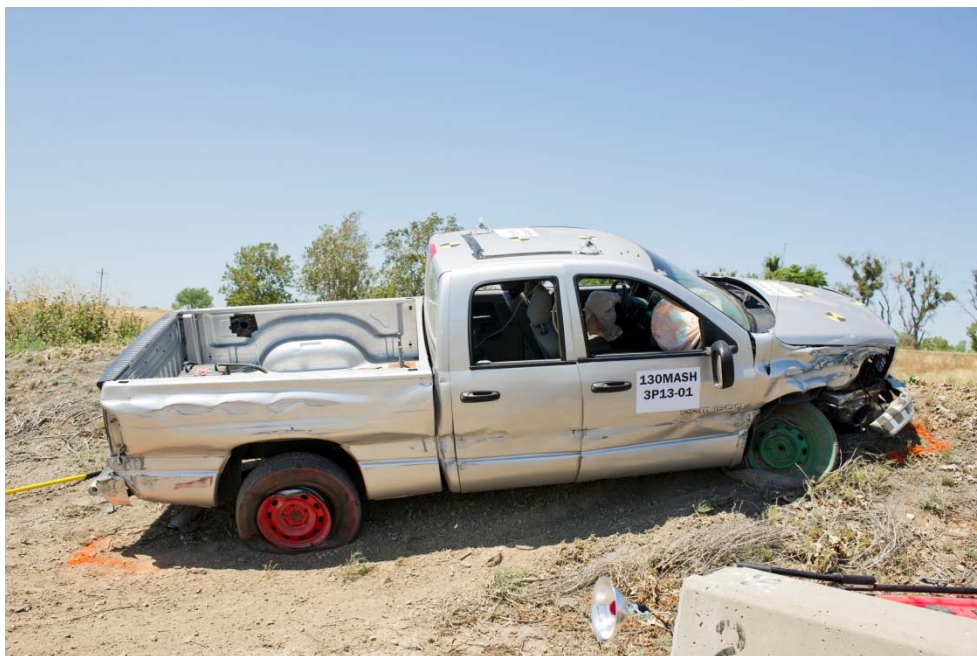
Figure 3-6 – Test vehicle after Test 130MASH3P13-01

The right front tire ruptured upon impact with the sidewalk. The right front corner of the vehicle was severely damaged in the impact with the barrier face. The right front fender, hood, bumper, headlamp area, grille, and suspension components were all affected. The passenger side doorframe was deformed outward but the doors remained latched. The left front and right rear tires were also ruptured. The top of the vertical concrete wall caused denting along the entire length of the passenger side as the vehicle continued to contact the barrier after the initial impact. The right front tire was pushed rearward and slightly into the passenger side foot well area. The maximum amount of passenger compartment deformation was 54 mm (2.1 in), which occurred in the floorboard and is below maximum MASH 09 limits. All other occupant compartment deformations were below MASH 09 limits for that area of the vehicle. The passenger side of the windshield cracked but did not separate or enter the occupant compartment.

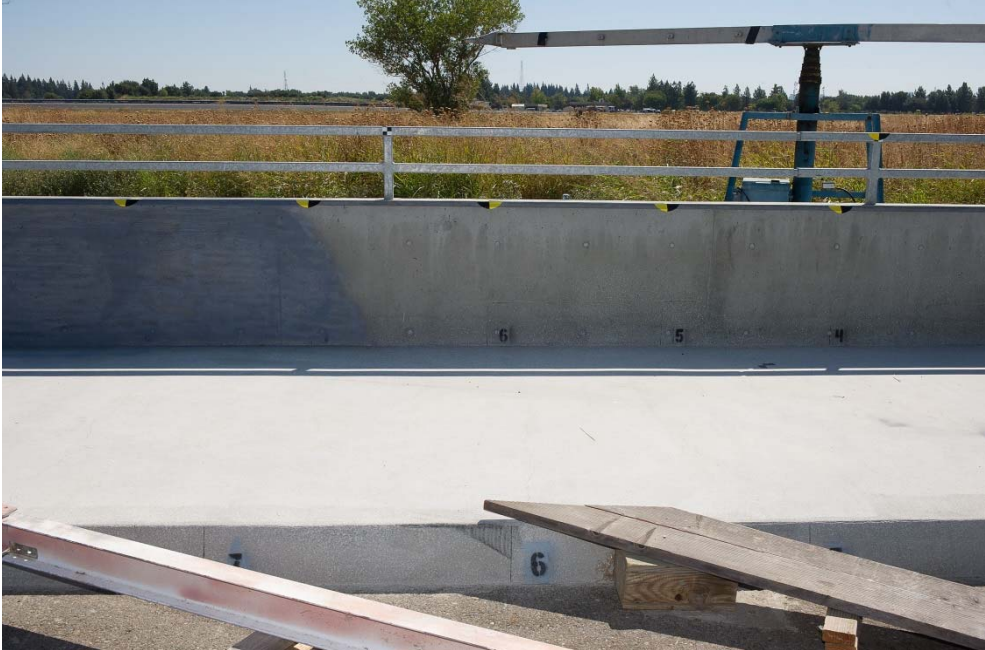
Figure 3-12 – Type 732SW test article prior to 130MASH3C13-02

There was essentially no permanent damage to the barrier during 130MASH3C13-02. The barrier scraped paint off the vehicle along the length of contact. There was a negligible amount of scraping and gouging of the concrete face. Although the vehicle hood snagged slightly on the barrier post, there was no damage to the post. There would be no need for repair by maintenance crews.

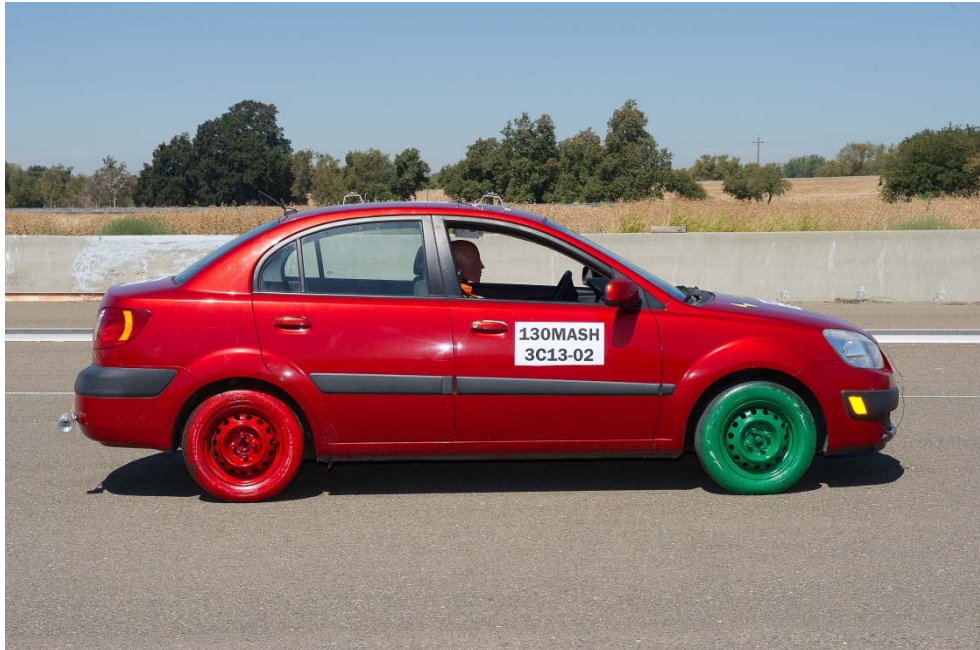
Figure 3-15 – Right side of test vehicle for 130MASH3C13-02

The front right wheel absorbed most of the impact with the barrier curb and face. The rim was bent during impact with the curb causing the tire to deflate. The wheel well of the test vehicle sustained most of the damage. Additional damage also occurred to the side of the vehicle as it scraped the barrier when redirected. Since the front right wheel took most of the impact, there was no distinguishable damage to the floorboard (see Figure 3-20). The right front corner of the vehicle was moderately damaged. The right front bumper and right fender were pushed rearward. The entire right side of the vehicle was moderately damaged. All four tires deflated during the impact. The maximum passenger compartment deformation was 1.7 inches at the floor pan near the center of the vehicle.

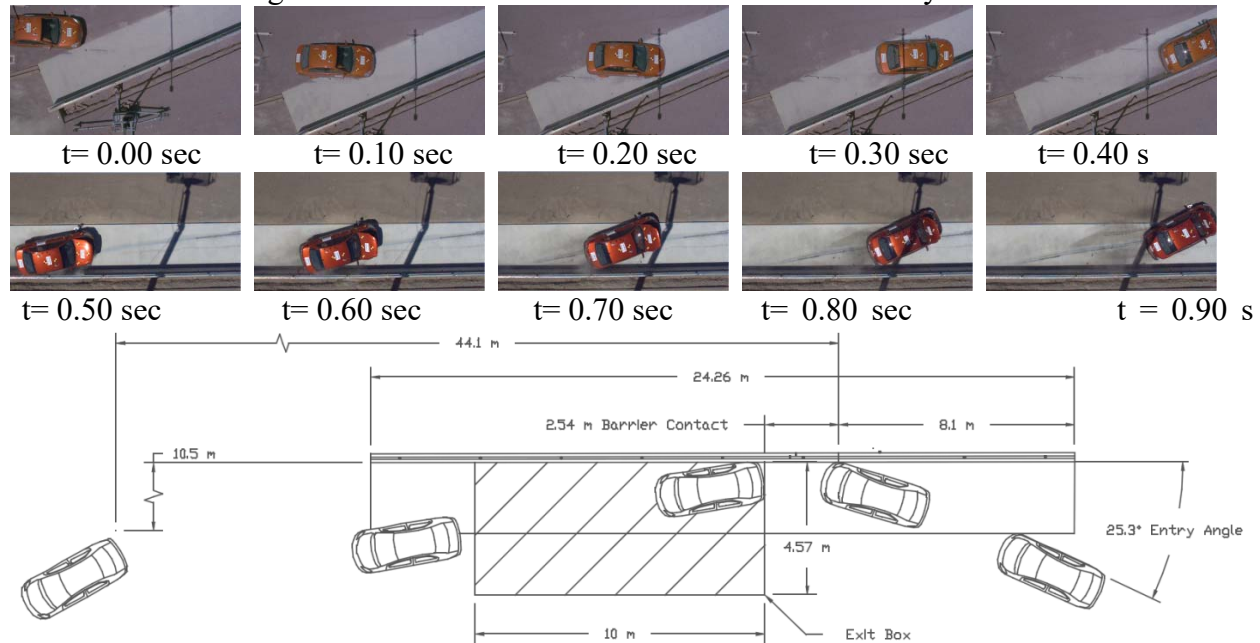
Figure 3-21 – Test 130MASH3C13-02 Data Summary Sheet

No deflection in steel handrail, minor superficial concrete spalling.

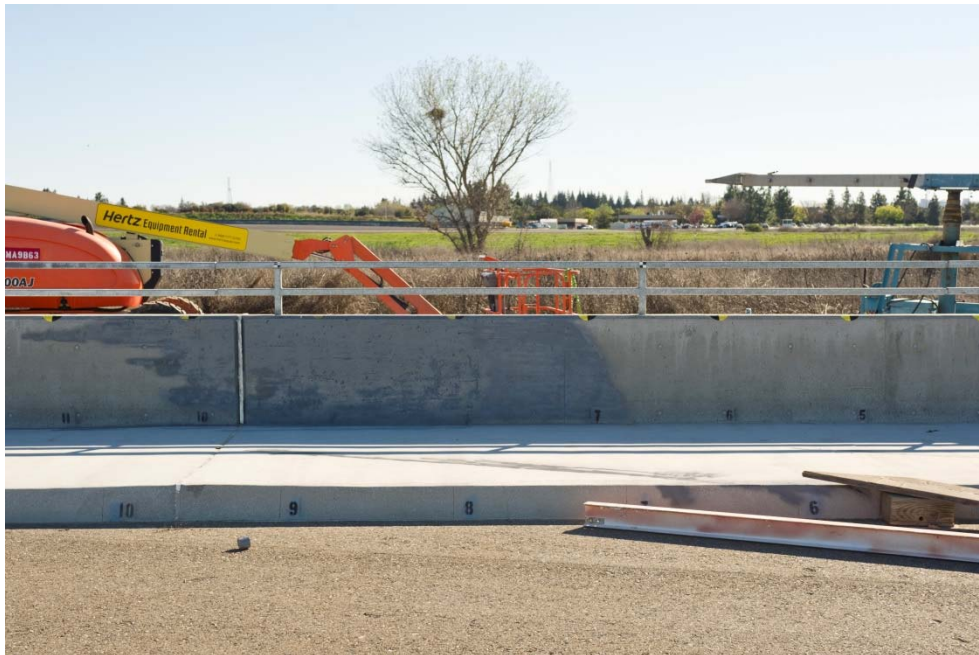
Figure 3-23 – Type 732SW test article prior to Test 110MASH2C14-01

There was essentially no permanent damage to the barrier during 110MASH2C14-01. The only damage was a negligible amount of scraping and gouging of the concrete face. Damage to the barrier was considered cosmetic and would not have required field repairs.

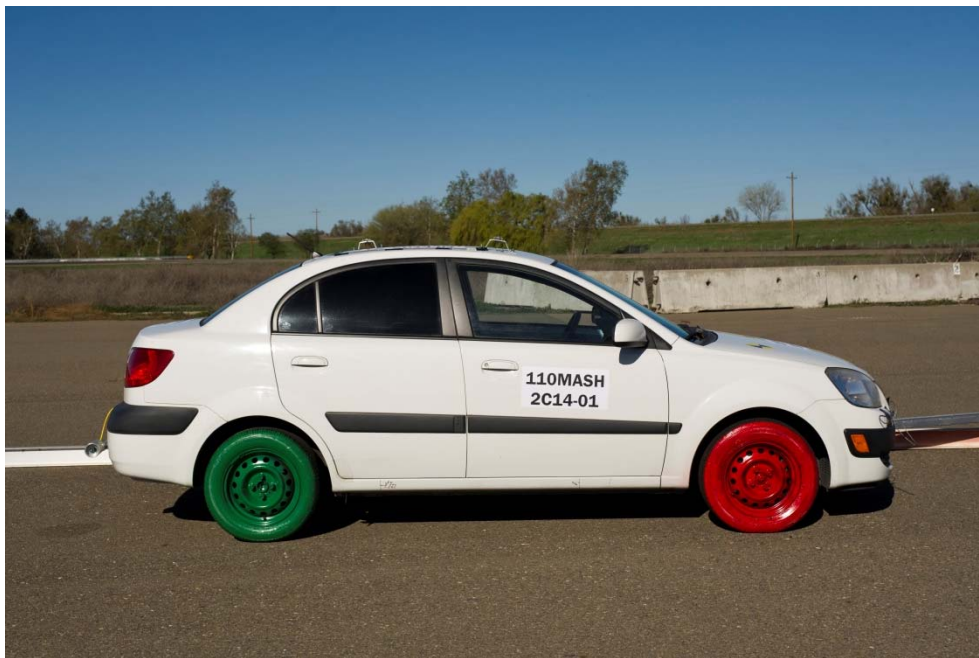
Figure 3-26 – Right side of test vehicle for Test 110MASH2C14-01

The front right wheel absorbed most of the impact. The rim was bent during impact causing the tire to deflate. The wheel well of the test vehicle sustained most of the damage. Additional damage also occurred to the side of the vehicle as it scraped the barrier when redirected. Since the front right wheel took most of the impact, there was no distinguishable damage to the floorboard (see Figure 3-31). The right front corner of the vehicle was moderately damaged. The right front bumper and right fender were pushed rearward. The right side of the vehicle at the front and rear was moderately damaged. The two front tires deflated during the impact. The maximum passenger compartment deformation was 0.6 inches at the floor pan near the passenger door.

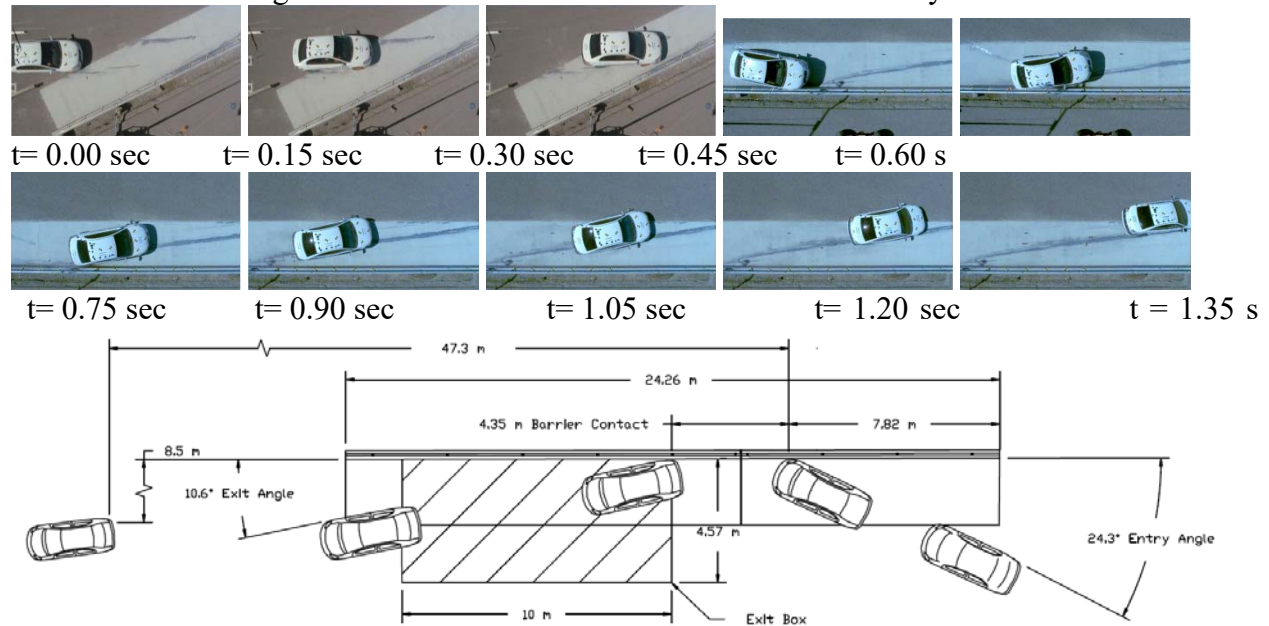
Figure 3-32 – Test 110MASH2C14-01 Data Summary Sheet

No deflection in steel handrail, minor superficial concrete spalling.
