1. REPORT NO. FHWA/CA10-0644	2. GOVERNMENT ACCESSION NO.	3. RECIPIENT'S CATALOG NO.	
4. TITLE AND SUBTITLE INVESTIGATION OF THE CRASHWORTHINESS OF BARRIER MOUNTED HARDWARE: BARRIER MOUNTED SIGN AND SIGNPOST		5. REPORT DATE June 2011

INVESTIGATION OF THE CRASHWORTHINESS OF BARRIER MOUNTED HARDWARE: BARRIER MOUNTED SIGN AND SIGNPOST

STATE OF CALIFORNIA
DEPARTMENT OF TRANSPORTATION
DIVISION OF RESEARCH AND INNOVATION
OFFICE OF SAFETY INNOVATION AND COOPERATIVE RESEARCH

June 2011

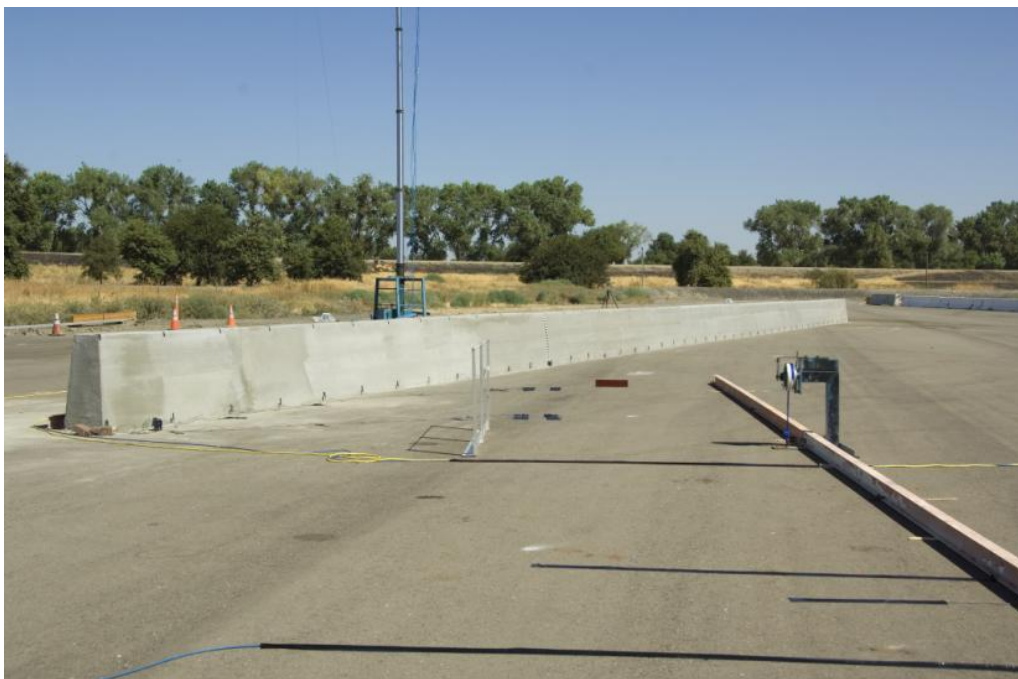
Figure 2-1 Type 60 Concrete Barrier Prior to Test

A private contractor, M. Bumgarner, Inc., constructed a 46-m (150-ft) section of Type 60 concrete barrier at the Caltrans Dynamic Testing Facility in 2005. The barrier design conformed to Caltrans 1999 Standard Plans A76A and A76B, shown in the Section 7.5. A photo of the completed test barrier (without the saddle-mounted post) is shown in Figure 2-1.

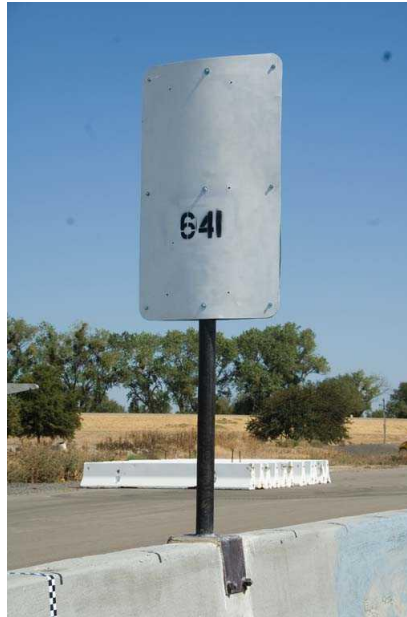
Figure 2-2 Signpost Mounted on Type 60 Median Barrier

The design of the signpost was based on the Type F configuration found in the “Placement of Roadside Sign (Barrier Mount)” plan, shown in the Section 7.5. This configuration requires that a 2748-mm by 88.9-mm (108-in by 3.5-in) nominal steel pipe (i.e. with an outside diameter of 101.6-mm (4.0-in)) be welded to a 10-mm (0.375-in) thick saddle. This assembly was then

mounted to the barrier with two 25-mm (1.0-in) bolts. The general shape of the signs was designed using the Caltrans standard plan for HOV sign R84-1 (CA) (Figure 7-8). The sign configuration used two 914-mm (36.0-in) by 1524-mm (60.0-in) panels placed back to back, negating the need for braces. A local contractor, National Concrete Cutting, was hired to use a coring drill to core two 32-mm (1.25-in) horizontal holes into the type 60 barrier. The impact point was then marked two meters upstream from the center of the signpost assembly.

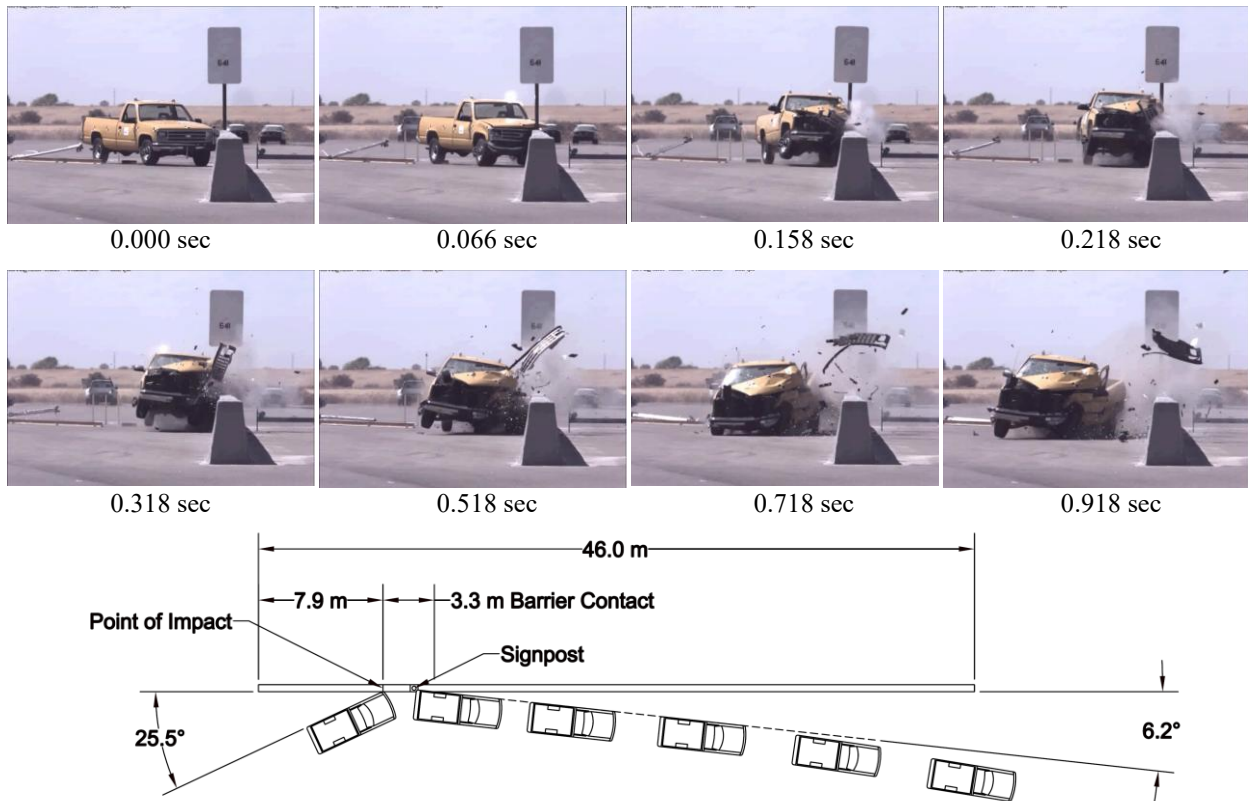
Figure 2-18 Test SS641 – Impact Sequence and Diagram

There was only cosmetic damage to the barrier. The signpost saddle was pushed 19 mm (0.75 in) downstream and the two bolts were also bent slightly downstream. The sign pole had a dynamic deflection of 10.6° and a static deflection of 3.4° leaning downstream of impact.

The occupant risk for this test is unacceptable. The hood penetrated the windshield by 250 mm (10 in) and would have showered the occupants with glass. The front grill broke off and would have been a hazard to opposing traffic. The battery was almost thrown from the vehicle and was only restrained by the negative terminal wire. There was excessive deformation on the driver side of the occupant compartment. Table 2-2 has a summary of the occupant risk. (Due to problems with the data acquisition system, there was no usable information to find the occupant impact velocities or ridedown accelerations.)
