**COMPLIANCE CRASH TESTING OF A STEEL VERSION
OF THE TYPE 732 BRIDGE RAIL**

DEPARTMENT OF TRANSPORTATION
ENGINEERING SERVICE CENTER
MATERIALS ENGINEERING AND TESTING SERVICES

January, 2002

1. REPORT NO. FHWA/CA/TL-2001/41	2. GOVERNMENT ACCESSION NO.	3. RECIPIENT'S CATALOG NO.	
4. TITLE AND SUBTITLE COMPLIANCE CRASH TESTING OF A STEEL VERSION OF THE TYPE 732 BRIDGE RAIL		5. REPORT DATE January, 2002

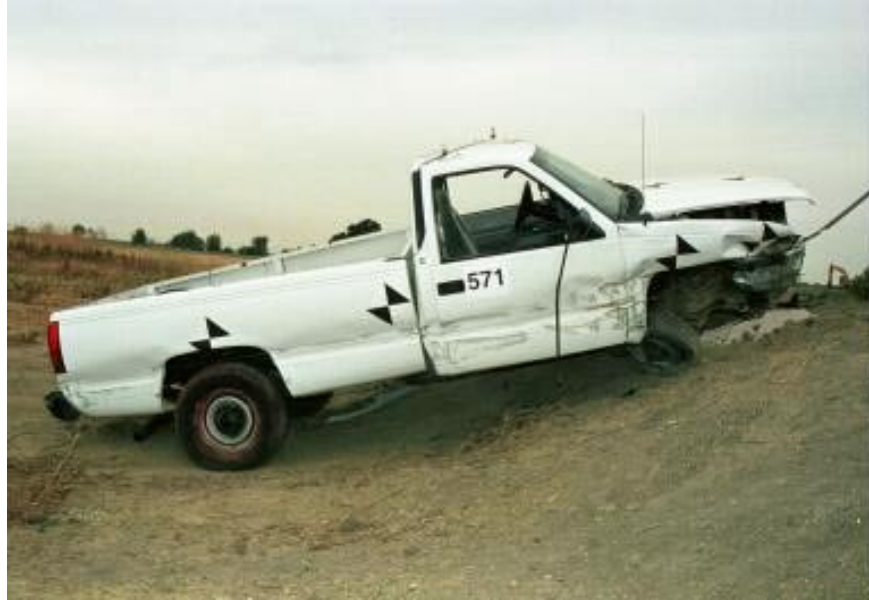
Figure 2-8 Test vehicle after Test 571

The right front corner of the vehicle was moderately damaged in the initial impact with the barrier. The right front fender, hood, bumper, headlamp area, grille, and suspension components were all affected. The passenger side doorframe was deformed outward but the door remained latched. The right front tire was also ruptured. Some minor damage along the right side of the vehicle and to the right rear quarter occurred as the vehicle continued to contact the barrier after the initial impact. The vehicle became briefly airborne, with the left rear corner reaching a maximum height of 900 mm. As the vehicle came back into contact with the ground it was in a nose-down pitch and right roll attitude which placed a majority of the landing force on the already damaged right front suspension components. This additional force caused the right front tire to push rearward and slightly into the passenger side footwell area. The maximum amount of passenger compartment deformation, 127 mm, occurred in the floorboard. This was within the accepted limit of 150 mm.¹

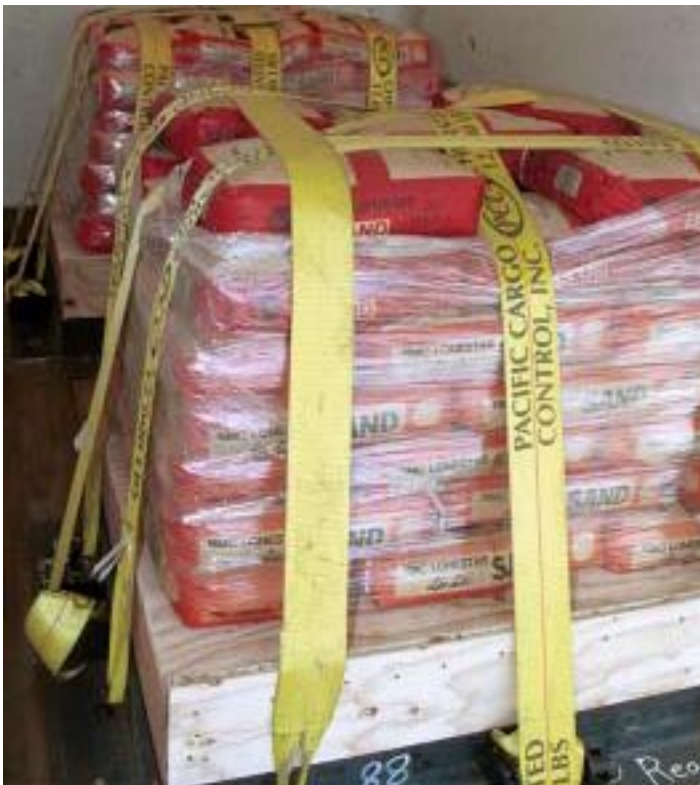
The 3049 kg of ballast was comprised of two separate pallets of sandbags and the associated mounting hardware all bolted and strapped down to the cargo floor. The pallets were constrained by 150-mm angle iron and the sandbags were held down by 100-mm nylon straps as shown in Figure 2-20. The sandbags shifted slightly, but it is unlikely that this affected the test. None of the sandbags broke loose during the test.

Figure 2-20 Ballast strapped down in cargo bed of test vehicle after Test 572

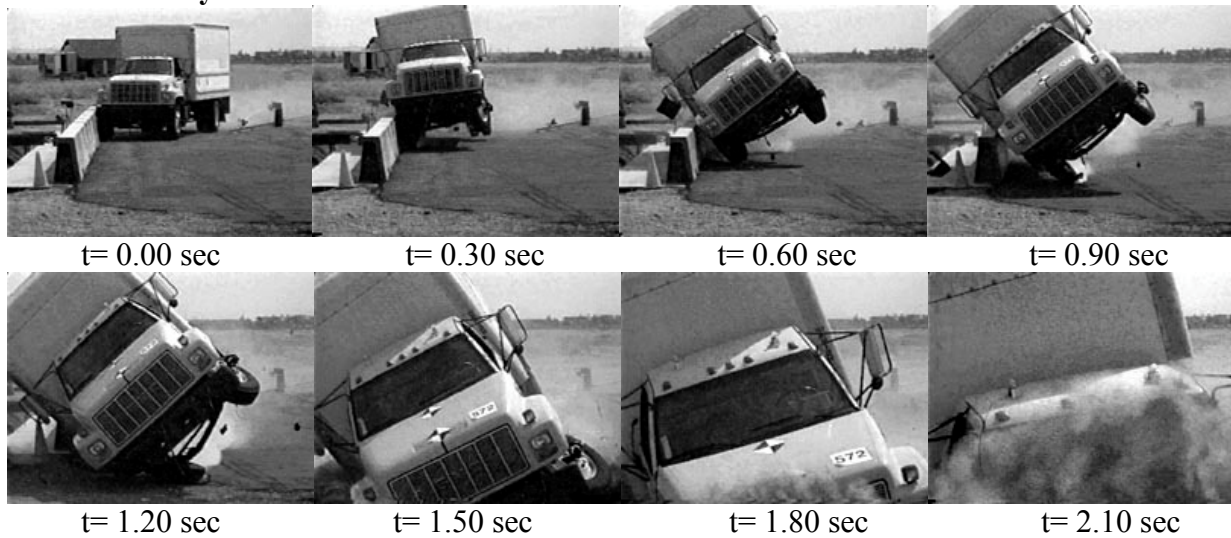
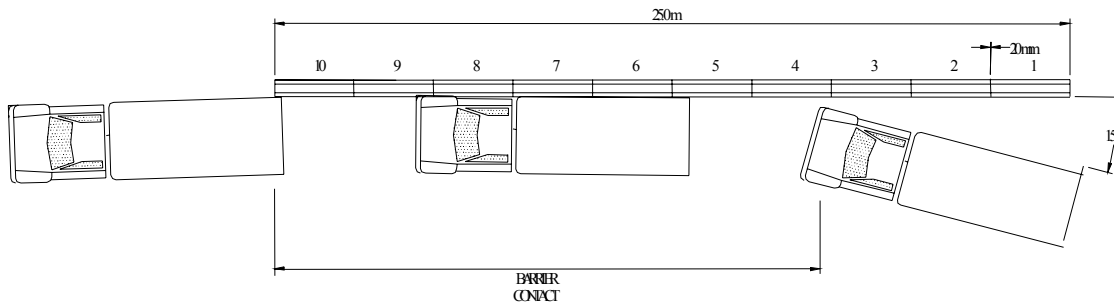
Figure 2-21 Impact sequence and diagram for Test 572

The right front corner of the vehicle and the fiberglass engine cowling were moderately damaged in the initial impact with the barrier. The right front bumper and right fender were pushed rearward. The right front tire and wheel assembly was broken loose from its attachment to the leaf springs, which allowed it to move rearward. The tire contacted the right-mounted diesel fuel tank, which damaged it and resulted in a minor leak. The tire also damaged the battery compartment and ruptured the battery, which was located directly under the passenger-side door. The passenger-side door remained latched even though film analysis showed a 25-50 mm gap opening and closing along the top of the door due to flexure of the cab and door. There was no passenger compartment or floorboard deformation.

As in Test 571, there was essentially no permanent damage to the barrier during Test 572. The vehicle did scrape the paint off the barrier along the length of contact and the vehicle lug nuts created some minor gouges, which were no more than 7 mm deep. These gouges could be ground and filled on-site by maintenance crews without removing any barrier segments.
