TEHAMA COUNTY TRANSIT FACILITY SITE STUDY

JUNE 2010

Facility Condition Assessment for the
Proposed Tehama County Transit Facility
Paratransit Services
June 15, 2010

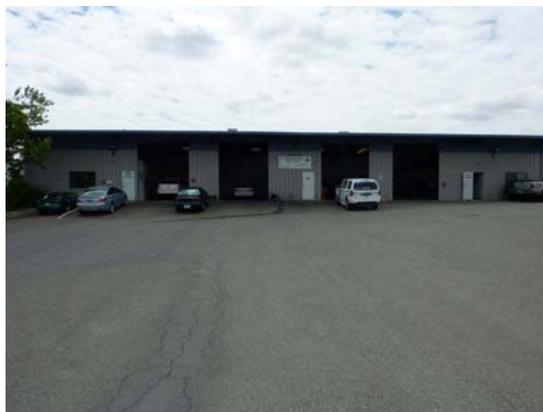
As the transit services (TRAX and ParaTRAX) have grown over the years, the number of transit employees and service vehicles has increased. In addition, as new components such as METS and ADA Certification have been added to the scope of work carried out at the facility, the need for office space has increased. The result is that the 1509 Schwab Street site has reached full capacity in its present configuration.

Limitations of the current 1509 Schwab Street site are as follows:

1. The current facility does not have a vehicle washing facility (a “wash rack”). As a result, the TRAX and ParaTRAX vehicles are shuttled 20 miles from Red Bluff to a commercial truck washing facility. This costs the County approximately \$50,000 annually.
2. There are only 7,860 sq ft of secure parking on the site as currently configured. This is well below program requirements for 25,560 sq ft.
3. The current office area is 1,700 sq ft, well below program requirements for 2,340 sq ft.
4. The lease arrangement costs the County \$37,000 annually and limits usage options of the property by the County.

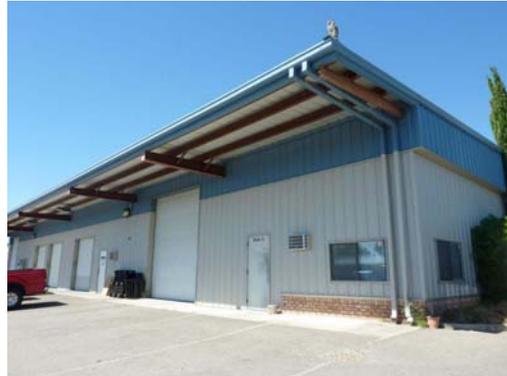
PROPERTY B: 1820 BIDWELL

The main attraction of Property B is that it is located on a 1-acre parcel adjacent to Property A.

The building, at 5000 sq ft (including 1250 sq ft of finished office space and an unfinished shop area) is much smaller than the current transit facility and would not be large enough in itself to house County's transit program needs. However, in combination with the Schwab Street parcel, parking capacity and office space would be greatly improved. This combination would meet current needs and provide the capacity to accommodate long term growth of the Tehama Regional Transit program.

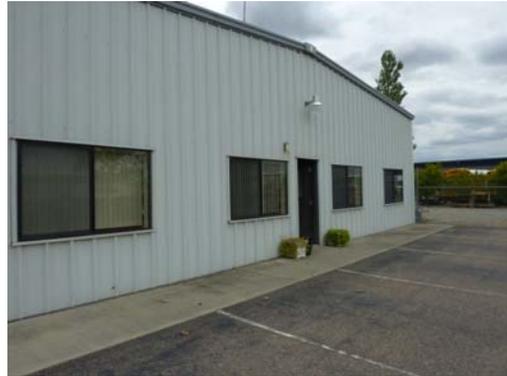
Proposed Improvements Property B

This property currently has 17,000 sq ft of paved parking which is not fenced, plus another 21,560 sq ft of fenced gravel area. Gravel portions of the site will require paving and the fencing will need to be modified, but this site would in itself resolve that parking issues for the transit vehicles.

The building exterior is in good shape and will require only minor improvements such as the installation an additional doors and repairs to the roof. The interior will need renovations to provide additional office space. Improvement costs are estimated to be \$760,532.

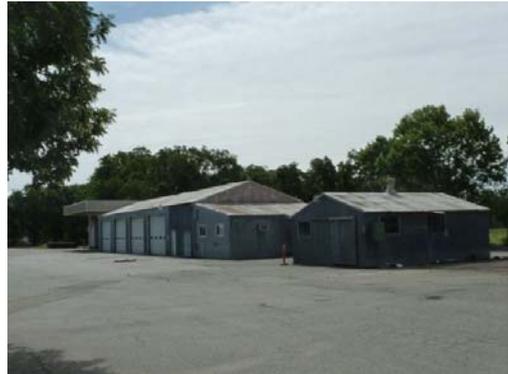
Proposed Improvements Property C

With improvements, this 5.45-acre parcel is certainly large enough to accommodate program requirements for the Regional Transit system. Space for vehicle parking would not be a problem for this location. However, the structural improvements required would be extensive. Although there are two shop areas, neither can accommodate a large transit bus, so it is recommended that a new metal shop building be constructed. The office currently on the site is only 960 sq ft, meeting only 41% program requirements for office area, so additional office space would need to be constructed.

In addition to the estimated improvements costs of nearly \$1 million, there are other concerns with this site. One is the possibility that it has been contaminated by hazardous waste. Caltrans will issue an environmental hazard report at a later date, but in the interim it should be assumed that there will be costs associated with cleanup at this site. Another concern is that the location is on a FEMA flood map which identifies the location as being in the 100 year flood zone. Finally, compliance with Americans with Disability Act (ADA) is also an issue which Caltrans identified in their justification to construct a new facility. These concerns make this location unadvisable. Purchase price for this site does not appear to be determinable at this point.

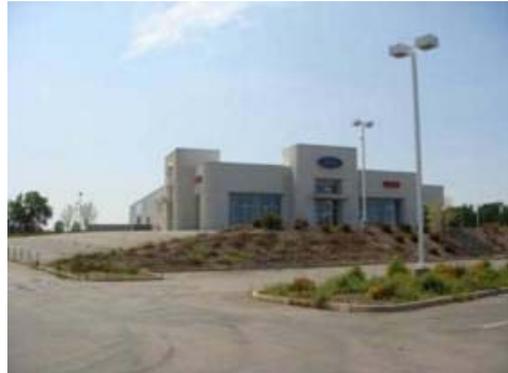
Proposed Improvements Property E

The building is only 8 years old, and is in good condition—no major improvements are required, just relatively minor renovations such as a wash slab for vehicle washing, secure fencing, and some HVAC work. Total costs for renovations are estimated to be \$114,690.
