| 4. TITLE AND SUBTITLE PPRC11 SPE 4.41.2: Laboratory and Accelerated Pavement Testing (APT) of Gap-Graded Rubberized Mixes (Hot Mix Asphalt and Warm Mix Asphalt) for the Department of Resource Recycling and Recovery (CalRecycle). Subtitle: Warm-Mix Asphalt Study - Field Test Performance Evaluation | | 5. REPORT DATE December 2013 |
| 7. AUTHOR D. Jones | | 6. PERFORMING ORGANIZATION CODE |
| 9. PERFORMING ORGANIZATION NAME AND ADDRESS California Department of Transportation Division of Research, Innovation and Systems Information, MS-83 P.O. Box 942873 Sacramento, CA 94273-0001 | | 8. PERFORMING ORGANIZATION REPORT NO. UCPRC-TM-2013-08 |

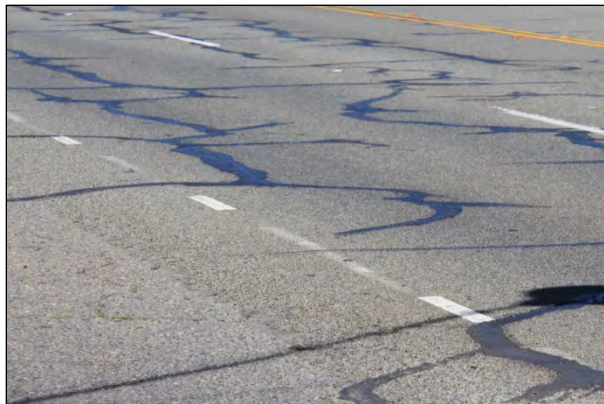
Figure 8.1: Auburn Evotherm, July 2010, one month prior to paving.
