1. REPORT NUMBER CA09-0678	2. GOVERNMENT ASSOCIATION NUMBER	3. RECIPIENT'S CATALOG NUMBER
4. TITLE AND SUBTITLE Pedestrian and Bicycle Safety Evaluation in a SMART Corridor	5. REPORT DATE October 2008

7. AUTHOR David R. Ragland, Terri O' Connor,		6. PERFORMING ORGANIZATION CODE
9. PERFORMING ORGANIZATION NAME AND ADDRESS University of California, Berkeley Traffic Safety Center 2614 Dwight Way Berkeley, CA 94720	8. PERFORMING ORGANIZATION REPORT NO.

David R. Ragland, PhD, MPH, and Terri O'Connor
UC Berkeley Traffic Safety Center (TSC)

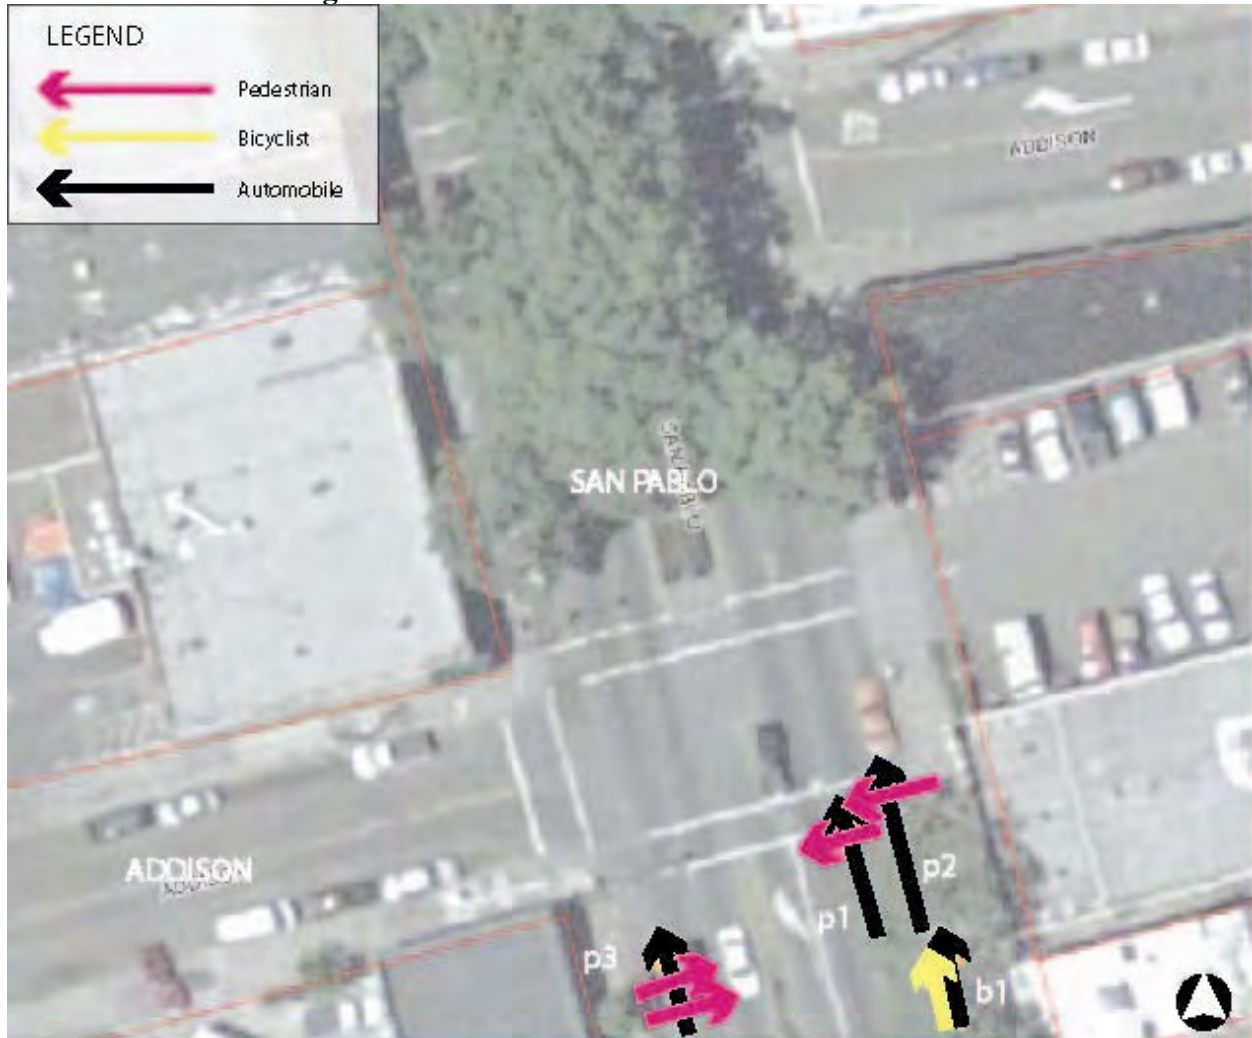
Figure 5.9. San Pablo Avenue and Addison Street

There were vehicle collisions with three pedestrians, and vehicle collisions with one bicyclist reported for this intersection in the past six years. The crashes appeared to be concentrated at the eastern side of the southern intersection and approach. It is not clear by the data provided whether the crashes occurred in the proximity of the northern or southern Addison crossing. The pedestrian crashes occurred in the intersection with vehicles stopping or proceeding straight, they occurred outside of the crosswalk between a vehicle backing up and two eastbound pedestrians. The bicycle crash occurred with a northbound vehicle entering traffic. The crash types and previous movements are illustrated in figure 5.9.

- Upgraded/extended median (pedestrian refuge island): reduce conflict, reduce number of trapped pedestrians, increase number of pedestrians using crosswalk.

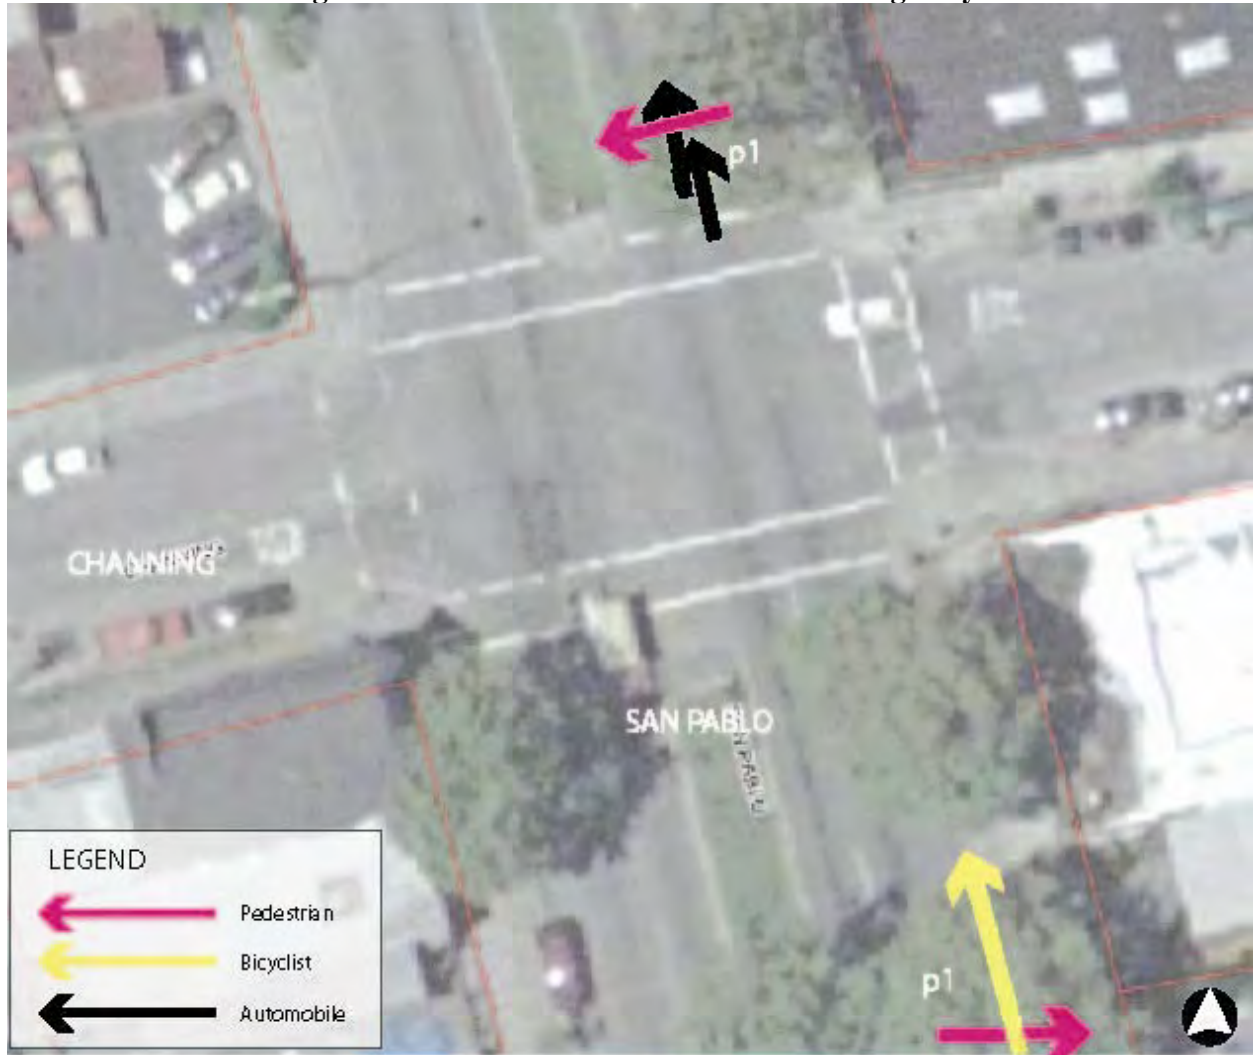
Figure 5.12. San Pablo Avenue and Channing Way

One vehicle collision with a pedestrian, and three vehicle collisions with bicycles were reported between 1998 and 2003. The pedestrian/vehicle crash occurred about 30 feet outside of the intersection on San Pablo Ave., with two northbound vehicles and a westbound pedestrian. The pedestrian/bicycle collision involved a westbound pedestrian and a northbound bicyclist on San Pablo over 100 feet from the intersection. The crash types and previous movements are illustrated in Figure 5.12.

- In-roadway knockdown signs, passive awareness: increases awareness, reduces conflict; however, may give pedestrian false sense of security.
- Speed trailers: discourages speeding, reduces conflict.
- Pedestrian activated flashing lights: reduces conflict, increases use of crosswalks; could reduce pedestrian awareness.
- Upgraded/extended median (pedestrian refuge island): reduce conflict, reduce number of trapped pedestrians, increase number of pedestrians using crosswalk.

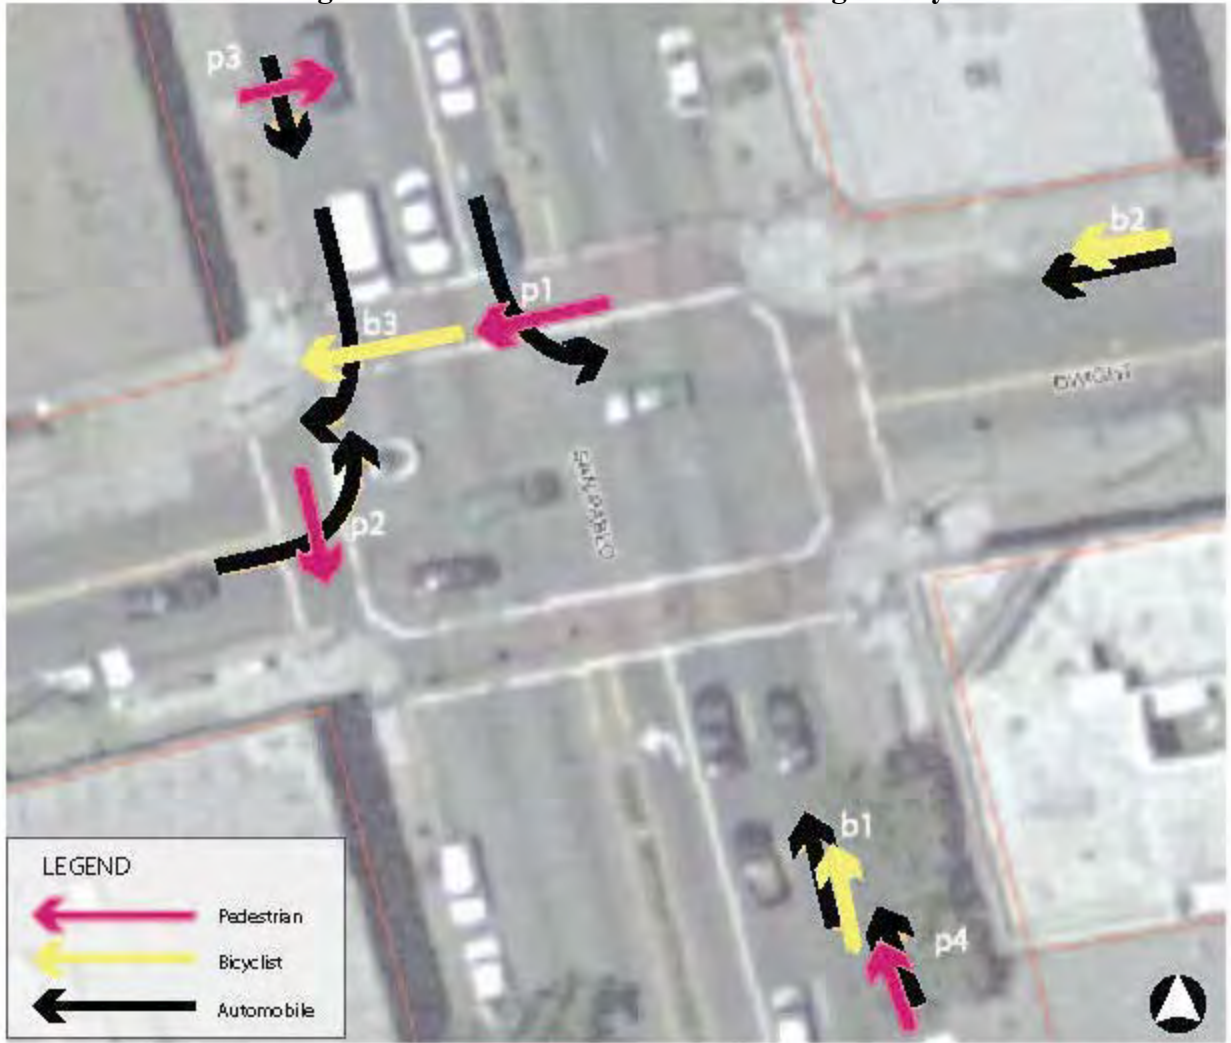
Figure 5.13. San Pablo Avenue and Dwight Way

Vehicle collisions with four pedestrians, and vehicle collisions with three bicyclists were reported between 1998 and 2003. The majority occurred in the northwest corner of the intersection and approach. Pedestrian crashes involved straight-moving and left-turning vehicles and included both driver and pedestrian violations. Two bicycle crashes involved a stopped or parked car with straight moving bicyclists, and one involved a right-turning vehicle into a bicycle traveling the wrong way against traffic. The crash types and previous movements are illustrated in figure 5.13.

- Upgraded/extended median (pedestrian refuge island): reduce conflict, reduce number of trapped pedestrians, increase number of pedestrians using crosswalk.
- Ample signage for bicyclists to guide them to alternative bicycle network, two blocks the west of this intersection.
- Signs encouraging motorist to “share the road” and warning of approaching bicycle boulevard intersection.
- Signs warning motorist parking on the street about “door zone vigilance.”

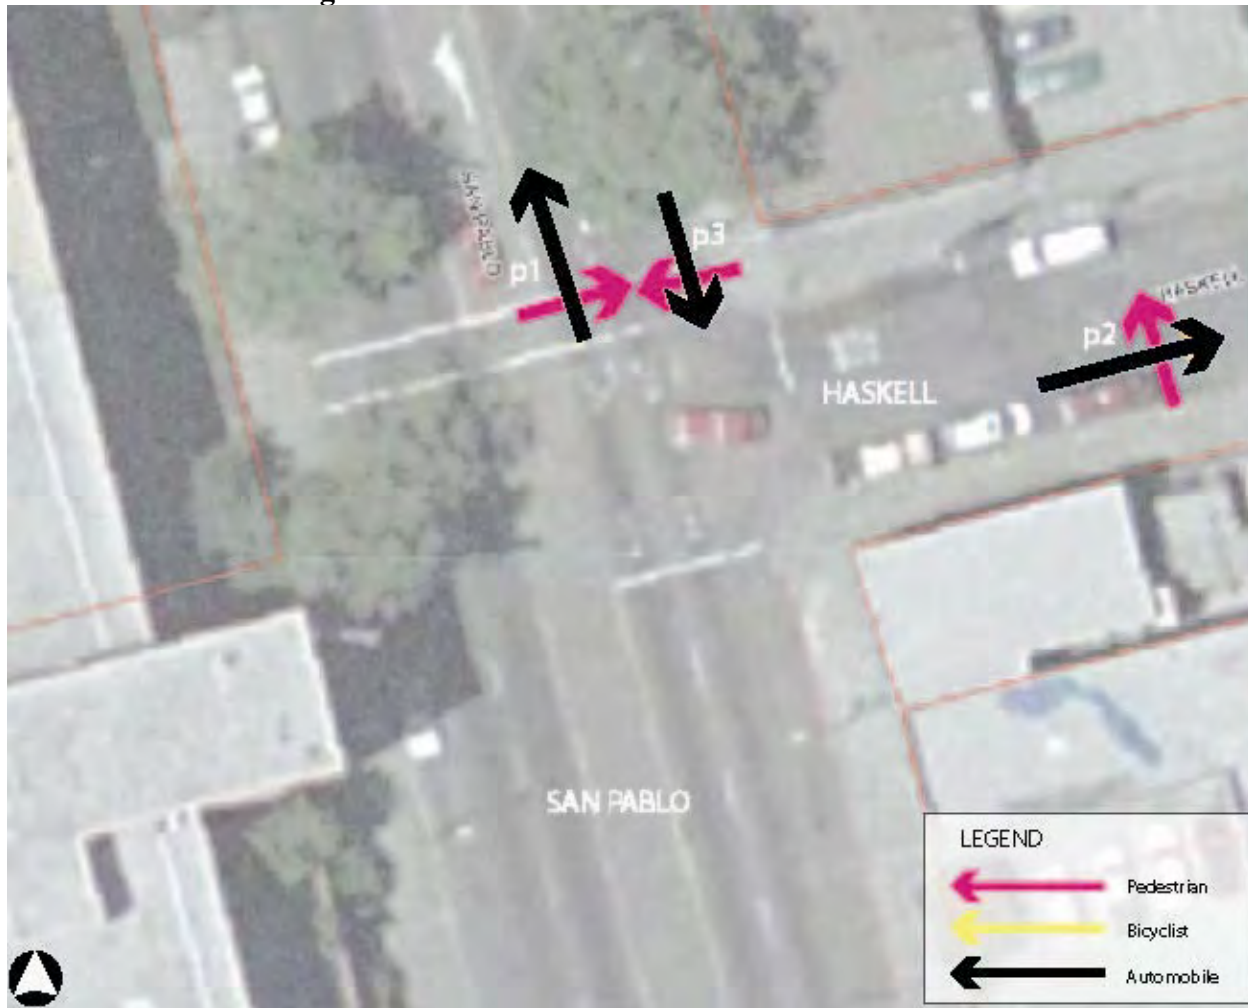
Figure 5.16. San Pablo Avenue and Haskell Street

There were vehicle collisions with three pedestrians reported for this intersection between 1998 and 2003. Two were determined to be the fault of the pedestrian. Pedestrian crashes involved vehicles backing up, a pedestrian jaywalking and an improper passing maneuver by a vehicle. The crash types and previous movements are illustrated in Figure 5.16 below.

- In-roadway knockdown signs (impactable yield), passive awareness: increases awareness, reduces conflict.
- Speed trailers: discourages speeding, reduces conflict.
- Pedestrian activated flashing beacons: reduces conflict, increases use of crosswalks; could reduce pedestrian awareness.
- Pedestrian activated flashing lights: reduces conflict, increases use of crosswalks; could reduce pedestrian awareness.

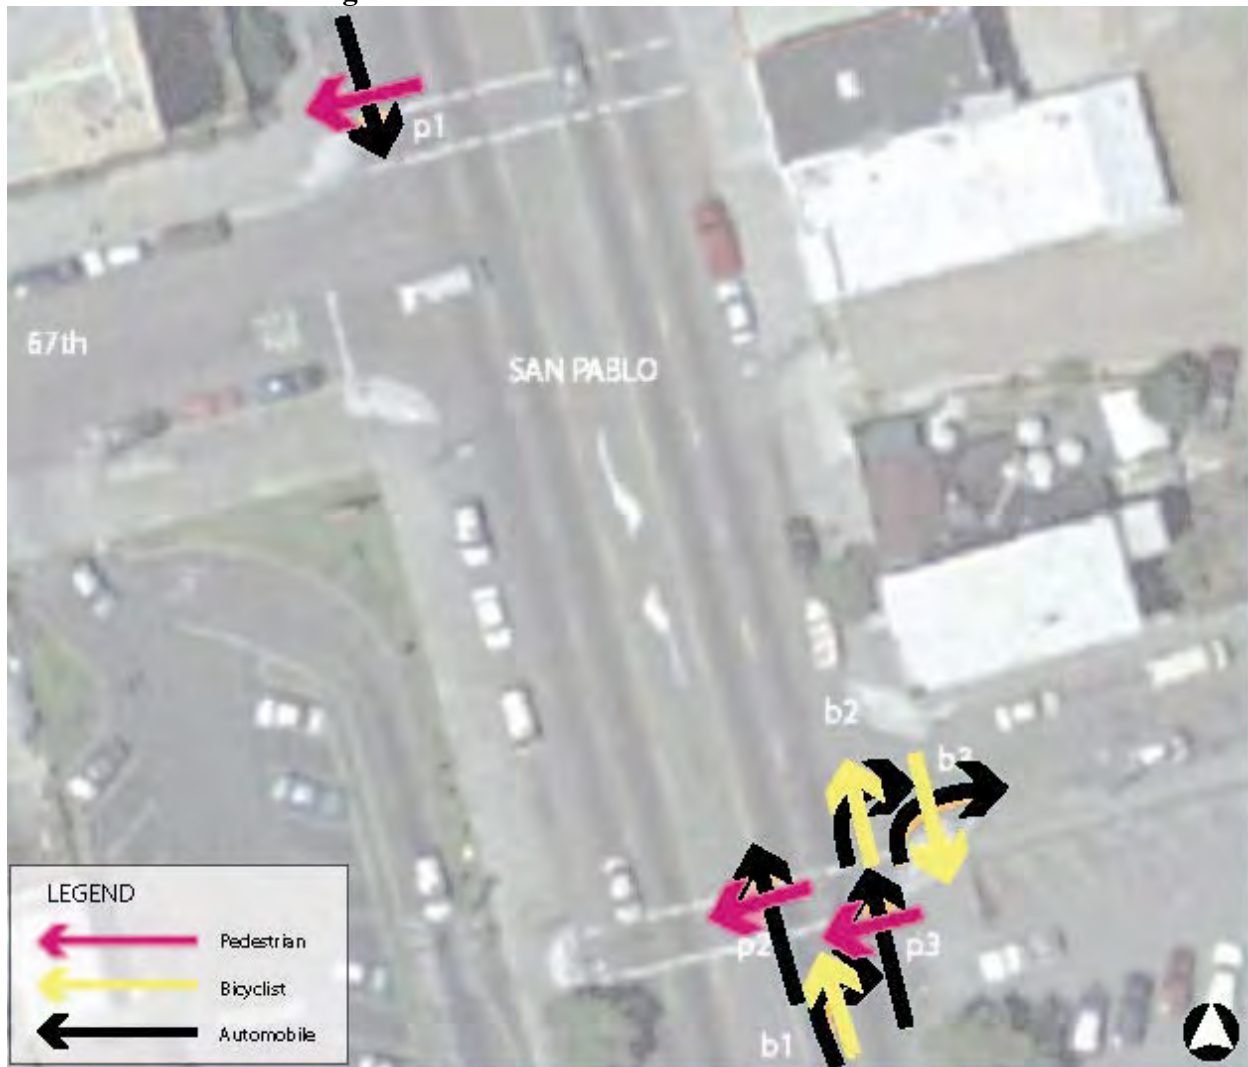
Figure 5.17. San Pablo Avenue and 67th Street

Vehicle collisions with three pedestrians, and vehicle collisions with three bicyclists were reported for this intersection between 1998 and 2003. Pedestrian crashes involved straight-moving vehicles and were at or within ten feet of the intersection. Bicycle crashes involved right-turning vehicles and were concentrated on the southeastern side of the intersection. The crash types and previous movements are illustrated in figure 5.17.

- Replace landscaping with higher canopy vegetation to improve crosswalk visibility.
- In-roadway knockdown signs, passive awareness: increases awareness, reduces conflict; however, may give pedestrian false sense of security.
- Speed trailers: discourages speeding, reduces conflict.
- Pedestrian activated flashing beacons: reduces conflict, increases use of crosswalks; could reduce pedestrian awareness.

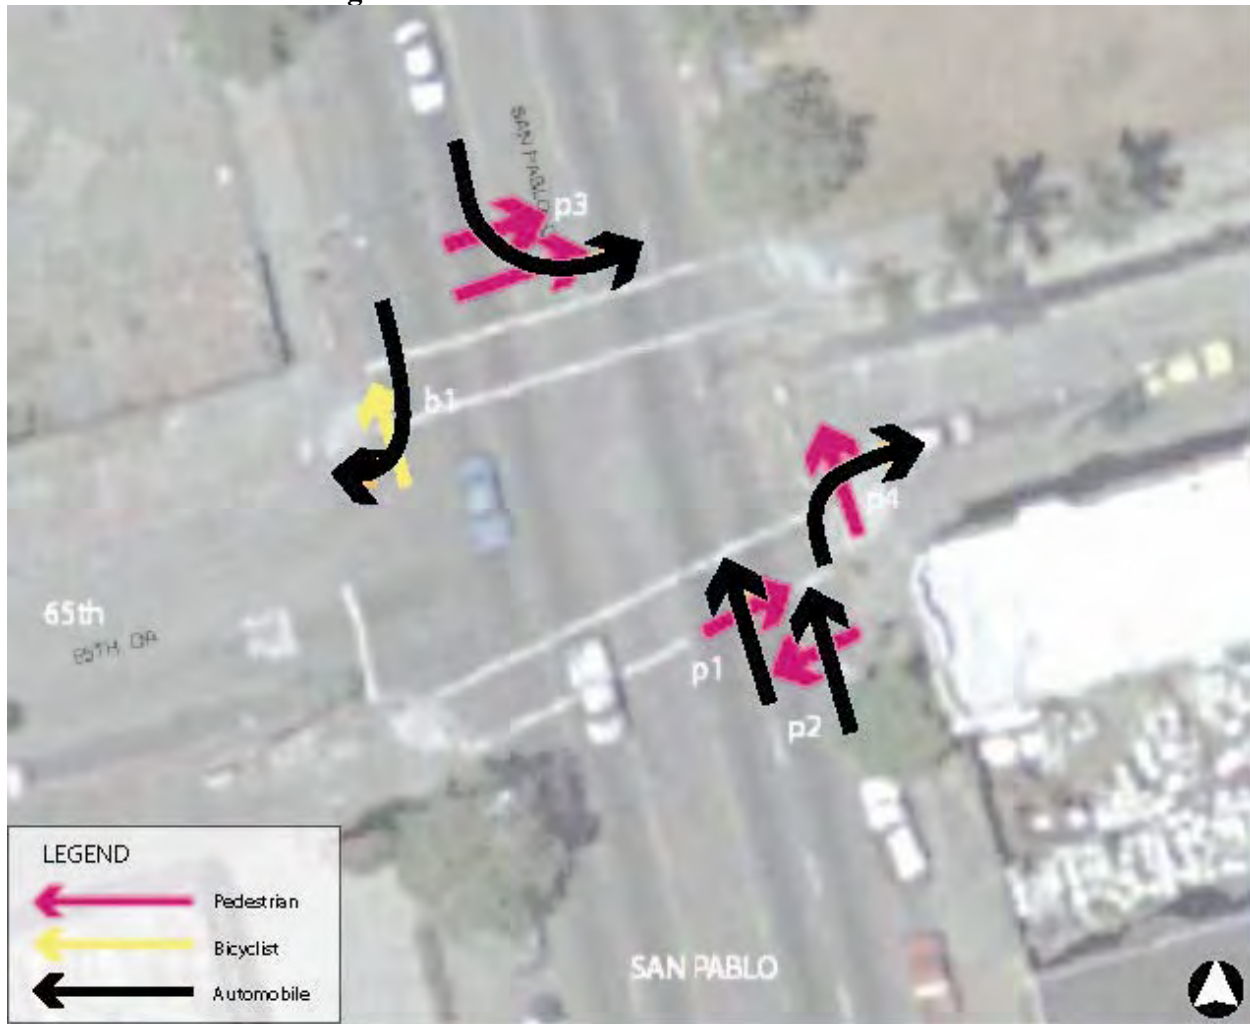
Figure 5.18. San Pablo Avenue and 65th Street

Vehicle collisions with four pedestrians, and vehicle collisions with one bicyclist were reported for this intersection between 1998 and 2003. Pedestrian crashes involved straight-moving, left-turning and right-turning vehicles. In all cases, the drivers were at fault. The bicycle crash involved a bicyclist traveling on the wrong side of the road with a right-turning vehicle. The crash types and previous movements are illustrated in figure 5.18.

- Median extensions to crosswalk (pedestrian refuge islands): reduce conflict, reduce number of trapped pedestrians, increase number of pedestrians using crosswalk.
- In-roadway knockdown signs (impactable yield), passive awareness: increases awareness, reduces conflict; may give pedestrian false sense of security.
- Speed trailers: discourages speeding, reduces conflict.
- Pedestrian activated flashing beacons: reduces conflict, increases use of crosswalks; could reduce pedestrian awareness.
