FHWA/CA/ESC-98/06 Part 3

Vehicle Crash Tests of The Type 80 Bridge Rail

March 1999

**VEHICLE CRASH TESTS OF THE
TYPE 80 BRIDGE RAIL**

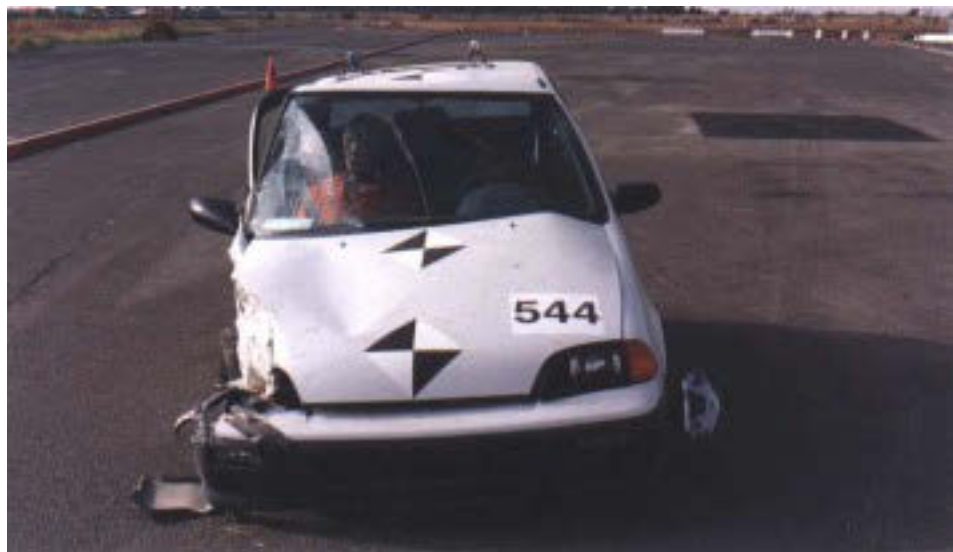
Figure 2-19 Post Impact View of Barrier and Vehicle 544

Contact with the bridge rail continued for approximately 2.5 m, determined by visible marks on the rail. The left rear wheel rose off the ground to a maximum of 0.1 to 0.15 m. As shown in Figure 2-19 through Figure 2-21, there were some black tire marks on the face of the barrier posts, but there was no evidence of wheel snagging. At 0.097 s after impact, the dummy's head was out of the right front passenger window. The dummy's head did not come into contact with the barrier or any other items and returned to its original position once the lateral accelerations decreased.

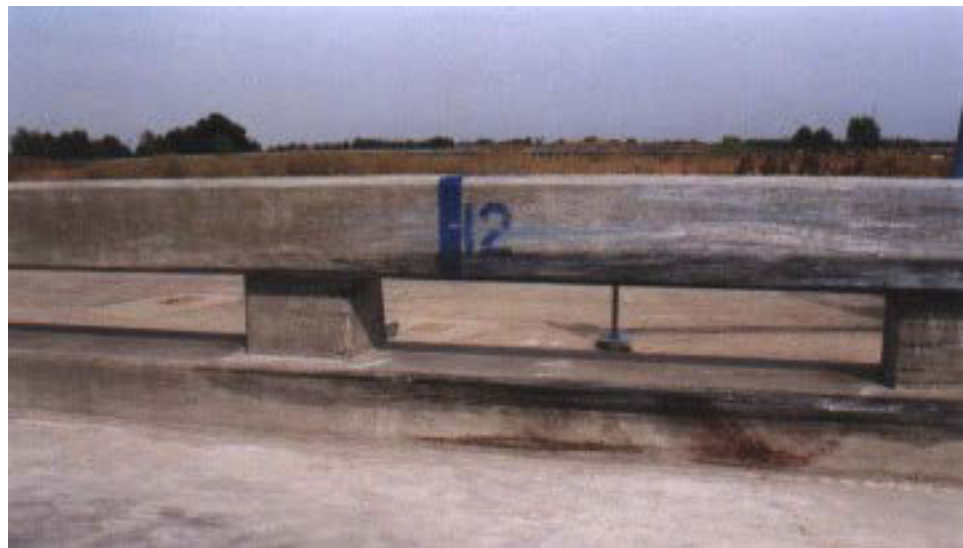
Figure 2-21 Post Impact Bridge Rail Scuff Marks Test 544

Barrier damage was cosmetic only, consisting of scrapes and tire marks. Both of the right side tires left marks on the curb and beam section of the bridge rail. Small amounts of concrete spalled from the face of the barrier where the vehicle's sheet metal and wheels made contact.

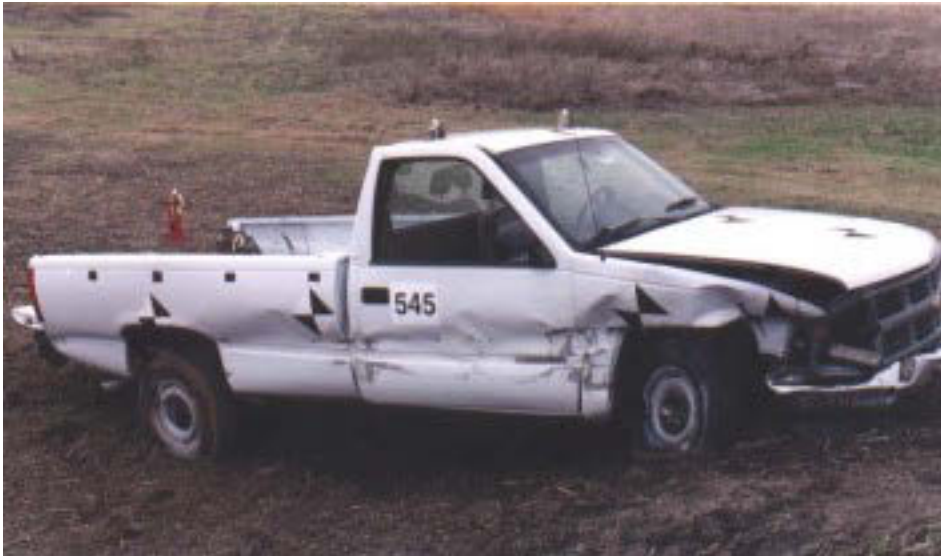
Figure 2-27 Post Impact Side of Test Vehicle 545

The vehicle received damage from the right front corner to the right rear corner, Figure 2-27. The right front and right rear wheel rims were deformed and the tires deflated. The left side wheels and tires were undamaged. The spare tire was forced from its undercarriage storage location and ended up about 15 m from the vehicle resting position.

The initial impact occurred on the right front quarter panel, resulting in substantial buckling and scraping, Figure 2-27. The right side of the bumper was pushed back about 260 mm. As the vehicle continued along the rail the entire right side was deformed where it contacted the bridge rail beam face. As a result, the right door did not operate due to moderate buckling and scraping. The truck bed was also scraped and buckled along the right side and the entire bed shifted to the right 40 mm. The tailgate did not function but the hood and left door were left in good condition and were operable. The roof of the truck did not have any signs of buckling. The windshield was cracked but remained mounted. The left and rear windows were not cracked.

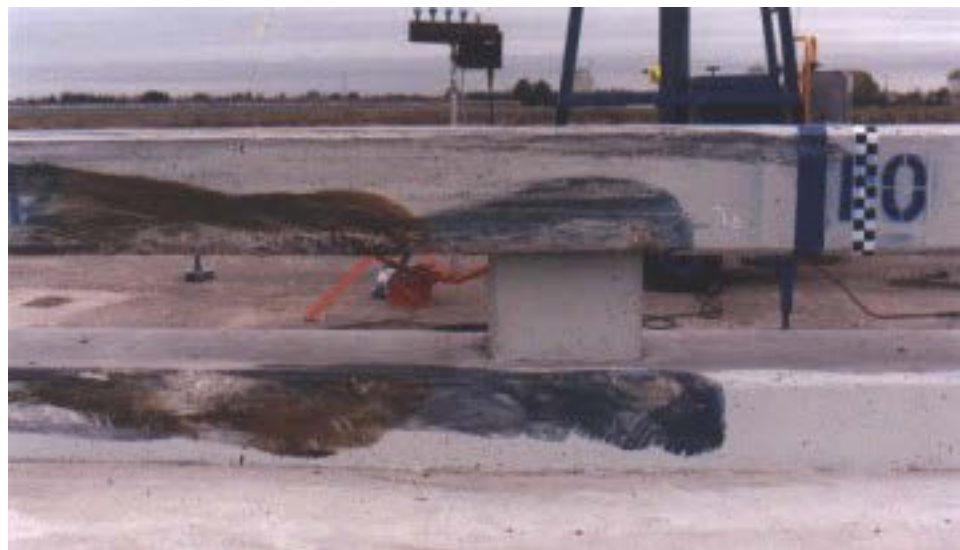
Figure 2-31 Test 545 Impact Area

The barrier received minor scraping and spalling, mainly at the lower edge of the beam section. Other barrier damage was cosmetic only, consisting of scrapes and tire marks. Both of the right side tires left marks along the face of the barrier.

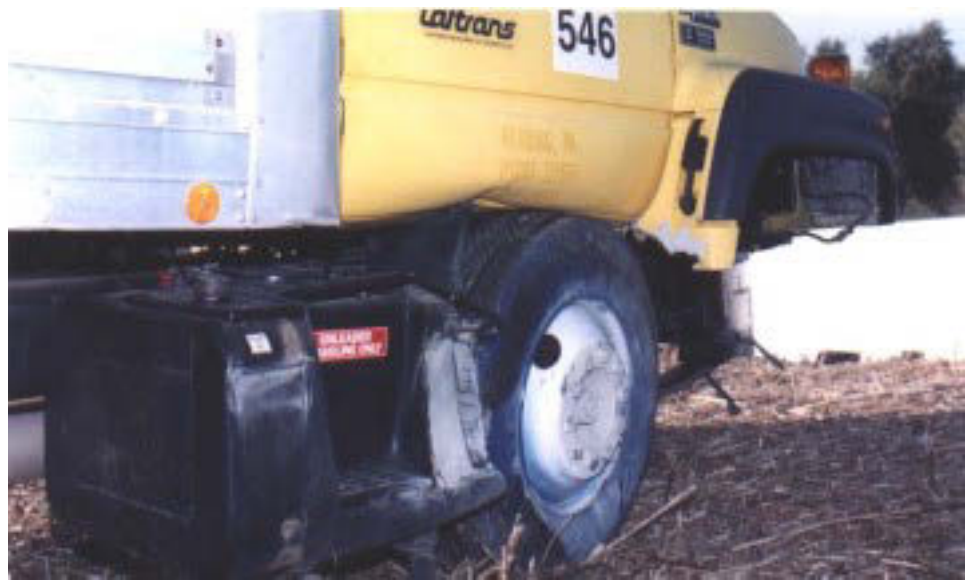
Figure 2-39
Close-up of Right
Front Wheel Area

The majority of damage occurred to the right front corner of the truck. The impacting tire was pushed back into the rear of the wheel well which severed the u-bolt connecting the leaf springs to the front axle. The steering rod and front axle on the right side were bent rearward. The battery box, located directly under the passenger door was completely crushed. The fuel tank was pushed rearward and moderately deformed while in contact with the beam face, Figure 2-39.

The right front wheel received substantial scraping on the studs from contact with the bridge rail concrete, with little other damage. All of the tires remained inflated except the outside right rear dual tire, which was deflated when the outer rim was bent during impact.

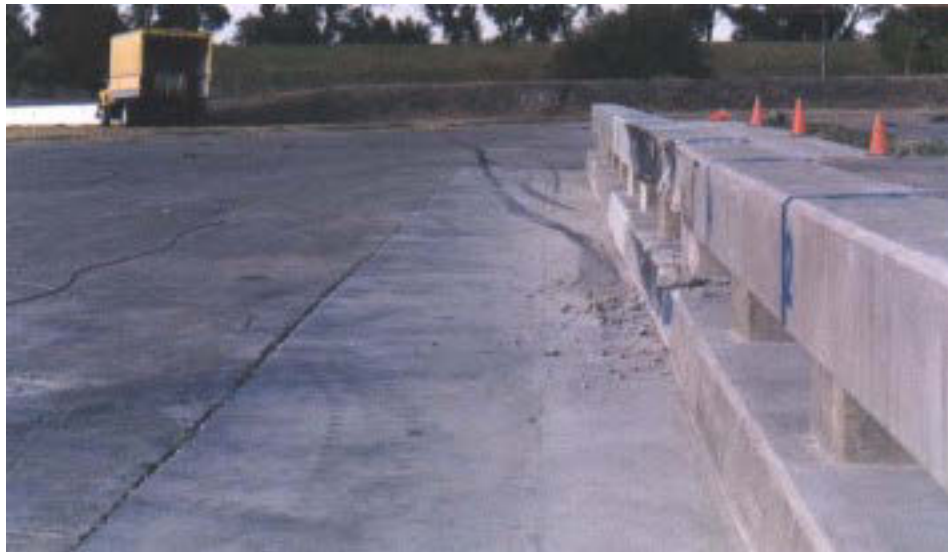
Figure 2-40
Barrier and Resting
Point of Vehicle

The 8056 kg van-bodied truck impacted the bridge rail at 80.1 km/h and 15.0 degrees. The impact location was 0.7 m in front of the bridge rail expansion joint, Figure 2-42. At impact the vehicle rolled to the right lifting both left wheels off the ground about 0.8 m. The U-bolt holding the front right leaf springs to the front axle broke, allowing the right front wheel to be pushed back under the cab, Figure 2-39. The vehicle continued to make contact with the barrier for 5 m. The approximate exit angle of the truck after it left contact with the beam face was 8 degrees. The truck then righted itself and continued to move away from the barrier at a shallow angle. The brakes were applied and the truck came to rest about 30 m and 65 m, respectively, from the point of impact, Figure 2-40.

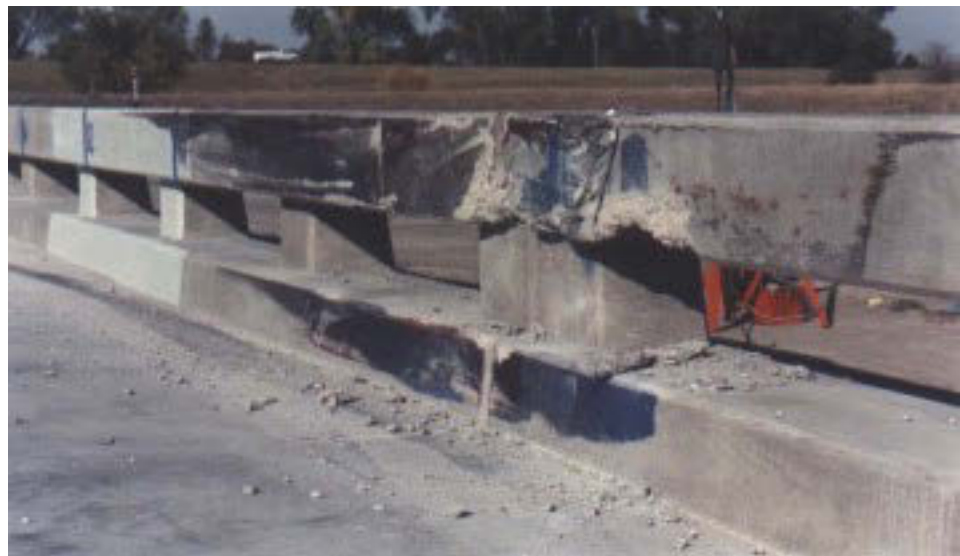
Figure 2-41
Impact Area

Barrier Damage: The barrier sustained minor spalling near the point of impact and at the expansion joint. Other barrier damage was cosmetic, consisting of scrapes and tire marks, with no structural damage.
