An Evaluation of Potential Effects on Old-Growth Redwoods
from Implementation of the Richardson Grove Operational
Improvement Project

August 14, 2015

Dennis Yniguez
Registered Consulting Arborist
Dennis@TreeDecisions.com
510-649-9291

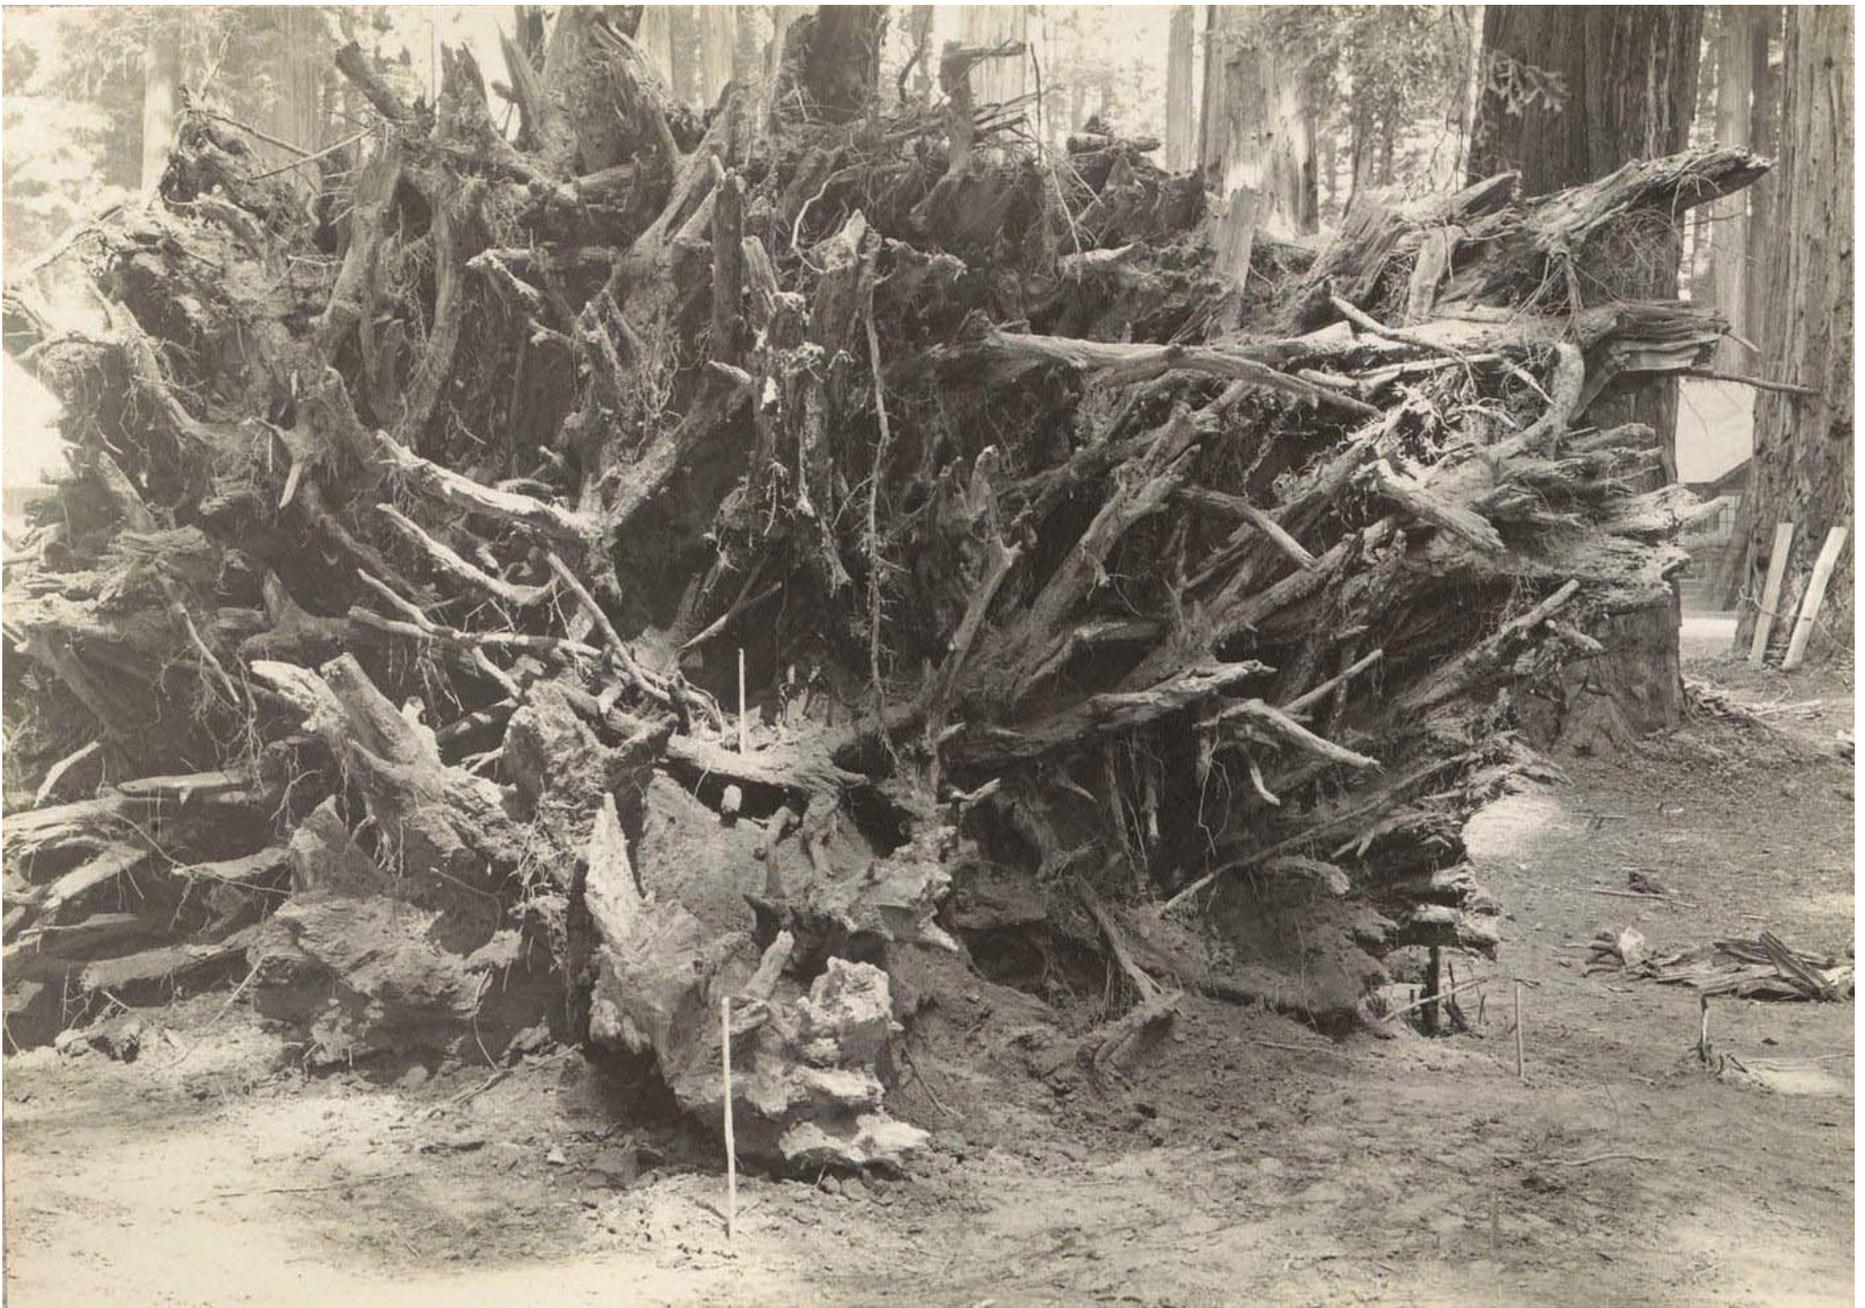
11. **1933:** This redwood was more than 1,200 years old when it fell in Richardson Grove in 1933. During its lifetime, the depth of soil at its base had increased by about 11 feet because of silt deposited by periodic floods. As soil accumulated, seven distinct layers of roots had formed. (Courtesy of the Marian Koshland Bioscience and Natural Resources Library, University of California, Berkeley: lib.berkeley.edu/BIOS/)

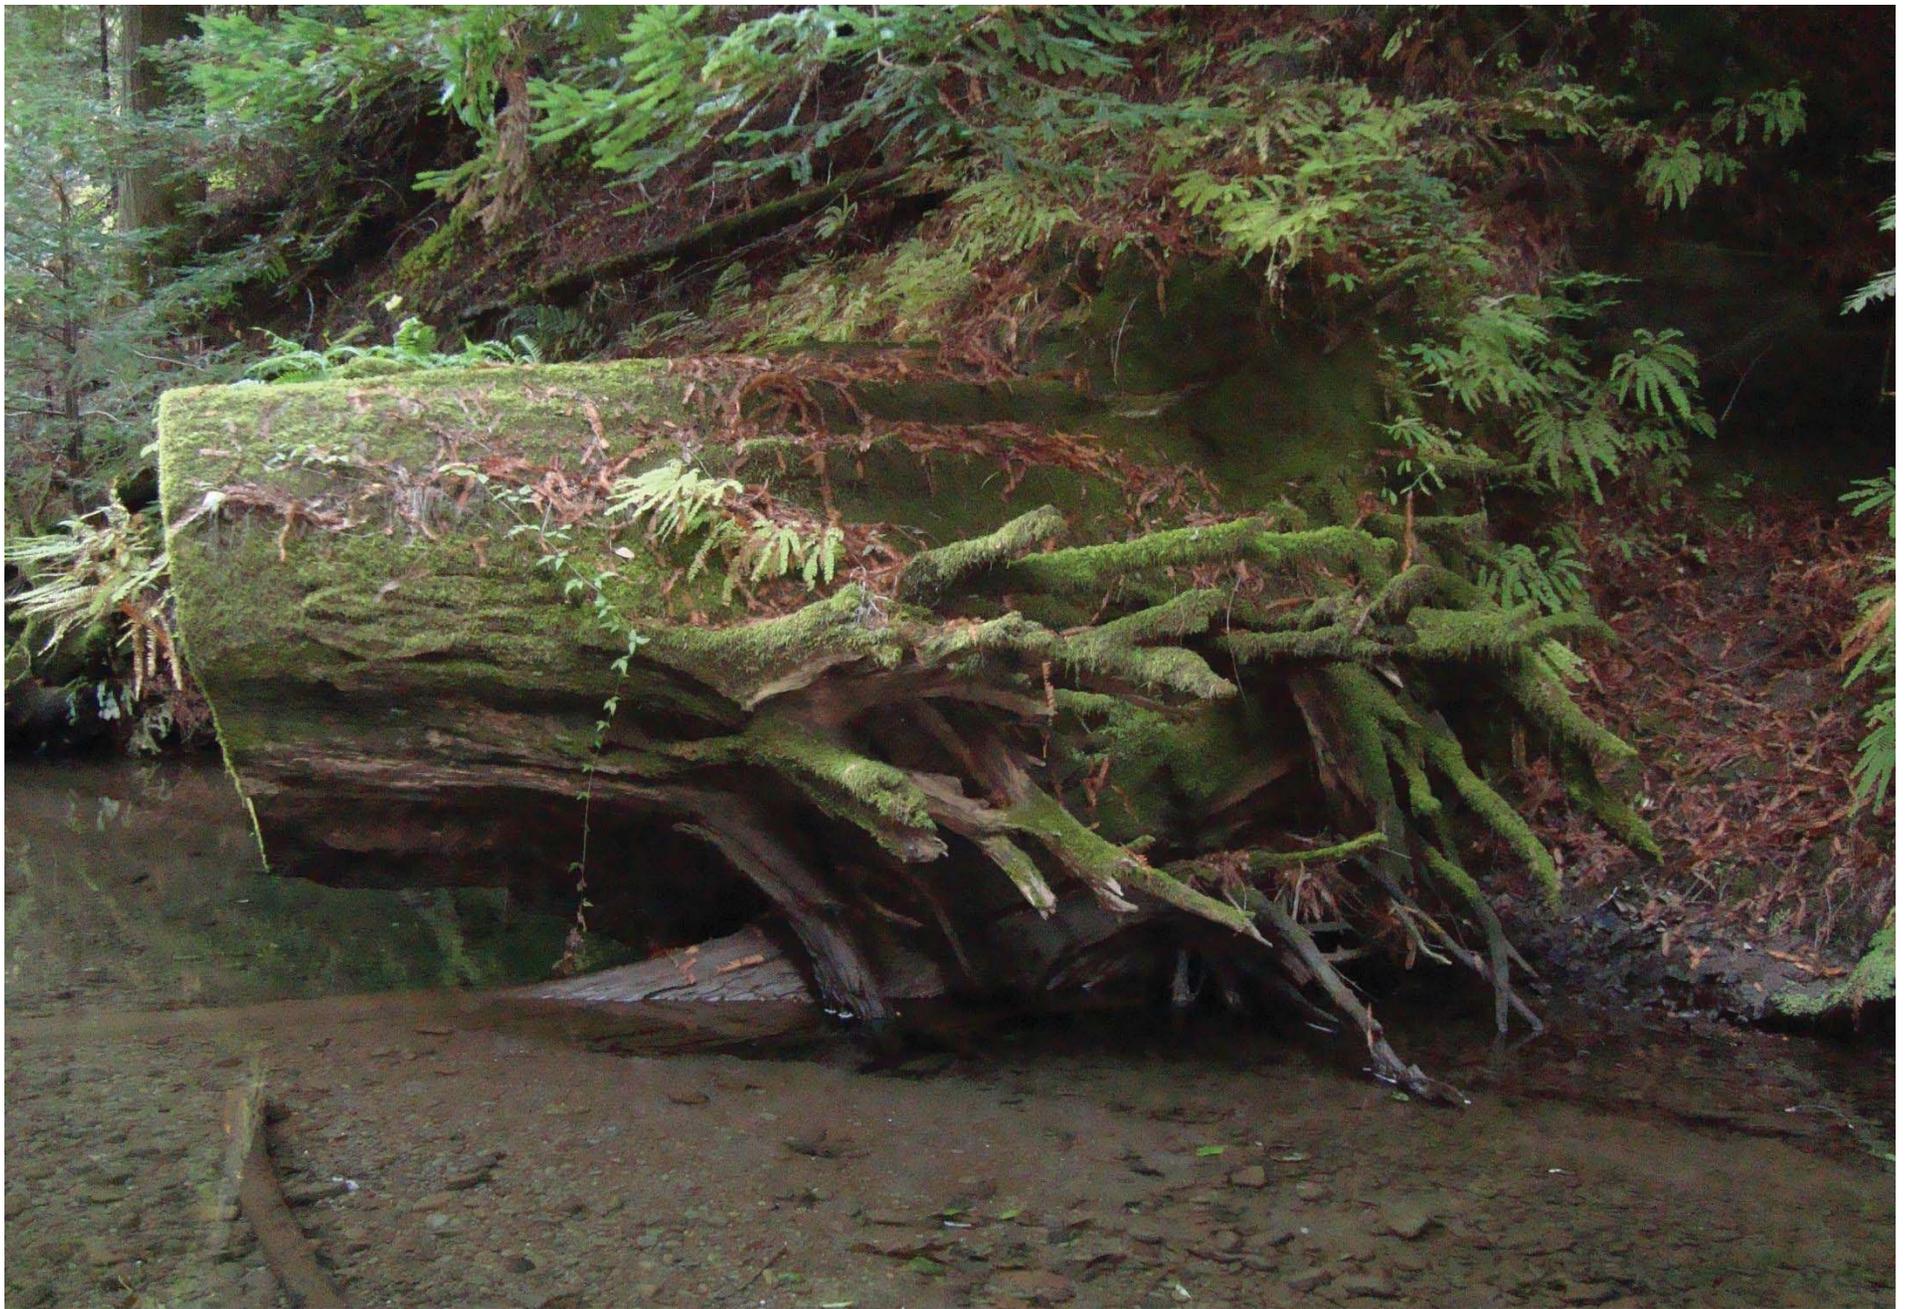
13. **2011:** This old-growth coast redwood toppled in the 1950s or 1960s during an extreme flood in Bull Creek. Soil had accumulated alongside the standing tree and new roots had formed from buried trunk tissue. This successful survival tactic enables redwoods to survive repeated flooding and sedimentation.

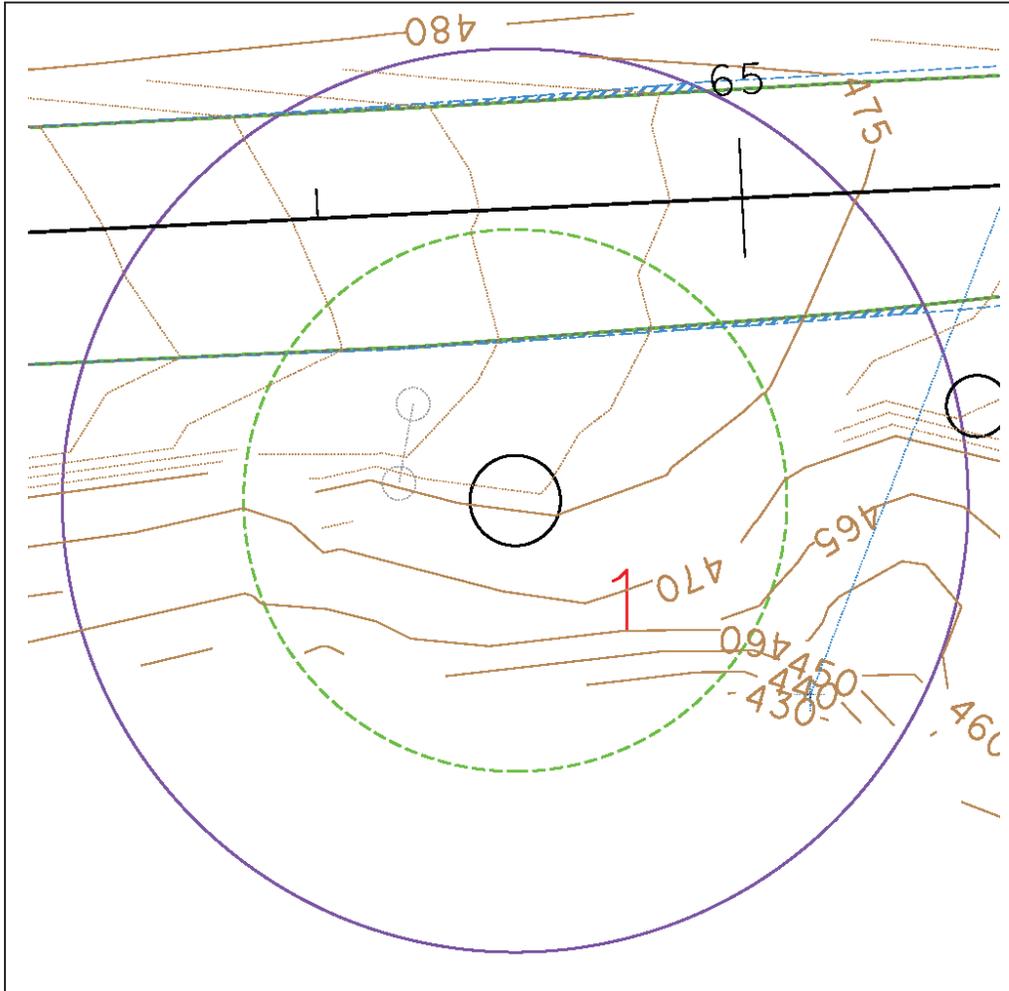
Description: Tree #1, 128 inches DBH (depicted in Attachment A, Sheet 3).

Details of work: New soils would be placed to construct embankment (average depth 0 to 6 inches). The top layer of roadway would be ground off and replaced with new asphalt.

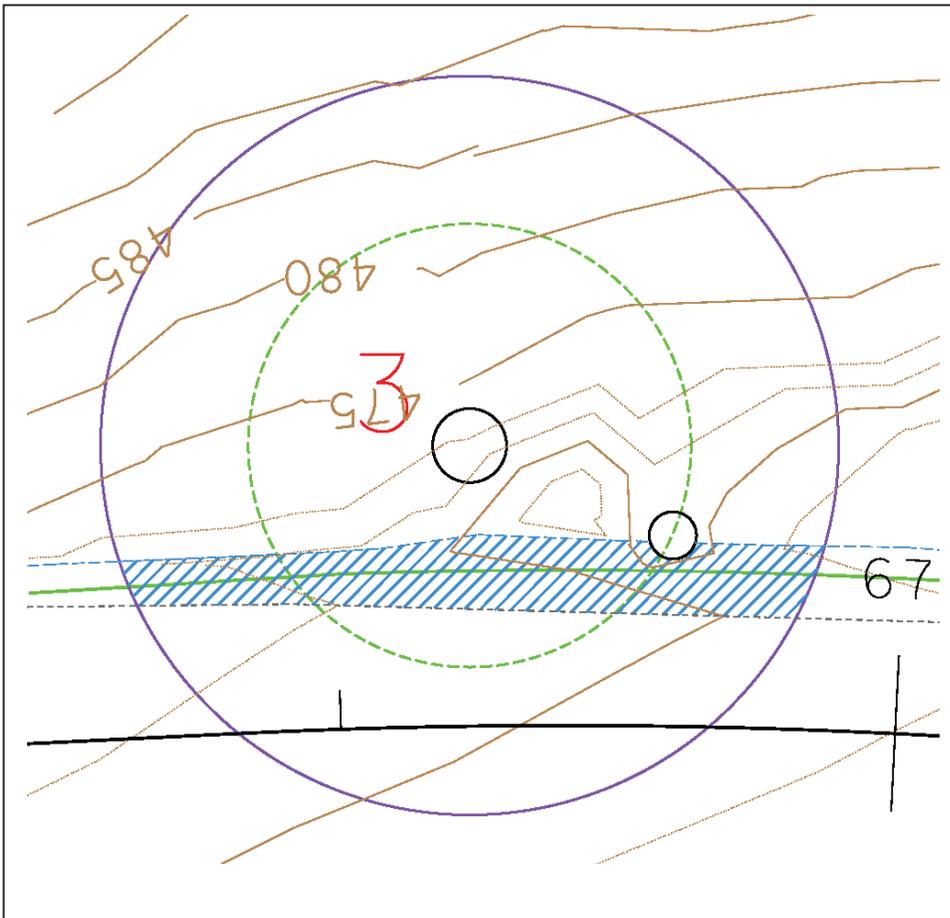
Description: Tree #3, 80 inches DBH (depicted in Attachment A, Sheet 4). Tree has three trunks.

Details of Work: The road would be widened up to 4 feet toward the tree. Where road would be widened, soil and old road materials would be dug out and replaced with new road materials. New soils would be placed to construct embankment (average depth 6 to 18 inches). The top layer of roadway would be ground off and replaced with new asphalt.

Evaluation: Effect of root zone disturbance is slight and there would be no decline in foliage density or tree health.

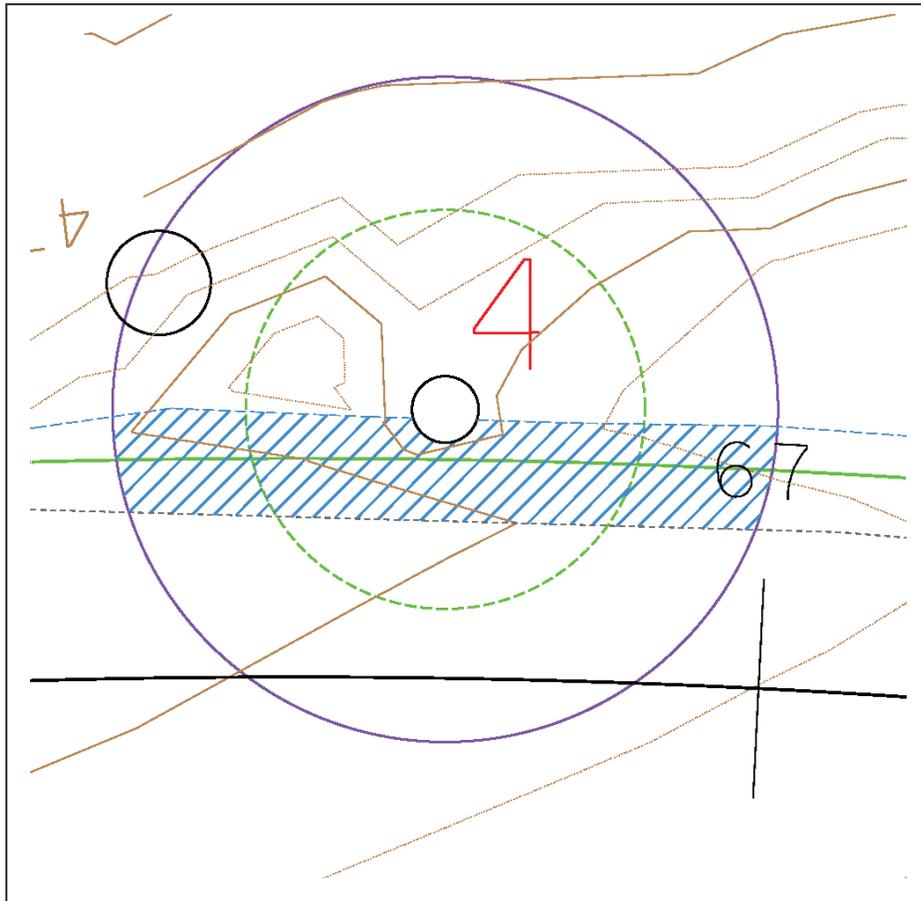
Description: Tree #4, 51 inches DBH (depicted in Attachment A, Sheet 4). Base of tree is elevated from road.

Details of Work: The road would be widened up to 4 feet toward the tree. Where road would be widened, soil and old road materials would be dug out and replaced with new road materials. New soils would be placed to construct embankment (average depth 6 to 18 inches). The top layer of roadway would be ground off and replaced with new asphalt.

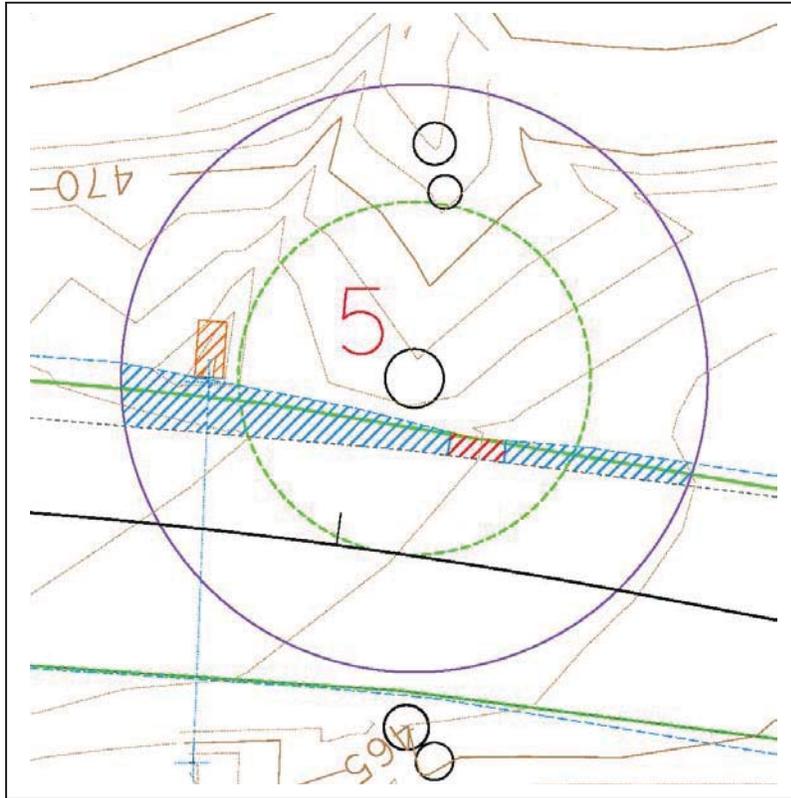
Description: Tree #5, 75 inches DBH (depicted in Attachment A, Sheet 4). Tree has numerous sprouts at the base.

Work in structural root zone? Yes

Evaluation: Effect of root zone disturbance may be a short-term visible reduction in foliage density that is still well within the adaptive capabilities of the tree.

Details of Work: The road would be widened up to 4 feet toward the tree. Where road would be widened, sprouts would be carefully cut from the tree base; soil and old road materials would be dug out and replaced with new road materials. New soils would be placed to construct embankment (average depth 6 to 18 inches). The top layer of roadway would be ground off and replaced with new asphalt. Outside of structural root zone an 18-inch diameter culvert would be extended approximately 6 feet with a new inlet structure.

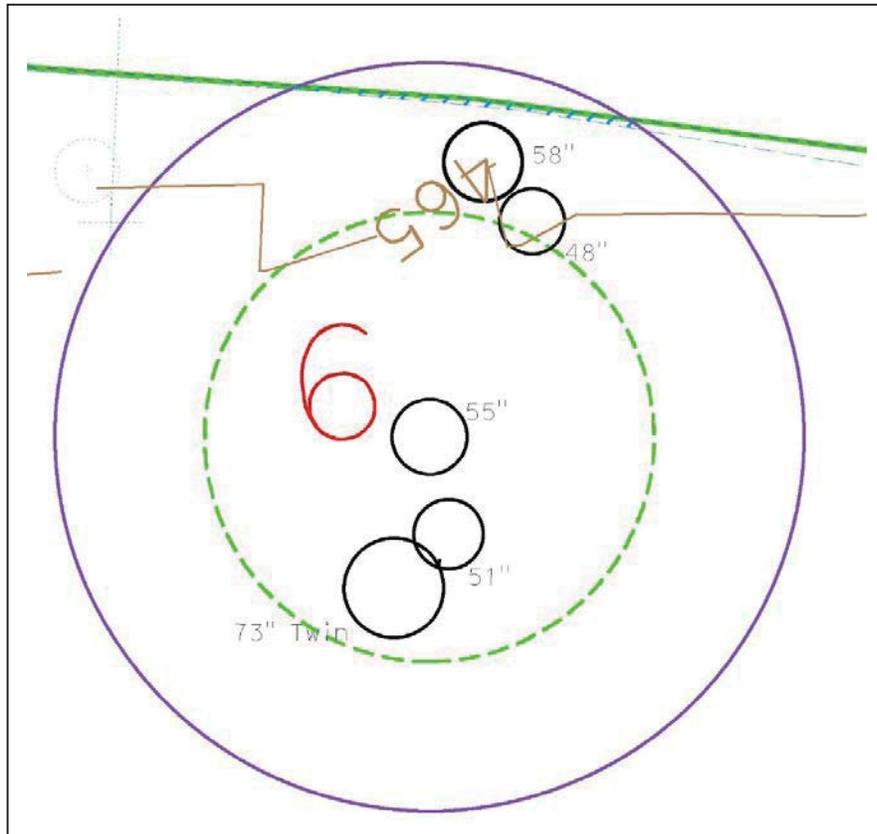
Description: Tree #6, 55 inches in diameter at breast height (depicted in Attachment A, Sheet 4).

Evaluation: Effect of root zone disturbance is extremely minor and there would be no decline in foliage density or tree health.

Details of Work: New soils would be placed to construct embankment (average depth 0 to 6 inches). The top layer of roadway would be ground off and replaced with new asphalt.

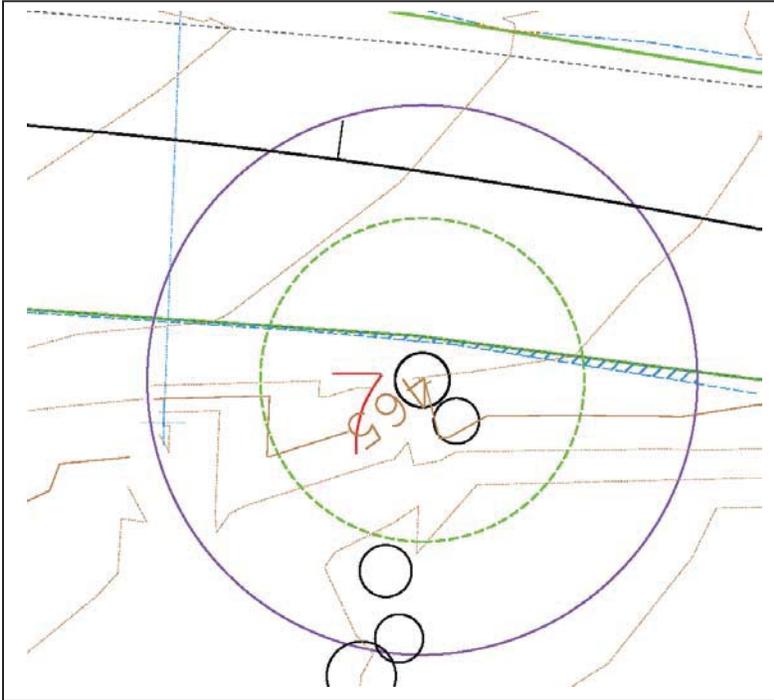
Description: Tree #7, 58 inches DBH (depicted in Attachment A, Sheet 4). Tree appears to have been struck by a vehicle on road side of trunk. Closer to the road than tree #6.

Work in structural root zone? Yes

Evaluation: Effect of root zone disturbance is very slight and there would be no decline in foliage density or tree health.

Details of Work: New soils would be placed to construct embankment (average depth 0 to 6 inches). The top layer of roadway would be ground off and replaced with new asphalt.

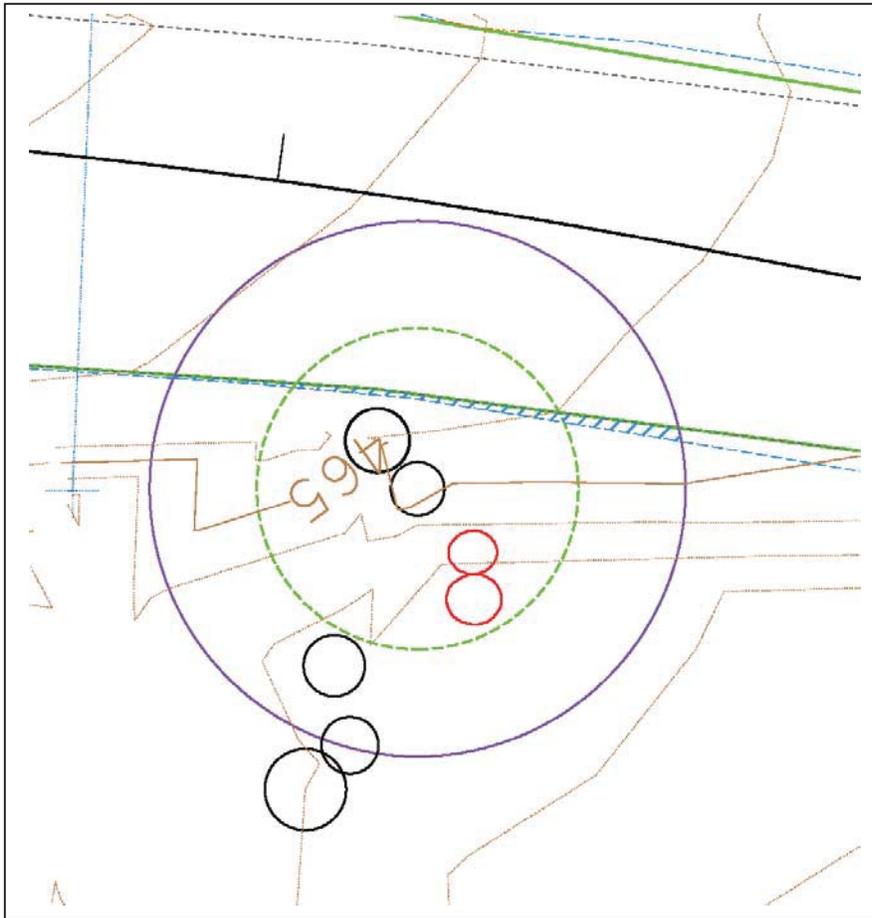
Description: Tree #8, 48 inches DBH (depicted in Attachment A, Sheet 4).

Evaluation: Effect of root zone disturbance is very slight and there would be no decline in foliage density or tree health.

Details of Work: New soils would be placed to construct embankment (average depth 0 to 6 inches). The top layer of roadway would be ground off and replaced with new asphalt.

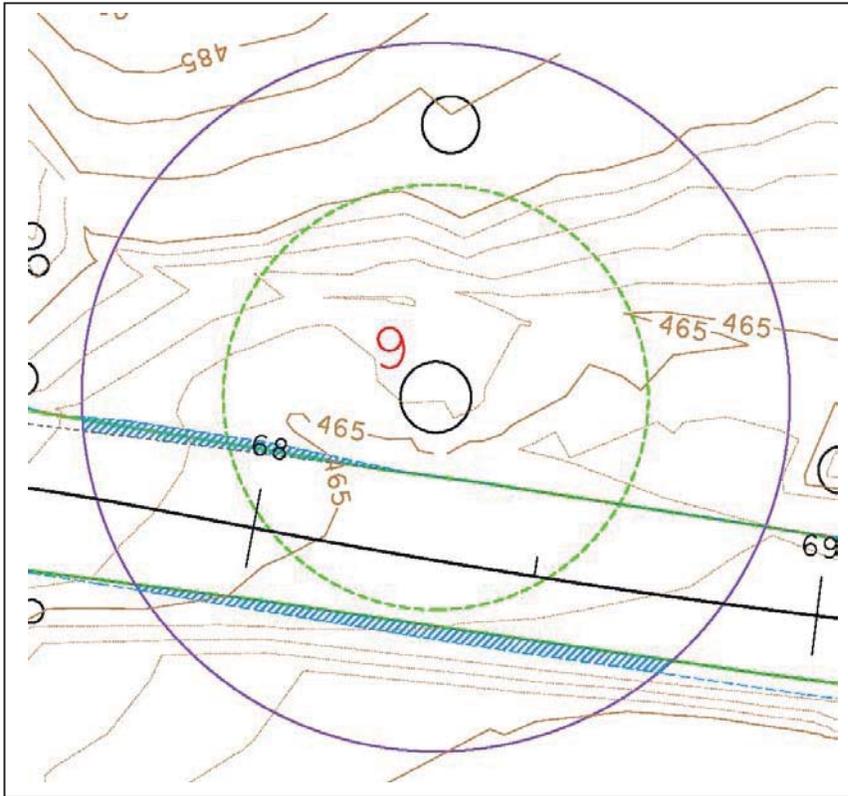
Description: Tree #9, 149 inches DBH (depicted in Attachment A, Sheet 4). Tree has two trunks.

Evaluation: Effect of root zone disturbance is slight and there would be no decline in foliage density or tree health.

Details of Work: The road would be widened up to 1 foot toward the tree; across the road it would be widened up to 1 foot. Where road would be widened, soil and old road materials would be dug out and replaced with new road materials. New soils would be placed to construct embankment (average depth 18 to 36 inches). The top layer of roadway would be ground off and replaced with new asphalt.

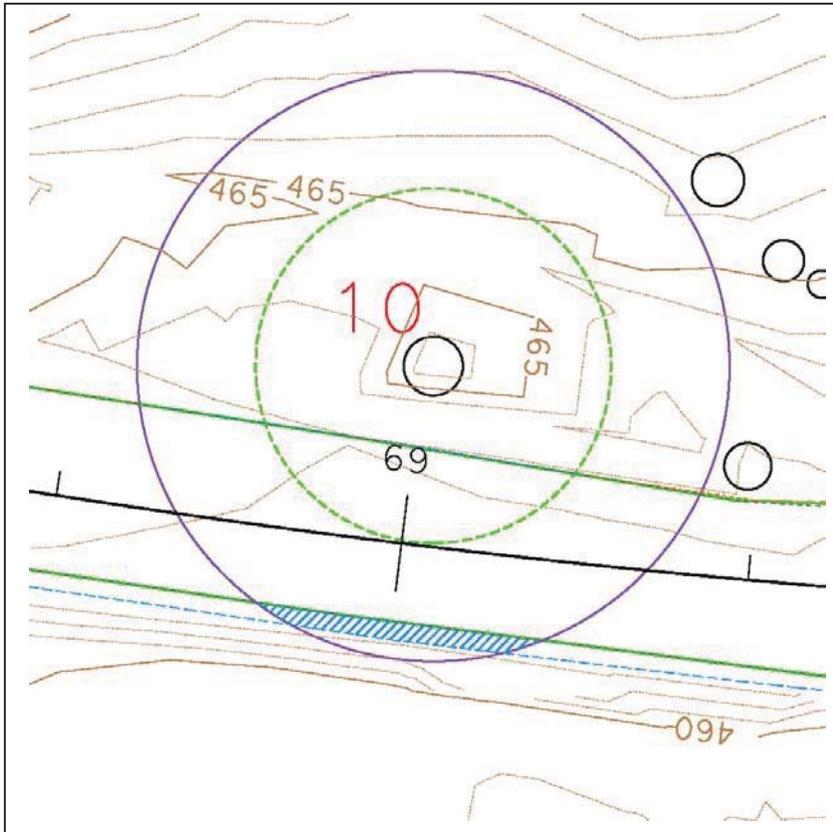
Description: Tree #10,103 inches DBH (depicted in Attachment A, Sheet 4).

Evaluation: Effect of root zone disturbance is very slight and there would be no decline in foliage density or tree health.

Details of Work: Across the road from the tree, the road would be widened up to 1 foot. Where road would be widened, soil and old road materials would be dug out and replaced with new road materials. New soils would be placed to construct embankment (average depth 18 to 36 inches). The top layer of roadway would be ground off and replaced with new asphalt.

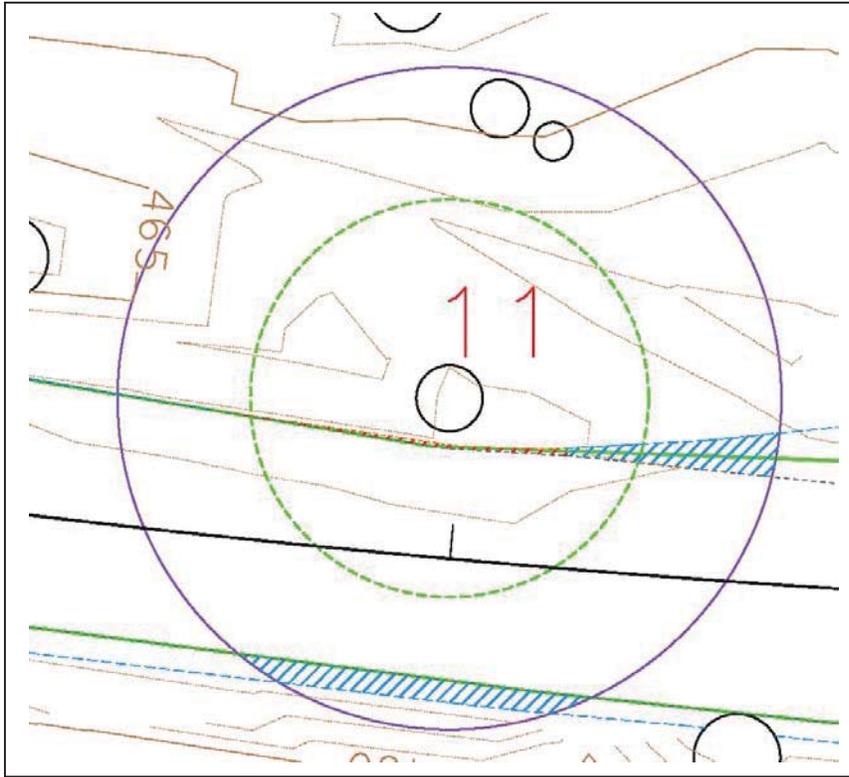
Description: Tree #11, 81 inches DBH (depicted in Attachment A, Sheet 5).

Evaluation: Effect of root zone disturbance is slight and there would be no decline in foliage density or tree health.

Details of Work: The road would be widened up to 3 feet toward the tree. Where road would be widened, soil and old road materials would be dug out and replaced with new road materials. New soils would be placed to construct embankment (average depth 0 to 6 inches). The top layer of roadway would be ground off and replaced with new asphalt.

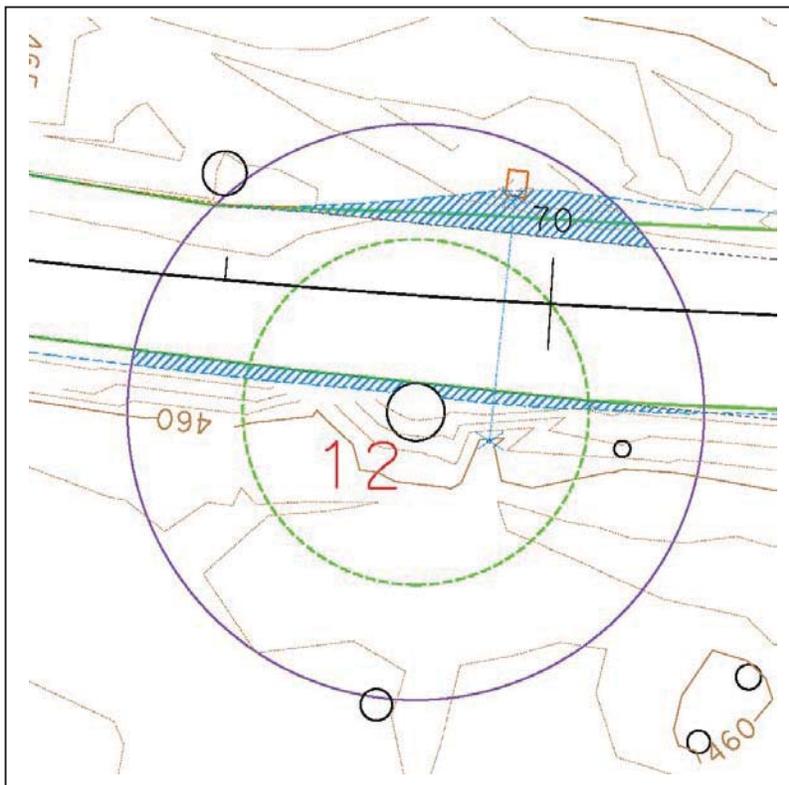
Description: Tree #12, 107 inches DBH (depicted in Attachment A, Sheet 5). Tree has two trunks. It appears to have been struck by a vehicle and has formed a callus roll.

Evaluation: Effect of root zone disturbance is slight and there would be no decline in foliage density or tree health.

Details of Work: The road would be widened up to 1 foot toward the tree; across the road it would be widened up to 4 feet. Where road would be widened, soil and old road materials would be dug out and replaced with new road materials. New soils would be placed to construct embankment (average depth 6 to 18 inches). The top layer of roadway would be ground off and replaced with new asphalt. An 18-inch culvert would be extended across road from tree.

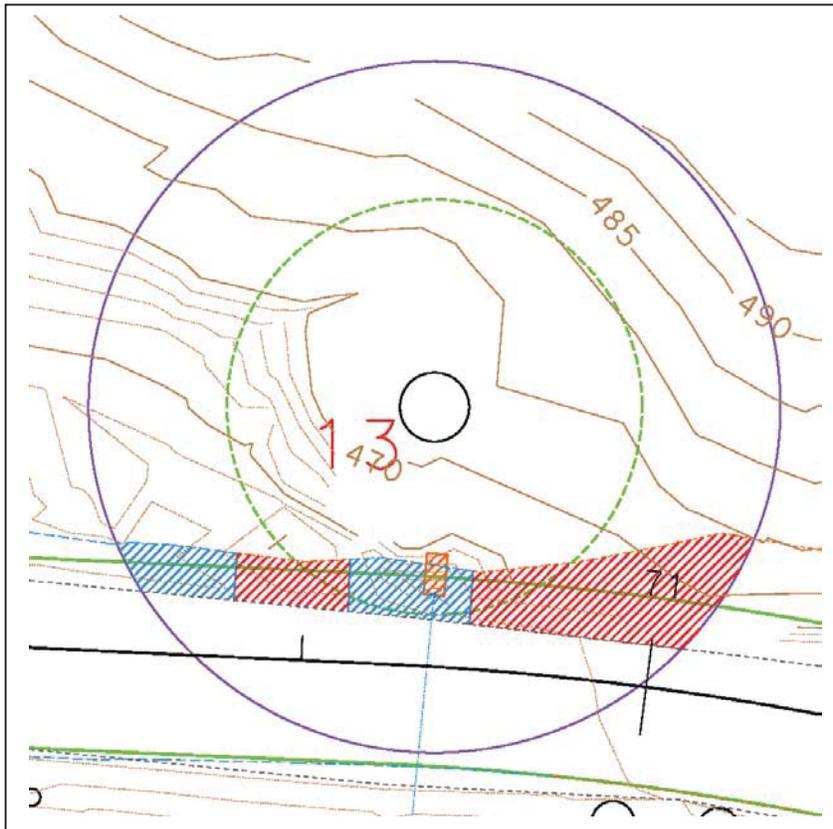
Description: Tree #13, 120 inches DBH (depicted in Attachment A, Sheet 5).

Evaluation: Effect of root zone disturbance may be a short-term visible reduction in foliage density that is still well within the adaptive capabilities of the tree.

Details of Work: The road would be widened up to 8 feet toward the tree. Where road would be widened, soil and old road materials would be dug out and replaced with new road materials. New soils would be placed to construct embankment (average depth 6 to 18 inches). Soils would be removed for new roadside cut slopes (average depth greater than 36 inches). The top layer of roadway would be ground off and replaced with new asphalt. An 18-inch culvert would be extended.

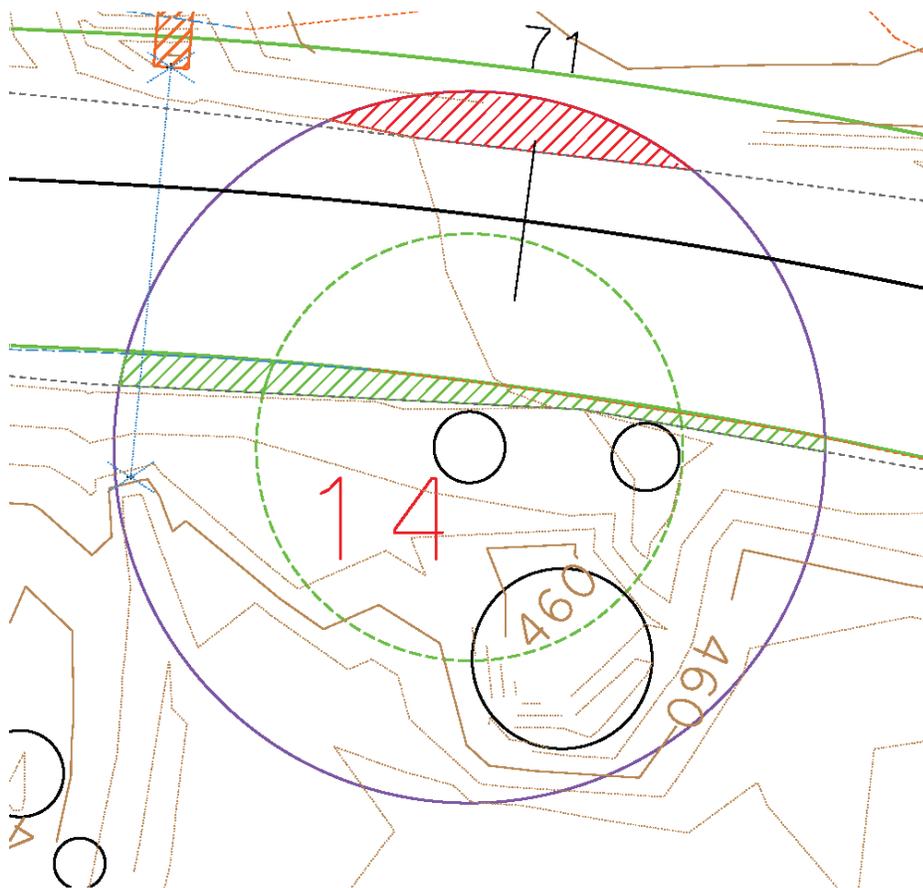
Description: Tree #14, 74 inches DBH (depicted in Attachment A, Sheet 5). Tree appears to have been struck by a vehicle, and a small portion of the base appears to have been cut back.

Evaluation: Effect of root zone disturbance is very slight and there would be no decline in foliage density or tree health.

Details of Work: The road would be moved up to 3 feet away from the tree. Across the road from the tree, the road would be widened up to 8 feet. Where pavement would be removed, road materials would be replaced with gravel at the road edge and native soils and duff beyond. Where road would be widened, soil and old road materials would be dug out and replaced with new materials. Soils would be removed for new roadside cut slopes (average depth greater than 36 inches). The top layer of roadway would be ground off and replaced with new asphalt.

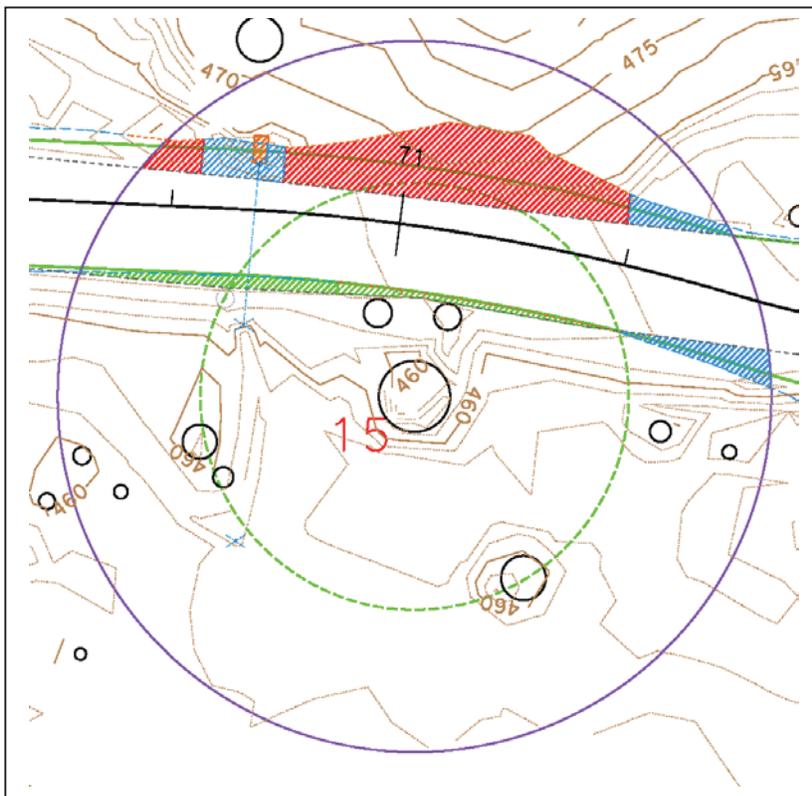
Description: Tree #15, 187 inches DBH (depicted in Attachment A, Sheet 5). Tree has multiple stems and a large central cavity.

Evaluation: Effect of root zone disturbance is very slight and there would be no decline in foliage density or tree health.

Details of Work: The road would be moved up to 3 feet away from the tree. Across the road from the tree, the road would be widened up to 8 feet. Where pavement would be removed, road materials would be replaced with gravel at the road edge and native soils and duff beyond. Where road would be widened, soil and old road materials would be dug out and replaced with new road materials. New soils would be placed to construct embankment (average depth 6 to 18 inches). Soils would be removed for new roadside cut slopes (average depth greater than 36 inches). The top layer of roadway would be ground off and replaced with new asphalt. An 18-inch diameter culvert would be extended. The extended culvert would conform to the new topography.

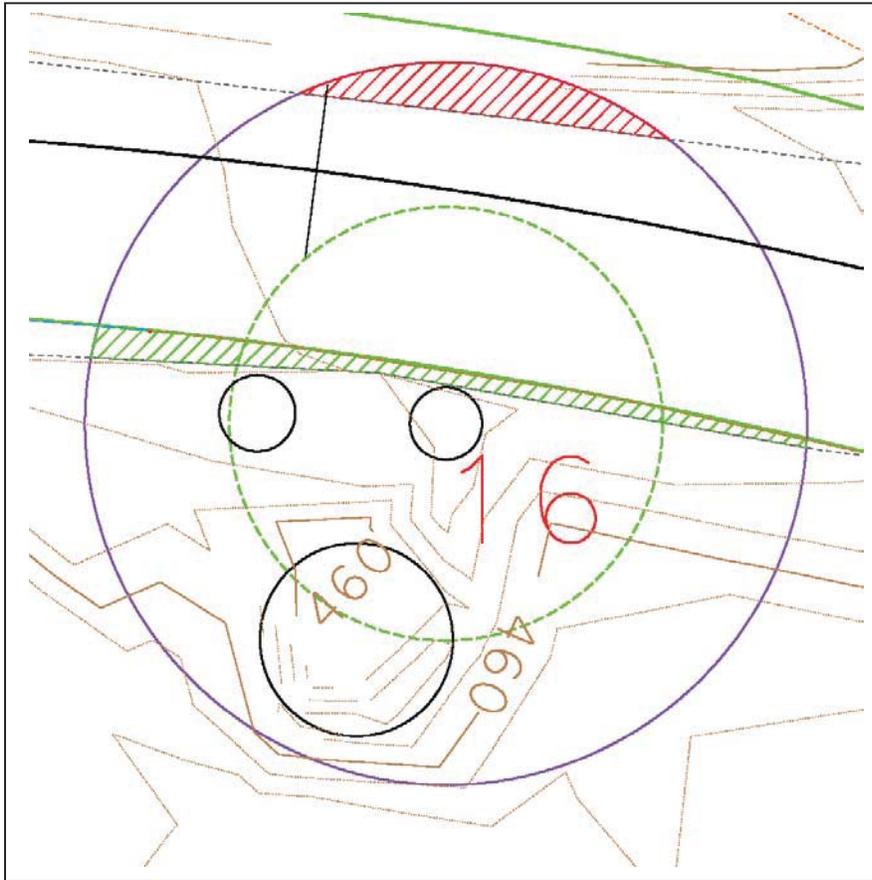
Description: Tree #16, 70 inches DBH (depicted in Attachment A, Sheet 5). Tree appears to have been struck by vehicles; basal flare has been cut back.

Details of Work: The road would be moved up to 3 feet away from the tree. Across the road from the tree, the road would be widened up to 8 feet, outside of the structural root zone. Where pavement would be removed, road materials would be replaced with gravel at the road edge and native soils and duff beyond. Where road would be widened, soil and old road materials would be dug out and replaced with new materials. Soils would be removed for new roadside cut slopes (average depth greater than 36 inches). The top layer of roadway would be ground off and replaced with new asphalt.

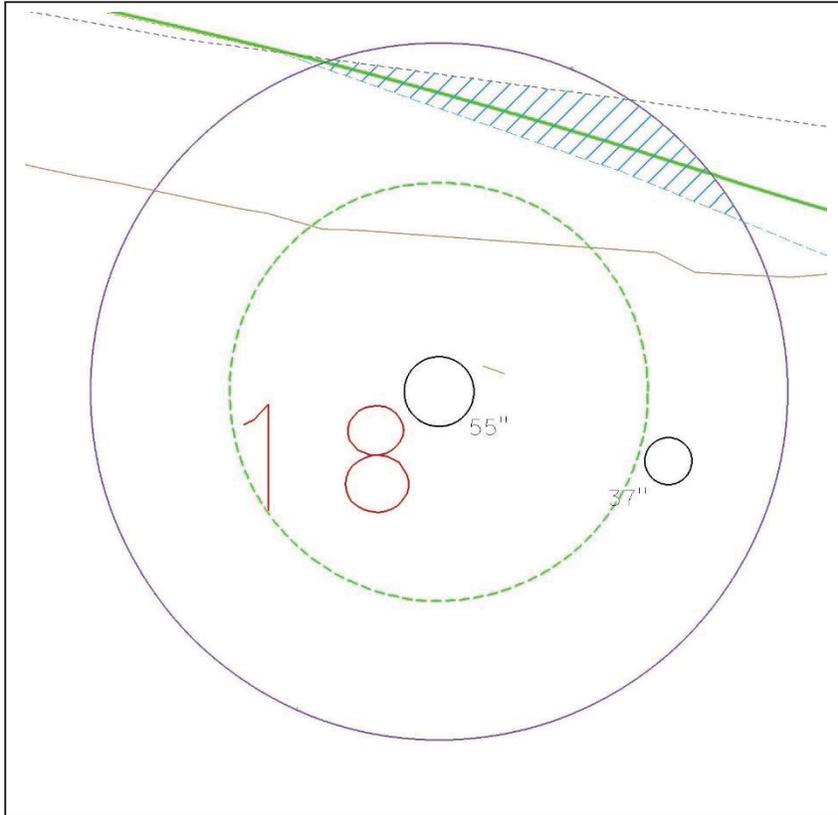
Description: Tree #18, 55 inches DBH (depicted in Attachment A, Sheet 5).

Evaluation: Effect of root zone disturbance is very slight and there would be no decline in foliage density or tree health.

Details of Work: The road would be widened up to 3 feet toward the tree. Where road would be widened, soil and old road materials would be dug out and replaced with new road materials. New soils would be placed to construct embankment (average depth 6 to 18 inches). The top layer of roadway would be ground off and replaced with new asphalt.

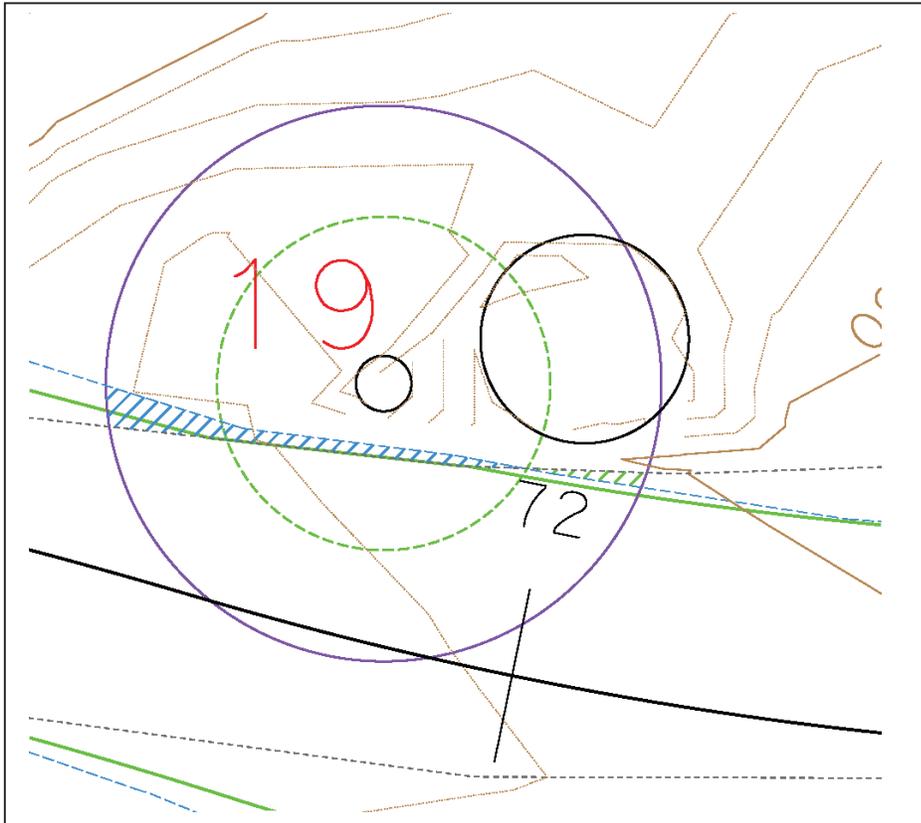
Description: Tree #19, 53 inches DBH (depicted in Attachment A, Sheet 5).

Evaluation: Effect of root zone disturbance is very slight and there would be no decline in foliage density or tree health.

Details of Work: The road would be widened up to 2 feet toward the tree. Where road would be widened, soil and old road materials would be dug out and replaced with new road materials. New soils would be placed to construct embankment (average depth 6 to 18 inches). The top layer of roadway would be ground off and replaced with new asphalt.

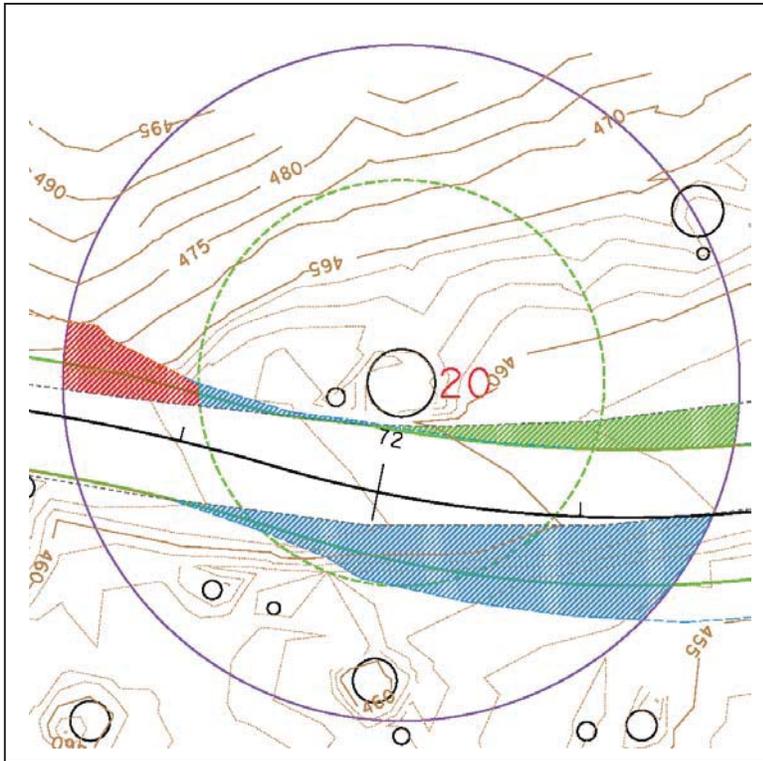
Description: Tree #20, 199 inches DBH (depicted in Attachment A, Sheet 6). Tree has two trunks and uppermost top of tree is dead (a “spike” top). A core sample of paving in this area revealed that asphalt material is 1.5 feet deep. Large-diameter buttress roots were cut, probably during construction of highway.

Evaluation: Effect of root zone disturbance is slight and there would be no decline in foliage density or tree health.

Details of Work: The road would be widened up to 5 feet toward the south side of the tree and narrowed up to 7 feet on the north side; across the road it would be widened up to 12 feet. Where road would be widened, soil and old road materials would be dug out and replaced with new road materials. New soils would be placed to construct embankment (average depth greater than 36 inches). Soils would be removed for new roadside cut slopes outside of structural root zone (average depth greater than 36 inches). Where pavement would be removed, road materials would be replaced with gravel at the road edge, and native soils and duff beyond. The top layer of roadway would be ground off and replaced with new asphalt.

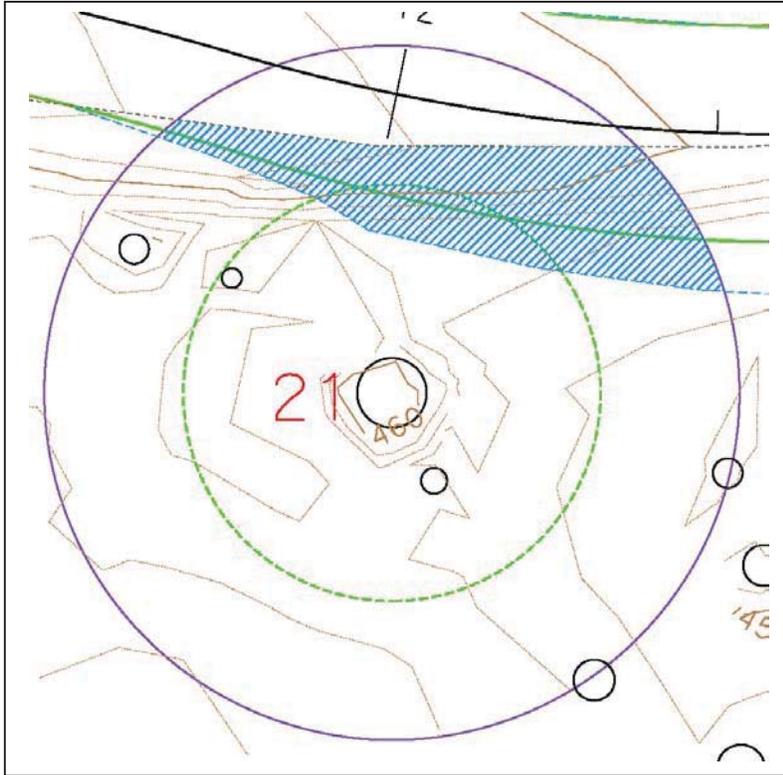
Description: Tree #21, 129 inches DBH (depicted in Attachment A, Sheet 6).

Evaluation: Effect of root zone disturbance is slight and there would be no decline in foliage density or tree health.

Details of Work: The road would be widened up to 14 feet toward the tree. Where road would be widened, soil and old road materials would be dug out and replaced with new road materials. New soils would be placed to construct embankment (average depth greater than 36 inches). The top layer of roadway would be ground off and replaced with new asphalt.

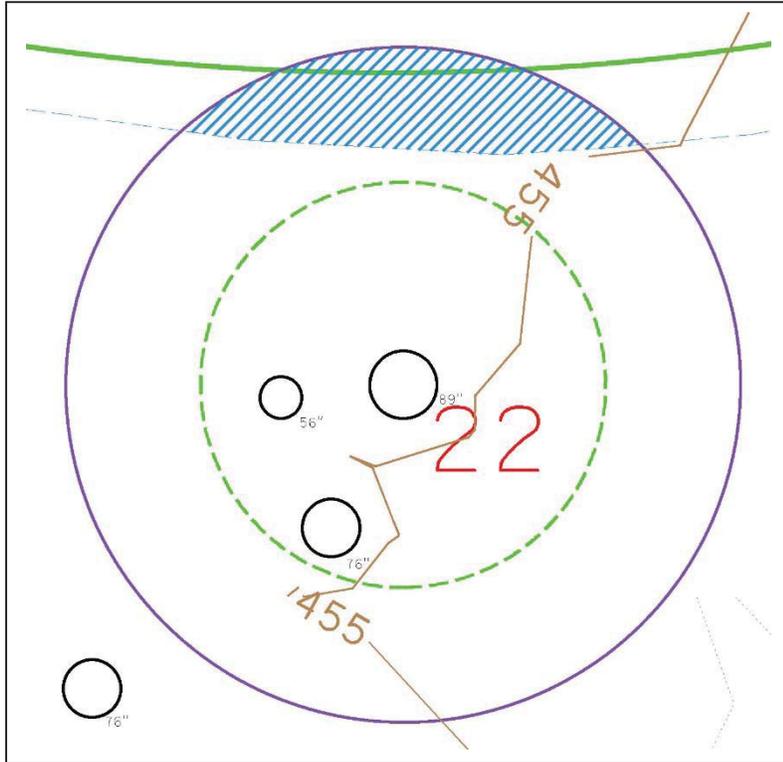
Description: Tree #22, 89 inches DBH (depicted in Attachment A, Sheet 6).

Evaluation: Effect of root zone disturbance is very slight and there would be no decline in foliage density or tree health.

Details of Work: The road would be widened up to 17 feet toward the tree. Where road would be widened, soil and old road materials would be dug out and replaced with new materials. New soils would be placed to construct embankment (average depth greater than 36 inches).
